LAND AT NANT CAERHEYDN, PONTERWYD, ABERYSTWYTH, CEREDIGION: ARCHAEOLOGICAL EVALUATION

ARCHAEOLOGICAL EVALUATION 2015

(NGR SN 7514 8318)

RHIF YR ADRODDIAD / REPORT NO. 2015/27 RHIF Y PROSIECT / PROJECT RECORD NO. 108525

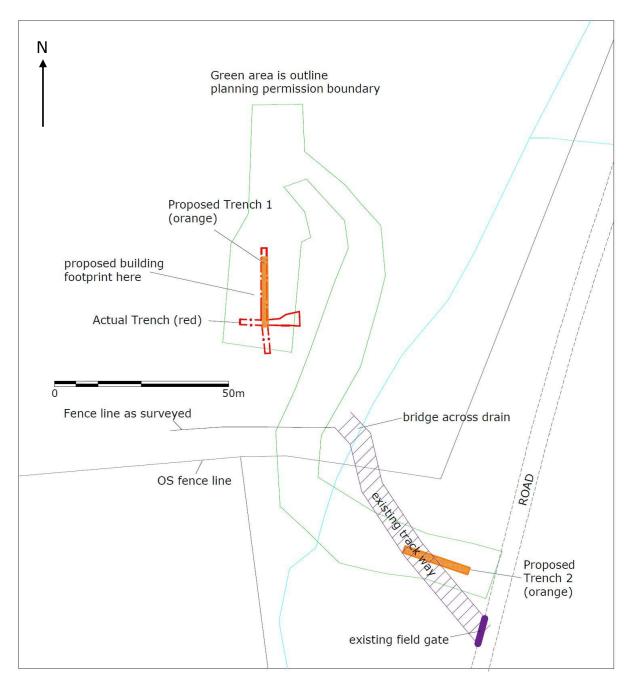
- 3.1.1 Initially the proposed plan had been to excavate two trenches within the planning permission boundary (Figure 3). Trench 1 was to be located within the footprint of the proposed dwelling aligned north to south. Trench 2 was planned to run roughly east to west within the entrance driveway adjacent to the road in the southeastern part of the development area. However, upon arrival on site it was noted that Trench 2 was located over an existing track way that was likely to have caused significant damage to any underlying archaeology. Therefore a single cross-shaped evaluation trench was excavated within and extending beyond the footprint of the proposed dwelling (Figure 3).

Figure 3: Location plan of proposed trenches and actual excavated trench.

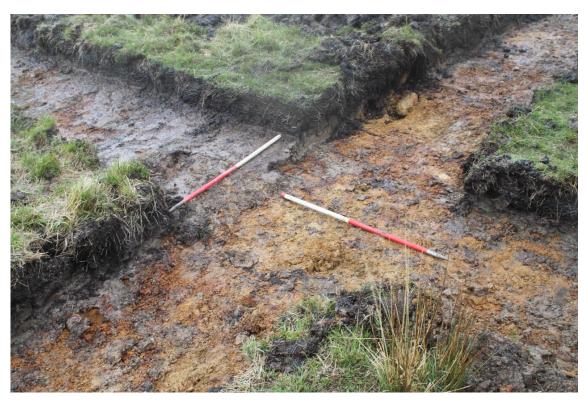
- 4.2 The cross-shaped trench was excavated to a maximum depth of 40cm to expose the natural strata or the top of any archaeological deposit if exposed at shallower depth. The topsoil/turf layer covered the extent of the trench to an average depth of 0.15cm and consisted of rich organic peat material, which was not surprising considering the moorland location of the site. Beneath the topsoil a grey clay layer was observed overlying the natural bedrock. This however, was not consistent across the trench and is probably the result of a natural process, such as hydrological activity beneath the ground surface resulting in the clay leaching between the topsoil and natural bedrock and accumulating in natural depressions. The natural bedrock consisted of yellow sandstone (Photo 1).

Photo 1: The excavated trench after topsoil stripping viewing northwest. The natural yellow sandstone is visible as well as a probable natural occurring layer of clay overlying the sandstone. 2x 2m scale.

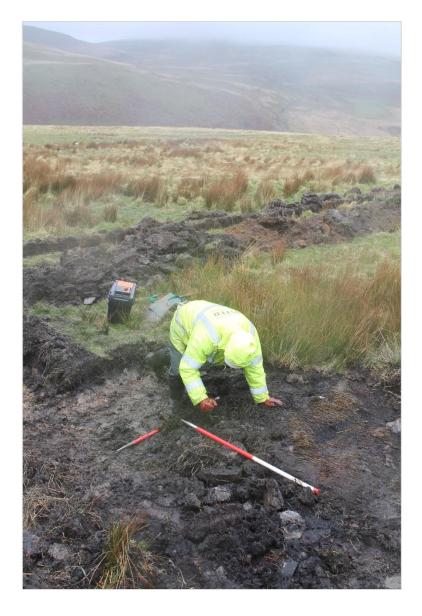
4.3 No obvious signs of archaeological deposits or features were observed in the north, south and west arms of the trench. However, whilst machine excavating the eastern arm of the trench three large stones were exposed appearing in a linear formation, and slightly set back behind these a large accumulation of smaller stones became visible. The eastern end of the trench was slightly widened to expose a larger area of stone (Photo 2).

Photo 2: Cleaning by hand the eastern end of the trench to expose stone structure. Looking northwest. 2 x 2m scale.

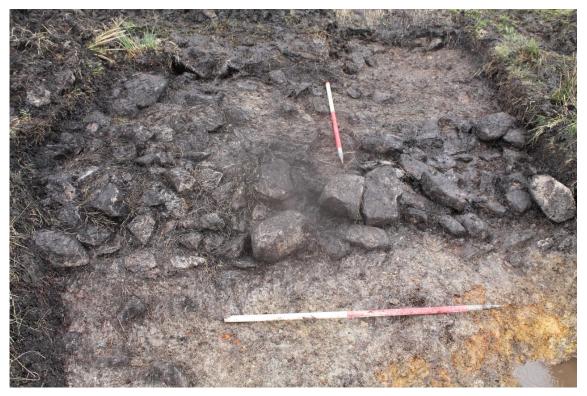
- 4.6 The north-south aligned wall was dry stone bonded and roughly faced on its western edge. The wall is approximately 0.80m wide and connects with the east to west aligned wall at its northern end. Typically the average size of stones making up the wall was approximately 5cm x 23cm x 20cm, but occasional boulders were used, the largest being approximately 20cm x 35cm x 8cm. Although some tumble had occurred the western edge was very well defined (Photo 3), most of the tumble appears to have occurred on the eastern side (internally).

Photo 3: The north to south aligned wall showing the well-defined western edge. Looking east. 1m scale

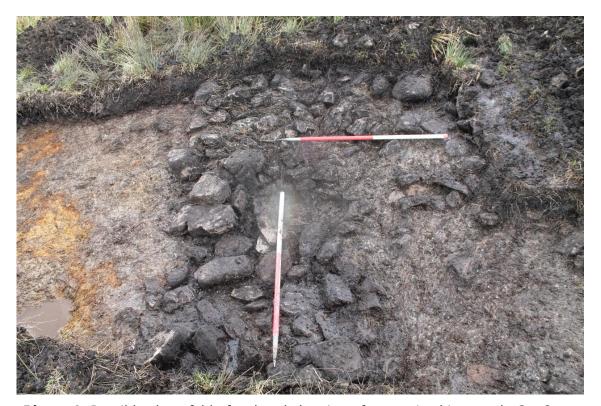
- 4.9 No archaeological artefacts were recovered during the course of this evaluation.
- 4.10 Photo 4 shows the archaeological feature after the area had been cleaned and recorded. The ranging poles demarcate the internal faces of the stone walls. The photograph illustrates the level of tumbling that has mostly occurred internally and the mottled clay that lines the internal floor. This also appears to be visible on the external side of the west facing wall but with a less mottled effect, underlying this can be seen the natural sandstone bedrock.

Photo 4: Possible sheepfold after hand cleaning of stone. Looking north. $2 \times 2m$ scale.

- 5.4 The exposed archaeological remains represent a fairly well preserved stone built structure and suggest the likely survival of further archaeological remains could exist in the wider area. The structure lies at shallow depth below the existing ground surface and could be impacted upon by ground works associated with the proposed development.

- 5.5 Although no evidence was recorded of prehistoric archaeological remains, there is still high potential for Bronze Age activity to exist in the development area considering the sites location, and its proximity to known prehistoric monuments. Further archaeological mitigation could be implemented by way of an archaeological watching brief during ground works that have the potential to expose, damage or even destroy archaeological remains.

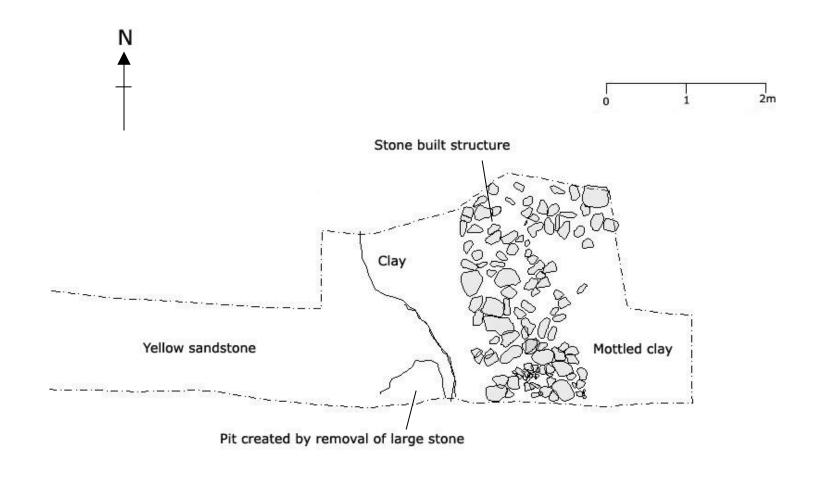
- 4.1 A single cross-shaped trench was excavated within and beyond the footprint of the proposed dwelling (Figure 3). North to south the trench was approximately 20m in length and 1m wide, east to west the trench was approximately 15m in length. A detailed scaled plan was drawn of the eastern arm of the trench where archaeological deposits were encountered and this can be seen in Figure 4.

- 4.5 Upon cleaning the arrangement of stones appeared to resolve into two adjacent linear wall-like structures, set at approximately 30° to each other. The stone structures appeared to be composed of local stone and occasional quartz.

Figure 4: Plan of eastern arm of trench showing where the archaeological probable sheepfold was encountered.
