ERECTION OF EXTENSION FOR TOILETS AT ST DAVID'S CHURCH, HUBBERSTON, PEMBROKESHIRE ARCHAEOLOGICAL WATCHING BRIEF (NGR SN 89068 06233)

Prepared by DAT Archaeological Services
For: Mr. Colin Croxford of Hubberstone
Parish Community Council

RHIF YR ADRODDIAD / REPORT NO. 2015/42
RHIF Y DIGWYLLIAD / EVENT RECORD NO. 108545

ARCHAEOLOGICAL WATCHING BRIEF

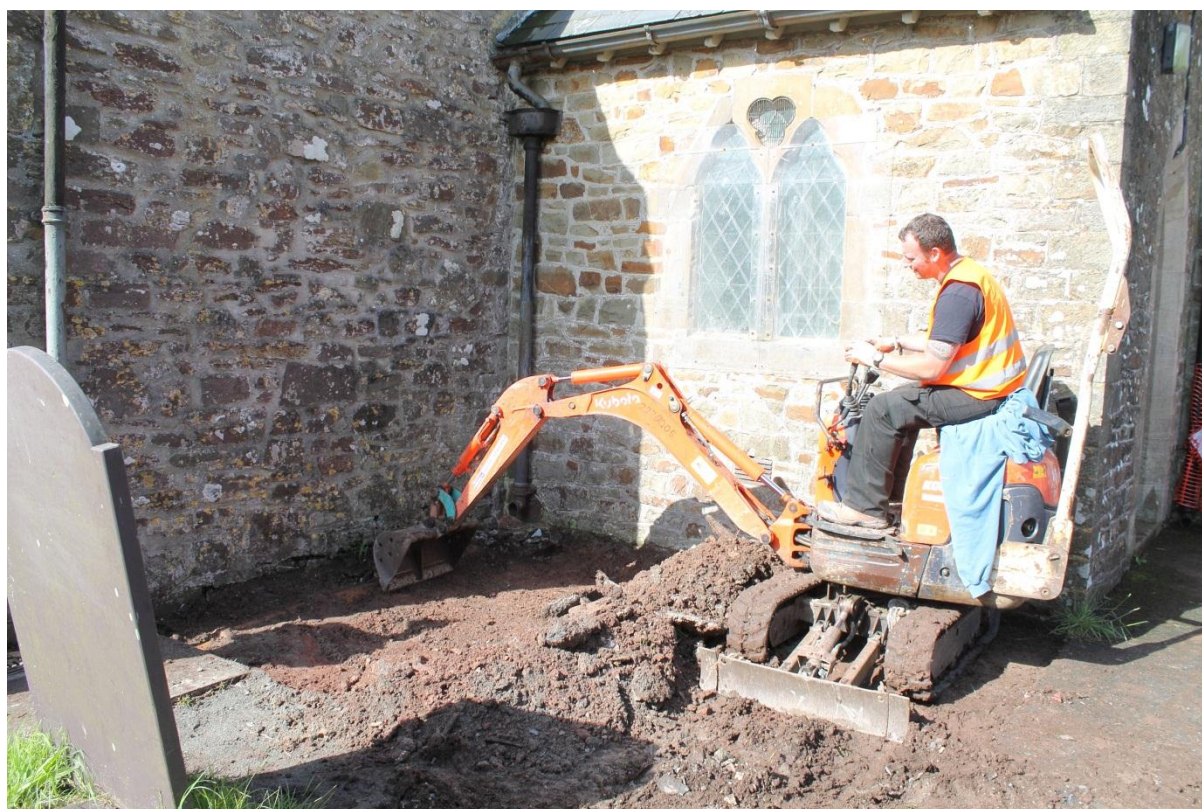
- 5.1.2 The ground level to the east of the vestry was reduced by approximately 0.30m. No features or grave cuts were identified at this level and the ground consisted of crushed brick and grit, indicating made ground. Some disarticulated bone fragments were retrieved from this material but no in-situ burials were found (Photos 1 and 2).

Photo 1: Excavation of the ground to the east of the vestry

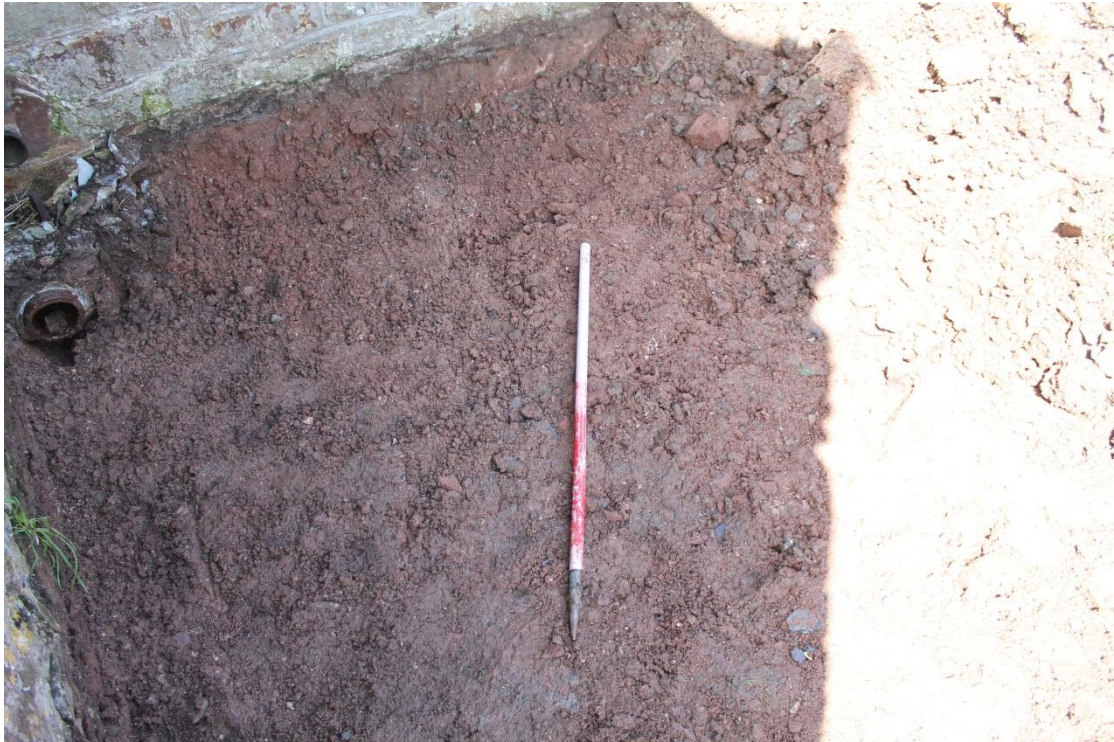
Photo 2: Reduced ground level within the footprint of the new toilet extension showing made-ground material

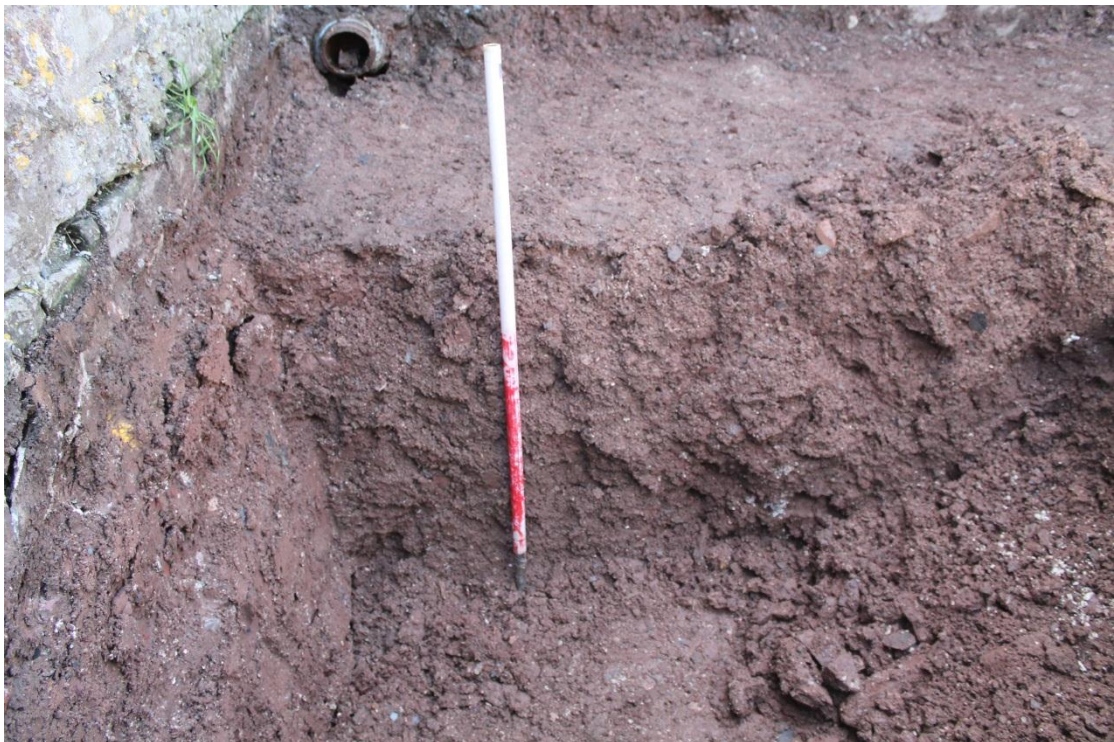
- 5.1.3 The footing trench was approximately 1.0m wide and excavated to a depth of 0.60m. Again, no archaeological features were identifiable and it appears that the depth of made ground containing grit and crushed brick was still visible at the lower levels of the footing trench (Photo 3). More disarticulated human bone fragments were retrieved, but no in-situ burials were located.

Photo 3: East facing section of footing trench.
The trench was excavated to a depth of approx. 0.60m and appears to consist of the same made ground with grit and crushed brick

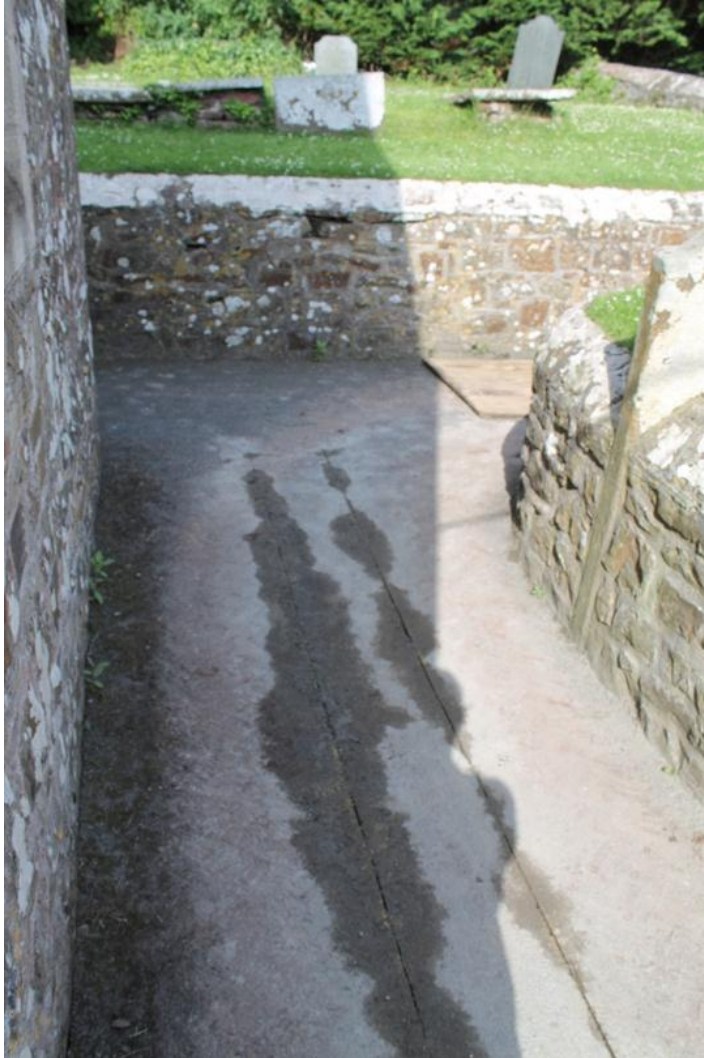
- 5.2.1 On the 9th and 13th of July 2015, the archaeologist attended the site again to observe excavations of the drainage trench.
- 5.2.2 The drainage trench was to be excavated through the existing footpath on an east-west orientation along the north wall of the north transept (Photo 4). At the footpath junction it would change direction and head north towards the lych gate (still following the existing footpath) and exit the graveyard.

Photo 4: The existing footpath along the north wall of the north transept before excavation.

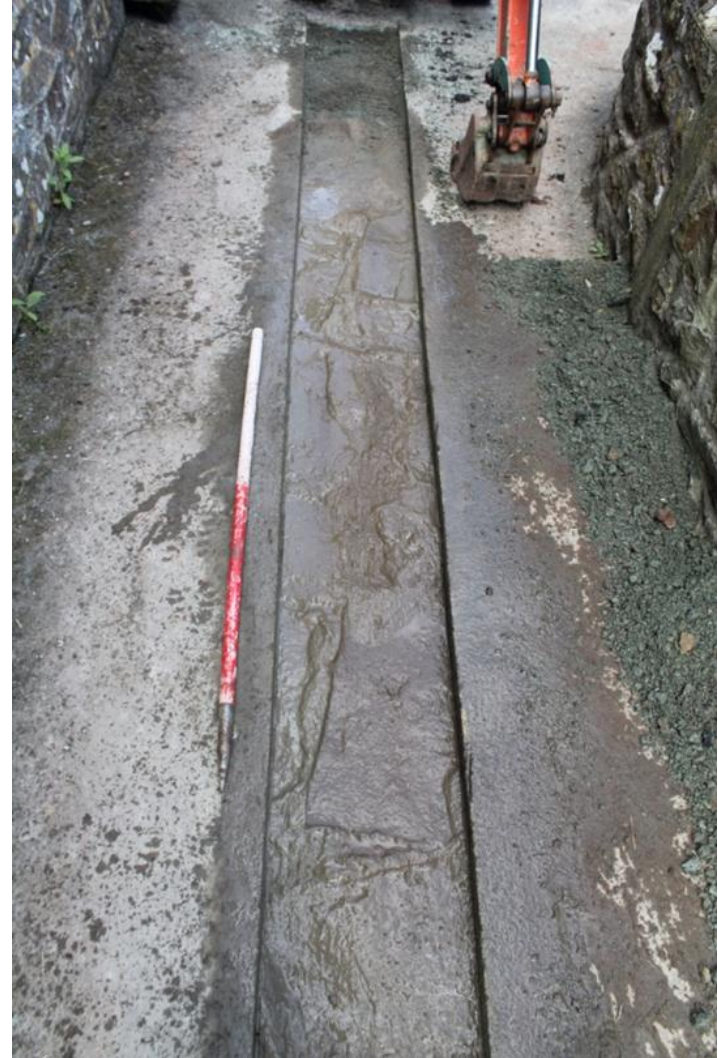
- 5.2.3 As the existing footpath surface was removed it became apparent that it was overlaid directly on top of a former stone slabbed pathway (Photo 5).

Photo 5: Removal of the existing tarmac path revealed the former stone paved path beneath. Viewing West along the north wall of the north transept.

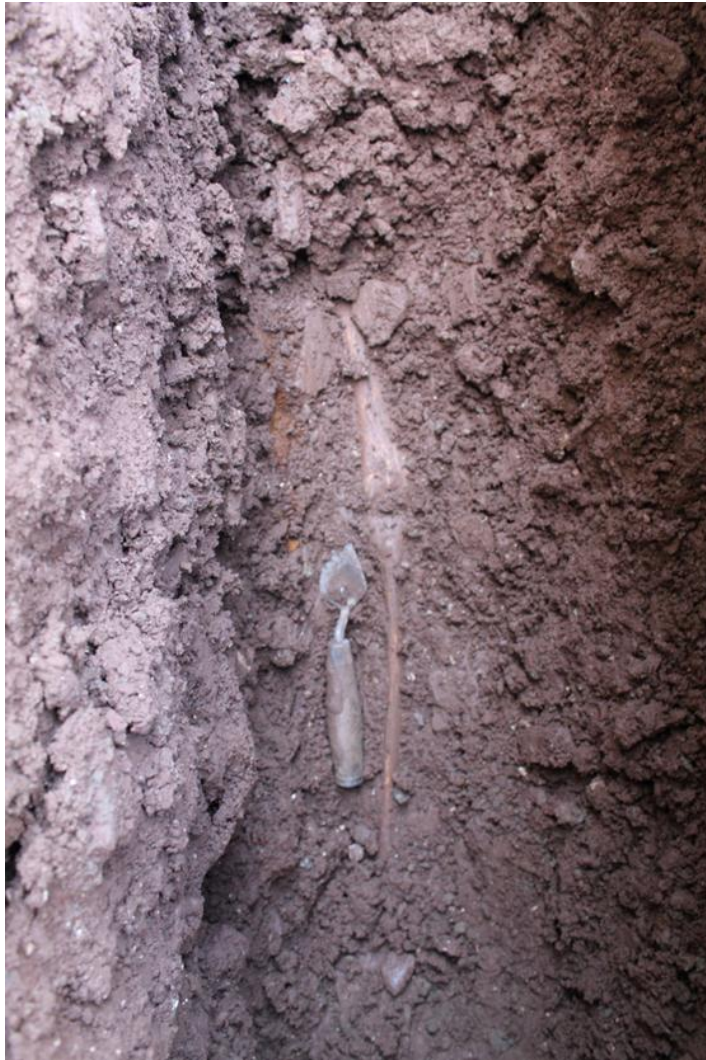
- 5.2.4 The trench was excavated to a width of approximately 0.30m and a maximum depth of 0.60m. At this depth in-situ human remains were partially exposed at the base of the trench, the burials orientated east-west (Photo 6). At least three in-situ inhumations were observed along the north wall of the north transept. It is possible that more burials may have been present, but due to the constraints of the trench size it was difficult to determine an exact number. Bone preservation of the inhumations was good. A number of wood fragments were identified, but it is uncertain if these were associated with coffins for the burials or later material disturbed in the upper ground levels.

Photo 6: In situ human remains (femur and tibia) partially exposed at the base of the trench along the north wall of the north transept.

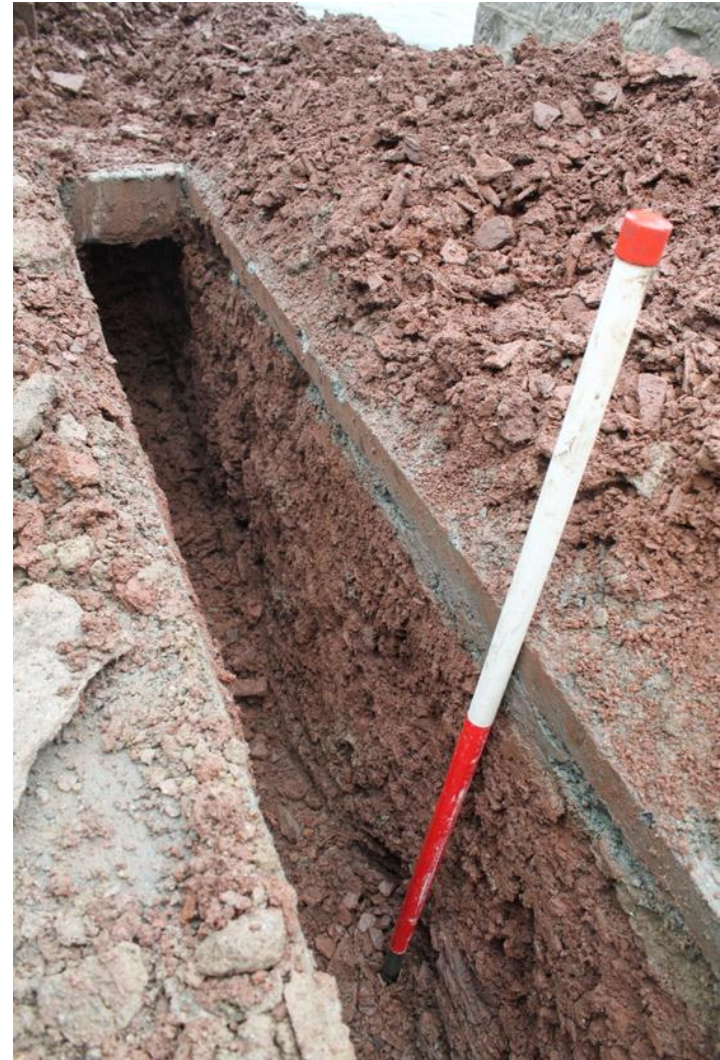
- 5.2.6 Generally the ground beneath the former footpath consisted of a mix of a reddish clay loam with an abundance of grit and large angular stones.
- 5.2.7 The drainage trench was not observed beyond the limits of the churchyard where it is presumed it met up with existing service trenches and sewers, where the ground would have already been disturbed.

Photo 7: Example section of drainage trench. Viewing north
