**LAND ADJACENT TO CROSS INN FARM,
CROSS INN, CARMARTHENSHIRE
ARCHAEOLOGICAL
WATCHING BRIEF
(NGR SN 29287 12446)**

RHIF YR ADRODDIAD / REPORT NO. 2015/52
RHIF Y DIGWYLLIAD / EVENT RECORD NO. 108639

LAND ADJACENT TO CROSS INN FARM, CROSS INN, CARMARTHENSHIRE ARCHAEOLOGICAL WATCHING BRIEF

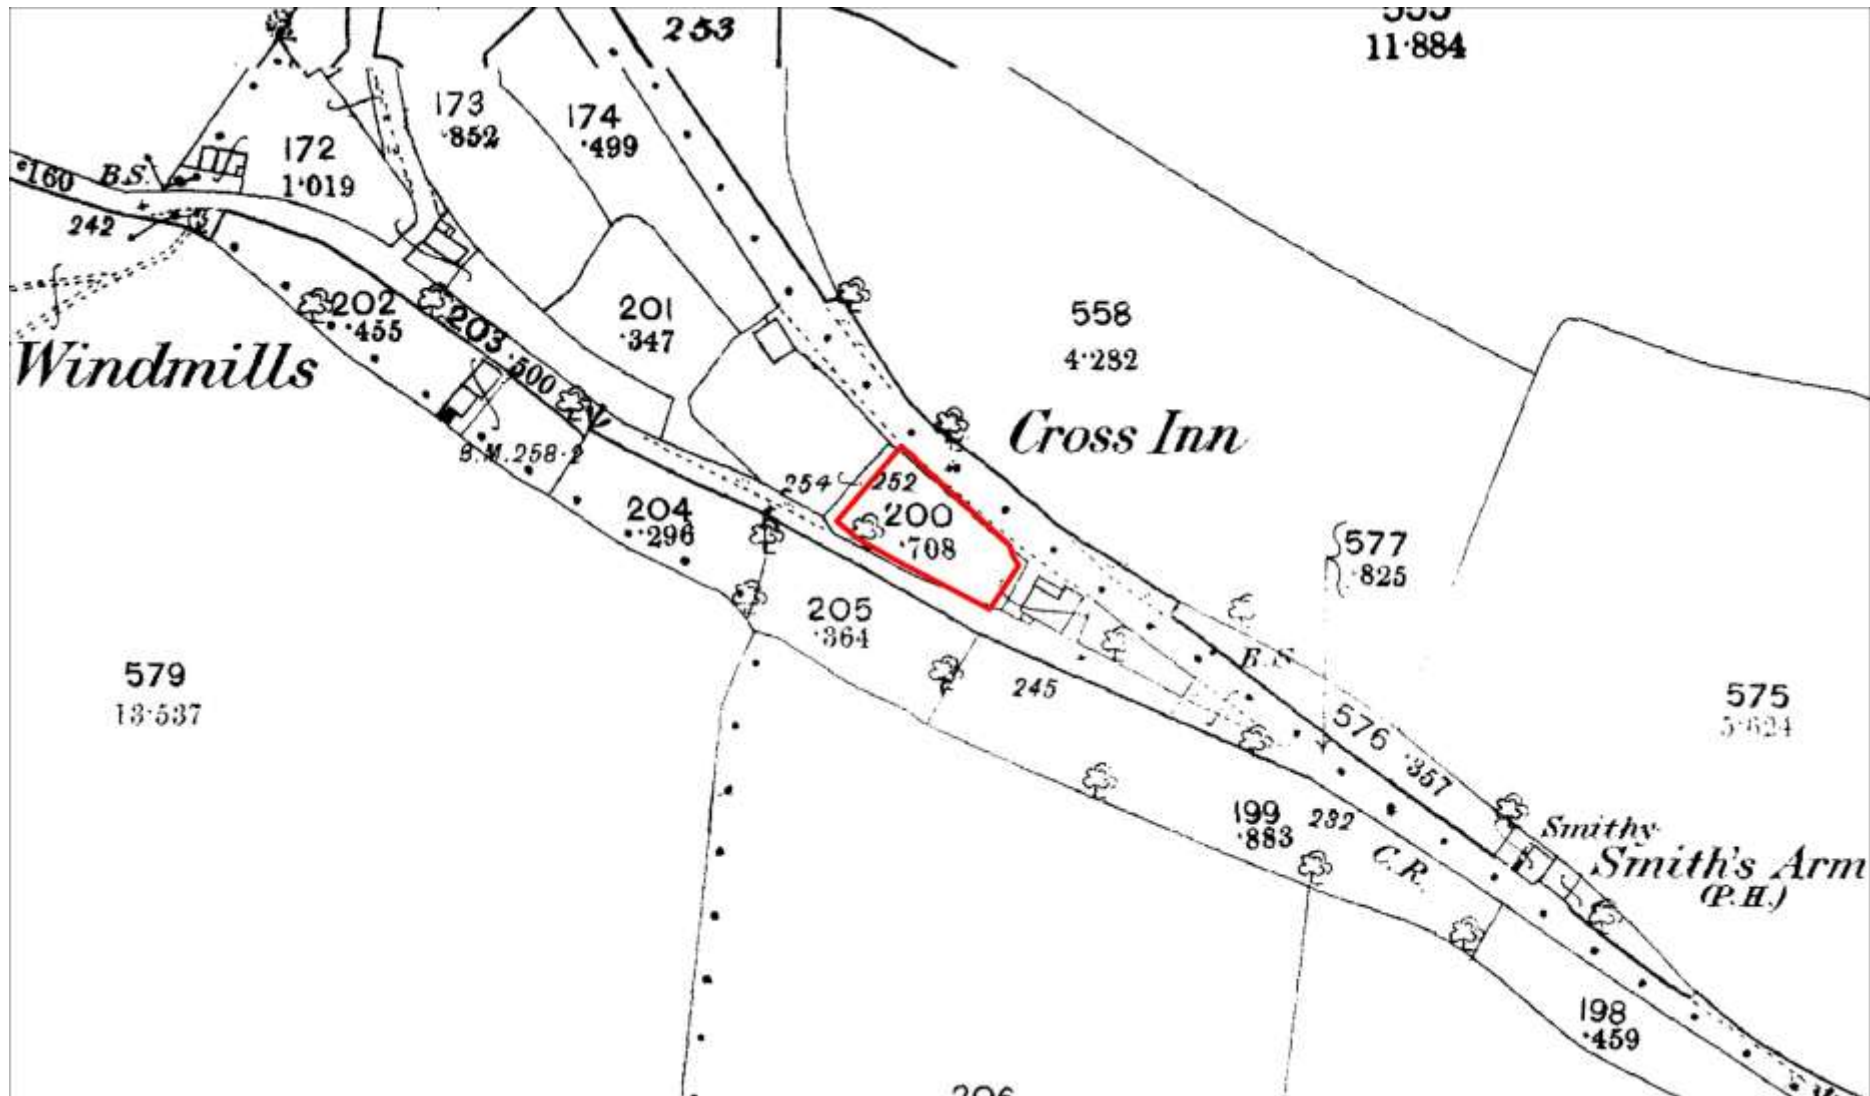
- 2.2.6 The development area boundary is indicated on the first edition Ordnance Survey map of the 1880s (Figure 3), although no structures are shown within this area. The name of Cross Inn is shown on the map and represents the houses around the road junction directly southeast of the development area.
- 2.2.7 Cross Inn remained as a small hamlet through much of the 20th century, although has expanded slightly in recent years with a number of new dwellings being built and development plots for sale.
- 2.2.8 A watching brief was undertaken on another development site in 2012 on land adjacent to Cross Inn Villa, to the northwest of this development plot (Meek 2012; ERN 102870). The watching brief revealed no significant archaeological remains.

Figure 3: Extract from the Ordnance Survey first edition map of 1880s and approximate location of development area

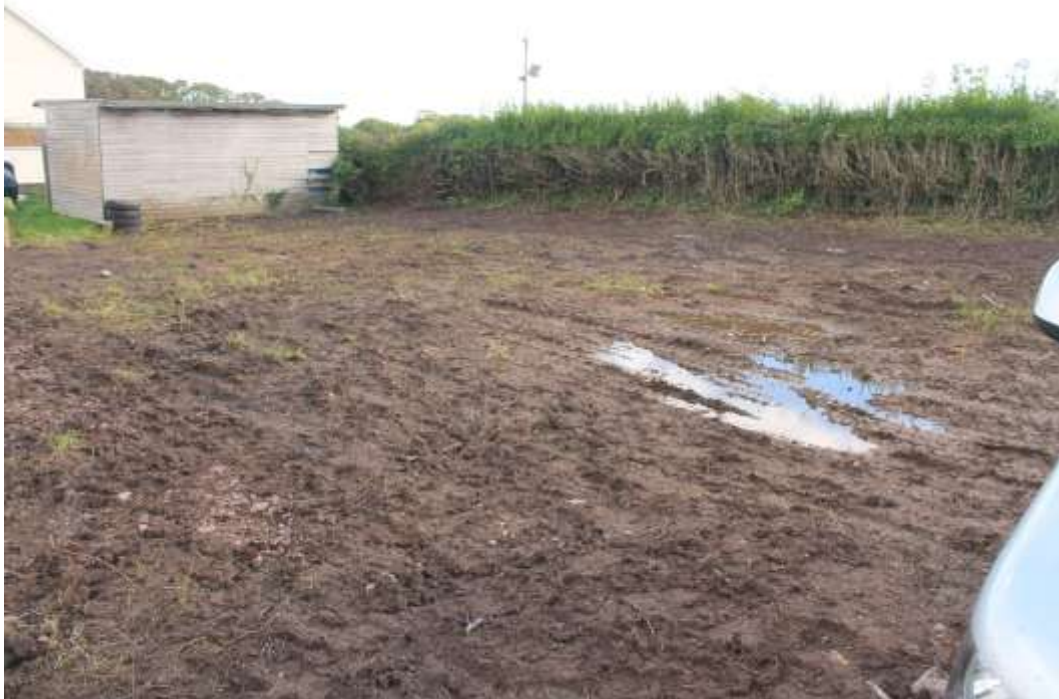
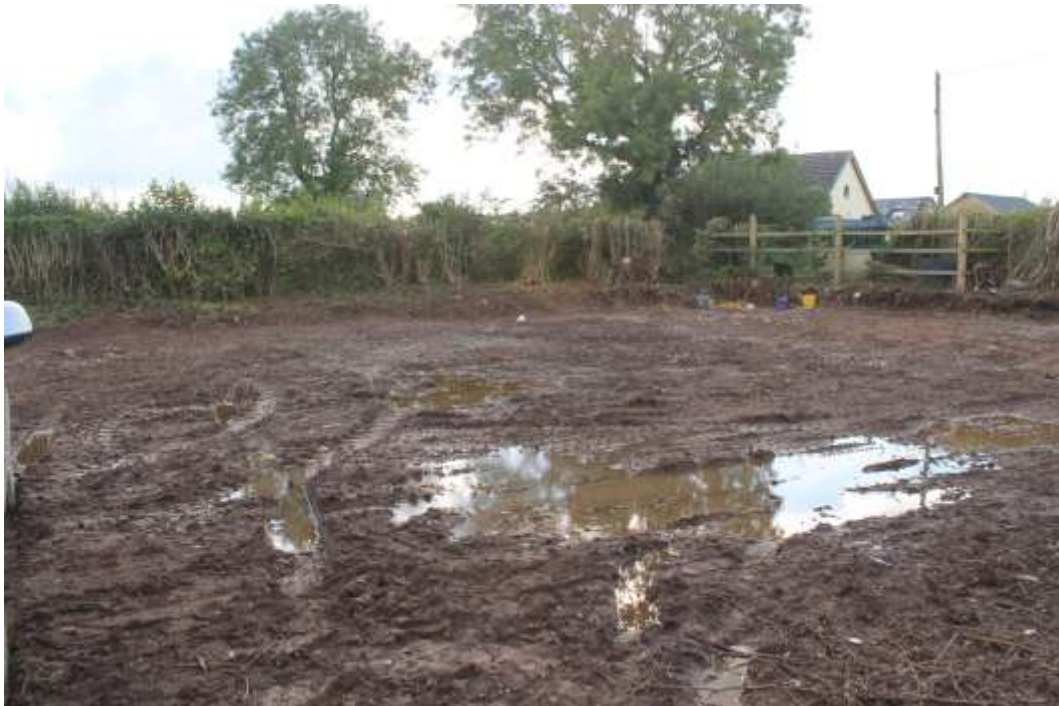
- 4.1 An initial site visit was made on 24th August 2015 to view the site and discuss the watching brief with the client. The site had been cleared of vegetation by this date and the former sheds on the northwestern side of the site had been demolished and the concrete floor slabs removed (Photos 1 & 2).

Photo 1: View south across the site following vegetation clearance and before the commencement of groundworks

Photo 2: View north across the site following vegetation clearance, demolition of former shed and concrete slab removal, and before the commencement of groundworks

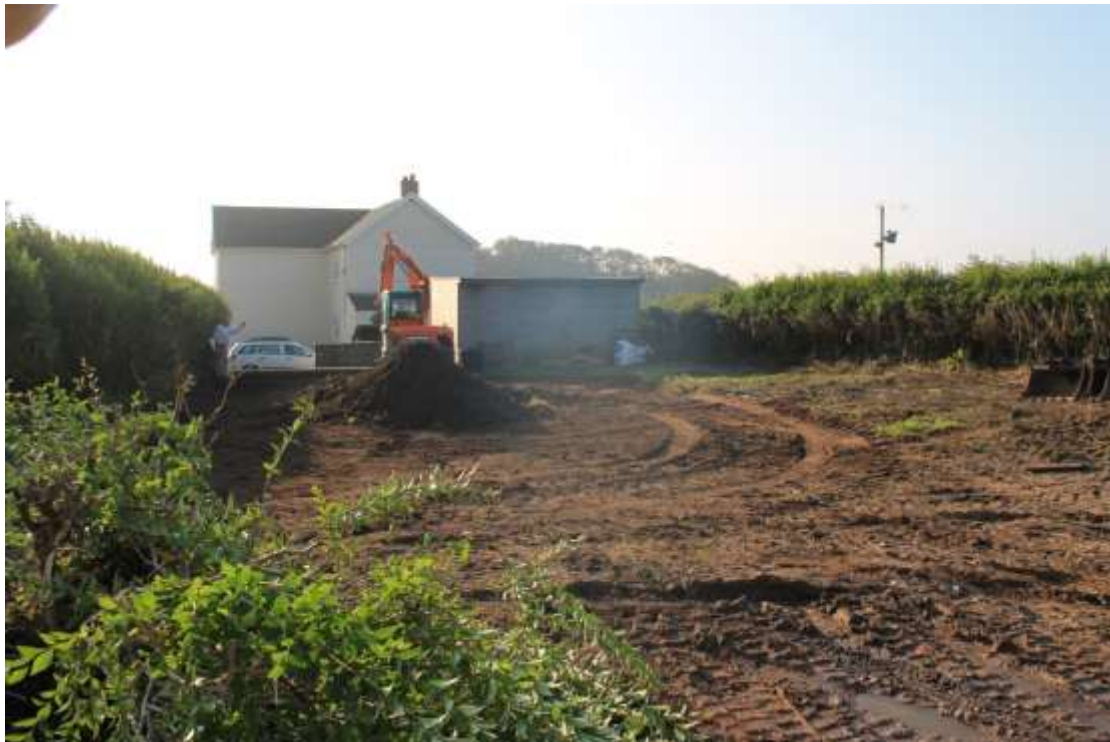
- 4.4 Groundworks associated with the development commenced on the 8th September 2015, which included levelling across the two house plot areas and slightly deeper excavations for the vehicle entrance into the site and driveways to each of the houses. Machining started on the southeastern house plot (Photo 3) with the area for the driveway undertaken first, before the remainder of the plot was levelled.

Photo 3: View southeast along site area towards Cross Inn Farm
during initial groundworks

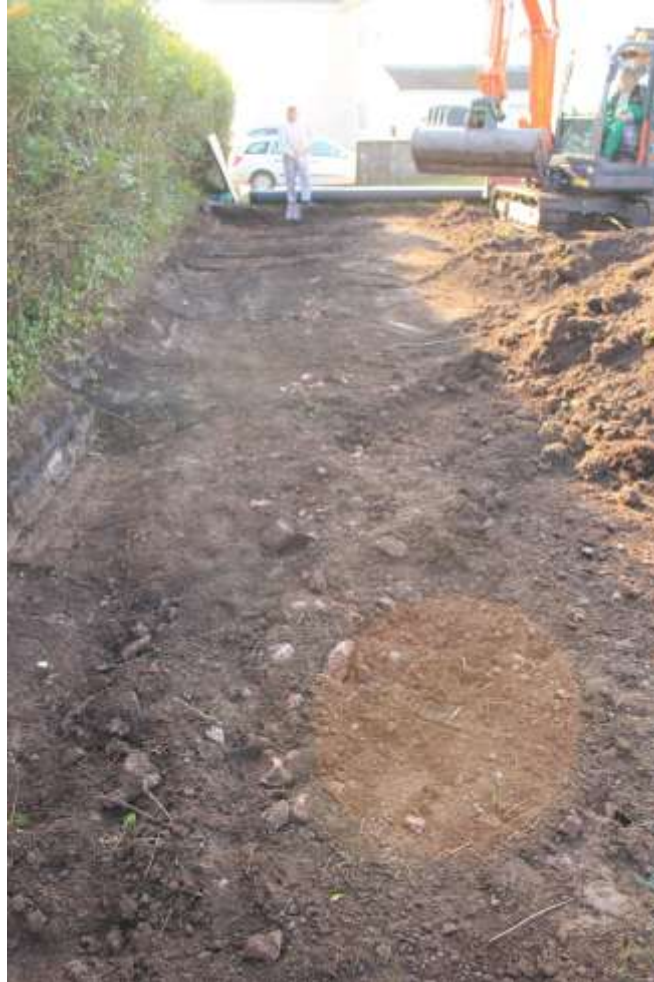
- 4.5 The driveway was excavated to a depth of around 0.40m below the former ground level. The material removed comprised dark greyish brown silt clay topsoil of c.0.20m depth containing occasional fragments of modern pottery and brick, animal bone and modern metal objects. The animal bone was mostly cow and showed evidence of butchering (the bones had been sawn, but there was no evidence for gnawing – if they had been waste products from the kennelling of greyhounds).
- 4.6 A rough alignment of stone rubble was visible along the northeastern side of this area, c.2.00m from the centre of the hedgebank (Photo 4). The

stone was red sandstone, which outcrops locally in Laugharne. An area of the rubble was cleaned to determine its composition and structure but no form could be determined, the material merely being an alignment of loose rubble. Potentially these stones marked the base of the former hedgebank representing tumble or the presence of a stone revetment. The southwestern part of the hedgebank had been removed by the machining.

Photo 4: Rough alignment of stone rubble along northeastern side of site, viewing southeast

- 5.4 The watching brief identified a line of rubble along the northeastern edge of the development area lying some 2m from the centre of the adjacent hedgebank. It is thought likely that this line of rubble was associated with the base of the former hedgebank and could represent either collapse of a stone façade to the bank or just stone debris removed from the area and piled along the hedgebank

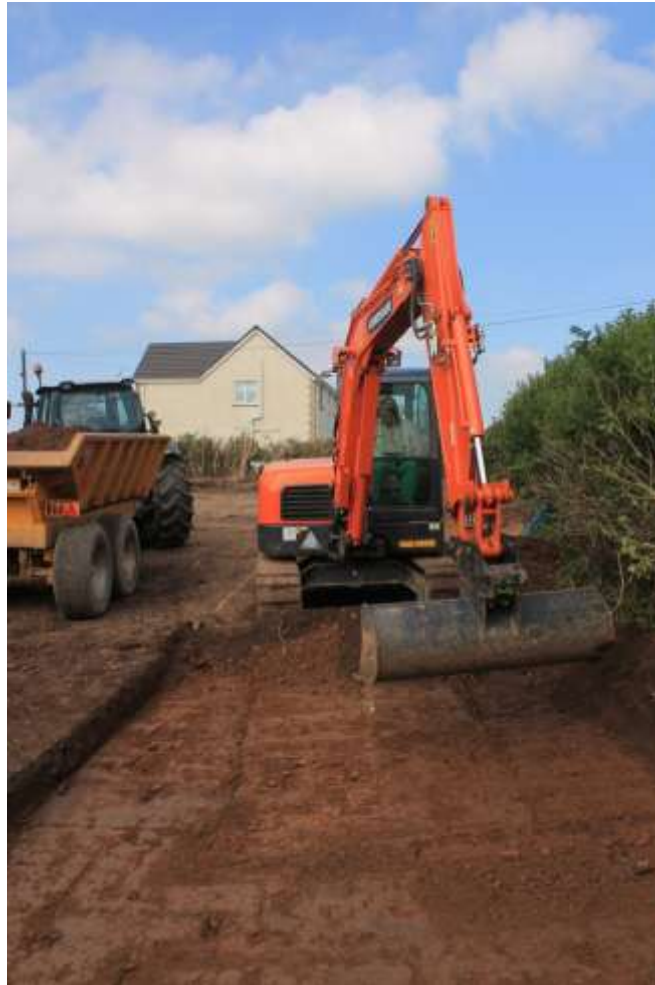
- 4.7 The topsoil lay on top of a subsoil of c.0.10m depth, a mix of the underlying natural geology and the upper topsoil. The rubble stone seen in the topsoil partially lay within this subsoil layer.
- 4.8 The underlying natural geology comprised clean reddish brown sandy clay silt, with occasional small stones (Devensian Till) (Photo 5). The exposed surface within the driveway area contained no archaeological features.
- 4.9 The remainder of the house plot area was levelled. It was evident that the depth of topsoil and subsoil reduced further to the southwest, such that even though only a maximum depth of topsoil of c.0.25m was removed from the area, the natural geology was exposed enabling a view of any potential archaeological remains to be exposed (Photo 6). Some areas of slightly deeper topsoil did remain, which merely represented undulations in the natural ground surface.

Photo 5: Stripping the area of the driveway for the southeastern house plot, showing the exposed natural geology, viewing northwest

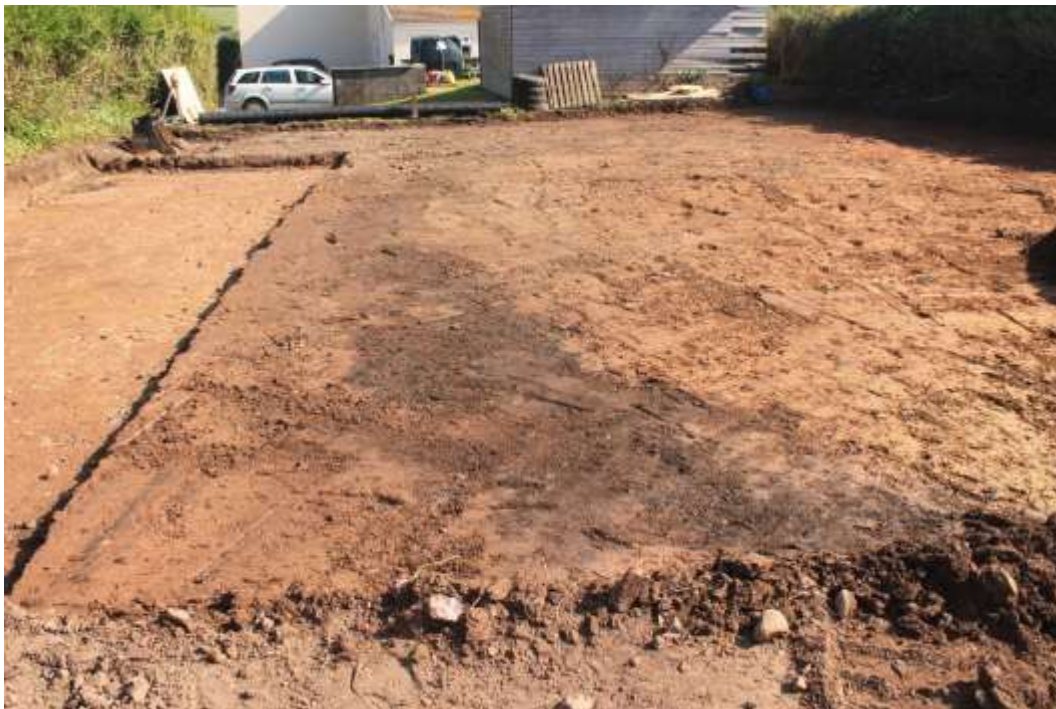
Photo 6: Completed strip for southeastern house plot, viewing southeast

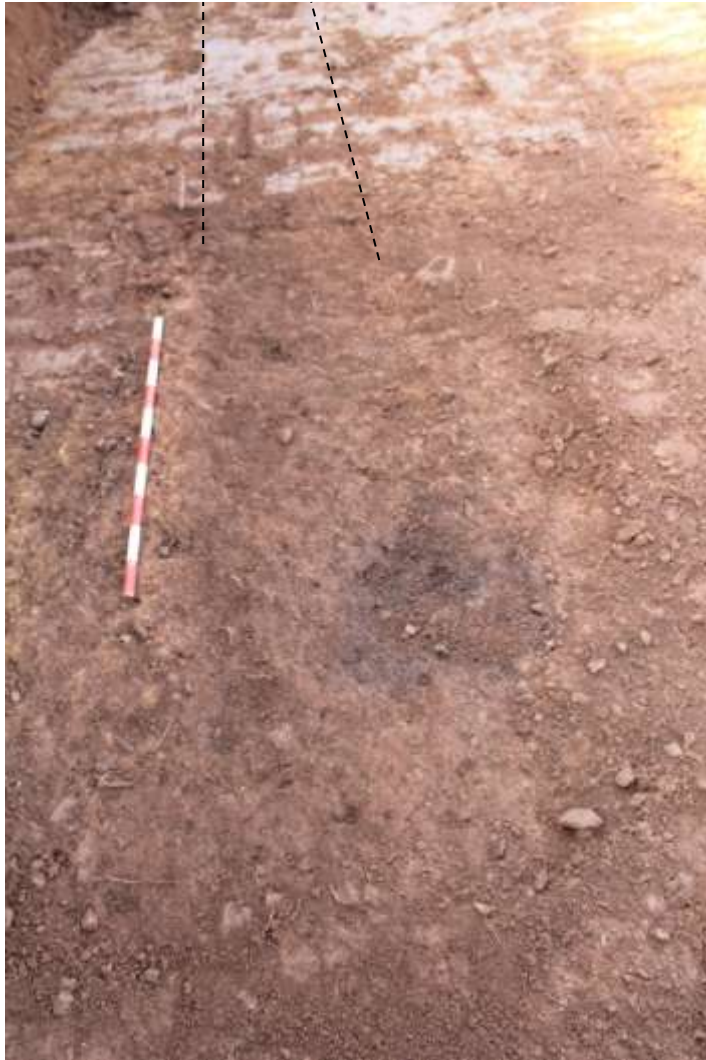
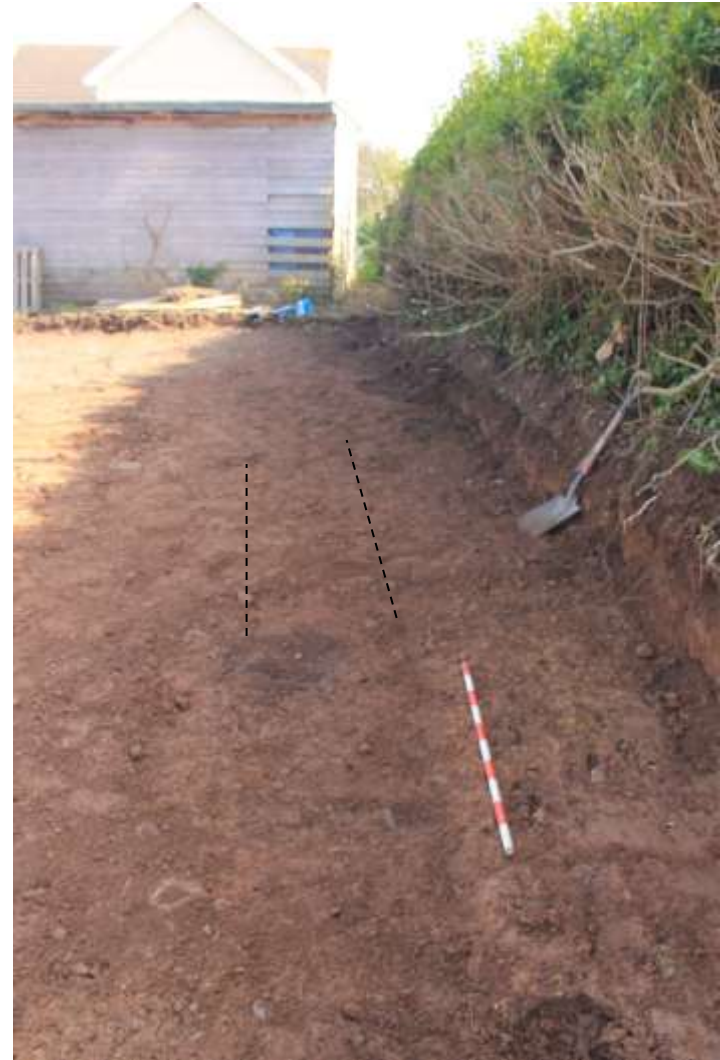
Photo 7: Linear feature revealed along the southwestern edge of the development plot viewing northwest (dotted line shows projection of alignment)

Photo 8: Linear feature revealed along the southwestern edge of the development plot viewing southeast (dotted line shows projection of alignment)

- 4.10 A linear feature was exposed along the southwestern side of the site, lying a regular 0.90m from the edge of the hedgebank, where it had been truncated by the machining (Photos 7 & 8). The feature was between 0.50 – 0.55m in width, although very shallow, less than 0.05m in depth. It was filled with a dark brown clay silt fill and occasional small stones. It was possible to trace the feature along the majority of the exposed area of the house plot.

- 5.5 A ditch was identified some 0.90m from the southwestern edge of the development area, which ran parallel with the hedgebank. It is assumed that this was the remains of a former shallow ditch which was used to help define the hedgebank. The section through the bank indicated the original topsoil lay buried within the bank, covered by a layer of subsoil which had presumably been removed from the ditch and piled up to form the bank. Above this subsoil was a layer of material which could have been the remains of turf or vegetation piled on top of the hedgebank when it was originally constructed. Modern topsoil derived from more recent vegetation growth survived above this material.

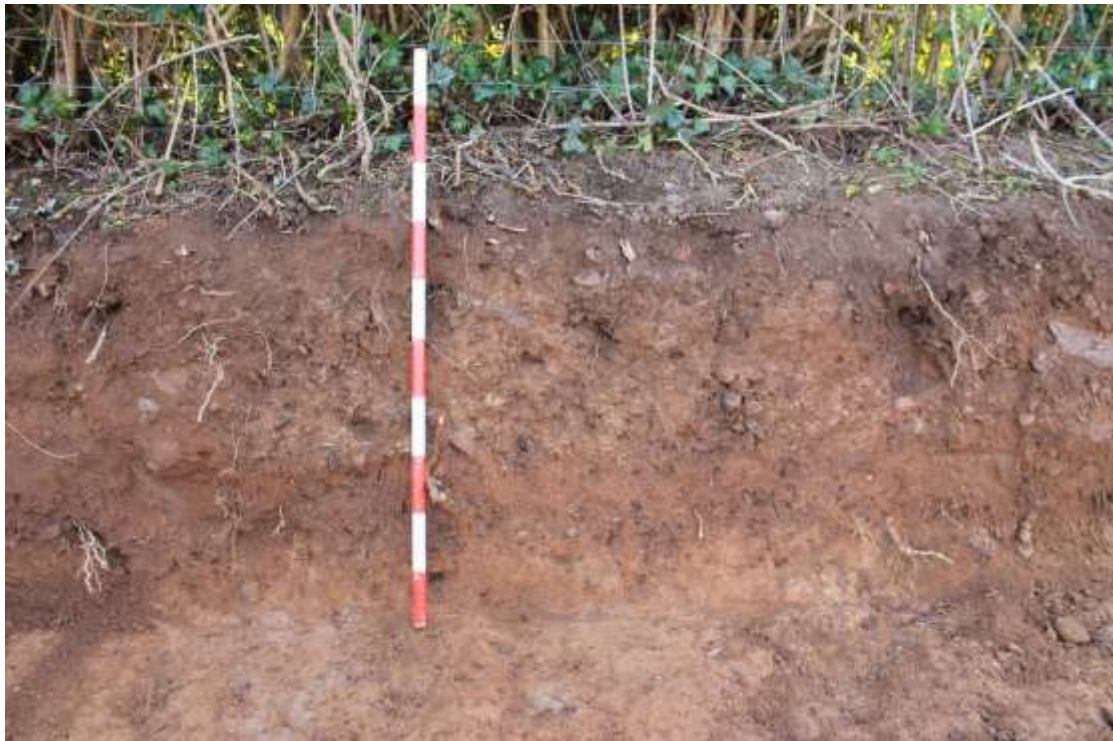
- 4.11 A section of the truncated hedgebank was cleaned to determine its structure and hopefully obtain an indication of its date (Photo 9). A depth of c.0.12m of natural was visible at the base, overlain by a 0.16m – 0.18m depth of dark greyish brown buried topsoil. Above this was a redeposited natural layer (presumably excavated from ditches to other side of the hedge) of c.0.15m depth. On top of this was a dark brown stony clay silt of 0.18m – 0.20m depth. The very top of the hedgebank comprised a 0.12m – 0.14m depth of topsoil.

Photo 9: Cleaned section through the hedgebank along the southwestern edge of the development plot, viewing southwest

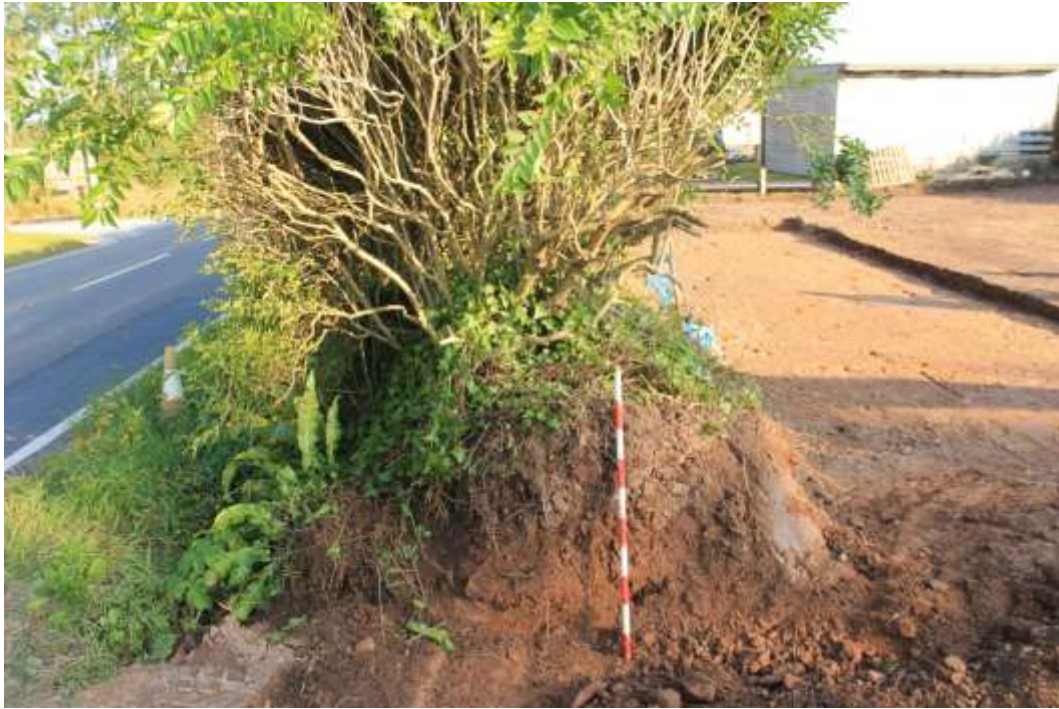
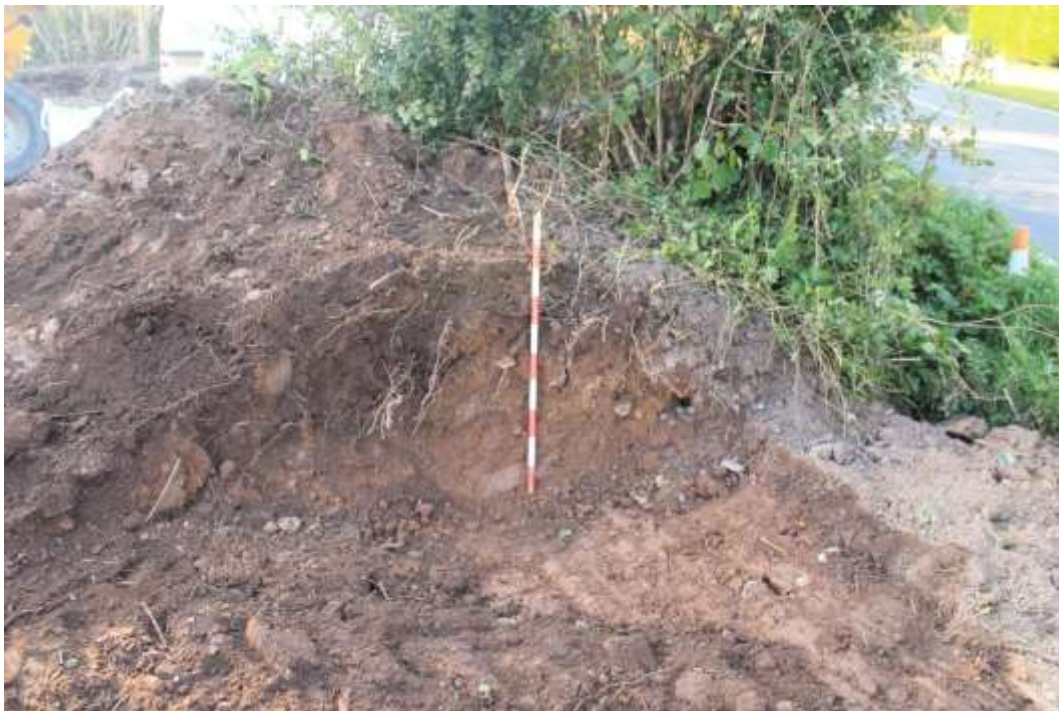
- 4.12 No further archaeological remains were identified within the exposed surface of the southeastern development plot area.
- 4.13 Further machining was undertaken within the vehicle entranceway into the site which enabled sections to be exposed through the northeastern hedgebanks (Photos 10 & 11). These revealed similar make-ups to that recorded on the southeastern side of the site.
- 4.14 No further archaeological features were identified within the area of the access road or driveways.

Photo 10: Entranceway cut through northeastern hedgebank, viewing southeast

Photo 11: Entranceway cut through northeastern hedgebank, viewing northwest

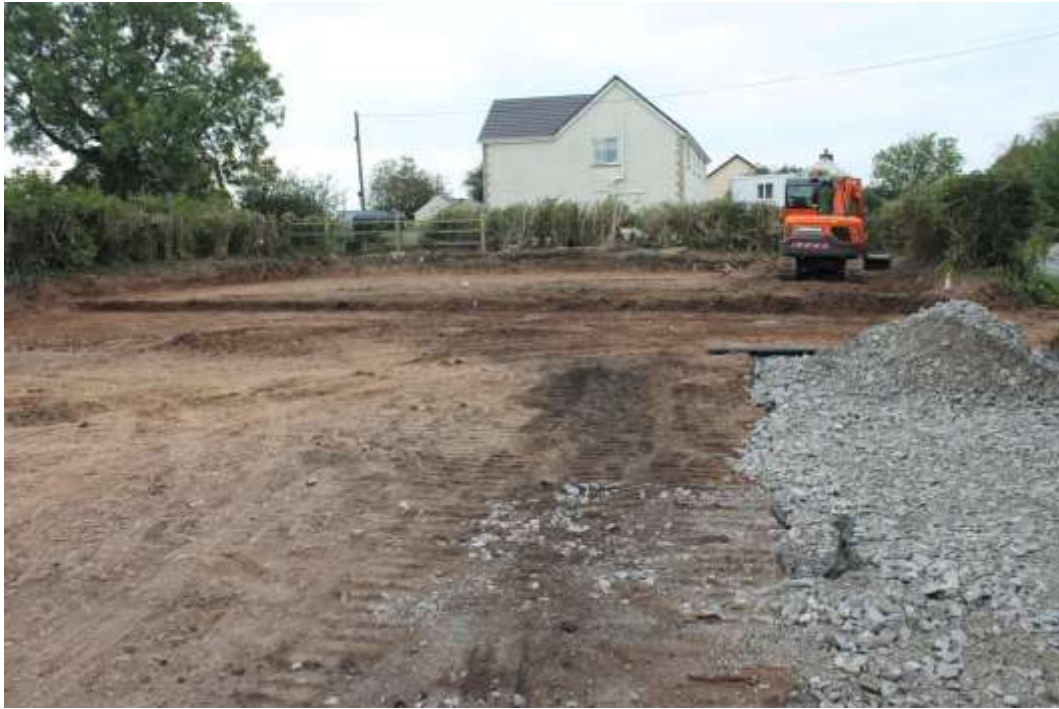
- 4.15 The machining of the northwestern house plot required a less substantial depth of material to be removed, although across the majority of the area the natural geology was exposed. The former locations of the sheds, where concrete floor slabs had been removed, were visible as areas of sub-base stone. These appeared to have been laid directly on the natural geology.

Photo 12: Completed site strip across northwestern house plot

- 4.16 No archaeological features were observed within the northwestern half of the site (Photo 12), excluding the continuation of the ditch seen on the inside of the southwestern hedgebank (Photo 13) and a few small modern post hole like features, associated with the former sheds.

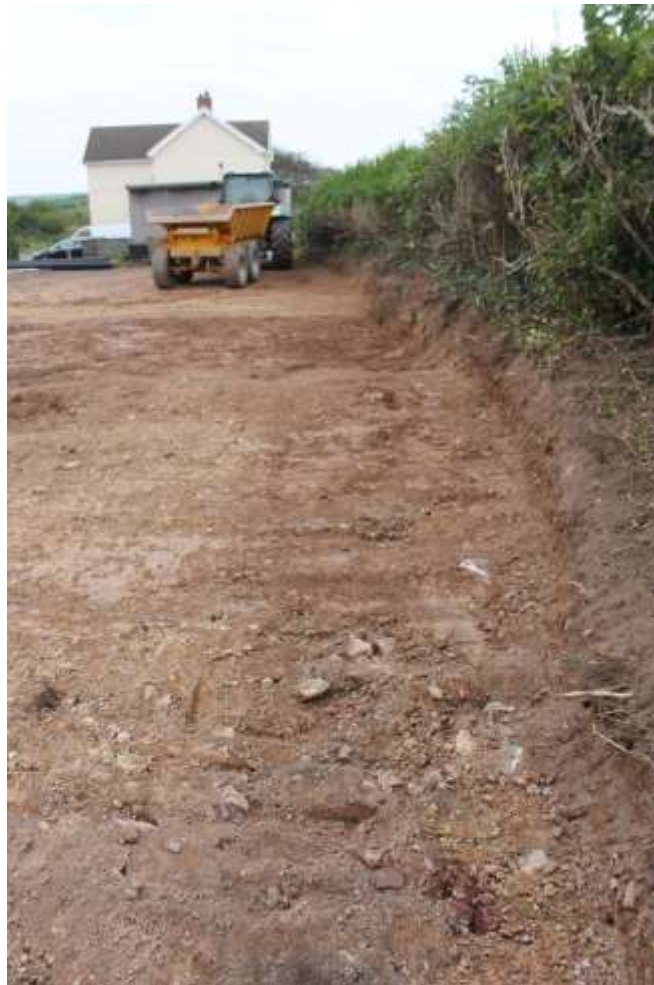
Photo 13: View southeast along southwestern edge of site
showing continuation of ditch along almost all of the site boundary
