**PROPOSED STAIR ACCESS TO
SOLAR, PEMBROKE CASTLE,
PEMBROKESHIRE:
ARCHAEOLOGICAL EVALUATION
2015**

(NGR SM 98177 01647)

Prepared by DAT Archaeological Services
For: Pembroke Castle Trust /
Acanthus Holden Architects

RHIF YR ADRODDIAD / REPORT NO. 2015/56
RHIF Y DIGWYDDIAD / EVENT RECORD NO. 108786

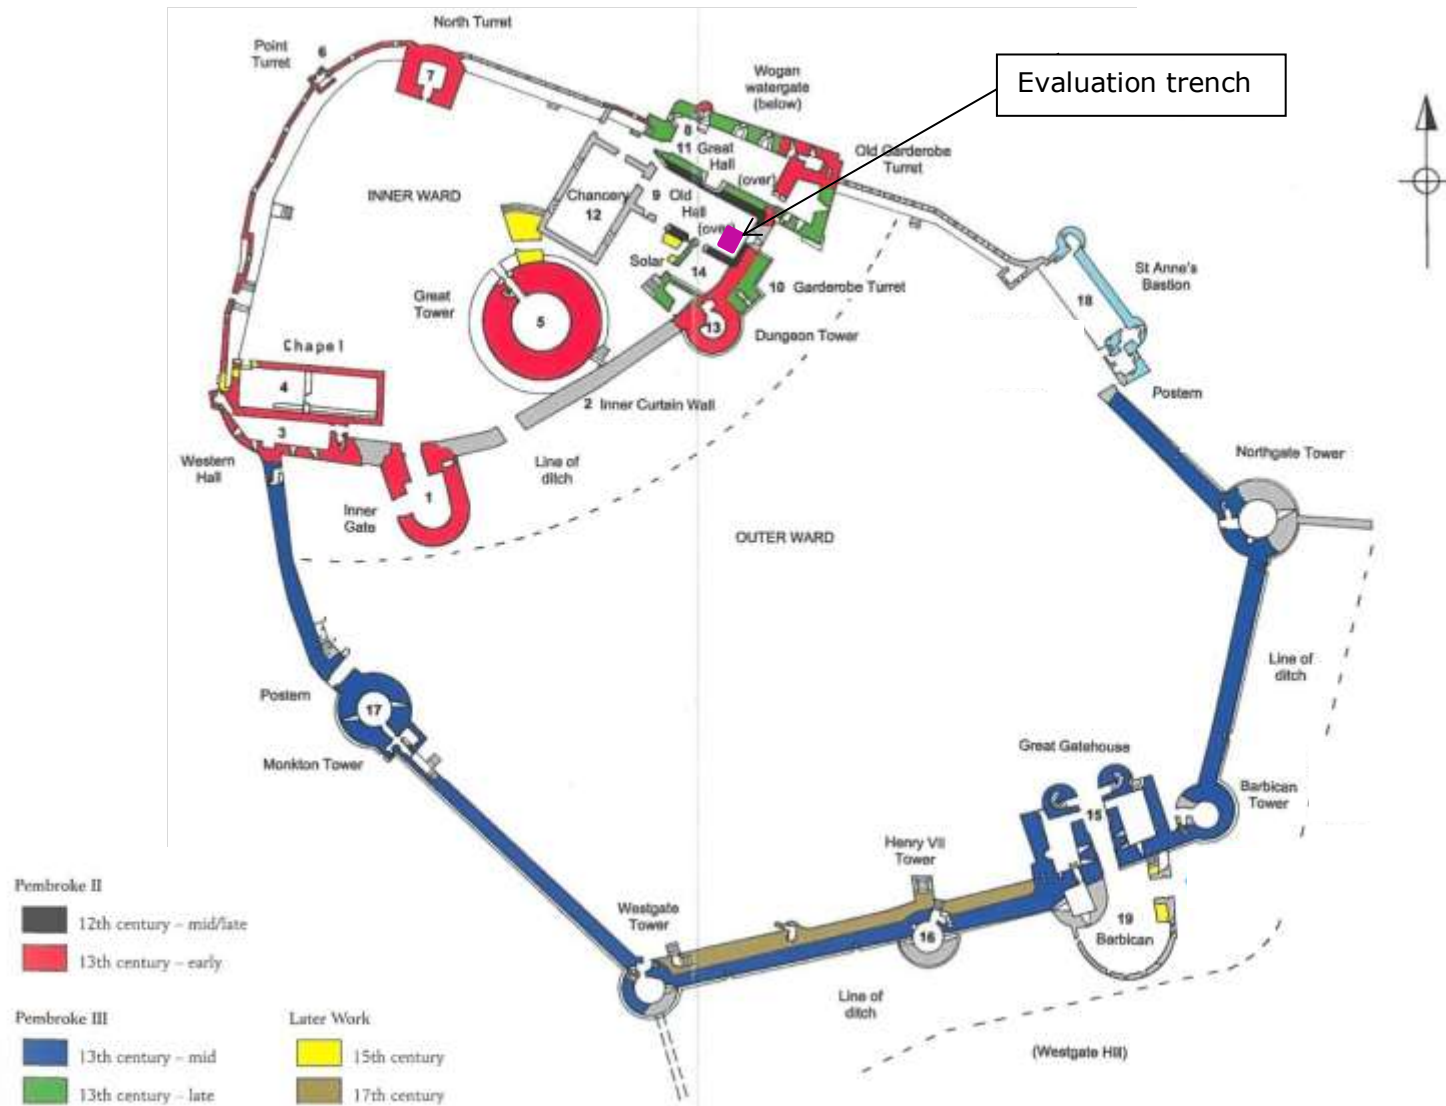
Figure 2: Approximate location of evaluation trench within Pembroke Castle indicated by purple square.
Phase plan by N. Ludlow, taken from 'Pembroke Castle, Birthplace of a Tudor Dynasty', Pembroke Castle Trust .

- 1.1.4 The evaluation trench was located in the south eastern corner of the undercroft of the Long Hall (also known as Old Hall or Norman Hall), at Pembroke Castle, Pembrokeshire (Figure 1 and 2; SM 98177 01647).

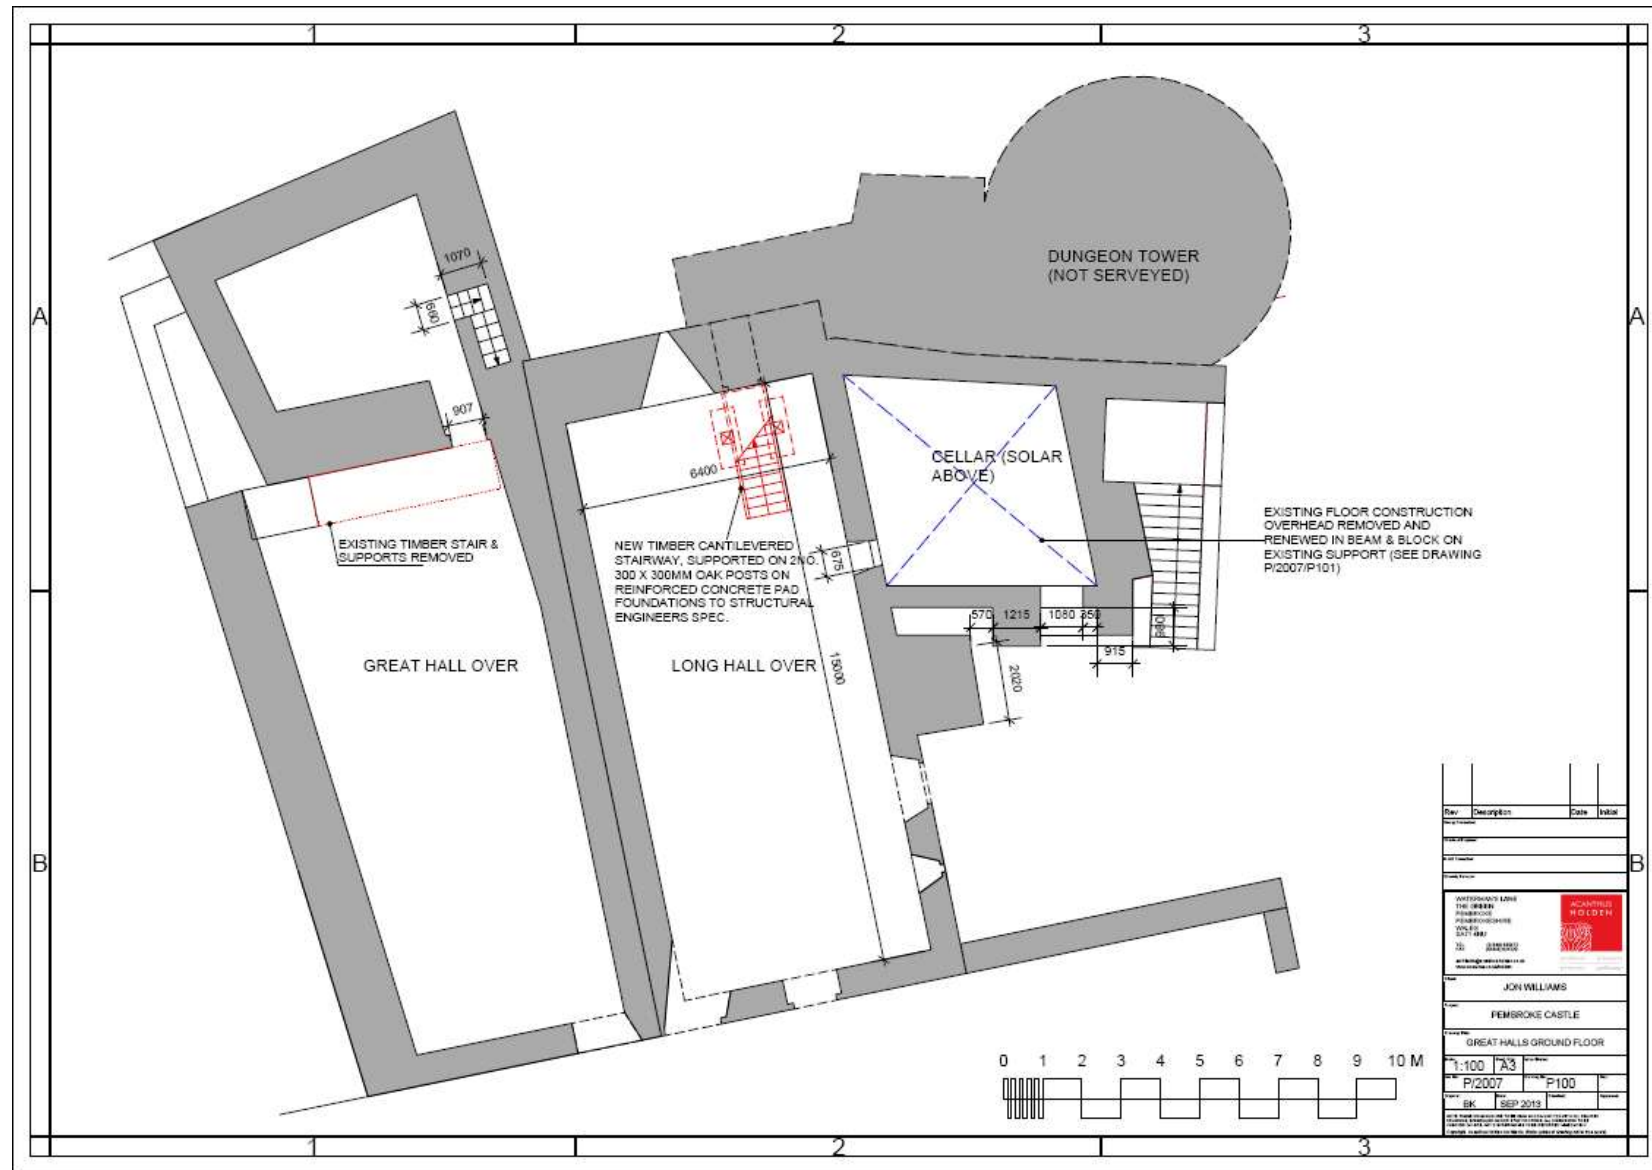
Figure 3: Plan of proposed stairs to solar (in red).
Drawing provided by Acanthus Holden Architects

- 4.1 A 2m x 1.4m trench was opened in the area of the footprint of proposed footings for the stairs to the Solar within the Long Hall (Figure 3). Once the excavation was complete a detailed scaled plan (Figure 4) of what was exposed was drawn as well as the four sections (Figures 5 and 6).
- 4.2 Bedrock was encountered across the trench at a maximum depth of 0.35m and a minimum depth of 0.1m. The bedrock was deepest in the north-eastern end of the trench.
- 4.3 The strata encountered during the excavation were as follows (Figure 5 & 6):

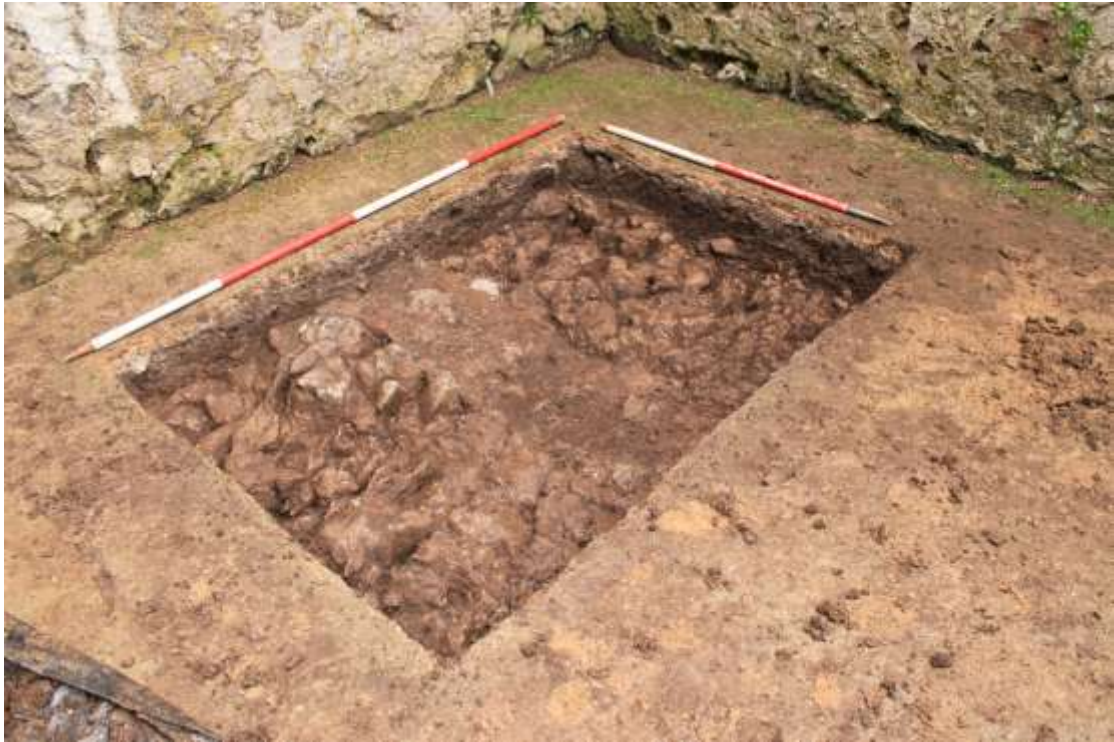
Photo 1: The excavated trench after topsoil stripping viewing south. The natural limestone bedrock is visible. Note the central baulk left in place is not an archaeological feature – but represents the remains of (005) left in-situ. 2m x 1m scale.

- 4.5 Layer 003 was then removed. Layer 004 was also removed at this time as it was of a very similar colour and texture to 003 but had far fewer inclusions or finds within it. The layer was most obvious in section (Figures 5 & 6). The underlying layer (005) was then hand cleaned before being removed on two sides of the trench, leaving a baulk in the middle (Photo 1 & 2).

- 4.7 The patch of exposed bedrock in the western corner was markedly finer and less peaked than in the rest of the trench. This may have served as a floor surface during the past, or perhaps had been worn down flatter through use, but a larger area would need to be exposed to confirm this.

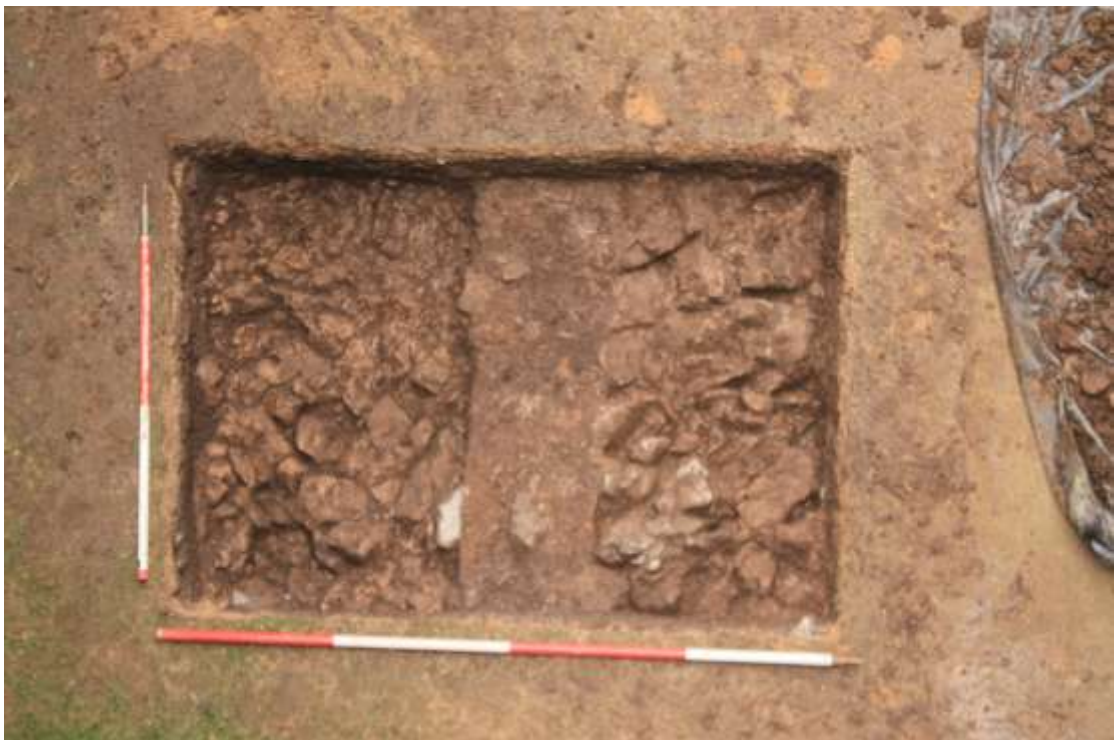
Photo 2: Plan view of the excavated trench. Note the exposed bedrock visible across the trench, with flatter area to top left. 2m x 1m scale

- 5.11 The exposed bedrock at the south east end of the trench was less peaked and had the appearance of being more worn than that surrounding it. This appearance may be due to it being used as a surface but could also relate to earlier activity on the peninsula, and may simply be the remains of weathering. A larger area would need to be exposed to be certain.

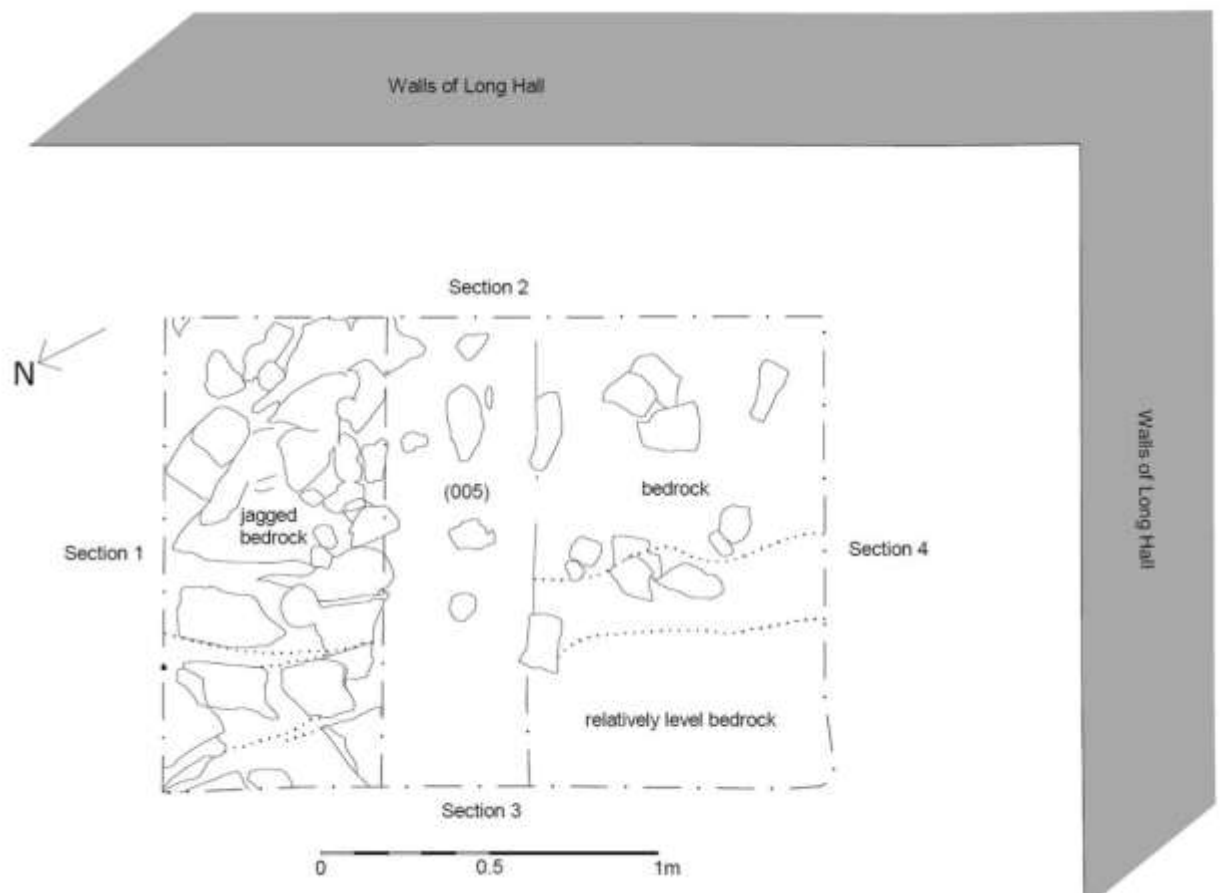
Figure 4: Location plan of trench in relation to the walls of the Long Hall.

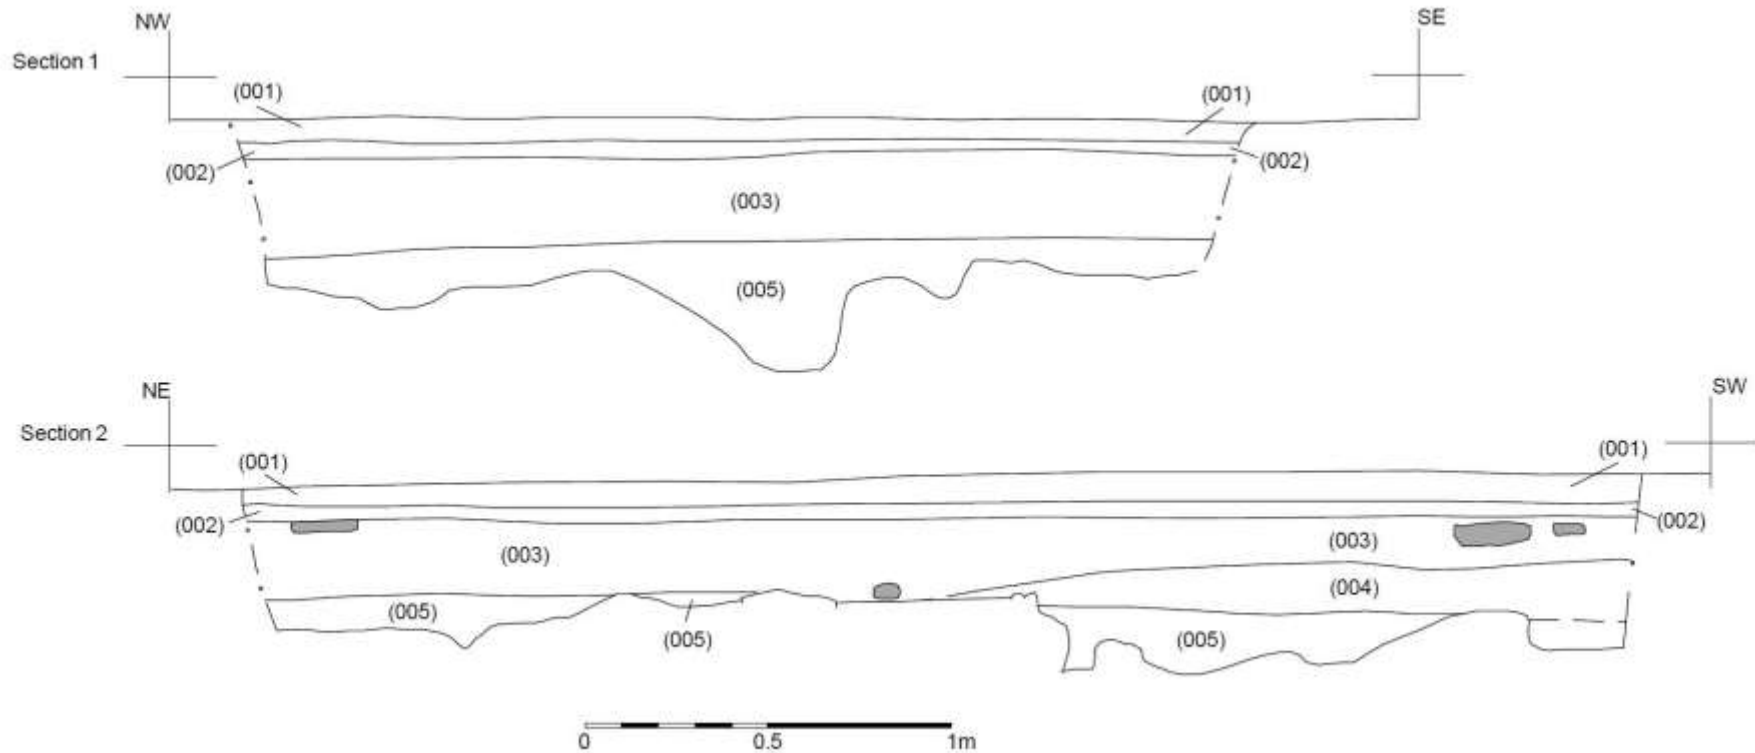
Figure 5: Sections 1 (southwest facing) and 2 (northwest facing) of trench.

The crosses used to mark the string heights of each end of the sections is the same height for each section in Figures 5 & 6

Context	Summary Description
001	The current floor surface. A pale, orangey-brown, crushed stone sand of 0.06m-0.07m thickness.
002	A substrate layer. A grey, crushed stone sand of similar consistency to (001) of 0.04m thickness.
003	A dark greyish-brown clay-silt layer. Inclusions of mortar flecks and small-medium stone. All recovered finds came from this layer including metal, broken glass, iron nails, pottery, bone, roofing slate. The deposit was between 0.12m – 0.24m thick.
004	A dark greyish-brown silt-clay layer at the southern end of the trench. Very few inclusions. The layer was between 0.12m and 0.16m thick.
005	A mixed layer immediately overlying the bedrock. A dark brown silty-clay with large patches of clayey-sand, mortar, stone between 0.02m and 0.35m thick.

the clay-sand deposits representing the remains of possible former floor surfaces. The mixed nature of the deposit and how it formed a broadly level surface (see Figures 5 and 6) with the outcropping bedrock from below, led to the interpretation as a possible occupation layer. The orangey inclusions within it were interpreted as being the remains of possible floor surface as the composition was markedly different from that observed in the other deposits.

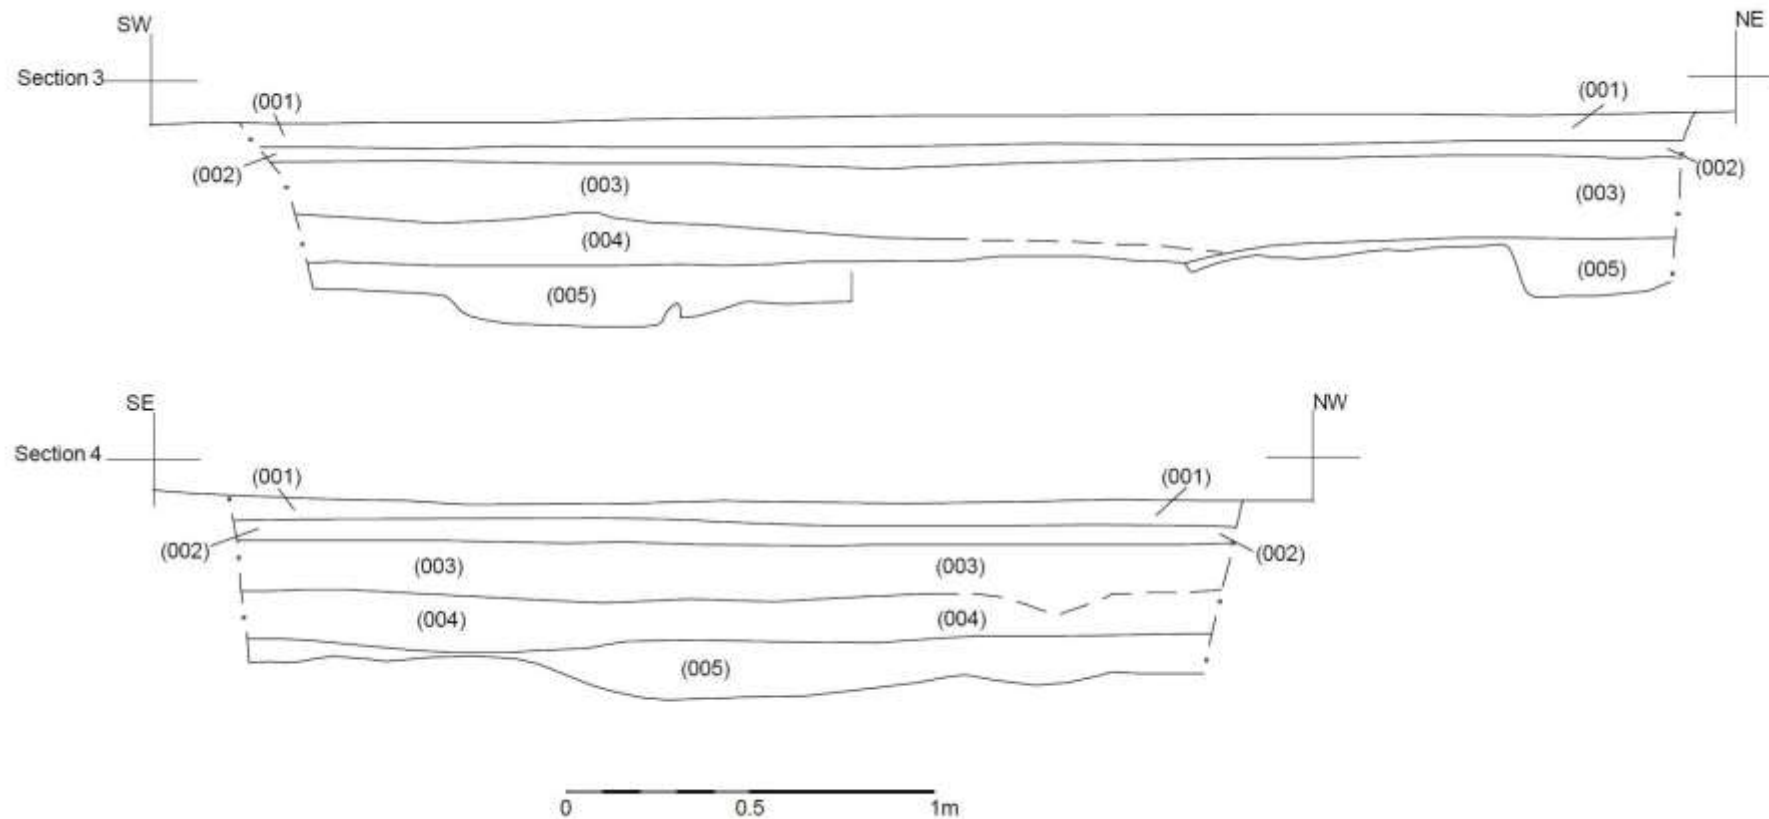
Figure 6: Sections 3 (southeast facing) and 4 (northeast facing) of trench.

The crosses used to mark the string heights of each end of the sections is the same height for each section in Figures 5 & 6
