MONKTON CHURCH PRIORY, PEMBORKESHIRE

ARCHAEOLOGICAL WATCHING BRIEF (SM 97962 01451)

RHIF YR ADRODDIAD / REPORT NO. 2015/67
RHIF Y DIGWYLLIAD / EVENT RECORD NO. 108990

**MONKTON CHURCH PRIORY, PEMBROKESHIRE
ARCHAEOLOGICAL WATCHING BRIEF
(SM 97962 01451)**

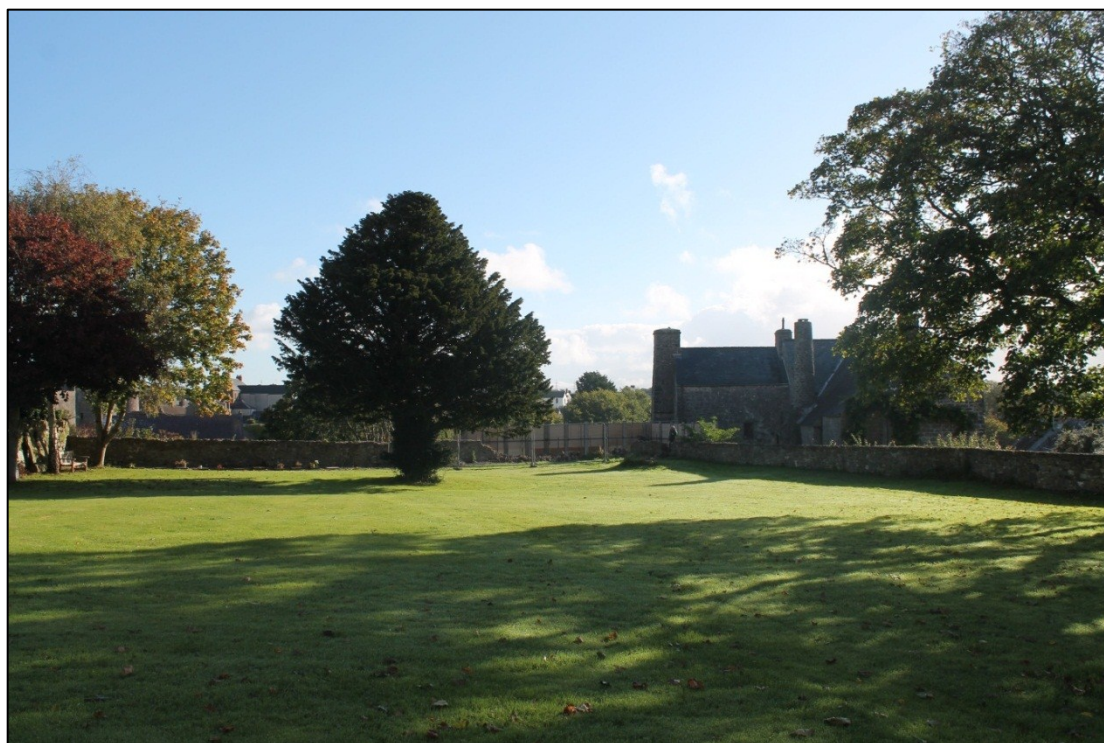
Photo 1: View facing the southeastern corner of the churchyard. The wooden fencing indicates the section of wall subject to repair works. The Old Hall is visible in the background. (DAT Photo IMG_5720-108990)

- 2.1.2 The churchyard, formerly a graveyard, but now used only for cremation burials, is grass covered, occupying a level terrace bounded by mortared stone walls (Photo 1). The ground drops away to the east, falling 3m to 3.5m onto another terrace occupied by Monkton Old Hall and its gardens. Beyond this the ground continues to drop into the valley occupied by Monkton Pill and Common Lake. Mature trees line the south-eastern edge of the churchyard in line with the parameter wall (PRN 60238).

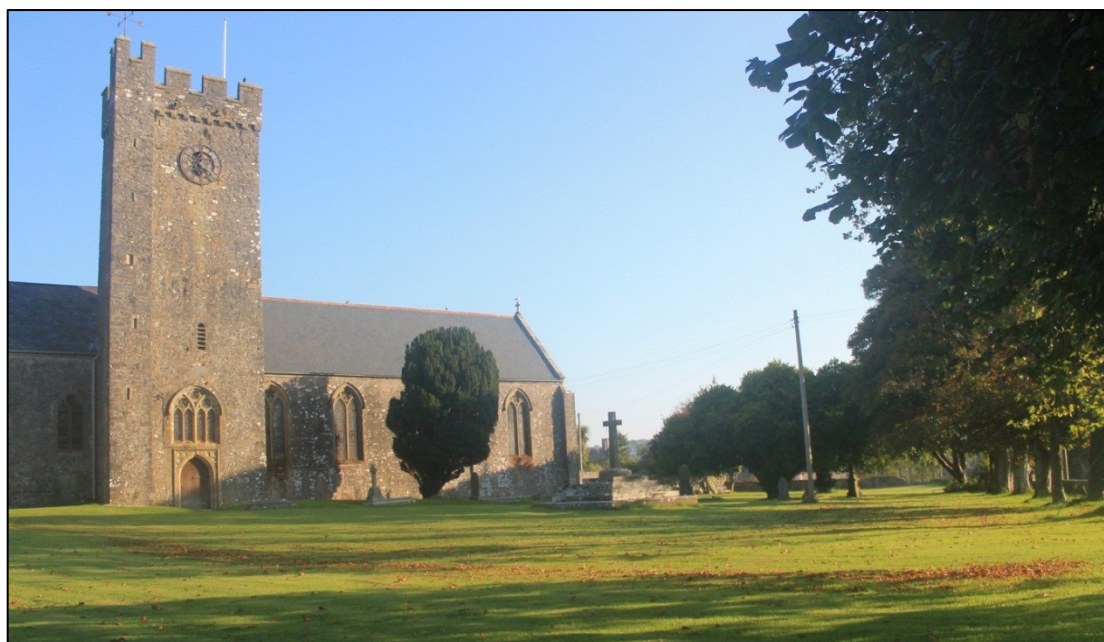
Photo 2: Monkton Church Priory with the southeastern corner just visible in the background. (DAT Photo IMG_5746-108990)

- 2.1.3 Monkton Priory Church (Photo 2) is a grade I listed building (ref. 6330), the surrounding churchyard walls and gateways are also grade II listed (ref. 6331). The church within its churchyard setting also forms part of the essential setting of the grade II* listed gardens of Monkton Old Hall and Vicarage (ref. PGW (DY) 40 (PEM)). The site also lies within the Conservation Area of Pembroke.

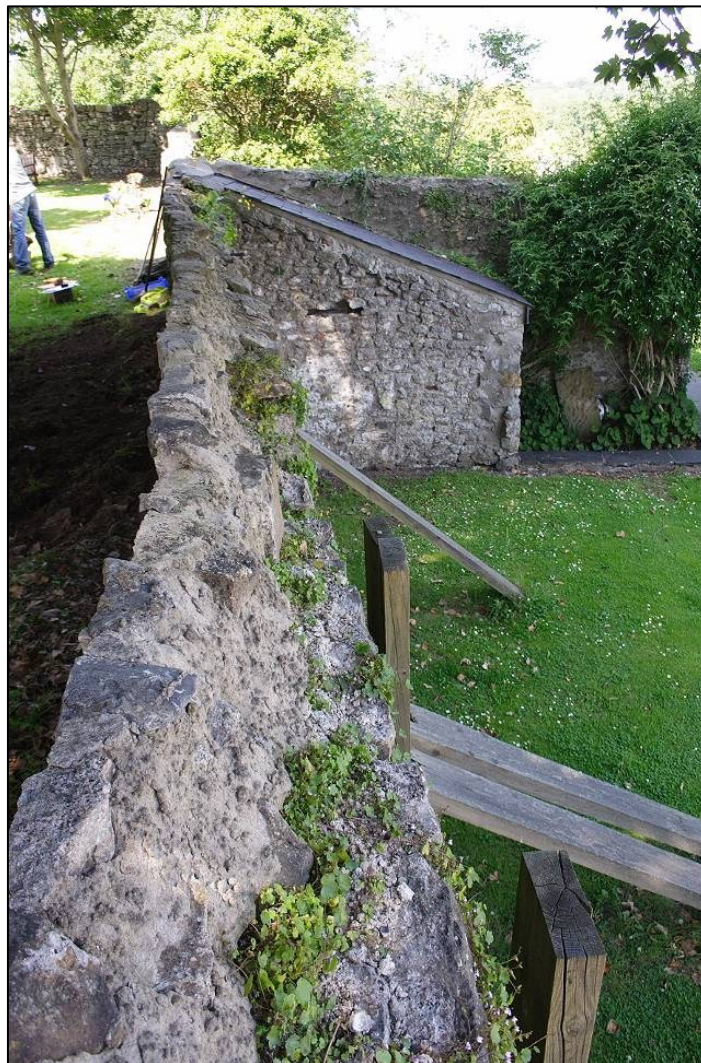
Photo 3: The bulging eastern boundary wall (06) prior to works. Note the temporary shoring. (DAT Photo from 2011).

- 4.1.1 This watching brief monitored groundworks associated with the consolidation of a section of the perimeter retaining wall of the churchyard (Figure 3). Work was concentrated on sections of the south-eastern corner, at the joining of the southern (07) and eastern (06) walls. Here, the walls had become increasingly unstable with the eastern wall (06) bulging severely and subsequently temporary shoring had been erected in an attempt to stabilise the walls in fear of collapse (Photo 3).

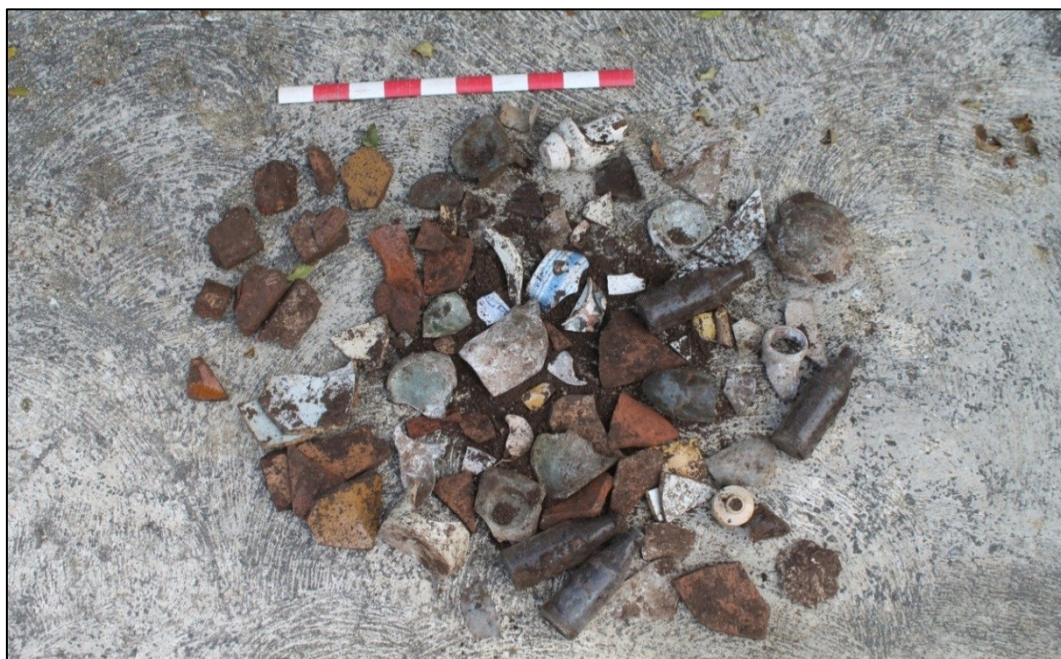
Photo 4: The mixed post-medieval to modern pottery from the fill (04) of the possible test pit (03). (DAT Photo IMG_5738-108990)

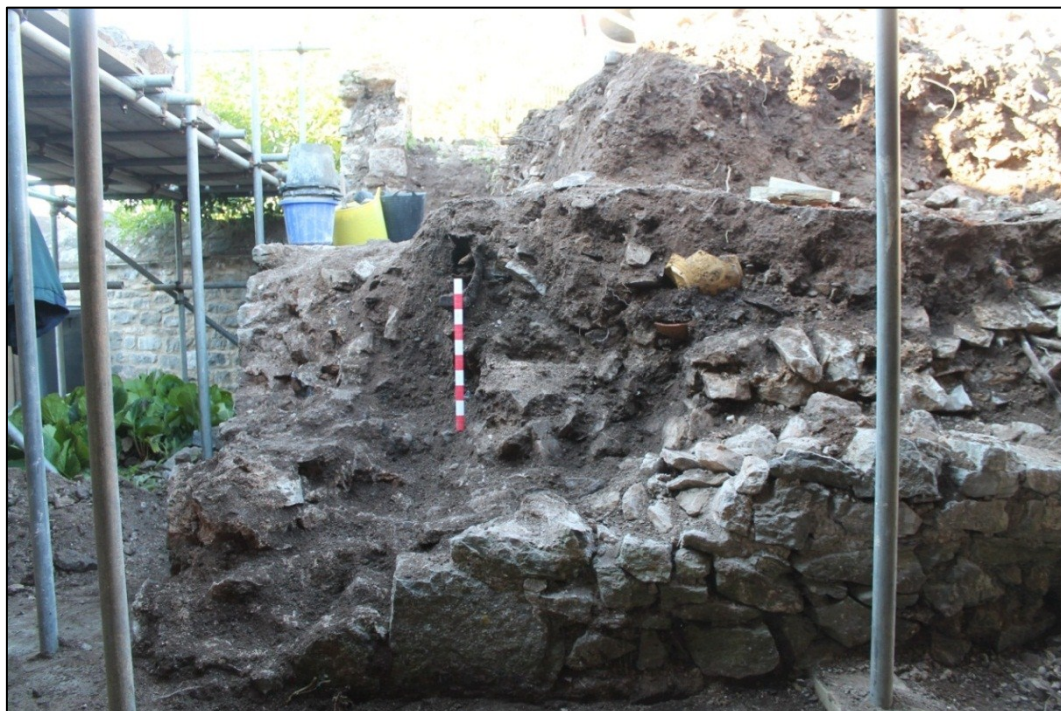
Photo 5: The south-eastern corner of walls (06) (orientated E-W) and (07) (orientated N-S) at the end of the dismantling process. The bulk of deposit (05) is left in situ and is overlain by (02); note the cream sherd of dairy-ware and the section of the railway sleeper as indicated by the red and white scale in (05). Also just visible in the background is the full height of wall (07).
(DAT Photo IMG_5786-108990)

- 4.1.3 Underlying this layer was a loose, dark grey, sandy silt (05) around 1.6m below the top of the wall (07), which varied in thickness from 0.35m to 0.8m although the final depth was not fully excavated. It contained large amounts of lime mortar, angular stones, fragments of slate, glass sherds, animal and human bone, eighteenth-nineteenth century Dairyware, an almost complete clay pipe, a few sherds of late medieval pottery, fragments of possible fifteenth to sixteenth - century floor tiles (James and Brennan 1998) and undatable pieces of CBM (Ceramic building materials). It also contained a partially decayed railway sleeper (Photo 5 and Figure 5).

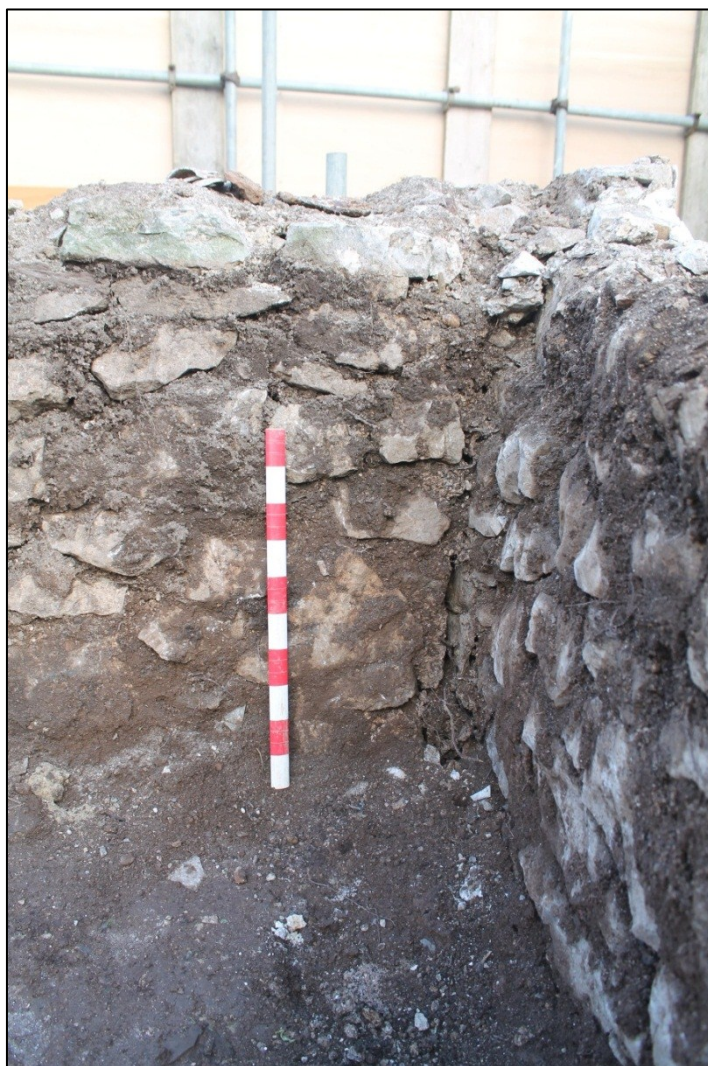
Photo 6: The butt joint of walls (06) (orientated E-W) and (07) (orientated N-S) seen prior to dismantling. (DAT Photo IMG_5734-108990)

- 4.1.4 The eastern wall (06) measured 0.6m wide, 2.8m high and was orientated north-east/south-west. The wall itself appeared to be comprised of a roughly coursed internal elevation, lime mortared angular limestone blocks, a rubble hard core (08) and a faced external elevation. It joined the southern wall (07) by means of a butt joint (Photos 6 & 7). Invasive root activity had significantly impacted the structural integrity of the wall, desiccating the lime mortar and exploiting the weaknesses in the joints. Around 3.1m of this unstable section was dismantled down to a stable height between 1.8m and 0.6m below ground level. At the corner point it was necessary to dismantle the wall down to the flagstone surface of the garden terrace of the Old Hall to the rear of the churchyard, some 1.9m below the churchyard ground level and 2.8m below the top of wall (07). This did not reveal the base of the wall which remains buried.

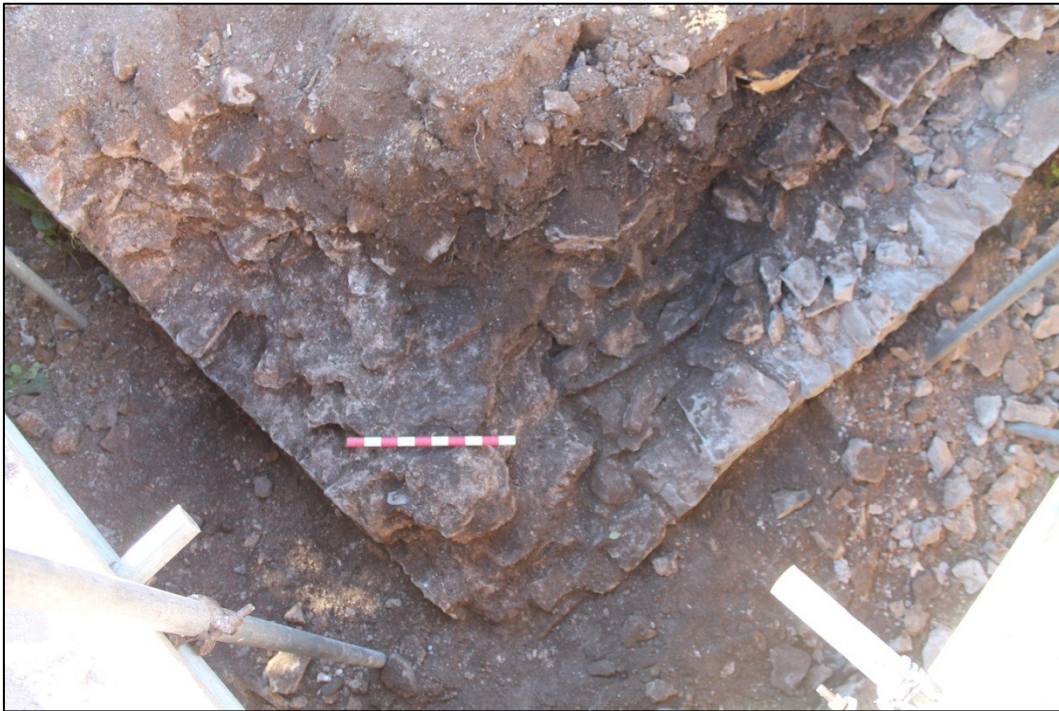
Photo 7: The southeastern corner of walls (06) and (07) viewed in plan after dismantling showing the butt joint between the walls.
(DAT Photo IMG_5770-108990)

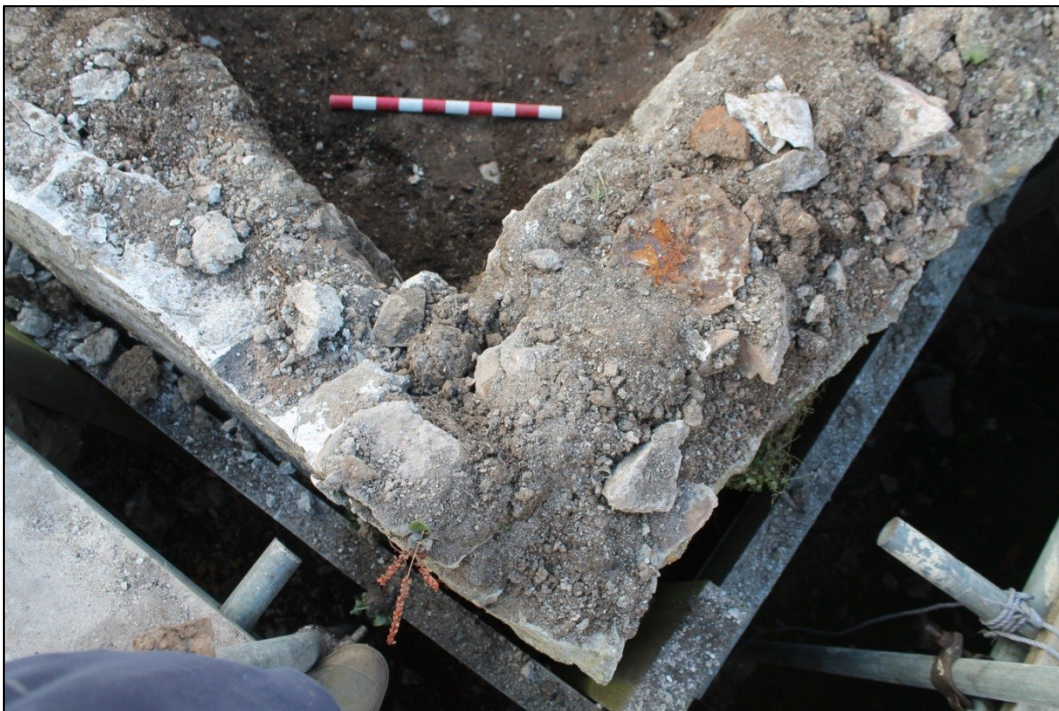
Photo 8: Viewed in plan prior to dismantling showing the tapered wall (07) butting wall (06). (DAT Photo IMG_5733-108990)

- 4.1.5 The southern wall (07) varied in width between 0.7m (at the base of that exposed) and 0.4m. It was orientated north-west/south-east. This too was comprised of a roughly coursed internal elevation, lime mortared angular limestone blocks, a mortared rubble hard core and a roughly faced external elevation. It appeared more structurally sound than wall (06) and showed evidence of being partially rebuilt towards the corner join. Here, the wall tapered to a width of 0.35m into the corner join (Photo 8). This

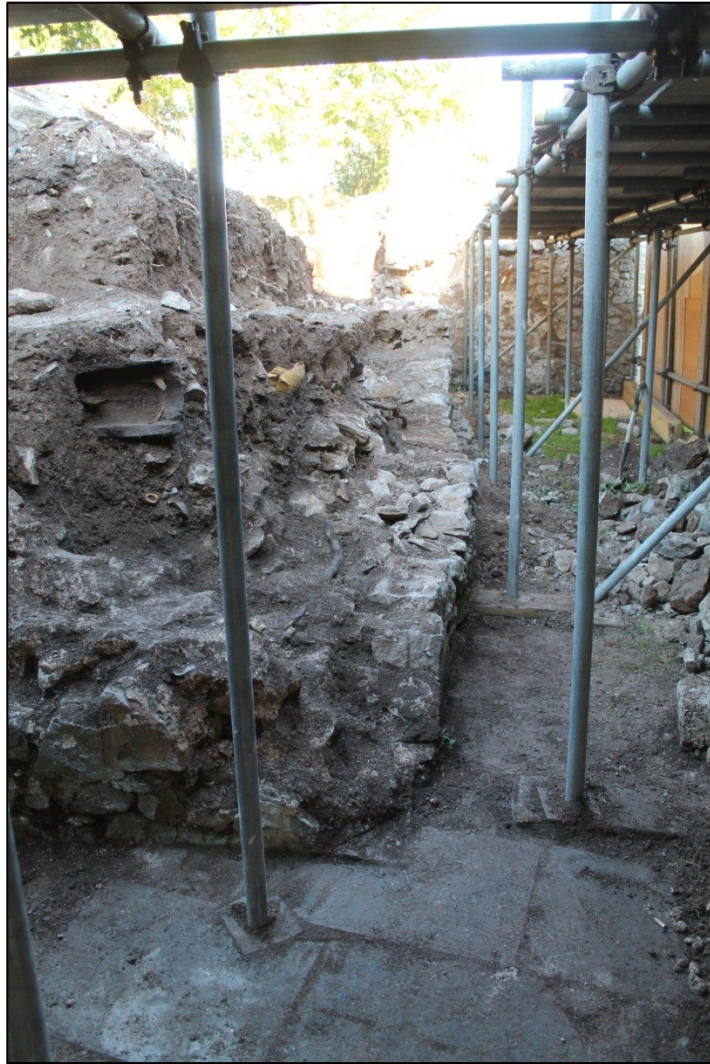
Photo 9: View facing north-west along the length of the eastern boundary wall (07). This photo shows the south-eastern corner of walls (06) and (07) after dismantling. Note the reduction down to the level of the flagged surface of the Old Hall garden terrace and the apparent continuation of the walls.
(DAT Photo IMG_5785-108990)

too was partially dismantled to the surface level of the Old Hall gardens where again, the final depth of the wall was not reached and remains buried (Photo 9).
