# LAND AT COED Y PIA, MEIDRIM CARMARTHENSHIRE ARCHAEOLOGICAL WATCHING BRIEF

Prepared by DAT Archaeological Services  
For: Keith and Pearl Powell

RHIF YR ADRODDIAD / REPORT NO. 2016/23  
RHIF Y DIGWYLLIAD / EVENT RECORD NO. 109354

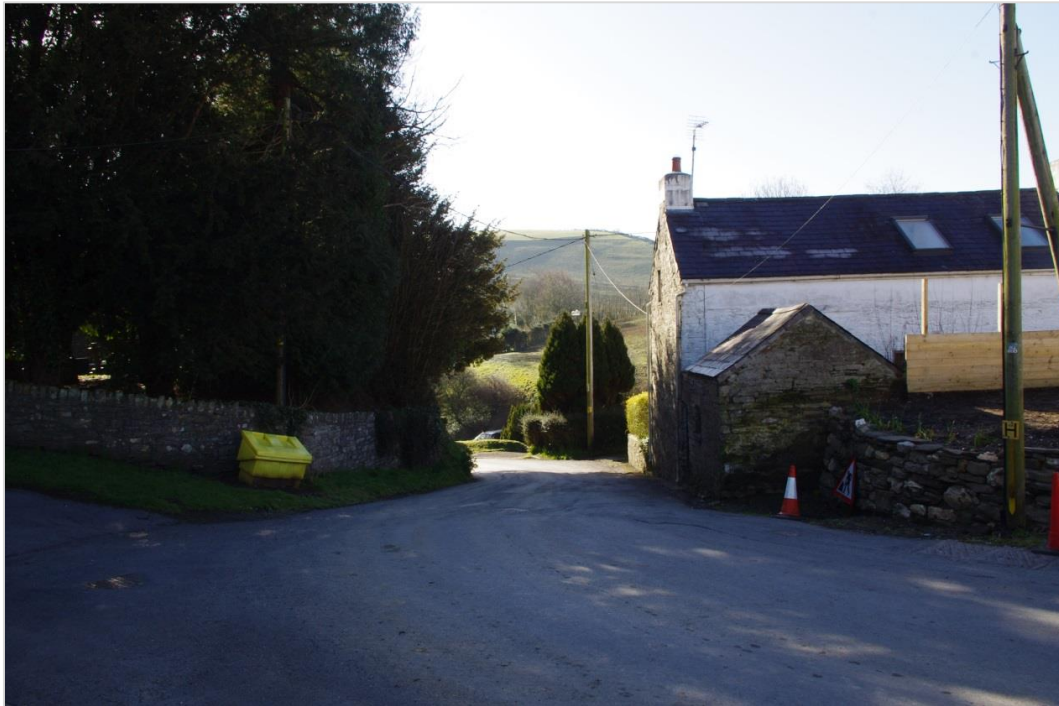
Photo 1: View southeast along Llanboidy Road, with churchyard wall to left and Penbryn and retaining wall around development site to right

- 4.2 The difference in ground levels between the development site and the adjacent property of Penbryn to the southeast and the road itself was clearly visible (Photos 1 and 2). Photo 1 shows the location of the

development site to the right, the Llanboidy road dropping to the east and the Churchyard around St Davids Church to the left.

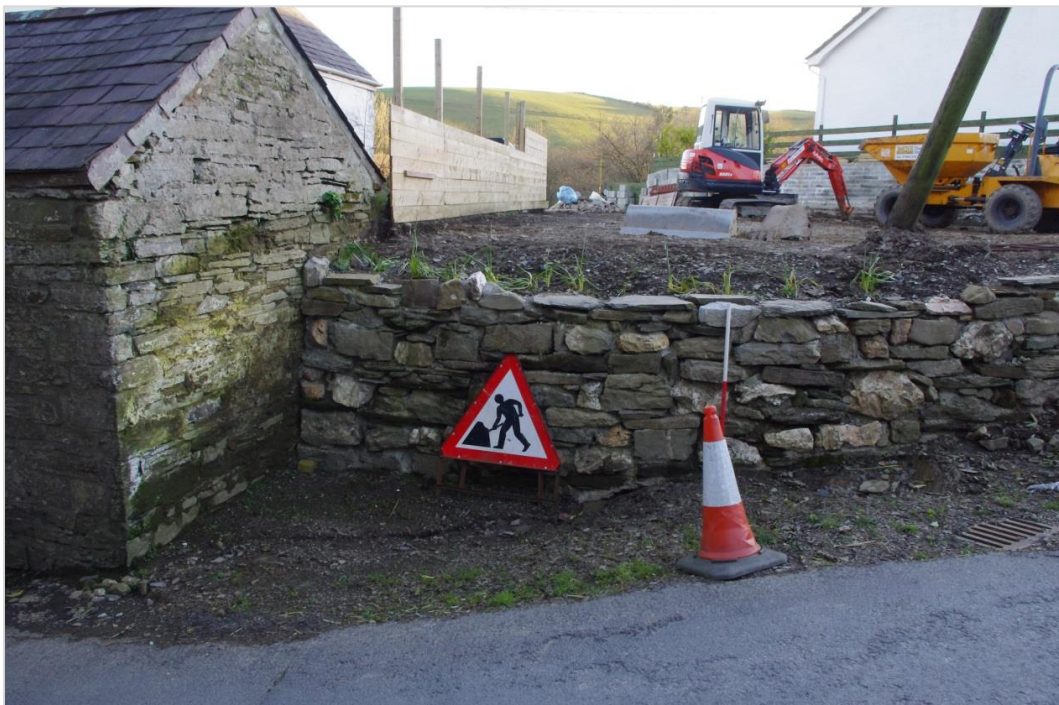
Photo 2: View south across the development site during ground reduction works showing the retaining wall on the Llanboidy Road frontage and ground levels

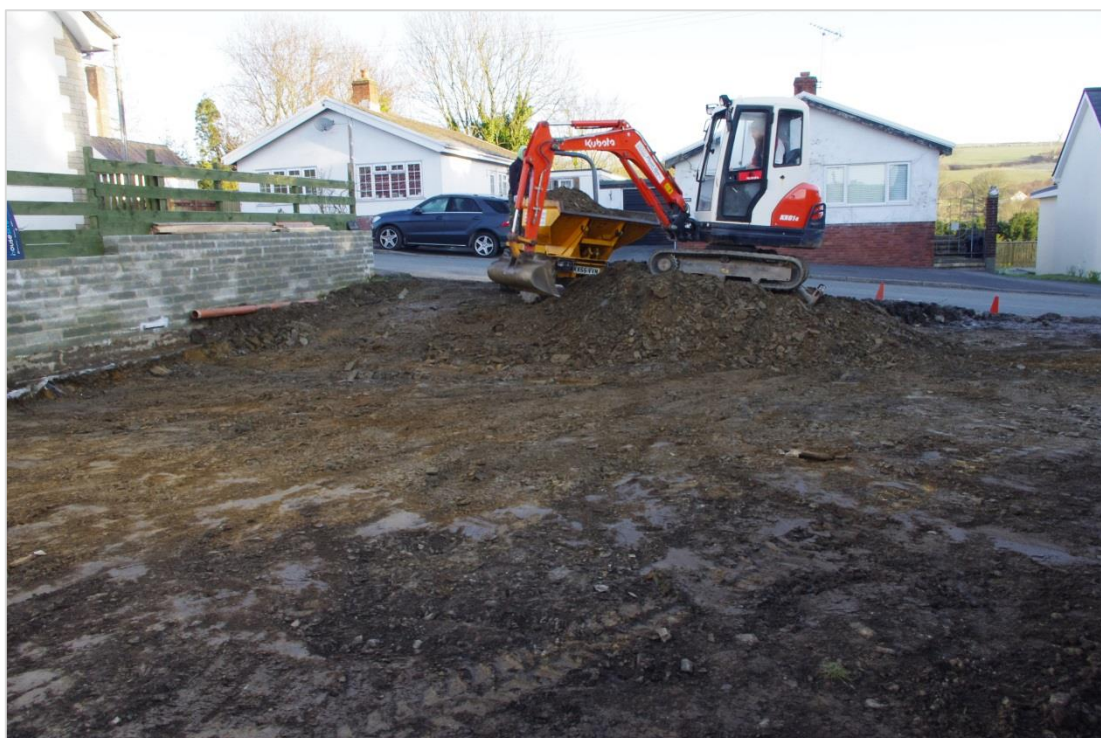
- 4.3 The retaining wall around the northern boundary of the site had been rebuilt recently, and had been moved slightly to the south to create a better view for access into and out of the property. The wall was reconstructed in the same stone that had been taken down from the original wall. The retaining wall had previously butted against the northwestern corner of an outbuilding belonging to Penbryn, and Mr Powell confirmed that loose backfilled soil had been present behind it (the extent of the former soil cover can be seen with the staining on the outbuilding wall in Photo 2). Bedrock was exposed at the base of the wall adjacent to the road line.
- 4.4 A shallow depth of dark garden soil was removed from across the development plot (Photo 3).

Photo 3: View northwest across the development area following site strip

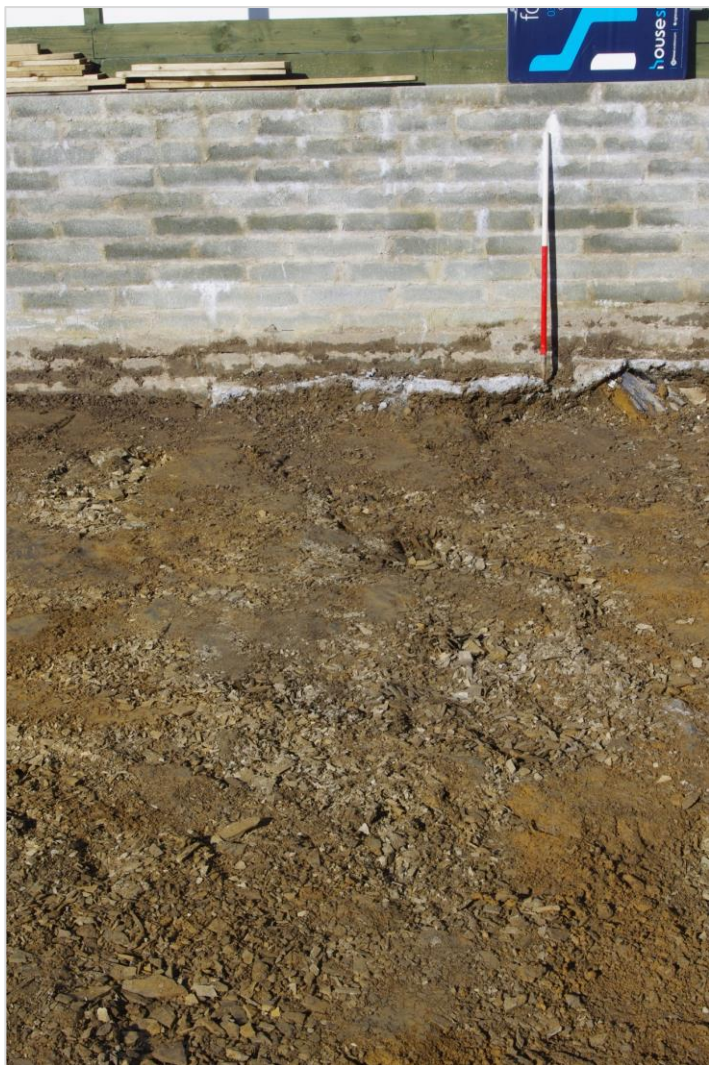
- 4.5 The retaining wall to the west, between the development site and Coed Y Pia, indicated a drop in ground level of almost 1m between the two (Photo 4). To the east there was a further drop, of possibly as much as 1.5m between the level of the proposed new building and that of Penybryn, although the drop was split into two terraced areas beyond the fence to the east (Photo 5)
- 4.6 Outcropping shale bedrock was exposed across the majority of the site area at the base of the initial site strip (Photos 4 & 5).

Photo 4: View west showing height of retaining wall to Coed Y Pia and outcropping shale bedrock at base of ground reduction works

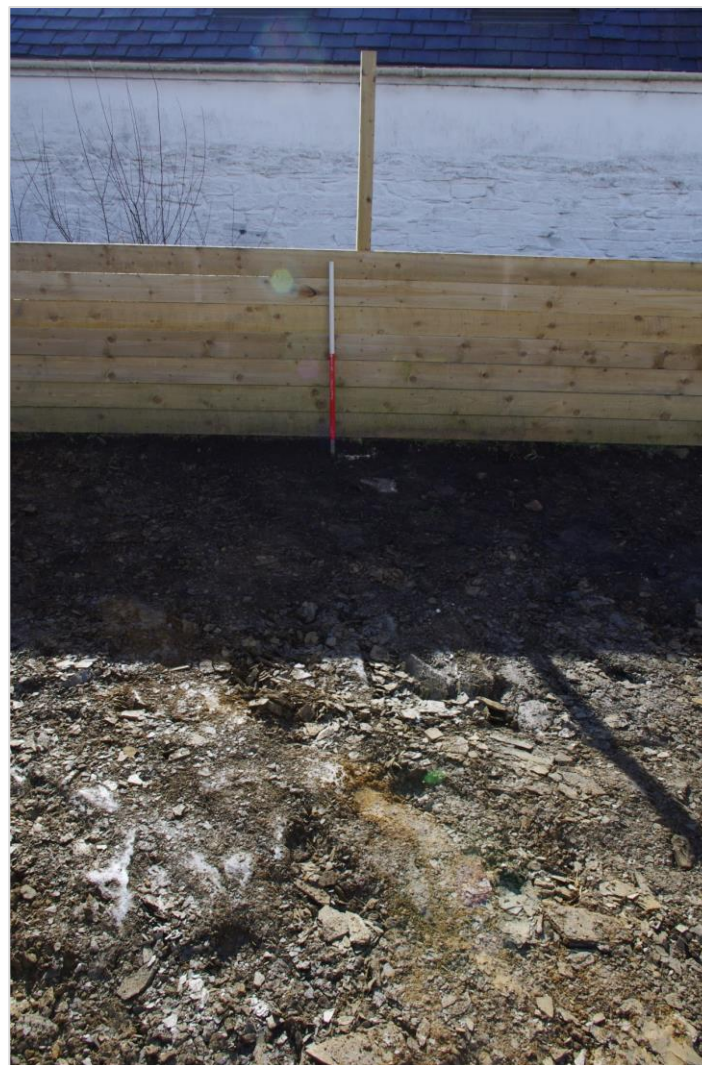
Photo 5: View east across development site after removal of shallow topsoil onto shale bedrock and the fence line to Penbryn beyond

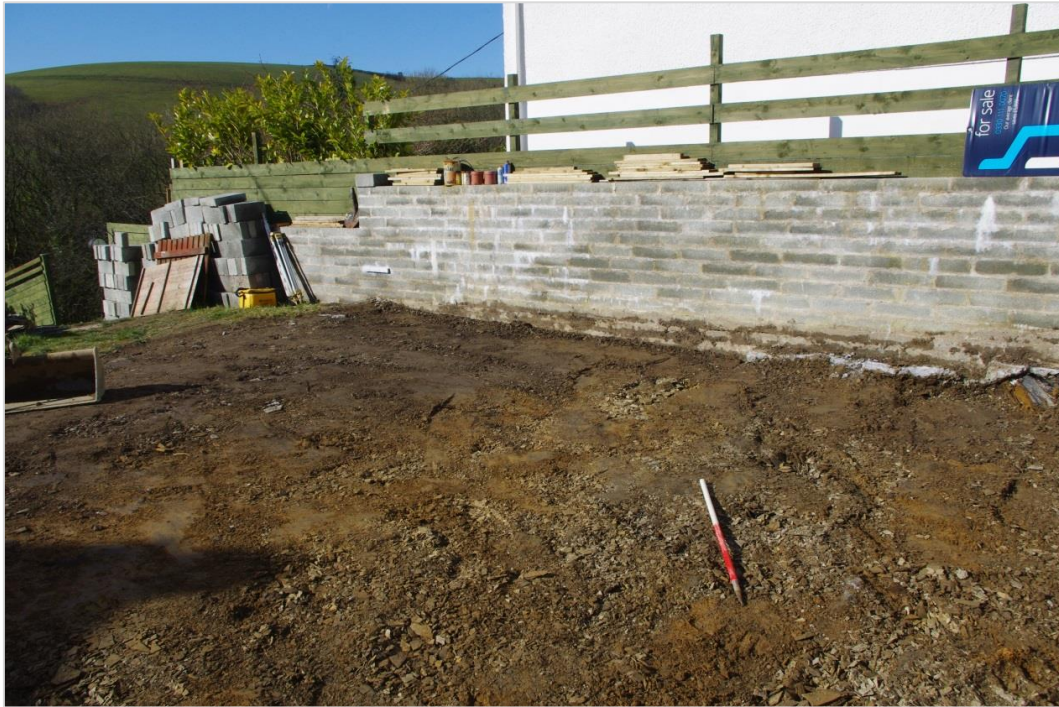
- 4.7 Bedrock was not exposed along the southern edge of the stripped development plot where a dark soil could be seen stretching across the majority of the width of the site (Photo 6).

Photo 6: View southwest across site area showing darker soil area to the south

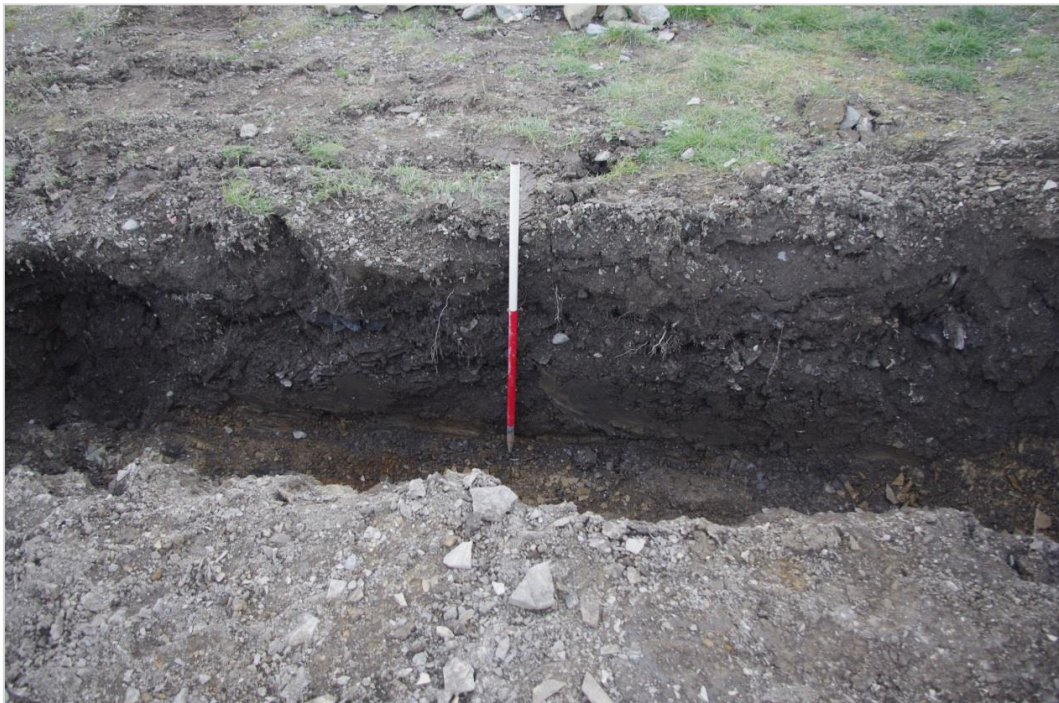
Photo 7: View south of the southern foundation trench for the new building cut through the darker soil area with bedrock exposed in base of trench

- 4.8 The southernmost foundation trench for the new building was excavated through this dark soil area (Photo 7) which indicated that it represented a greater depth of garden soil built up over the bedrock, and that it became

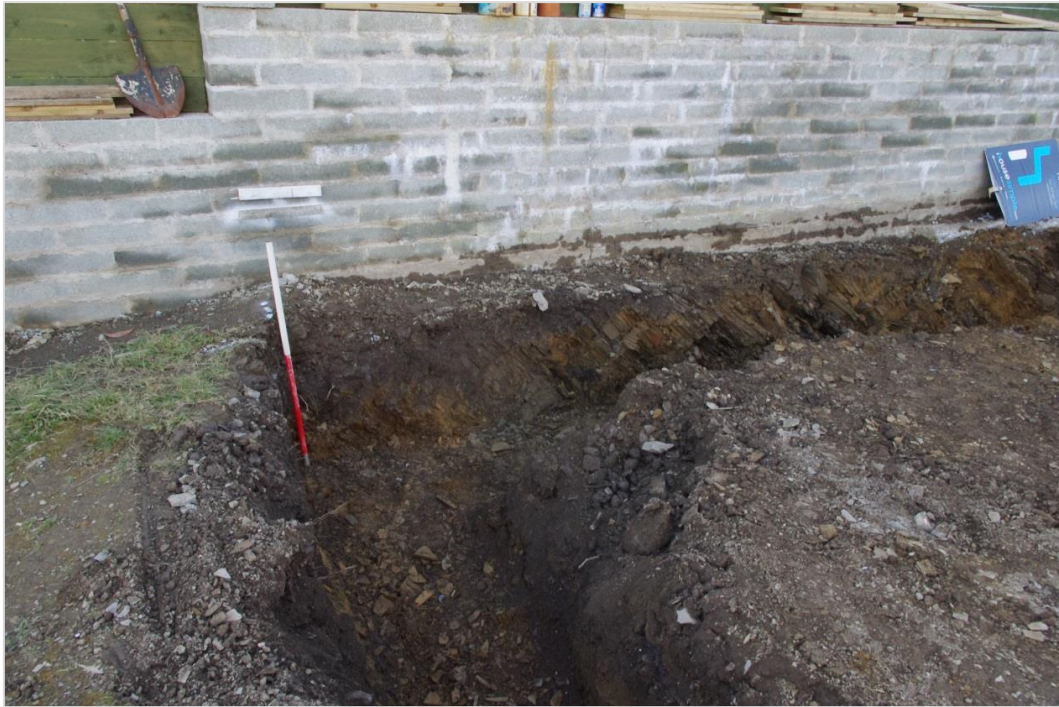
far shallower to the north where the underlying bedrock could be seen clearly rising and thus presumably representing the original gradient of the natural slope (Photo 8). The dark garden soil layer was a maximum of 0.75m depth. A retaining wall was present further to the south, with the remainder of the garden level sloping down beyond this.

Photo 8: View west along southern end of the new building foundation showing the drop in bedrock level to the south

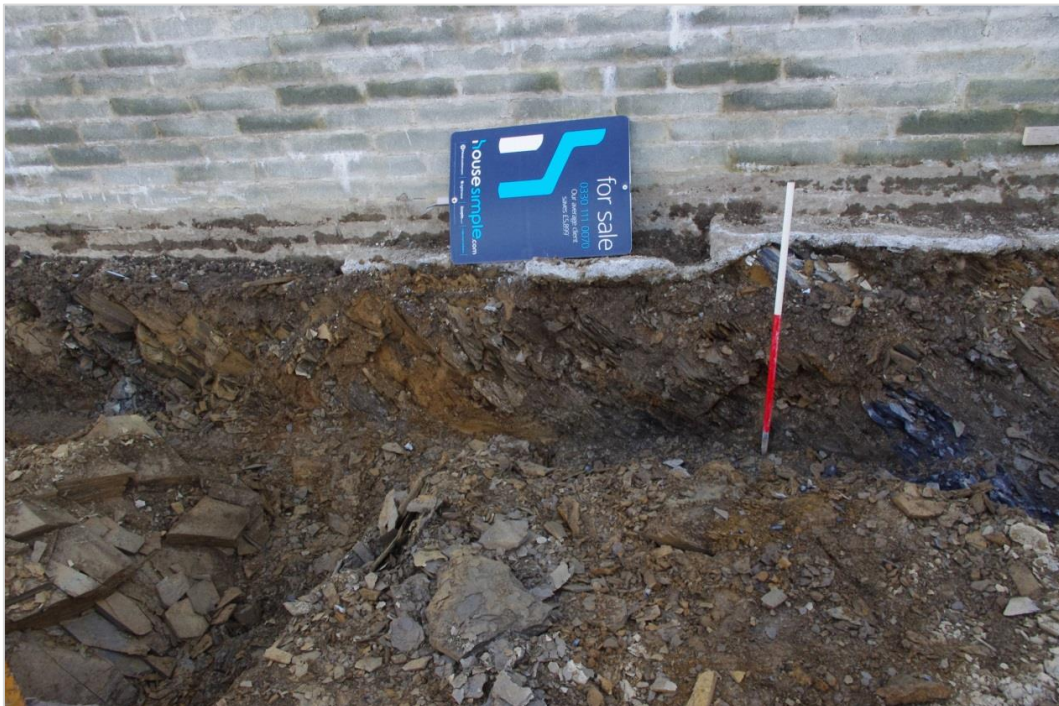
Photo 9: Bedrock exposed in western foundation trench adjacent to Coed Y Pia retaining wall, which sits directly upon the bedrock

- 4.9 Further observation of the foundation trenches demonstrated that they were being excavated directly through bedrock. It was also noted that the retaining wall to Coed Y Pia to the west was built directly upon this lower bedrock level.
- 4.10 Along the northern edge of the site, behind the recently rebuilt retaining wall, a thin area of dark soil behind the wall was present. It is thought that this too represents a deeper depth of garden soils above the bedrock which naturally slopes to the level of the road to the north.
- 4.11 The foundation trenches at the southern end of the site were archaeologically observed, but due to the presence of the bedrock across the development area, further monitoring was not considered necessary.
