EAST QUAY, CARMARTHENSHIRE DOCK, LLANELLI: ARCHAEOLOGICAL WATCHING BRIEF

Prepared by Dyfed Archaeological Trust
For: Morgan Sindall

RHIF YR ADRODDIAD / REPORT NO. 2016/52
RHIF Y DIGWYLLIAD / EVENT RECORD NO. 109389

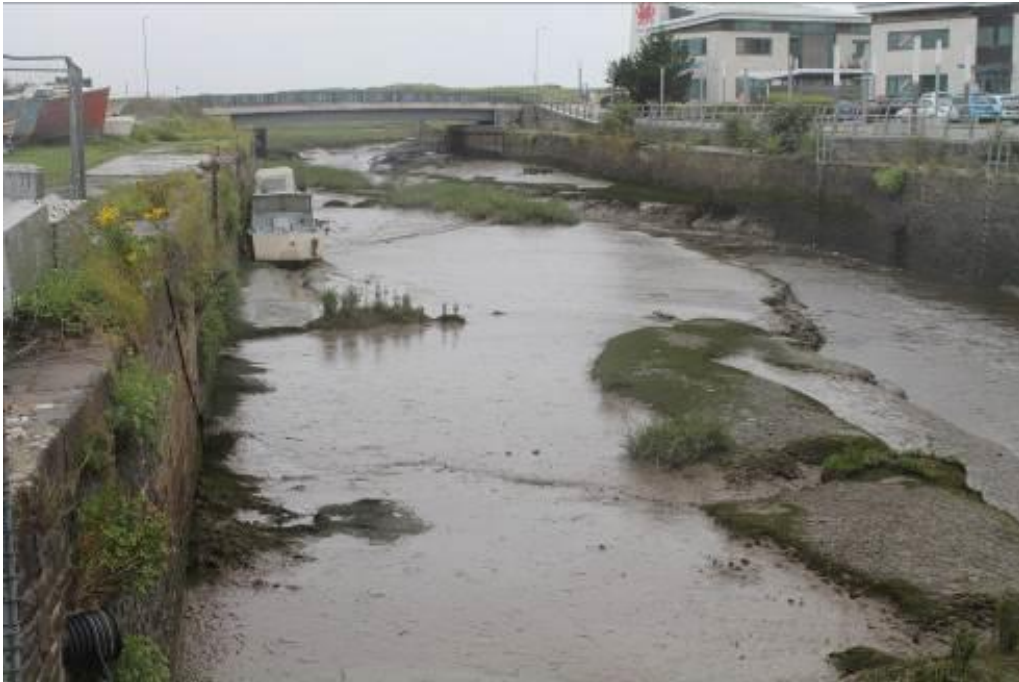
Photo 1: Carmarthenshire Dock looking south-southwest. The metal barriers on the quay at the top left of the picture indicate the position of the trench

- 4.1 Photos 1-3 show Carmarthenshire Dock and the position of the works. In the section of the quay where the works took place (Photo 3), the top two metres of the wall had been repaired. The older phase of wall below this was made up of neatly cut and coursed cuboid blocks of Pennant Sandstone in courses of 18cm on average. The repair was of the same stone and also neatly cut, but in larger blocks up to 36cm tall and with less variable course heights. The upper three of eight courses were thinner.

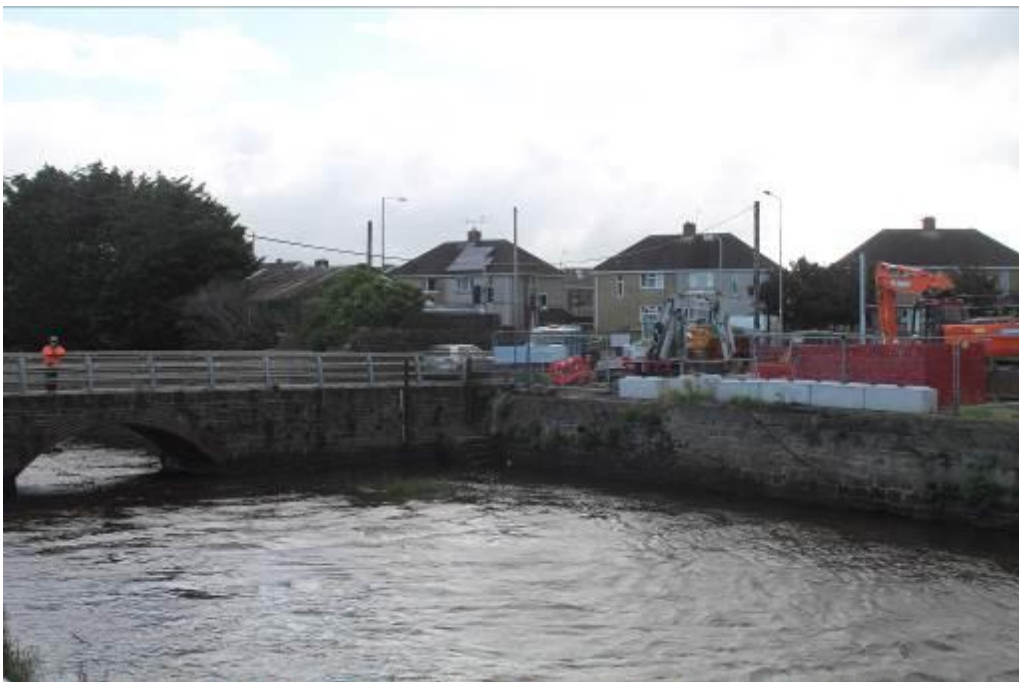
Photo 2: Carmarthenshire Dock East Quay looking east-northeast. The metal barriers and red box at the right of the picture indicate the position of the trench

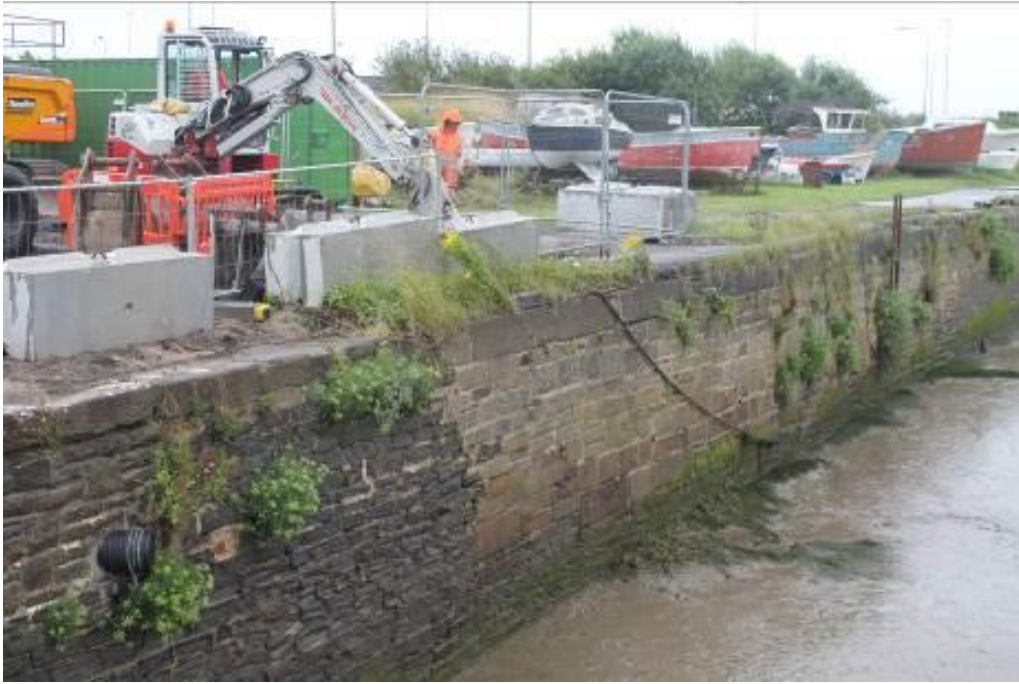
Photo 3: Carmarthenshire Dock East Quay looking south. The taller metal barriers and the digger indicate the position of the trench

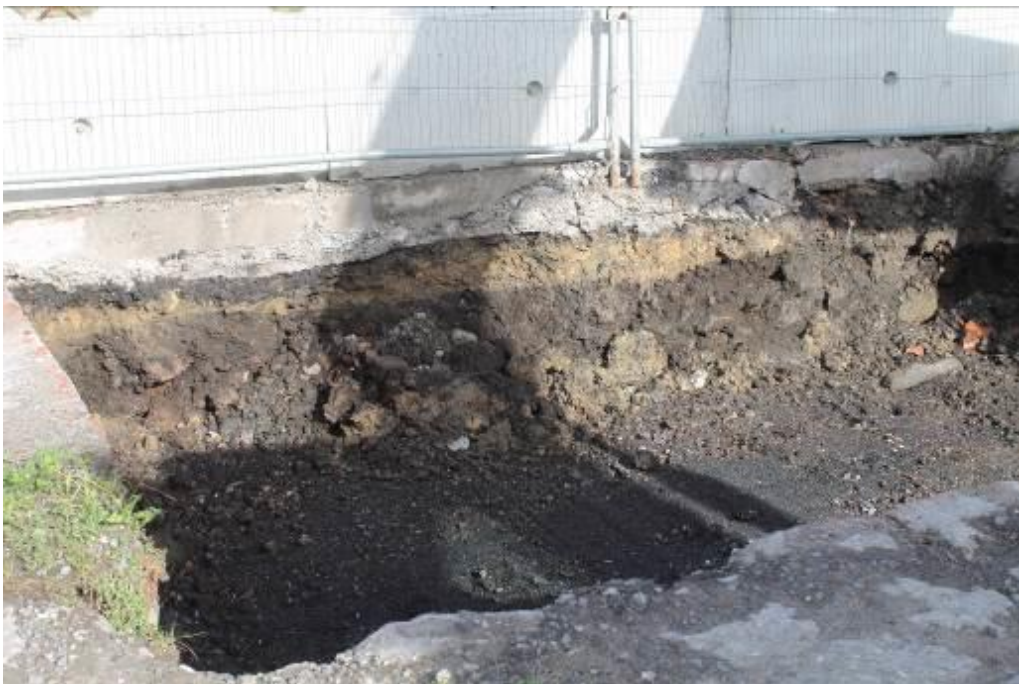
Photo 4: The partially excavated trench against the internal face of the quay wall, looking northwest

- 4.2 The works involved the excavation of a rectangular trench approximately five metres long against the internal wall of the quay, using a seven-ton digger with a toothless bucket. The trench stretched away from the quay wall by three metres – far enough to reach the section of the outflow pipe that had already been installed two metres below the surface of the quay some months previously (not observed by DAT Archaeological Services). The excavation of the new trench had also already been commenced at that time before proceedings were suspended, to a depth of 0.9m. Photo 4 shows the trench at the commencement of the watching brief.

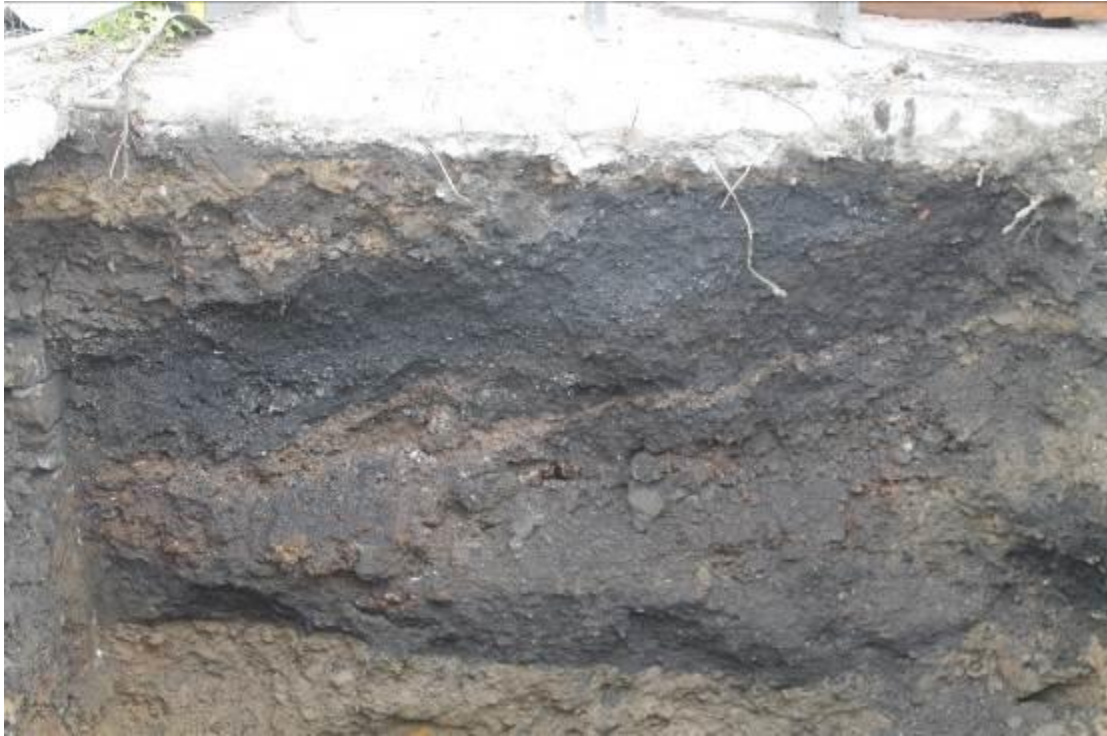
- 4.4 Further excavation of the trench continued to a depth of c.2.8m. At a depth of about 2.2m the relatively flat surface of a layer of re-deposited boulder clay was reached, and no further deposits were found during its removal. Photos 5 and 6 show the two shorter trench edges and all the aforementioned deposits after the groundworks were finished. It can be seen that the clay layer capping the dark industrial material is thickest at the wall and then diminishes in depth until it is absent about 1m away from the wall. In profile it is a flat-topped layer but its bottom edge slopes, and this seems due to the fact that all of the bands of industrial wastes also slope. This would be consistent with the wall having been built first and then the space behind it infilled with dumps of different material.

Photo 5: The south-facing section of the trench (quay wall to left), showing the sloping layers of material making up the quay on top of a relatively flat layer of re-deposited river material

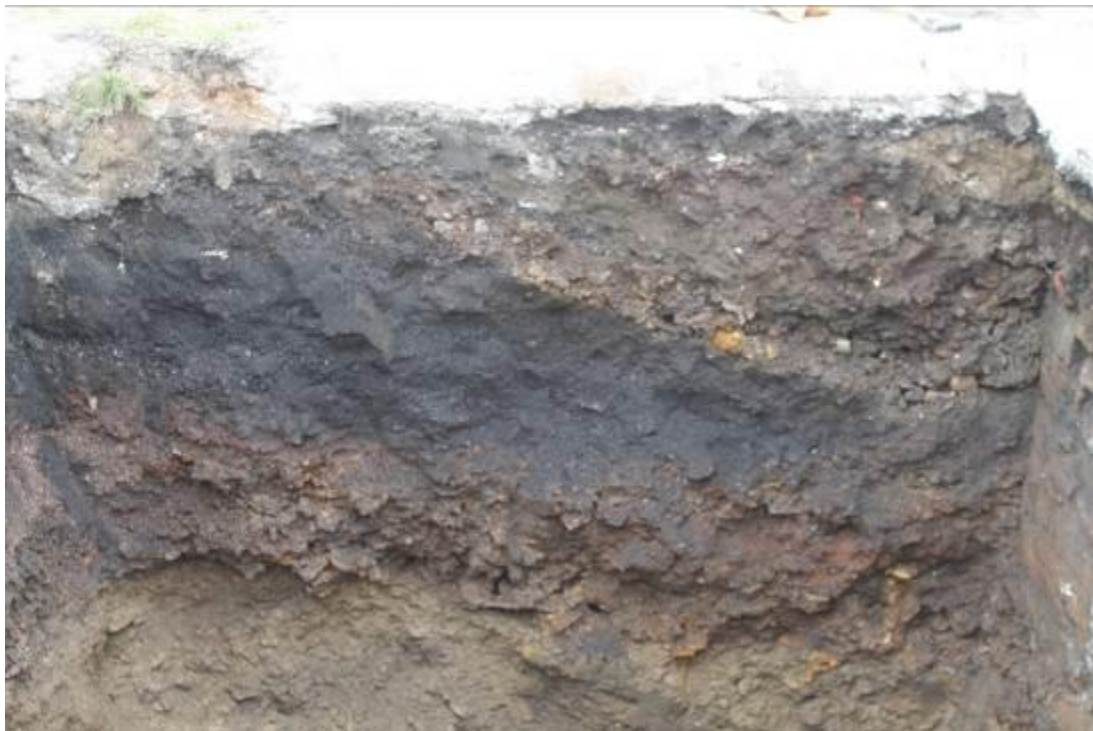
Photo 6: The north-facing section of the trench (quay wall to right), showing the sloping layers of material making up the quay on top of a relatively flat layer of re-deposited river material

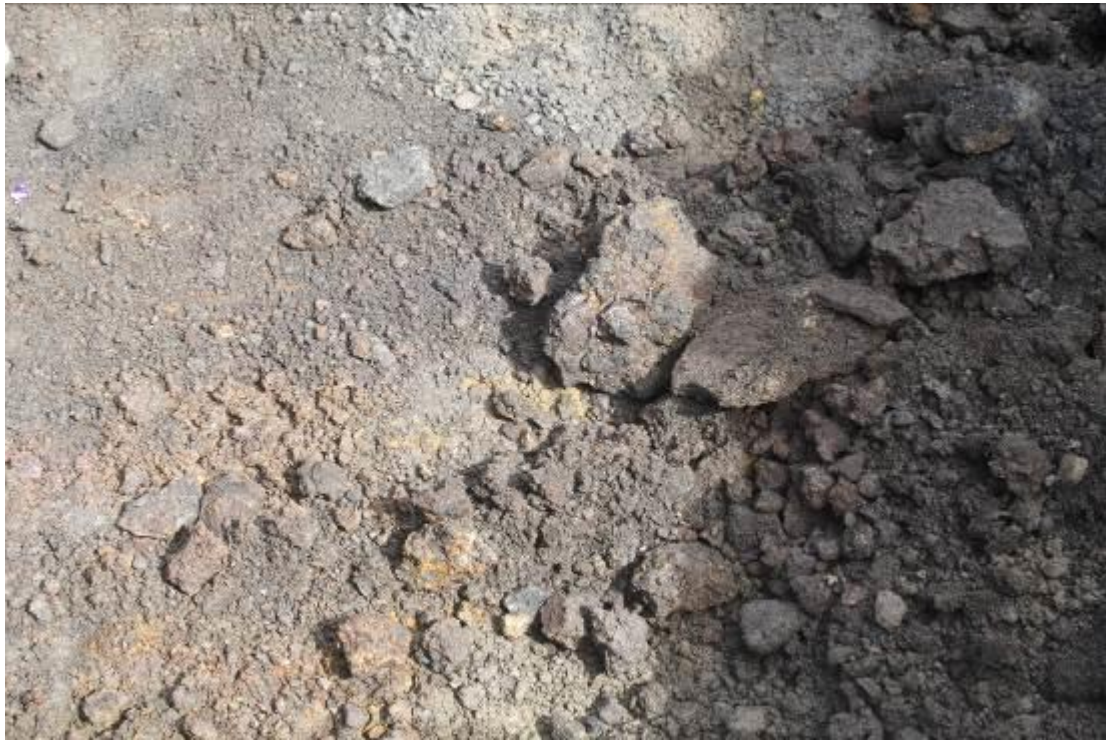
- 4.5 The deepest layer of industrial fill was mainly iron slag (including tap slag with sub-aerial flow patterns) and coal ashes. Between this layer and the clay capping was a less deep and lighter layer containing a far higher percentage of ash. Below the iron slag deposit, a thin layer of pinkish ash separated it from another deep layer of mainly copper slag, ash, and a small amount of copper ore. Photo 7 shows the composition of the thick copper slag layer, mixed up by the digger with a little of the boulder clay, and a typical piece of the slag found in the trench is shown in Photo 8.

Photo 7: The material of the thick copper slag layer, mixed up by the digger with a little of the yellow boulder clay

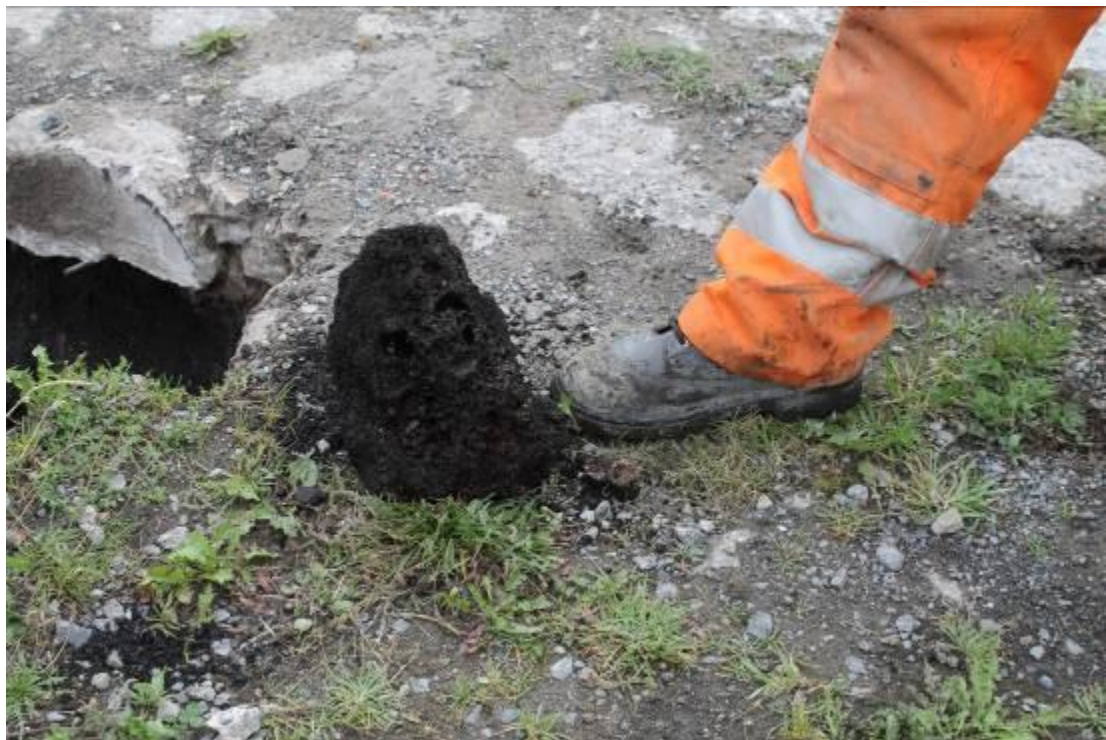
Photo 8: A typical piece of slag found in the trench

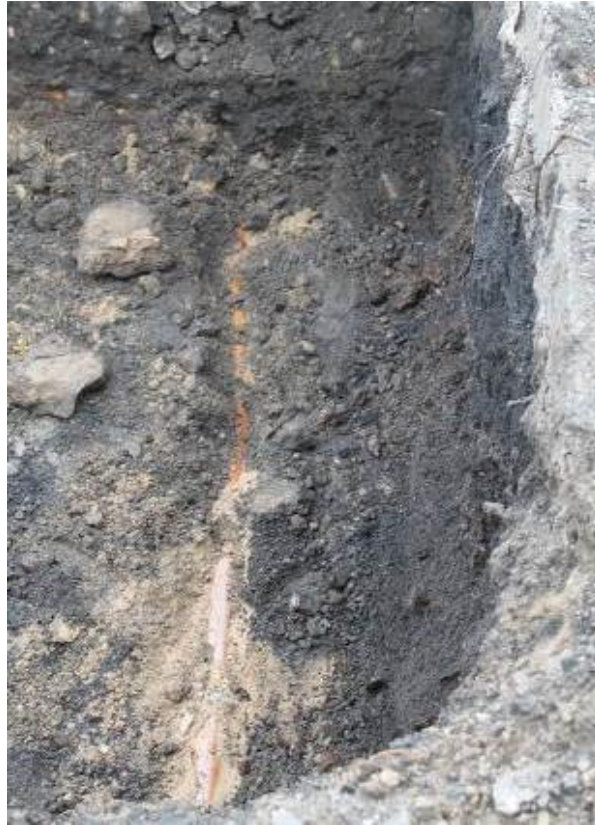
- 4.7 A ceramic drainage pipe of c.10cm in diameter was discovered at a depth of about 1.5m below the top of the trench (Photo 9). Its presence was not wholly unexpected as its exit could be seen in the outer face of the quay wall (see Photo 3). It ran roughly east-west through the trench close to its northern edge. It no longer flowed and was removed. It is thought to have been an outflow pipe for an office building that once stood 5m east of the trench, which is shown on 1970s OS mapping.

Photo 9: The disused ceramic drainage pipe near to the northern trench-edge, looking west-northwest

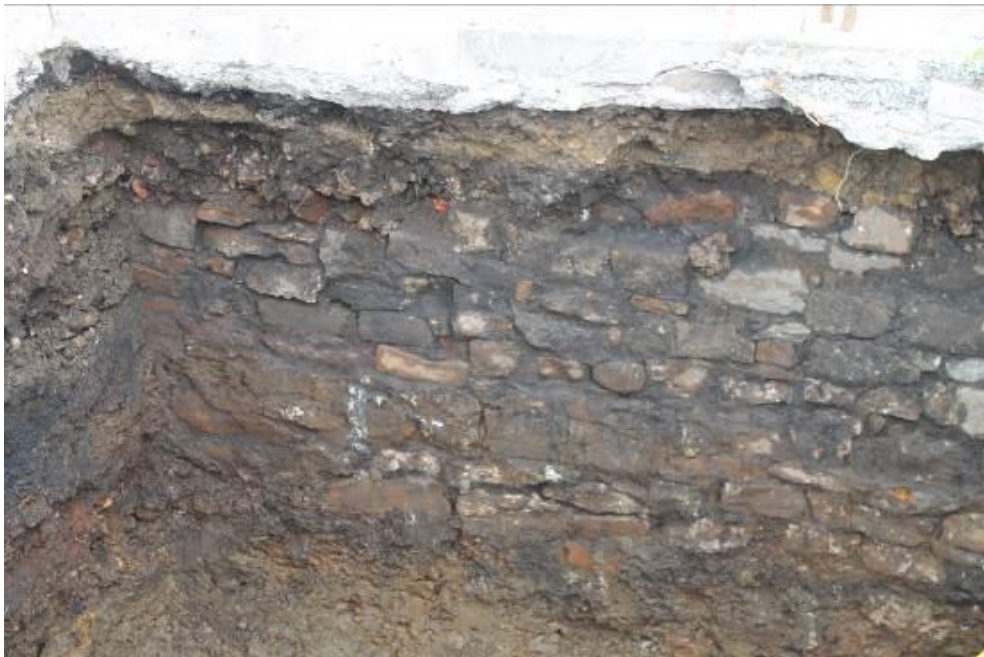
- 4.8 The inner face of the quay wall was cleared of loose fill material using a shovel and then cleaned up further using a trowel (Photos 10 and 11). The wall had a stepped construction, with two steps showing (Photo 12). The first was at 0.3m below the top of the wall/base of the concrete. The width of this step was not established as the clay layer infilled it and supported the concrete cap that had been left above and it seemed wise not to disturb it. The width of the wall below this step was estimated to be c.0.45m. The second step was 0.3m below the first, and was 12cm wide, making the wall about 0.57cm thick at this point. The wall then gently increased in thickness by about 10cm to the bottom of the trench.

- 4.9 The wall construction was of the same material as seen on the outer face, but with rougher coursing and a greater variety of stone in shape and size. The odd brick and lumps of lime mortar and slag were included in the build. It is not possible to say whether this phase of construction was concurrent with the patching to the outside face, which may just have been a facing patch. However, the construction of the inner face does change slightly at a similar depth to that of the outer face, at about 2m below the top of the wall, implying that the whole thickness of the wall may have been re-built. The lower coursing of the inner face is

Photo 10: Inner face of the quay wall, southern end of the trench, looking west

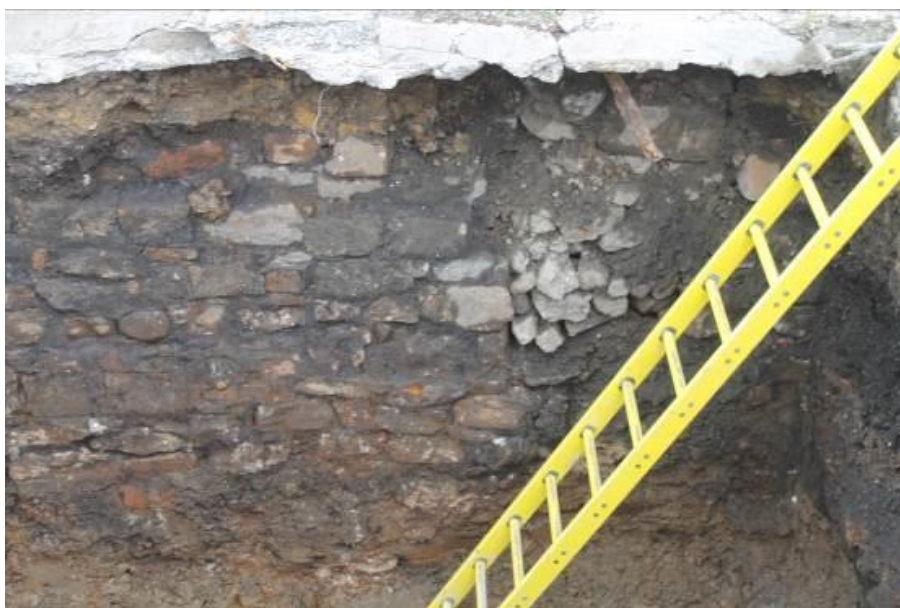
- 4.10 A disturbance to the inner face of the wall was seen in the northern 1.2m of the trench, leaving it only about 0.35m thick and showing a much rougher interior construction to the wall. An old iron pipe containing an electrical cable hung down in this area from the beneath the concrete, giving the impression that the disturbance was probably due to a cut being made from the top of the quay in order to install a cable run, perhaps for ~~former~~ lighting on the quay. Stone rubble, probably from cutting into the inner face of the wall from above, comprised the backfill for the void created as well as at. ~~There was at~~ least one concrete block ~~too~~. Photos 11 and 12 show the disturbed area. Stone rubble was removed from this area during excavation.

Photo 11: Inner face of the quay wall, northern end of the trench, looking west-northwest

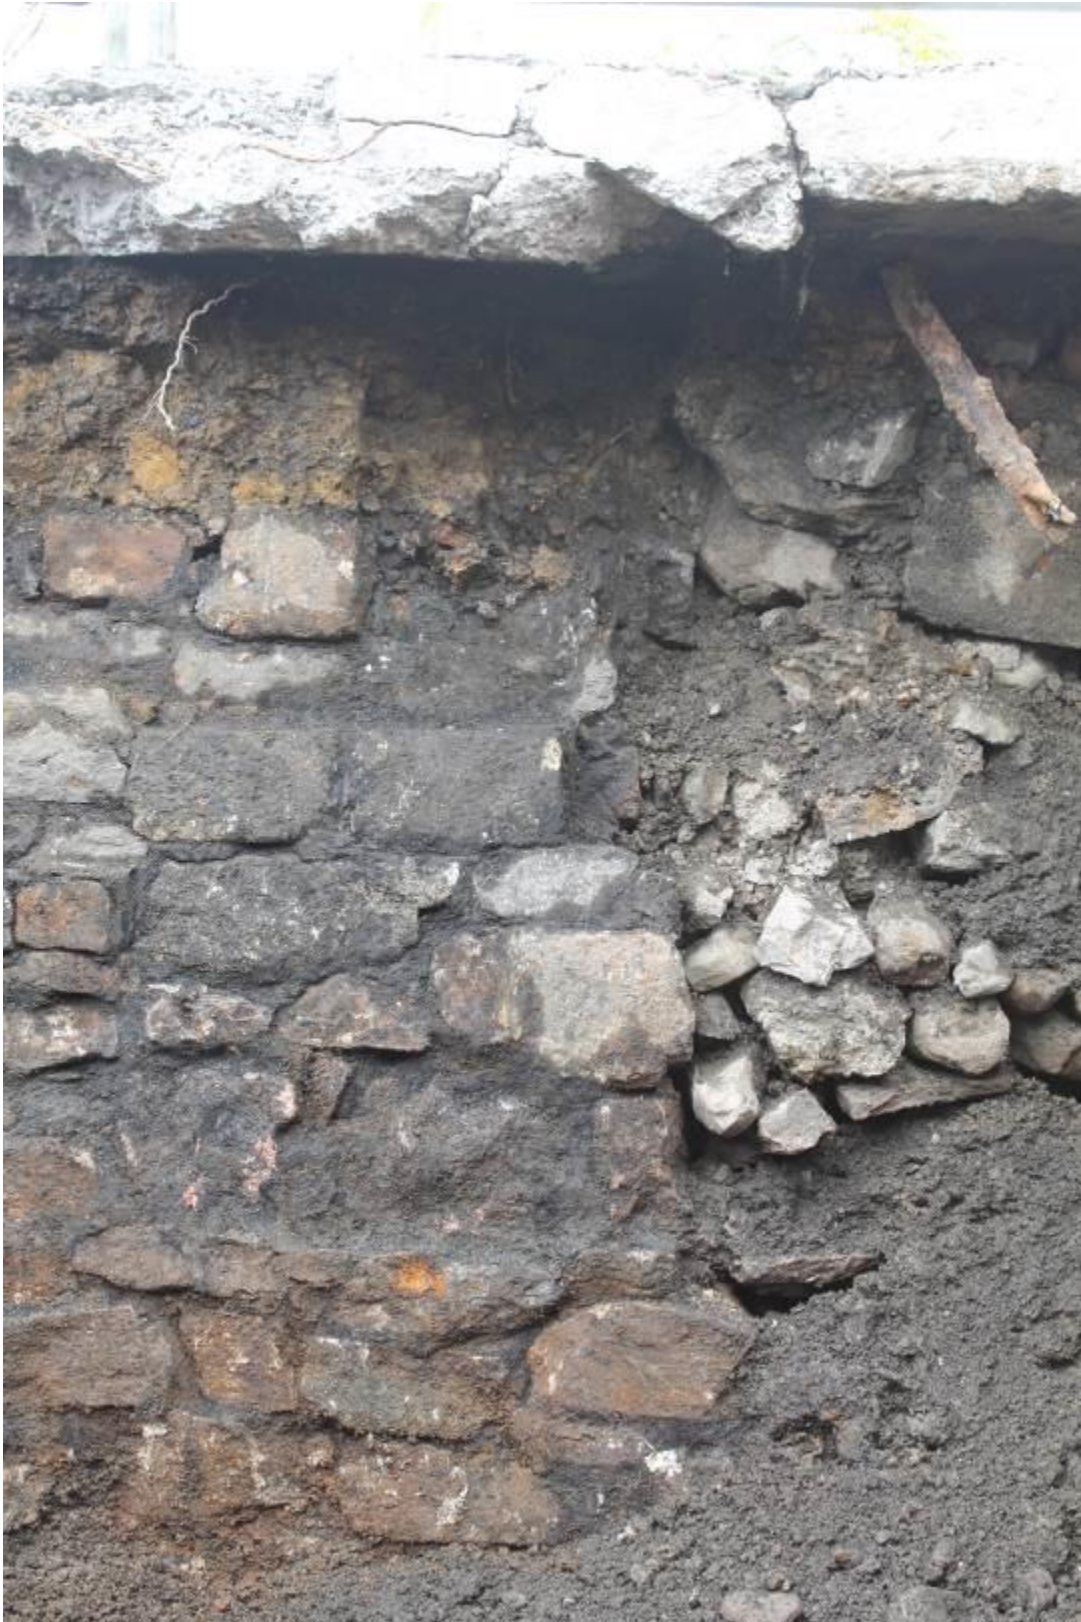
comparatively more regular, with larger more angular stones and less small stones in between them (Photo 12).

Photo 12: The inner face of the quay wall near to the northern edge of the trench. On the left side of the image the wall's stepped construction can be seen along with the change in coursing towards the base. On the right, the disturbed area of the wall shows, backfilled with stone and with the old metal pipe containing an electrical cable hanging down beneath the concrete.

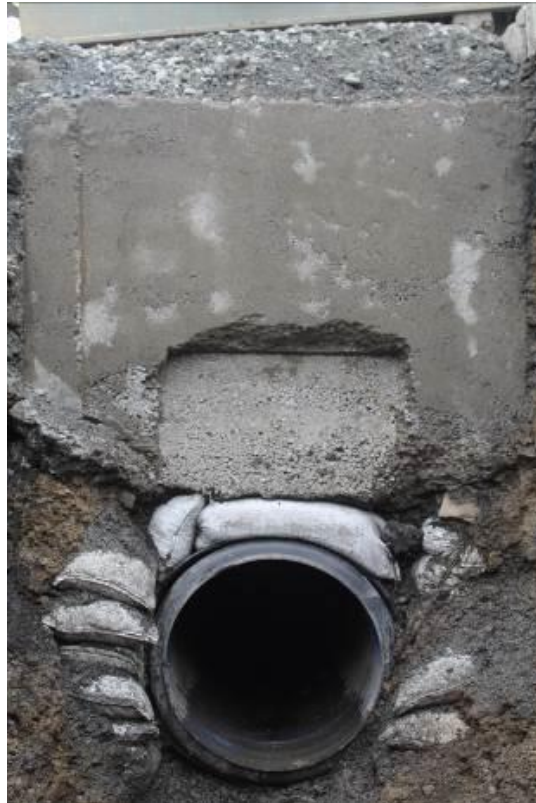
- 4.11 Photo 13 shows the pipe that had already been installed to the rear of the trench. Its diameter was 0.7m and its depth at the top lip was about 1.8m. This diameter of hole at this same depth was needed to be inserted through the quay wall for the pipe outflow. This was not observed during the watching brief as the inner face of the wall had already been recorded during the watching brief, and the outer face by Cotswold Archaeology. The inner core of the wall had also already been observed in the disturbed area.

Photo 13: The eastern face of the trench, showing the previously installed pipe, 0.7m in diameter with its top lip at a depth of about 1.8m.
