PROPOSED NEW GARAGE, SUN ROOM AND HIGHWAY ACCESS AT WEST TARR FARM, ST FLORENCE, PEMBROKESHIRE

ARCHAEOLOGICAL WATCHING BRIEF (SN08900075)

RHIF YR ADRODDIAD / REPORT NO. 2016/55 RHIF Y DIGWYLLIAD / EVENT RECORD NO.109392

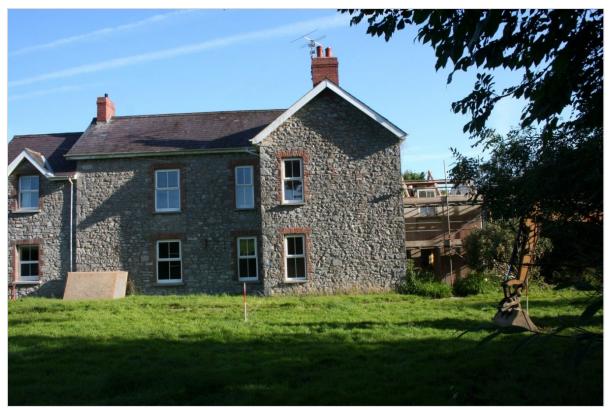
Photo 1: The southern gable end of West Tarr Farmhouse prior to groundworks (DAT Photo 109392-4101)

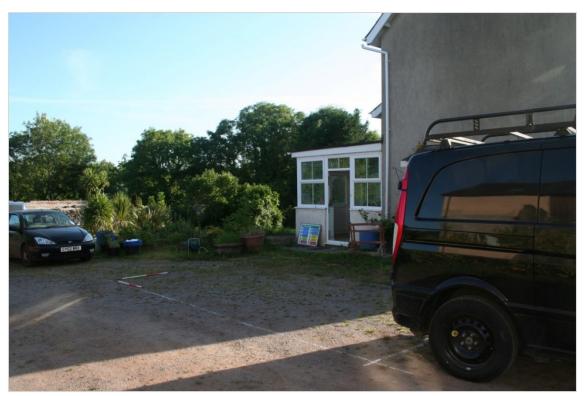
Photo 2: The western end of West Tarr Farmhouse prior to the commencement of groundworks (DAT Photo 109392-4104)

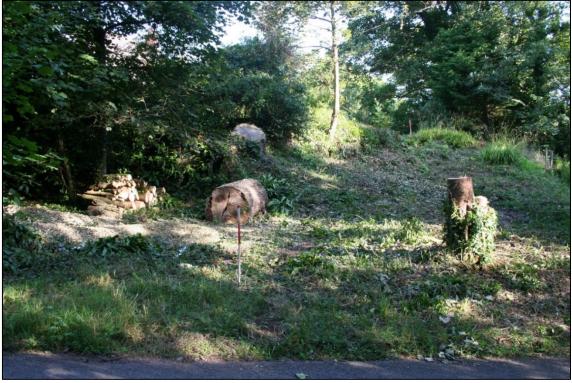
Photo 3: The proposed route of the new highway access to West Tarr Farmhouse. Note the ranging poles in the foreground and background indicating the difference in ground level (DAT Photo 109392-4102)

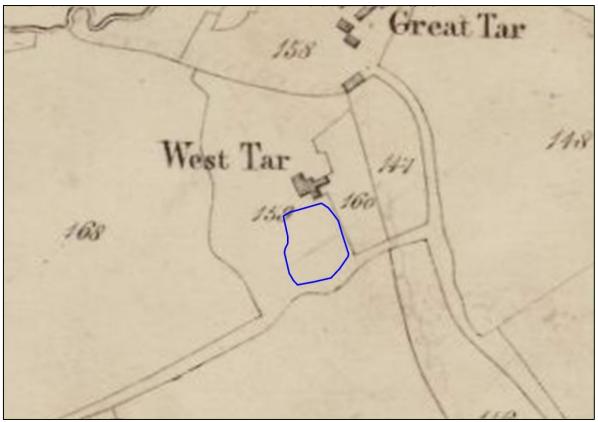
Figure 5: An extract from the Penally tithe map c.1842 showing the West Tar farmstead and the vacant development area (outlined in blue)

3.2.1 The Penally Parish tithe map depicts the modest farmstead of "West Tar" which comprises a single building sited in the area encompassing West Tarr vaulted hall house (PE423) (Figure 5). This presumably is a farmhouse which most likely encompassed the earlier, medieval building. The present farmhouse has yet to be constructed and consequently the development area is shown to be vacant and undeveloped.

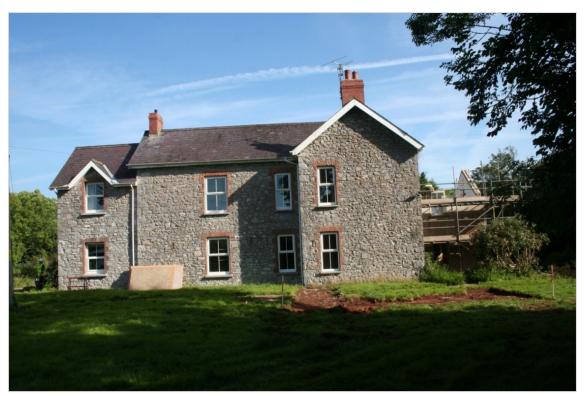
5.3 Work began with the topsoil stripping of Trench 1 at the southern gable end of the house. A modern concrete path truncated across the width of the trench area. Trench 1 actually comprised a trench measuring approximately 7.2m east-west and 8.6m north-south (Photo 4). Between 160mm – 250mm of loamy, medium brown topsoil (101) was removed, from which fragments of late, post-medieval white-glazed pottery, fragments of animal bone, coal, glass and slate were recovered but not retained. Removal of the topsoil revealed an orange-brown, clay-silt subsoil (102) through which the limestone bedrock (103) was protruding (Photo 5). No archaeological deposits or features were seen in this trench.

Photo 4: The stripped Trench 1 located at the southern gable of the farmhouse. 2 x 1m scales (DAT Photo 4117-109392).

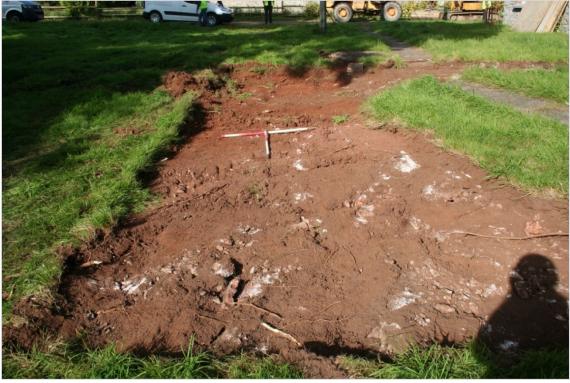
Photo 5: The limestone bedrock (103) protruding through the clay-silt subsoil (102) in Trench 1. 2 x 1m scales (DAT Photo 4112-109392).

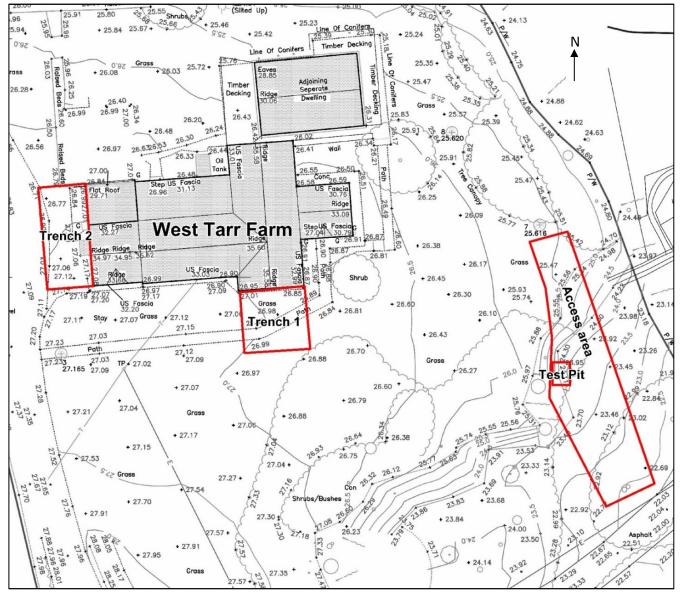
- 5.1 This watching brief monitored the mechanical topsoil stripping of two foundation trenches and a new highway access to West Tarr Farm (Figure 8).
- 5.2 On arrival, the locations of the foundation trenches, and new access route were demarcated and photographed. Foundation Trench 1 was located at the southern gable end of the farmhouse (Photo 1) with the Trench 2 located to the rear of the house, along the western end (Photo 2). The new highway access commenced south-east of the farmhouse, curving gently up to the house with an ascent of around 3m (Photo 3).

Figure 8: Plan showing location of the foundation trenches, and extent of watched area for new highway access and excavated test pit. (Plan not to scale; supplied by Tim Colquboun Architects Ltd)

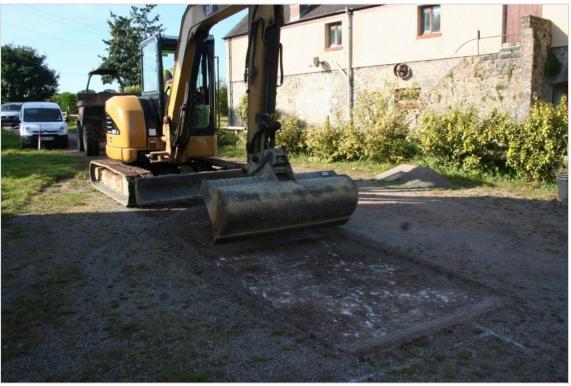
5.4 Trench 2 was located parallel to the western end of the house, in an area of gravel hardstanding (Photo 2). Trench 2 was an irregular shaped trench of maximum dimensions 6.1m x 6.8m x 1.2m wide (a single bucket width as before). Around 100mm of gravel hardstanding material (201) was removed to reveal that the area had previously been stripped of soil (presumably during periods relating to the construction and recent extension to the house), revealing limestone bedrock (202) (Photos 6 & 7). A small exploratory hole was excavated by the contractors against the base of the wall at the southern end of the trench to locate a modern cable. No archaeological features or deposits were seen in this trench.

Photo 6: Stripping the gravel hardstanding (201) within Trench 2 revealing the limestone bedrock (202) below (DAT Photo 4106-109392).

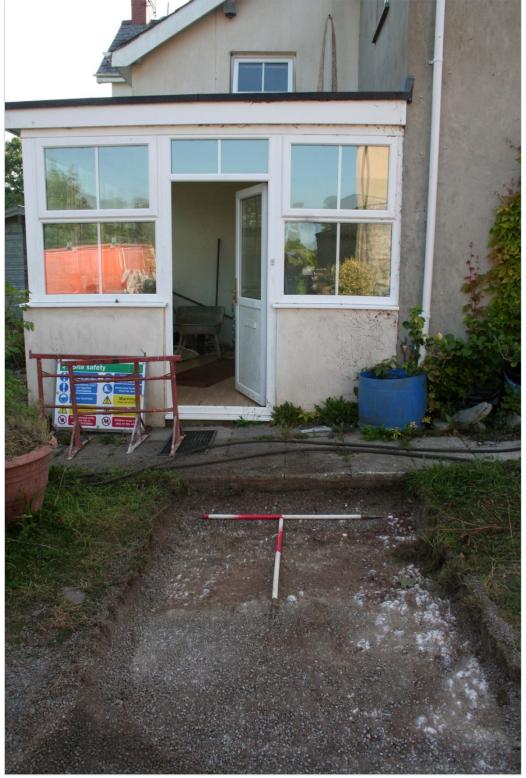
Photo 7: Trench 2 – after the removal of gravel hardstanding (201) revealing limestone bedrock (202). 2 x 1m scales (DAT Photo 4118-109392).

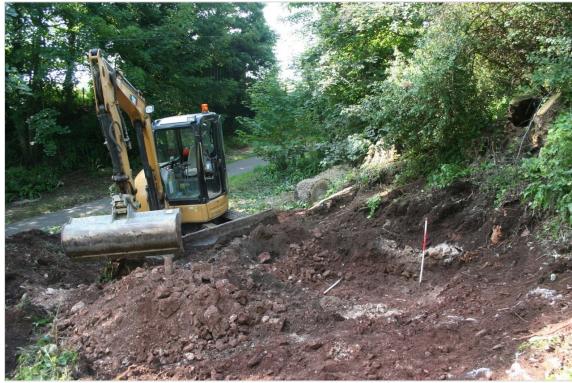
- 5.5 Finally, work progressed to the removal of vegetation and stripping for the new highway access route. As identified on historic mapping, there is a disused quarry located at the south-east of the limestone outcrop on which the house sits. The quarry has been disused for some time and consequently heavily vegetated and has been partially backfilled. The new highway traverses the eastern edge of the quarry (Photo 3). Up to 450mm of humic topsoil and detritus (301) was removed and a small test pit measuring approximately 1.5m wide and 2m long was excavated along the western side of the edge of the route, nearest to the quarry face (SN0892800749) (Photo 8). A layer of slacked lime (302) was revealed to be underlying the humic overburden. This layer of lime varied in thickness from around 50mm - 250mm, appeared to contain charcoal and overlay up to 650mm of limestone rubble in a light brown-grey, silt (303) which overlay the limestone bedrock (304). This test pit was backfilled and no further levels were excavated (Photo 9.) although it was possible to reveal a small section of the quarry face above the test pit (Photo 10).

Photo 8: The ranging poles indicate the location of the test pit excavated within the new access area. 1m scale (DAT Photo 4129-109392).

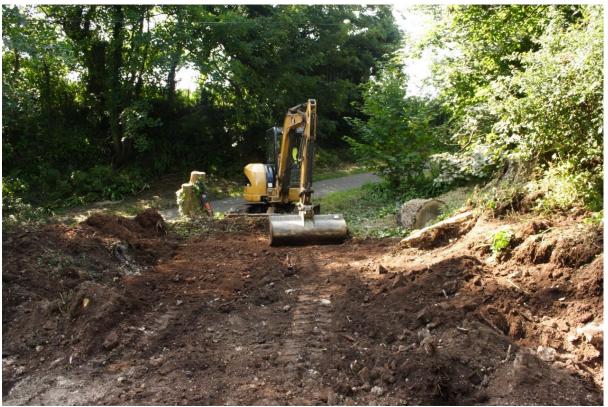
Photo 9: The stripped new highway access route (DAT Photo 4133-109392).

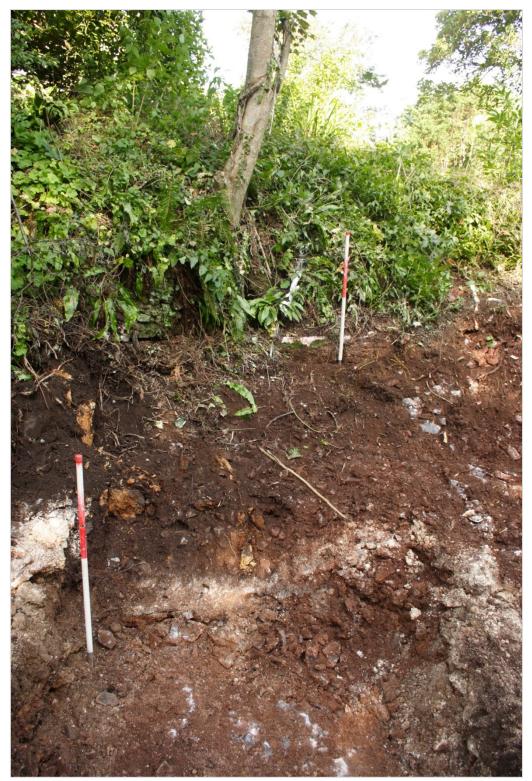
- 5.6 In the limited area of the test pit it was not possible to identify any associated cuts, features or structures with the lime layer (303). It is possible that this layer represents kiln waste from nearby limekiln (PRN 15877) situated some 100m north of the test pit, or *in situ* slacking of quicklime for the production of mortar.

Photo 10: The lower ranging pole indicates the approximate base of the lime layer (302) whilst the upper pole indicates a small section of the quarry face revealed above the test pit excavated within the new access area. 2 x 1m scales (DAT Photo 4132-109392).
