MACHYNYS HOUSE, LLANELLI, CARMARTHENSHIRE ARCHAEOLOGICAL EVALUATION 2016: INTERIM REPORT

Prepared by Dyfed Archaeological Trust
For Cadw

REPORT NO. 2016/63
EVENT RECORD NO. 109401

March 2017

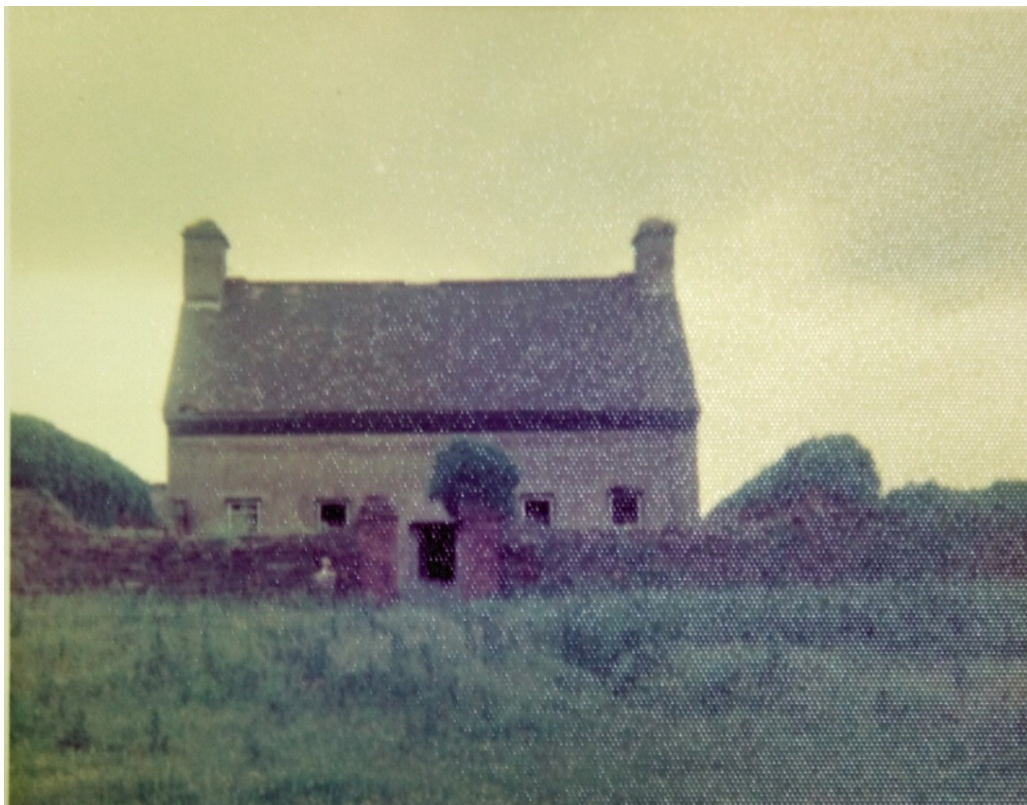
Photo 4: Western façade of Machynys Farm c.1970 (CRO ref: DX/35/2)

The western façade of the building as shown in Photo 4 shows a stone built front with only ground floor windows visible. This is considerably different to the building to the rear (Photo 5) and is most likely an earlier building that was incorporated into the later double piled house. The building is said to have had a vaulted cellar with a cobbled floor.

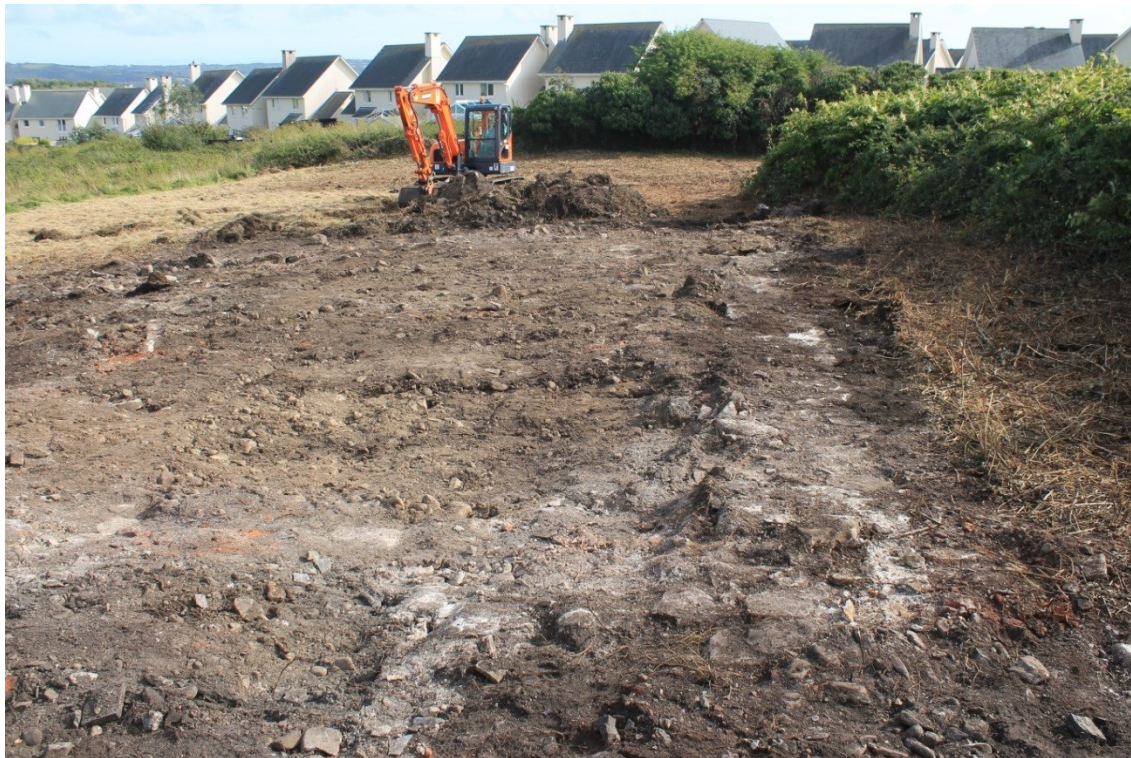
Photo 9: The front west wall of Machynys House made visible during machining.

Following the vegetation clearance a 360° mechanical excavator fitted with a flat bladed bucket removed a shallow layer of soil and demolition. Beneath this rubble the footprint of the west end of the house (Photo 9) could be clearly seen, as well as the outline of cellar areas.

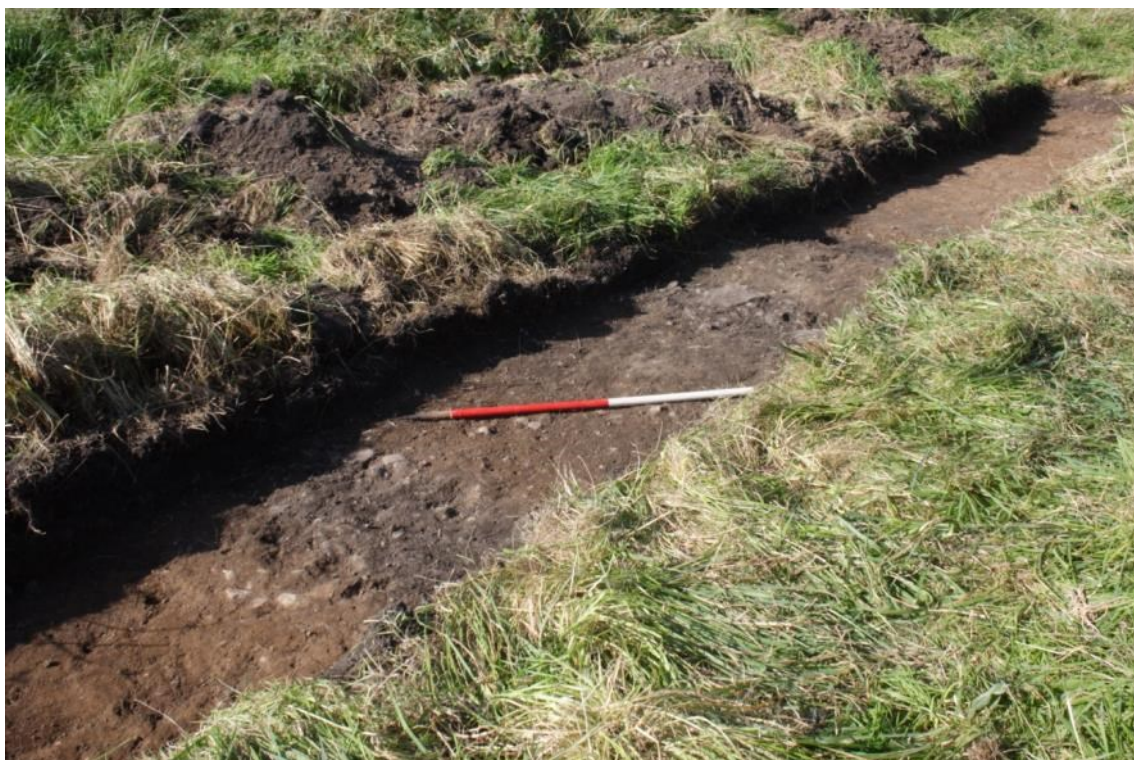
Photo 12: Evidence of a former trackway running across Trench 4. 1m scale

A number of trenches (Figure 3) were excavated by mechanical excavator down onto either archaeological levels or the underlying natural undisturbed ground surface. The trenches were cleaned by hand (Photos 10 & 11). Few archaeological features could be identified apart from a number of cultivation marks [304] & [314] (from which we had pottery) in Test Pits 2 and 3 and a spread of stone (103) across the southern half of Trench 1. There was evidence of a former trackway running diagonally across Trench 4 (Photo. 12). The trackway was visible as an area of compacted natural subsoil with 3 parallel shallow stone filled linear cuts; probably ruts filled with stone.

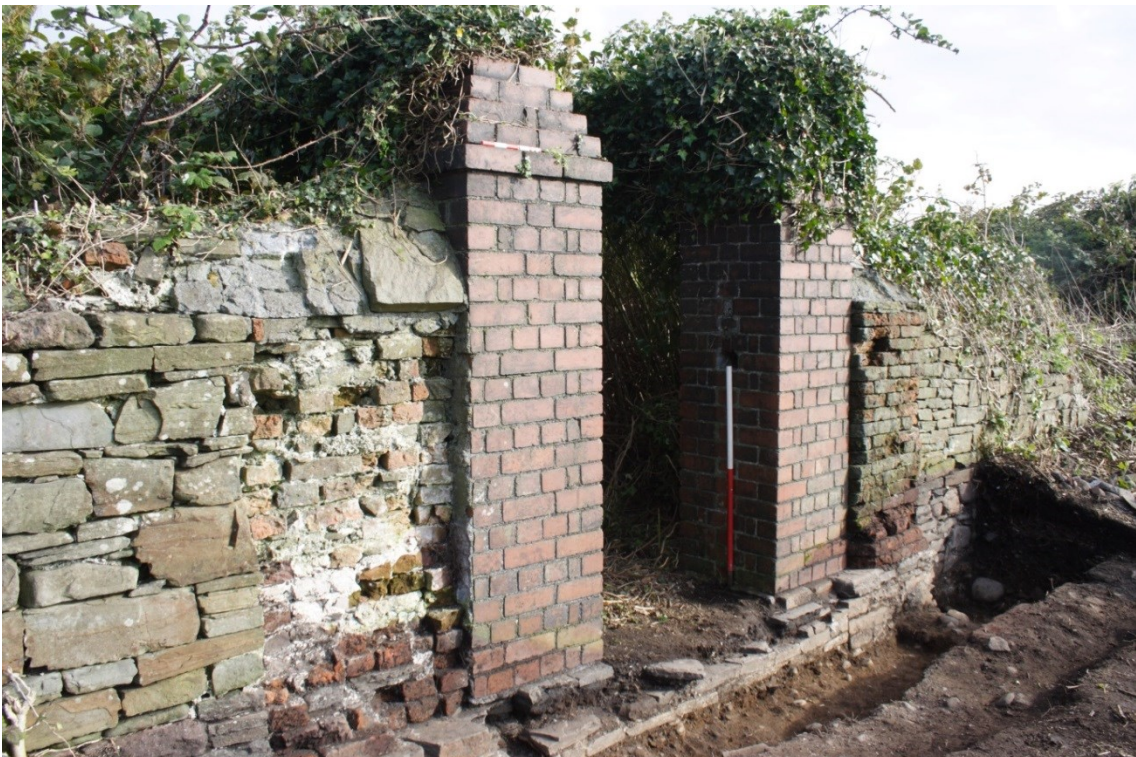
Photo 18: Trench A – showing the pillars of the west gateway. 1m scale

The foundations of the main wall lay roughly 0.40m below the current ground surface but approximately 0.25m lower were two stone pillar bases that projected 0.14m out into the trench. Constructed on these two bases were two pillars built from red handmade bricks without indentations. The pillars were c.1.85m high and c.0.75m wide forming an entrance just over 2m wide; wide enough for a cart perhaps. These earlier pillars were not keyed into the stone walls to the north and south and may not be the original pillars that sat on the projecting stone bases.

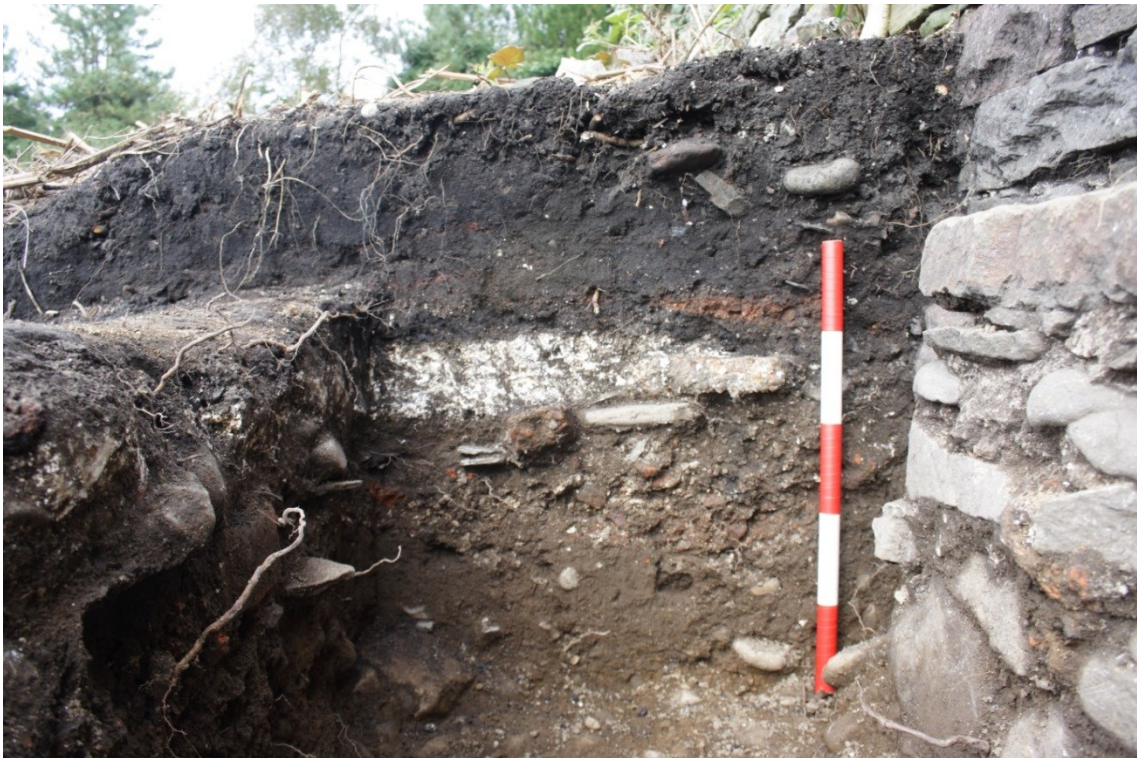
Photo 20: The layers of ash, clinker and chalk built up against the west wall in the gateway area. 0.5m scale

the cut for the wall cut through a loose mid brown sandy silt with 40% angular small stone. Overlying the backfilled wall construction cut were a number of deposits butting up against the wall indicative of a sequence of different dumps of discarded material and rubbish deposited over some period of time. The deposits included much ash and clinker, smashed window glass and gravel; containing, in contrast to the test pits, quantities of 18th, 19th and 20th century pottery, window and bottle glass, slate, iron objects including quantity of nails, animal bone, many showing butchery marks, clay pipe fragments and mussel and cockle shells. Within Trench A and B these deposits overlay an obvious deposit of chalk and flint nodules (1102). Within Trench C they overlay a thick layer of rounded stones within a silt matrix similar to that recorded in the southern half of Trench 1.

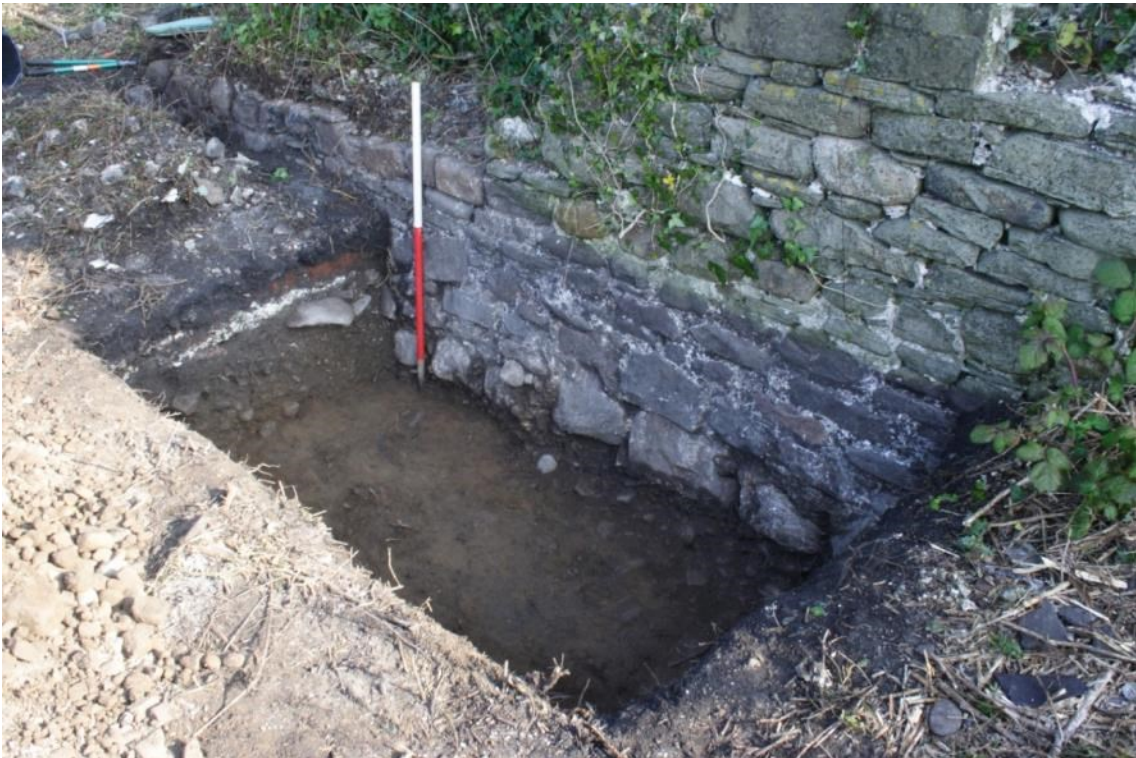
Photo 22: Looking northeast at Trench B showing the substantial foundations of the garden wall. 1m scale.

Trenches A, B and C revealed the substantial depth of the foundations for the garden wall; in Trench B they extended 0.60m below the current ground surface and in Trench C 0.85m below. There was some evidence for a narrow construction cut [1107] running parallel with the wall that was difficult to see in plan but visible in section. No datable finds were recovered from this cut so it was not possible to date the wall construction.
