**MAIDENWELLS RELIEF ROAD,
PEMBROKESHIRE
ARCHAEOLOGICAL
WATCHING BRIEF
(NGR SR 196920 199730)**

RHIF YR ADRODDIAD / REPORT NO. 2017/01
RHIF Y DIGWYLLIAD / EVENT RECORD NO. 110317

MAIDENWELLS RELIEF ROAD, PEMBROKESHIRE
ARCHAEOLOGICAL WATCHING BRIEF

ARCHAEOLOGICAL WATCHING BRIEF

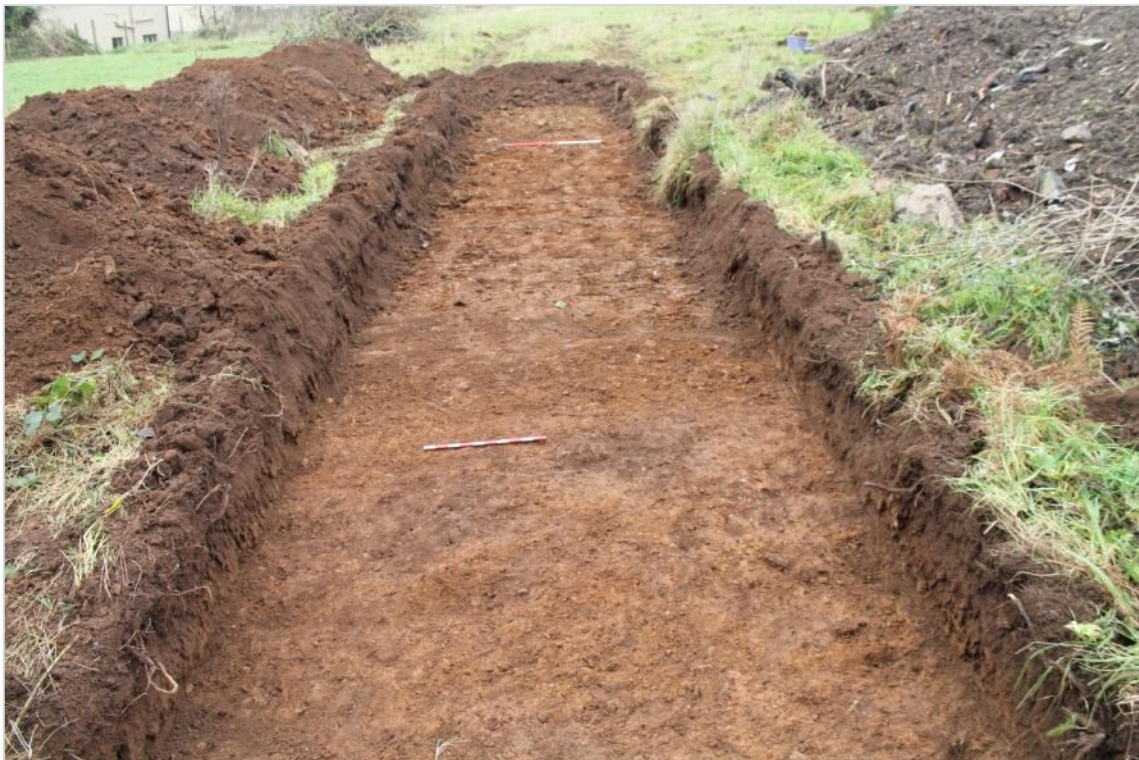
Photo 3: View west along Trench 1 showing root disturbance in the natural ground. 1m and 0.5m scales.

- 4.1.1 Trench 1 (Photo 3) was located at the eastern end of an approximately 80m long by 3m wide curvilinear feature (Figure 6). It is described by AB Heritage; in the legend accompanying their geophysical survey, as 'positive features with associated negative areas' - possible bank and ditch (Figure 5).
- 4.1.2 The trench measured 12m in length and was 2.2m wide with an average depth of 0.3m. It was aligned in an east-west direction and was excavated to the underlying natural undisturbed ground surface.
- 4.1.3 The medium brown loamy topsoil was of a consistent depth along the whole length of the trench and stood directly on top of the orangey-brown, silty-clay natural. At the east end of the trench the natural became yellower and stonier.

- 4.1.4 Within Trench 1 at the western end, there was evidence of root action penetrating the upper surface of the natural subsoil. No archaeological evidence for a bank or ditch was identified.

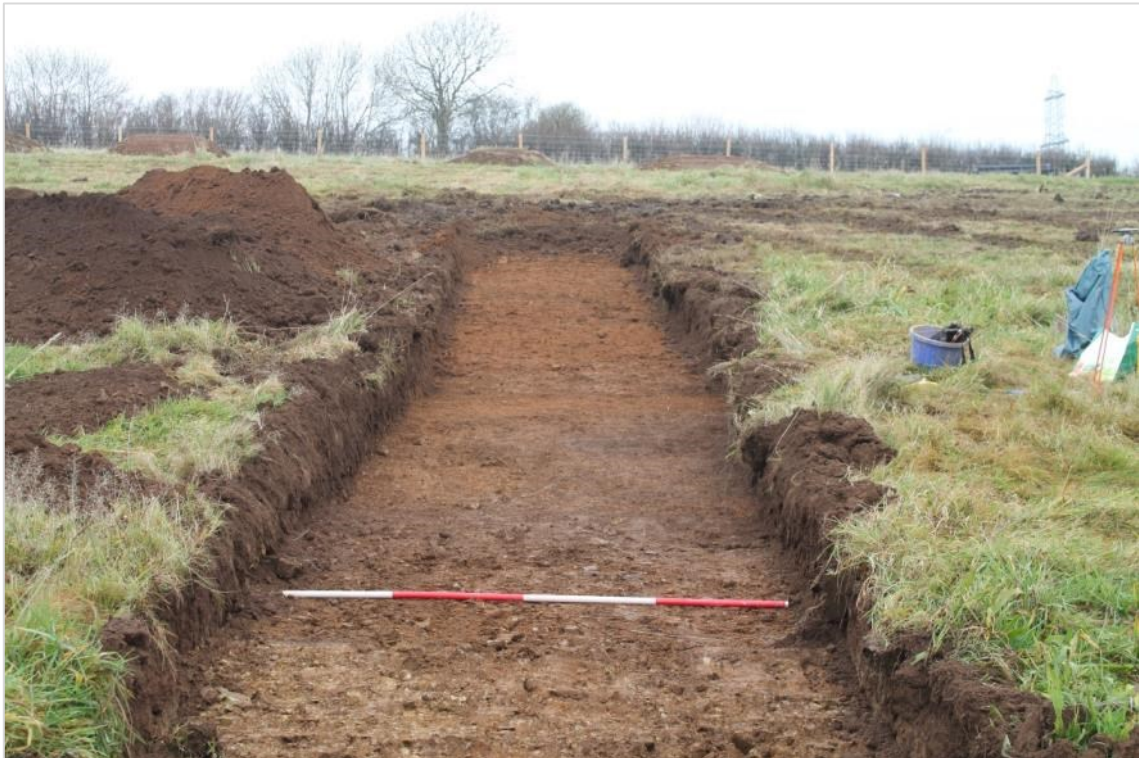
Photo 4: View north along Trench 2 - band of silting visible above 2m scale.

- 4.2.4 A band of medium brown, silty clay c. 2m wide traversed the trench in approximately the position identified by the geophysical survey (Photo 2). When this was further investigated by trowelling it was discovered to be only c. 0.05m thick and resolved itself into thin amorphous patches on the surface of the natural (Photo 5).

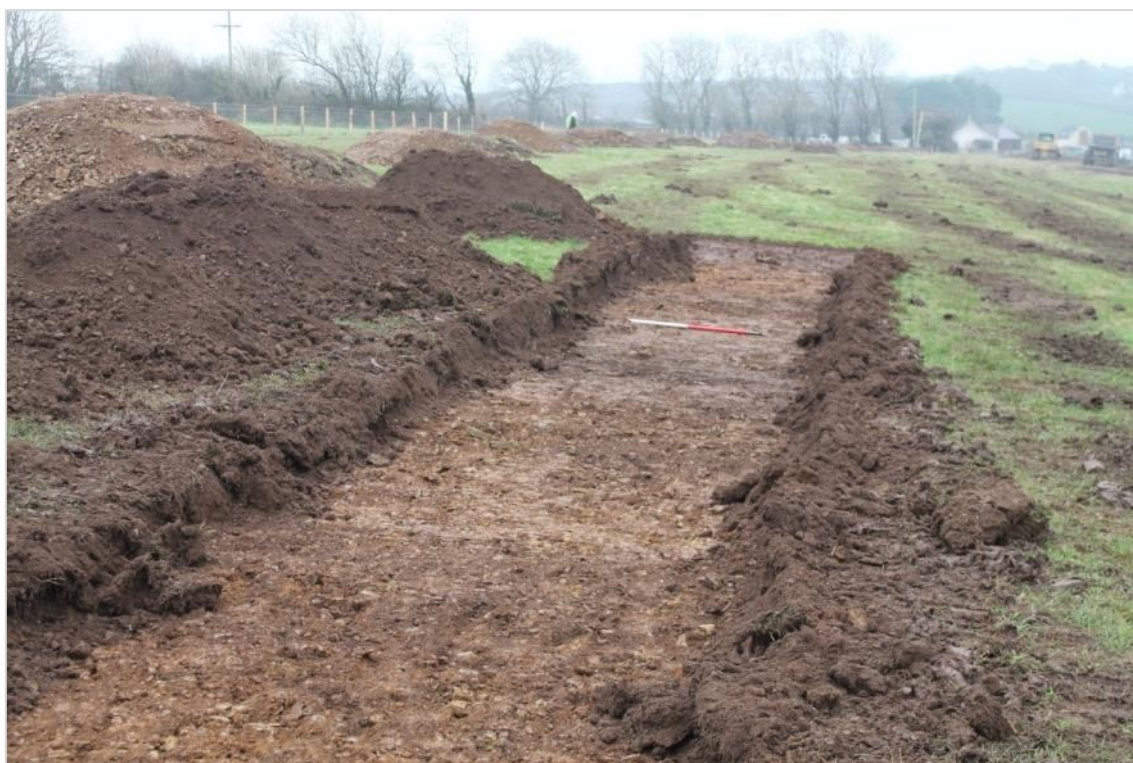
Photo 6: View east along Trench 3; band of darker material can be seen traversing trench in front of 1m scale.

- 4.3.4 A band of dark brown, silty clay c. 2.5m wide traversed the trench in a similar position identified by the geophysical survey (Photo 6). Upon further investigation the deposit was revealed to occupy a gentle undulation in the bedrock and was approximately 0.1m thick at its deepest (Photo 7). No further archaeological features were revealed during the excavation of this trench.

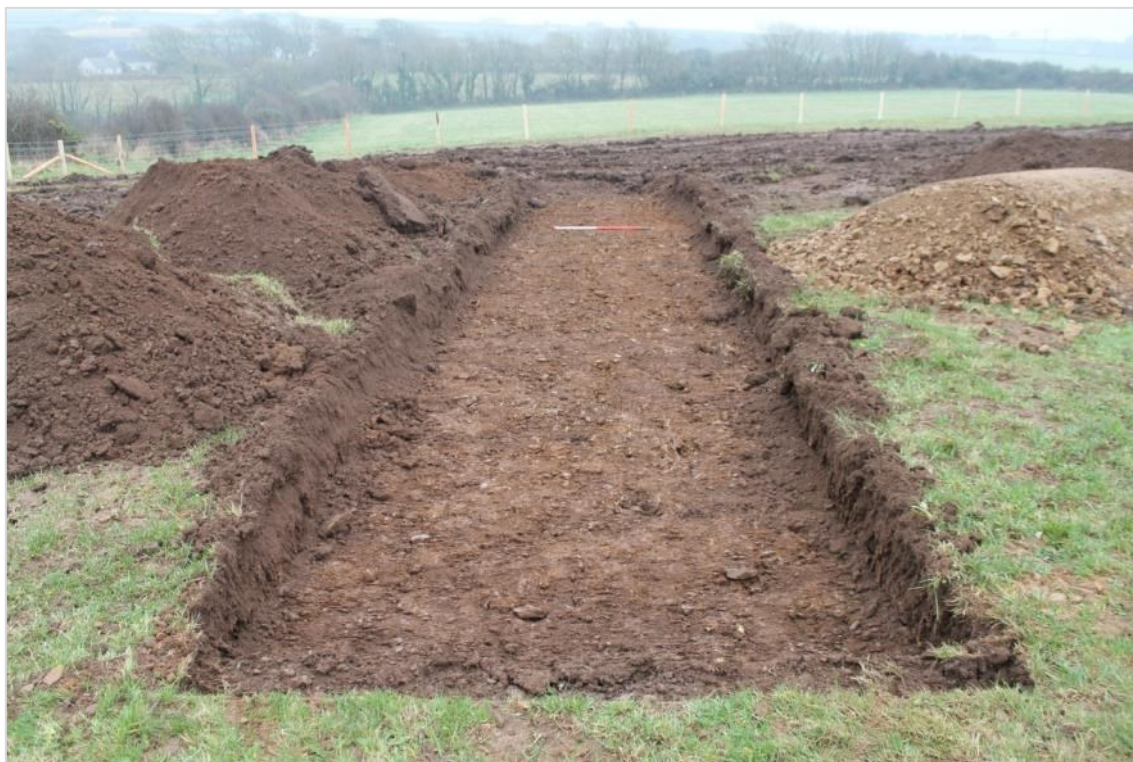
Photo 8: View southwest along Trench 4. 1m scale.

- 4.4.1 Trench 4 was positioned across a small linear feature measuring c. 15m in length and approximately 2m wide. It is described by AB Heritage in the legend accompanying their geophysical survey as a 'positive linear' – a possible ditch (Figures 6; Photo 8).

- 4.4.3 The medium brown, loamy topsoil was of a consistent depth of 0.26m throughout the trench. This stood directly above the orange-brown, silty-clay, stony natural. A vague band of darker material was observed crossing the trench which, when cleaned, was seen to be a thin layer of medium brown, silty clay 0.02m thick. It was decided to cut another trench (Trench 5) to further investigate the feature (Photo 9).

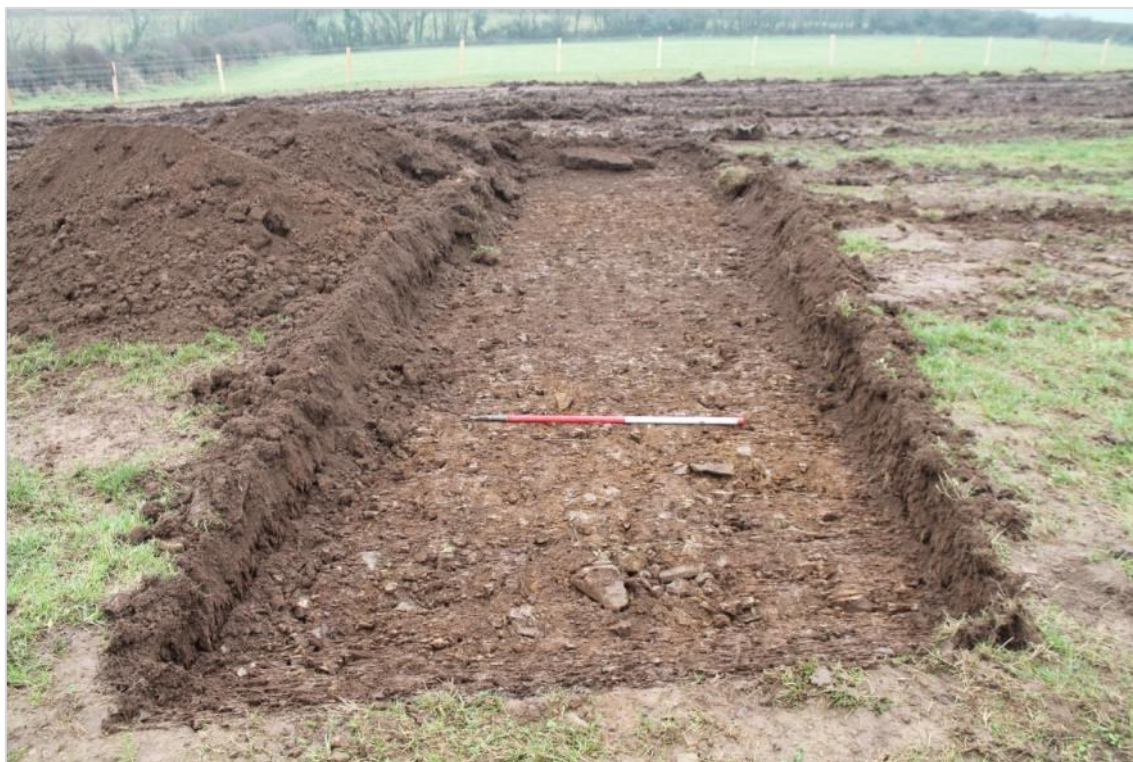
Photo 9: View southwest along Trench 5 showing darker band of material crossing trench above the 1m scale

- 4.4.5 The medium brown, loamy topsoil was of a consistent depth of 0.26m throughout the trench. This stood directly above the orange-brown, silty-clay, stony natural. A band of dark material, 2.3m wide, crossed the trench in a similar position as identified by the geophysical survey. When investigated, this dark brown, silty-clay deposit was a mere 0.04m thick. No cut was discerned at the edges of this feature. It was either filling a gentle undulation in the natural or was pressed into it. No other archaeological features were observed within this trench.

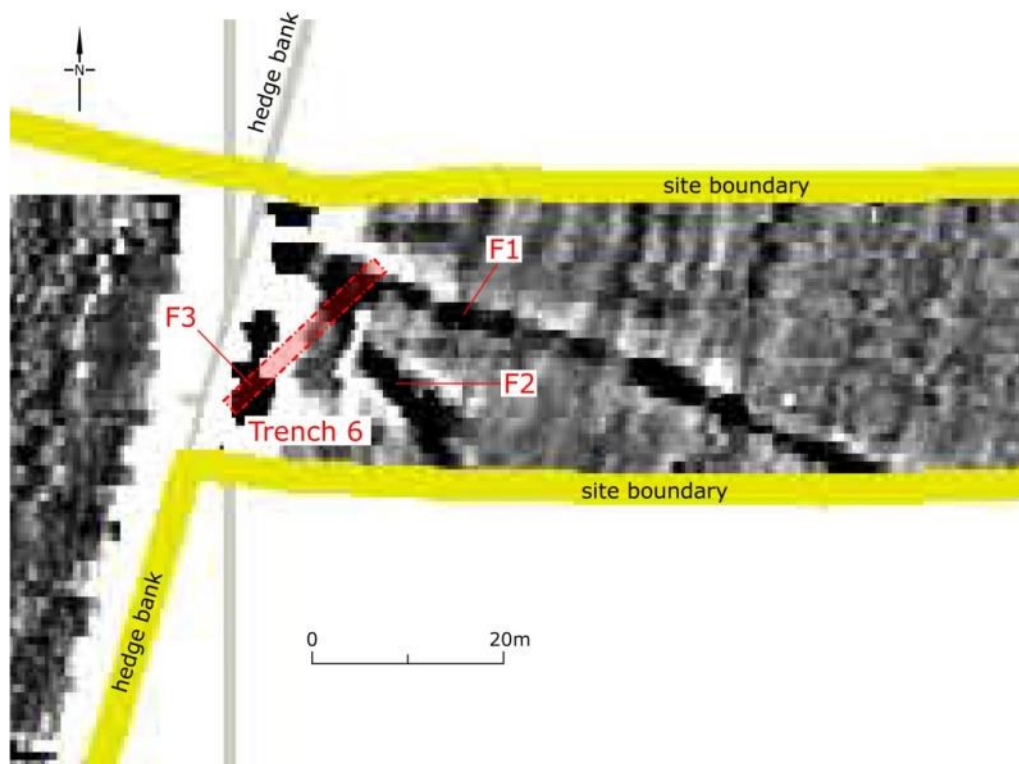
Figure 7: Detail of features identified in Field B during geophysical survey.

- 4.5.1 Trench 6 (Figures 6 and 7) was positioned to overlie a number of features identified from geophysical survey; including two linear features converging near the hedge bank (F1 and F2) and a third feature (F3) running parallel with the hedge bank. Features (F1) and (F2) are described as 'positive linears' in the legend accompanying the geophysical survey, whilst (F3) is described as 'magnetic disturbance'.

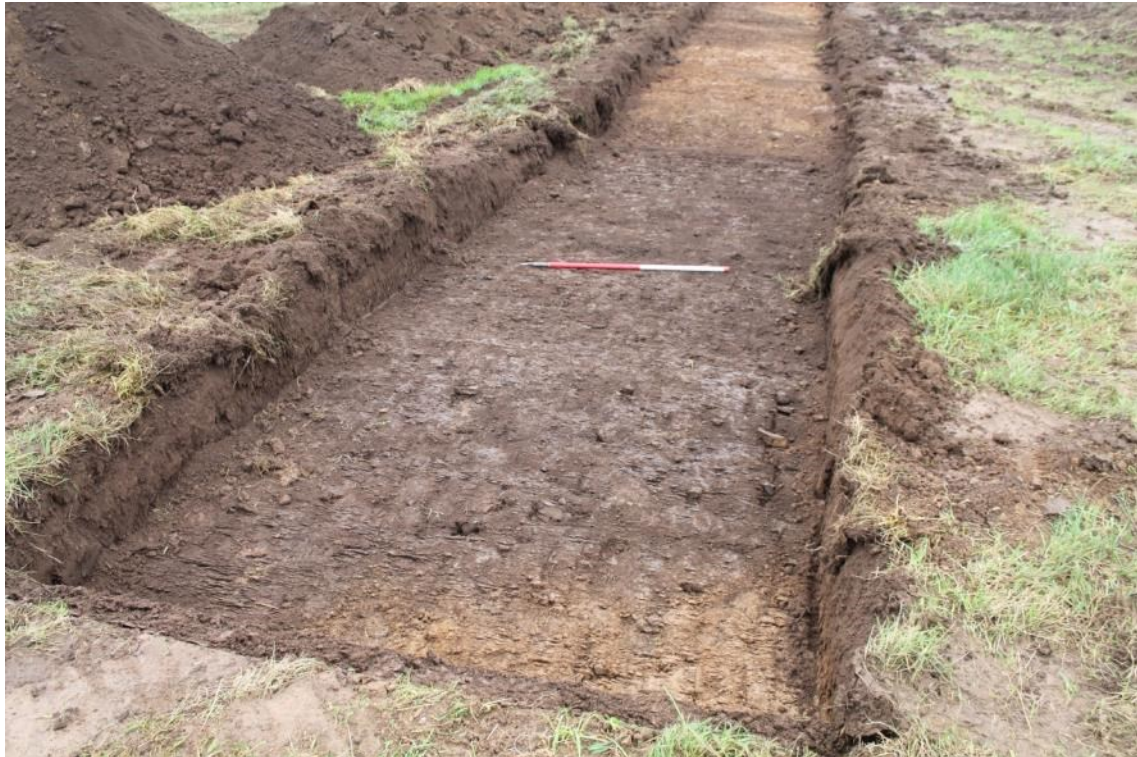
Photo 10: View SW along Trench 6 showing features (F1) and (F2) converging in foreground and feature (F3) in the background. 1m scale.

- 4.5.4 At the northern end of Trench 6 a wide area of dark compacted silt was revealed (Photo 10). It appears this is where features (F1) and (F2) converge. Subsequent machining and trowelling delineated the merged features of (F1) and (F2) into their constituent parts (Photo 11). (F1) resolved into two linear bands (? vehicle tracks) approximately 2.5m wide, whilst (F2) became a single linear – it was probably a pair of linears also but was over-dug by the machine.

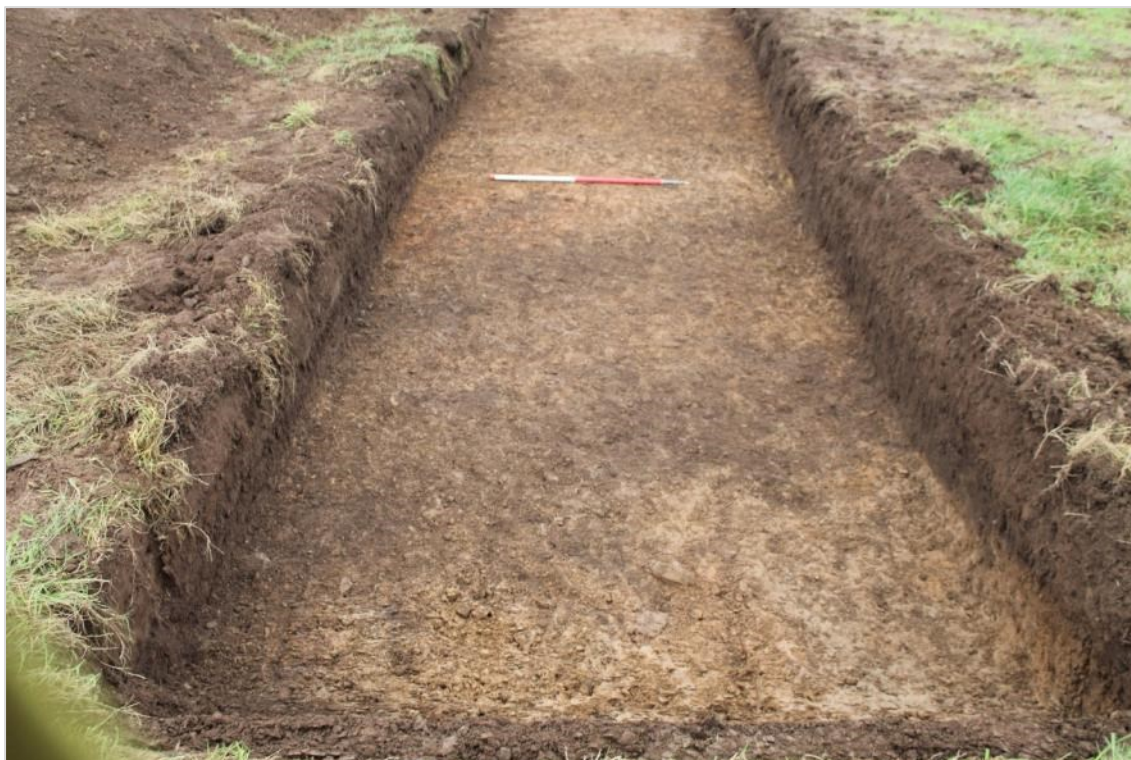
Photo 11: View SW along Trench 6 showing features (F1) in the foreground – now shown to be a pair of parallel linears – and linear (F2) in background above 1m scale.

- 4.5.5 Both features had identical deposits; a stone-free, dark brown, clay-silt which occupied a 7.6m wide flat-bottomed hollow with gently sloping sides. In section the deposit was up to 0.2m thick and lay directly below the topsoil (Photo 12). There was no indication in section of the deposit being within a cut feature.

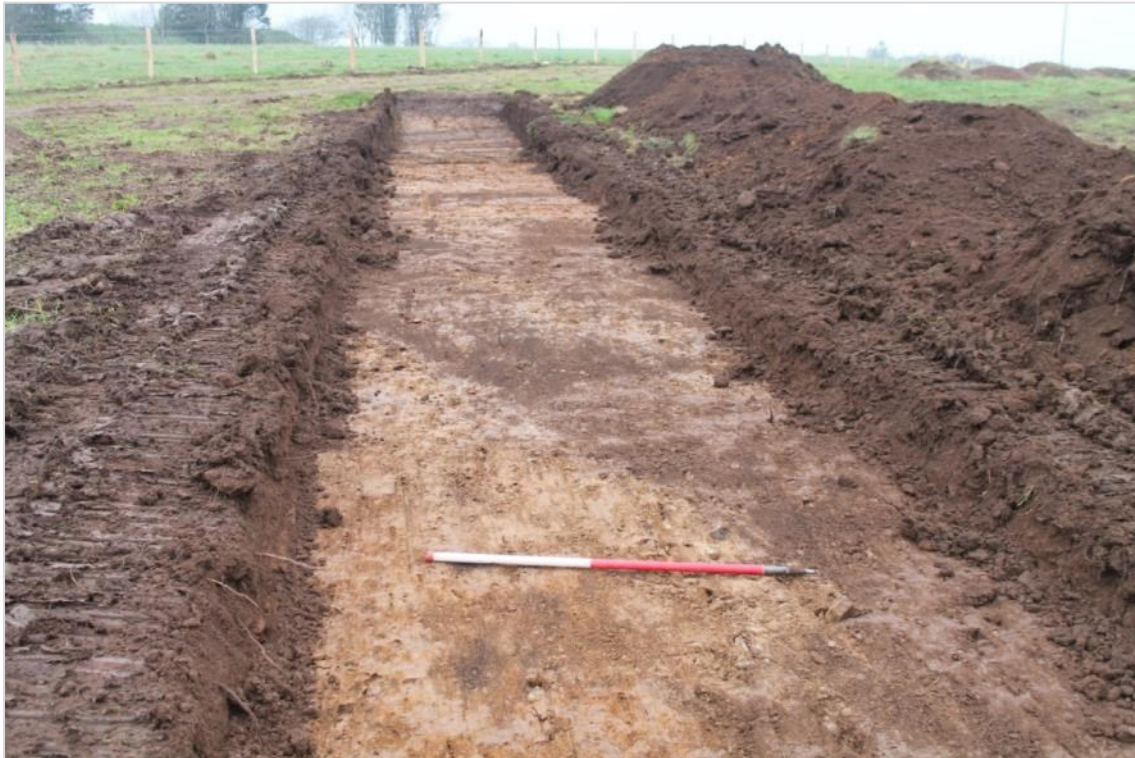
Photo 13: View NE along Trench 6 showing (F3) in foreground. 1m scale.

- 4.5.6 (F3) was a 2m wide, linear deposit lying on top of the natural. It crossed the lower half of Trench 6 at an angle and ran alongside the grubbed-out hedge bank situated a few metres to the west of the trench (Photo 13).
- 4.5.7 The deposit was a medium brown, silty-clay (similar to the topsoil). When cleaned with a trowel the deposit resolved itself into a pair of caterpillar track marks and proved to be only 0.03m thick (Photo 14 and 15).

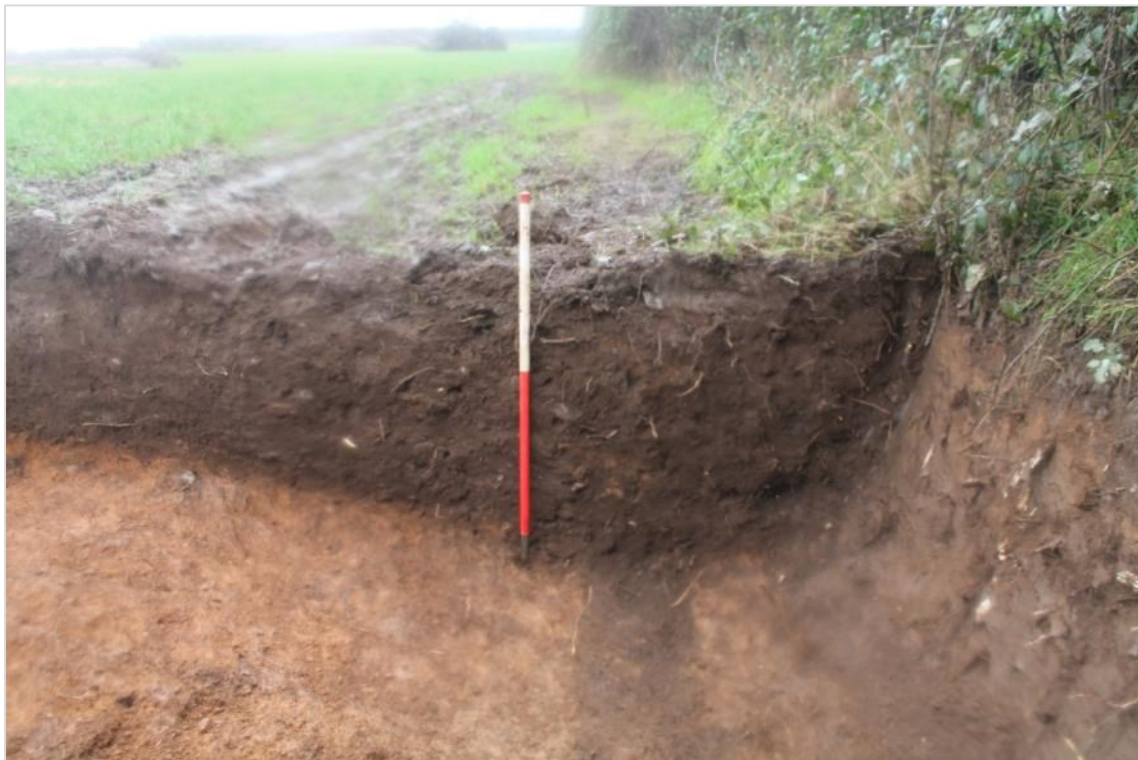
Photo 16: NW facing section at southern end of Trench 7 showing break of slope in the natural subsoil and modern machine cut - seen as a linear in surface of natural ground and as mottled fill in section. 1m scale.

- 4.6.2 In both trenches the exposed natural subsoil surface was observed sloping downwards from north to south towards the C3138 road which was situated c. 2.5m away from the end of the trenches; separated by a hedge without any evidence for a bank. Only one deposit of dark brown silty-clay topsoil was recorded in section lying above the natural orange-brown, silty-clay subsoil. This topsoil increased in depth towards the southern ends of the trenches. Due to the build-up of colluvium, this was relatively deep compared to the topsoil depths observed in earlier trenches and averaged 0.5m thick increasing to 0.9m at the bottom of the break of slope towards the southwest end of the trenches.

- 4.6.3 In Trench 7 the topsoil was fully excavated and at the southern end of the trench a narrow 0.25m wide linear cut running parallel with the hedge, cutting into the natural subsoil, was revealed (Photo 16). In section it was apparent that it was cut from the present ground surface and probably indicates it is a modern cut perhaps for drainage. The fill of the cut was a mottled mixture of topsoil and orange silty-clay.
