# ST. ISHMAELS CHURCH, PEMBROKESHIRE: ARCHAEOLOGICAL WATCHING BRIEF

RHIF YR ADRODDIAD / REPORT NO. 2017/5  
RHIF Y DIGWILLIAD / EVENT RECORD NO. 110321

# ST. ISHMAELS CHURCH, PEMBROKESHIRE ARCHAEOLOGICAL WATCHING BRIEF

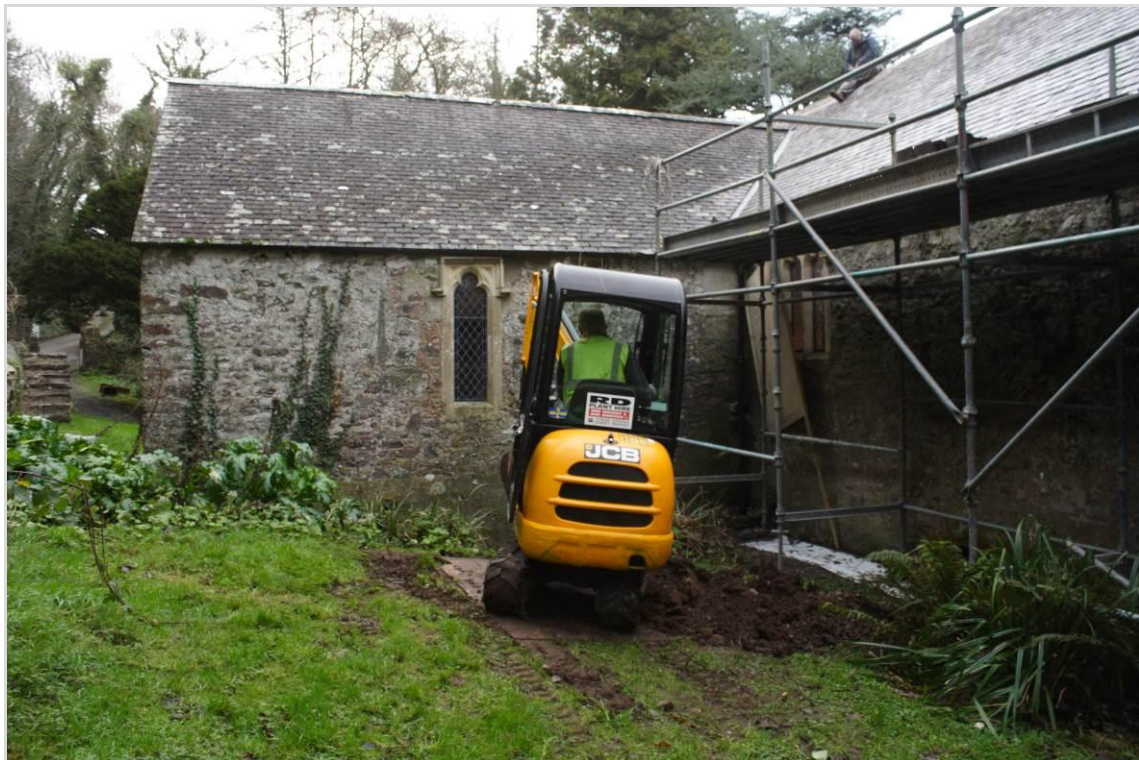
4.2.1 Trench 1 was excavated at an angle from the north wall of the nave towards and into the gully that surrounds the north transept on this side (Photo 1).

4.2.2 The trench measured c.6.0m long and was between 0.3-0.6m deep.

**Photo 1:** The machine excavation of Trench 1. Looking east.

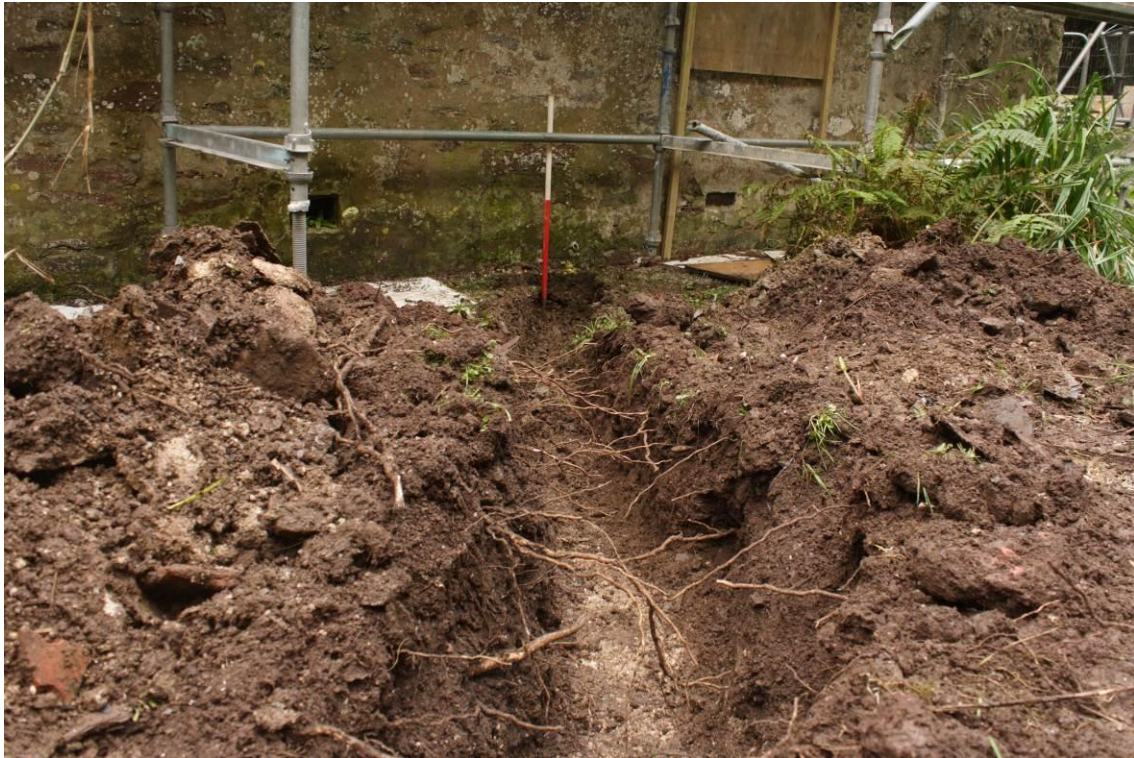
4.2.3 Roughly 1.30m out from the north wall was evidence of a cut that doubtless runs parallel with the north wall of the nave, filled with stone chippings probably to facilitate drainage. Elsewhere the trench cut through a dark brown loam containing pieces of 20<sup>th</sup> century red ceramic pipe, as well as fragments of brick and slate.

4.2.4 The dark brown loam was approximately 0.50m deep and lay above a very loose deposit of light brown silt containing large amounts of lime mortar and stone and roofing slate fragments (Photo 2).

4.2.5 No archaeologically significant features were revealed within the trench. No artefacts, apart from 20<sup>th</sup> century ceramic pipe, were recovered from the excavated deposits.

**Photo 2:** Looking south towards the north wall of the nave at completed drainage  
Trench 1. 1m scale

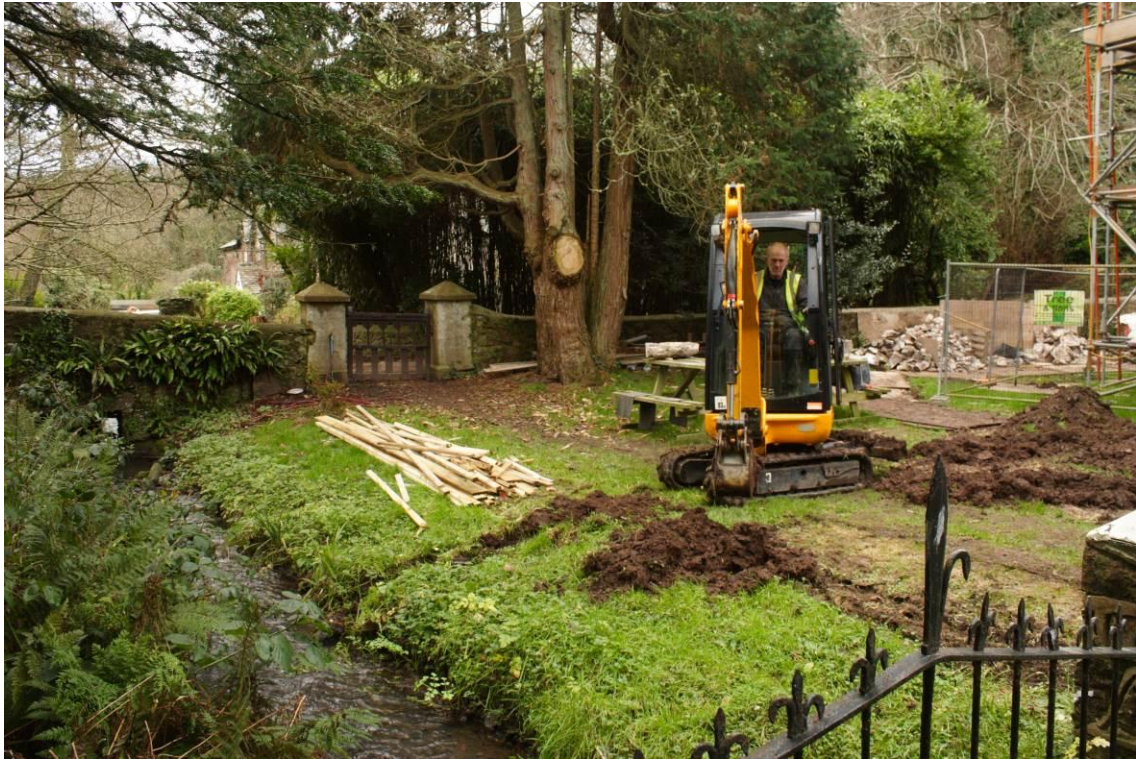
- 4.3.1 Trench 2 measured 10.40m in length and ran from the southwest corner of the nave southwards to the stream (Photos 3 & 5). It had an average depth of 0.5m.
- 4.3.2 Trench 3 measured 3.9m long, with an average depth of 0.5m. It ran from the west wall of the south porch in a southwest direction until it converged with Trench 2 (Photo 4).
- 4.3.3 Both Trenches 2 & 3 were excavated through approximately 0.30m depth of dark brown loam containing large amounts of broken fragments of roofing slate, brick and stone. Below this was a much lighter, looser brown silt matrix, full of voids; containing large amounts of lime mortar, stone fragments and broken roofing slate.
- 4.3.4 No archaeologically significant features were revealed within the trench. No artefacts were recovered from the excavated deposits.

**Photo 3:** Looking west at the machine excavation of Trench 2.

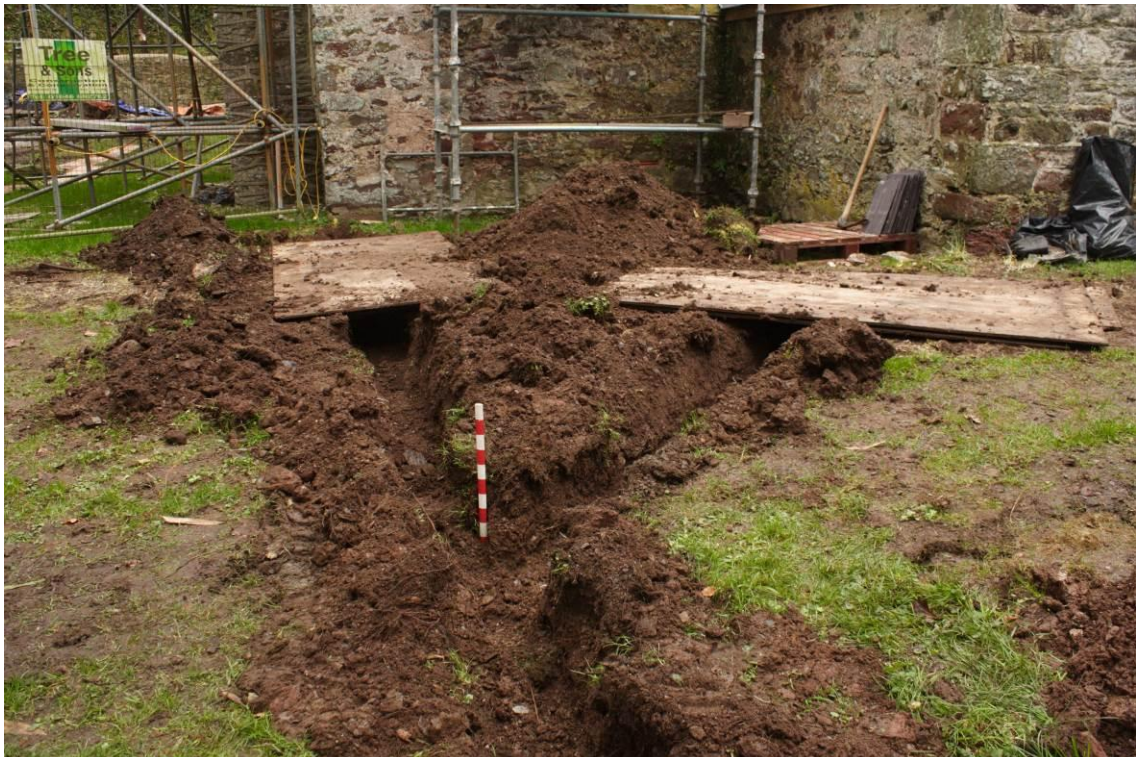
**Photo 4:** Looking north at the convergence of Trenches 2 & 3. 0.5m scale

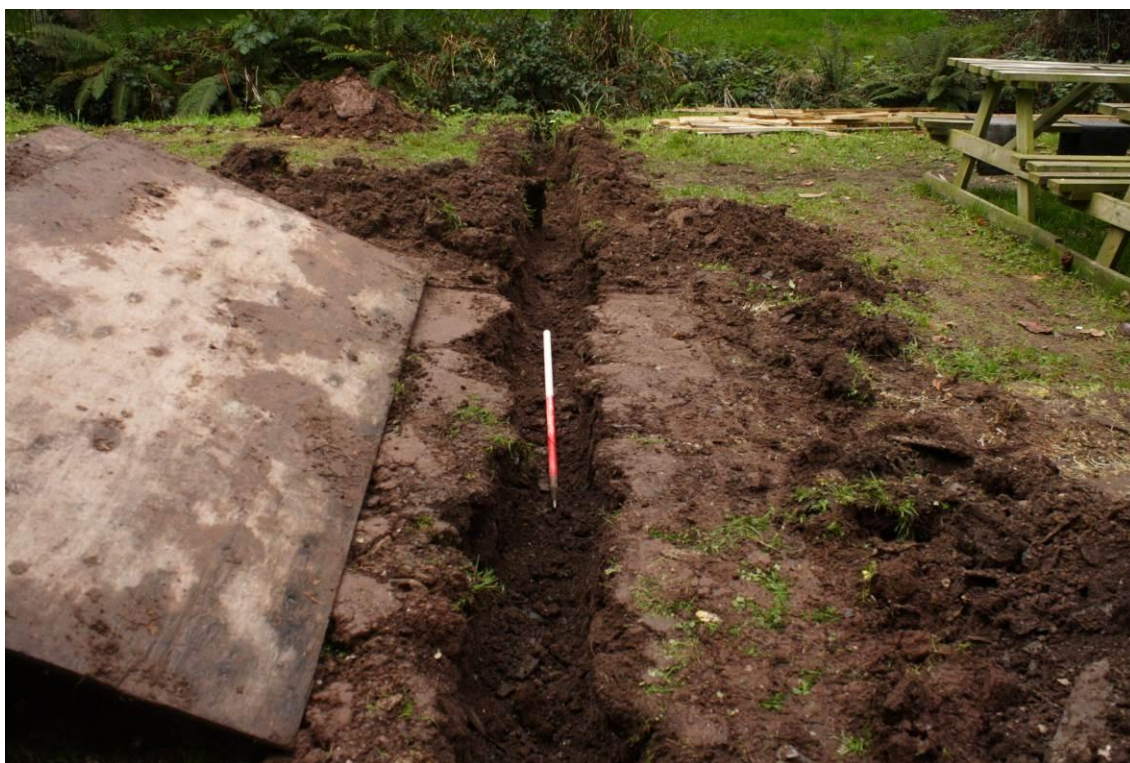
**Photo 5:** Looking south along excavated Trench 2. 1m scale

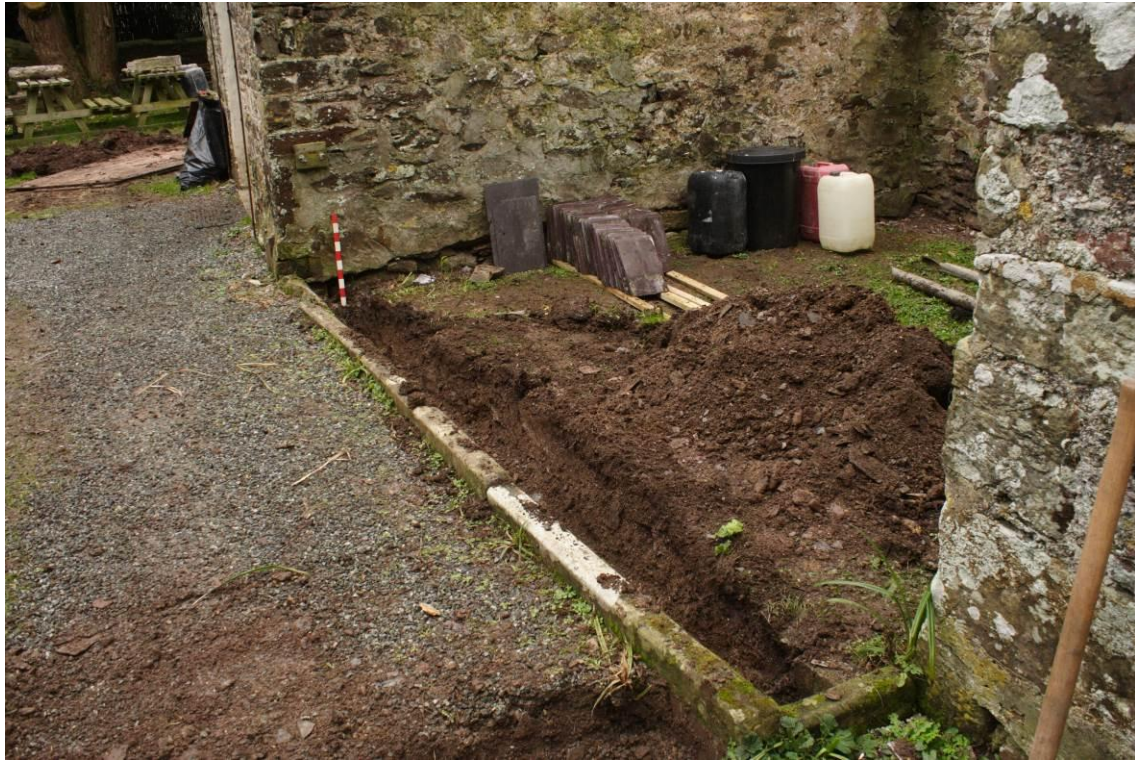
- 4.4.1 Trench 4 measured 3.70m and ran from between the east wall of the south porch and west wall of the south transept (Photo 6). It had an average depth of 0.3m
- 4.4.2 The trench was excavated along the alignment of a former drainage trench and a plastic drain pipe was removed during its excavation.
- 4.4.3 No archaeologically significant features were revealed within the trench. No artefacts were recovered from the excavated deposits.

**Photo 6:** Looking northwest at excavated Trench 4. 0.5m scale

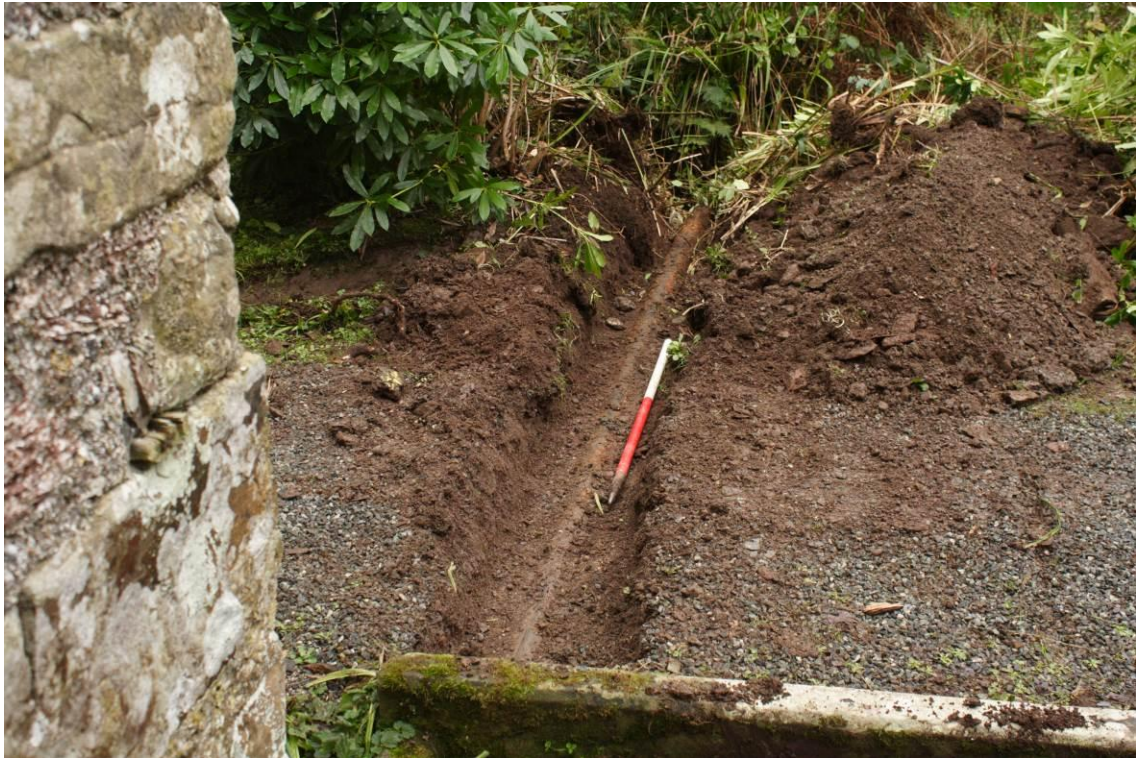
- 4.5.1 Trench 5 measured c.4.80m long and ran from the west corner of the south transept southwards towards the stream (Photo 7). It had an average depth of 0.30m.
- 4.5.2 Trench 6 measured c.8.0m long and ran from the southeast corner of the south transept where it meets the nave southwards until it met the stream (Photo 8). It had an average depth of 0.30m.
- 4.5.3 Both trenches were excavated along the alignments of previous drainage pipes. Within both trenches a steel drainage pipe was revealed at approximately 0.20m depth. The steel pipes were removed by machine (Photo 9).
- 4.5.4 No archaeologically significant features were revealed within the trench. No artefacts were recovered from the excavated deposits.

**Photo 7:** Looking south at Trench 5, showing the steel pipe within the trench.  
1m scale

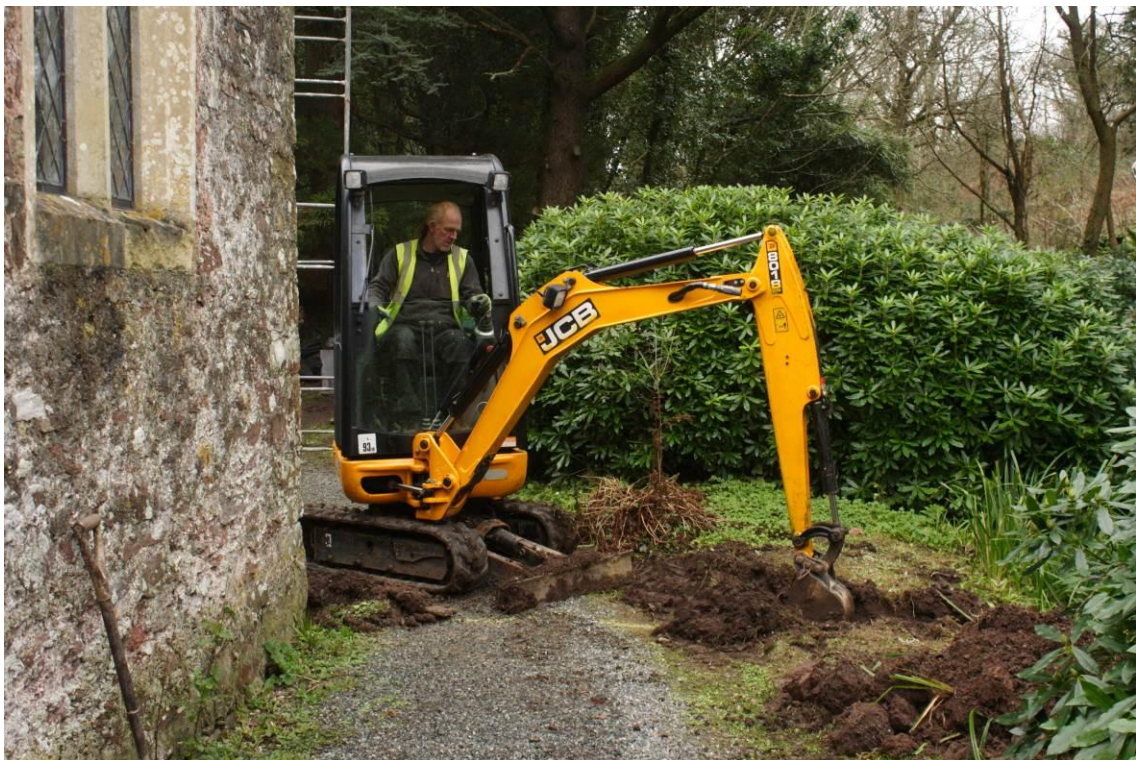
**Photo 8:** Machine excavation of Trench 6.

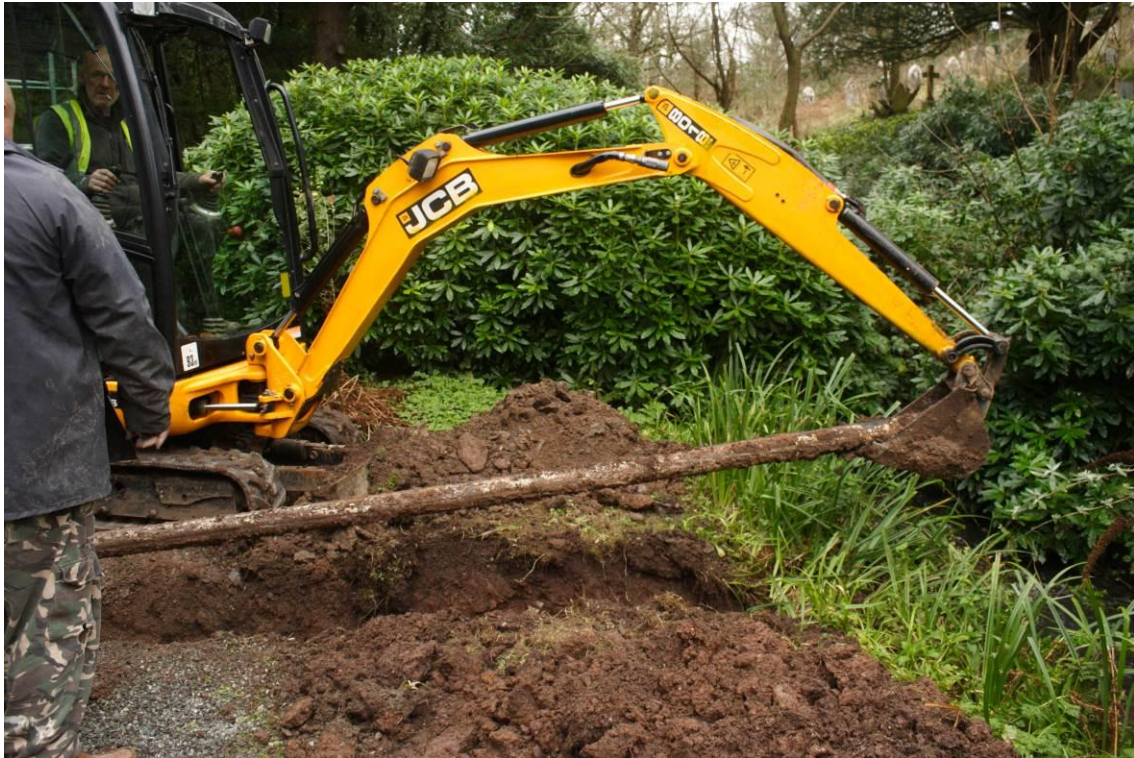
**Photo 9:** Looking east at removal of the steel drainage pipe in Trench 6.

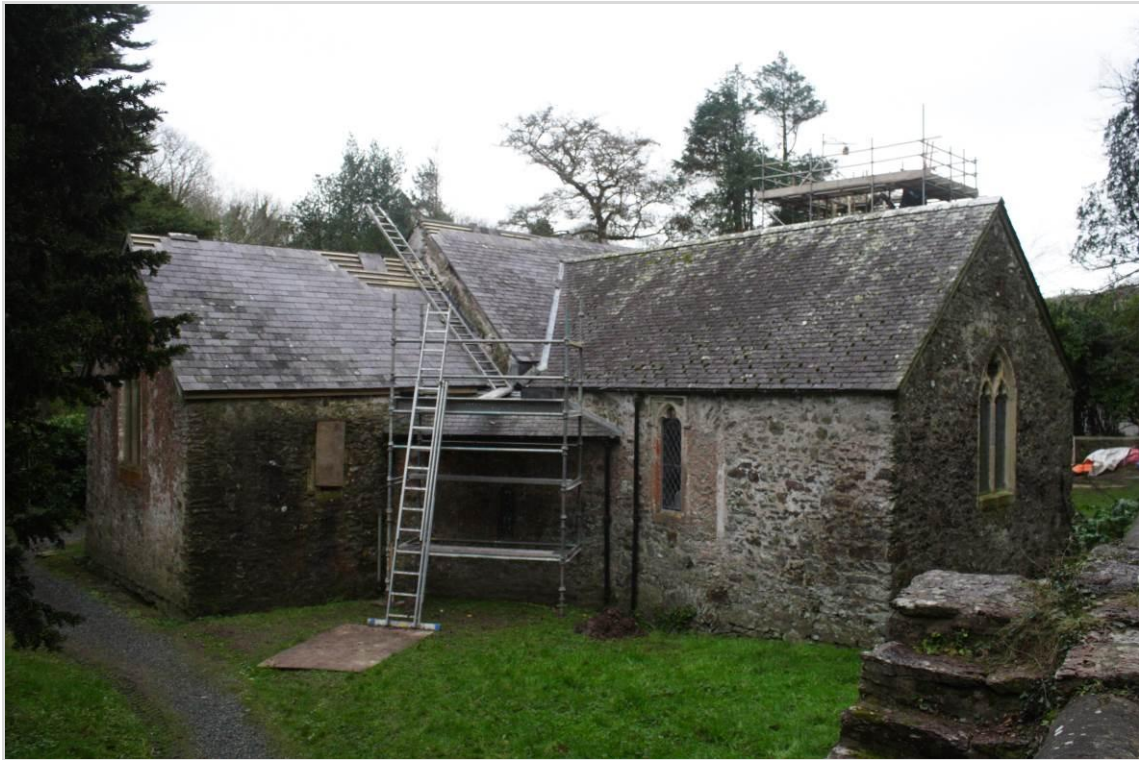
- 4.6.1 Trench 7 was planned to be excavated between the east facing wall of the north transept and the north wall of the chancel. However, the presence of a temporary scaffold in the same position (Photo 10) meant that the trench could not be machine excavated. Therefore a section of the trench was excavated by hand to ascertain what deposits the trench would be excavated through (Photo 11).
- 4.6.2 The hand dug section was excavated to the required depth of 0.30m and revealed that the material the trench would be excavated through was a dark brown loam containing stone and roofing slate fragments.
- 4.6.3 It was decided that it was unlikely that any significant archaeological features would be damaged by the excavation of a trench at this depth in this area.

**Photo 10:** Looking southwest at angled corner between north transept and chancel end where Trench 7 was to be located under the scaffold.

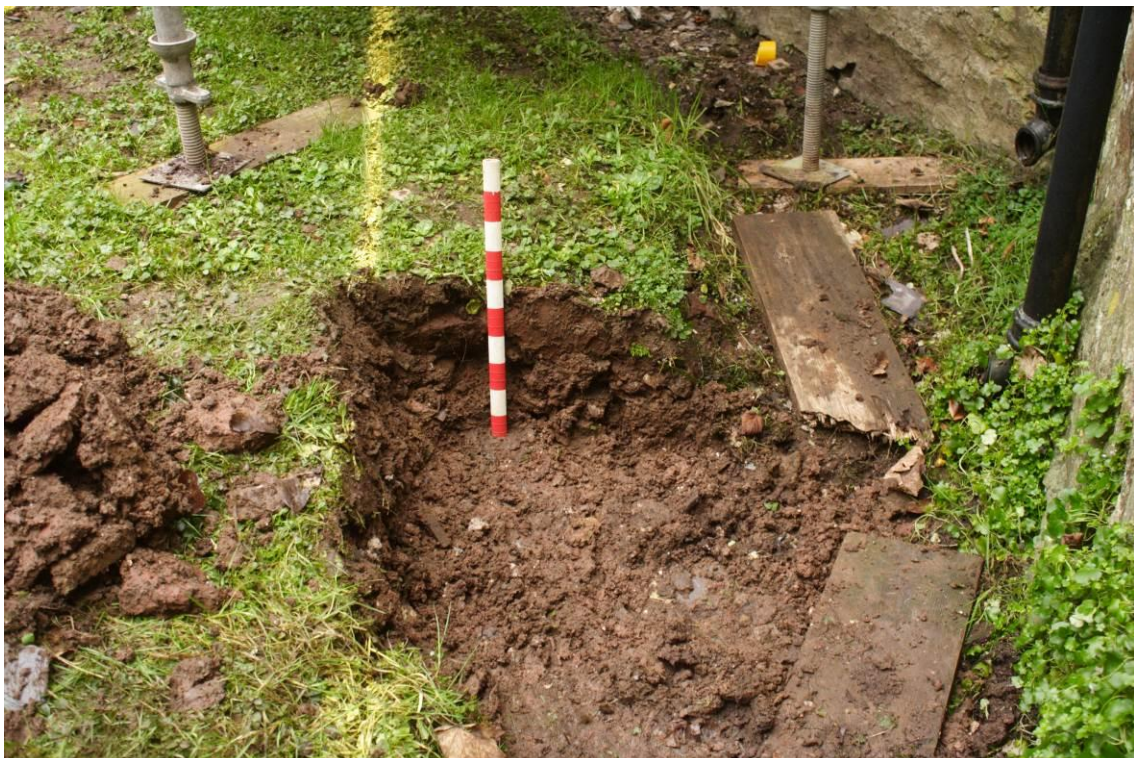
**Photo 11:** Section excavated by hand through position of drainage Trench 7.  
0.5m scale

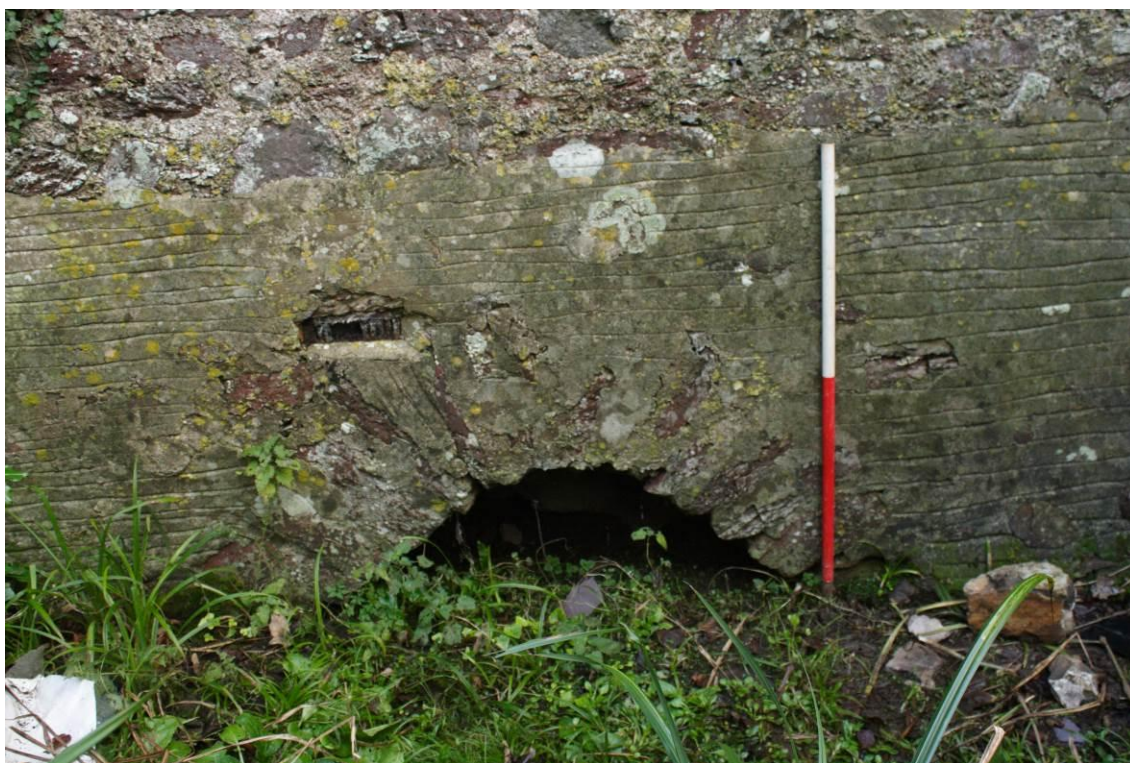
- 4.7.1 Of note is the evidence of an unusual stone arched culvert running under the north transept (Photos 12 & 13) that appears to have been blocked up in the past; at least on the west.
- 4.7.2 It is possible that the stream that runs parallel and to the south of the church once ran along a different route, perhaps under the north transept.

**Photo 12:** East facing wall of north transept showing culvert that runs underneath north transept. 1m scale

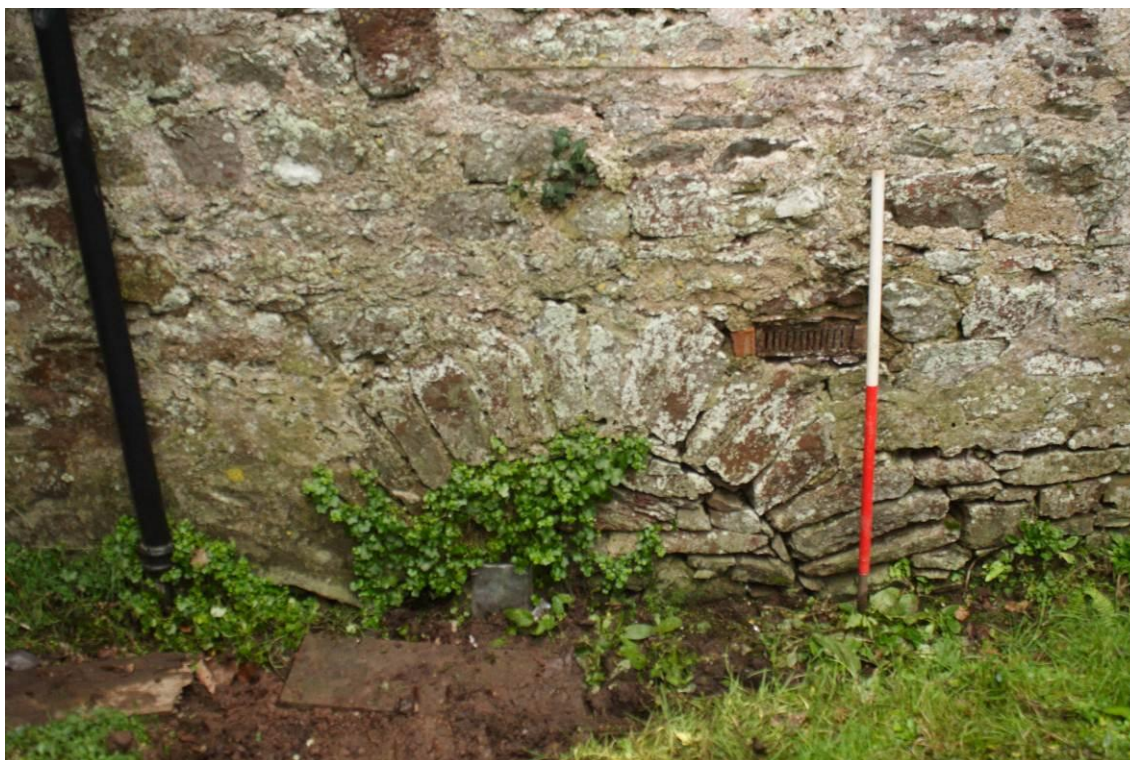
**Photo 13:** West facing wall of north transept showing blocked entrance to culvert that runs underneath north transept. 1m scale
