TY HIR, CILCENNIN, CEREDIGION: ARCHAEOLOGICAL WATCHING BRIEF

Prepared by Dyfed Archaeological Trust
For: Mr Carwyn Iles

RHIF YR ADRODDIAD / REPORT NO. 2017/15
RHIF Y DIGWILLIAD / EVENT RECORD NO. 110331

**TY HIR, CILCENNIN, CEREDIGION:
ARCHAEOLOGICAL WATCHING BRIEF**

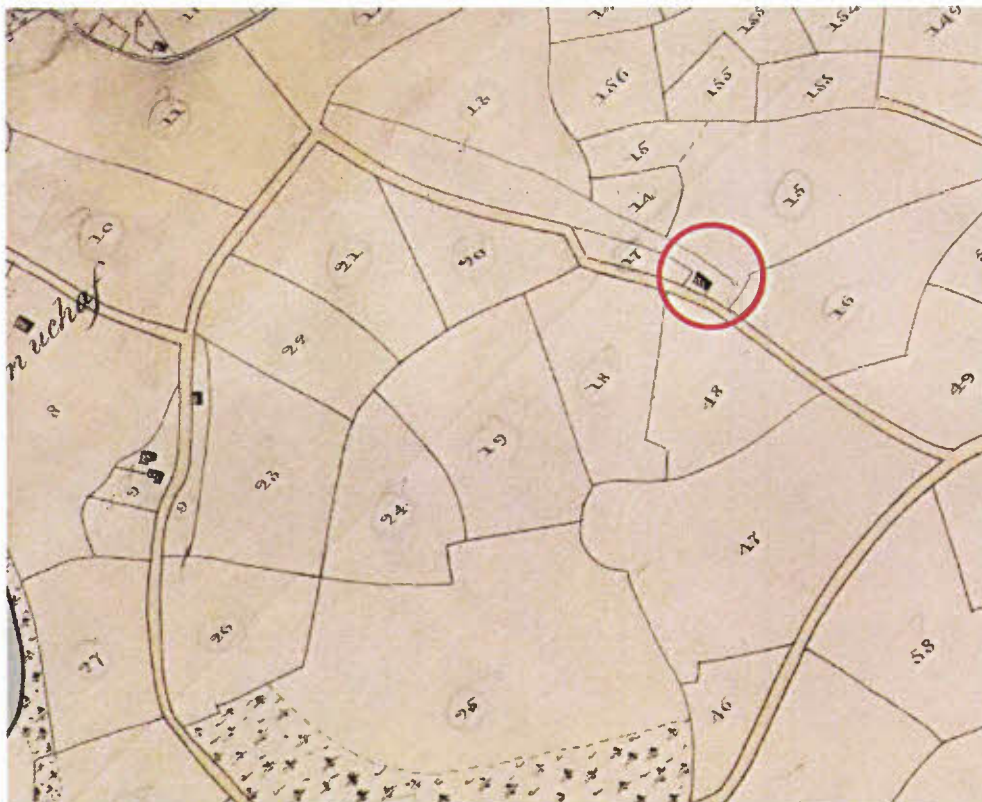
Figure 3: Extract of the Cilcennin Parish Tithe Map of 1843, with a red circle outlining the approximate location of Ty Hir

- 2.2.1 The origin of Ty Hir is not known and no previous archaeological work has taken place there. The first known record of the site is the 1843 Tithe Map of Cilcennin (Figure 3), which shows a building that is possibly the same one that still stands, although it is shown in a different parcel of land, west of the Ty Hir shown on all later maps. As it is shown in roughly the same place as the existing structure, any discrepancy could be due to the limitations of survey methods at that time. The Apportionment to the Tithe Map gives little detail about the surrounding parcels of land; of the fields immediately surrounding the building it only says that they are part of Tyglyn Uchaf, which is the farm at the western edge of Figure 3. Tyglyn Uchaf, later the site of Tyglyn Aeron Mansion (PRN 7010) is recorded as being owned and occupied by Rachel Winwood.

The existing building of Ty Hir may be shown on the 1843 Tithe Map of Cilcennin (Figure 3). A building is shown in roughly the same place as the existing structure and any discrepancy is likely to be due to the limitations of survey methods at that time. Ty Hir is named on the 1889 1:2500 scale ordnance survey map (Figure 4). It is this likely that the building is of at least early 19th century date. The 1889 map also indicates that Ty Hir was formed by two distinct parts, with a small outbuilding to the northeast (Figure 5). The 1905 1:2500 scale map shows the buildings slightly more clearly, with a definite division of the structure (Figure 6). By 1905 the outbuilding to the northeast was no longer present and a new outbuilding is present directly east of Ty Hir. This building corresponds with the existing outbuilding to the east of the property.

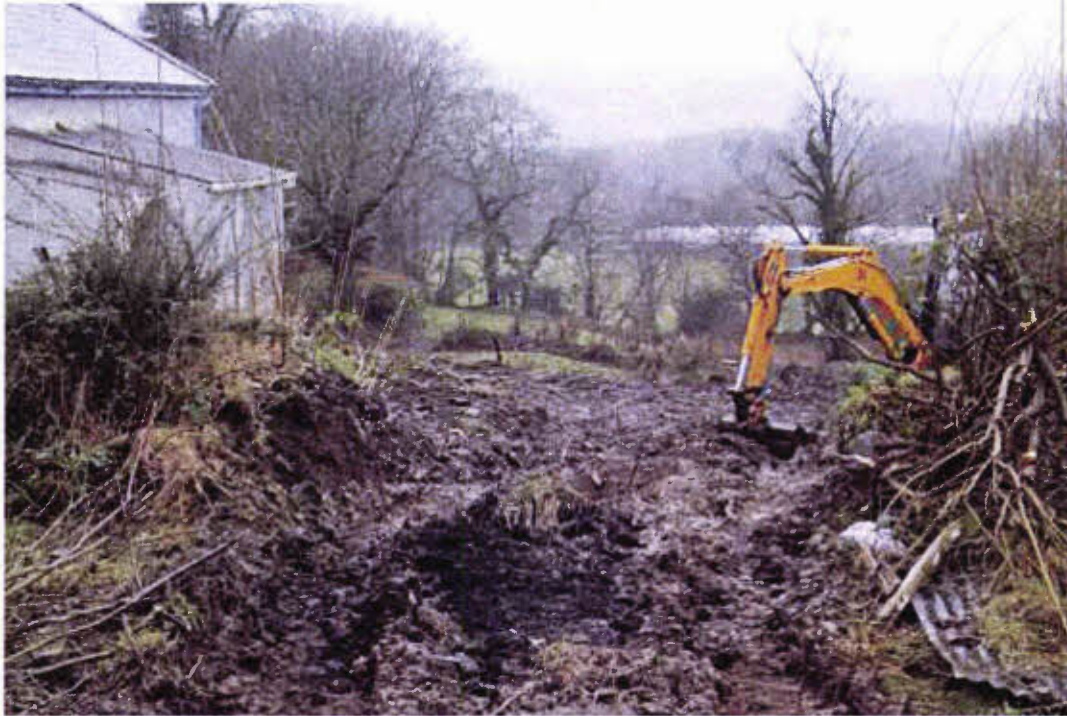
Photo 1: Facing northwest. Recently-created gap in the east wall of the rear garden, to improve access.

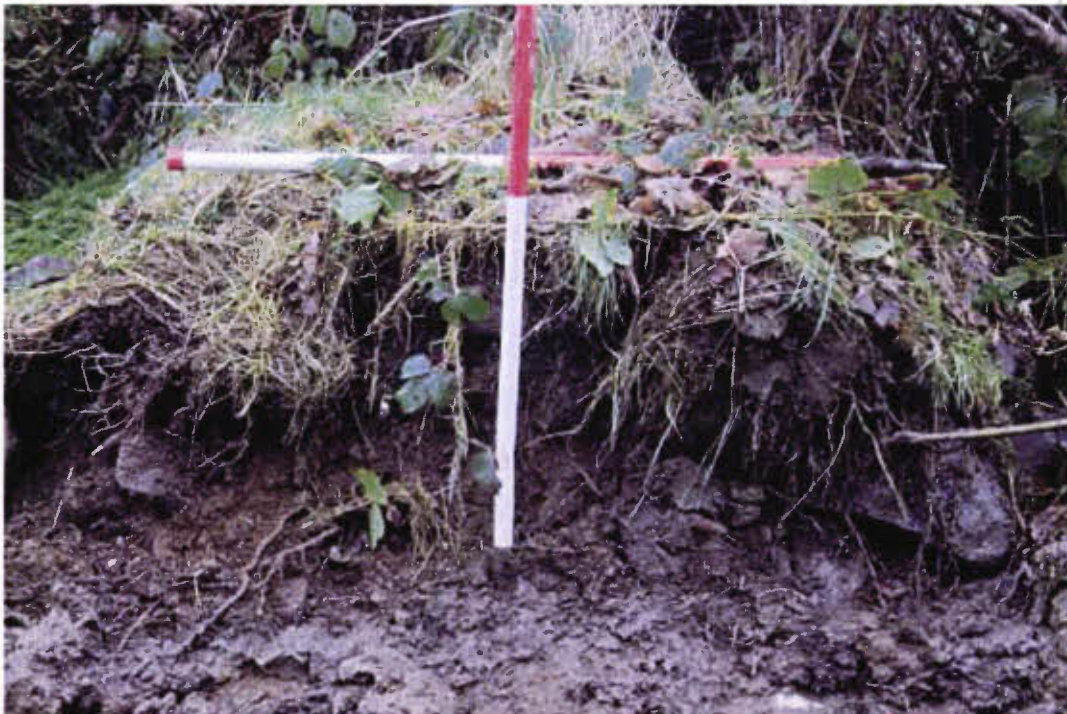
Photo 2: Facing north-northeast. Section through the east wall of the rear garden where a gap had recently been created to improve access. Two 1m scales.

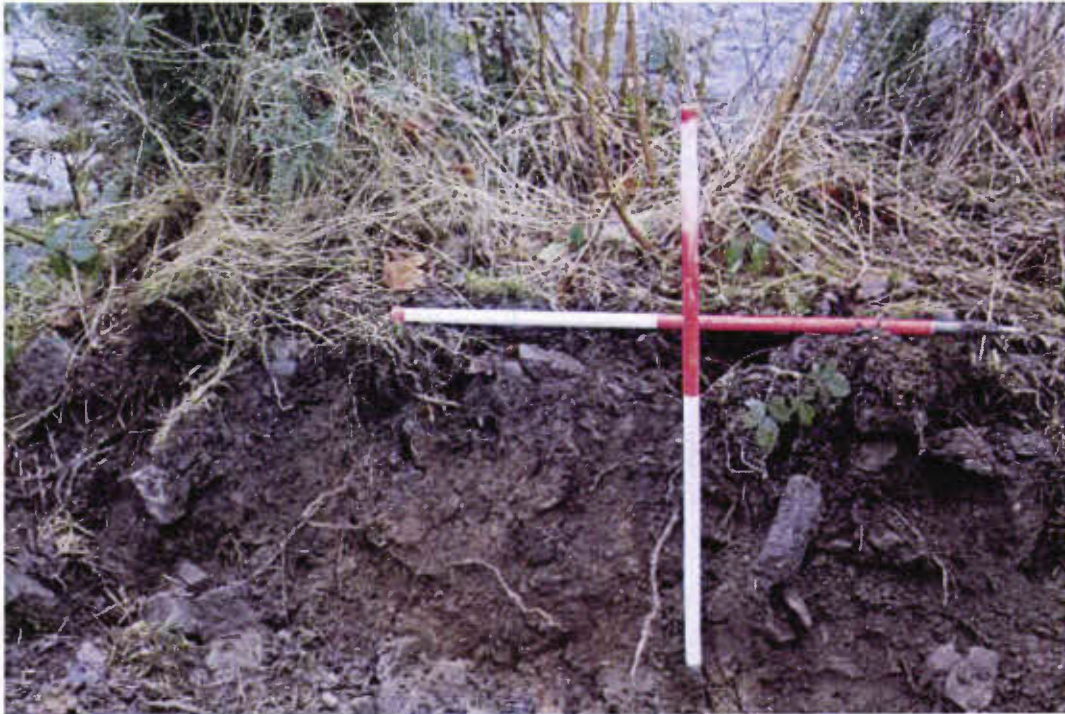
Photo 3: Facing south-southwest. Section through the east wall of the rear garden where a gap had recently been created to improve access. Two 1m scales.

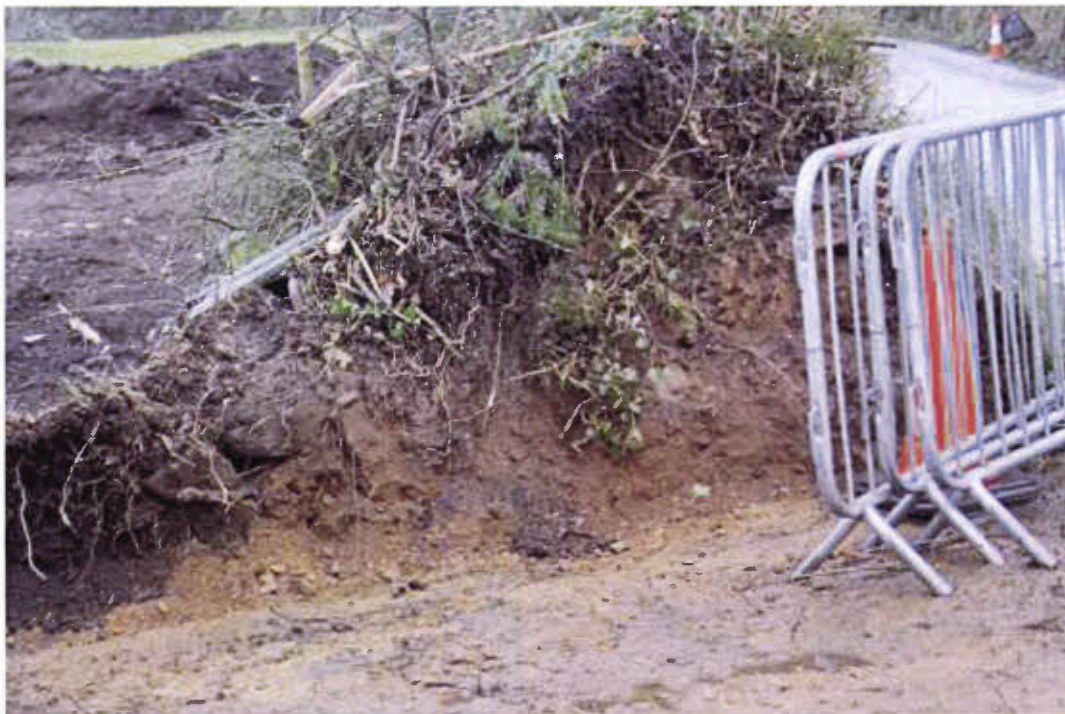
Photo 4: Facing southeast. Section through the wall along the road where it had recently been cut through to improve access to the property.

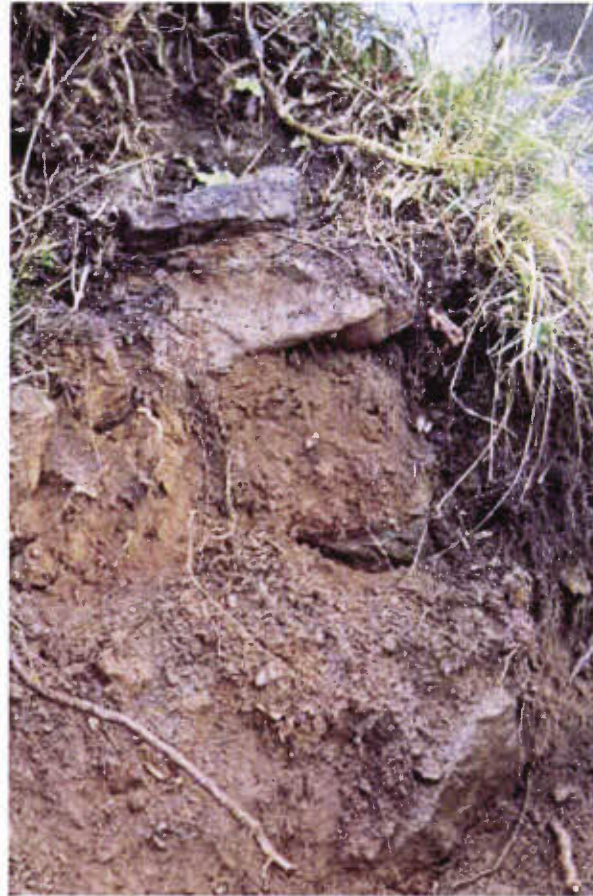
Photo 5: Facing southeast. Close-up of stones in section through the wall along the road where it had recently been cut through.

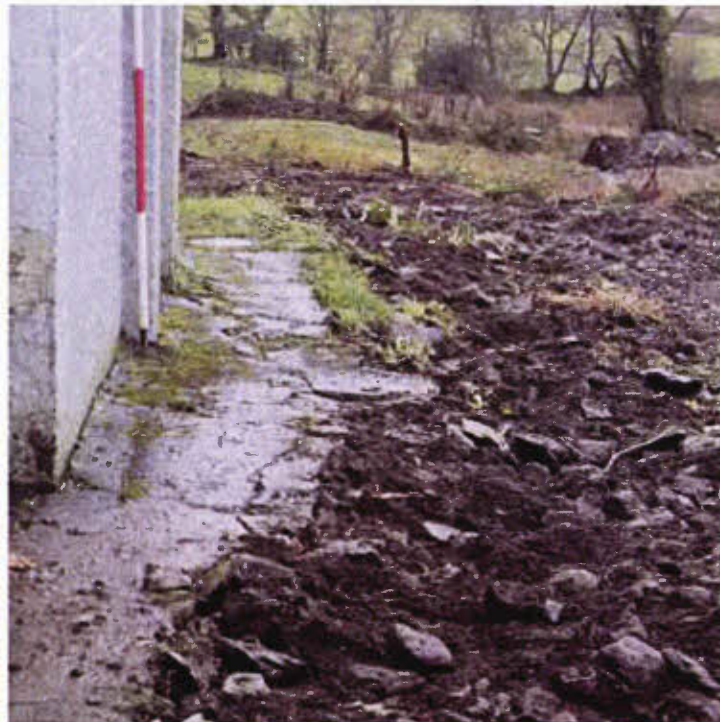
Photo 6: Facing west-northwest. View along rear of cottage lean-to showing strip of stone rubble where a concrete patio had recently been dug up. 2m scale.

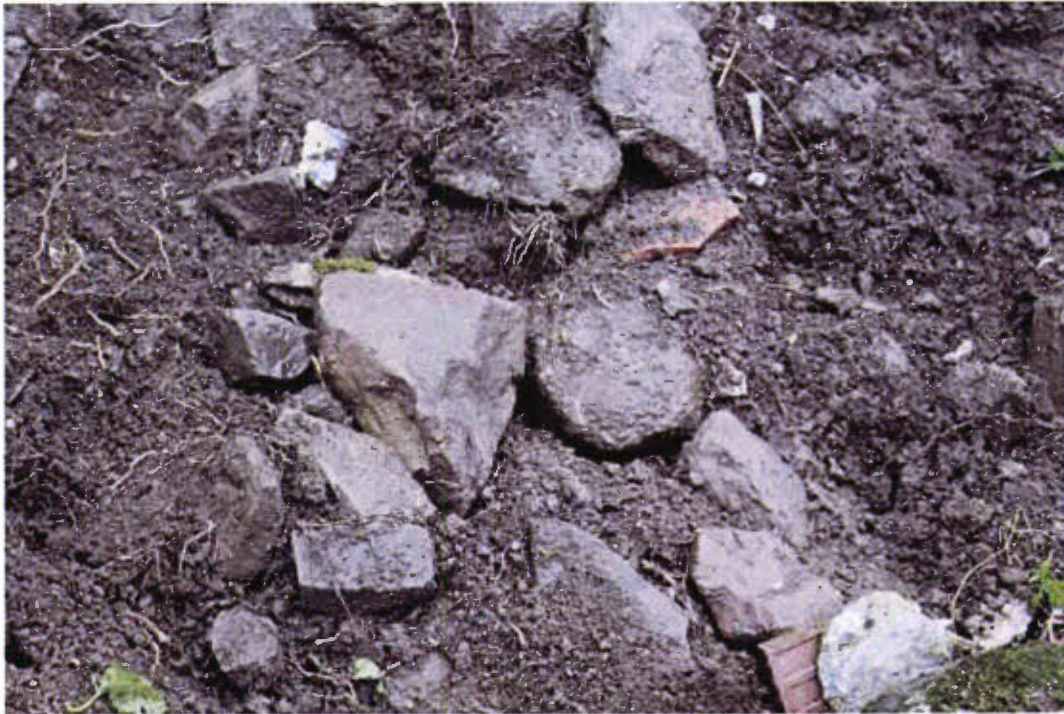
Photo 7: Close-up of stone rubble where a concrete patio had recently been dug up at the rear of the cottage.

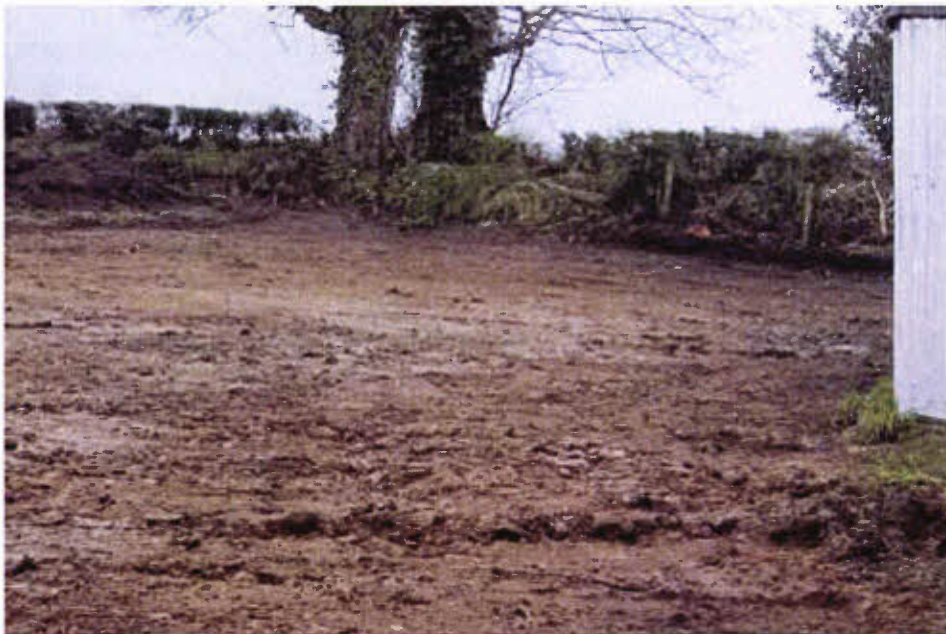
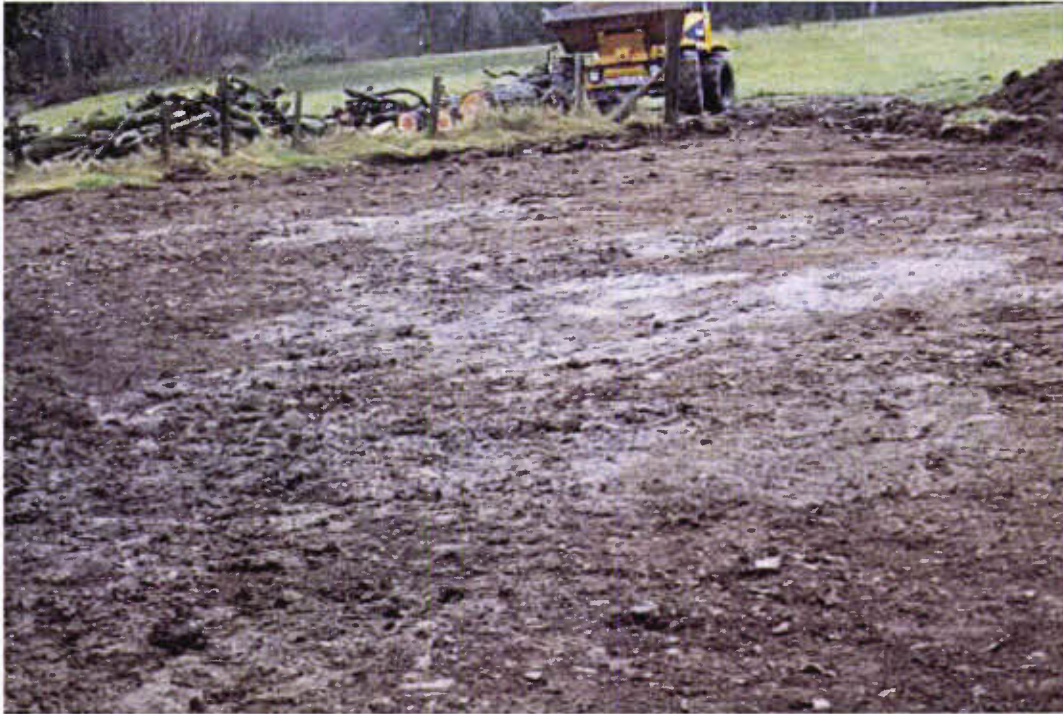
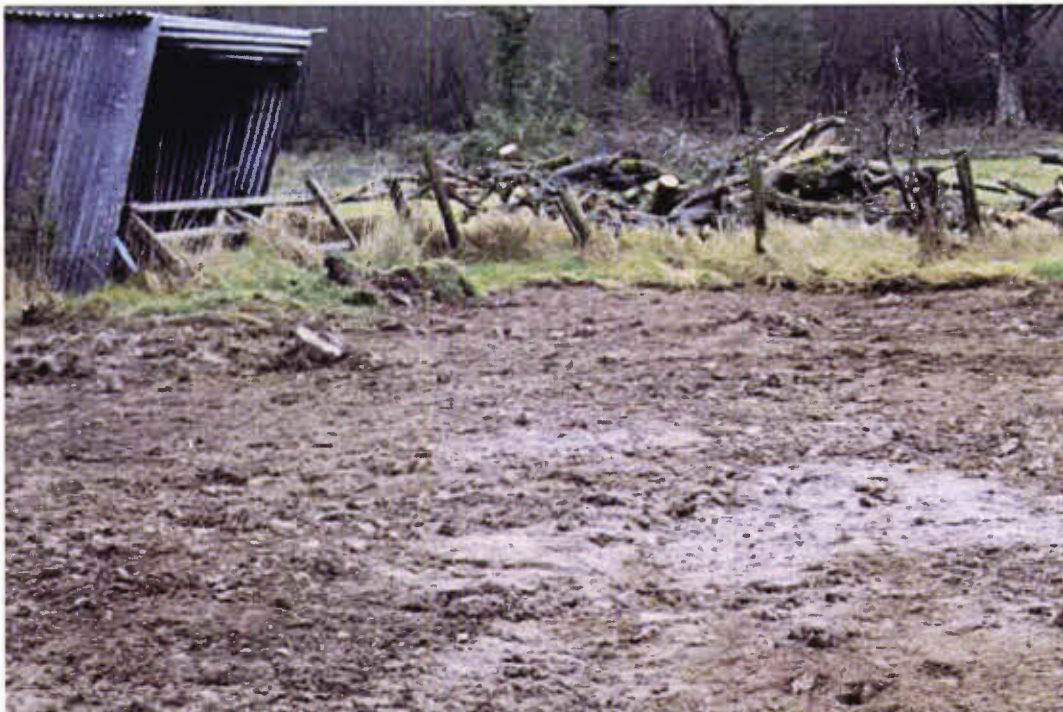
- 4.6 In the larger area to the east of the cottage, intended for the siting of a new agricultural shed, the topsoil was c.20cm deep and the subsoil revealed beneath was mid-brownish-yellow and sandy, reflecting the sandstone bedrock geology of this area of Ceredigion. There were no archaeological features and no finds save for Post-Medieval and Modern rubbish. In the footprint of the proposed cesspit, the same was observed except that the topsoil was 60cm deep, probably because it had been gardened for many years. Bedrock was encountered at a depth of around 0.9m.

Photo 10: Facing south-southeast. Area for new shed following topsoil strip.

Photo 11: Facing northeast. North half of the footprint of the new shed following topsoil strip.

Photo 12: Facing north. North corner of the footprint of the new shed following topsoil strip.

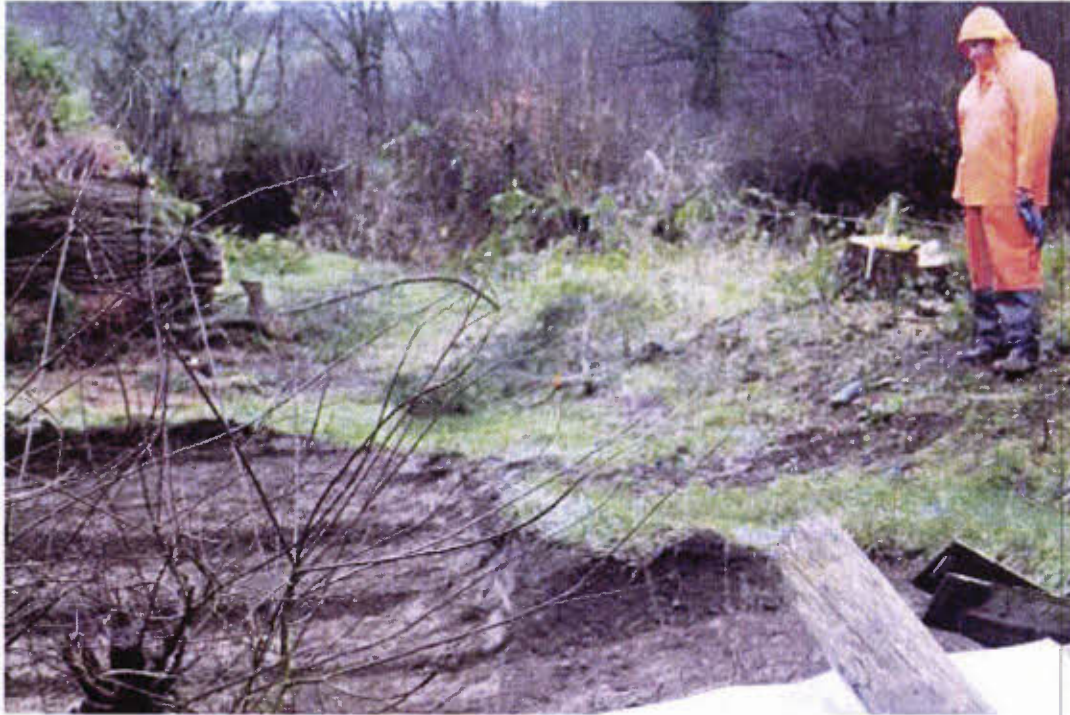
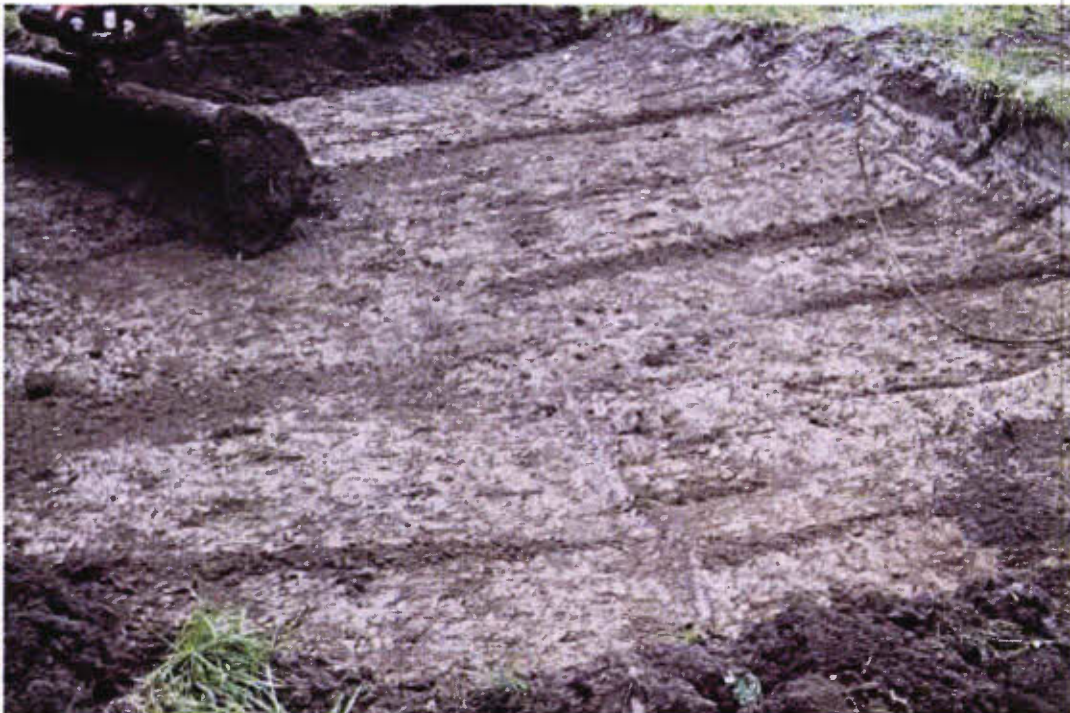
Photo 13: Facing west-northwest. Area of ground in rear garden looking along the northern stonewall, showing topsoil stripped area for the cess pit.

Photo 14: Facing northwest. Topsoil stripping of the footprint of the cess pit

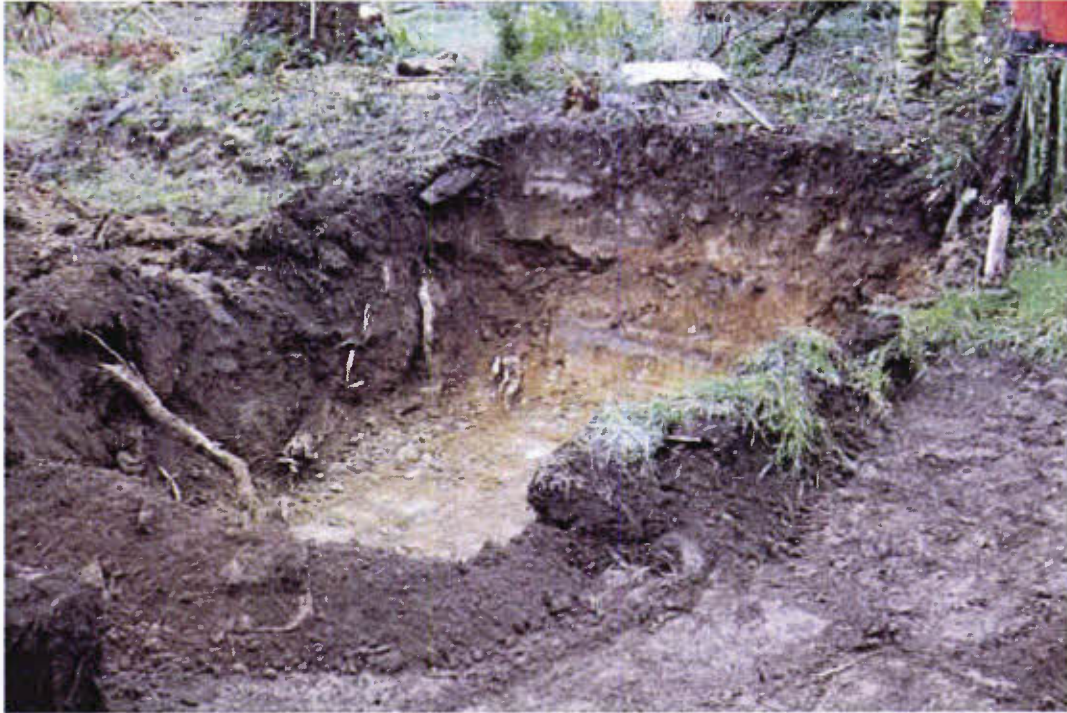
Photo 15: Facing north. Area for cess pit after partial excavation into the bedrock.

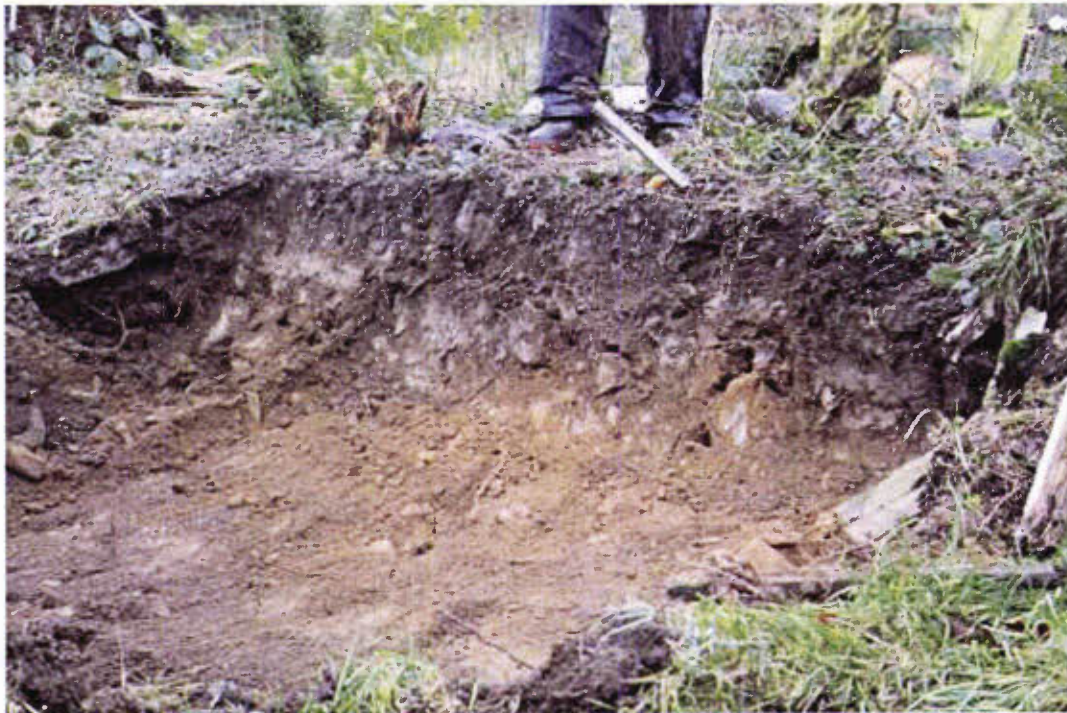
Photo 16: Facing north. Close up of the section of the cesspit excavation intruding into the rear garden wall.

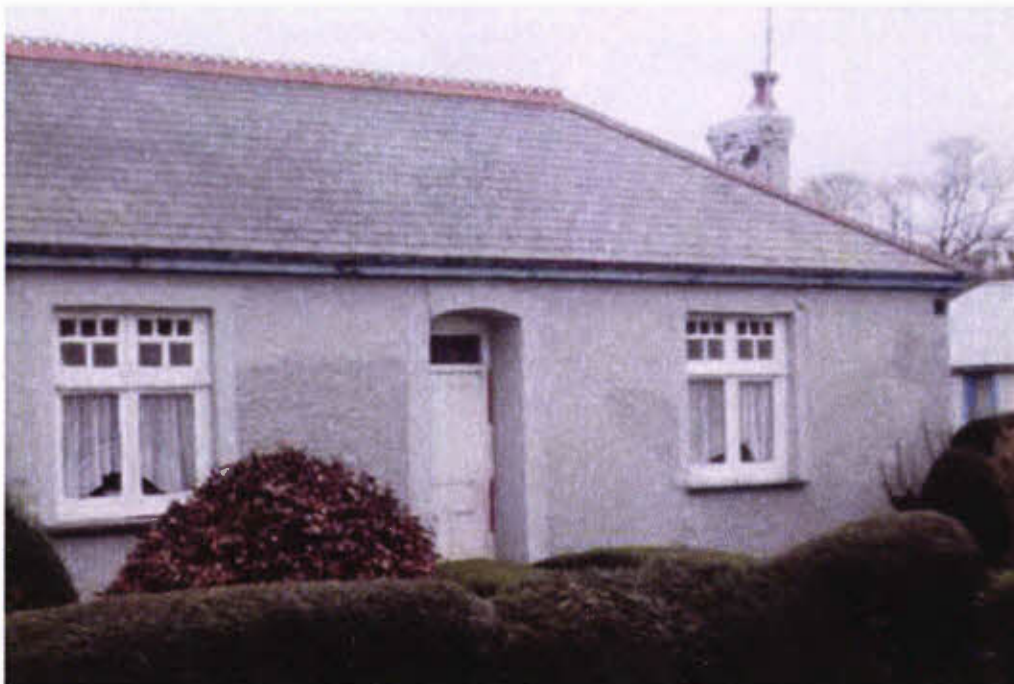
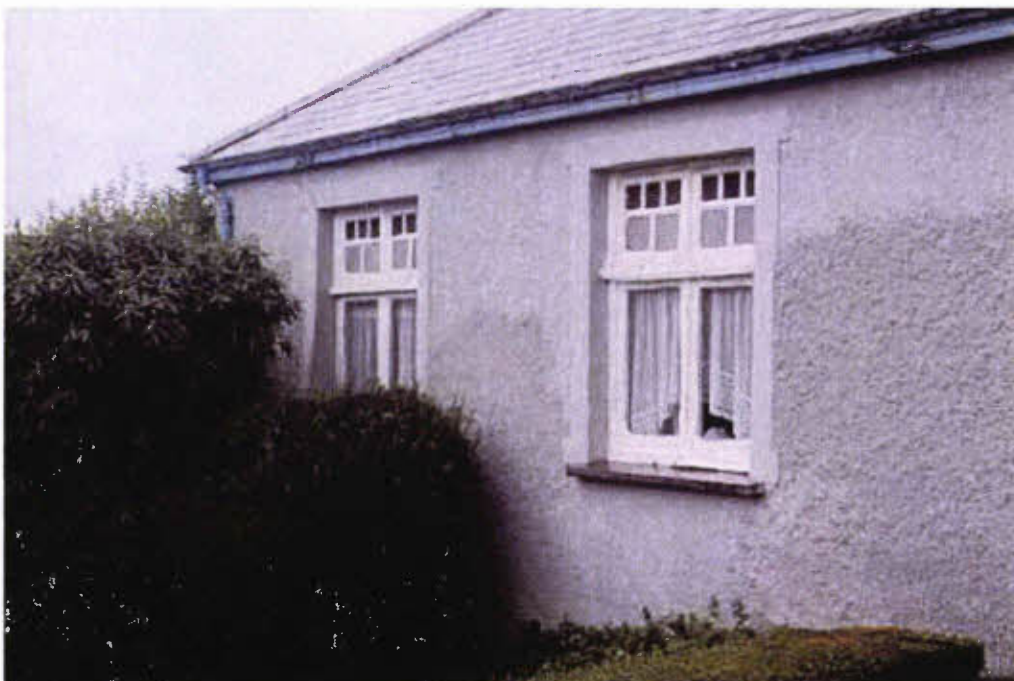
- 5.1 The main building of Ty Hir is a single storey stone built structure. The hipped roof is covered with slate, with red ceramic ridge tiles (Photo 17). Those on the apex of the ridge are two holed, crested tiles. The roof appears to have been replaced at some point in the 20th century. Chimneys are present at the two ends of the building, rising from the wall plate level (there are no gables). These may be of 19th century date.

Photo 17: Facing east-northeast. East end of front of Ty Hir cottage.

Photo 18: Facing northwest. West end of front of Ty Hir cottage.

- 5.2 There is a front door on the eastern side of the main façade, with two windows flanking to the west and single window to the east (Photos 17 and 18). All of these appear to be 20th century inserts. The three windows are all double, single pane casement windows under two fixed fanlights, formed of 5 panes (two larger under three smaller). The upper three panes are coloured red and yellow (Photo 23). The front door is recessed at the back of the exterior wall indicating a substantial thickness to the front wall of the cottage.

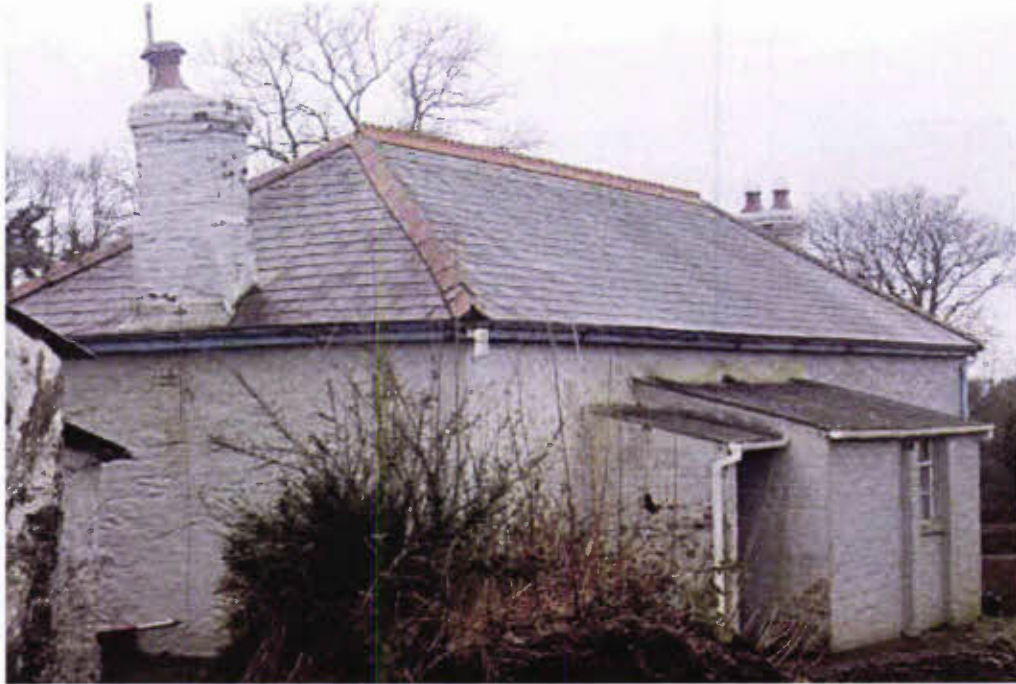
Photo 19: Facing west. Rear of Ty Hir cottage.

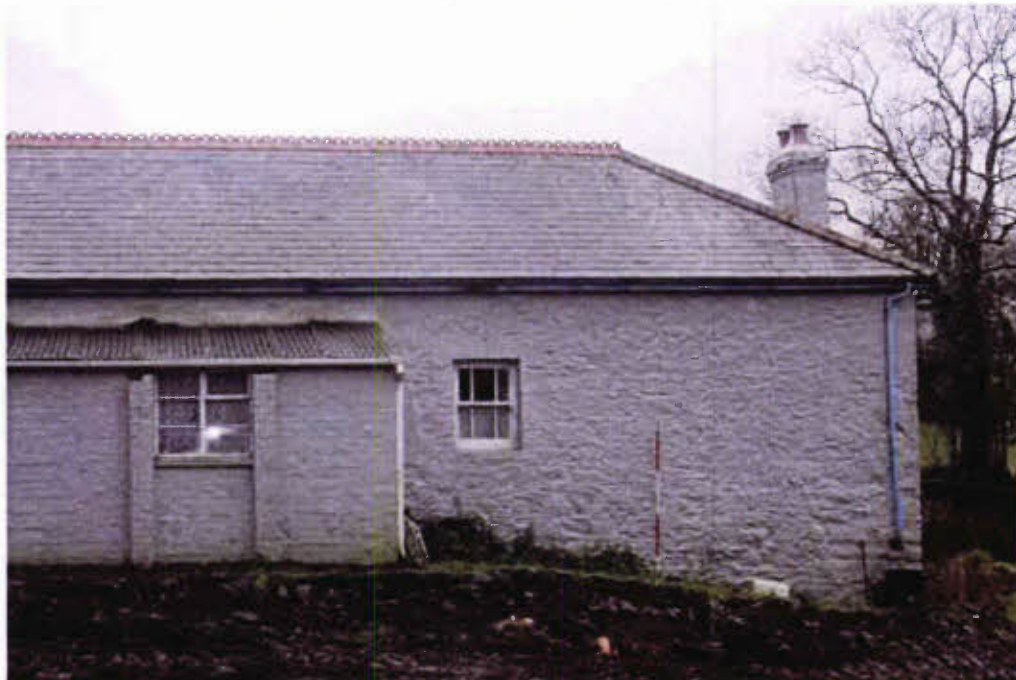
Photo 20: Facing south-southeast. West end of rear of Ty Hir cottage, with 2m scale.

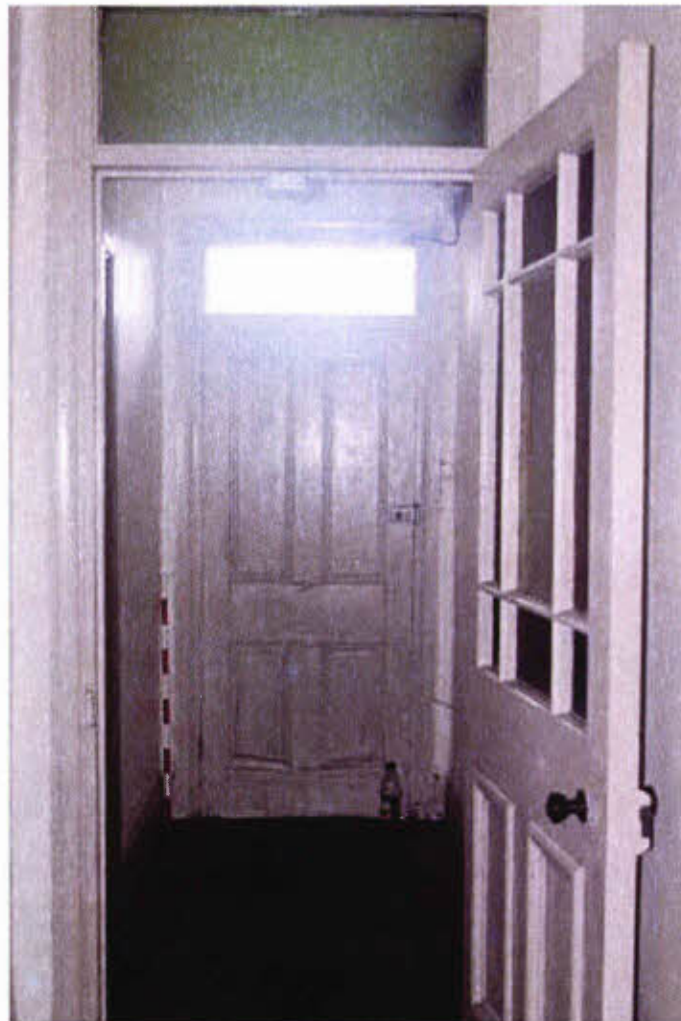
- 5.5 Internally the building has been much altered and plaster covered to prevent any phasing of the structure to be determined. The layout of the building comprises a hallway across the width of the building with the front door to the south and doorway into 20th century extension to the south. This corridor was separated by a second partition doorway beyond the internal doorways leading to the east (living room) and west (bedroom) (Photo 21) the hallway adjacent to the front door had a red and black glazed tile floor. This door was half glazed, with Bakelite door handle of 20th century date. The front door was a four panelled door of probable 19th century date (Photo 21).

Photo 21: View south along entrance hallway, towards front door

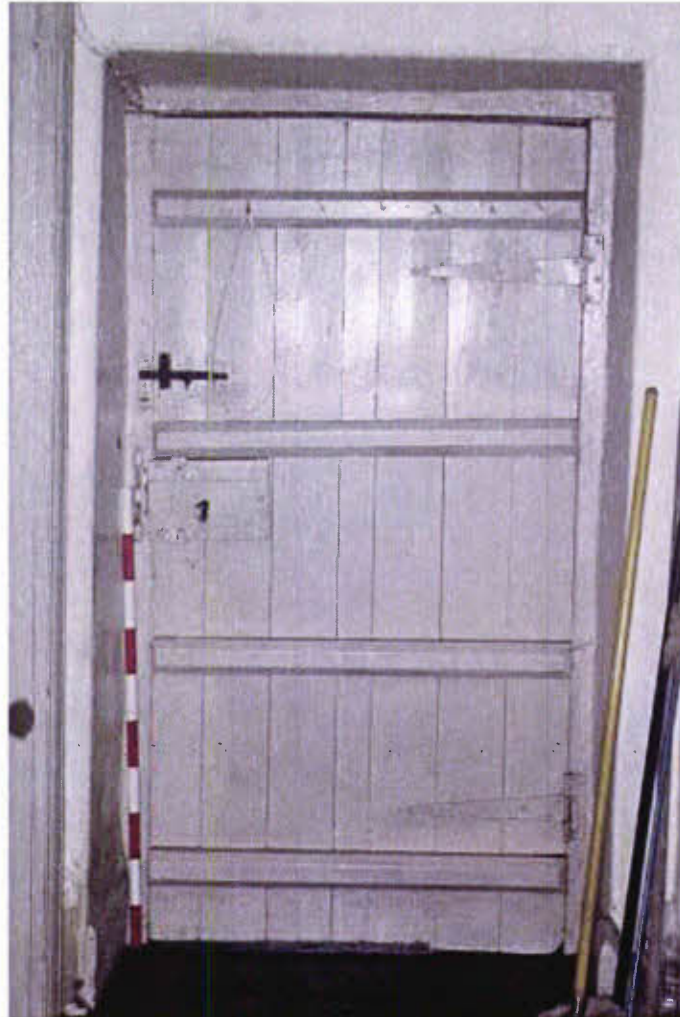
- 5.6 The doorway to the 20th century rear extension at the northern end of the hallway would have originally been the back door to the property and its appearance suggests it may have been an original feature (Photo 22). The door was of simple ledged construction, with smaller central plank. The hinges were of T-strap design. A simple latch was present with a large lock beneath. All of the door furniture may have been original.

Photo 22: View north towards door at northern end of hallway leading to the rear extension.

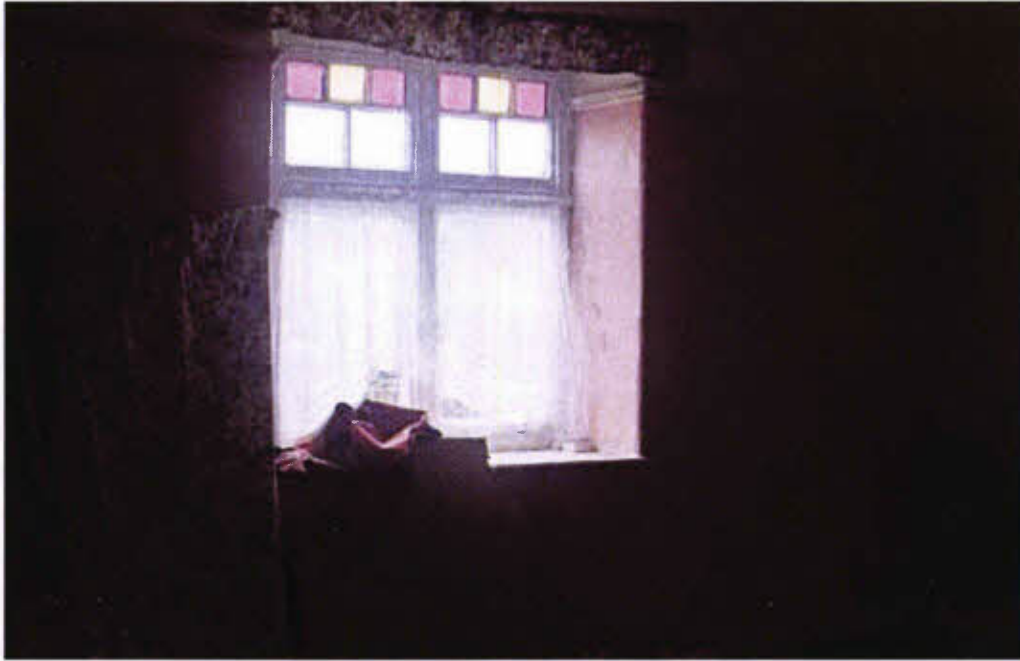
- 5.7 The living room, to the east of the entrance hallway covered the full width of the building, with window to the front (Photo 23) and fireplace on the eastern end wall (Photo 24). A quarry tiled floor was visible under the carpet in the corner of this room (Photo 26). The doorway (not pictured) was of 1930s style comprising a brass doorknob at chest height, with three tall panels below and a single panel at the top of the door.

Photo 23: Window to southern façade within sitting room, showing coloured glass

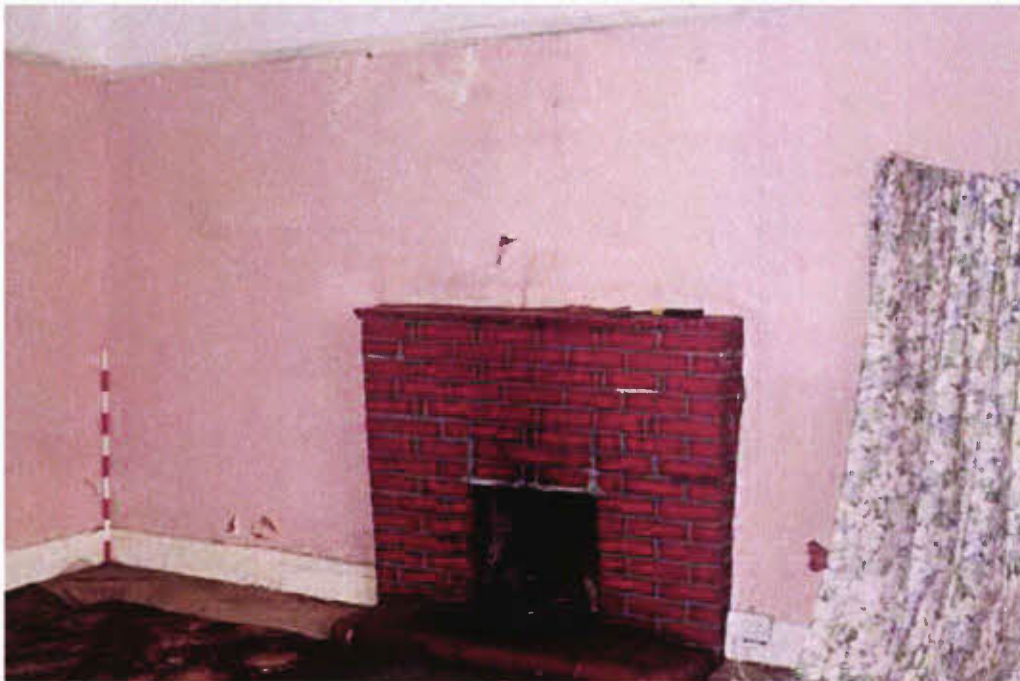
Photo 24: Facing northeast. The painted brick fireplace in the room at the east end of Ty Hir cottage. 1m scale.

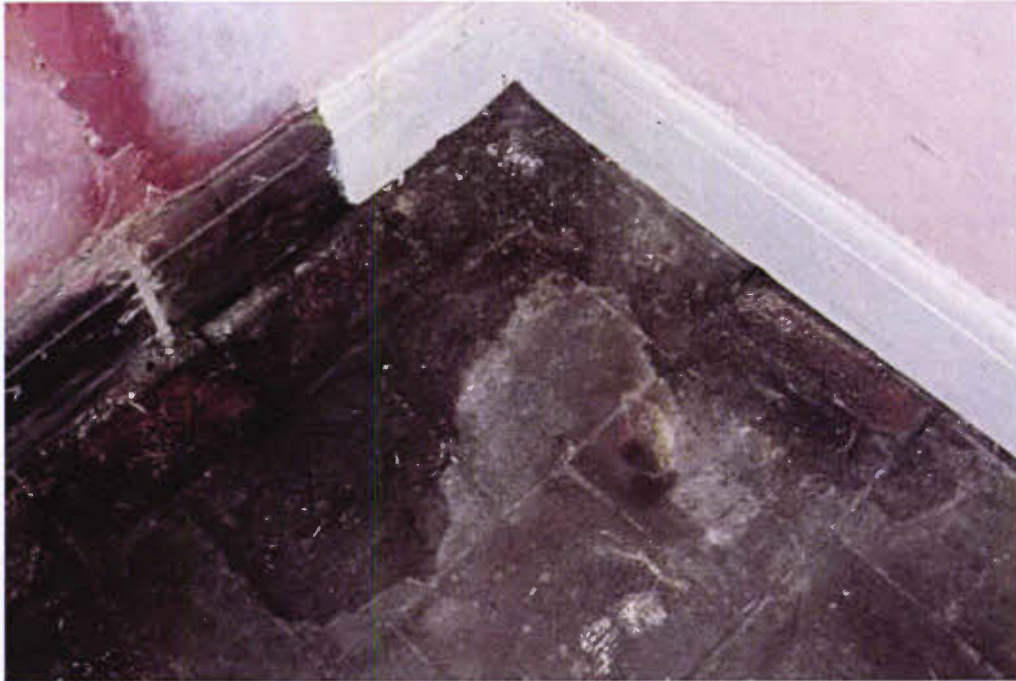
Photo 25: Facing northwest. Tiled floor seen under carpet in northwest corner of the room at the east end of Ty Hir cottage.

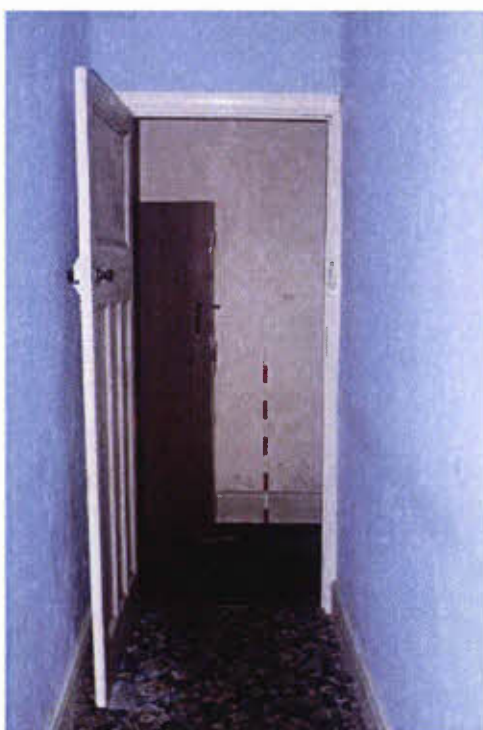
- 5.8 The room to the west of the entrance hallway was previously used as a bedroom. It had an identical door to that which provided access to the sitting room to the west. A single window was present on its southern wall, with the other walls being featureless. The room did not extend the full width of the house, being separated from the back wall by a corridor leading from the northern end of the entrance hallway. A doorway separated this corridor from the entrance hallway, which was of 1930s style (of same design as those to the sitting room and bedroom) and had a Bakelite door knob (Photo 26).

Photo 26: View east towards doorway separating the entrance hallway from the corridor. 1m scale.

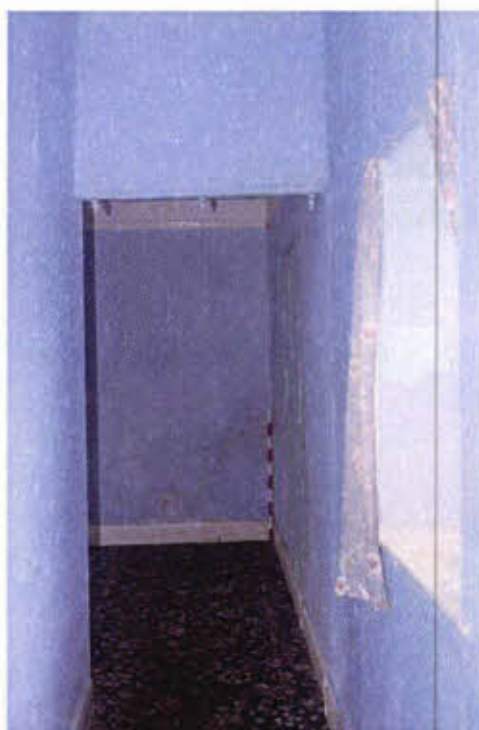
Photo 27: View west along corridor leading from entrance hallway to western room, showing partial partition at ceiling height and rear window opening. 1m scale.

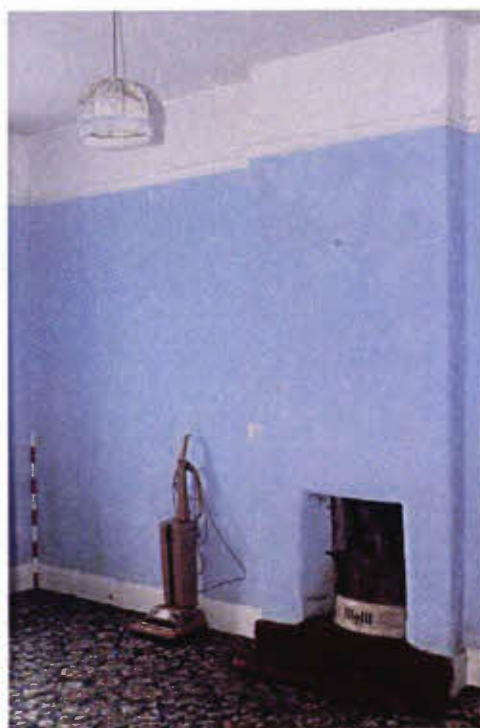
- 5.10 The western room had a fireplace on the western end wall (Photo 29) and a window to the southern façade.
- 5.11 The rear extension was accessed from the entrance hallway through the possible original ledged door. The substantial width of the rear wall of the original Ty Hir building was visible in this doorway (Photo 30). A further doorway led to the east from the extension into a small covered porch (smaller extension noted above) that led into the garden.

Photo 29: View southwest in western room showing fireplace with 1m scale

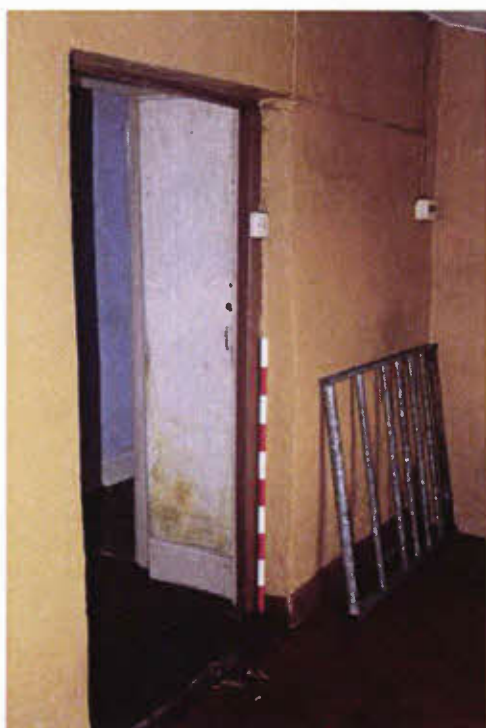
Photo 30: View southwest within rear extension showing doorway into main house and thickness of the rear wall

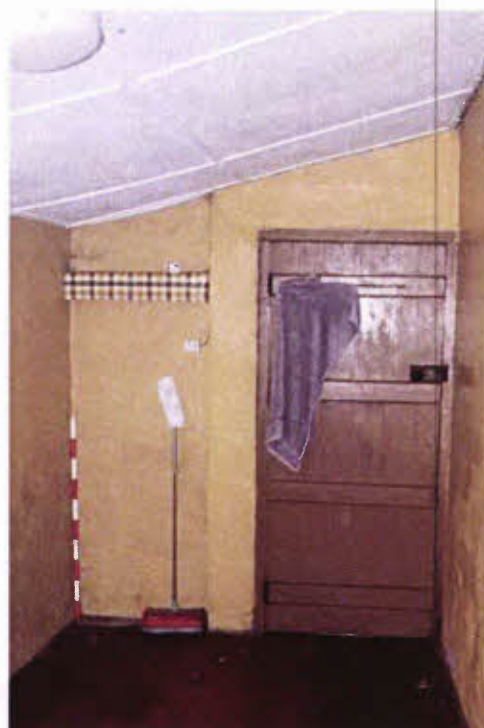
Photo 31: Facing east. Interior of lean-to at rear of Ty Hir cottage, towards rear door, with 1m scale.

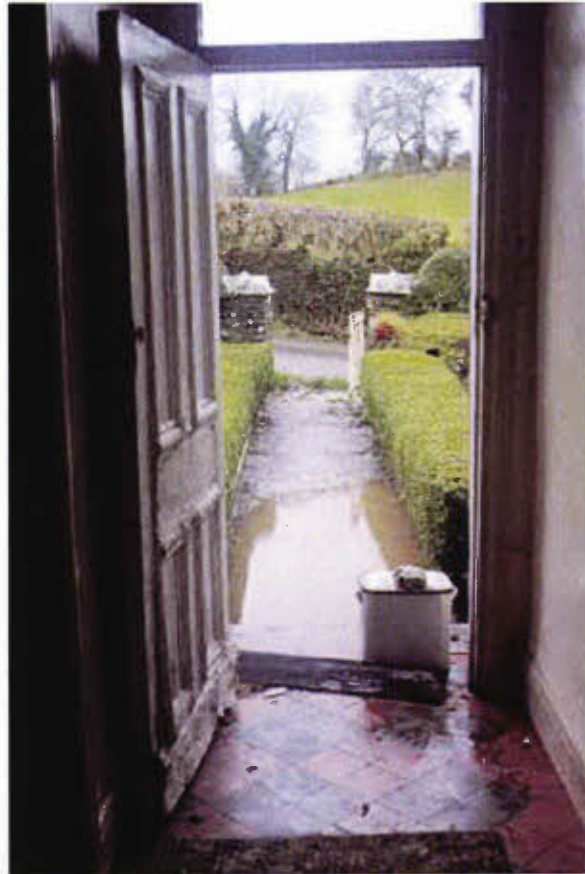
- 5.12 At the front of Ty Hir a small pathway led from the front door to a stone built entranceway gateway onto the road front (Photos 32 and 33).

Photo 32: View south from Ty Hir front door along garden path to entrance gate and road

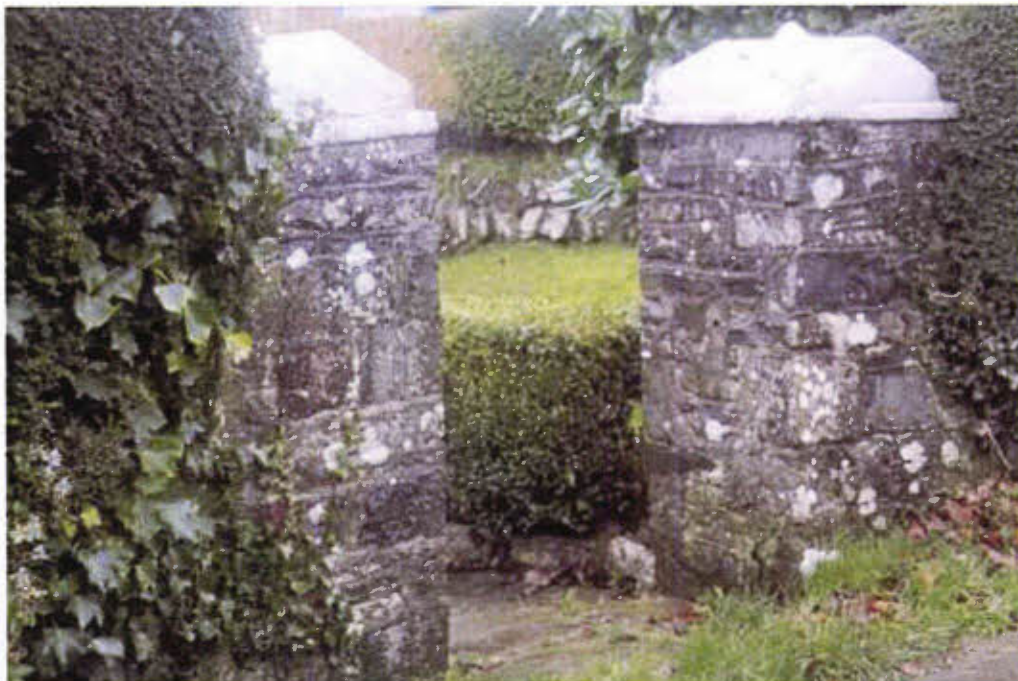
Photo 33: Facing northeast. Main front gateposts at Ty Hir.
