TY HIR, CILCENNIN, CEREDIGION: ARCHAEOLOGICAL WATCHING BRIEF

Prepared by Dyfed Archaeological Trust
For: Mr Carwyn Iles

RHIF YR ADRODDIAD / REPORT NO. 2017/15
RHIF Y DIGWILLIAD / EVENT RECORD NO. 110331

**TY HIR, CILCENNIN, CEREDIGION:
ARCHAEOLOGICAL WATCHING BRIEF**

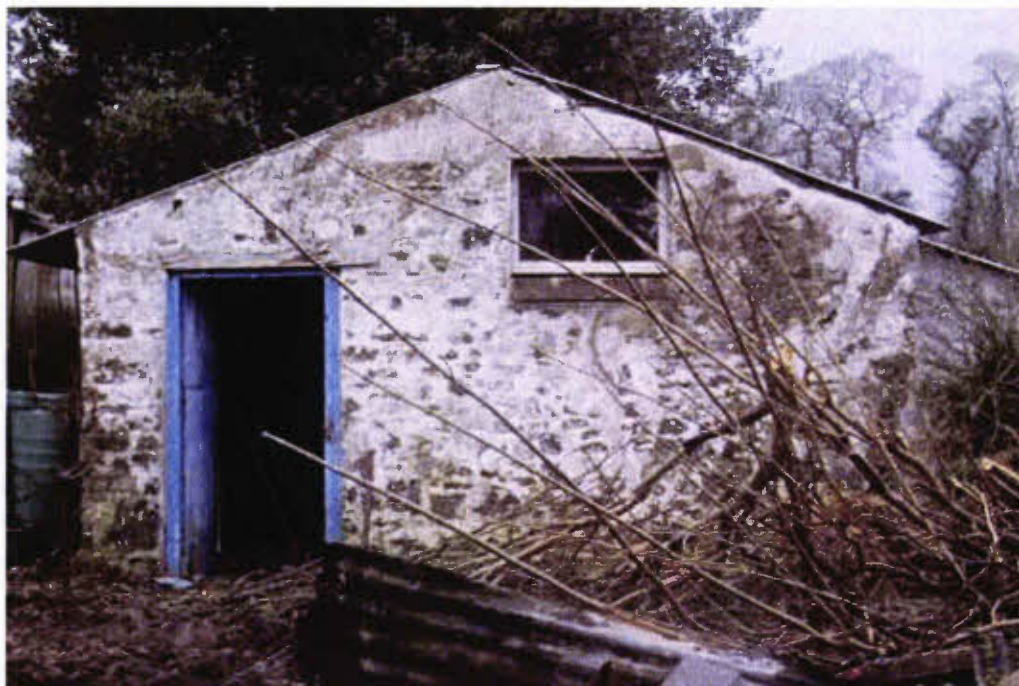
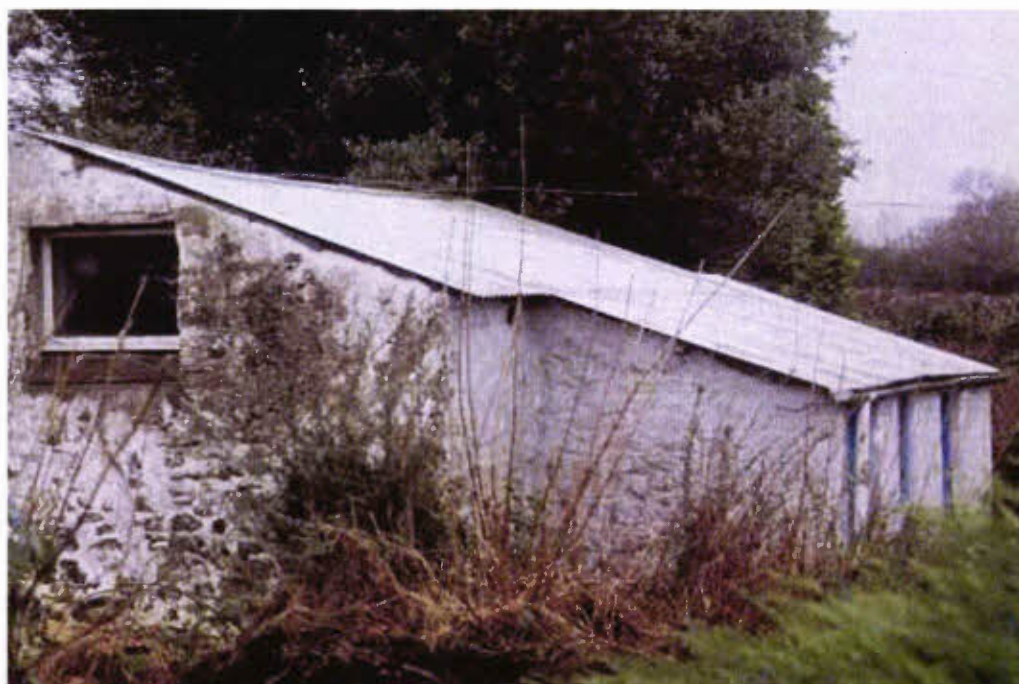
- 5.13 The outbuilding to the northeast of Ty Hir was also of stone construction, but with a number of additions (Photos 34 and 35). The building comprised a main simple rectangular building with gable ends to the north and south, with a lean to extension on its western side also constructed of stone.

Photo 34: Facing south-southwest. Northern side of stone outbuilding at Ty Hir.

Photo 35: Facing south. Stone outbuilding at Ty Hir.

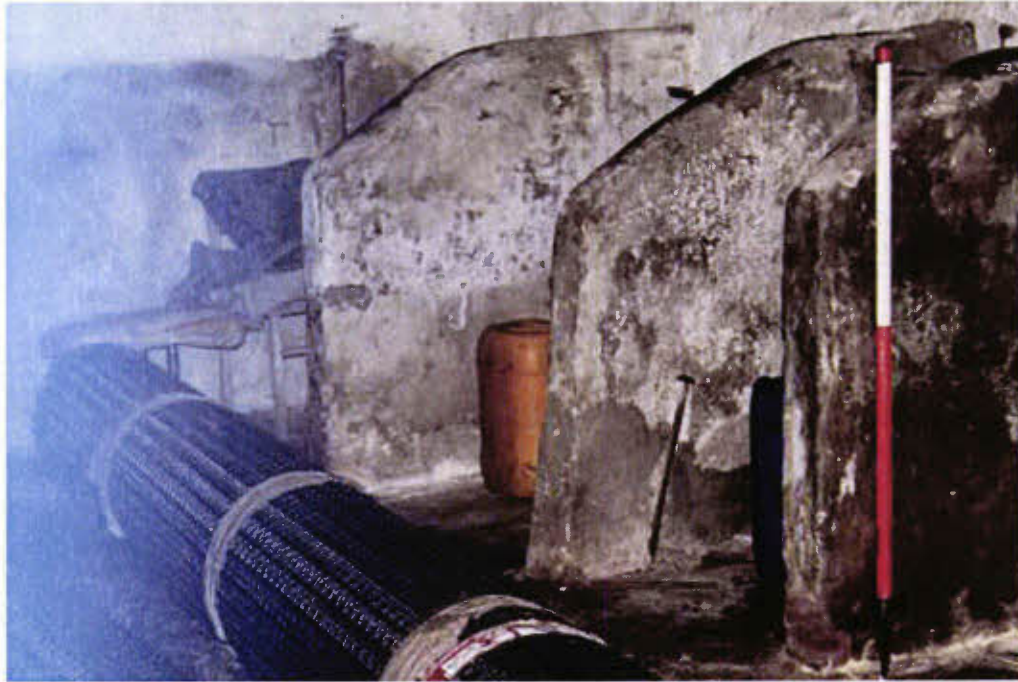
- 5.14 The main outbuilding has evidently been used for animals previously, the internal area having a number of animal stalls within (Photo 36). The lean-to extension comprised two small rooms, one with a window, previously used for storage.

Photo 38: View inside stone outbuilding, facing southwest, showing animal stalls

- 6.8 The stone outbuilding may 19th century addition. It was certainly used for animal housing, as indicated by the animal stalls. These appeared to be of concrete construction and could have replaced earlier timber ones. It is possible that the concrete stalls were contemporary with the 1930s renovations to the main building.

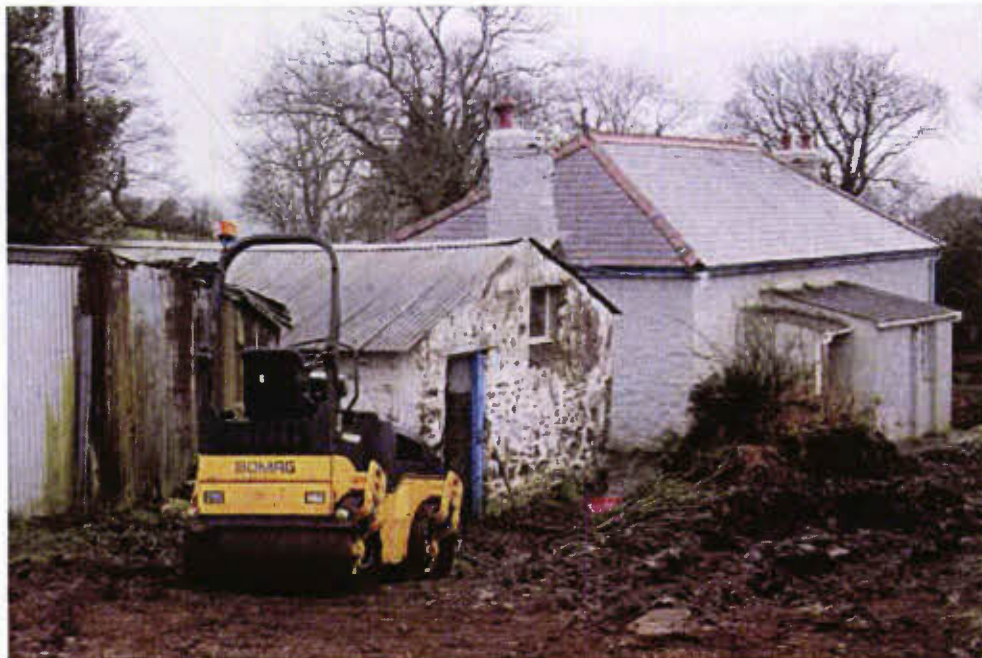
Photo 37: View southwest showing stone built outbuilding, Ty Hir cottage and corrugated metal shed to east of outbuilding.

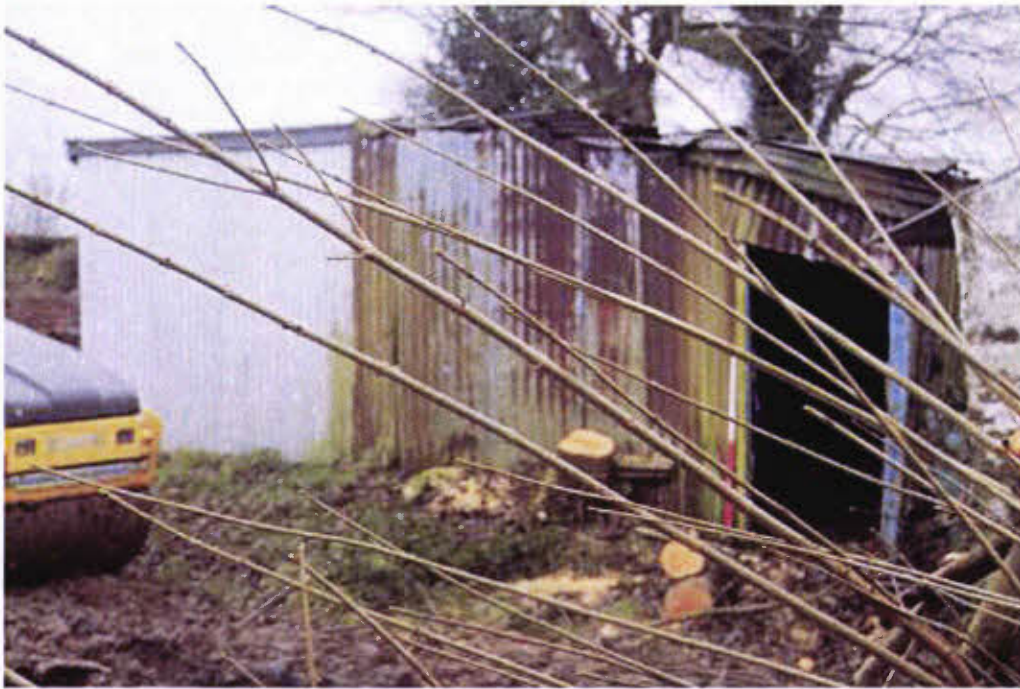
- 5.15 To the east of the outbuilding stood a small corrugated metal shed in a poor state of repair (Photo 38 and 39), which may have replaced an earlier building as a cobbled floor was present inside of it (Photo 40).

Photo 38: View south showing corrugated metal outbuilding.

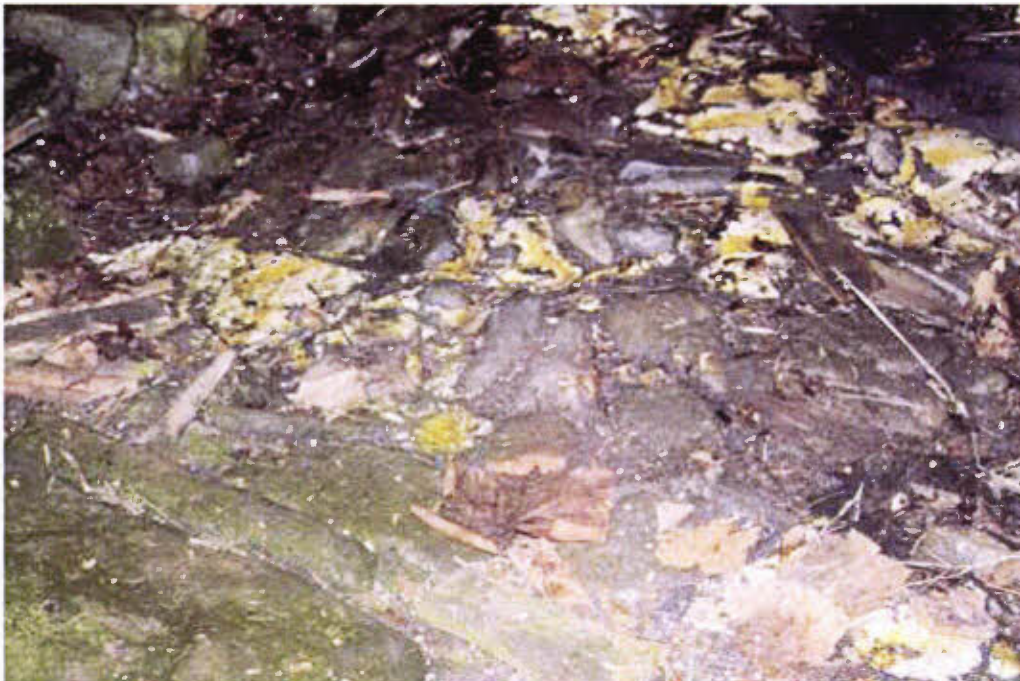
Photo 39: Facing south. Cobbled floor inside corrugated metal shed.

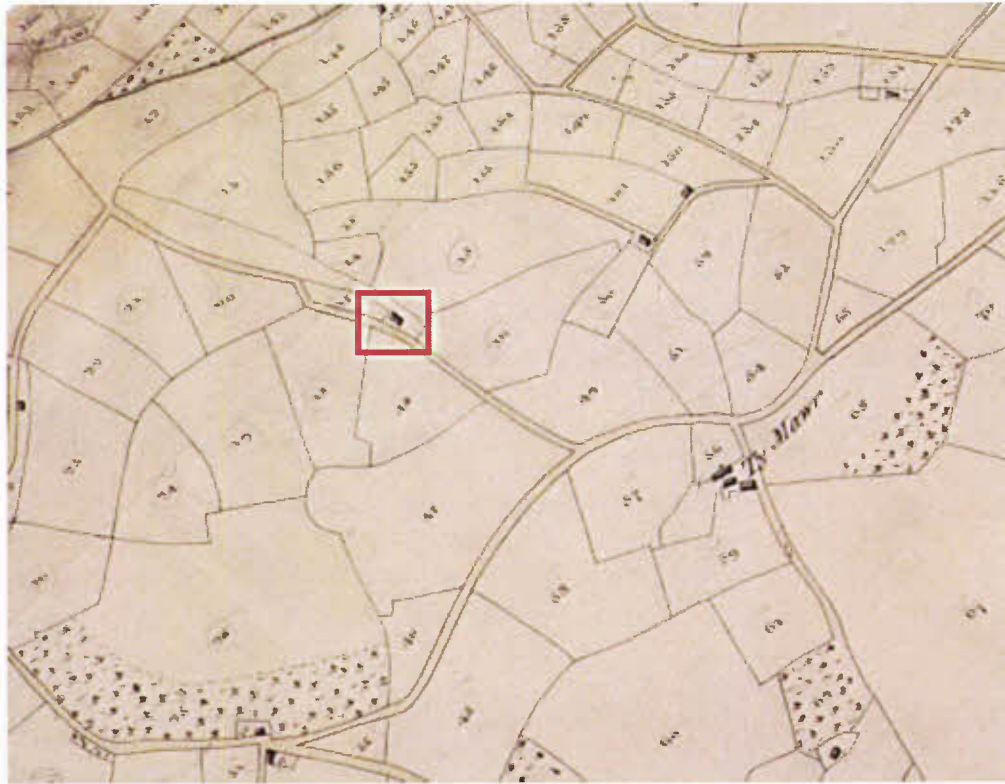
Figure 3: Extract of the 1843 Tithe Map of Cilcennin, with approximate location of Ty Hir highlighted
