**CHIMNEY'S LINK PHASE 1,
FISHGUARD, PEMBROKESHIRE:
ARCHAEOLOGICAL EVALUATION
2017**

Prepared by DAT Archaeological Services

For: Pembrokeshire County Council /
Atkins

RHIF YR ADRODDIAD / REPORT NO. 2017/20
RHIF Y PROSIECT / PROJECT RECORD NO. 110435

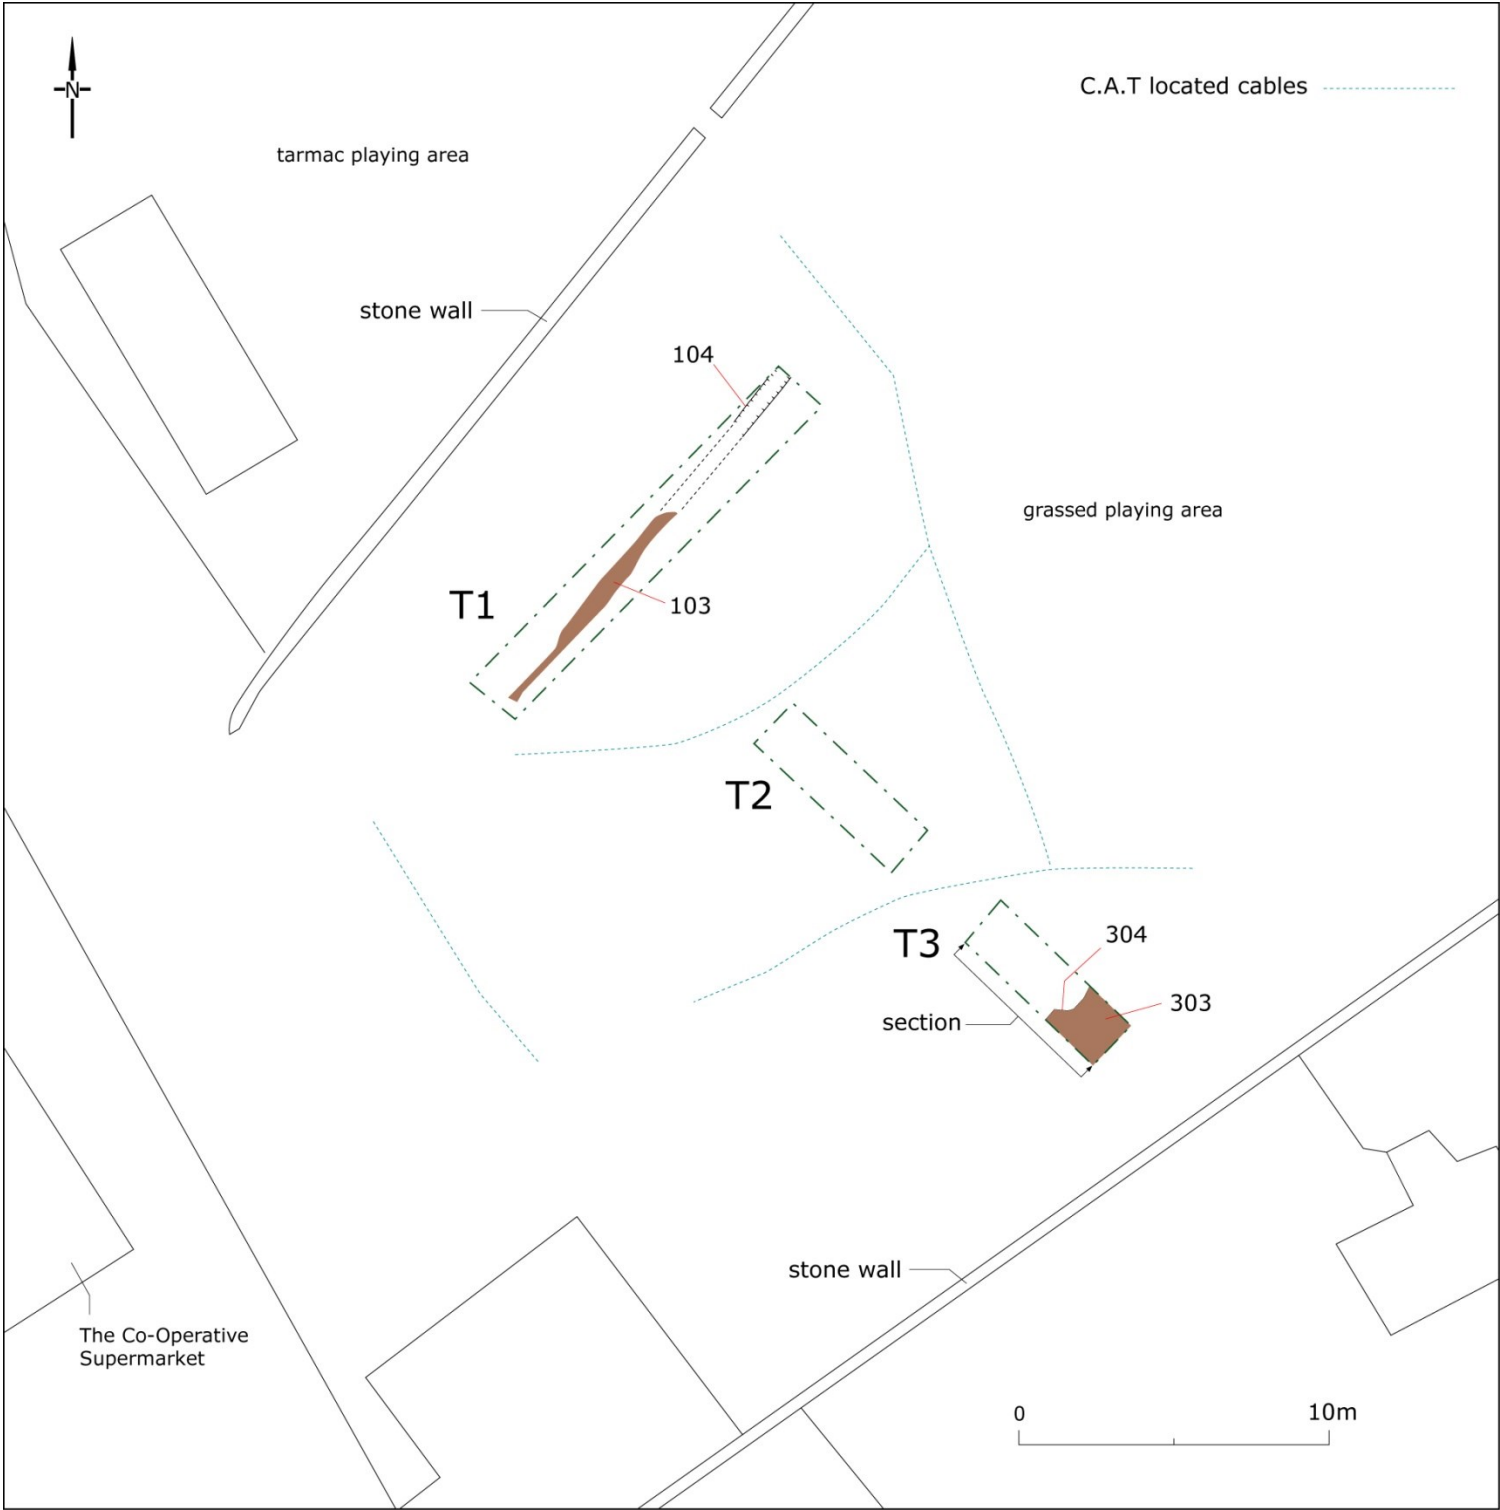
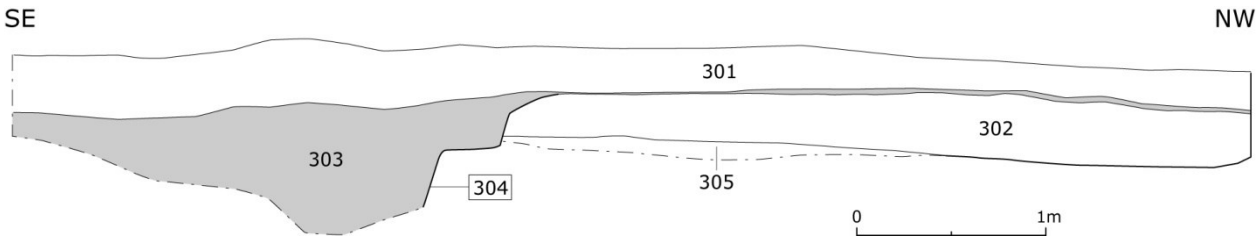
Figure 3: Trench plan and section drawing

Trench plan

Section drawing Trench 3, northeast facing section

4.1 All individual archaeological deposits or features were numbered using the open-ended numbering system and each numbered deposit was described. Each trench was recorded with plan drawings and section drawings where appropriate (Figure 3).

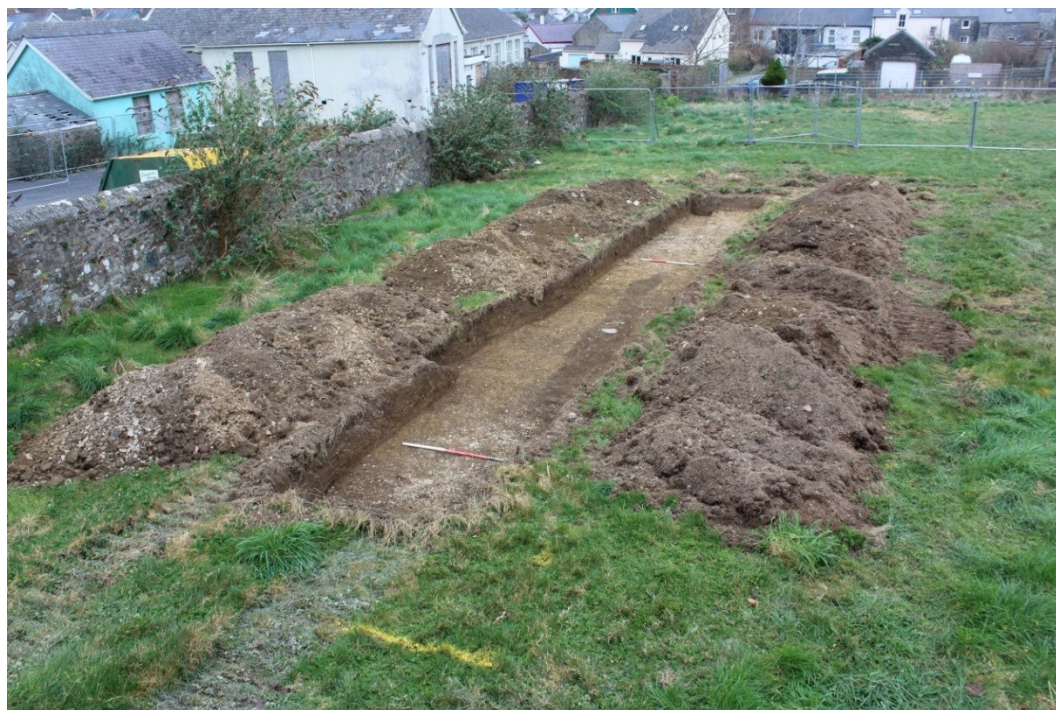
Photo 1: Overview of Trench 1 following cleaning showing linear feature [104]. Fishguard Junior School boundary wall is visible to left of photograph. Viewing north.

- 4.2.4 A linear feature could be clearly seen cutting through the natural geological layer. The cut [104] was that of a gully, of around 0.55m width which extended across the trench from the northwest corner to the southeast corner measuring 20m long (Photo 1).
- 4.2.5 A section of [104] was excavated to reveal a shallow gully with a rounded profile (Photo 2). At the most northern end the gully was approximately 0.05m deep gradually sloping up as it went south so that virtually no depth survived of the feature at all. The gully was filled with (103), a dark brown silt. Occasional finds of modern material were found including glass and pottery.

- 5.3 The linear gully exposed in Trench 1 at a depth of 0.54m below ground level was easily discernible due to its dark fill contrasting with the light coloured natural geology it cut into. One section of the gully was excavated at the northern end of the trench which showed it to have a rounded profile and was approximately 0.05m deep. As the gully extended to the south it gradually became shallower until it was virtually nonexistent. Artefactual evidence recovered during excavation of the gully dated from the 20th century and included fragmented glass and pottery. It is likely the gully represents a former boundary or drainage ditch. Examination of available cartographic sources suggests the area has not been previously developed.

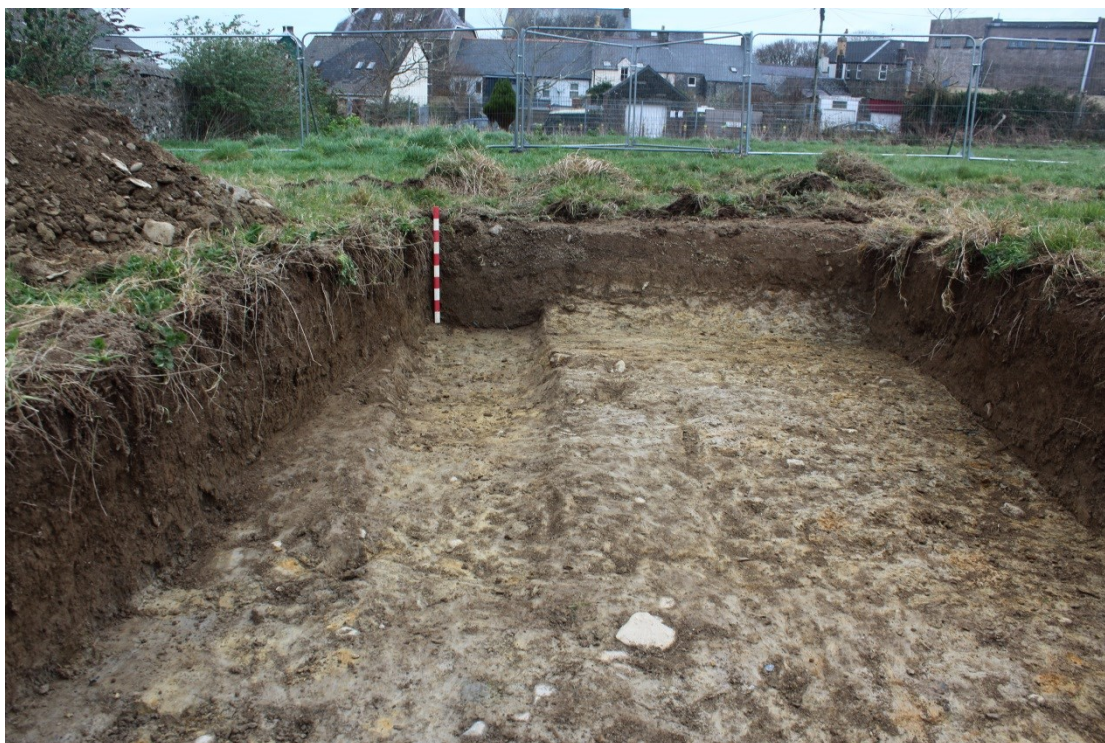
Photo 2: Trench 1, linear feature [104] following excavation at northern end of trench. Viewing north with 0.5m scale.

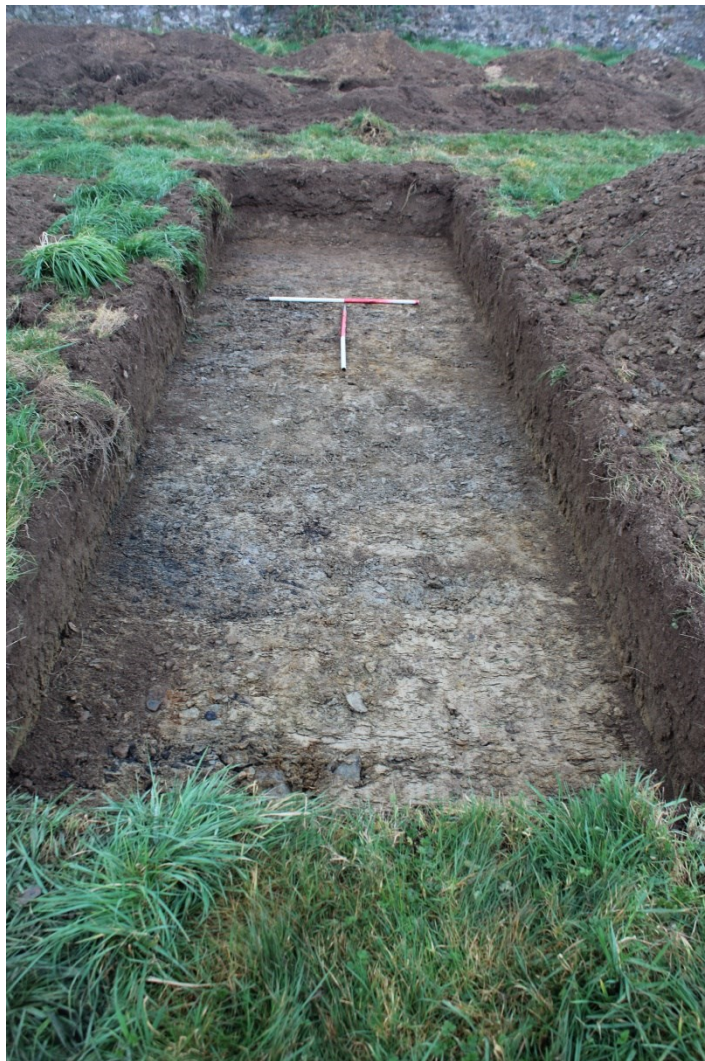
- 4.3.1 Trench 2 measured 7m x 2m and was orientated roughly east to west, perpendicular to Trench 1 in the mid-section of the proposed development area (Photo 3). The trench was restricted by services indicated by the CAT scan of the area.
- 4.3.2 The trench was machined through a similar topsoil to that seen in Trench 1, with an average depth of 0.19m, layer (201). This overlay a light brown clayey silt subsoil, layer (202) of around 0.30m depth.

- 4.3.3 The base of the trench comprised a light brown sandy clay natural subsoil (203). Occasional patches of bedrock were seen to protrude through this, consisting of a compressed slate shale. No archaeological finds or features were recorded within this trench.

Photo 3: Overview of Trench 2 following cleaning. Viewing west.

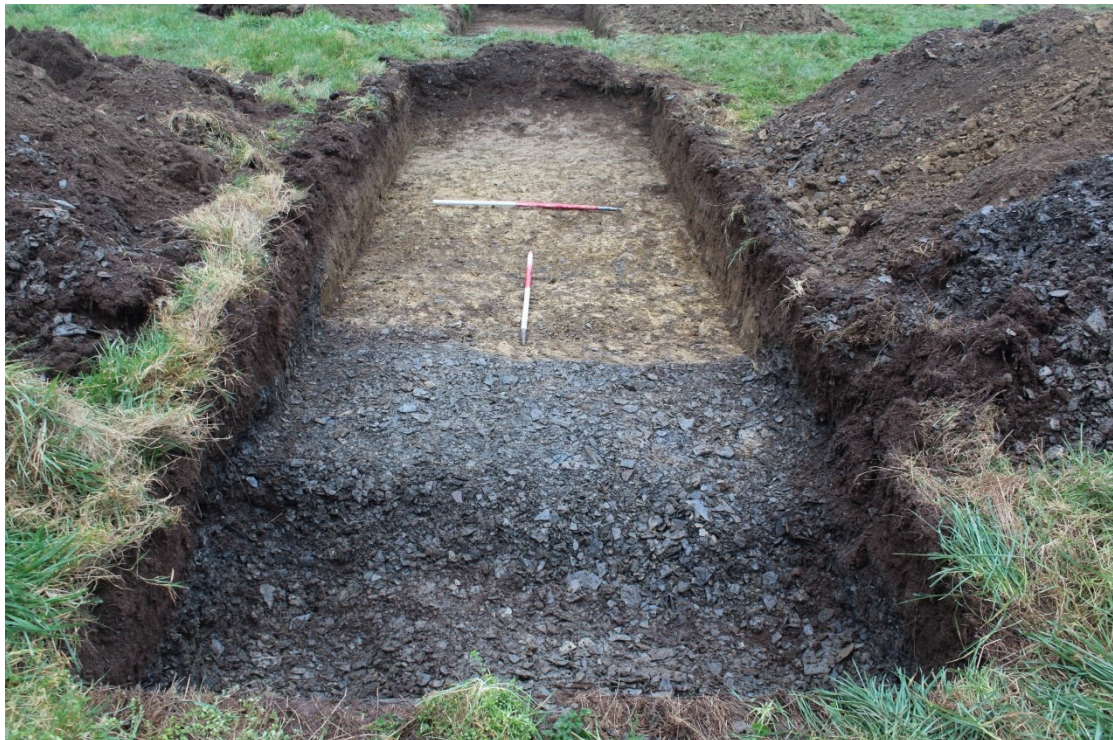
Photo 3: View west along trench 3 showing natural geology (305) truncated by cut [304] in the foreground.

- 4.1.12 Cut [304] was filled with (303), a loose slate/shale, possibly fragmented bedrock. This backfill material was clean and not mixed with any other materials. No artefactual evidence was recovered from the fill.
- 4.1.13 The subsoil (302) and cut [304] were overlain by 0.24m thick layer of topsoil and turf across the trench. This varied in colour and was particularly dark at the eastern-most end of the trench where it overlies [304]. Gradually moving west along the trench the topsoil became lighter in colour.

- 5.4 The feature recorded in the eastern half of Trench 3 appears to be a relatively recent disturbance. The loose slate/shale backfill appears to be clean fragmented local bedrock. This may indicate a quick excavation and backfill exercise as might be expected by a test-pit for a geotechnical survey or a deliberate laying down of crushed stone as might be expected for a soak-away or similar. In addition to this, the darker topsoil overlying this area of the trench supports the hypothesis that this feature is a recent disturbance, such as a geotechnical test-pit.
