**FALCONRY CENTRE,
NATIONAL BOTANIC GARDEN OF WALES,
CARMARTHENSHIRE
ARCHAEOLOGICAL EVALUATION
(SN 51895 81940)**

RHIF YR ADRODDIAD / REPORT NO. 2017/26
RHIF Y DIGWYLLIAD / EVENT RECORD NO.110450

**FALCONRY CENTRE,
NATIONAL BOTANIC GARDEN OF WALES,
CARMARTHENSHIRE
ARCHAEOLOGICAL EVALUATION**

**FALCONRY CENTRE,
NATION BOTANIC GARDEN OF WALES, CARMARTHENSHIRE:
ARCHAEOLOGICAL EVALUATION**

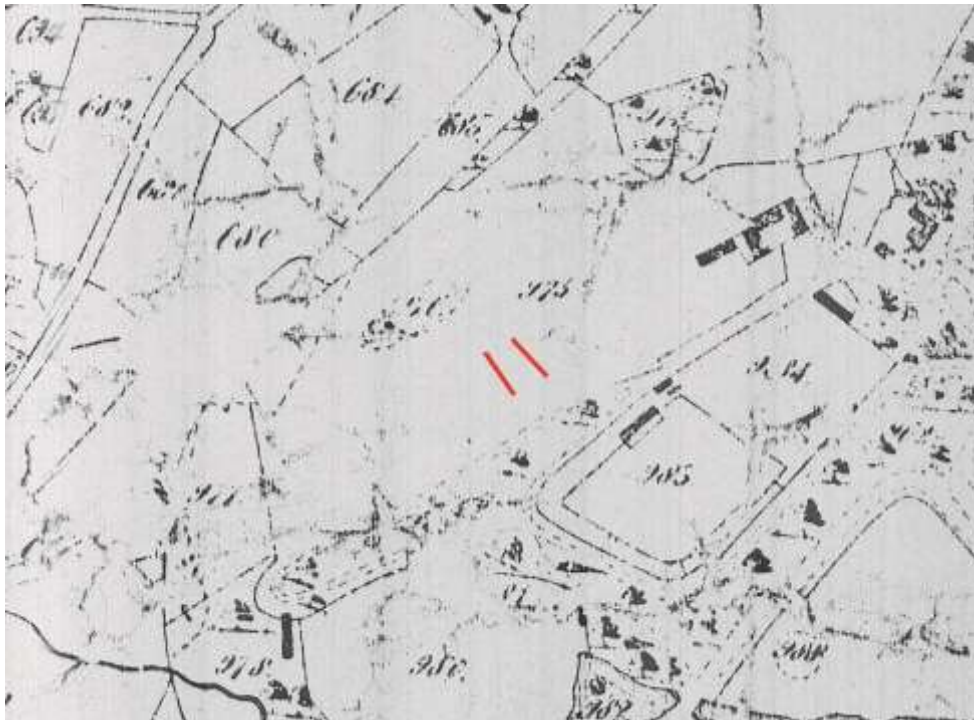
Figure 3: Detail of 1847 tithe map showing approximate location of evaluation trenches (in red).

- 2.2.9 The apportionment for the 1847 tithe map shows the area of development to be free of structures and field boundaries (Figure 3). The accompanying apportionment describes the parcel of land (975) thus: *Graig including land got in Exchange* (Figure 4).

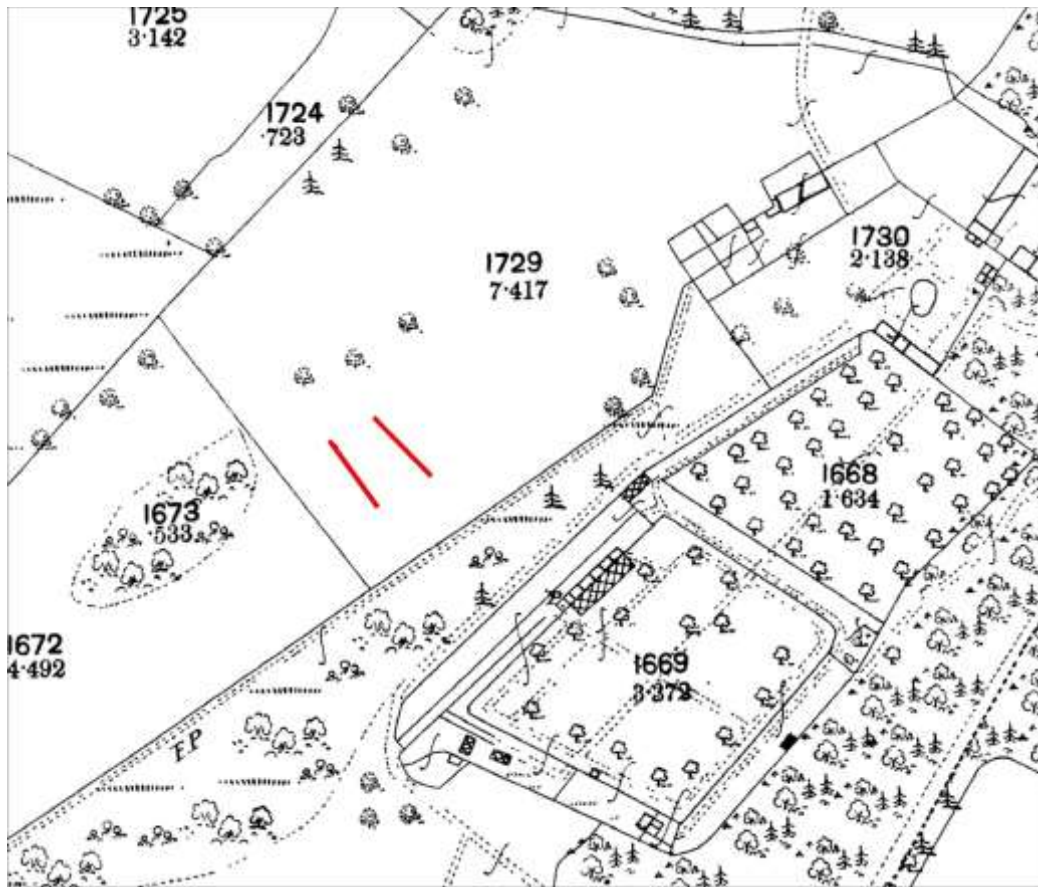
Figure 5: Extract from the Ordnance Survey first edition map of 1880s showing approximate positions of evaluation trenches (in red).

- 2.2.10 The first edition Ordnance Survey 1:2500 scale map shows the layout of the area in 1888 (Figure 5). The site area is again shown as lying within a

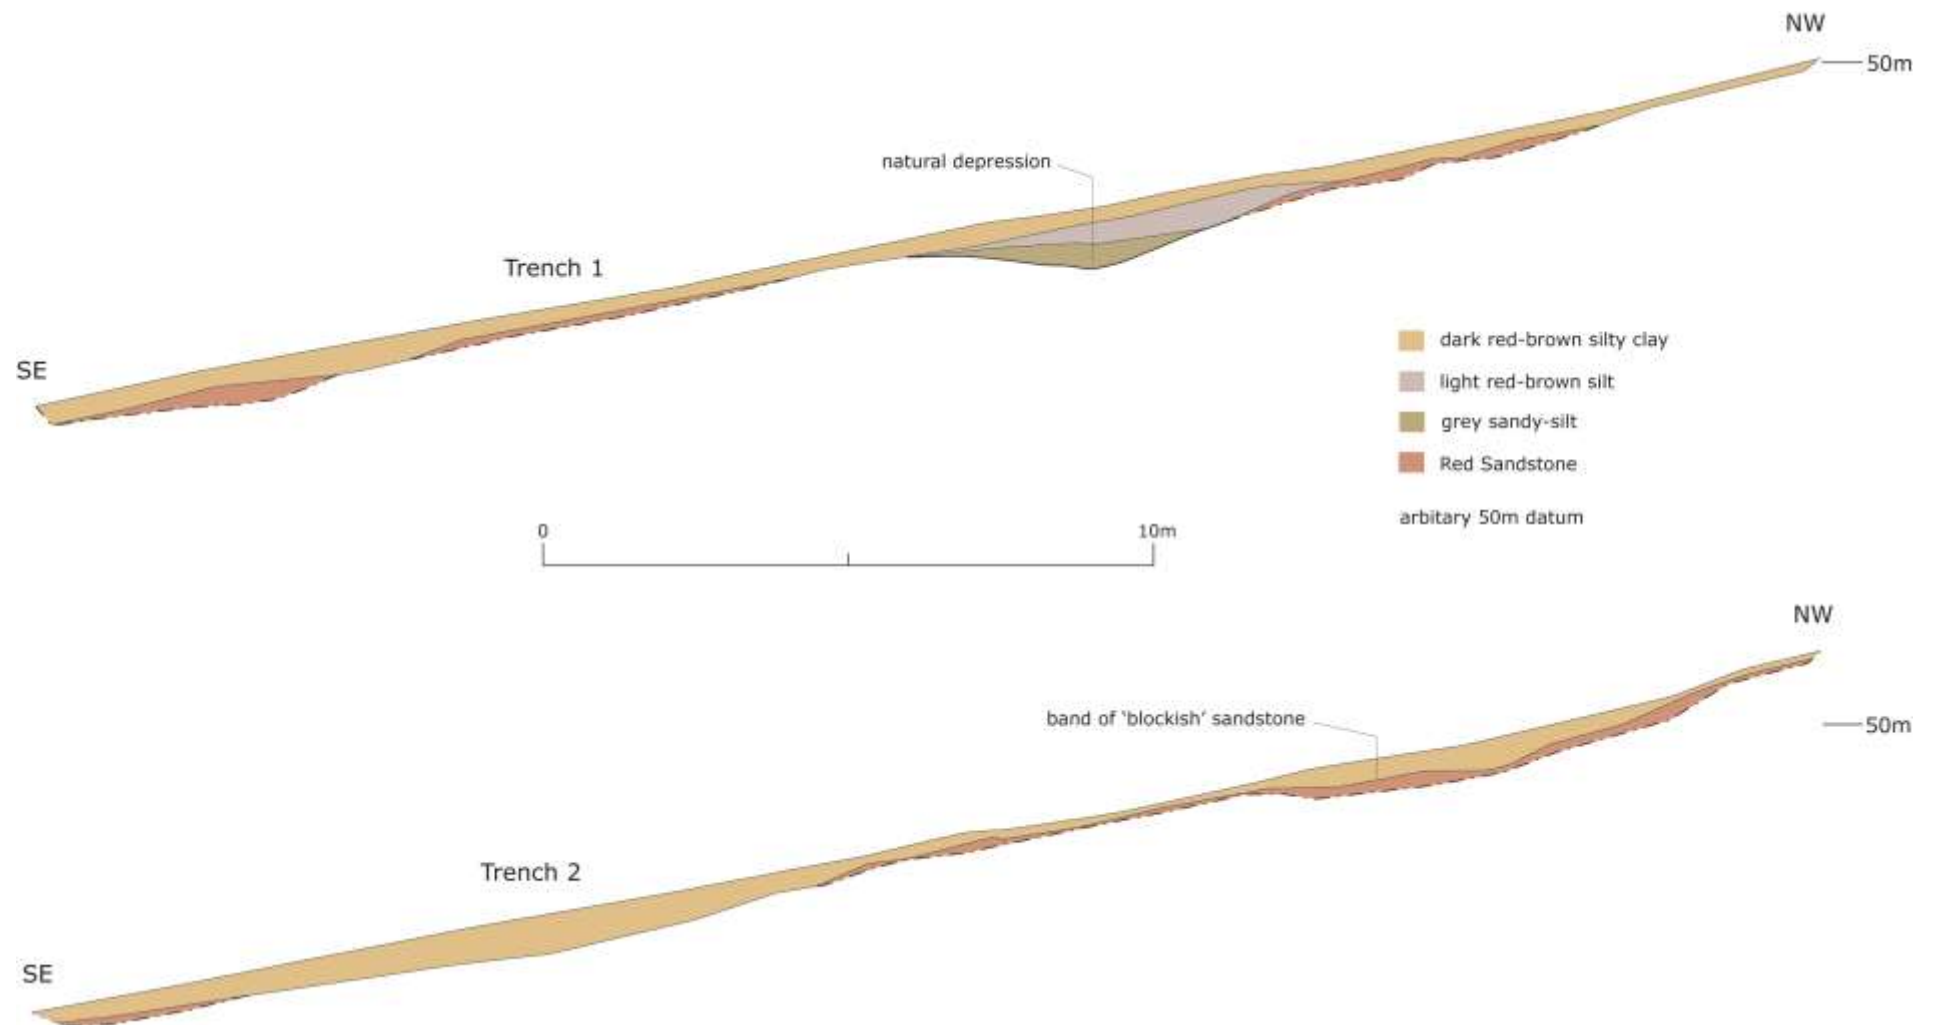
- 4.4 Approximately 11m from the NW end of the trench a depression in the bedrock, approximately 6.5m wide and 0.75m deep, was visible. Initially this was thought to be possibly an archaeological feature but further investigation revealed that no cut was present and that the fills of the hollow were natural – light reddish brown silt below which lay a grey sandy-silt (Photo 3; Figure 10).

Figure 10: NE facing sections of evaluation trenches

- 5.5 In Trench 2 a band of naturally deposited sandstone, blockish in appearance was revealed. This is very likely to account for the possible stone walling revealed in the initial test pit (Photo 6, Figure 10).

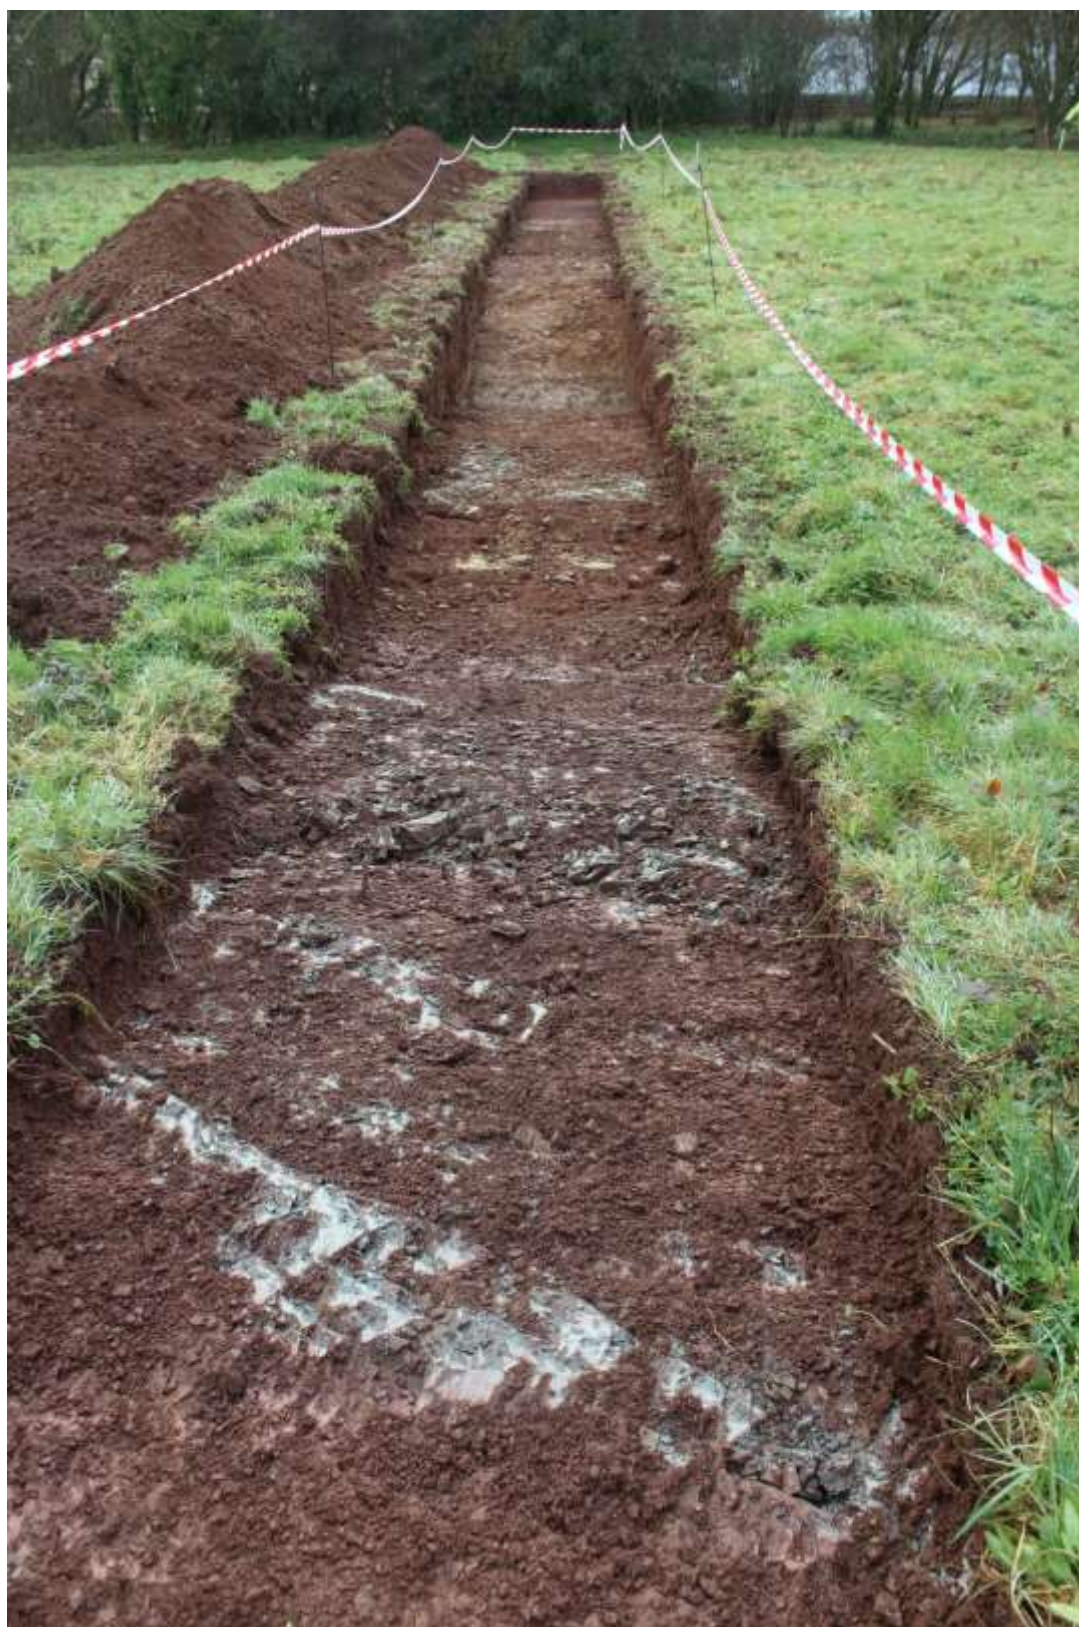
- 4.2 Trench 1 measured 30m in length and 1.6m wide (Photos 1 and 2; Figure 9).
- 4.3 The topsoil (reddish-brown, silty-clay) at the NW end of the trench was 0.12m deep and lay directly above the bedrock. At the SE end of the trench the depth of topsoil had increased to an average of 0.30m

Photo 1: Trench 1 looking SE (downslope) showing Red sandstone beds diagonally crossing trench.

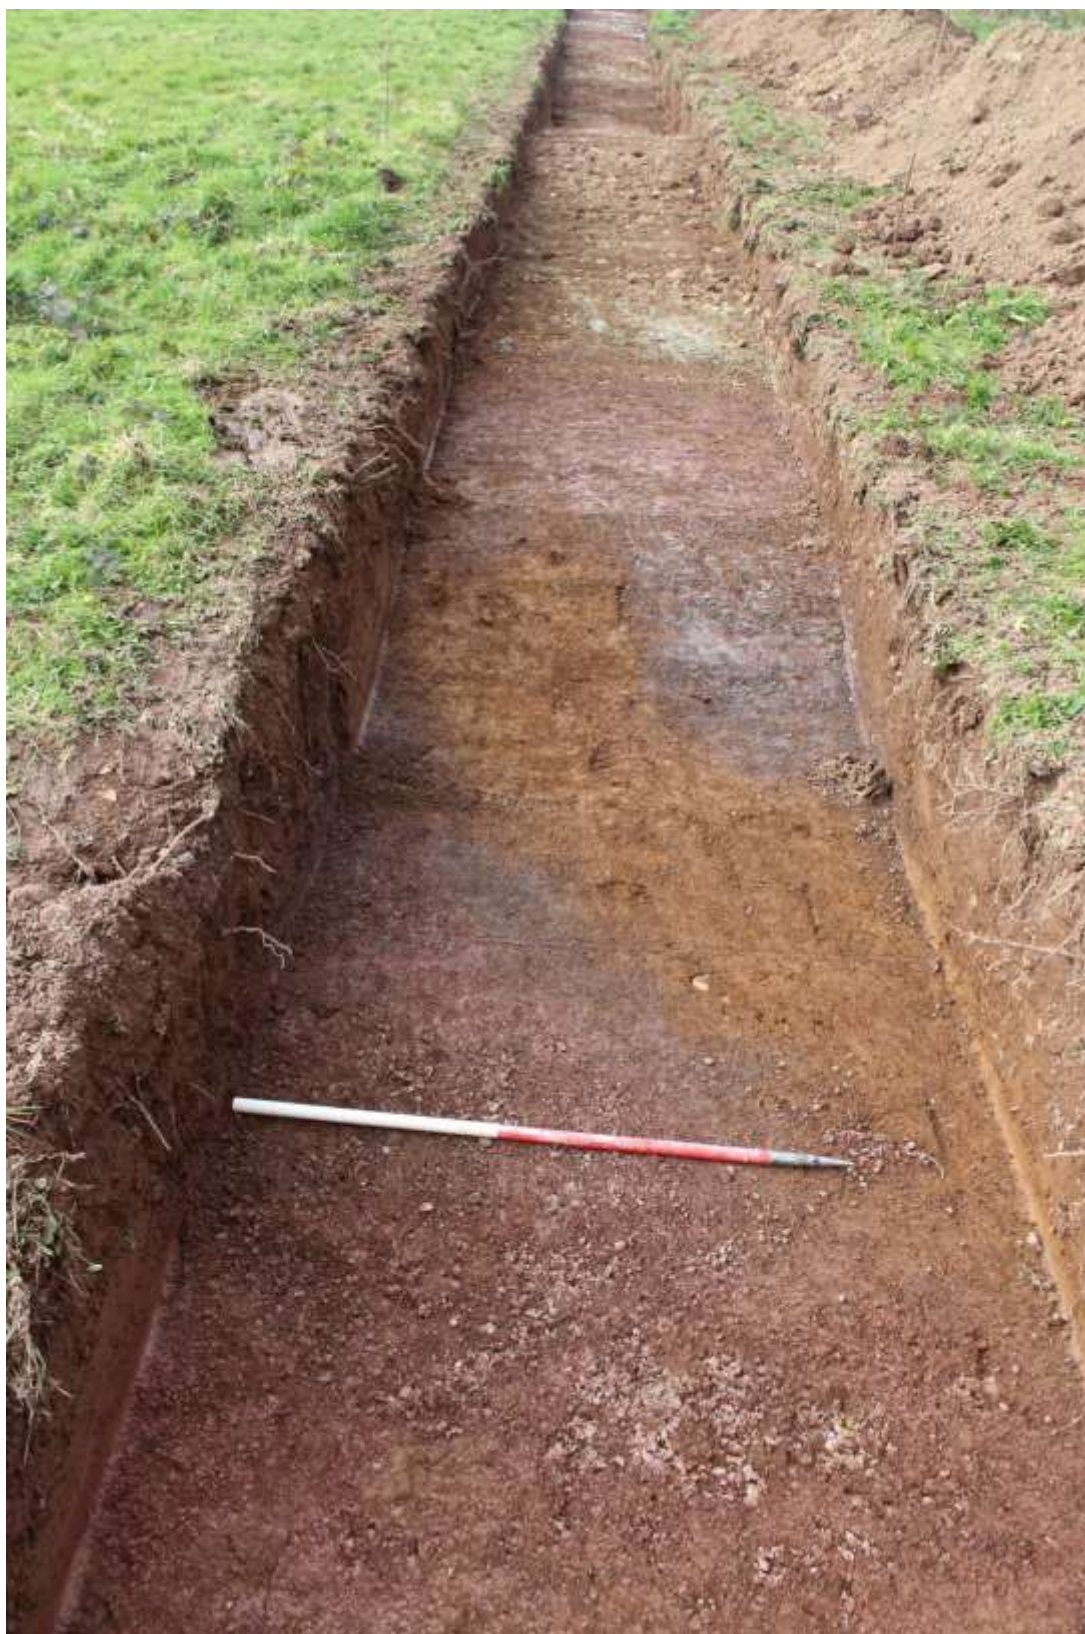
- 4.5 Approximately 4.5m from the SE end of the trench a curvilinear band of orange brown silt was revealed intruding into the fragmented red sandstone. A small sondage was excavated into this deposit which revealed feature to be of natural origin – possibly periglacial (Photo 2).

Photo 2: Trench 1 looking NW (upslope) showing bands of red and green sandstone diagonally crossing the trench. Note band of band brown silt in the foreground – possible periglacial feature. 1m scale.

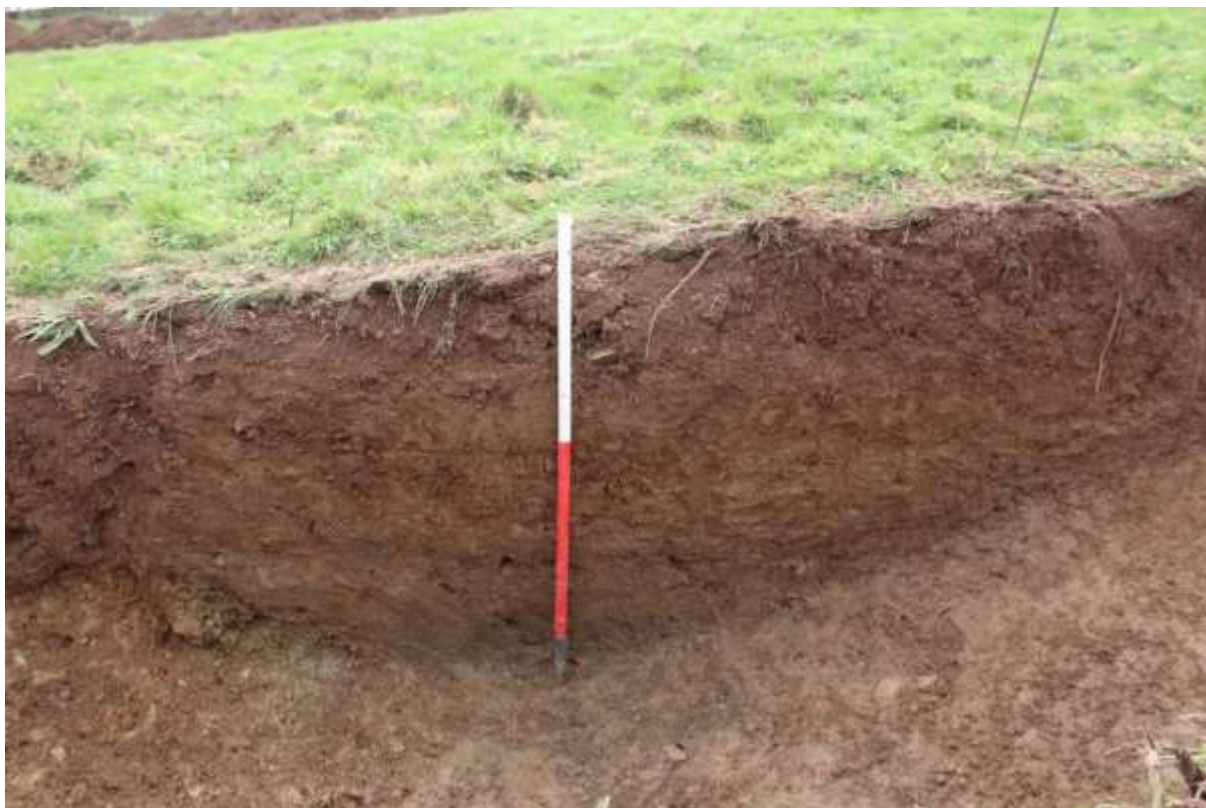
Photo 3: Trench1 looking SW at natural silts filling a depression in the bedrock.
1m scale.

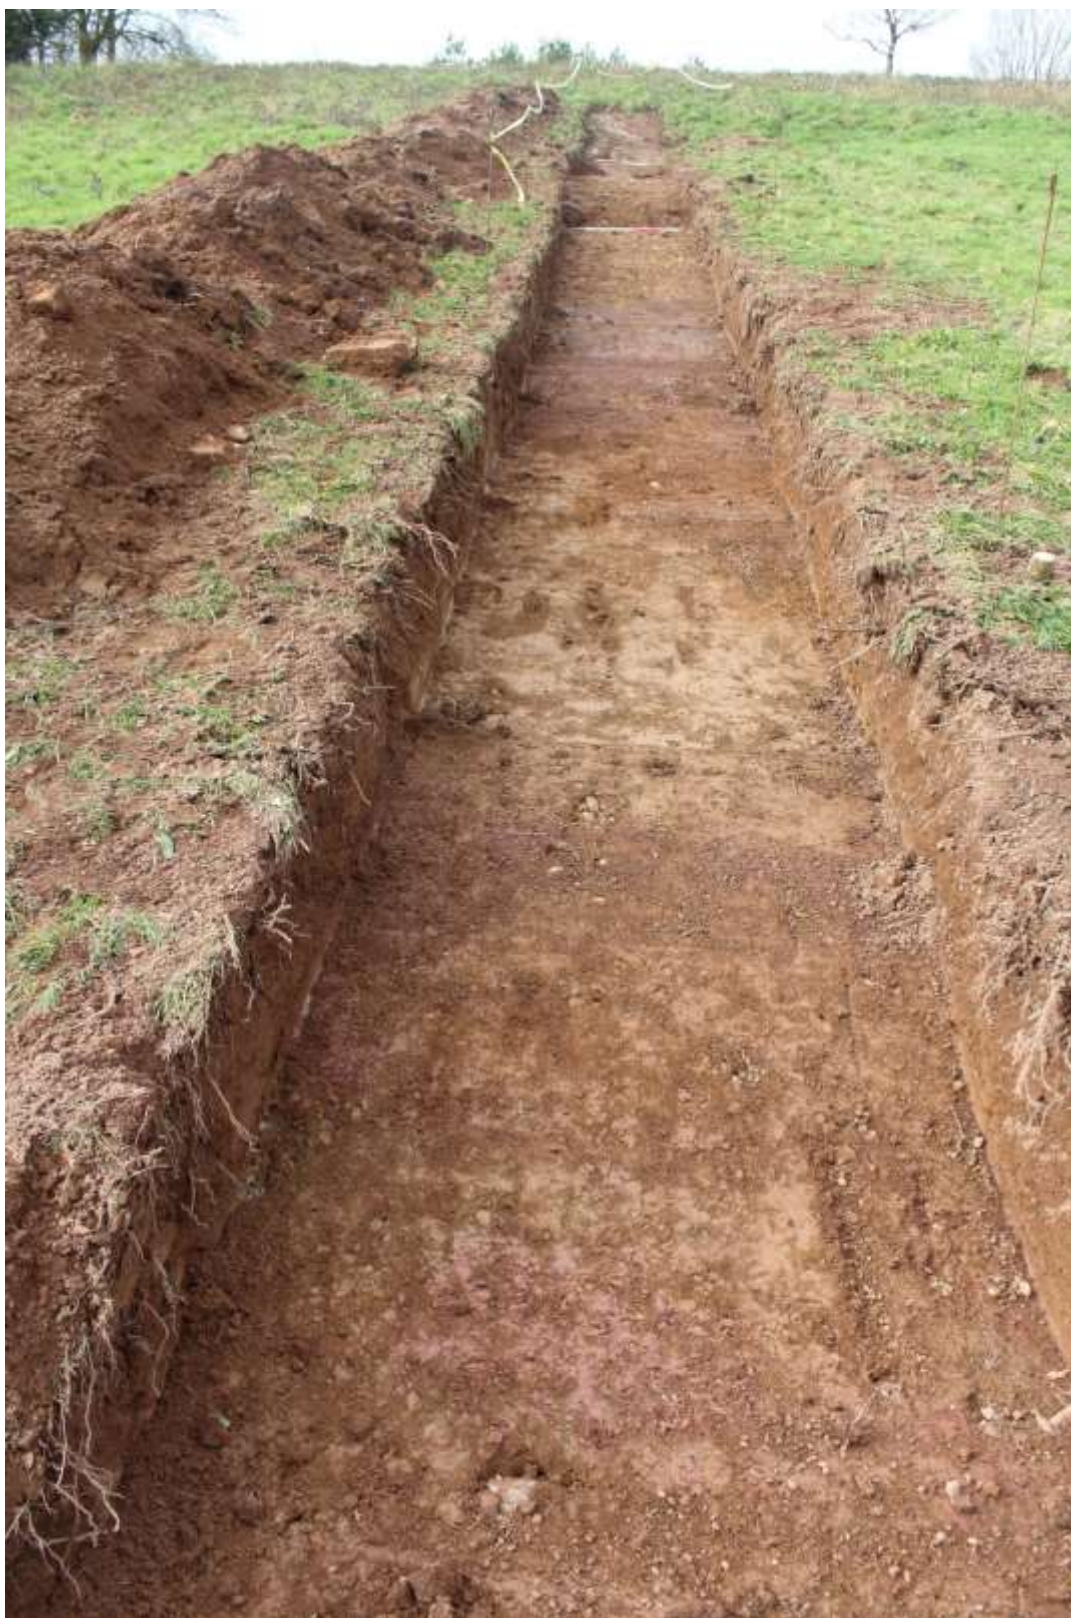
- 4.7 Trench 2 measured 30m in length and 1.6m wide, was positioned to target the possible linear features and also to investigate the nature of a small hollow situated at the upper levels of the slope (Photos 4 and 5; Figure 9).

Photo 4: Trench 2 looking NW (upslope) showing bands of red sandstone and intervening silts diagonally crossing the trench.

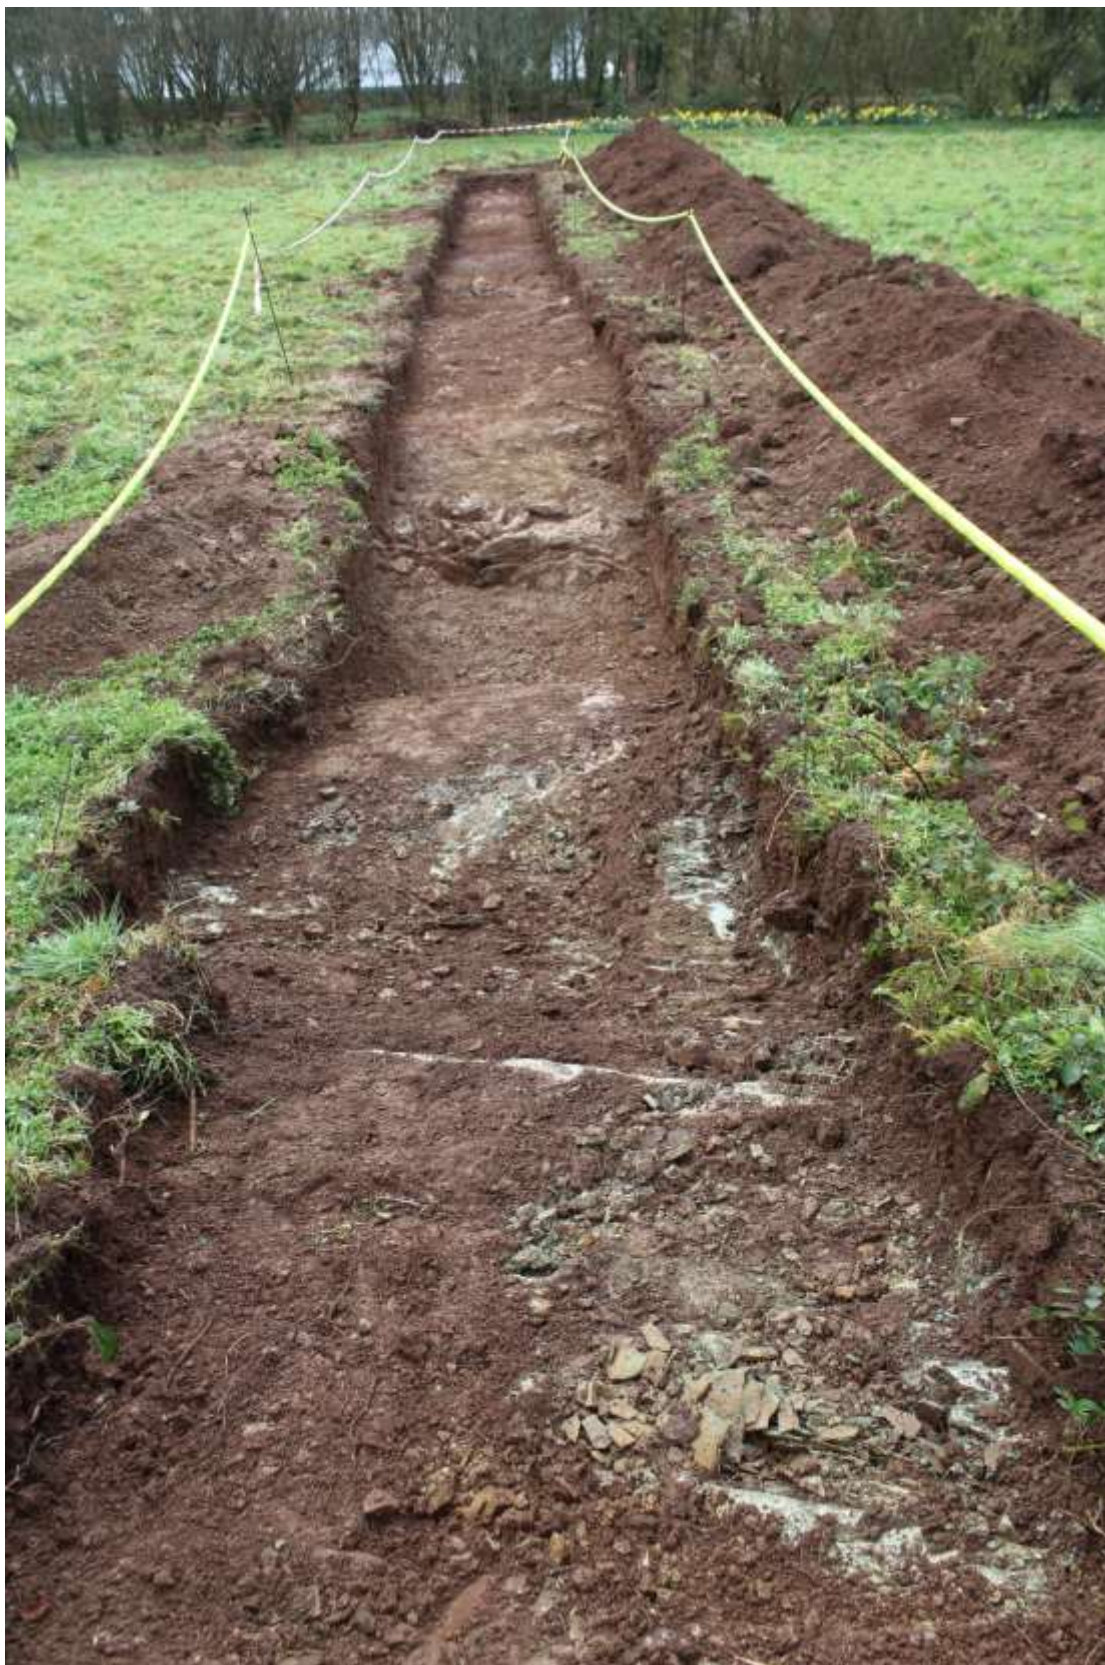
Photo 5: Looking SE along trench 2. Note 'blockish' band of Red sandstone crossing the trench in the middleground .

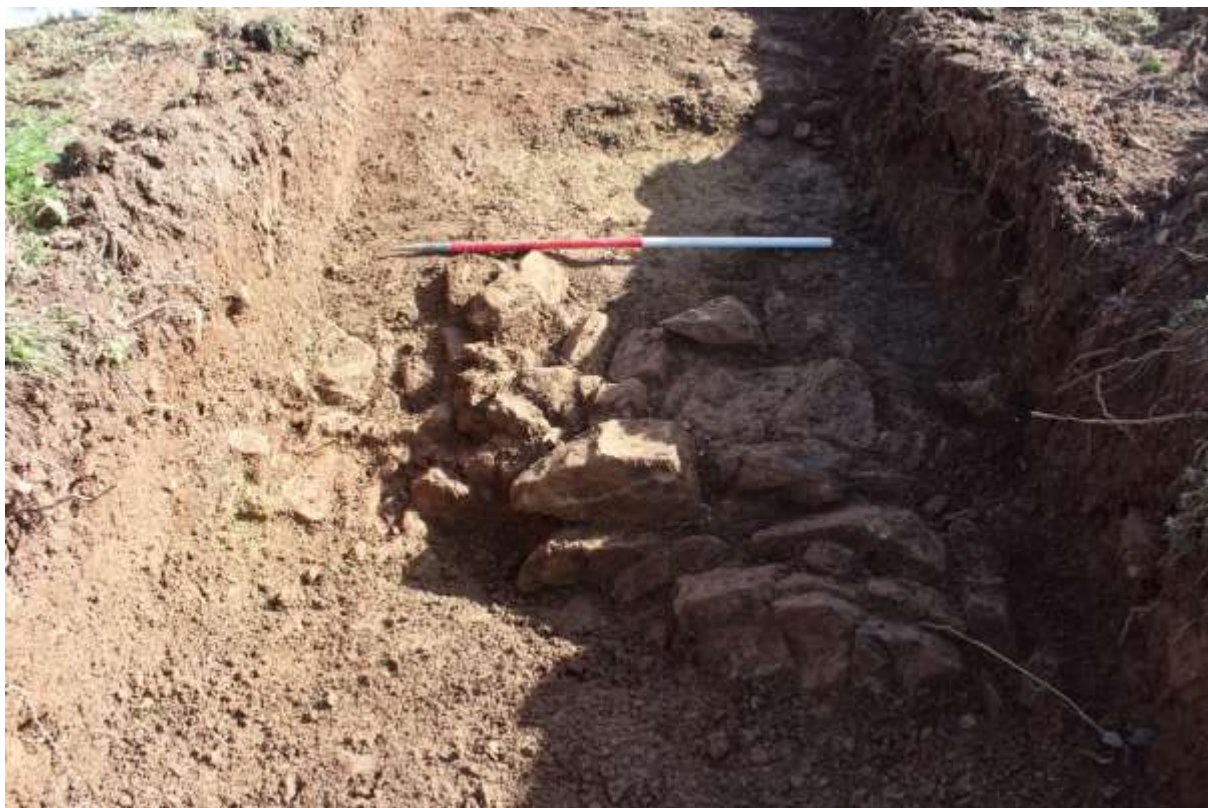
- 4.10 Approximately 7m from the NE end of the trench a band of red sandstone, which had fractured into discrete blocks of various sizes crossed the trench (Photo 6).

Photo 6: Looking SE towards band of 'blockish' sandstone. Some stones have been removed from the left side of the band. 1m scale.
