CARMARTHEN TOWN FOOTBALL GROUND, PITCH REPLACEMENT: ARCHAEOLOGICAL WATCHING BRIEF

RHIF YR ADRODDIAD / REPORT NO. 2017/39
RHIF Y DIGWILLIAD / EVENT RECORD NO. 110468

**CARMARTHEN TOWN
FOOTBALL GROUND, PITCH REPLACEMENT:
ARCHAEOLOGICAL WATCHING BRIEF**

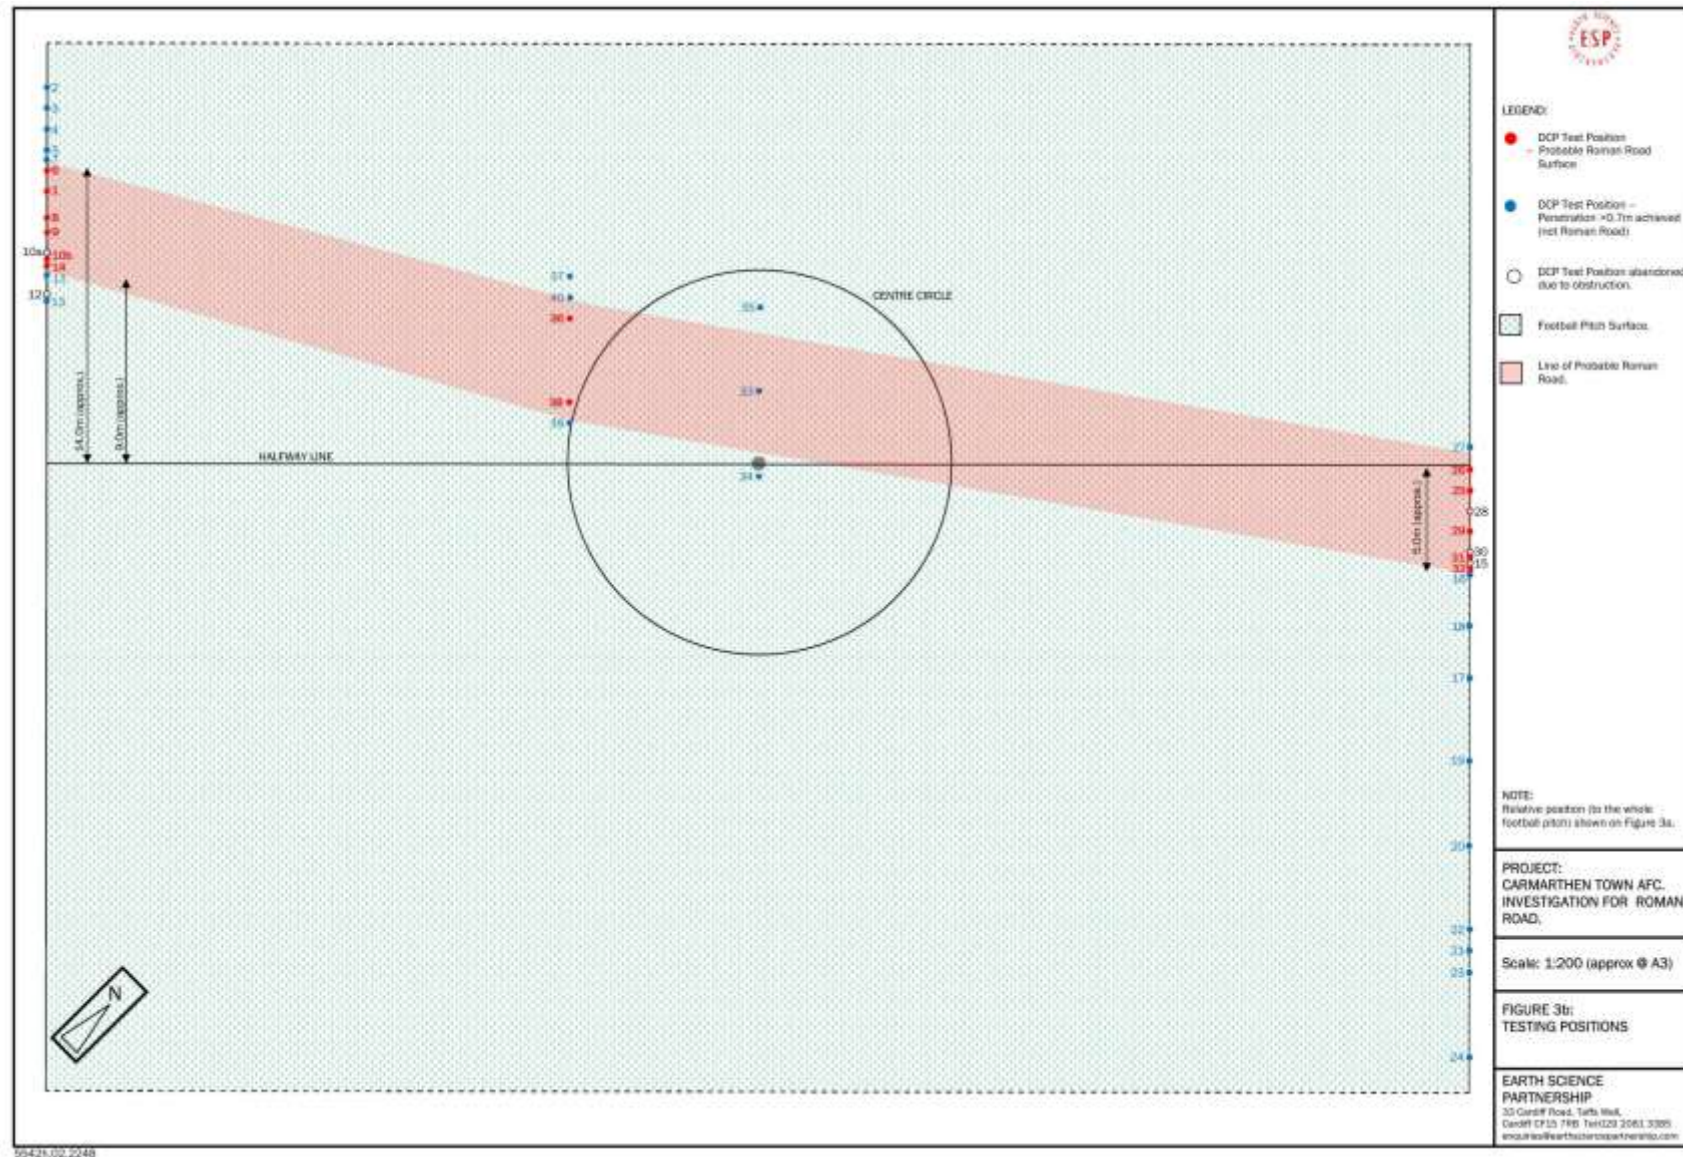
- 2.3.9 Overall, the line of the Roman road was confirmed at depths of between 0.4–0.6m between the touchlines in the centre of the pitch (Figure 6). It was absent in the centre of the pitch, which concurred with the results of the previous geophysical survey and suggested that it had been removed by later activity. The survey showed a number of other obstructions within the football pitch, possibly walls. Areas where cone penetration was less could be softer archaeological deposits such as pits, mortar/beaten earth floors or general deposition layers.

Figure 6: ESP DCP test locations, showing Roman Road in pink (plan supplied by client)

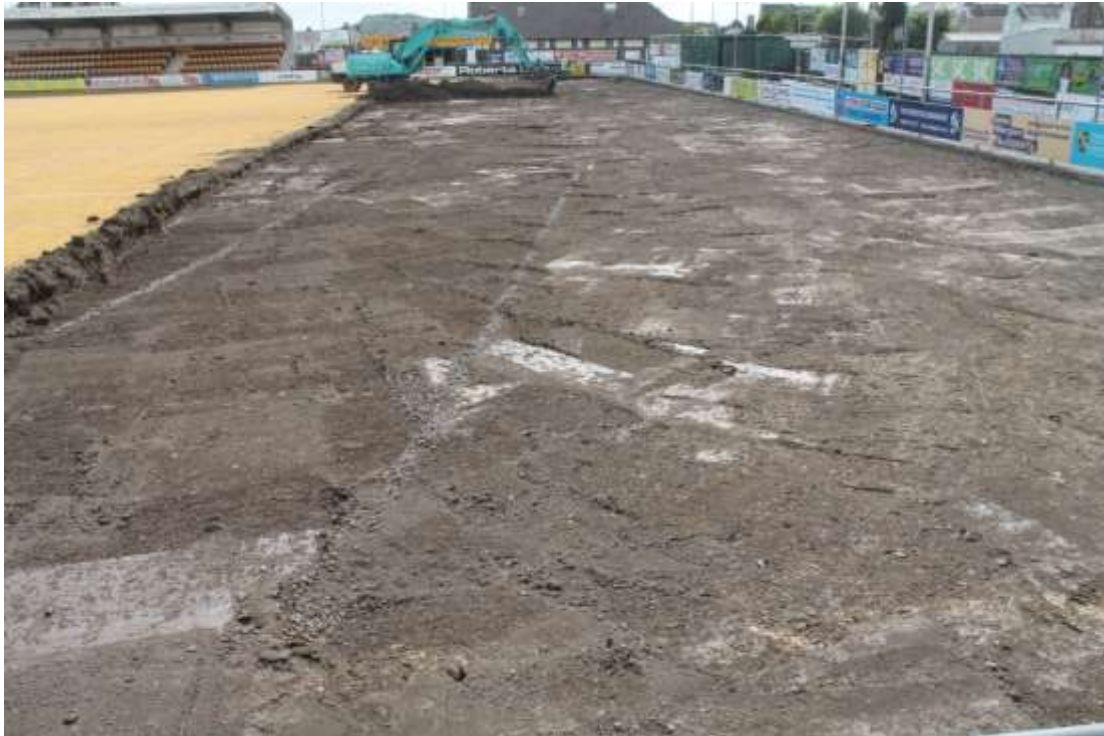
- 4.2 Before the turf and topsoil was removed an area of turf was rotavated into the underlying topsoil to a depth of 0.1m. The soil was lifted using a 360 degree excavator and removed from the site by 6 ton dumper trucks fitted with non-cleat flotation tyres. The soil was removed down to the top of the underlying garden soil. The average depth of soil removed was between 0.15m and 0.20m. A slight hollow within the garden soil at the NE corner of the ground increased the depth of topsoil removed to approximately 0.35m. A collapsed brick wall and the tops of stone-filled drains were observed at the surface of the exposed garden soil (Photo 1).

Photo1: View SW across exposed garden soils at the northern edge of the ground during topsoil stripping (Figure 9).

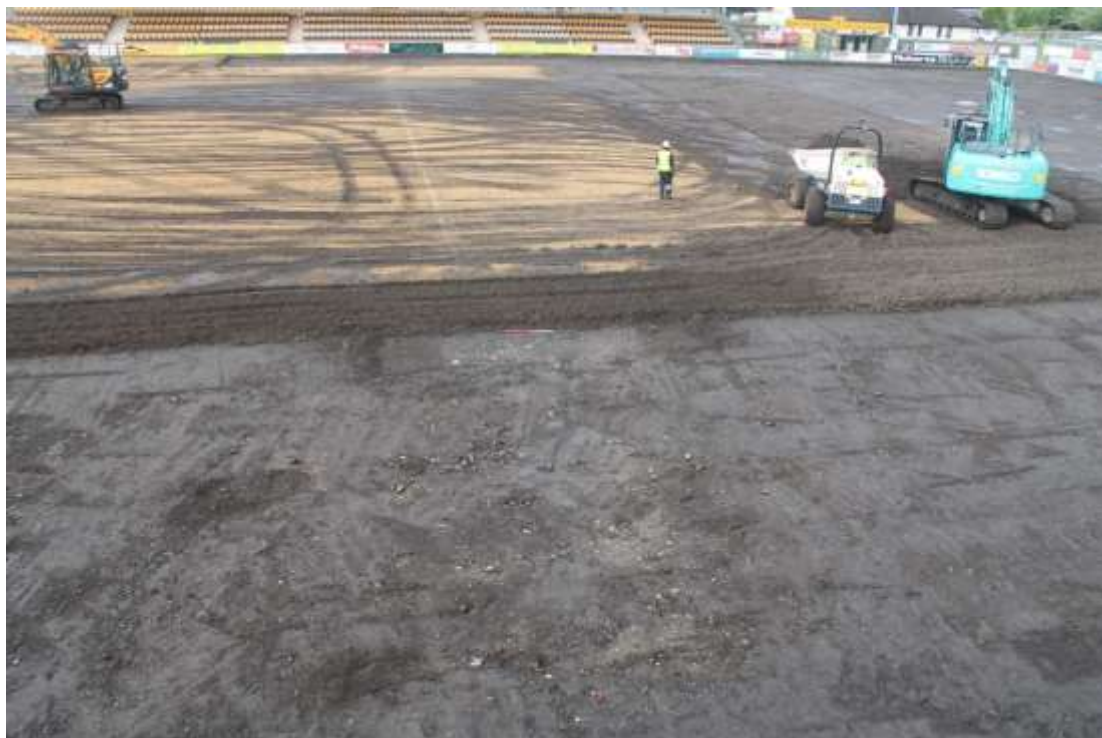
- 4.3 Heavy rain prevented the middle of the ground being stripped on the 8th June. It was therefore decided to work at the edges of the ground. A 14m wide corridor was stripped adjacent to the east side of the ground. Close to the half-way line and extending towards the middle of the ground, small areas of cobble, pebbles and gravels were revealed. The exposed areas were within the Roman road shown on the geophysical survey and are doubtless associated with the road make-up, with the possibility that outlying patches are associated with yards or lanes contemporary with the Roman road or a later period (Photo 2).

Photo 2: View SW during topsoil stripping. Exposed cobbles and gravels associated with the Roman road can be seen in the foreground (Figure 9).
1m scale.

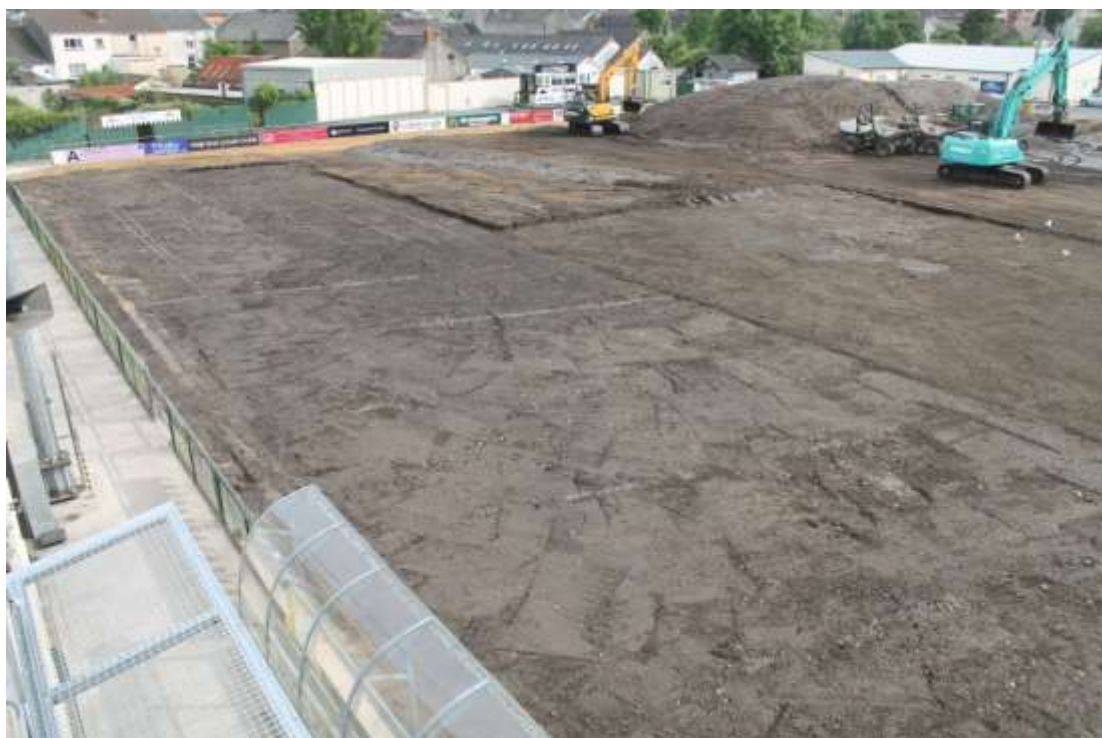
Photo 3: View South. Linear features are exposed drainage trenches. Background shows the stockpiled topsoil prior to removal (Figure 9).

- 4.4 The area of discrete patches of cobble, pebble and gravels were on the eastern side of the ground, with a smaller area of discrete patches of material towards the centre of the ground (Figure 9, Photos 4 to 10). They stood approximately 0.15m below the former pitch surface and 0.55m below the top of the adjacent concrete path bedside the dug-out. The overall length of the largest area measured approximately 10m long and in the main was approximately 8m wide (Photo 3).

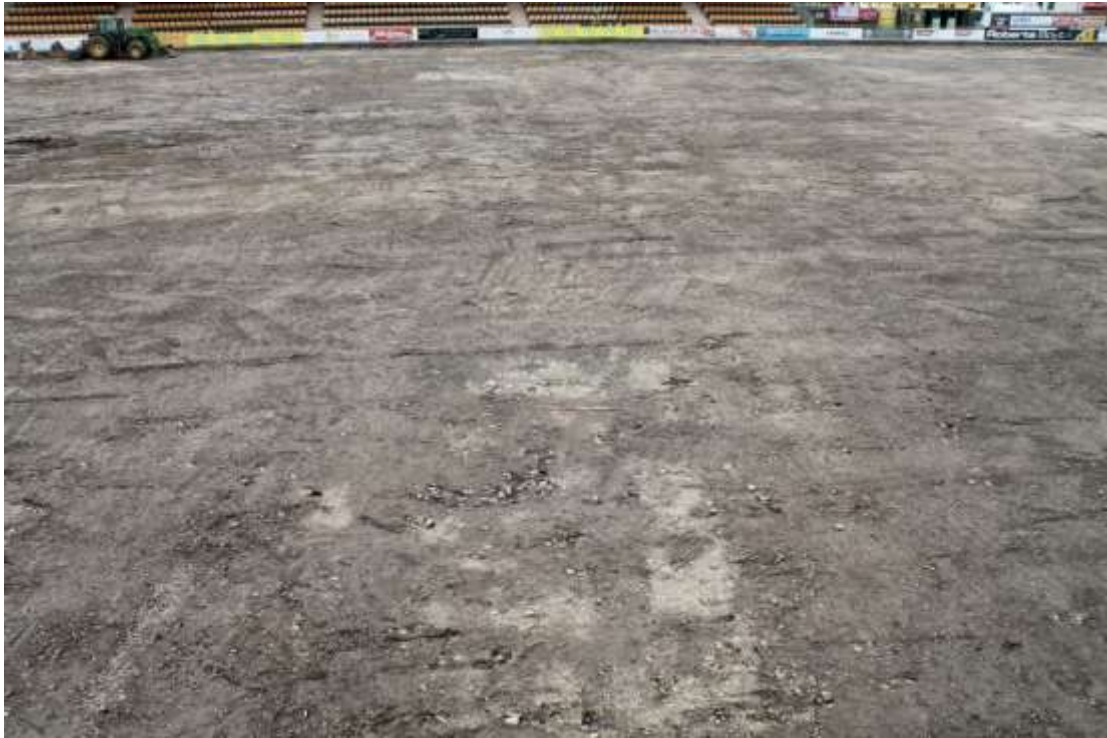
Photo 4: View SW after completion of topsoil stripping. Roman road material can be seen in the foreground. 2x1m scales

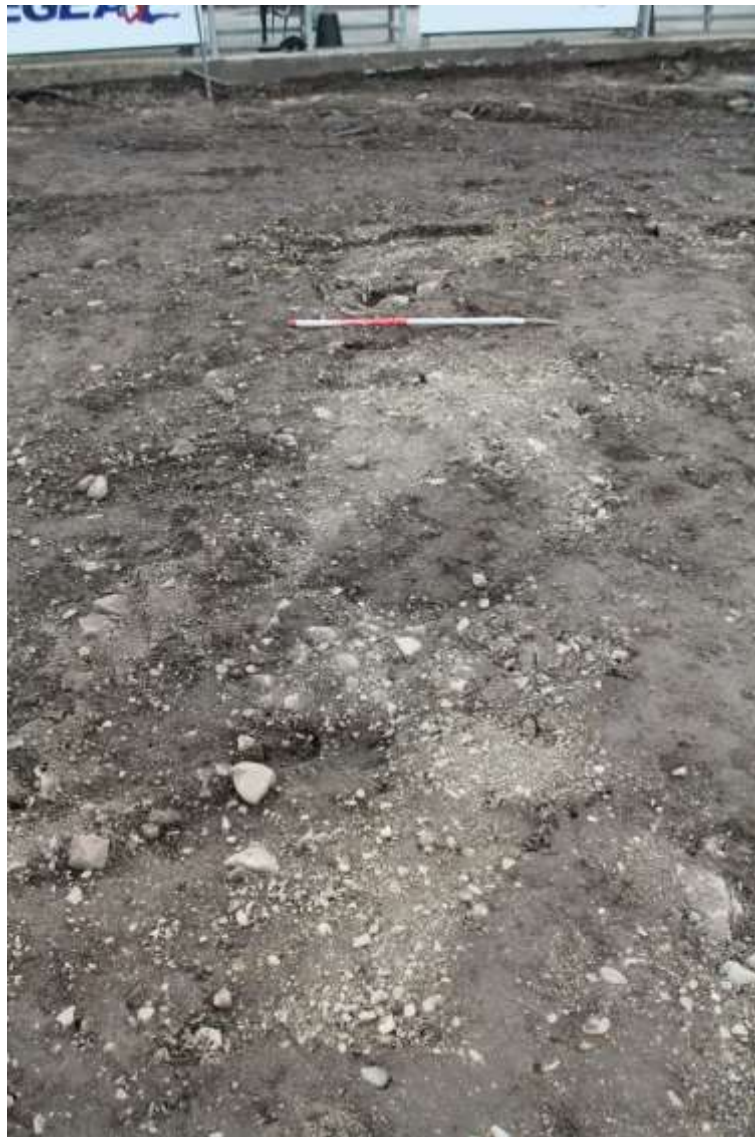
Photo 5: View NE towards dug-out, showing area of pebbles and gravels associated with the Roman road. 1m scale (Figure 9).

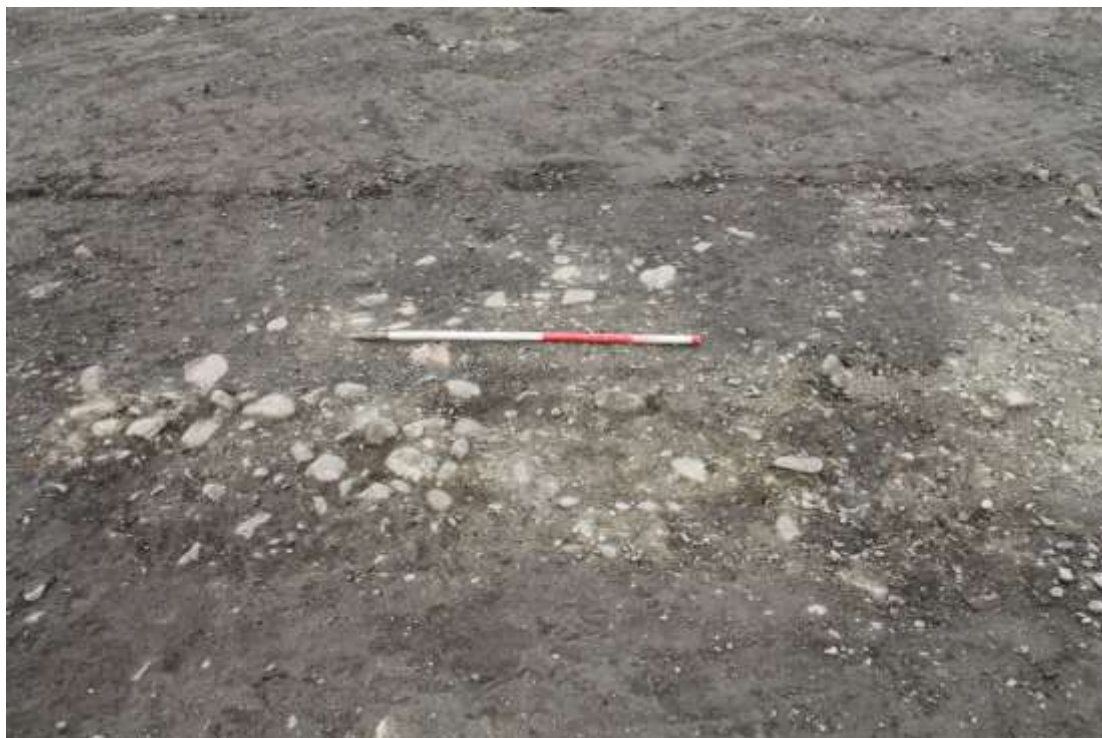
Photo 6: View SW across patch of exposed cobble and gravels. Note modern drain *T10* (dark band) to the right of the 1m scale (Figure 9).

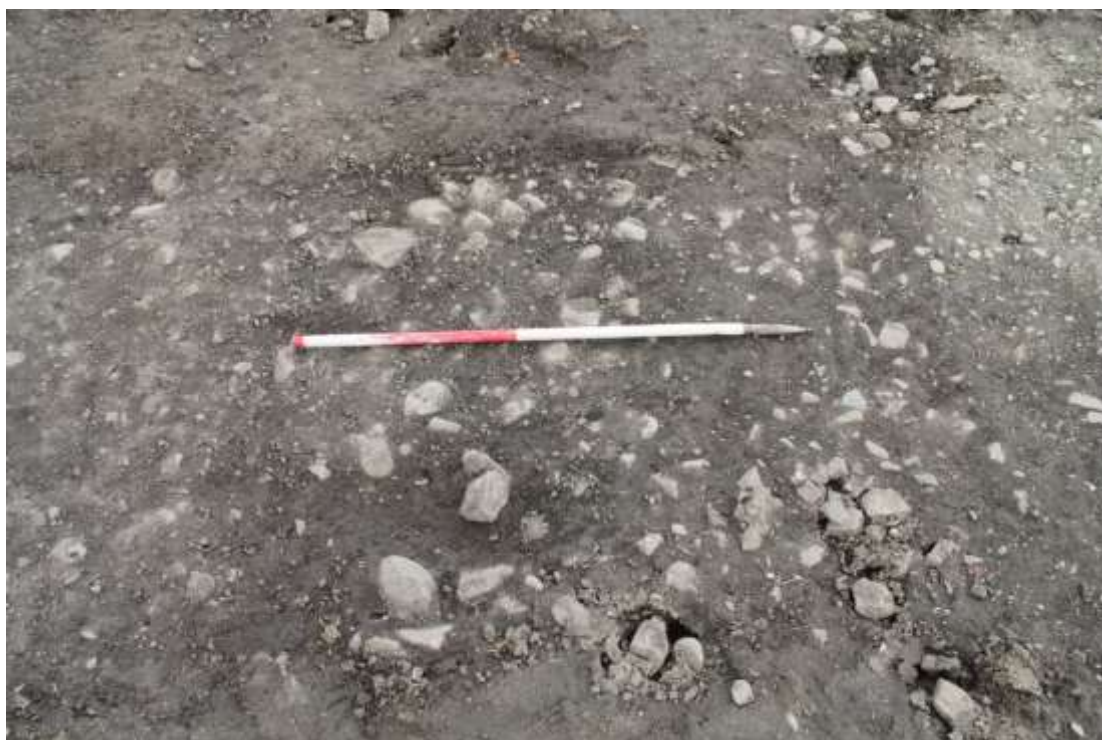
Photo 7: View NE across an exposed area of smaller, more angular stone. 1m scale (Figure 9)

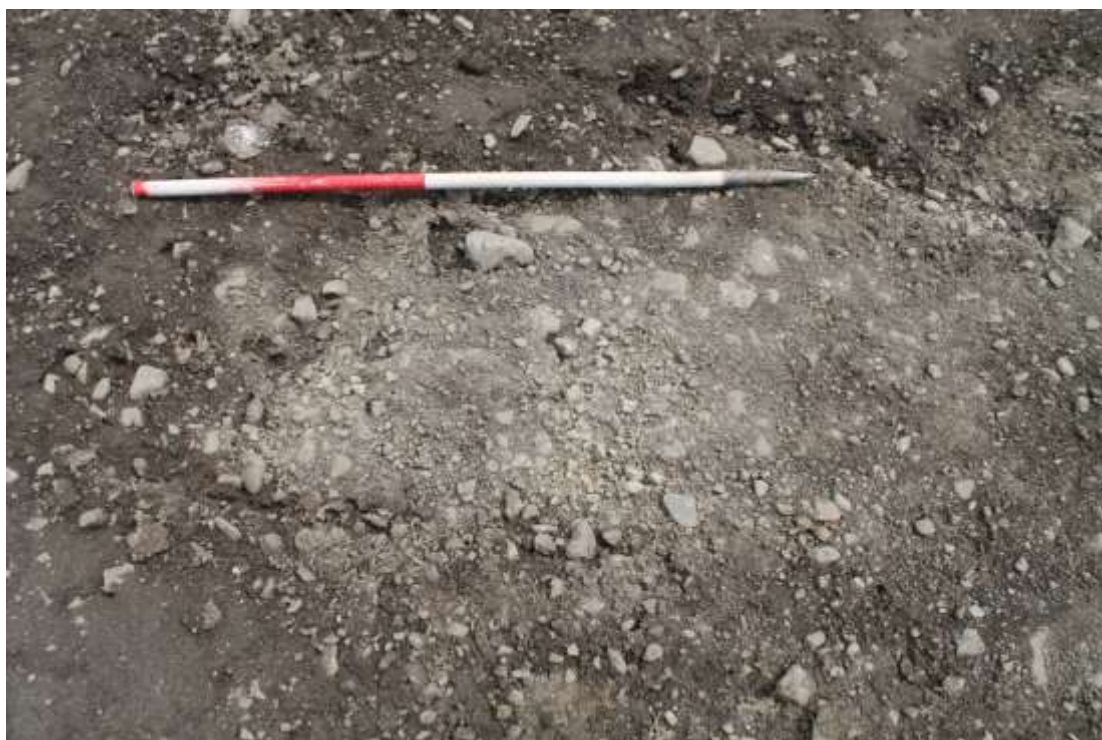
Photo 8: View NE. Outlier of exposed cobble and gravels located approximately 3m south of the main band of material. 1m scale (Figure 9)

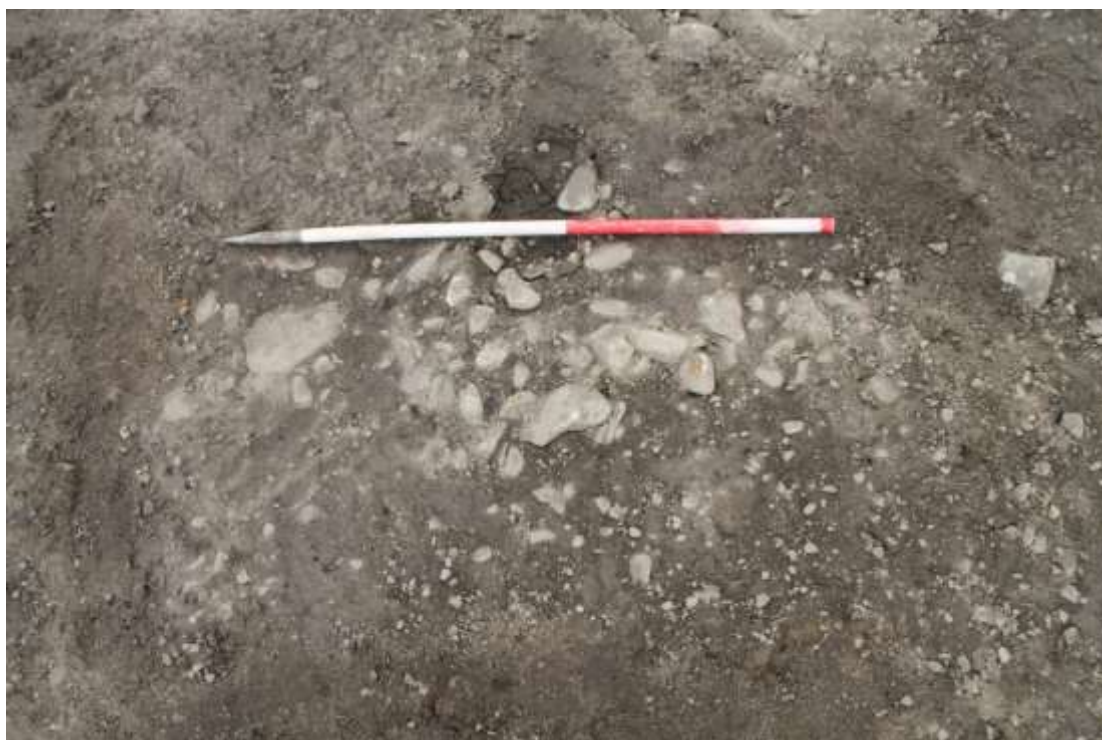
Photo 9: View NW across patch of exposed cobble situated near centre of ground. 1m scale (Figure 9).

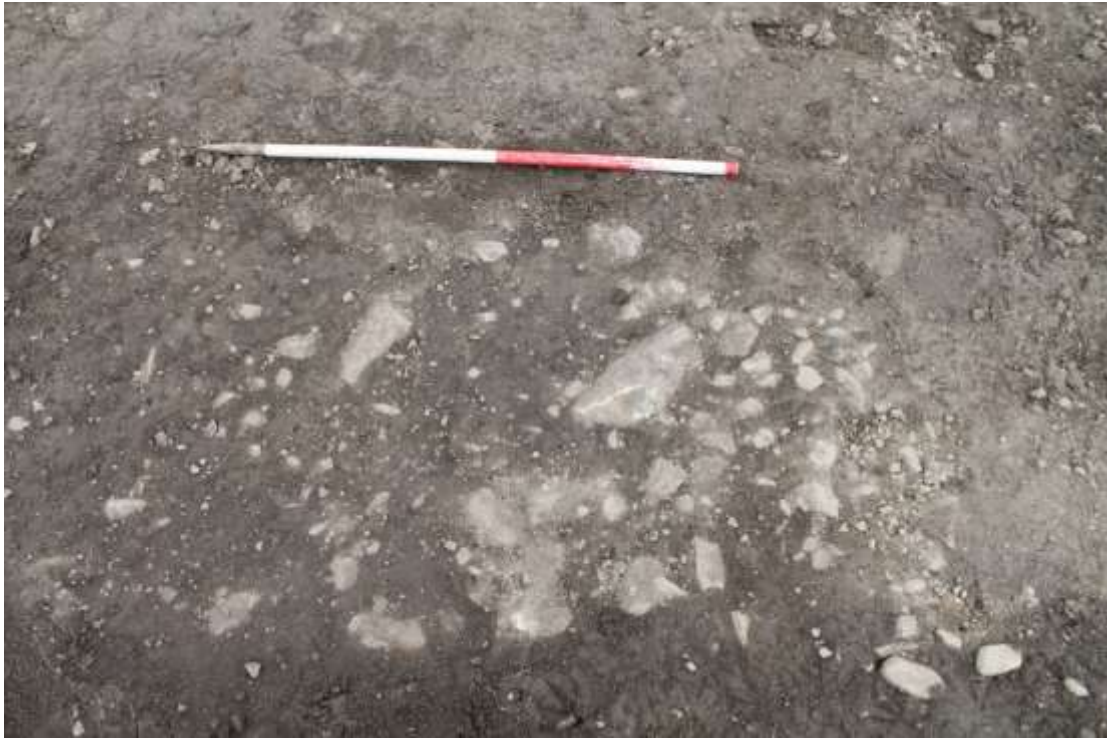
Photo 10: View NE of exposed cobbles situated near centre of ground.
1m scale (Figure 9).

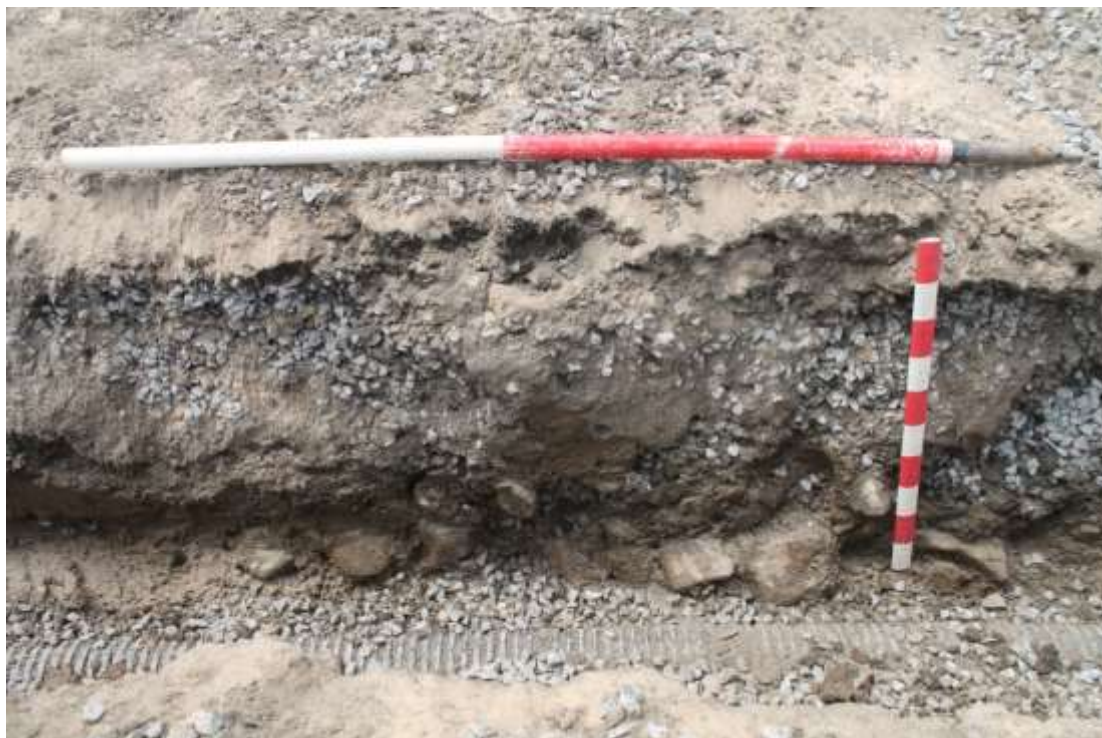
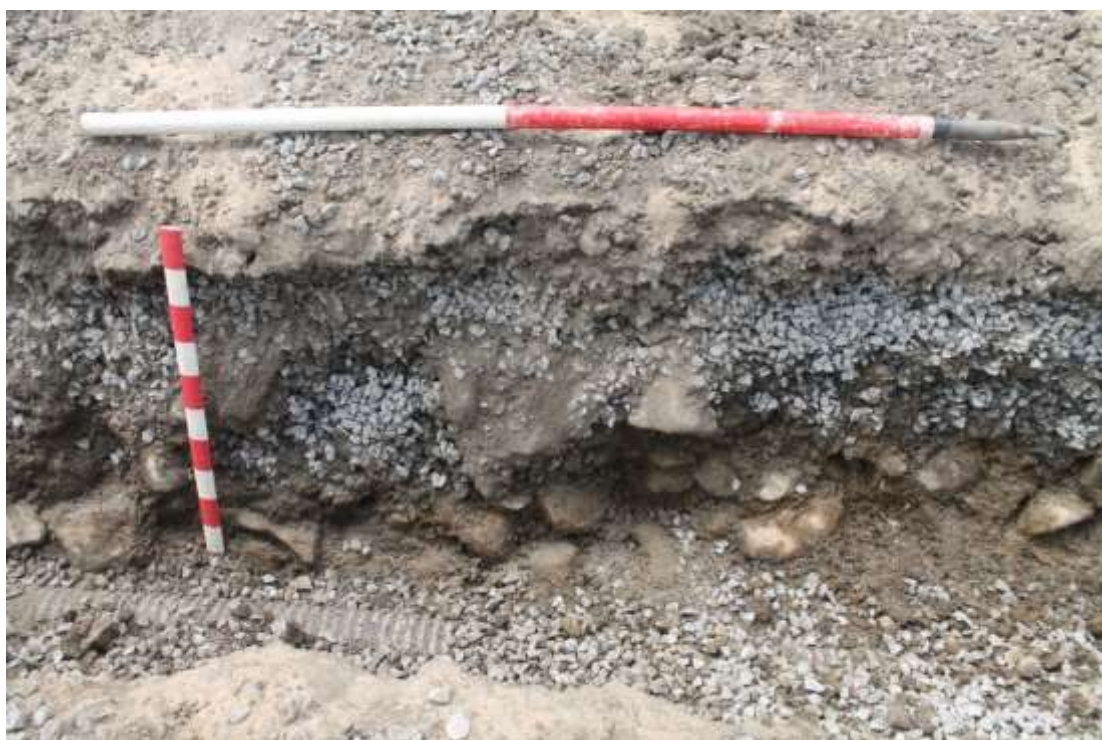
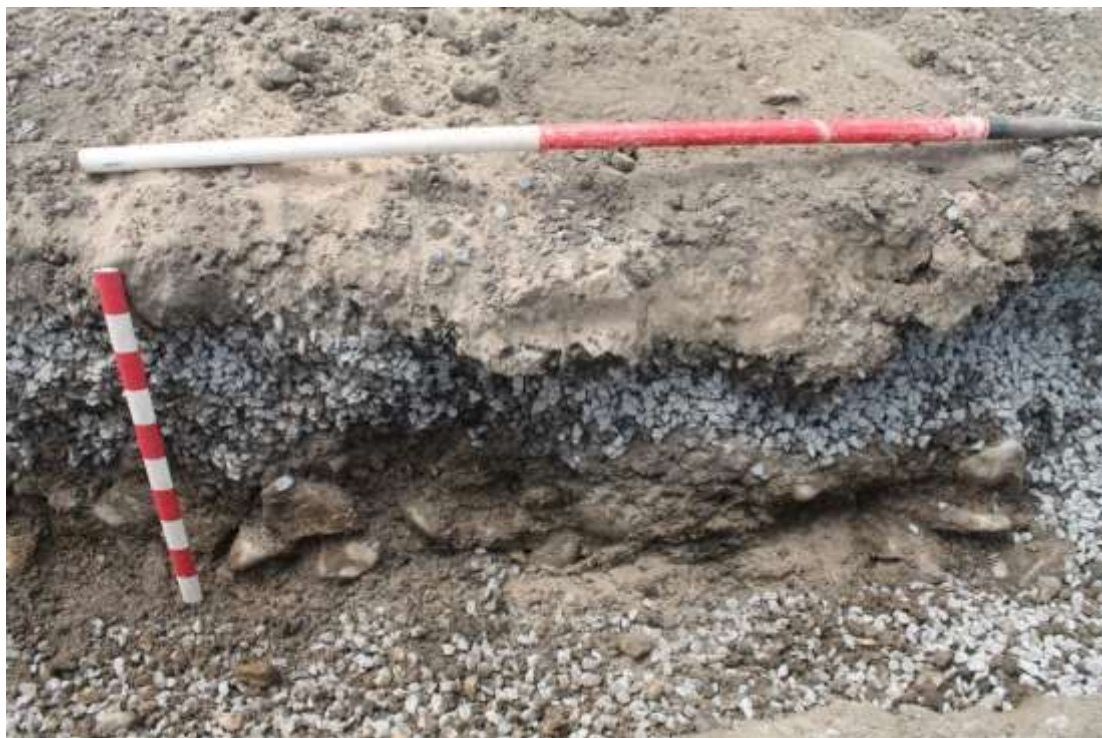
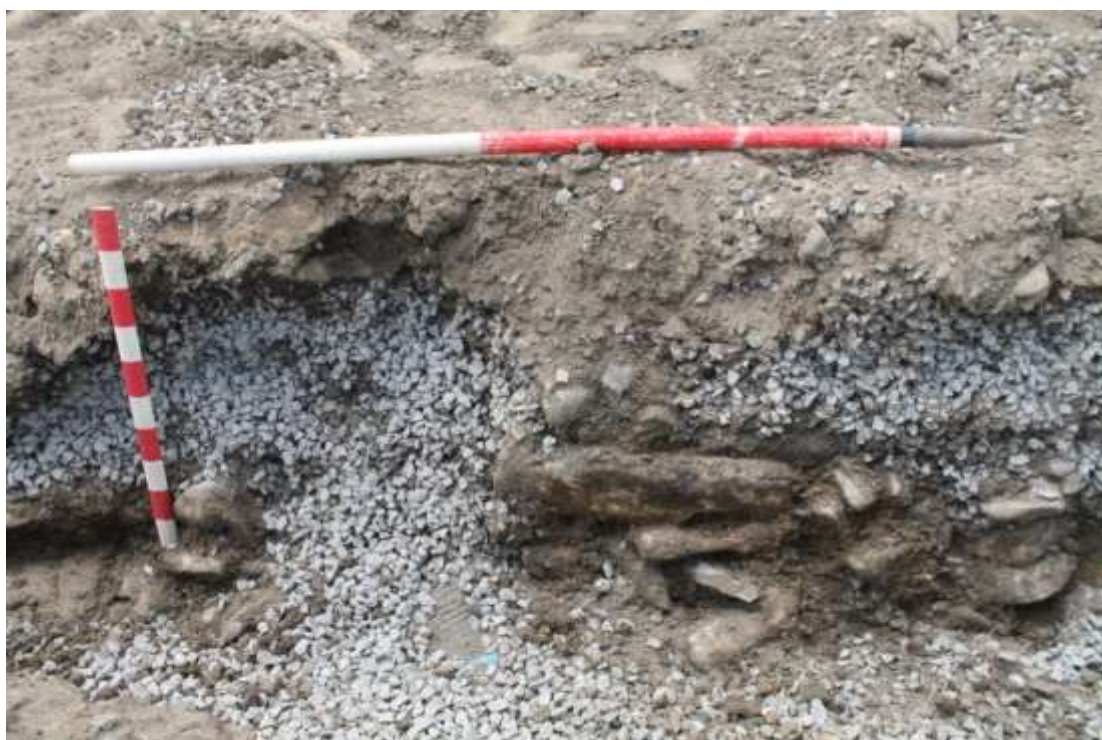
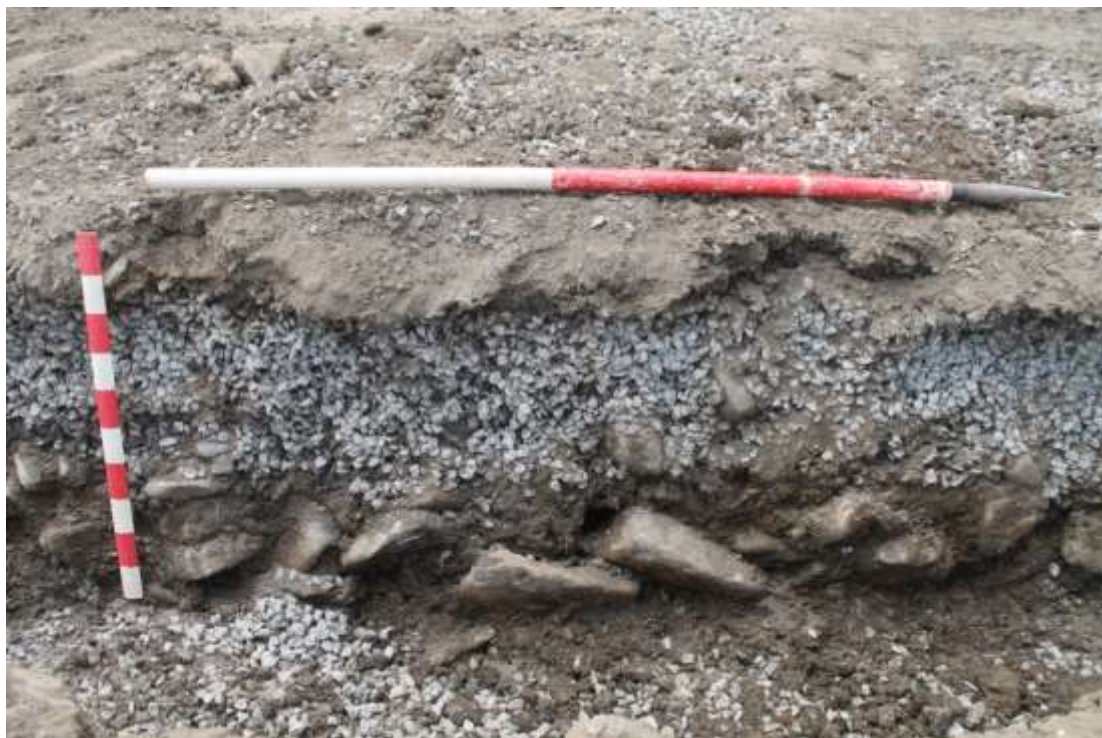
- 4.9 At the Western side of the ground, approximately 9m inside the pitch, another stone-filled drain (*TB*) which cut the Roman road at a right angle, was emptied of stone aggregate. This exposed a shallow cross-section through the road approximately 6.7m wide and up to 0.25m deep, consisting of cobble and gravels. The highest point of the section lay approximately 0.35m below the original pitch surface and 0.75m below the top of the adjacent concrete path below the terraces. It was observed that both ends of the section sloped down as if cambered. The centre of the section had been breached by a stone drain entering from the west. A fragment of Roman brick/tile, sealed within the road make-up, was recovered from the section (photos 16/17) - photos of the section through the Roman road are shown in sequence from photos 11 to 16, beginning at the SE end of the section.

Photo 11: View SW at SE end of section through Roman road in *TB* (Figure 9). 1m and 0.5m scales.

Photo 12: View SW – detail of cross section through Roman road in *TB* (Figure 9). 1m and 0.5m scales.

Photo 13: View SW – detail of cross section through Roman road in *TB* (Figure 9). 1m and 0.5m scales.

Photo 14: View SW – detail of cross section through Roman road in *TB* (Figure 9). 1m and 0.5m scales.

Photo 15: View SW – detail of cross section through Roman road in *TB* (Figure 9). 1m and 0.5m scales.

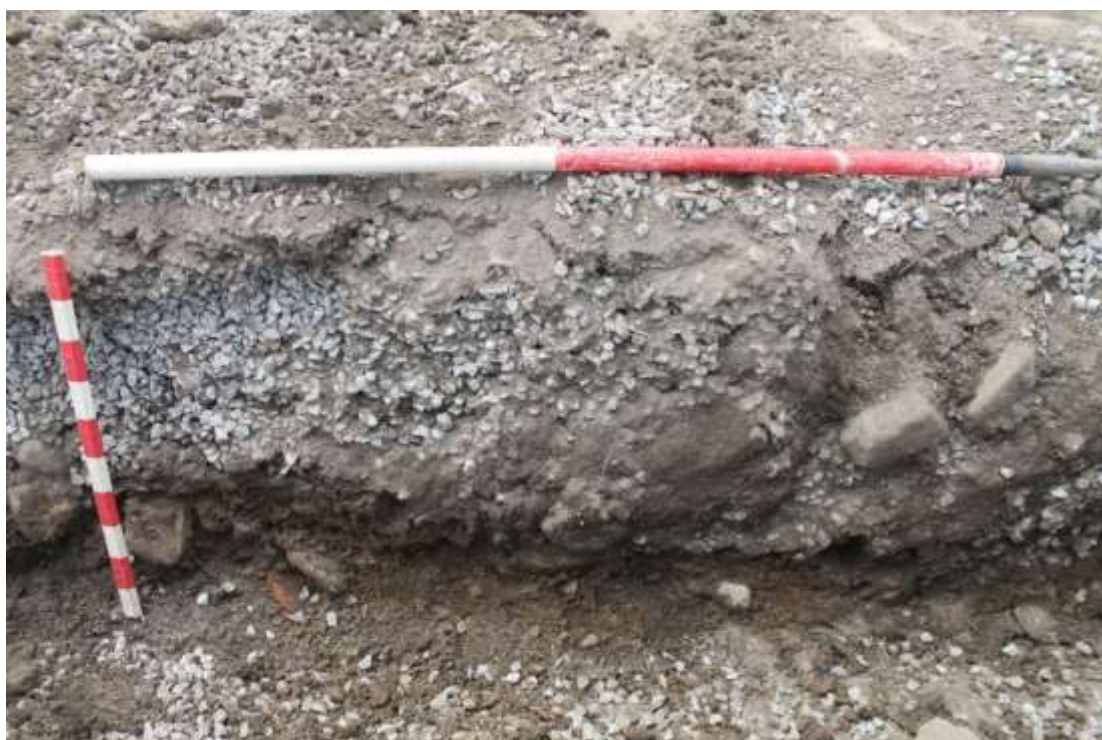
Removing the aggregate from the drainage trench (TB), which cut the Roman road at the western end of the ground, exposed a cross section of the upper levels of the road, consisting of cobbles and gravels. A piece of broken Roman brick/tile sealed within the road material was recovered.

Photo 16: View SW at NW end of section through Roman road; note Roman brick/tile fragment (Figure 9). 1m and 0.5m scales.

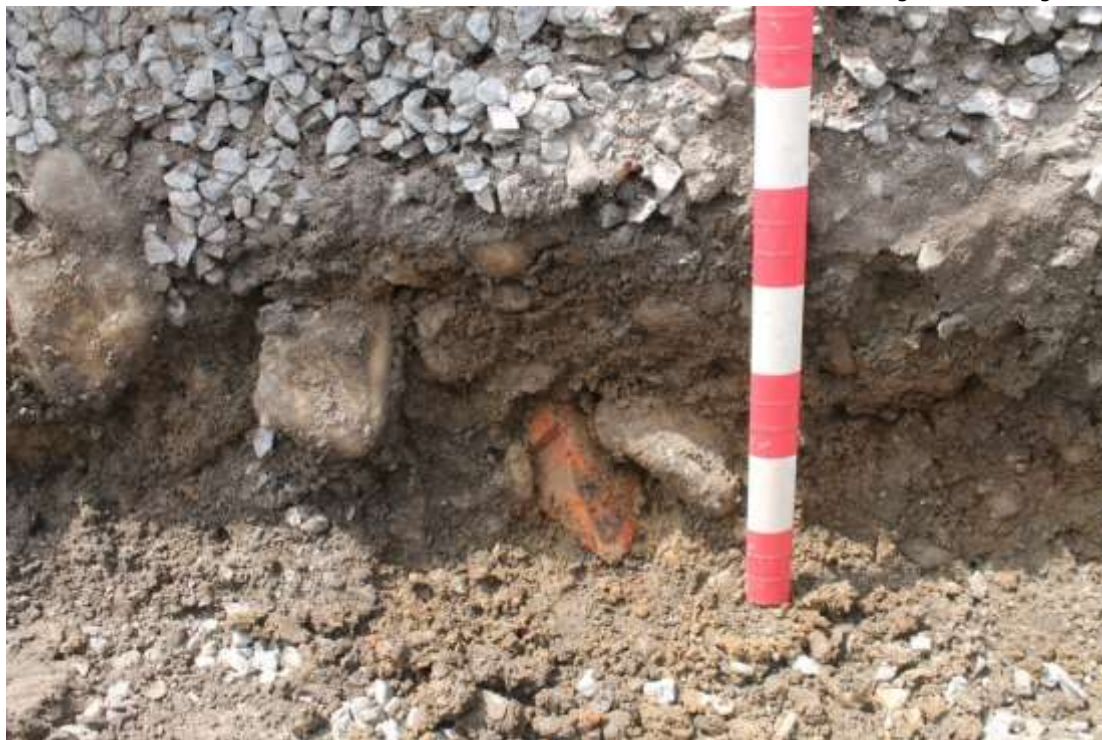
Photo 17: View SW – close-up of Roman brick/tile fragment sealed within road.
(Figure 9) 0.5m scales.

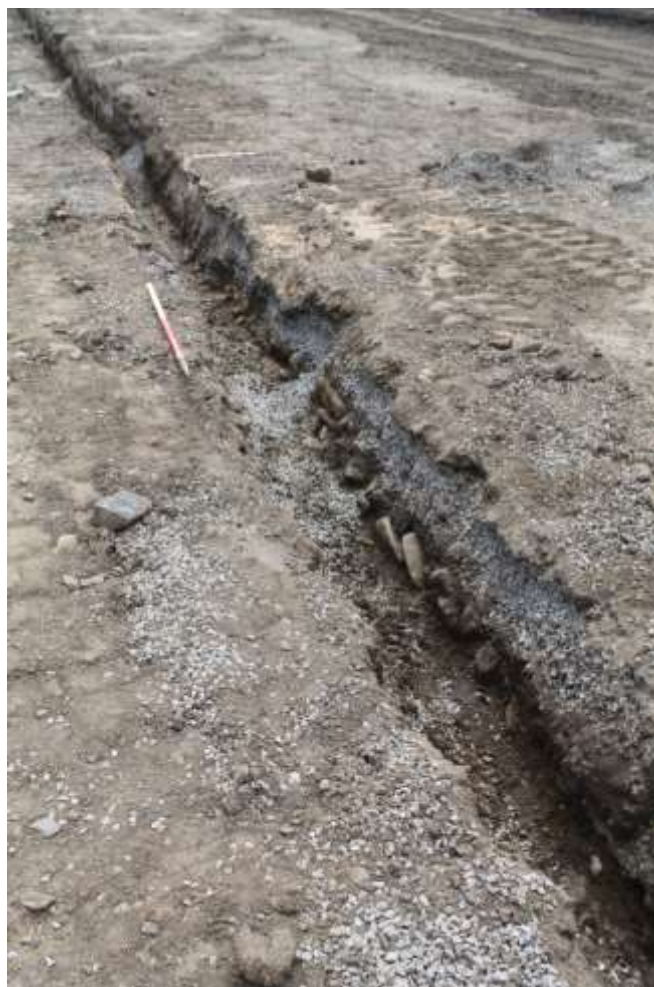
Photo 18: View SW at whole of Roman road section revealed in *TB*
(Figure 9). 2x1m scales

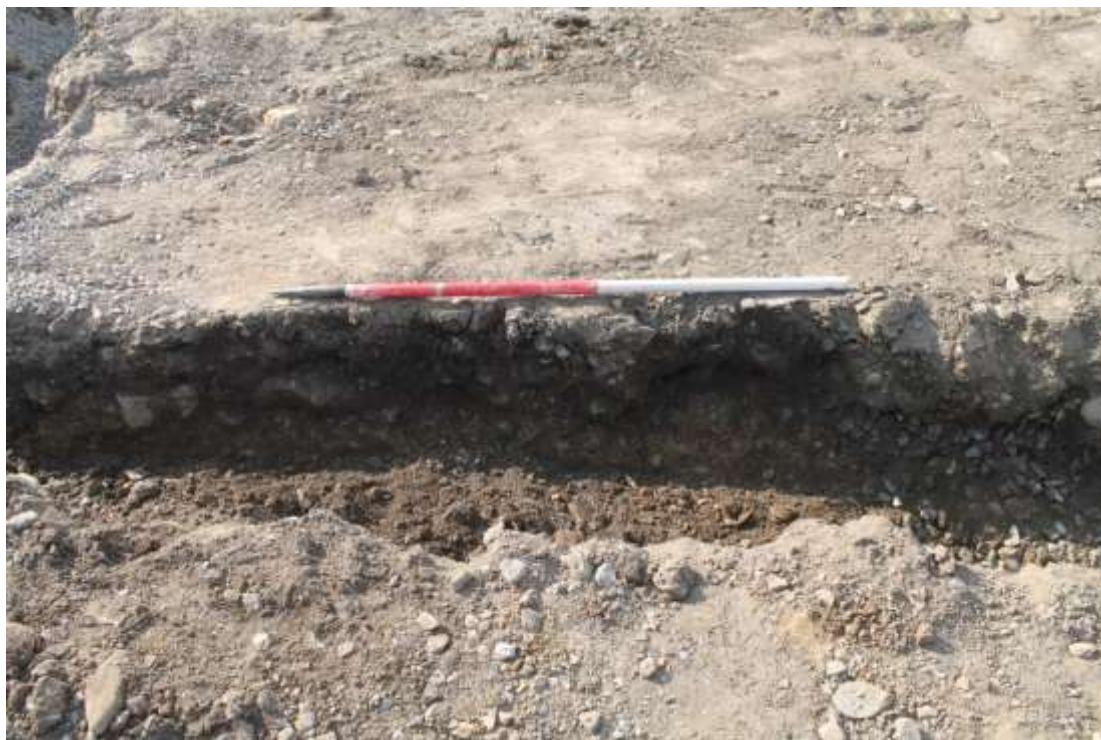
- 4.10 A small section of the Roman road, approximately 1.5m long by 0.2m deep was revealed during the operation to empty *T11* where it joined with *TB* at its western end revealing a conglomeration of gravels and cobble (figure 9, photo 20).

Photo 20: View NW showing small section of Roman road at west end of *T11* (Figure 9). 1m scale.

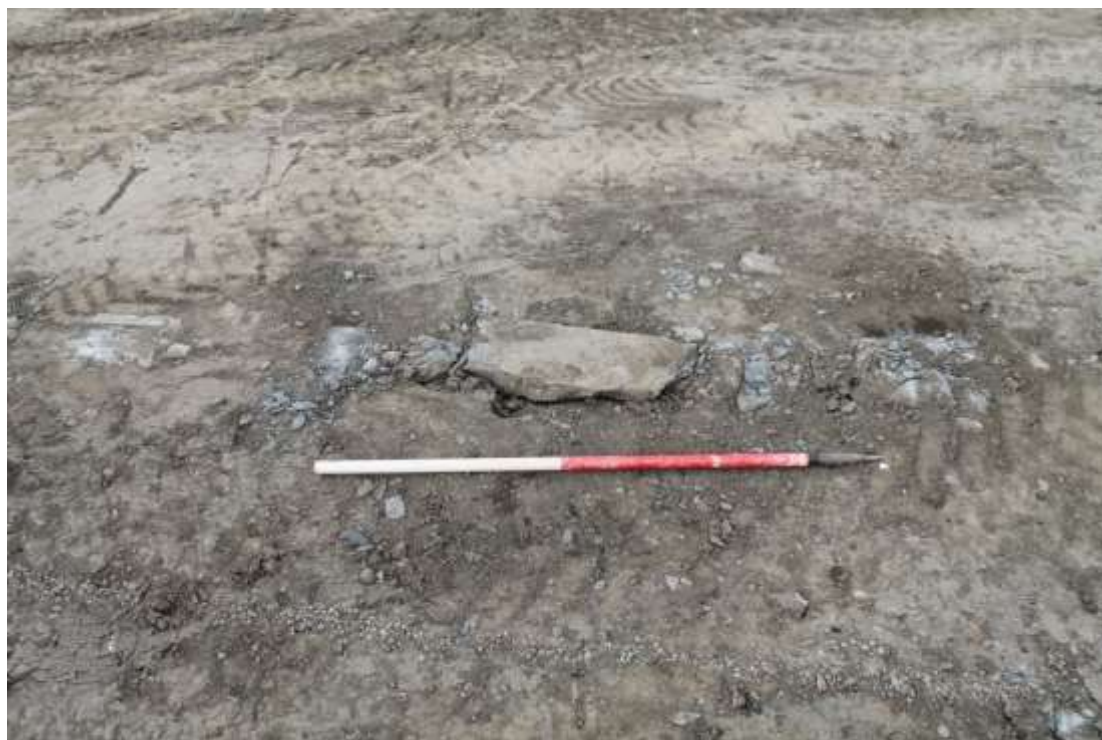
- 4.11 During topsoil stripping, roughly three metres south of the halfway line and within the western half of the centre circle, a fragmented, linear slate feature 3.7m long and 0.3m wide was observed on the surface and within the garden soil. When the surveyed plan of the development site was superimposed onto the OS 2ND edition 1906 map the slate linear tallied with a boundary line running down the long axis of the pitch (figure 9, photo 22).

Photo 22: View NE at remnant of slate linear corresponding with boundary on the OS 2nd edition 1906 map (Figures 8 and 9) 1m scale.

- 5.7 A 3.7m by 0.3m piece of thick, partially crushed slate lay within the garden soils towards the centre of the ground. This was found to be a remnant of a former post-medieval boundary wall when the surveyed information was superimposed onto the OS 2nd edition 1906 map.
