CARMARTHEN TOWN FOOTBALL GROUND, PITCH REPLACEMENT: ARCHAEOLOGICAL WATCHING BRIEF

RHIF YR ADRODDIAD / REPORT NO. 2017/39
RHIF Y DIGWILLIAD / EVENT RECORD NO. 110468

**CARMARTHEN TOWN
FOOTBALL GROUND, PITCH REPLACEMENT:
ARCHAEOLOGICAL WATCHING BRIEF**

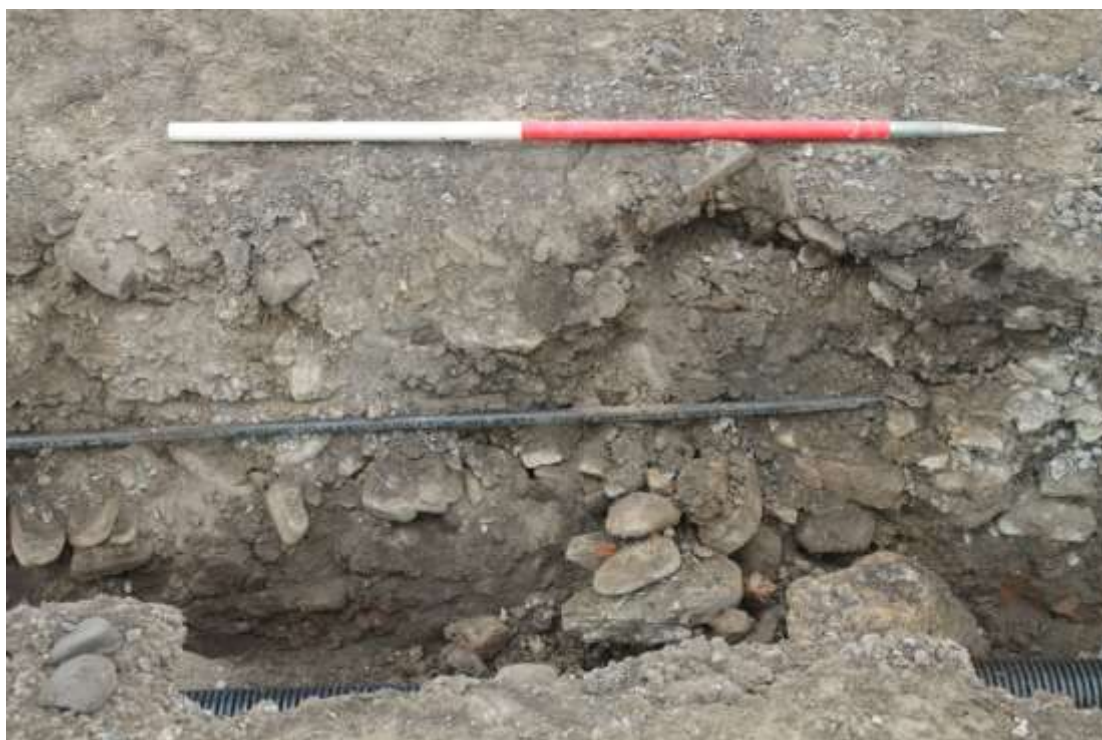
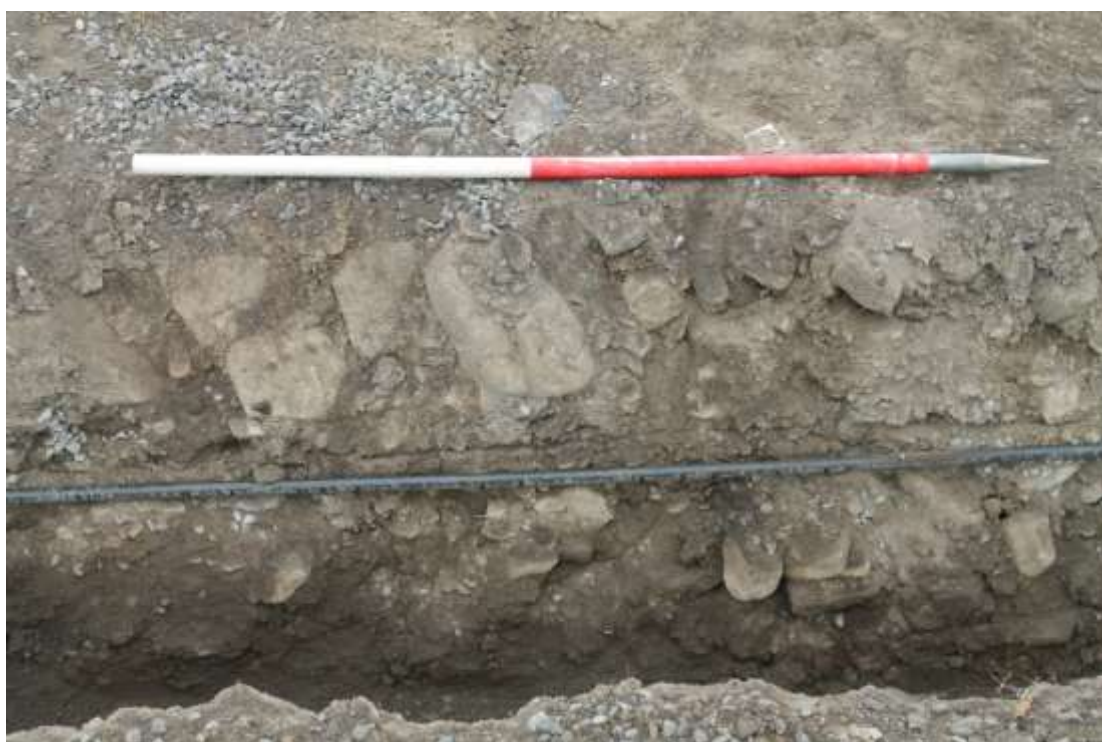
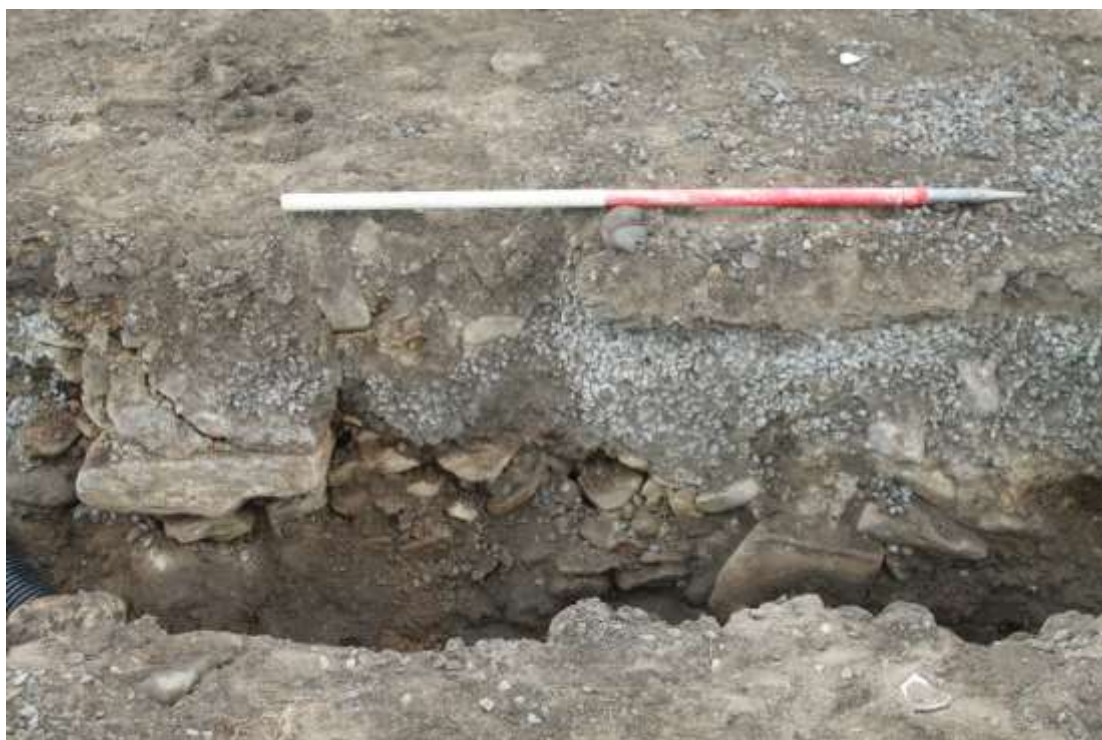
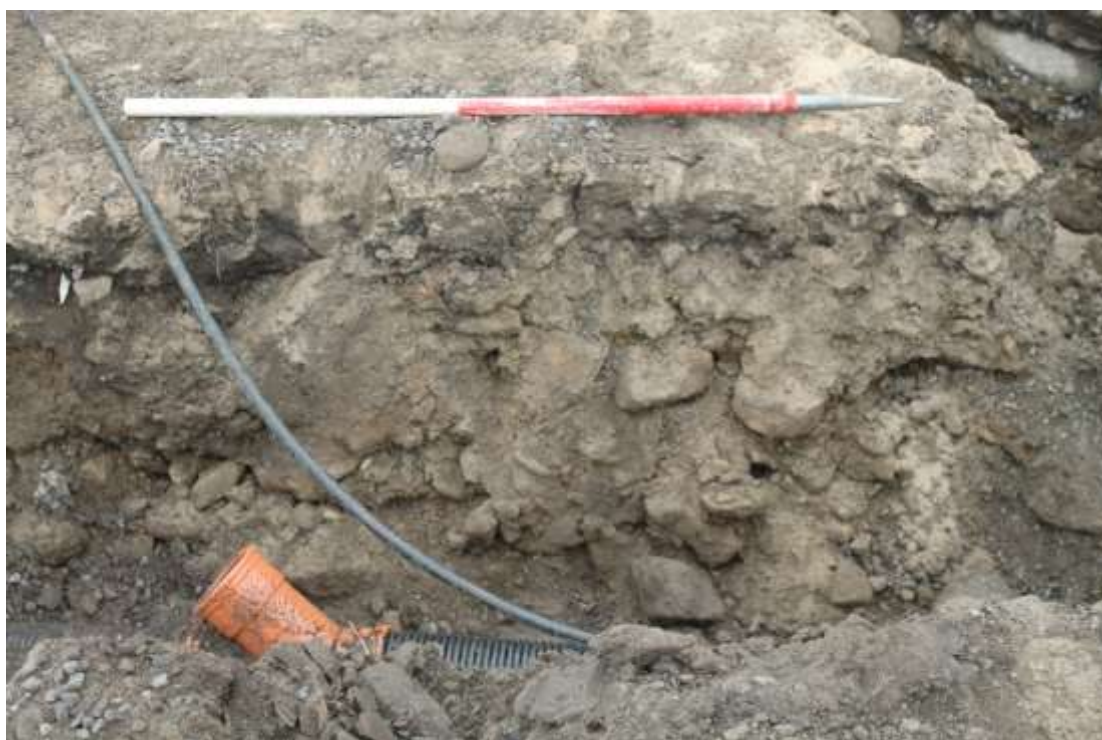
- 4.13 Re-excavation of the drainage channels in the vicinity of the Roman road was completed on this day. Fragments of Roman brick and pottery were present in the sides of the trenches which were starting to fall out due to the dry weather. These were collected to prevent loss. Some of the stones making up the Roman road also became unstable in the dried trench sections, but loss was low level. Photos 27 to 33 show sections through the Roman road along the main NW-SE drainage trench (*TB*).

Photo 27: View NE at detail of section of Roman road in *TB* (Figure 9). 1m scale

Photo 28: View NE at detail of section of Roman road in *TB* (Figure 9). 1m scale

Photo 29: View SW at detail of section of Roman road in *TB* (Figure 9). 1m scale

Photo 30: View SW at detail of section of Roman road in *TB* (Figure 9). 1m scale

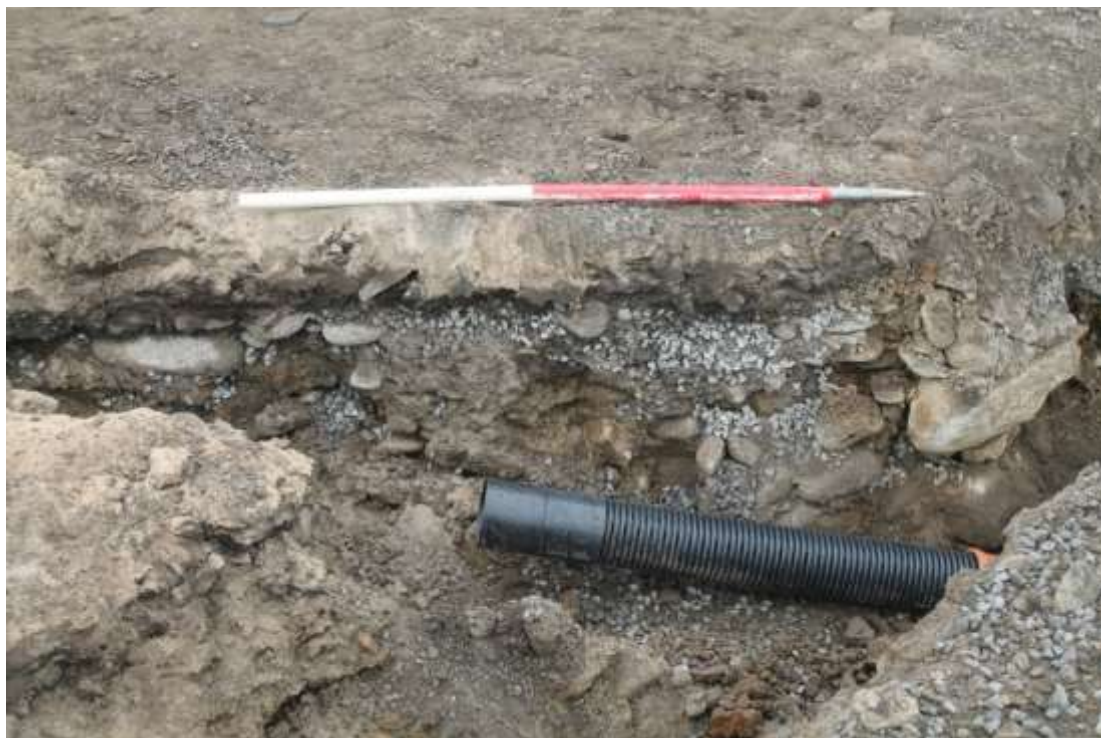
- 4.14 West of the main NW-SE drainage channel, a short diagonal drainage run was re-excavated. This also exposed the Roman road in section (photos

Photo 31: View SW at section of Roman road where TB meets diagonal drainage trench (Figure 9). 1m scale

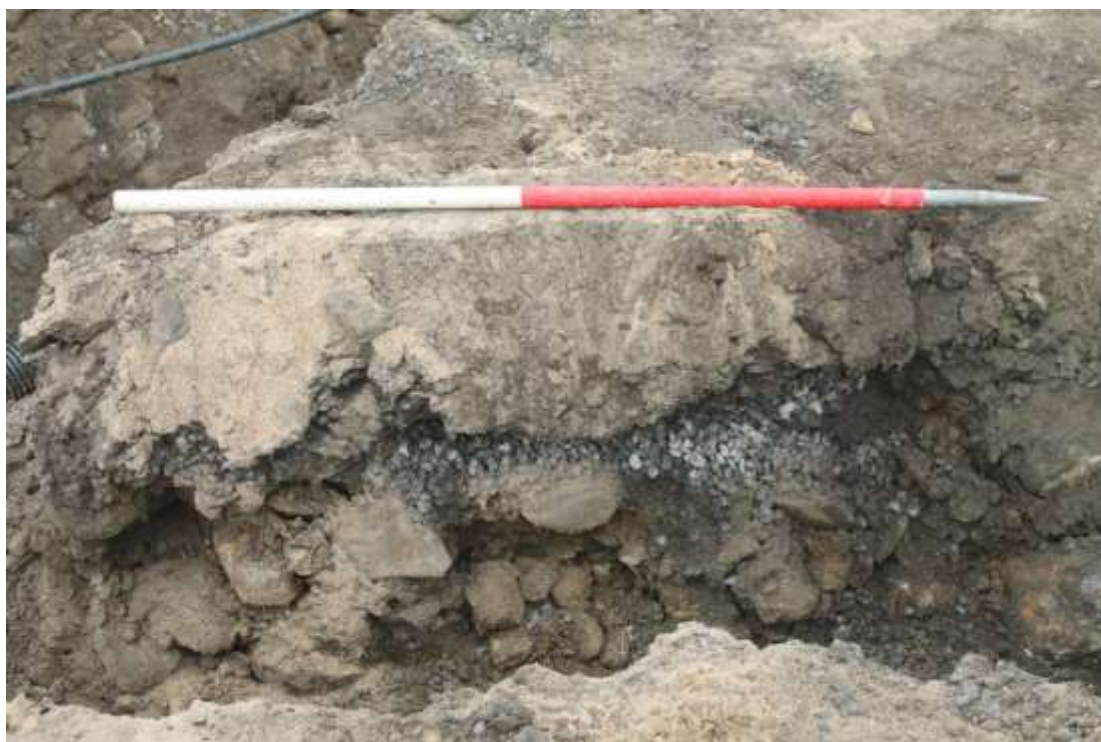
Photo 32: View NE at section of Roman road in diagonal drainage trench (Figure 9). 1m scale

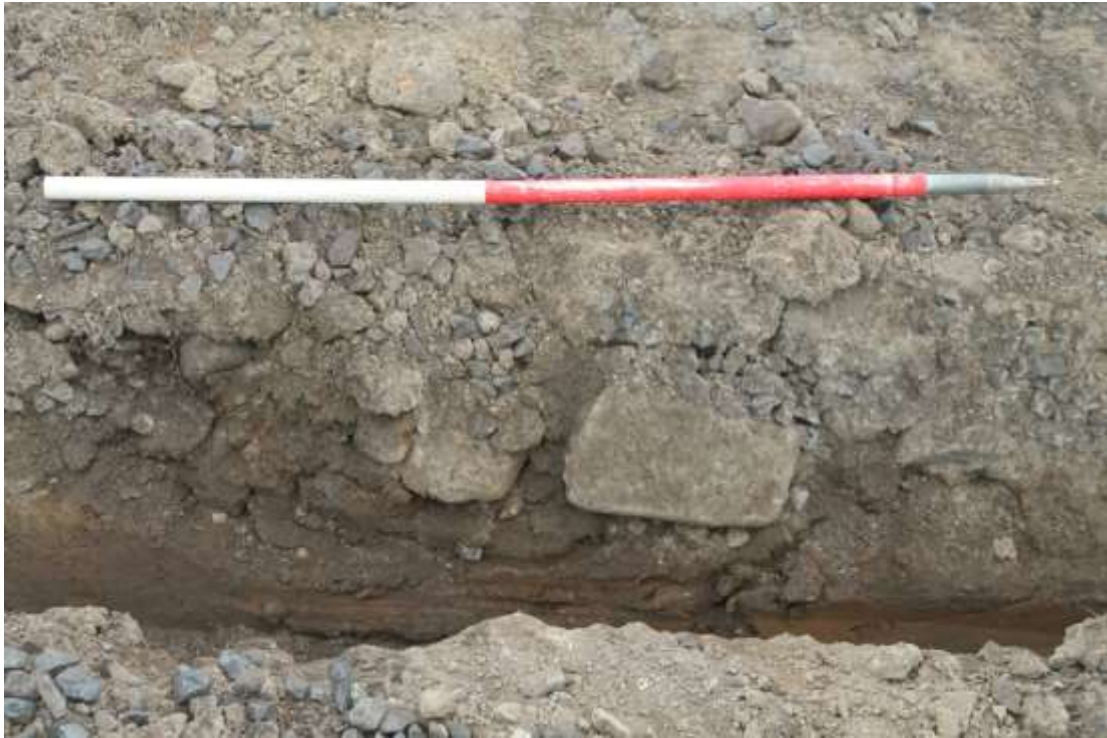
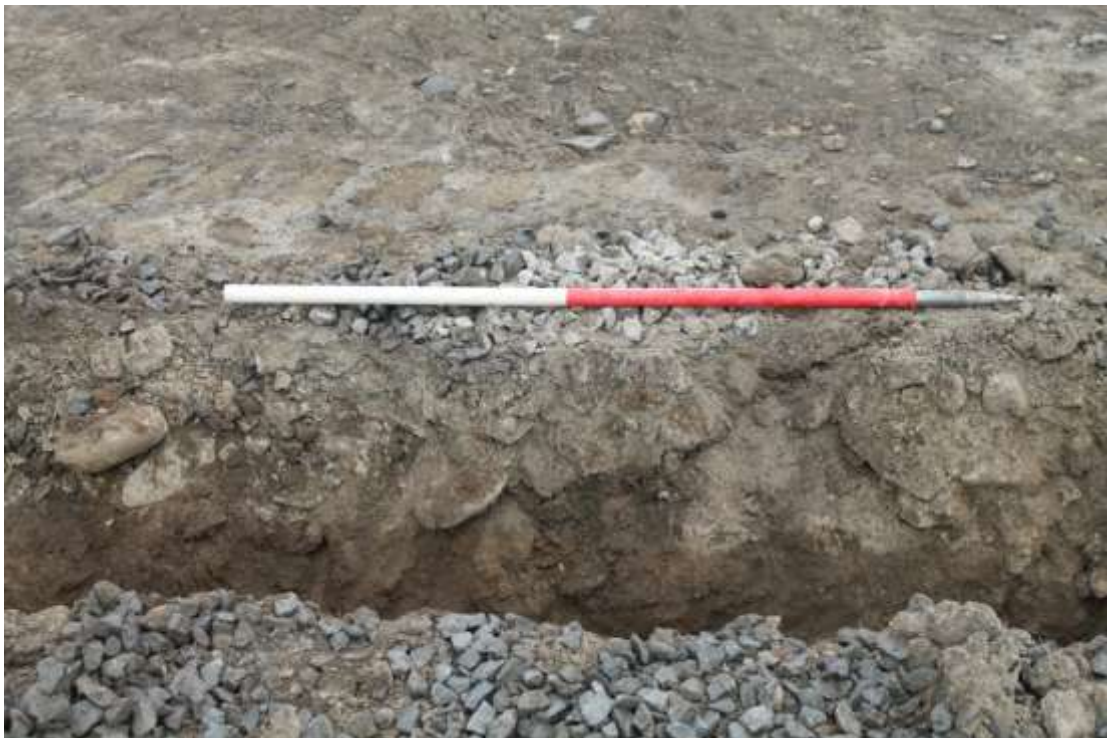
- 4.15 The Roman road was also seen in the sides of the long NW-SE drainage channel (*TB*) that ran roughly parallel to it. At the NW end of this channel the road was clear to see (Photo 35) but further SE it appeared only in places (its projected line diverges from that of the channel) and it may be that the stone seen belonged to other structures (Photos 36 and 37). Photo 38 shows the view SE along the channel after its complete re-excitation, and Photo 39 shows a final overview of part of the works as they neared completion. At this point many of the drainage channels had already been re-laid with new pipe and backfilled with gravel.

Photo 36: View NW at detail of section of Roman road in *T11*
(Figure 9). 1m scale

Photo 37: View NW at detail of section of Roman road in *T11*
(Figure 9). 1m scale
