**WATER MAINS RENEWAL SCHEMES AT  
DRUIDSTON CROSS, PEMBROKESHIRE  
(NGR SM 86949 16638)**

**DEVONSHIRE DRIVE, TENBY, PEMBROKESHIRE:  
(NGR SN 0985 0283)**

**ARCHAEOLOGICAL WATCHING BRIEFS 2017**

RHIF YR ADRODDIAD / REPORT NO. 2017/45  
RHIF Y PROSIECT / PROJECT RECORD NO. 110483 & 111171

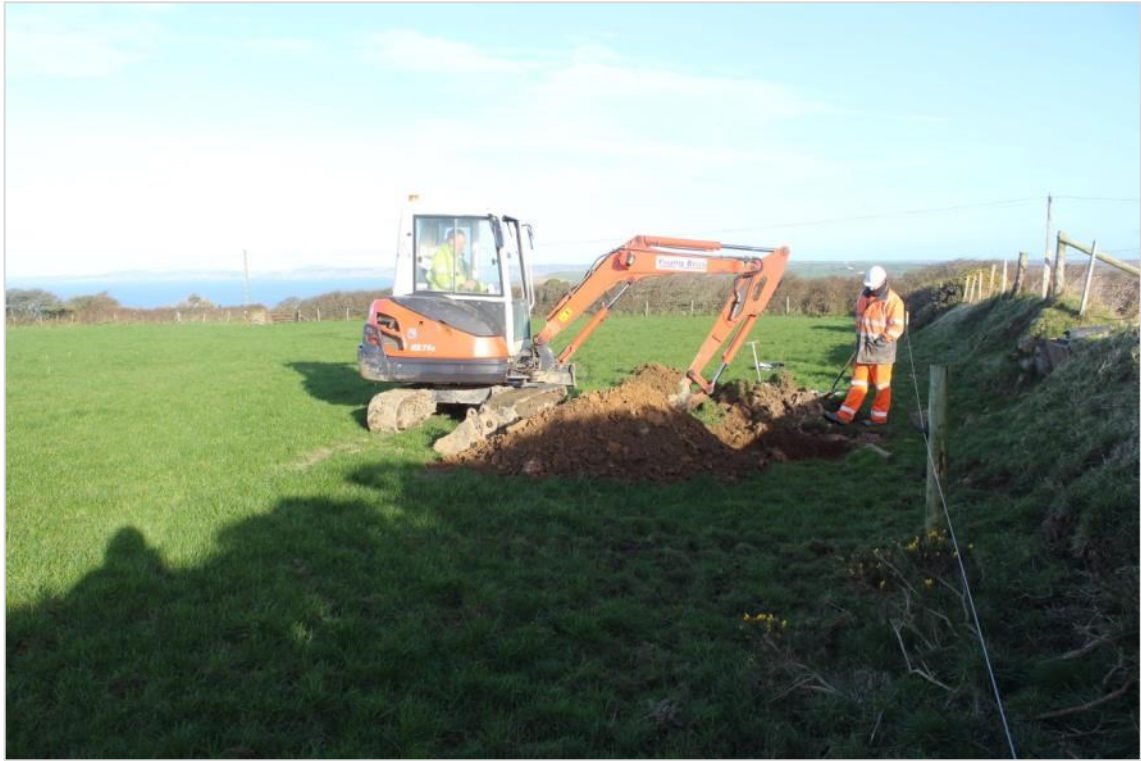
**Photo 1:** Excavating trench T1.

- 4.1.1 Inspection trench T1 was excavated adjacent to a hedgebank within a gently sloping field, in order to locate the whereabouts of the existing water main (Photo 1). It measured approximately 13.0m by 1.5m and was aligned north-south (Photo 2, Figures 5 and 6).
- 4.1.2 The average depth of the plough soil was 0.2m and consisted of a friable, grey-brown, silty-clay. It lay directly above the natural subsoil which comprised hard, yellow-brown, silty-clay containing angular stone. The underlying bedrock consists of Telpyn Point Sandstone Formation – Sandstone.
- 4.1.3 No features, finds or deposits of archaeological significance were observed within this trench during its excavation.

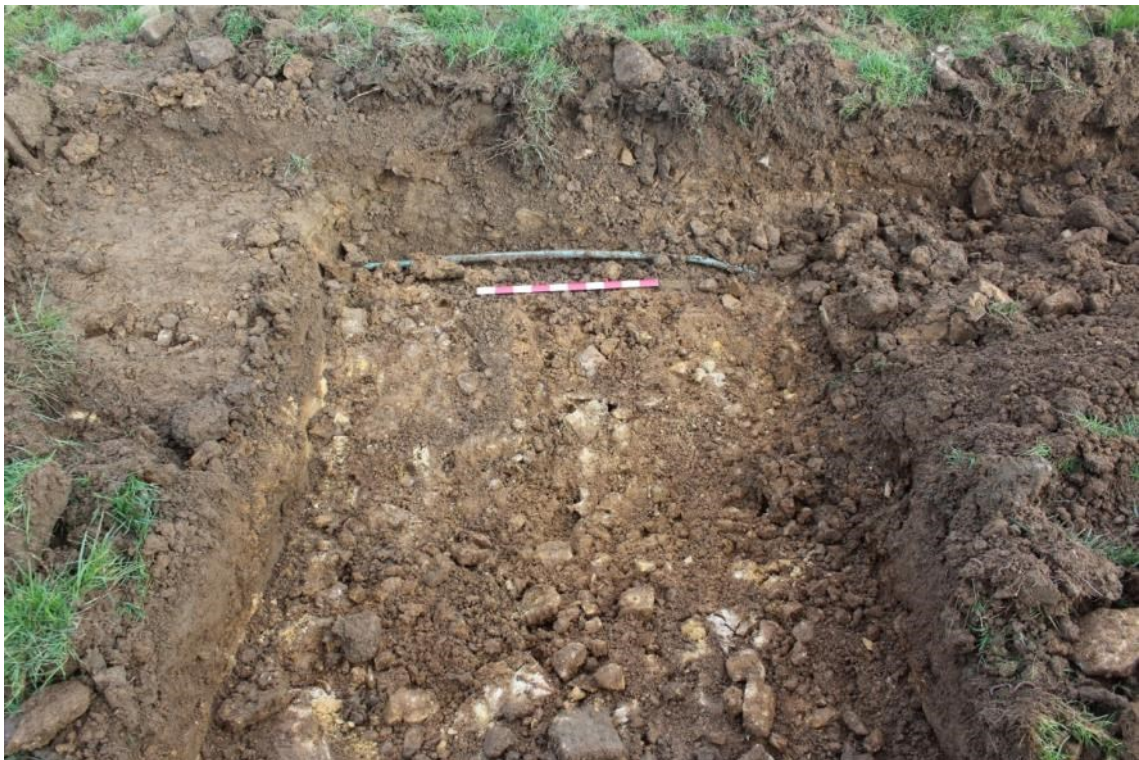
**Photo 2:** Looking east at north end of T1 (rest of trench has been back-filled).  
0.5m scale

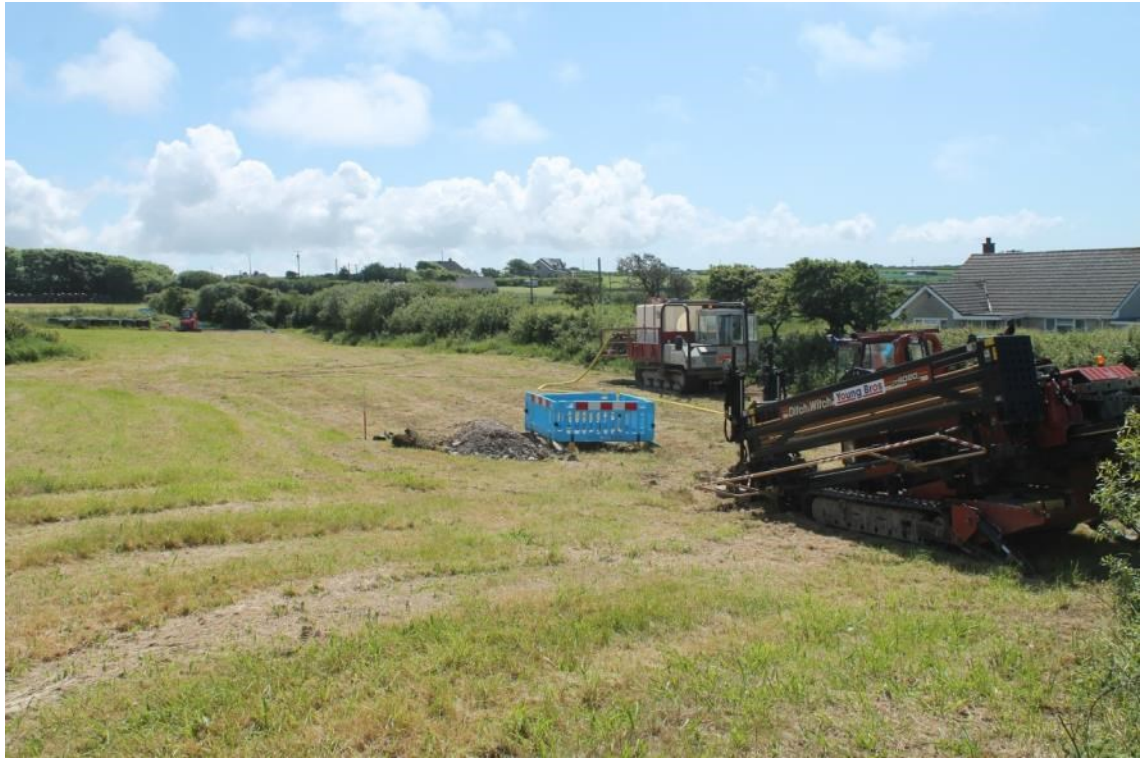
- 2.2.5 Table 2 details the sites, shown in Figure 3, that are recorded on the Dyfed HER within close proximity of the water mains renewal scheme.
- 2.2.6 Connection trench T4 is situated approximately 5m west of defended enclosure (PRN 2983), a little beyond its western bank (Photo 5, Figure 7).

**Photo 3:** Looking south from trench T4 towards trenches T3 and T2. Slight slope in foreground is west bank of defended enclosure (PRN 2983).

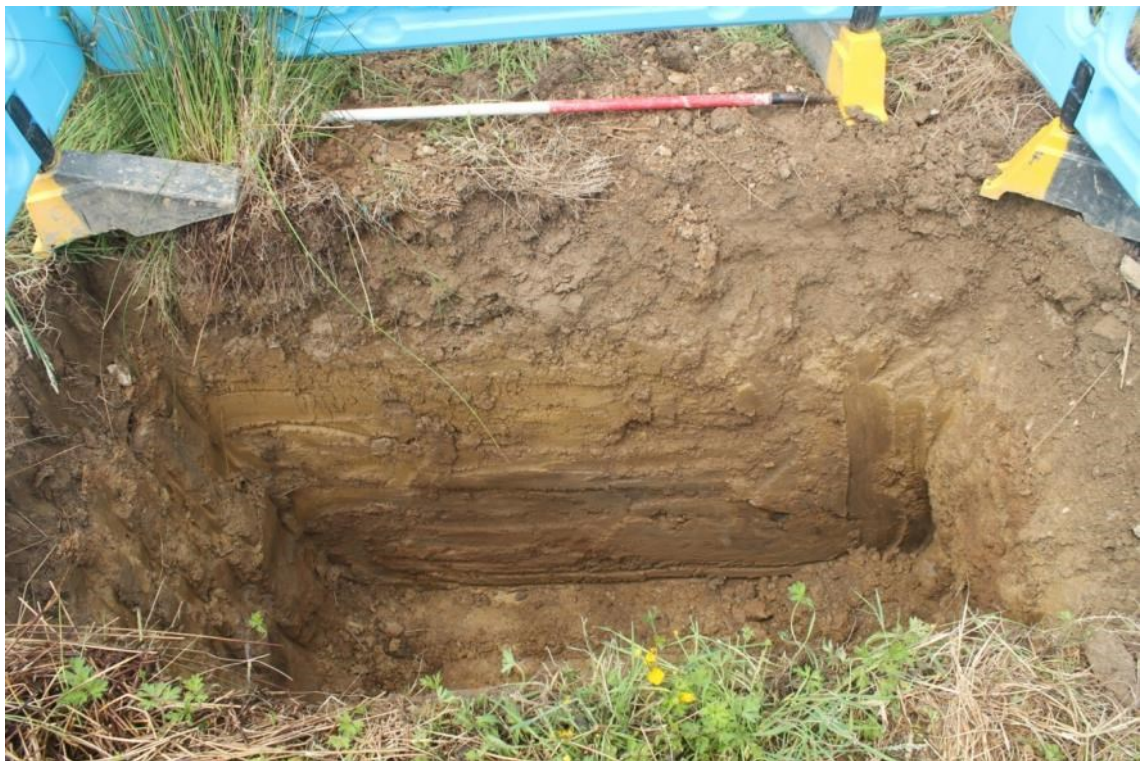
- 4.2.1 Connection trench T2 was located 60m NE of Druidston Cross. It was situated 10m away from the western hedgebank of a gently sloping field, close to the 100m contour (Photo 3, Figure 7). It measured 1.0m by 2.0m by 1.35m deep, and was aligned approximately north-south. The plough soil, a medium brown, silty-clay was 0.25m deep, below which stood the natural subsoil; a compact, yellow-brown, silty-clay becoming darker towards the base of the trench (Photo 4).

- 4.2.2 No features, finds or deposits of archaeological significance were observed within the sections of the excavated trench.
- 4.2.3 Connection trench T3 was located 145m north of the centre of Druidston Cross and was approximately 13m away from the western hedgebank of a gently sloping field close to the 100m contour (Figure 7). It measured 1.0m by 2.0m. This trench had recently been 'reamed', a process that widens the original pilot bore-hole, which results in the trench becoming inundated with liquid mud. This made the observation of the sides of the trench impossible (Photo 5).

**Photo 4:** East facing section of T2. 1m scale

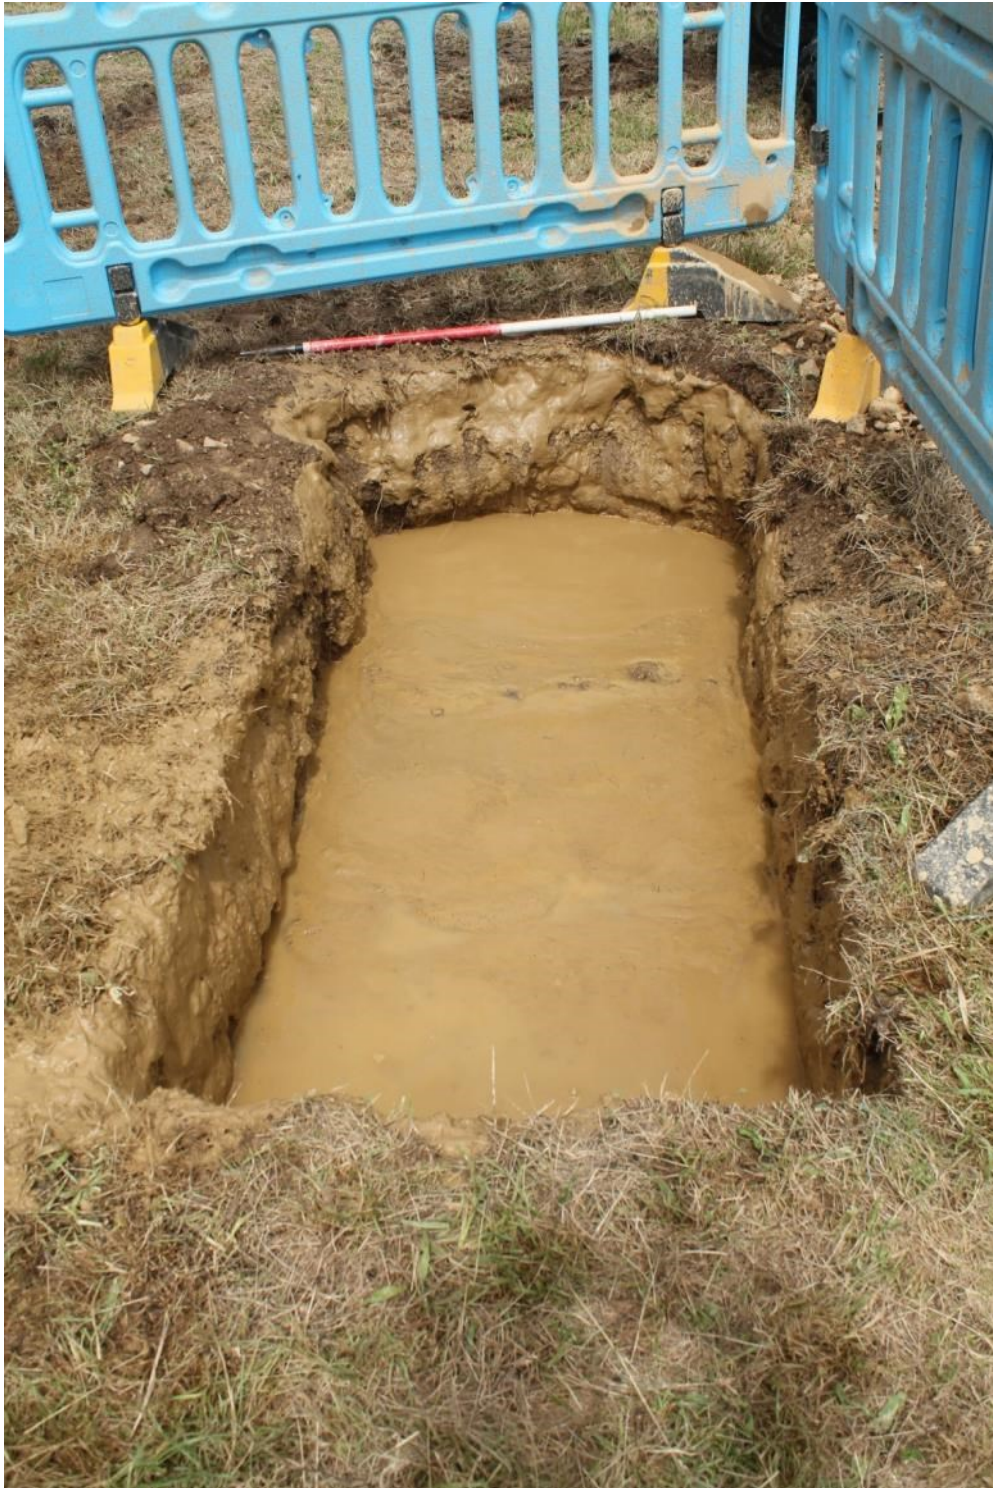
- 5.1.3 Within excavated trench T3 liquid mud from the reaming process made it impossible to describe the sections of the trench.
- 5.1.4 Within trench T4 the band of stiff orange clay and possibly the fractured mudstone beneath it could be remnants of the west bank of the Iron Age defended enclosure (PRN 2983). Unfortunately as only a small section of the trench was visible this is speculative but not entirely inconceivable.

**Photo 5:** Looking north along T3. Bore hole leading to trench has been 'reamed', creating fluid mud in the trench. 1m scale

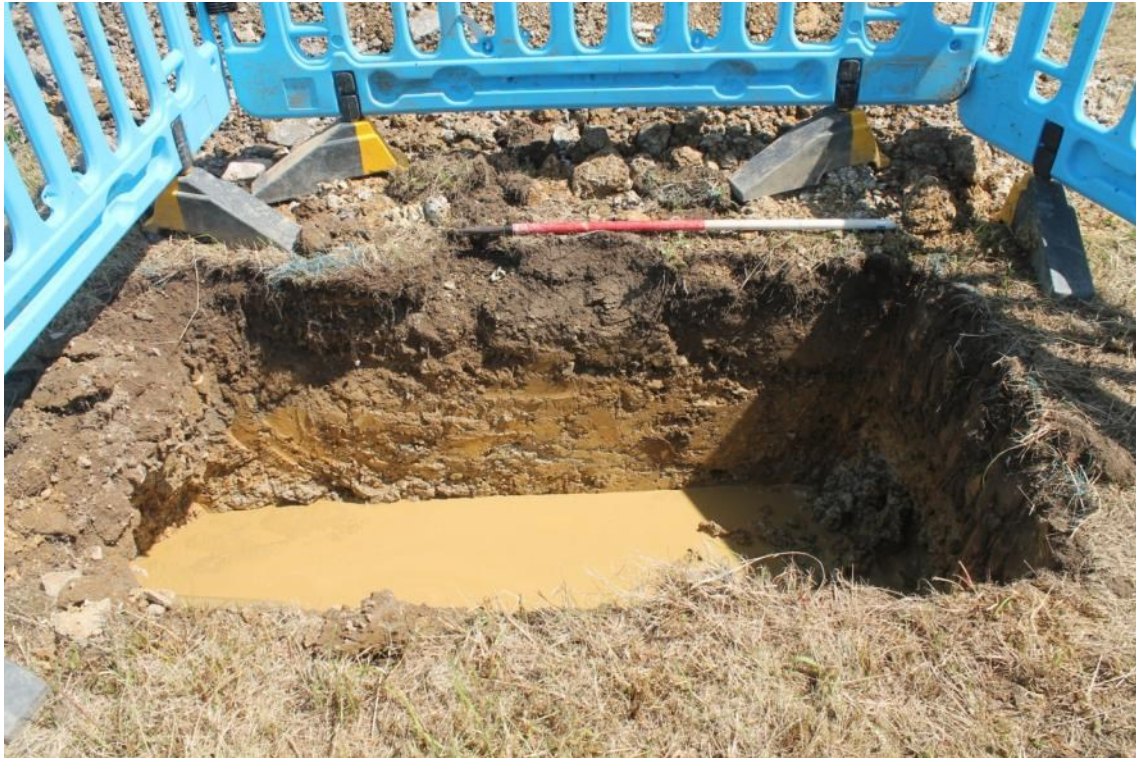
- 4.2.4 Connection trench T4 was located 245m north of the centre of Druidston Cross and was approximately 3.0m to the west of the defended enclosure PRN 2983 (Figure 7). It measured 2.0m by 1.0m and lay close to the 100m contour. The section adjacent to the Iron Age defended enclosure (PRN 2983) consisted of 0.23m depth of orangey-brown, silty-clay plough soil below which stood a band of compact, orange clay approximately 0.2m deep. Beneath this layer a band of fractured mudstone within a clay matrix was observed. Liquid mud from the reaming process obscured the lower reaches of the trench (Photo 6).

**Photo 6:** West facing section of T4. Band of orange clay and fractured mudstone below possibly associated with PRN 2983. 1m scale

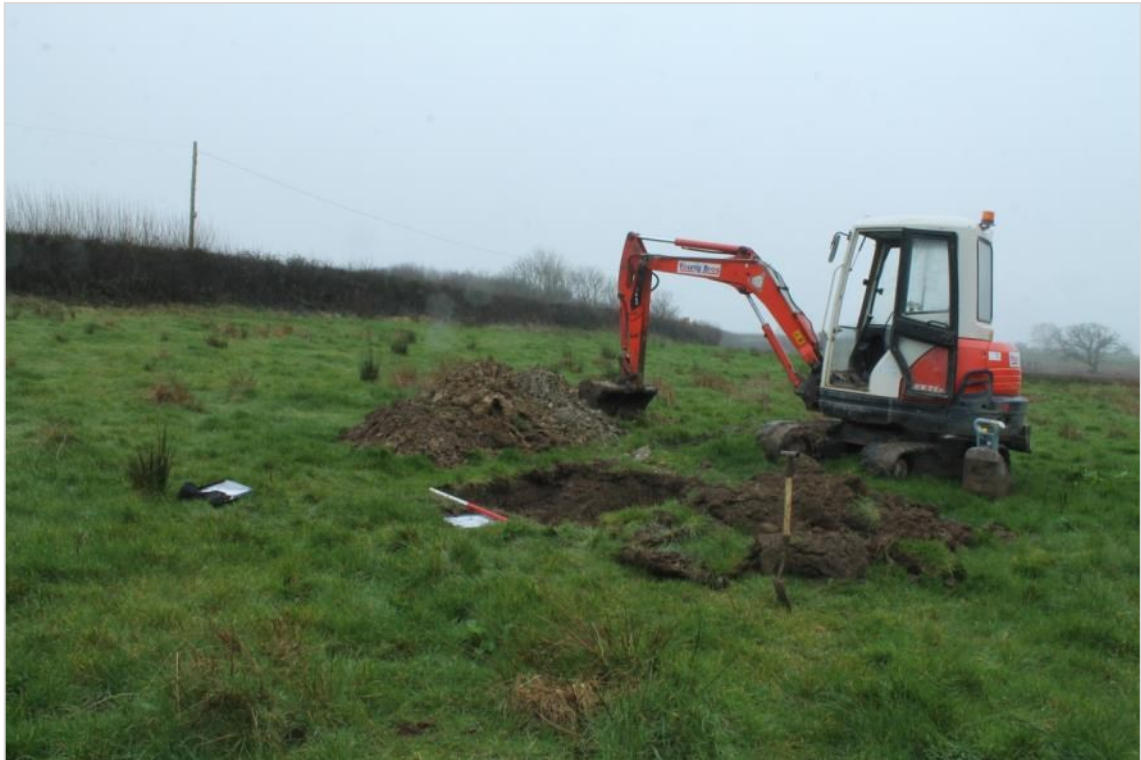
**Photo 8:** Excavating the trial hole.

- 4.3.1 A trial hole measuring approximately 1.5m<sup>2</sup> was excavated adjacent to an air release valve located by the site contractors (Photo 8).
- 4.3.2 The earliest deposit within the trench was the natural (undisturbed) ground consisting of blue shale clay, observed at an upper height of approximately 0.80m below ground level.
- 4.3.3 Overlying the natural, was light brown silty clay subsoil recorded at an upper height of 0.30m below ground level. Cutting the subsoil was a rectilinear cut, aligned roughly north/south and approximately 0.40m wide (Photo 9). The cut contained clay back fill material and the existing water main pipe.

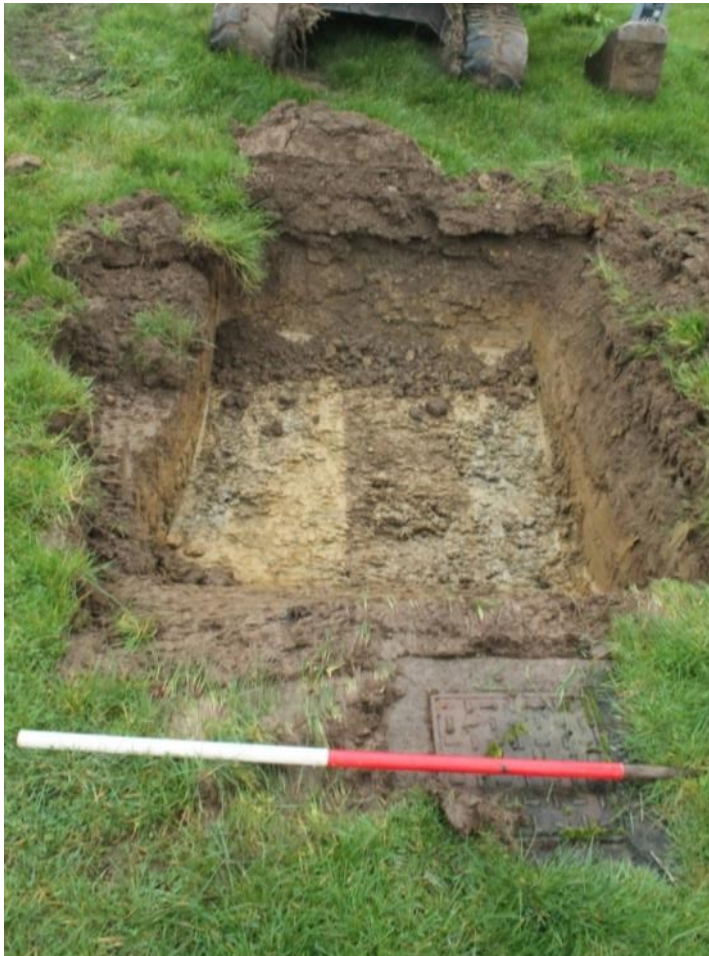
**Photo 9:** The rectilinear cut associated with the existing water mains is visible cutting the subsoil. View south, 1m scale.

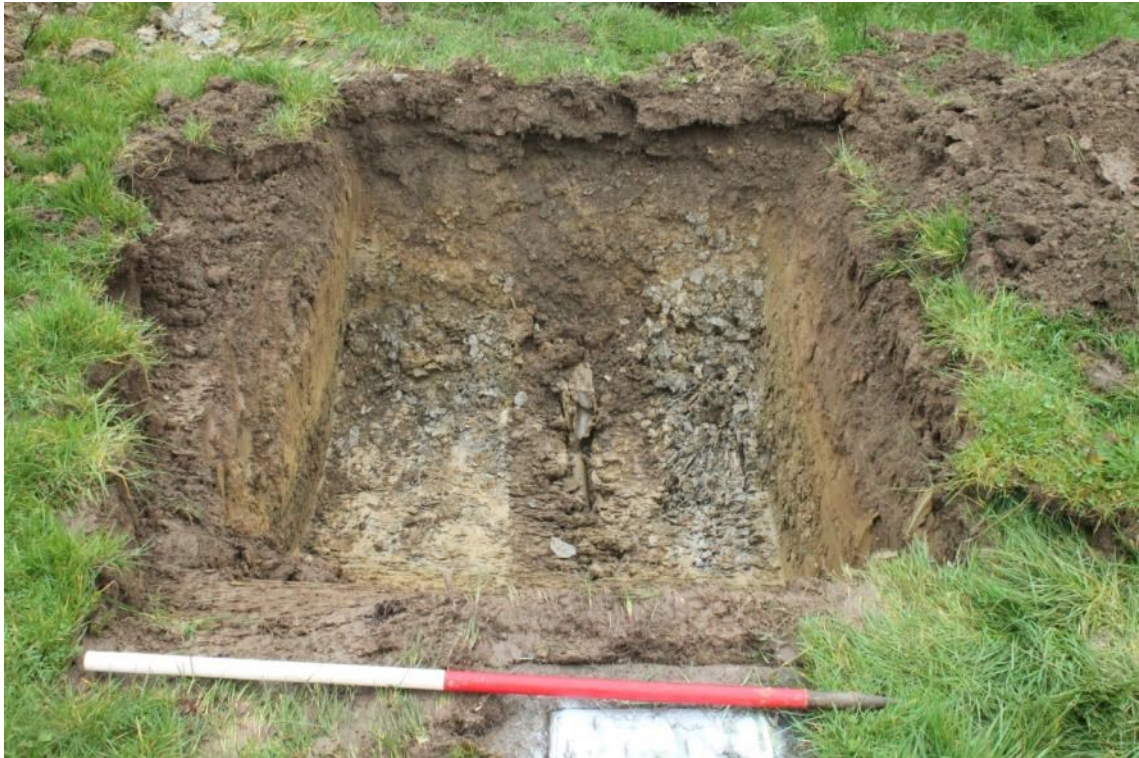
- 4.3.4 The entire trench was overlain by a 0.30cm thick topsoil layer and turf.
- 4.3.5 Photo 10 shows the trench on completion of the excavation with the existing water mains pipe exposed within the base of the trench at a depth of approximately 0.80m below ground level.
- 4.3.6 No archaeological finds or deposits were observed during the course of the watching brief.

**Photo 10:** The trial trench upon completion of excavation. The trench was excavated to a depth of approximately 0.80m to the existing water mains. The natural (undisturbed) ground was exposed at this depth. View south, 1m scale.
