**PENYSTAR, SHINGRIG,  
ST DOGMAELS, PEMBROKESHIRE:  
ARCHAEOLOGICAL EVALUATION  
2017  
(NGR SN 16443 45806)**

Prepared by DAT Archaeological Services  
For: Mr Joe Rainsbury

RHIF YR ADRODDIAD / REPORT NO. 2017/60  
RHIF Y DIGWYDDIAD / EVENT RECORD NO. 111138

**PENYSTAR, SHINGRIG,  
ST DOGMAELS, PEMBROKESHIRE:  
ARCHAEOLOGICAL EVALUATION  
2017**

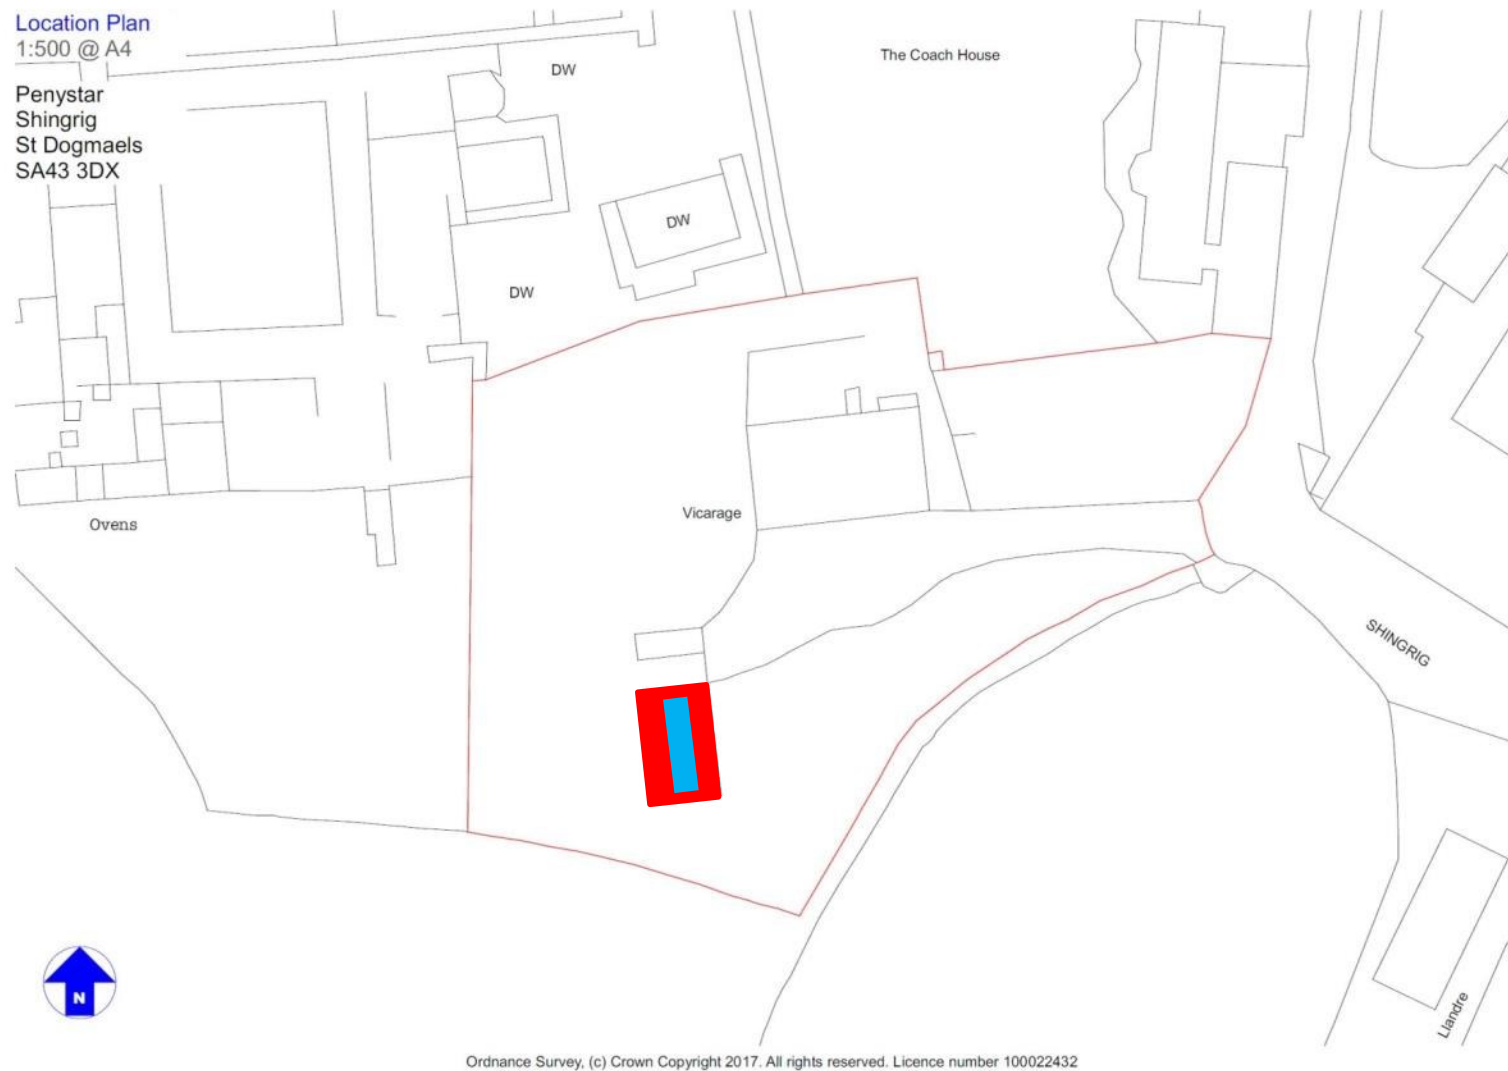
**Figure 2:** Development proposals plan showing footprint of proposed new garage (in red) at Penystar, Shingrig, St Dogmaels with proposed evaluation trench in blue (Plan taken from Pembrokeshire County Council Planning website)

- 2.1.1 The proposed garage site is situated within the garden of the former vicarage, St Dogmaels, Pembrokeshire (centred on NGR SN16443 45806 (Figures 1 and 2). The property has recently been sold and is now known as Penystar.
- 2.1.2 The site is under grass and is situated on a gentle east facing slope at about 20m OD.
- 2.1.3 The underlying solid geology is comprised of the Dinas Island Formation - Sandstone and Mudstone. Sedimentary Bedrock formed approximately 449 to 458 million years ago in the Ordovician Period. The recorded superficial deposits are sedimentary deposits; glacial in origin. Geological information has been obtained through the British Geological Survey mapping portal.

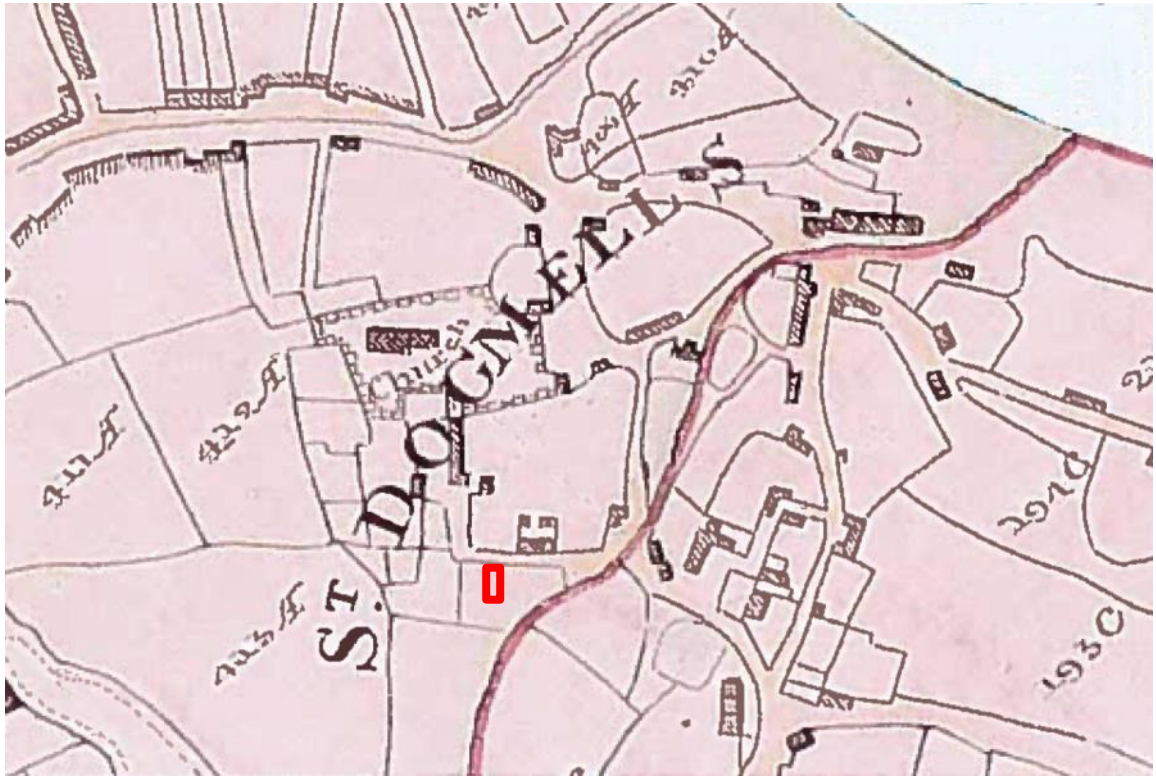
**Figure 3:** An extract of the St Dogmaels tithe map of 1838 with the approximate position of the proposed garage area outlined in red.

2.2.9 The 1838 St Dogmaels parish tithe map shows the vicarage (Photo 2) but no buildings are shown within the proposed garage development area (Figure 3). The 1890 Ordnance Survey 1st edition 1:2500 map (Figure 4) and the 1904 second edition again show the vicarage, with the area of the proposed garage set within undeveloped land to the southeast.

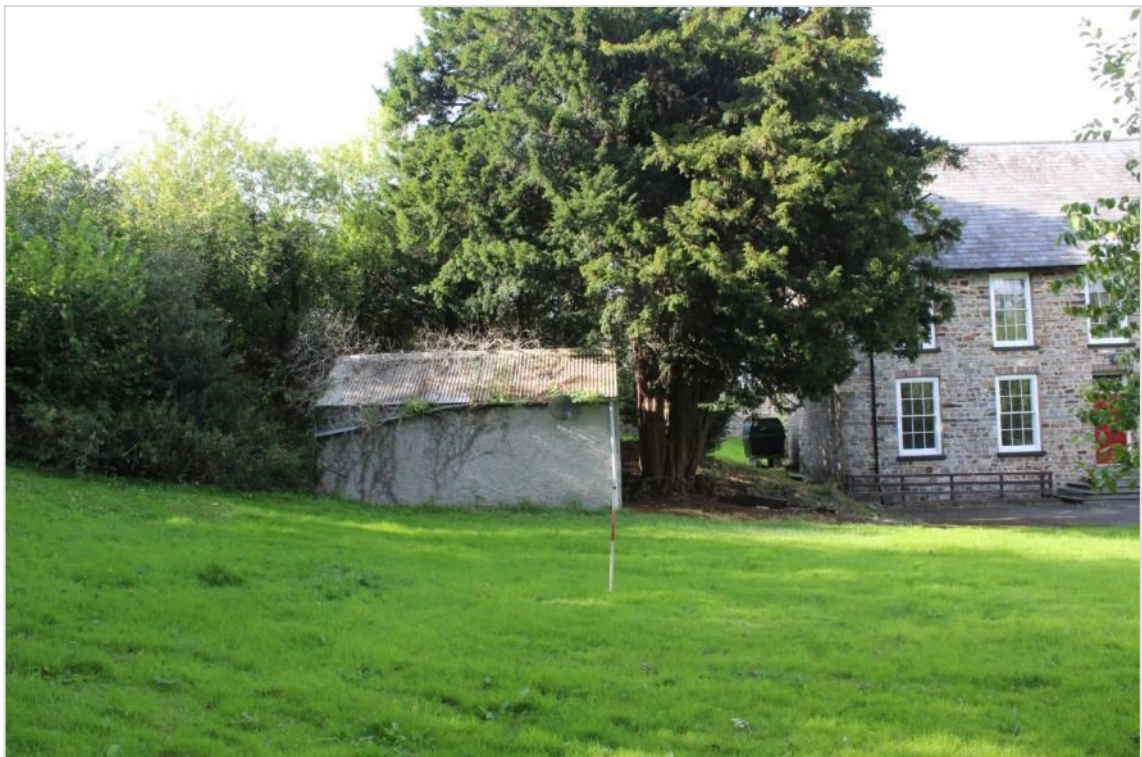
**Photo 3:** Looking north at the area proposed for the new garage. 1m scale

- 4.1 The evaluation was carried out on the 22<sup>nd</sup> September 2017 in wet weather. A single trench c.9.0m in length and 1.8m wide, orientated north-south was initially excavated along the length of the proposed foot print of the garage (Photos 3 & 4). Another shorter trench, measuring around 2.0m in length and 1.8m wide, was excavated at a right angle on the east side of the main trench, creating a stout "T"-shaped trench (Figure 5, Photo 6).
- 4.2 All individual archaeological deposits or features were numbered using the open-ended numbering system. Each numbered deposit was described and is shown within rounded brackets ( ) in the text. A summary of the descriptions are listed in Appendix I.

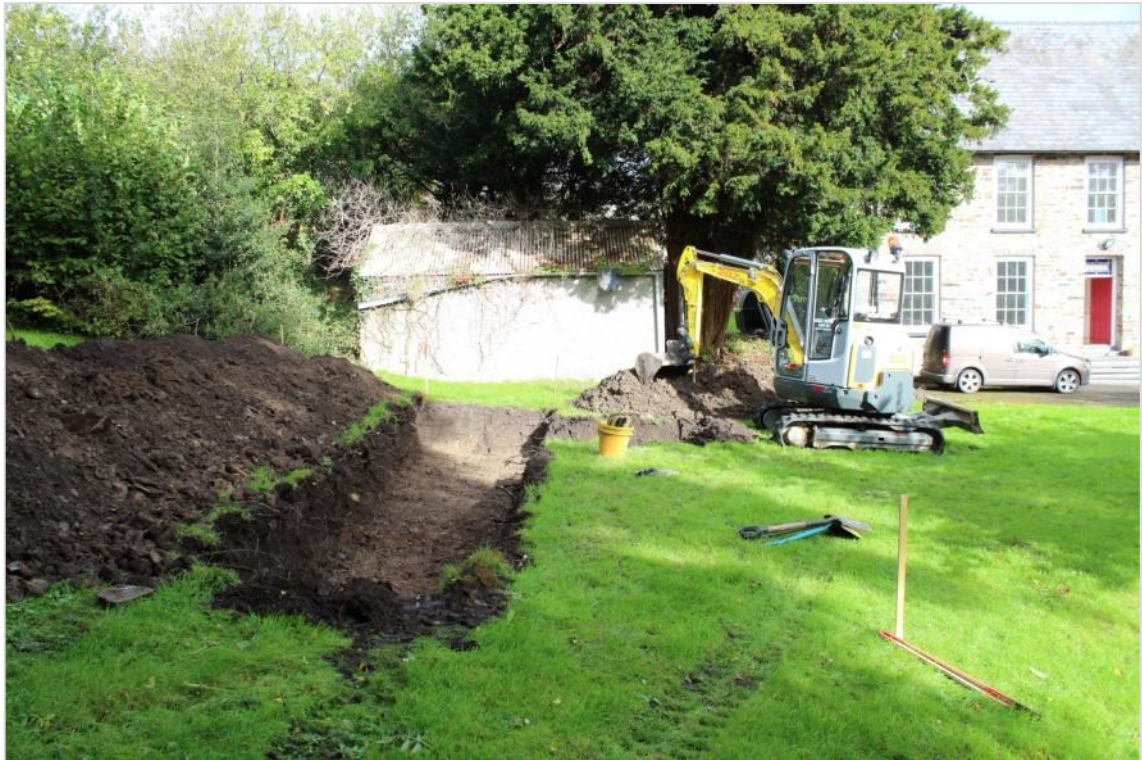
**Photo 4:** Excavating the evaluation trench. Looking north

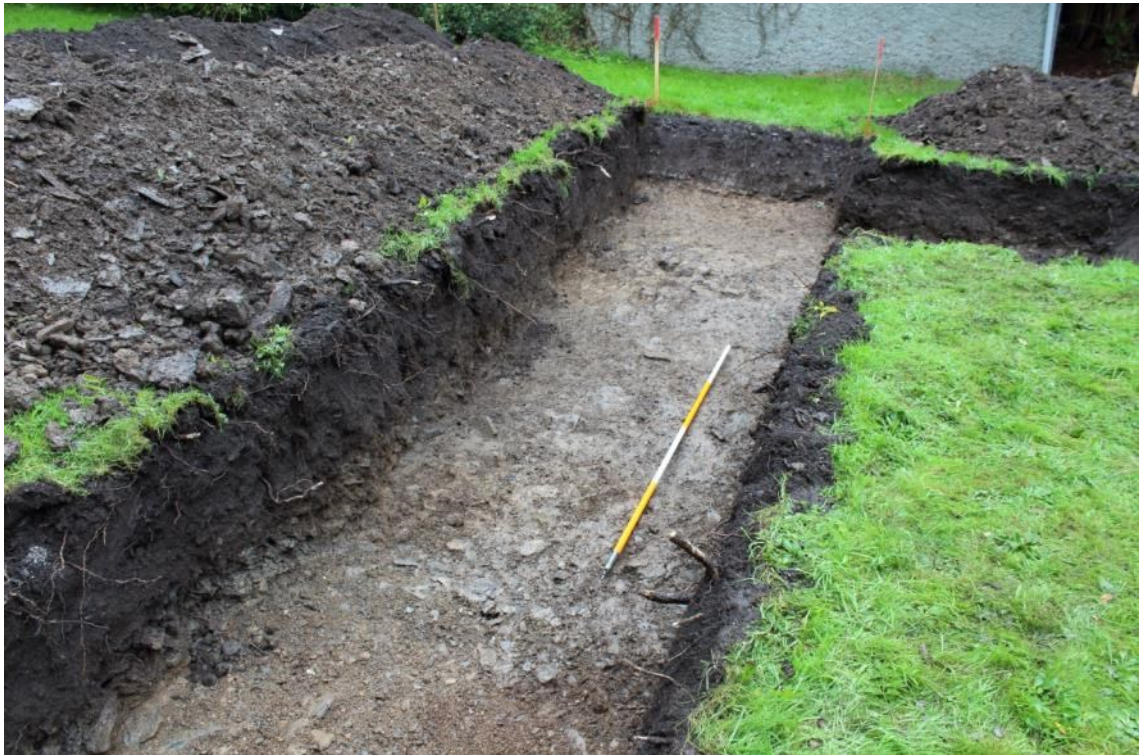
**Photo 5:** The north-south evaluation trench after it had been cleaned by hand.  
2m scale

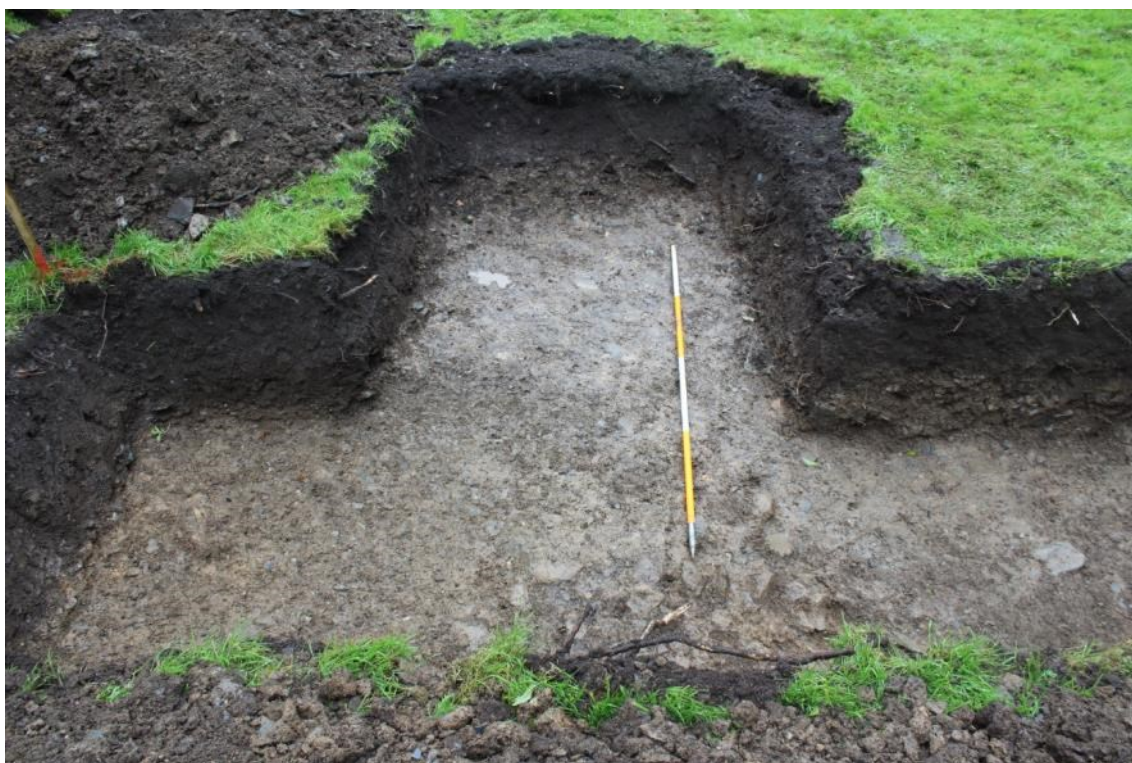
**Photo 6:** The east-west evaluation trench. 2m scale

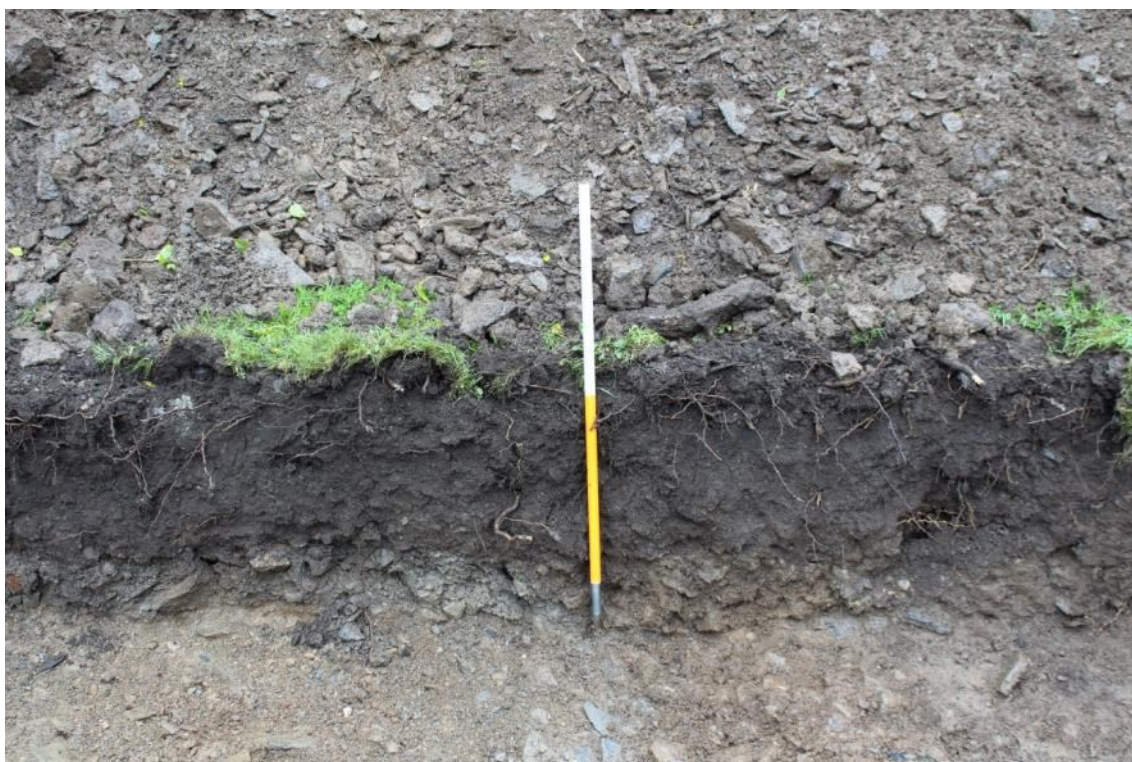
**Photo 7:** The east facing section of the north-south evaluation trench. 1m scale

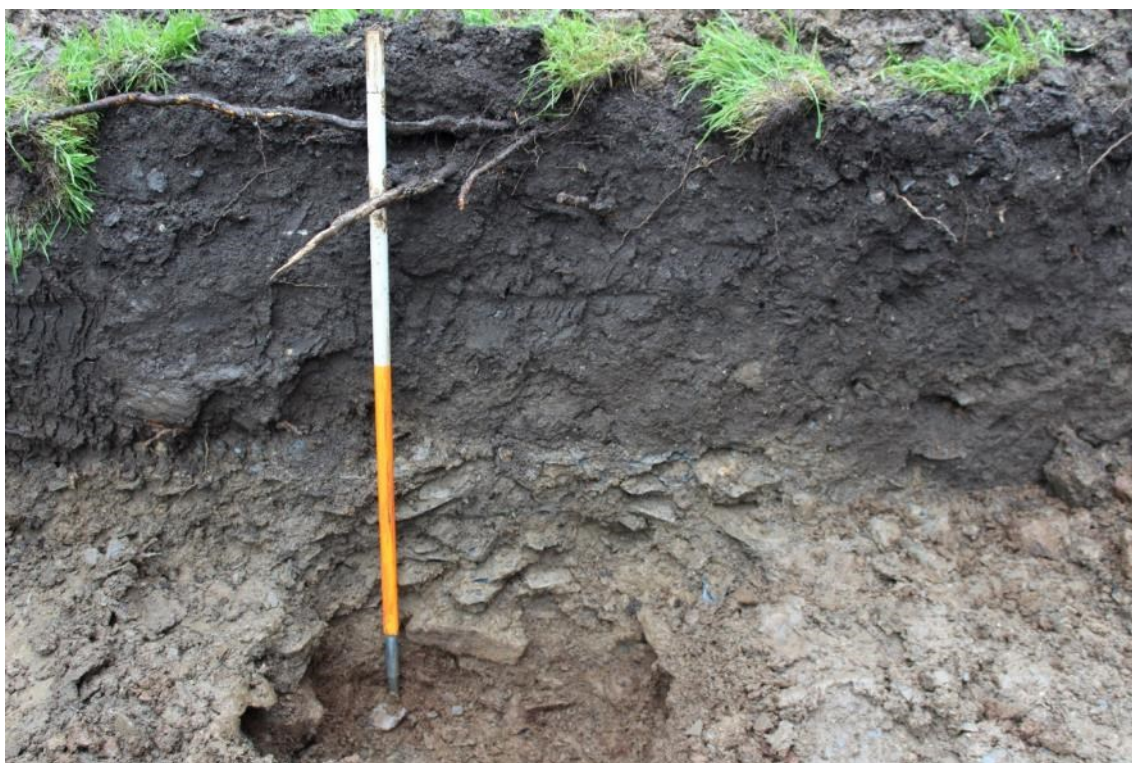
- 4.8 A small test pit was excavated through deposit [102] at the northern end of the north-south trench against its east facing section (Figure 5, Photo 8). Within the test pit deposit (102) was shown to be approximately 0.18m deep and it was confirmed that deposit (102) lay directly above the natural sand and gravel subsoil.

**Photo 8:** The east facing section through the test pit excavated down to natural subsoil. 1m scale

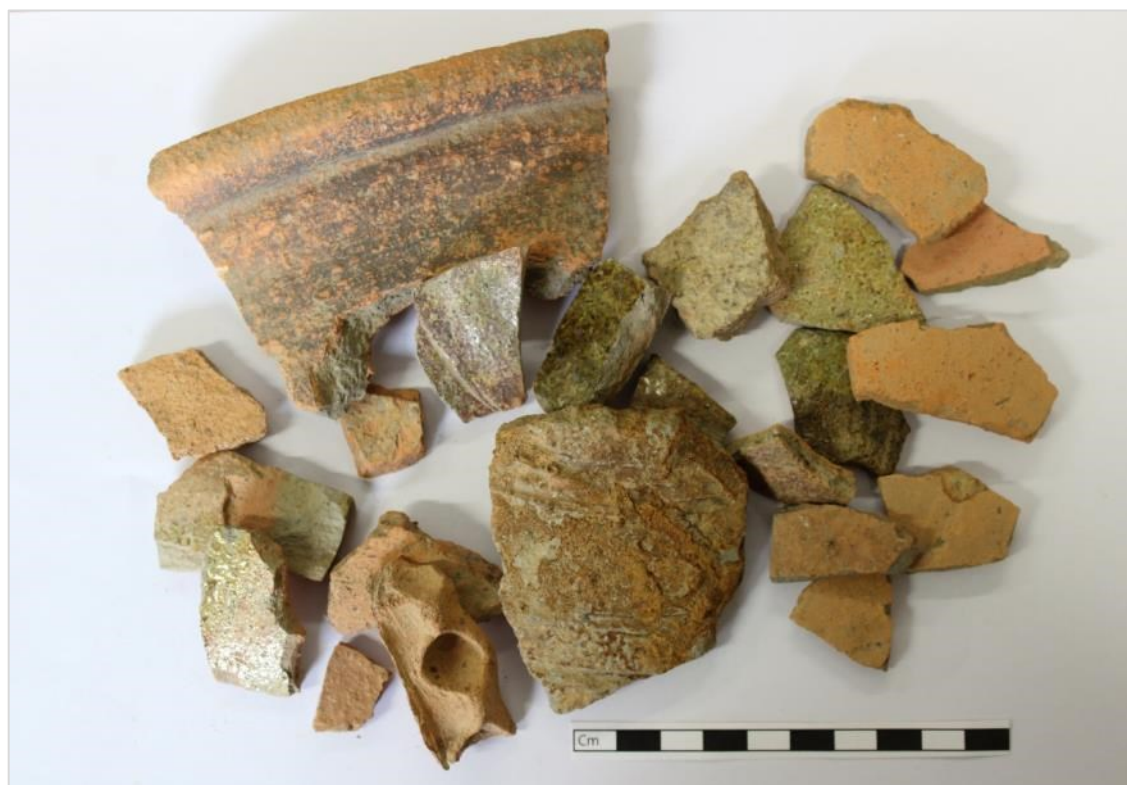
- 4.3 The excavated trenches revealed a similar sequence of soils in all the trench sections. Underlying the grass ground surface was a deep layer (101) of consistent loam or 'garden soil', measuring 0.50-0.60m in depth (Photo 7). This layer contained very few finds apart from a few abraded sherds of 20<sup>th</sup> century pottery.
- 4.4 Removal of deposit (101) revealed a compacted deposit of light brown dirty silty clay mixed with gravel and stone (102) (Figures 5 & 6). Within this deposit were numerous fragments of animal bone; some showing butchery marks, pottery sherds (Photo 9), fragments of ceramic floor tile

**Photo 9:** The 15<sup>th</sup>/16<sup>th</sup> century pottery sherds

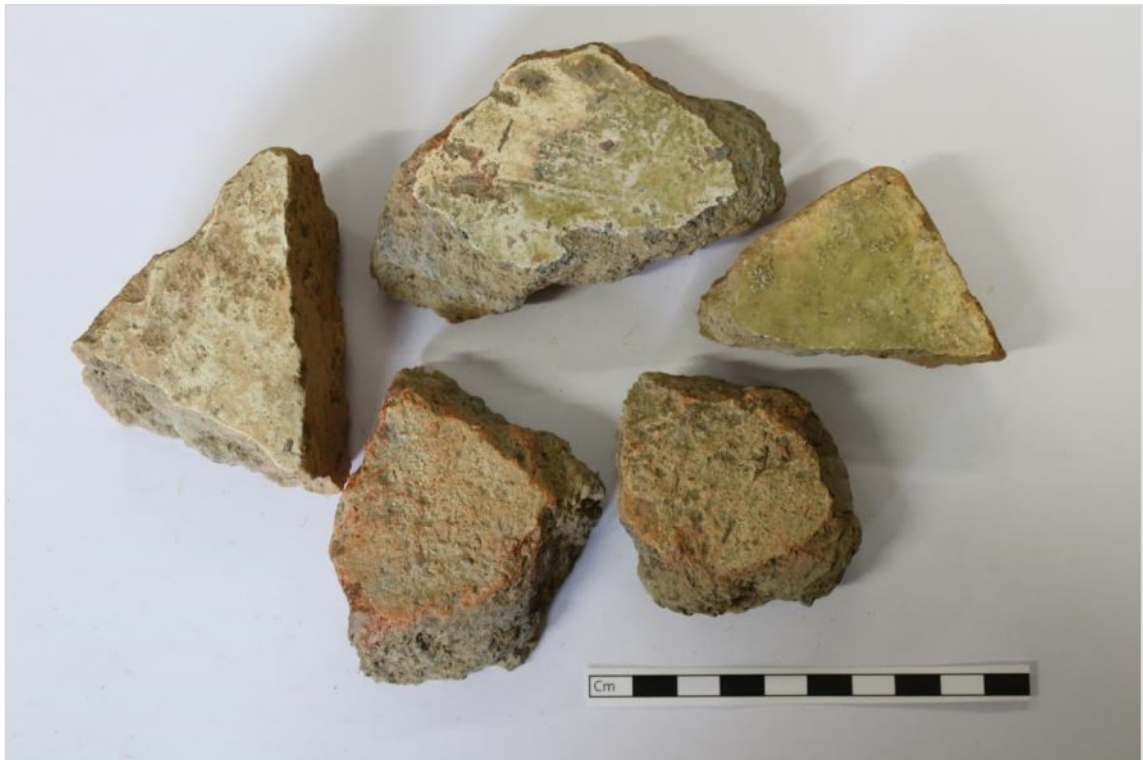
(Photo 10), ceramic ridge tile (Photo 11), roofing slate, iron nails and pieces of ceramic brick.

**Photo 10:** Fragments of medieval floor tile

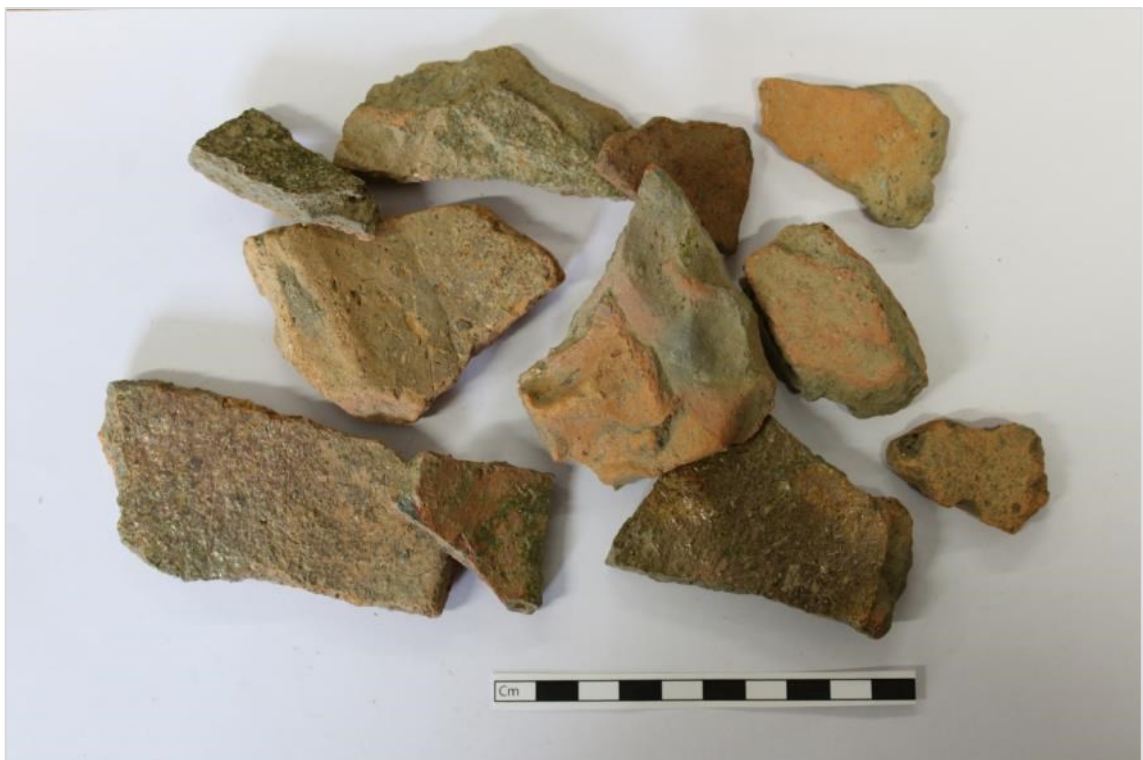
**Photo 11:** Fragments of medieval ceramic ridge and flat roofing tile
