**FOUNDRY POINT CARAVAN PARK,
WISEMAN'S BRIDGE, PEMBROKESHIRE:
HISTORIC ENVIRONMENT APPRAISAL
(SN 14340598)**

RHIF YR ADRODDIAD / REPORT NO. 2017/36
RHIF Y DIGWYDDIAD/ EVENT RECORD NO. 111142

**FOUNDRY POINT CARAVAN PARK, WISEMAN'S
BRIDGE, PEMBROKESHIRE:
HISTORIC ENVIRONMENT APPRAISAL
(NGR SN 1434 0598)**

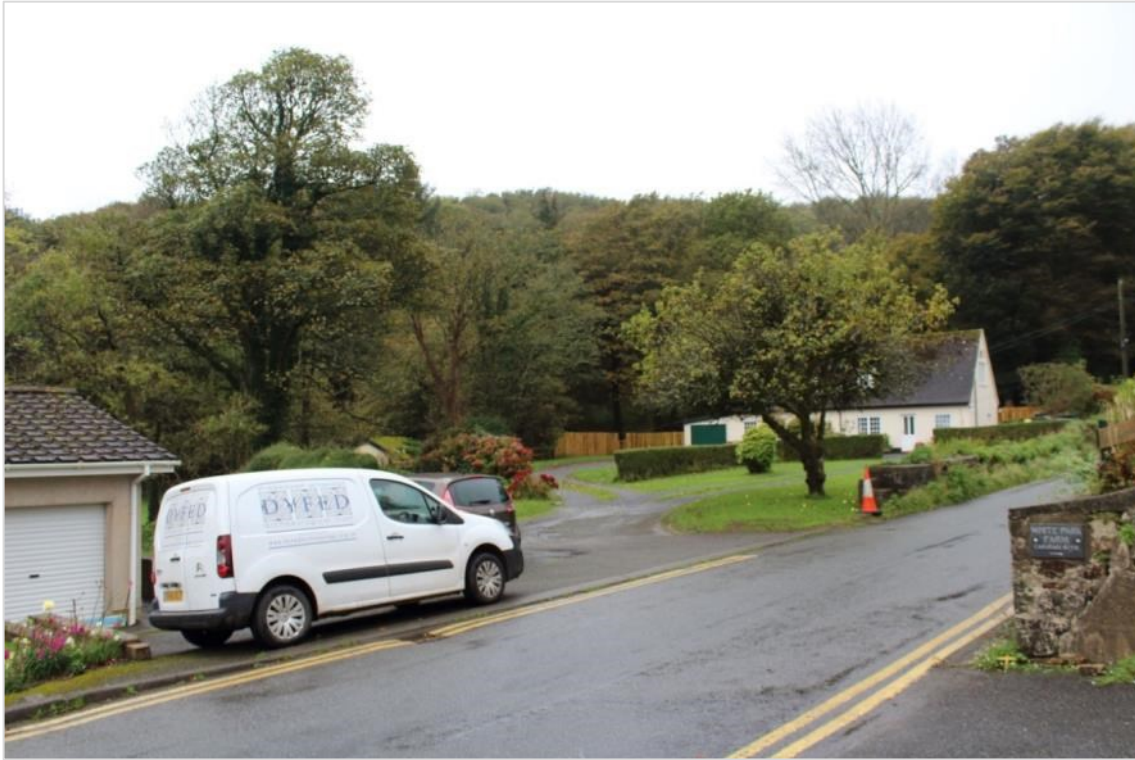
- 4.5.3 The site of the foundry buildings as shown on the 1st and 2nd edition Ordnance Survey maps is now occupied by the modern Devonshire Cottages and the adjoining driveway. There does not appear to be any evidence on the ground of the former foundry buildings (Photo 1).

Photo 1: View facing south-west showing in the background the driveway leading to Devonshire Cottages; the site of the iron foundry buildings. The garage of adjacent Culverton Cottage is just visible behind the DAT vehicle (DAT Photo 111142_0048).

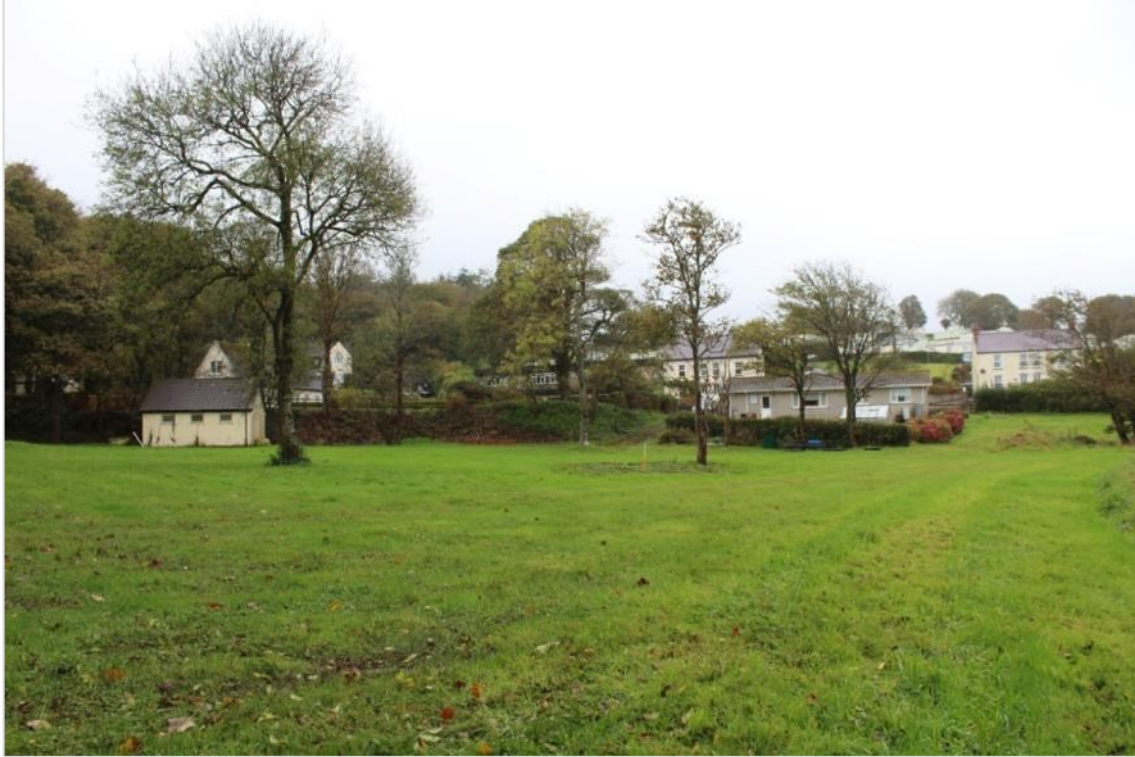
- 4.5.4 The eastern section of the development area comprises a relatively flat and well maintained grassed area which overlooks the coastal path (formerly the route of the Saundersfoot railway). There are no visible earthworks or above ground remains of any of the buildings identified on historic mapping (Figures 7 & 8) in this area. Two patches of recently disturbed ground near the centre of this area indicated the recent geotechnical investigations and locating of Woolson's Pit (PRN 23790) which was found to be capped with a brick lined arch (Beattie, 2017) (Photo 2). There was also no evidence of the former tramway that once ran across the area from the woodland at the south-eastern corner of the development area (Photo 3).

Photo 2: View facing north across the former site of the brickworks in the eastern section of the development area. Just visible in the centre of the field is an area of disturbed ground marked by a ranging rod indicating the location of Woolson's Pit. The former toilet block of the caravan site is present in the background to the left (DAT Photo 111142_0007).

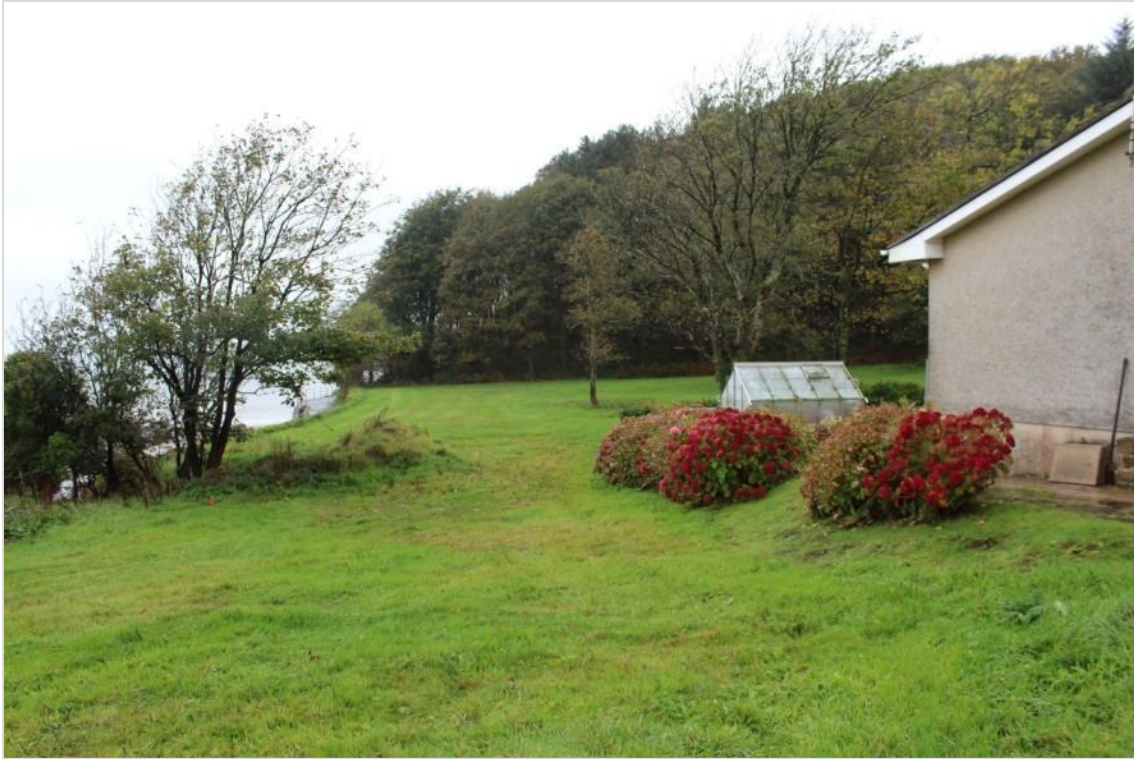
Photo 3: View facing south from the eastern side of Culverton cottage looking towards the site of the former brickworks (DAT Photo 1111_0005).

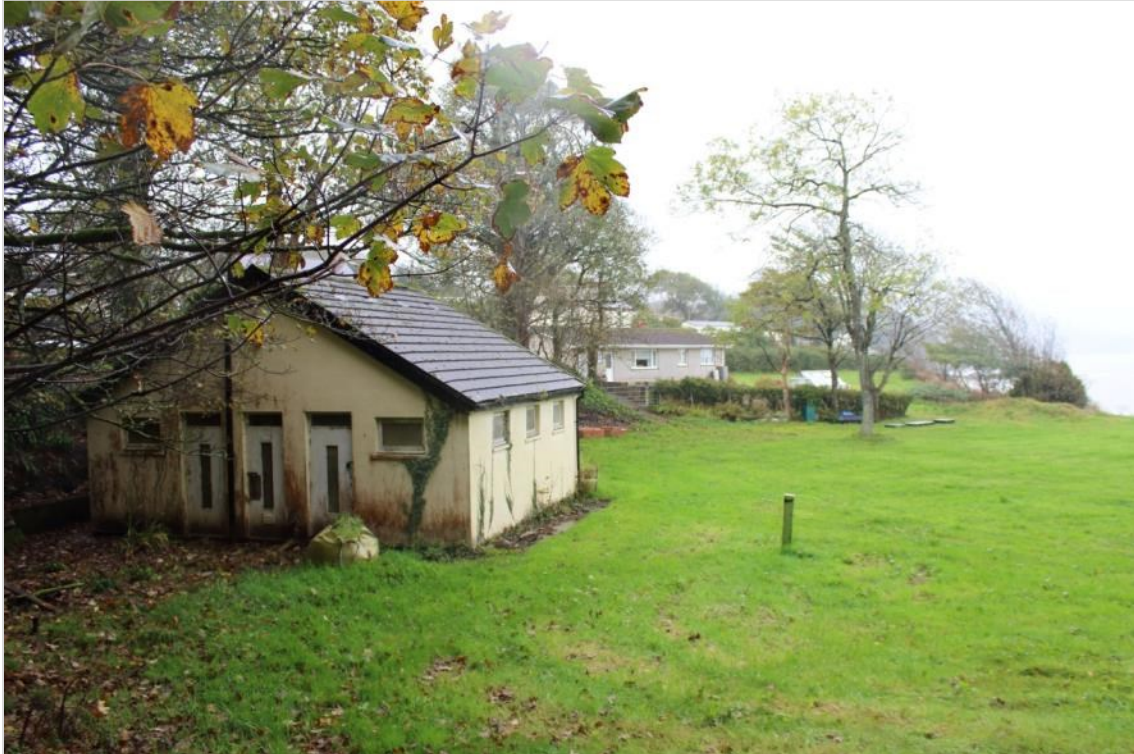
- 4.5.5 The former toilet block/caravan site facility building is situated parallel to the southern boundary of Devonshire Cottages and according to historic mapping, directly on the site of a former kiln (Photo 4). There are no indications of any above ground earthworks in this area. Situated only a few metres west of this redundant building is the eastern end of a modern culvert (Photo 5). This culvert truncates the central section of the development area along a northwest-southeast axis.

Photo 4: View facing north-east showing the caravan park building that is situated on the site of a former kiln (DAT Photo 111142_0012).

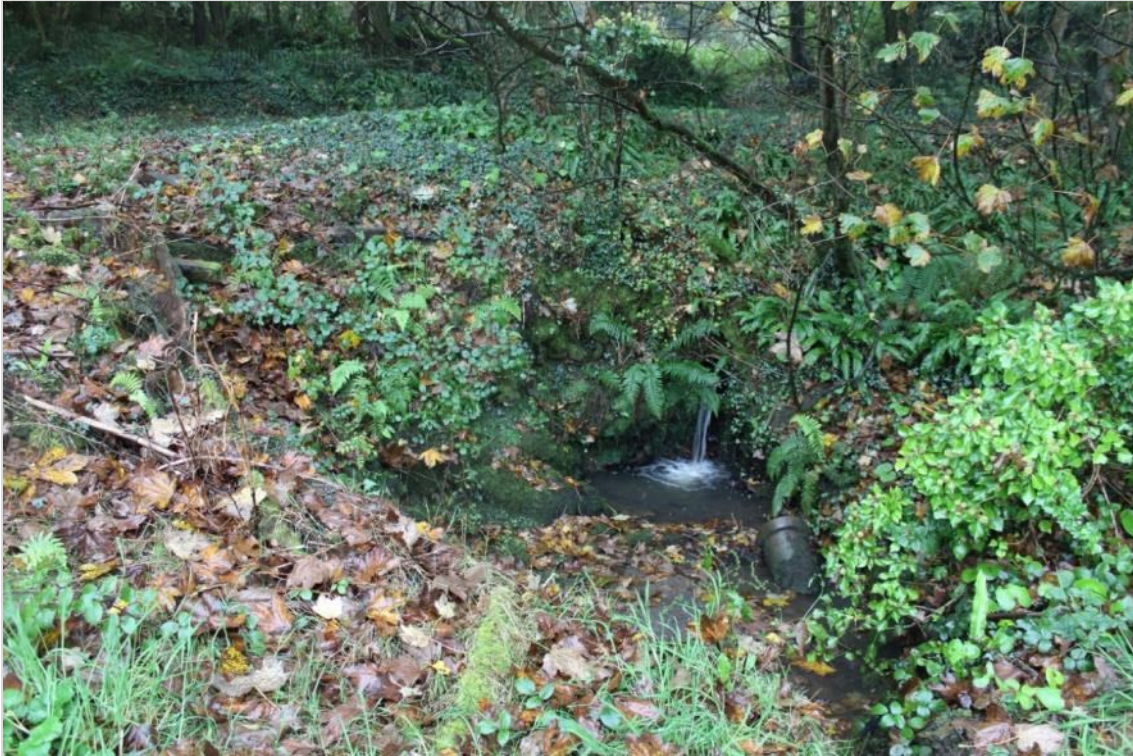
Photo 5: The eastern terminal end of a modern culvert which truncates the development area (DAT photo 111142_0015).

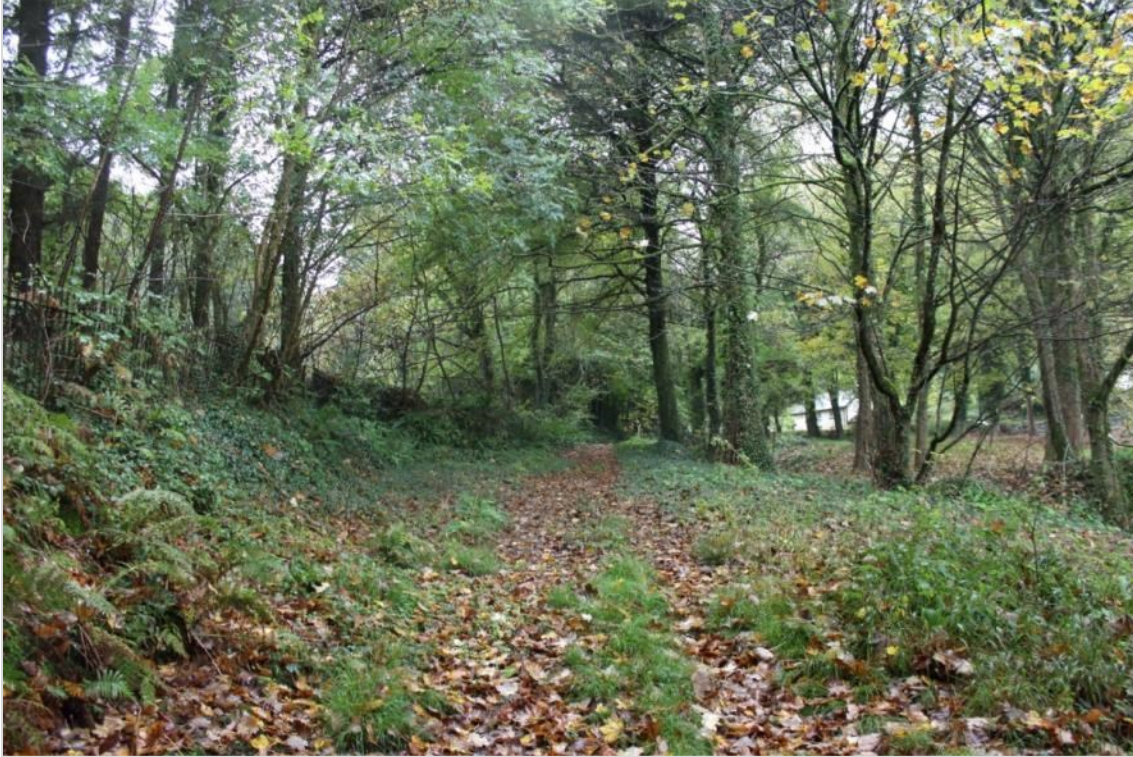
Photo 6: View facing west showing the lightly wooded central area and the former vehicle track joining the western and eastern areas of the development area. The remains of the estate fencing are just visible to the left of the photograph (DAT Photo 11142_0016).

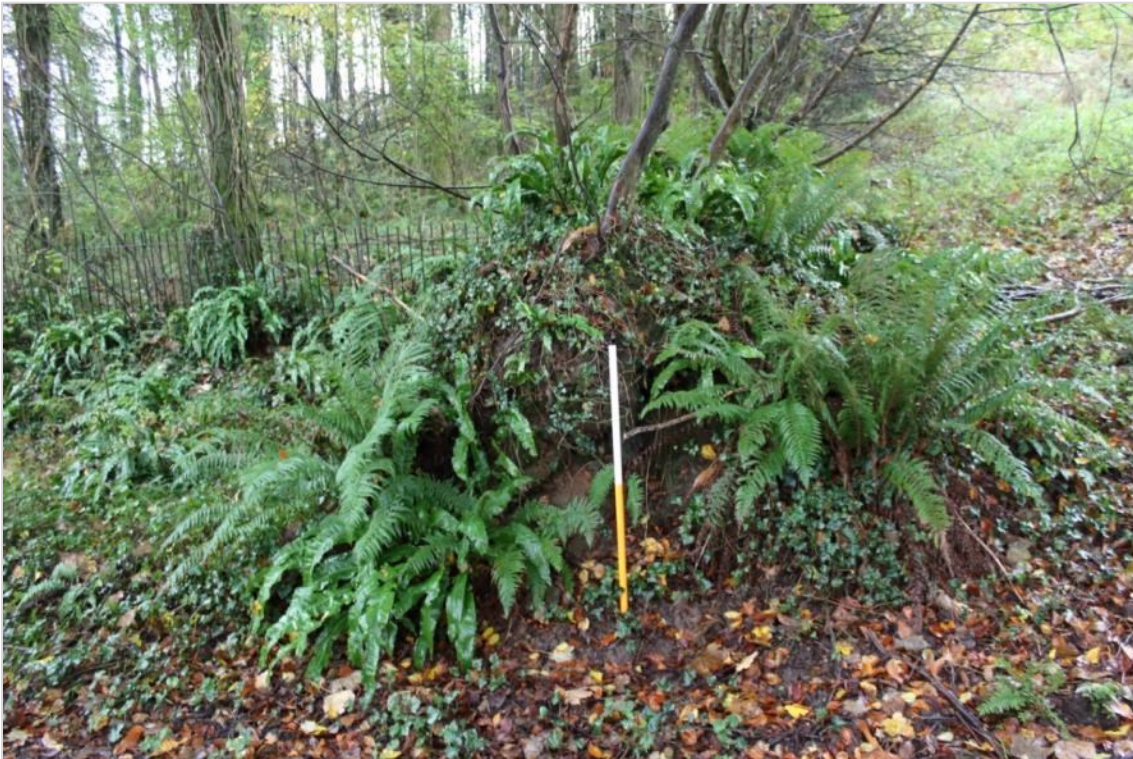
Photo 7: The truncated northern end of a former field boundary in the central section of the development area (DAT Photo 11142_0047).

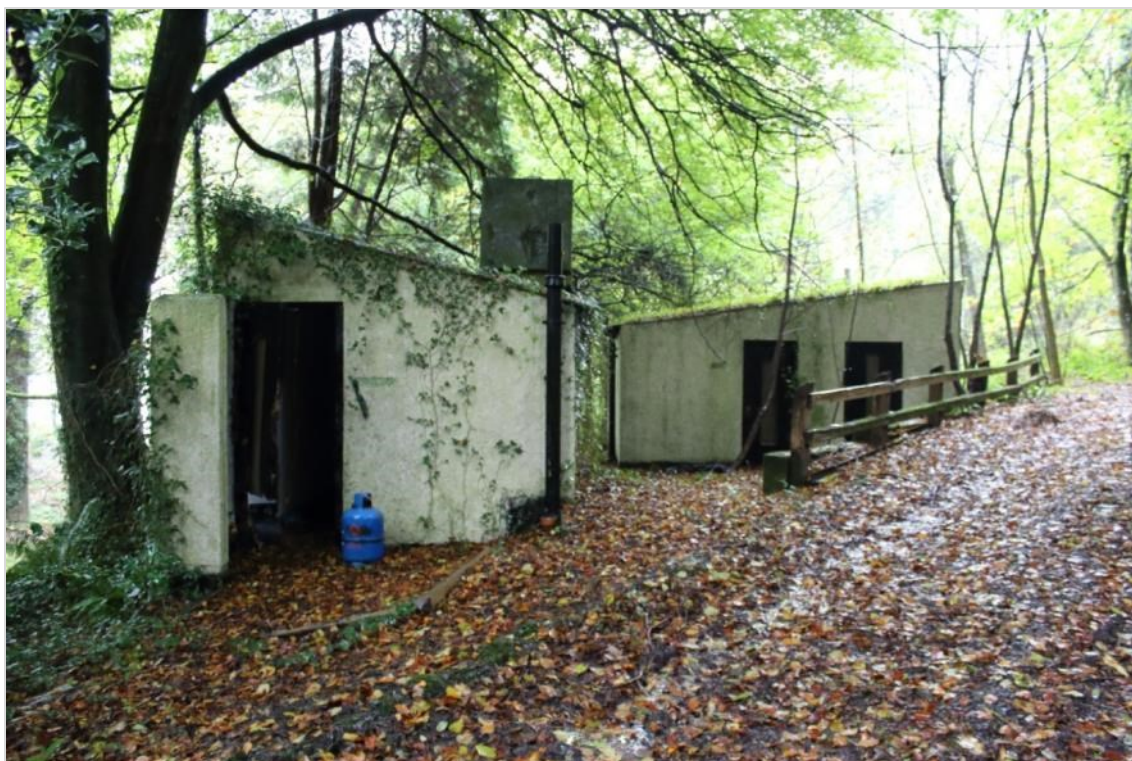
- 4.5.7 There was no suggestion of any above ground remains and the ground in this area was very soft under foot and undulating. There was evidence of recently dumped material in the north-eastern corner forming the boundary with Devonshire Cottages and the ground was highest in this area (Photos 8 & 9).
- 4.5.8 This central area of the site can be accessed via a road site gate situated opposite a detached property known as Woodside. From here a rough track winds southwards before curving westwards and continuing down the centre of the western section of the development area. A pair of redundant modern buildings associated with the former caravan park survive along the eastern side of this track (Photo 10).

Photo 10: The redundant buildings of the former caravan park still stand against the vehicle track in the western section of the development area (DAT Photo 111142_0024)

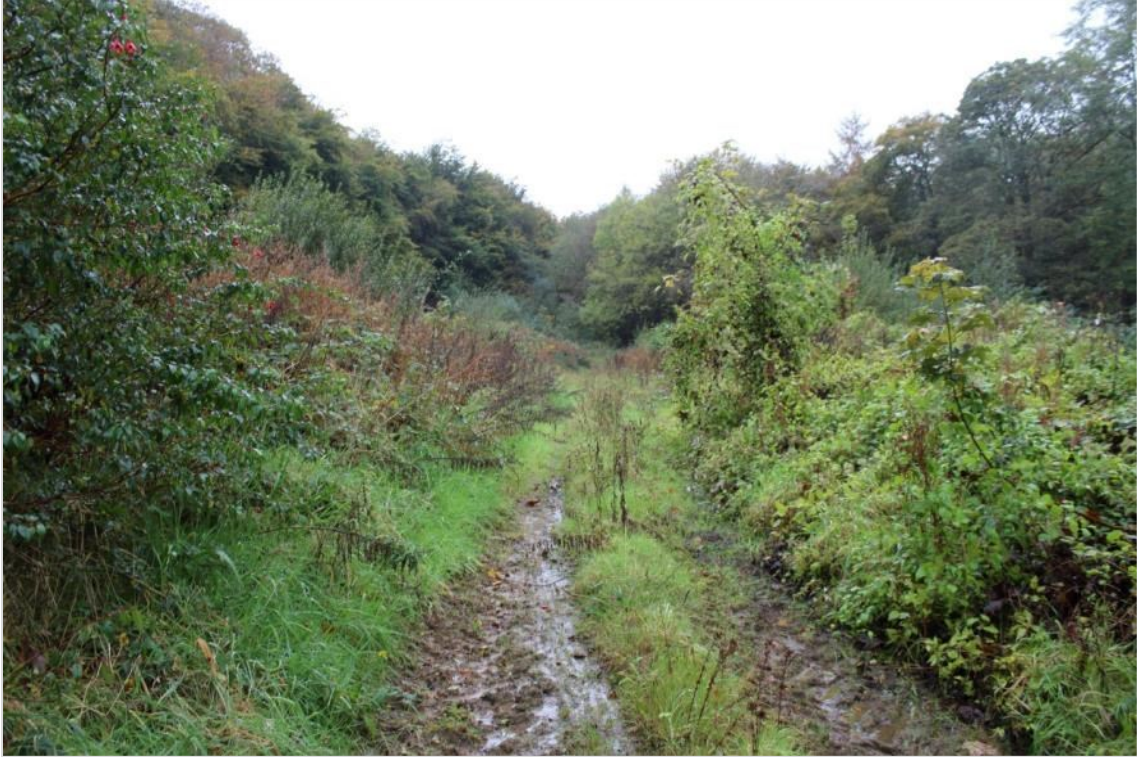
Photo 11: View looking westwards along the track in the densely overgrown western section of the development area (DAT Photo 111142_0025).

- 4.5.9 The western area comprises a large, roughly rhombic shaped area which narrows at its western end and is bordered by tall, mature trees on all sides. It is understood that the previous pitches for static caravans still remain within this area. However, the area was densely overgrown with a succession of shrubs to juvenile trees (Photo 11). A large volume of building demolition material has been dumped at the western end of the area (Photo 12).

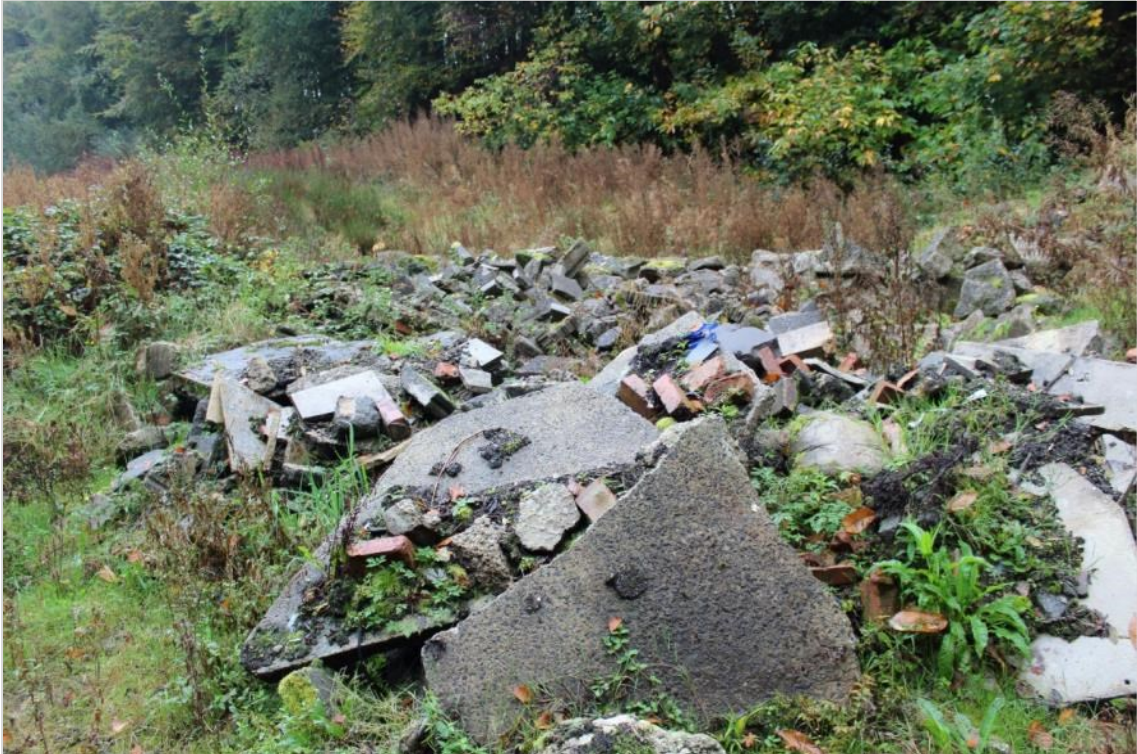
Photo 12: Recently dumped building demolition material at the end of the western section of the development area (DAT Photo 111142_0032)

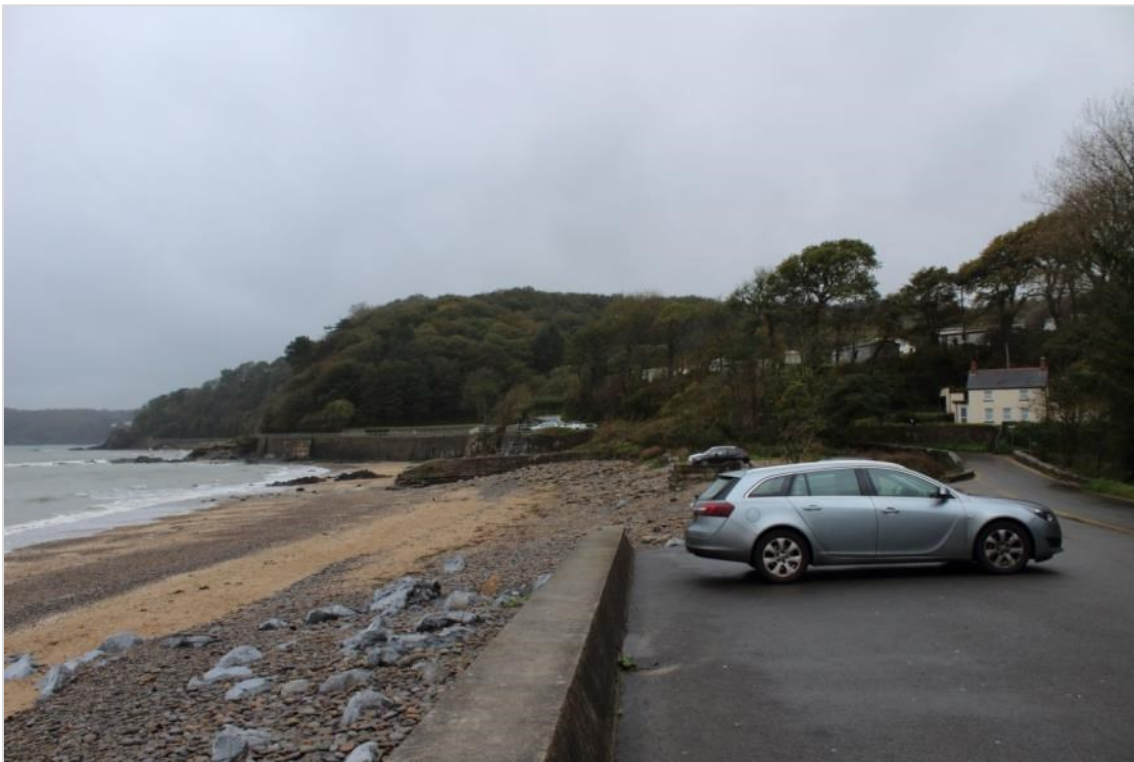
Photo 13: View facing southwest towards the development area from the public car park some 230m north-east from the site. The eastern section of the development area is just visible as a grassed area in the foreground of the woodland beyond (DAT Photo 111142_0049)

- 5.3.1 The proposed development is not situated within a registered Historic Landscape Area or any other designated area. The majority of the proposed caravan park will be obscured from view by dense woodland with only the eastern area, where it is proposed to site accommodation pods, visible from the incoming road into the village or indeed from the coastal foot path (Photo 13). However, the proposed layout for these pods shows the pods are somewhat set back from the edge of the site (Figure 2).
- 5.3.2 As previously described, the proposed development area is not situated within close proximity to any listed buildings or scheduled monument and none are inter-visible with the development area.
- 5.3.3 Overall, it is considered that the proposed development plans will cause minimal change to the outward appearance of the development area.
