# **MYRTLE HILL GUEST HOUSE, LLANSADWRN, CARMARTHENSHIRE: ARCHAEOLOGICAL WATCHING BRIEF (SN 6952 3159)**

RHIF YR ADRODDIAD / REPORT NO. 2017/73  
RHIF Y DIGWYDDIAD/ EVENT RECORD NO. 111195

## MYRTLE HILL GUEST HOUSE, LLANSADWRN, CARMARTHENSHIRE: ARCHAEOLOGICAL WATCHING BRIEF

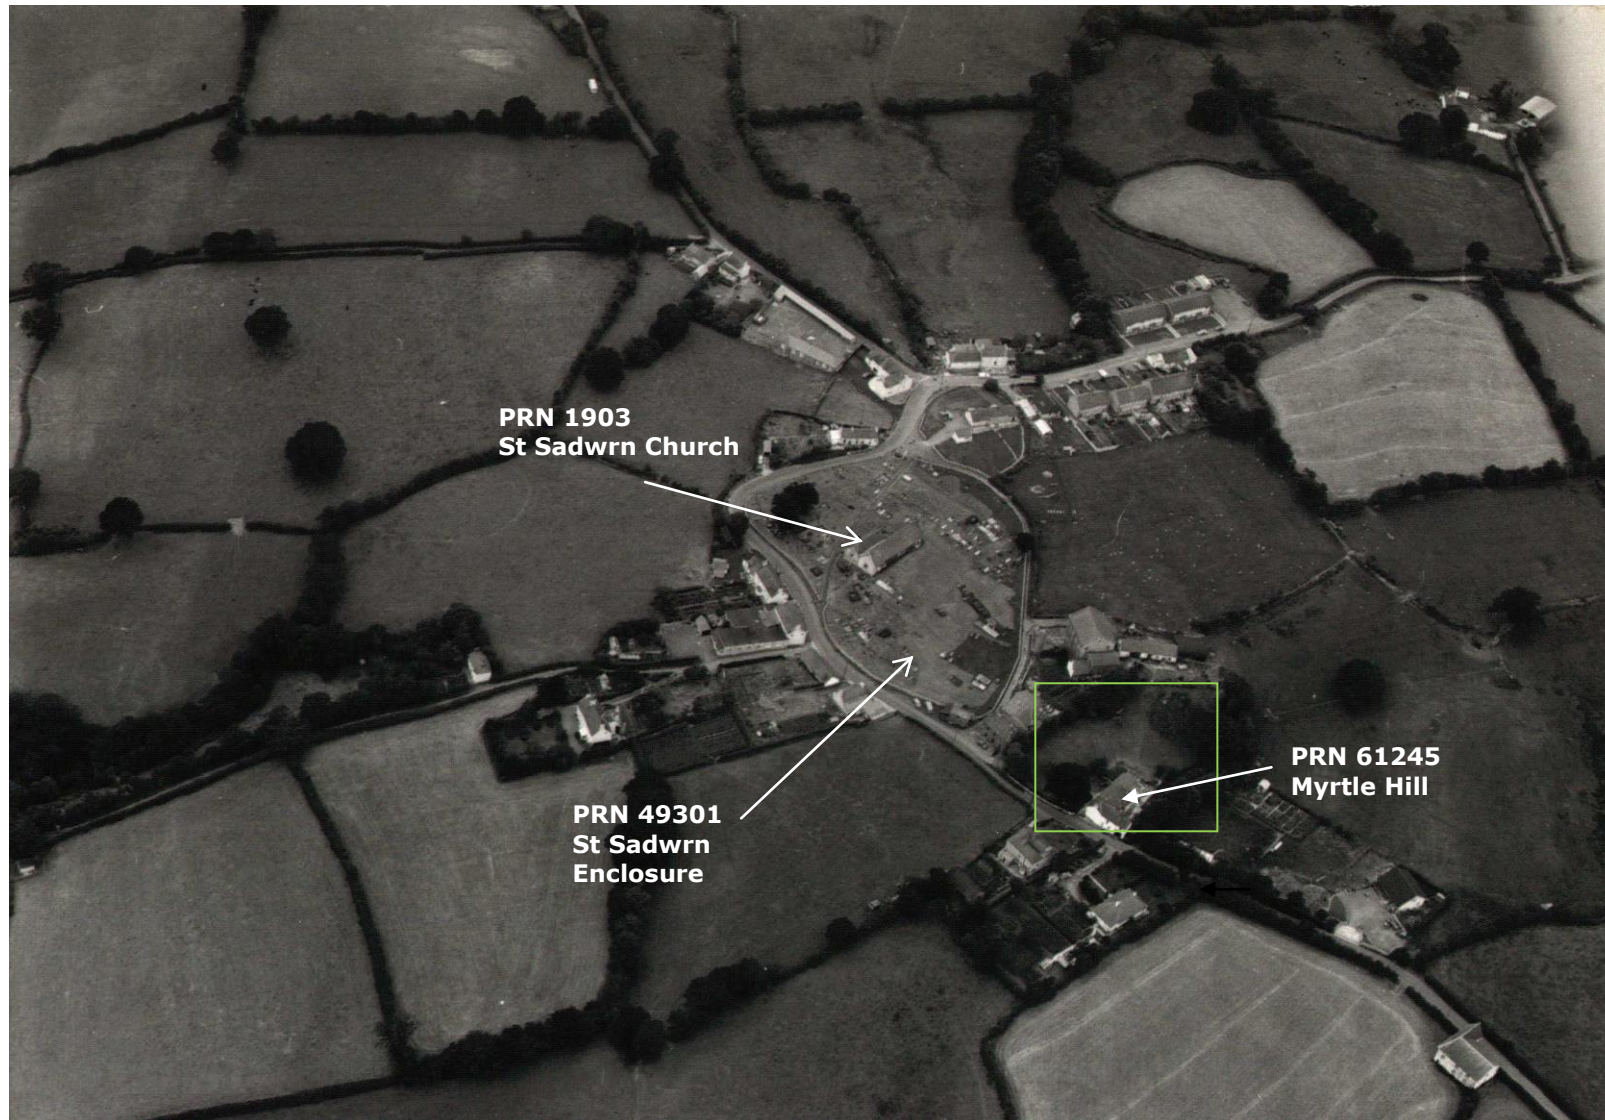
**Figure 3:** Oblique aerial photograph of Llansadwrn (© DAT). The proposed development area lies within the green rectangle.

- 2.2.1 The Dyfed Historic Environment Record (HER) records 4 archaeological sites lying within 100m of the centre of the development area. These sites include the medieval parish church of St Sadwrn (PRN 1903) and its associated churchyard enclosure (PRN 49301) (Figures 3 & 6). Nothing is known of the early history of the church, but the dedication to St Sadwrn, former knight and brother of St Illtyd, suggests a pre Anglo-Norman conquest foundation (which could potentially date from as early as the 6th century AD). It became a parish church in the 16<sup>th</sup> century.

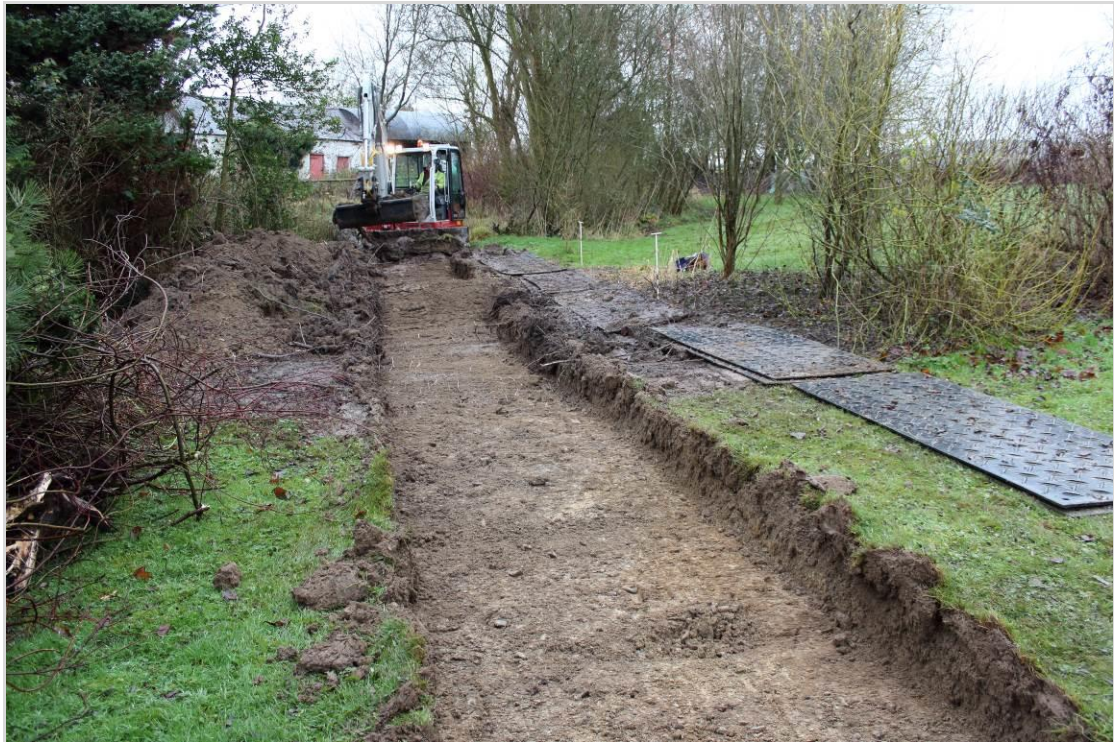
**Photo 1:** Looking west during the excavation of Trench 1.

- 4.3 **Trenches 1 & 2 (Figure 7)**
- 4.3.1 Trenches 1 and 2 were excavated along the length of the proposed new driveway. Trench 1 measured approximately 17.5m long (Photo1) and Trench 2 was roughly 20m long (Photo 2). The trenches were 1.6m wide; equal to one bucket width.

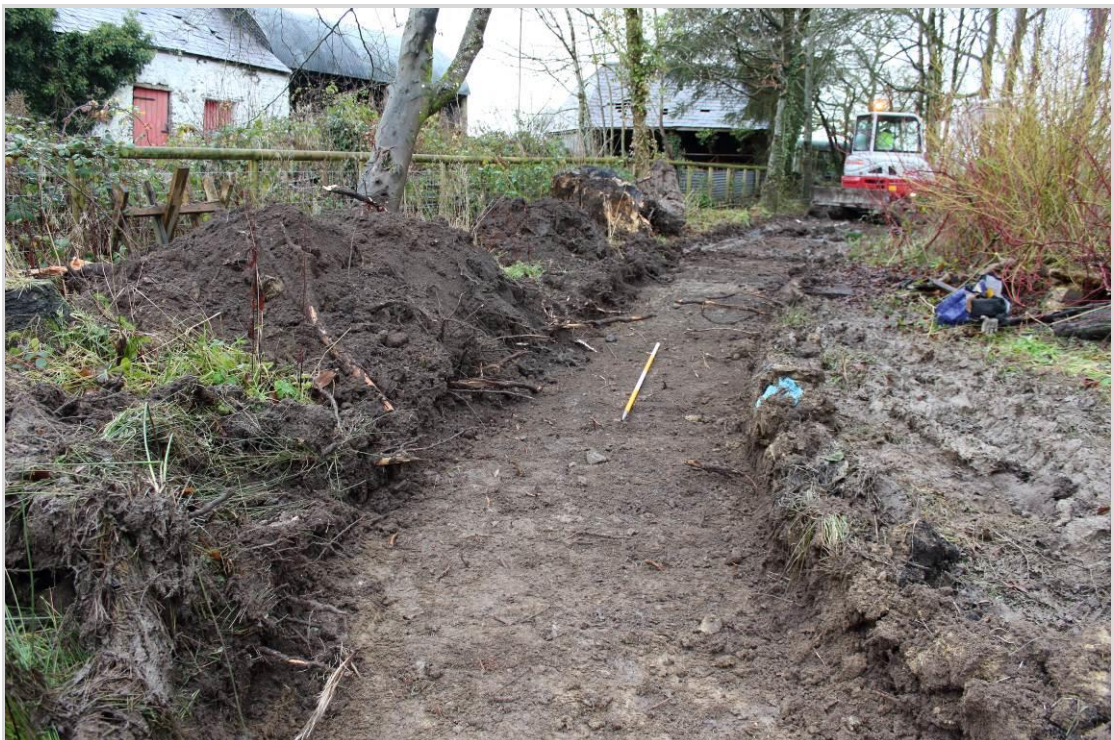
**Photo 2:** Looking roughly northwest at Trench 2 after completion of its excavation. 1m scale

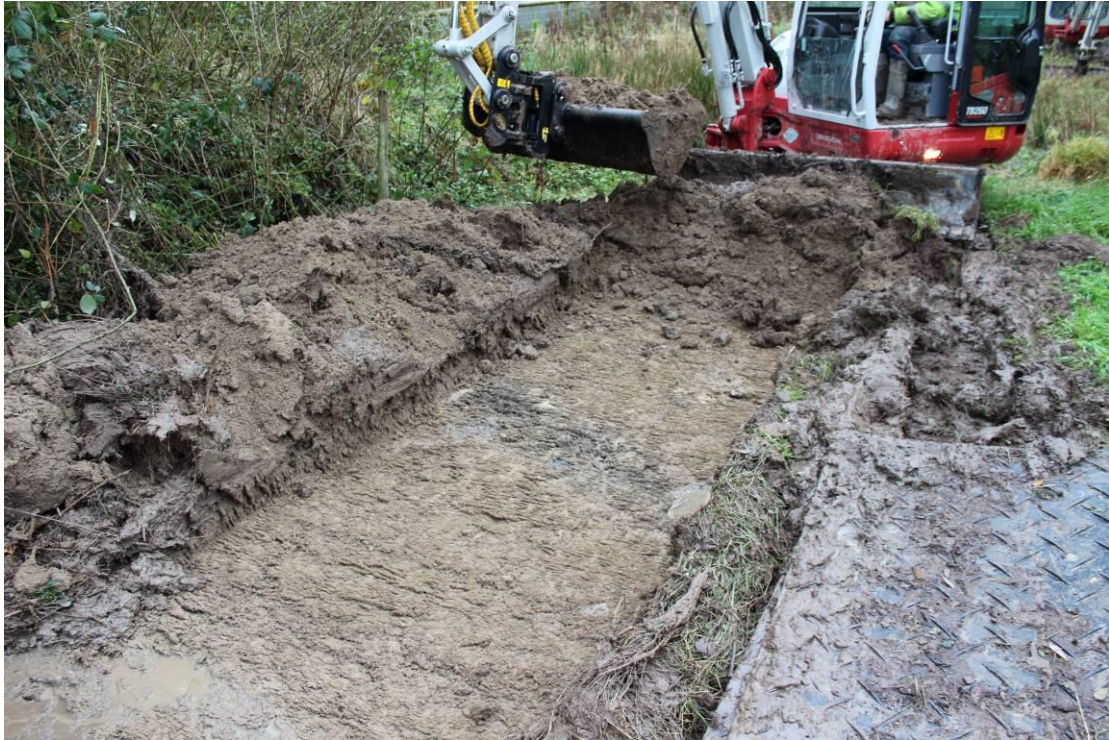
**Photo 3:** Looking roughly west at the western end of Trench 2 showing the narrow modern pipe trench running roughly north to south across the trench, visible as a darker strip of soil.

- 4.3.2 Approximately 0.30m of loamy topsoil was removed to underlying undisturbed clay subsoil. One modern pipe trench was recorded at the western end of Trench 1 (Photo 3). No further archaeological features or deposits were revealed during the course of the watching brief. No medieval or Roman finds were recovered during the groundworks within the development area and no waterlogged deposits were revealed within the depth of the ground works.

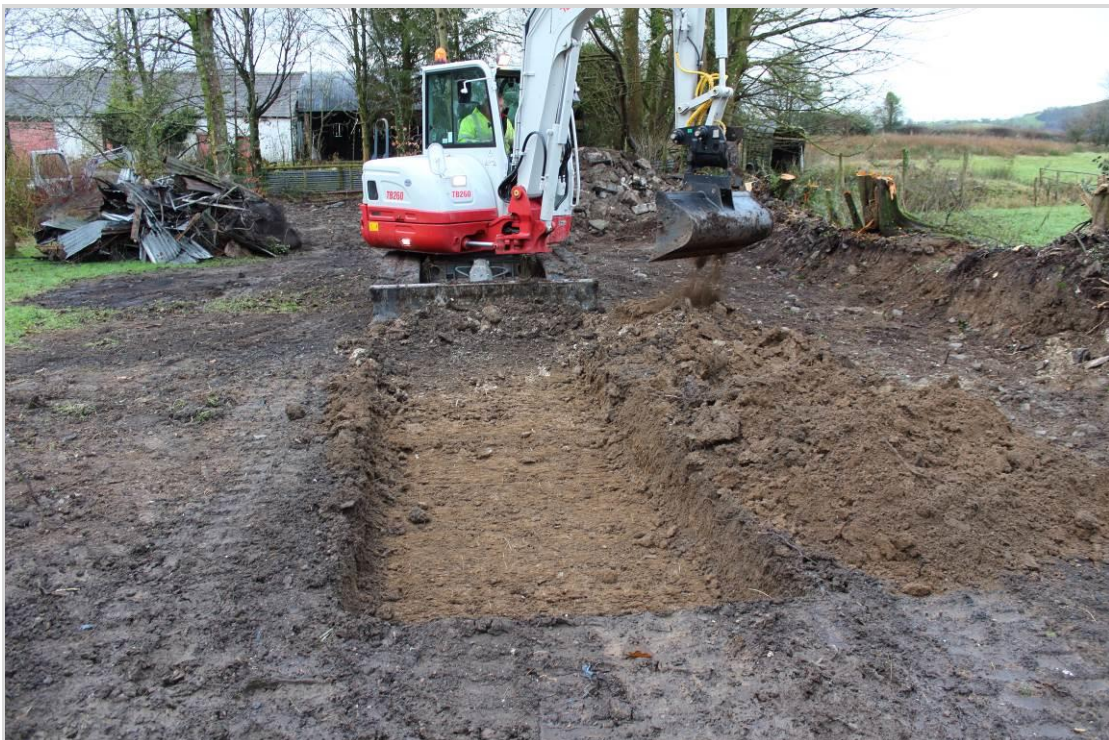
**Photo 4:** Excavation of Trench 3; looking southwest.

- 4.4.2 As with Trenches 1 and 2 roughly 0.30-0.35m of dark brown silty loam was machine excavated down to underlying compact lighter brown clay subsoil (Photos 4 & 5). As it was possible to identify archaeological features cut into this subsoil the machine excavation was halted at this depth.

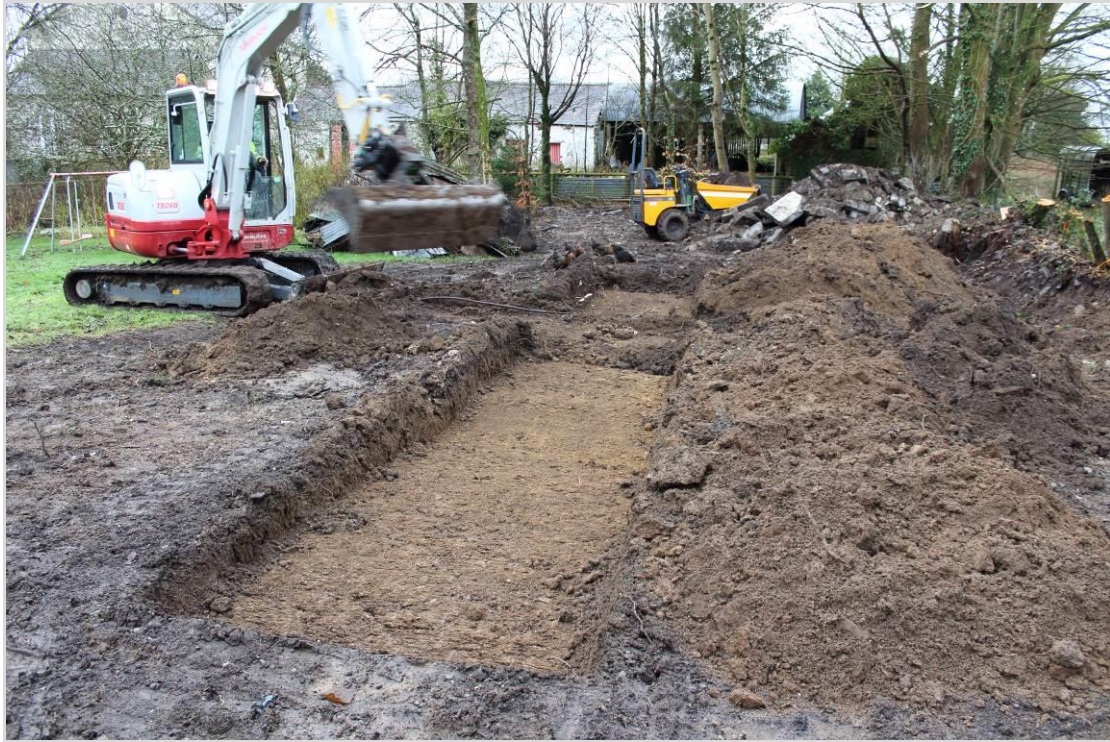
**Photo 5:** Excavation of Trench 3; looking southsouthwest

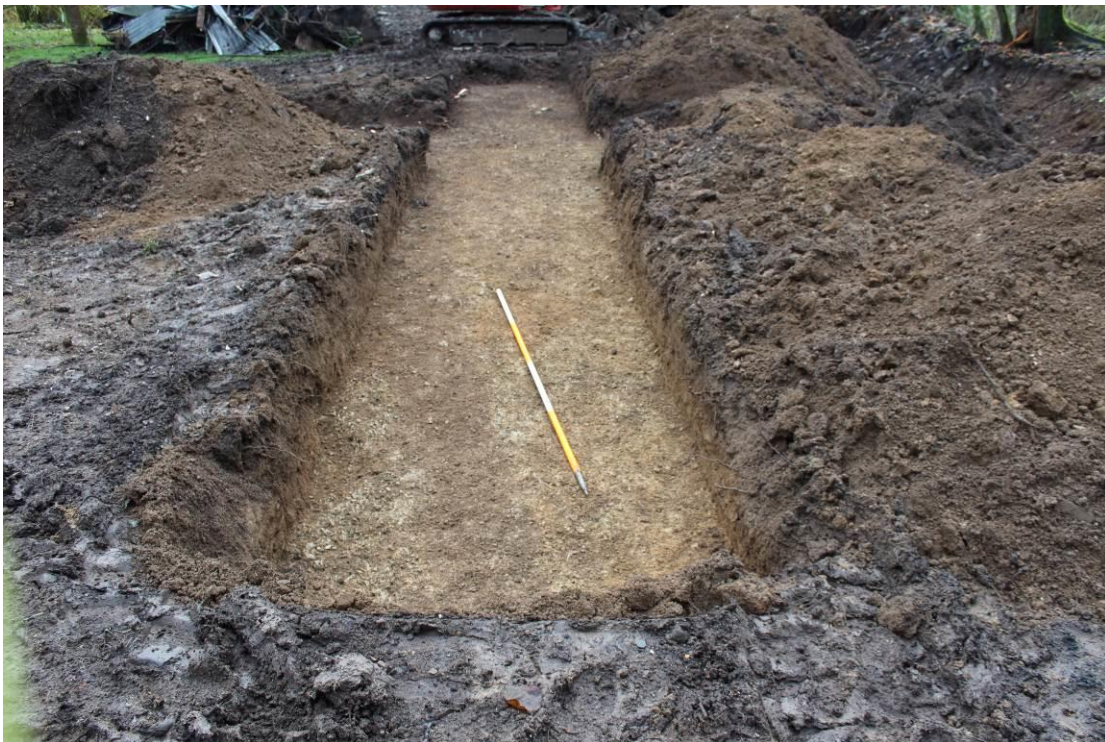
**Photo 6:** Unexcavated linear feature [A] running across the northeastern arm of Trench 3; looking southwest. 1m scale

- 4.4.4 Feature (A) was visible as a band of darker soil against the lighter subsoil (Photos 6 & 7) running in a NE-SW direction; somewhat parallel with the current northern fence boundary. In plan and section Feature (A) was broader at its SW end, as recorded in the trench, where it measured 0.80m wide and 0.24m deep (Photo 8). The cut had gently sloping sides to a flattened base and there was some evidence that it may have been recut at least once. At its NE end, as recorded in the trench, the feature was narrower and shallower at 0.37m wide and 0.10m deep. The fill of linear (A) was mid brown clayey silt containing infrequent stones and charcoal.

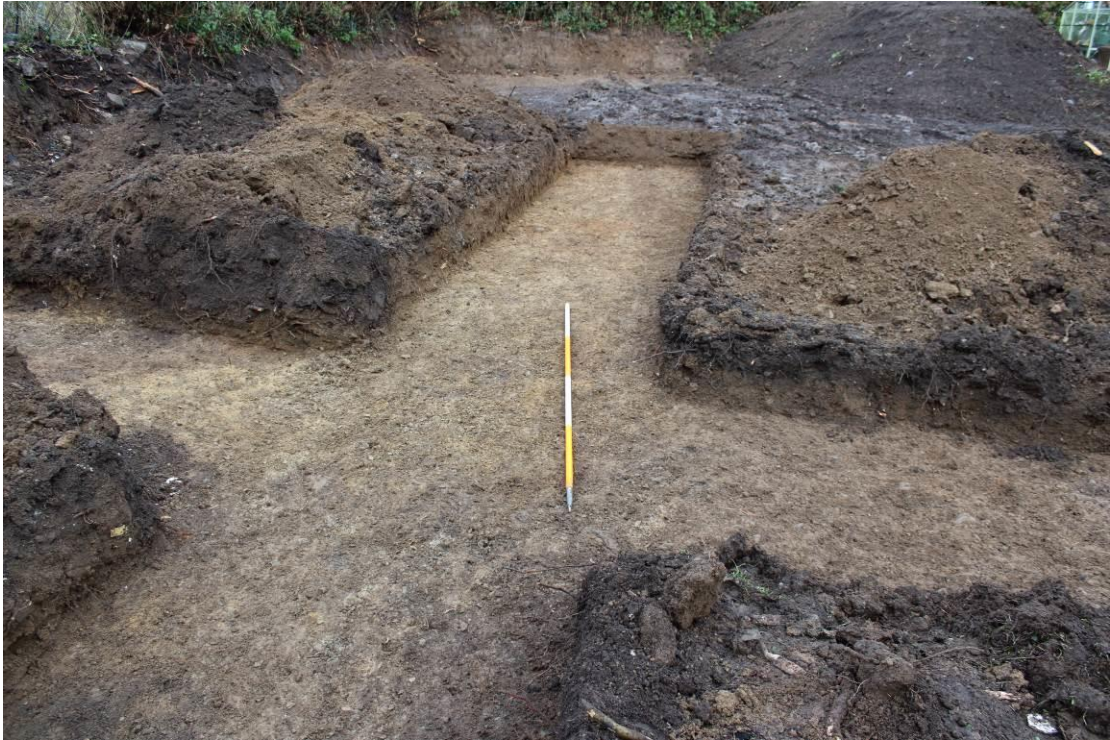
**Photo 7:** Looking approximately northeast at unexcavated linear feature [A].  
1m scale

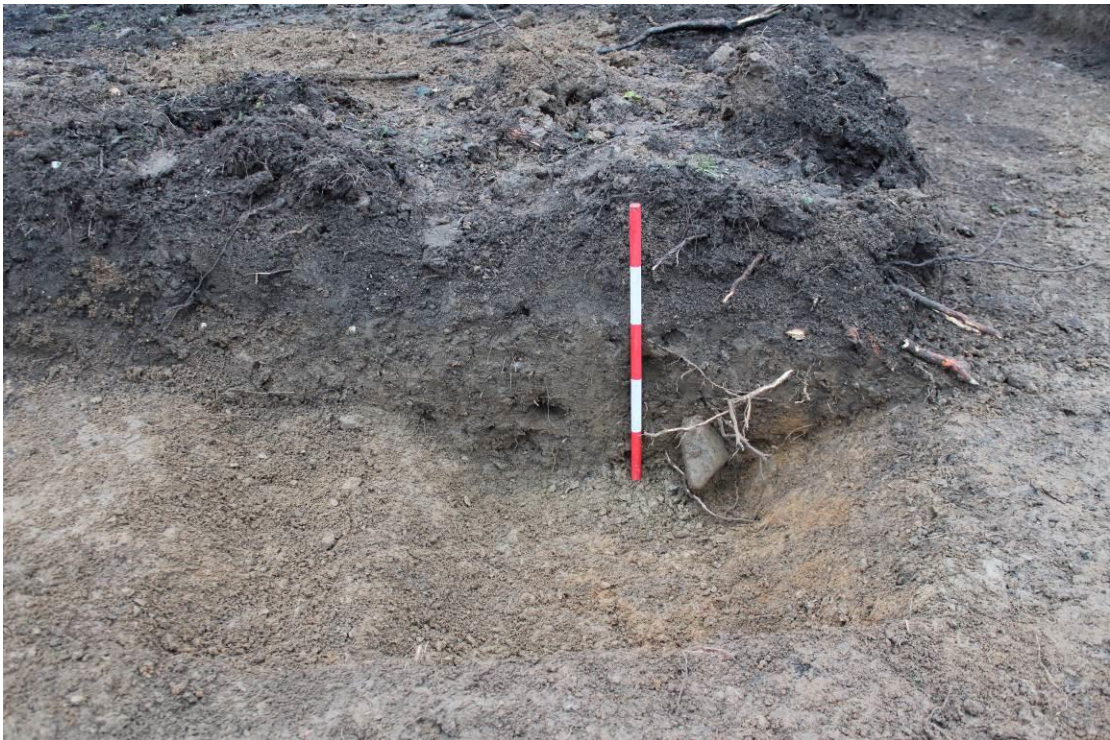
**Photo 8:** Northeast facing section through linear feature [A] showing evidence of possible recut to the left? 0.5m scale

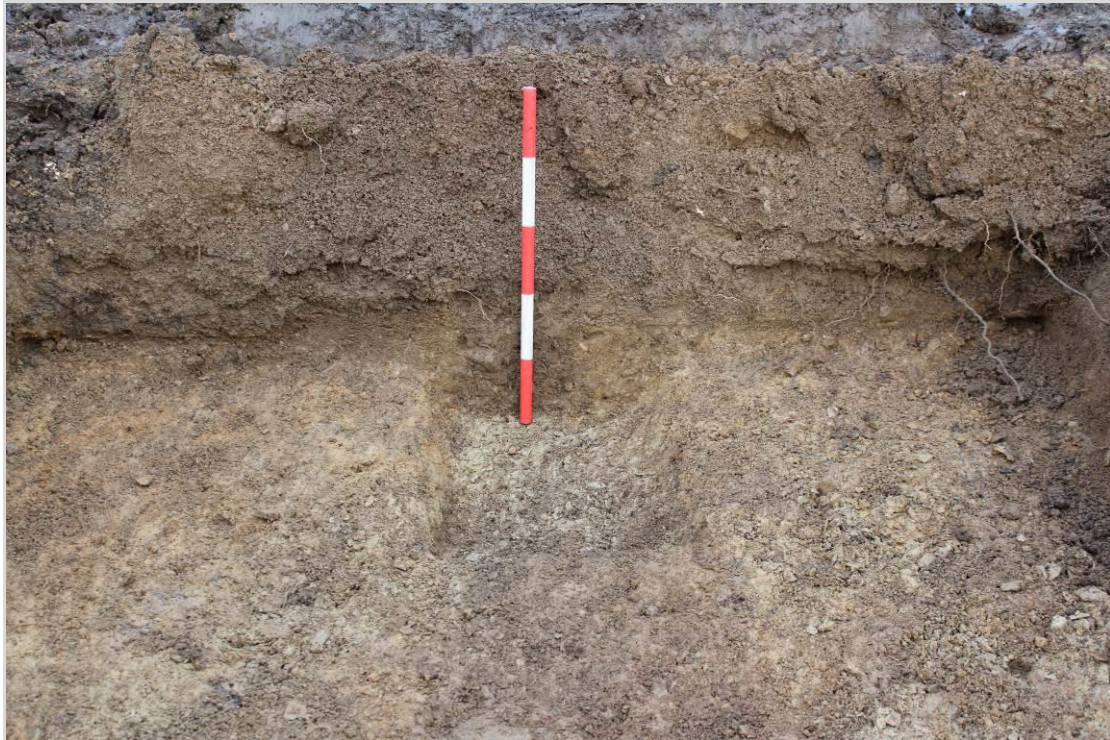
**Photo 9:** Southwest facing section through shallow linear feature or gully [A].  
0.5m scale

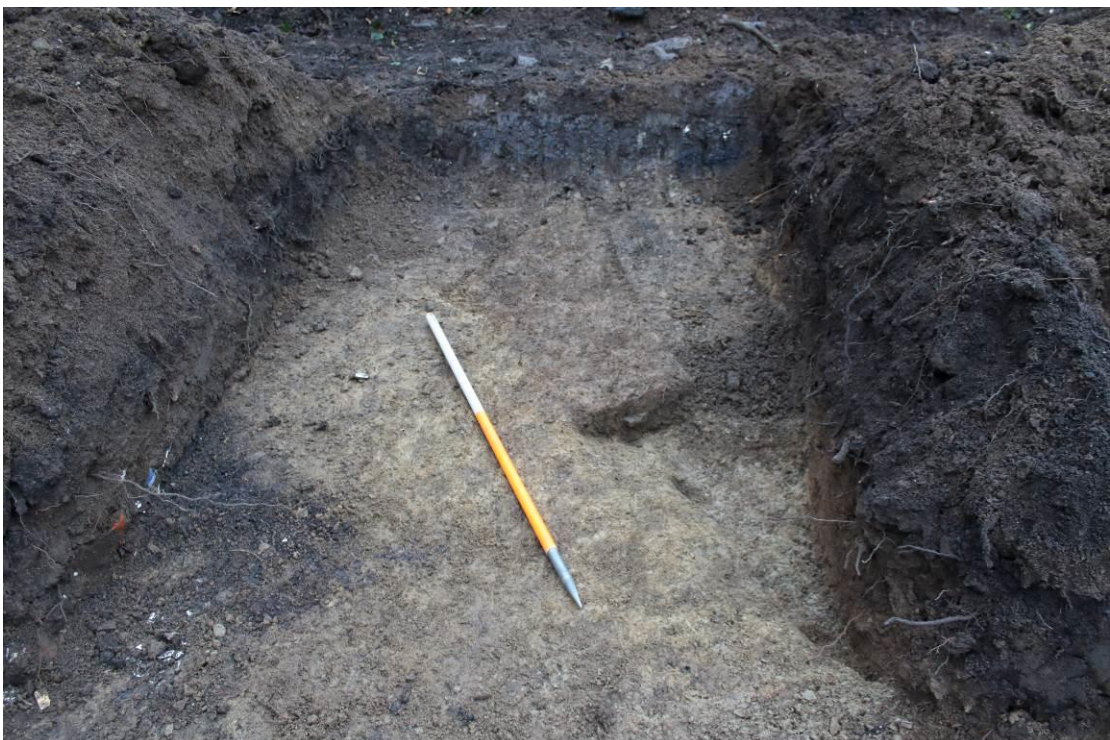
**Photo 10:** Looking roughly north at partially excavated curving gully feature [B].  
1m scale

- 4.4.5 Feature (B) was visible as an arc of darker soil in the NW arm of the cross-shaped trench (Figure 8, Photo 10). It proved to be a curving gully approximately 0.40m wide and 0.13m deep with a flattened U-shaped profile. The fill of curvilinear (B) was very similar to that of feature (A) being mid brown clayey silt containing some charcoal.
