**CARMARTHEN LIBRARY  
PROPOSED ARCHIVES BUILDING,  
CARMARTHEN:  
ARCHAEOLOGICAL  
WATCHING BRIEF  
(SN 4145 2026)**

Prepared by DAT Archaeological Services  
For: Carmarthenshire County Council

RHIF YR ADRODDIAD / REPORT NO. 2018/05  
RHIF Y DIGWYDDIAD/ EVENT RECORD NO. 111238

# CARMARTHEN LIBRARY PROPOSED ARCHIVES BUILDING, CARMARTHEN: ARCHAEOLOGICAL WATCHING BRIEF

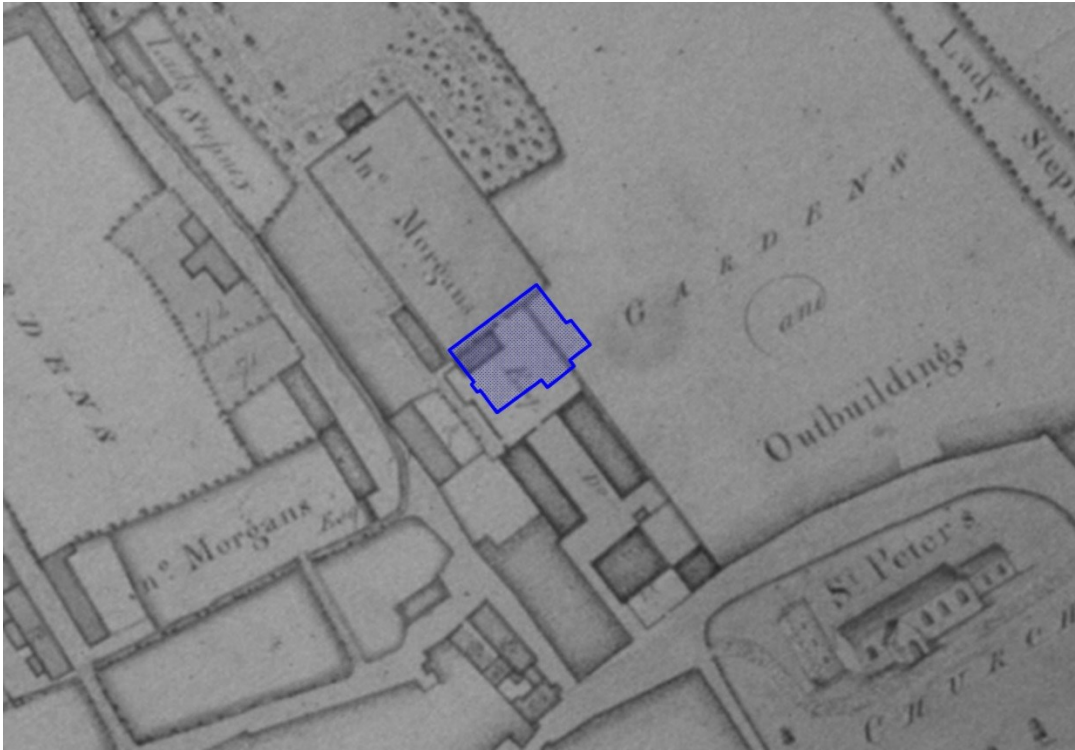
**Figure 4:** Extract of 1786 Golden Grove Estate Map showing approximate footprint of proposed Carmarthen Archives

- 3.8 The earliest map consulted was the 1786 Estate map of Carmarthen (Figure 4). This shows that the proposed location of the archives store was mostly undeveloped at this time, forming part of the area of gardens to the north of Furnace House. A structure lies within the northwestern part of the development site and a garden plot boundary runs through the eastern side.

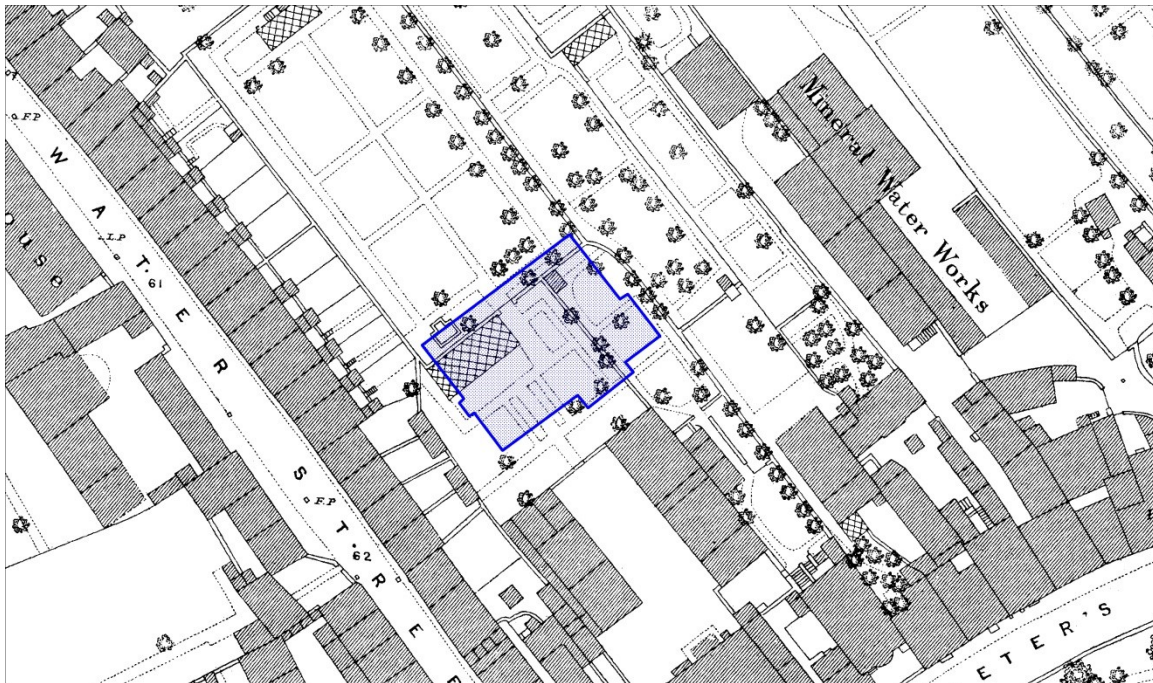
**Figure 6:** Extract of 1888 1:500 Ordnance Survey Map with approximate footprint of proposed Carmarthen Archives building overlaid

- 3.10 The 1888 1:500 scale Ordnance Survey map (Figure 6) shows a more accurate representation of structures on King Street, including Furnace House, adjacent structures no longer present and a formalised garden layout to the north. This covers the area of the proposed archive store and includes a structure shown as a cross hatch, which would indicate a glass house within the northwestern part of the site area. It is possible that this is the same structure as shown on the 1786 and Woods map of 1834, although this could not be confirmed.

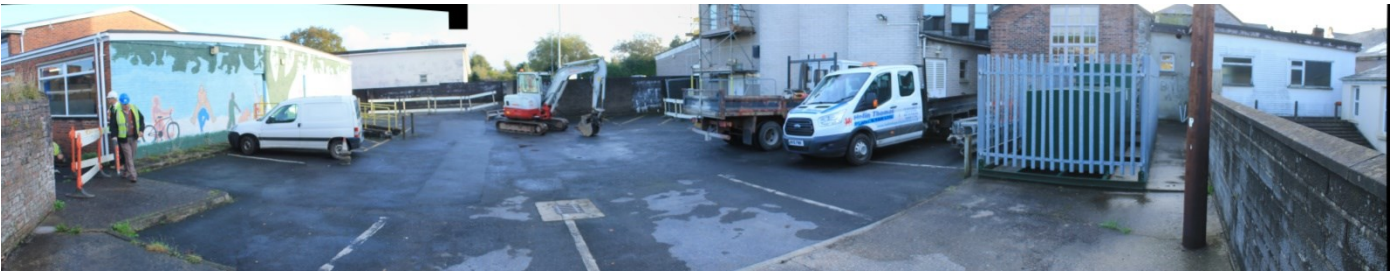
**Photo 1:** Panoramic view east across the proposed footprint of the Carmarthen Archives building with the (Community Centre to left and oil tank visible to right)

- 5.1.1 An archaeological watching brief was maintained during the excavation of two small geotechnical test pits within the footprint of the proposed archive building (Figure 7). On arrival the area was seen to comprise a roughly level car park area free of buildings (Photo 1). The ground level was relatively similar to that of St Peter's Car park, and mostly level across the site with perhaps a small dip in the centre of the car park area. A number of service trenches could be seen within the car park surface, including drains and other marks in the tarmac implying other buried services. An oil tank was present in the southwestern corner of the car park area. A small walled enclosure was present on the eastern side of the area adjacent to the car park. A raised kerb and footpath ran along the western edge of the site between the Community Centre and the retaining wall to the properties on Little Water Street.

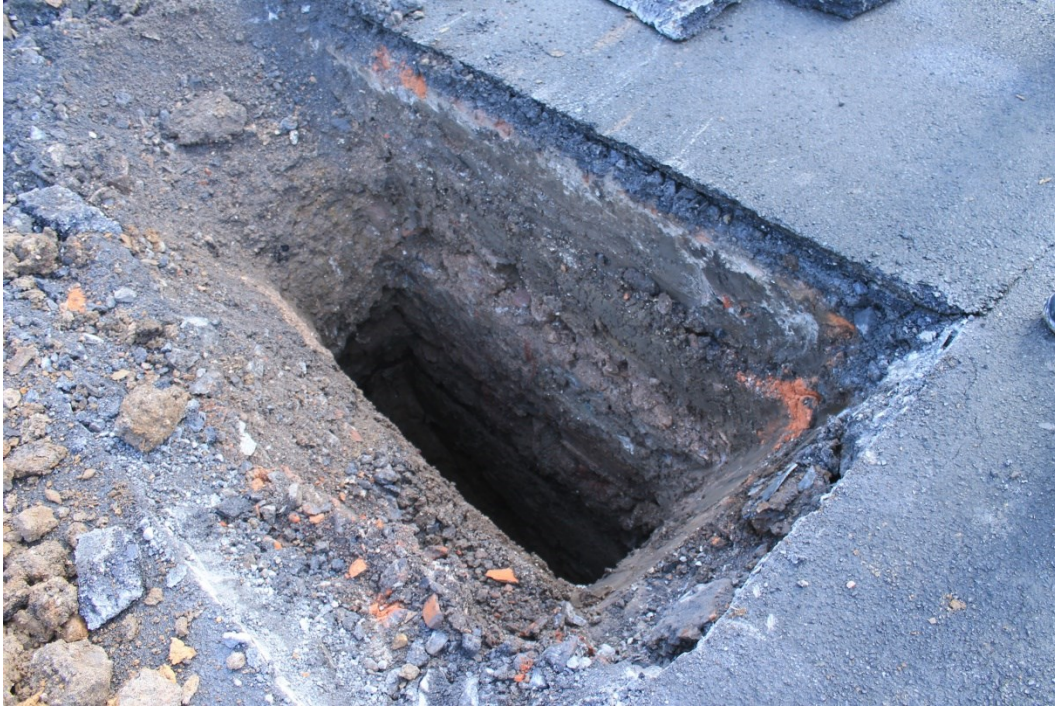
**Photo 2:** Test Pit 1 after excavation

- 5.1.2 The first test pit was excavated roughly in the northwestern corner of the proposed archive building, aligned northeast to southwest. An area of around 5m x 2m was cleared of tarmac to expose the underlying ground surface through which a 0.60m wide toothless bucket was used to excavate down into the underlying strata, the base of the trench measuring roughly 0.6m x 1m in size (Photo 2). The second test pit was located on the eastern side of the car park area, on a similar alignment, adjacent to the small brick walled enclosure in the southeastern corner of the plot for the proposed Archive building.
- 5.1.3 It was not possible to access the test pits as they were too narrow and deep, but measurements were made of the layers machined through (Photos 2 - 5; Tables 2 & 3). An assessment of their archaeological potential was made.

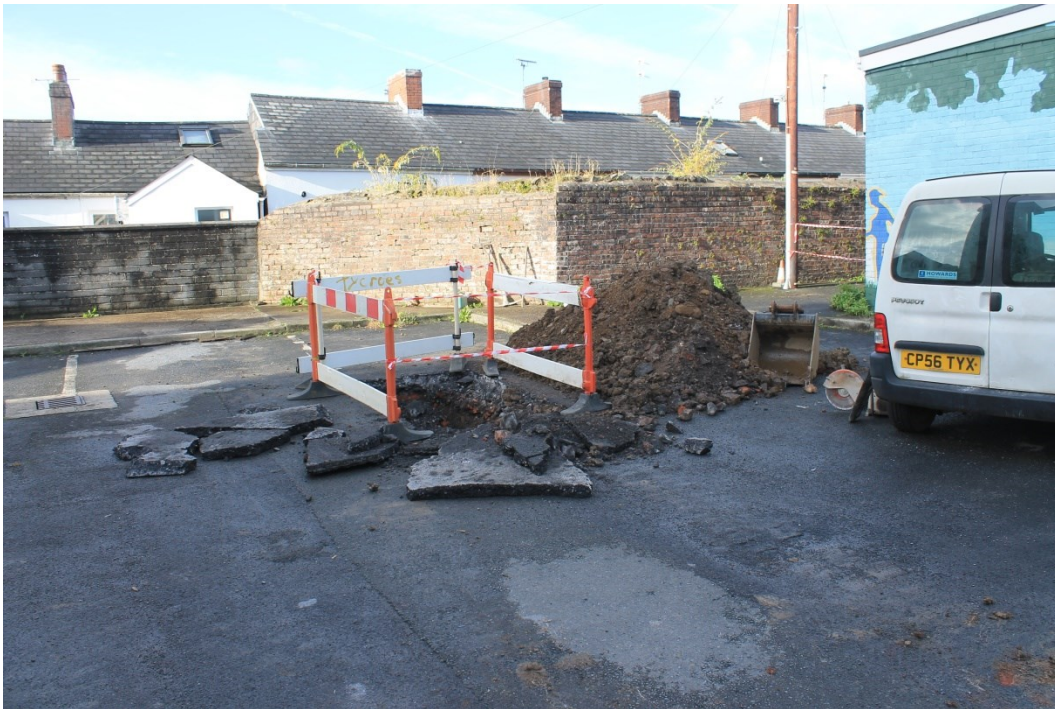
**Photo 3:** General view showing location of Test Pit 1, viewing northwest

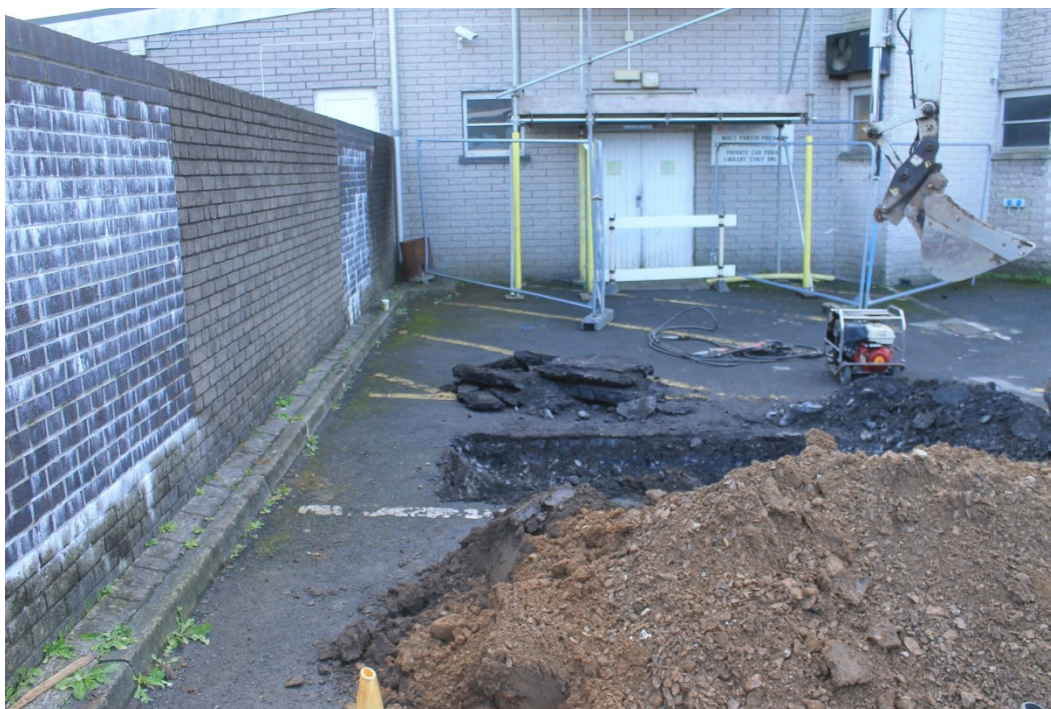
**Photo 5:** General view showing location of Test Pit 2, viewing south towards rear of 1970s library building, with walled enclosure to left

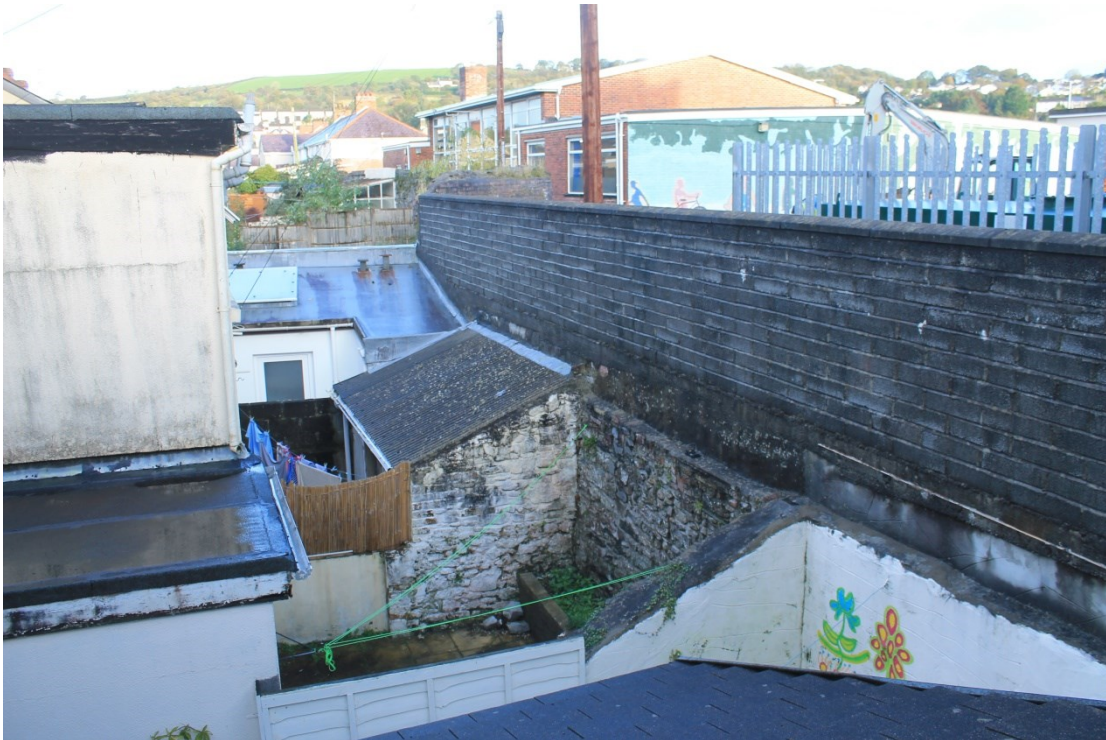
- 5.1.4 During the test pitting it was also possible to view the difference in ground levels between the rear of the properties fronting Water Street and the boundary wall to the library (Photo 6). As noted above, the difference in ground level is around 2m. There is a stone revetment wall at the bottom, which changes to a modern brick wall roughly at the ground level height for the rear of the library.

**Photo 6:** View roughly north across the rears of the properties fronting Water Street towards Community Centre showing the difference in ground levels

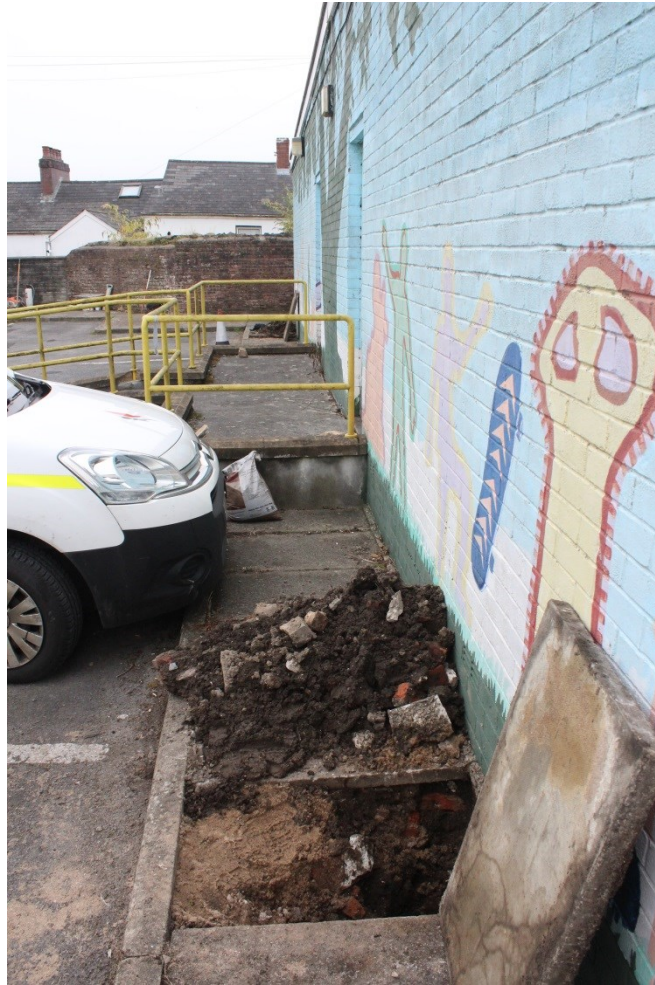
**Photo 7:** View southwest across test pits on southeastern wall of Community Centre

- 5.2.1 The two test pits hand excavated against the Community Centre and the two against the Library all indicated foundation depths of over 1.2m, with the pits themselves being excavated through backfill of the foundation trenches so no earlier archaeology was present (Photos 7 and 8). These had been excavated prior to the archaeologist attending the site, as had been agreed with the client.

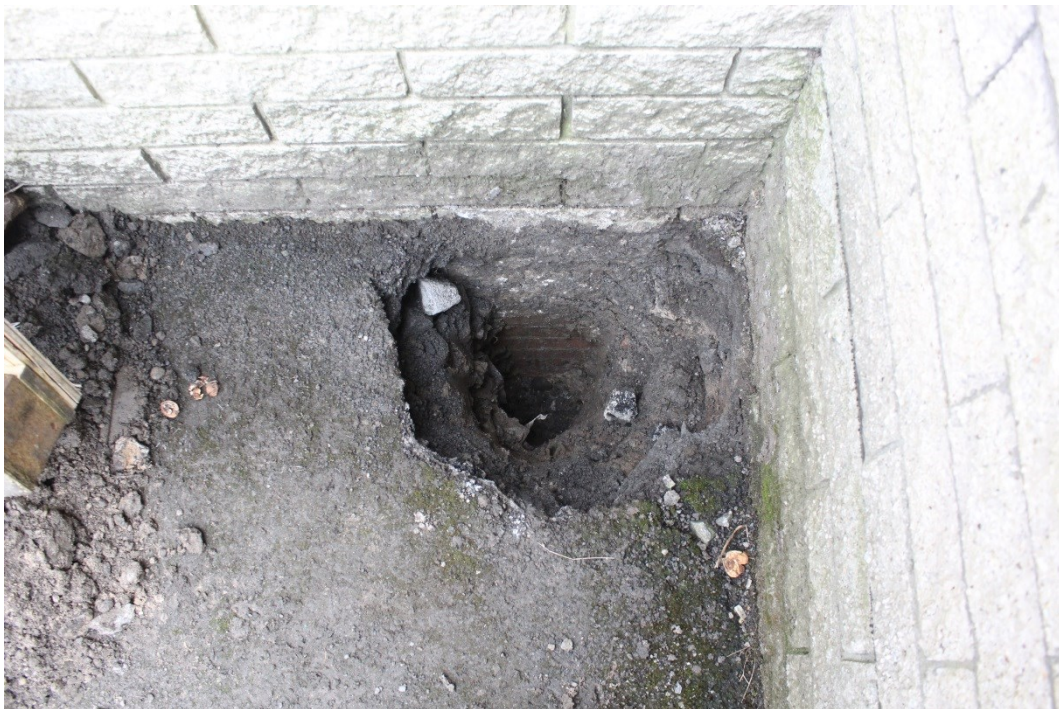
**Photo 8:** hand excavated test pit against north wall of Carmarthen Library

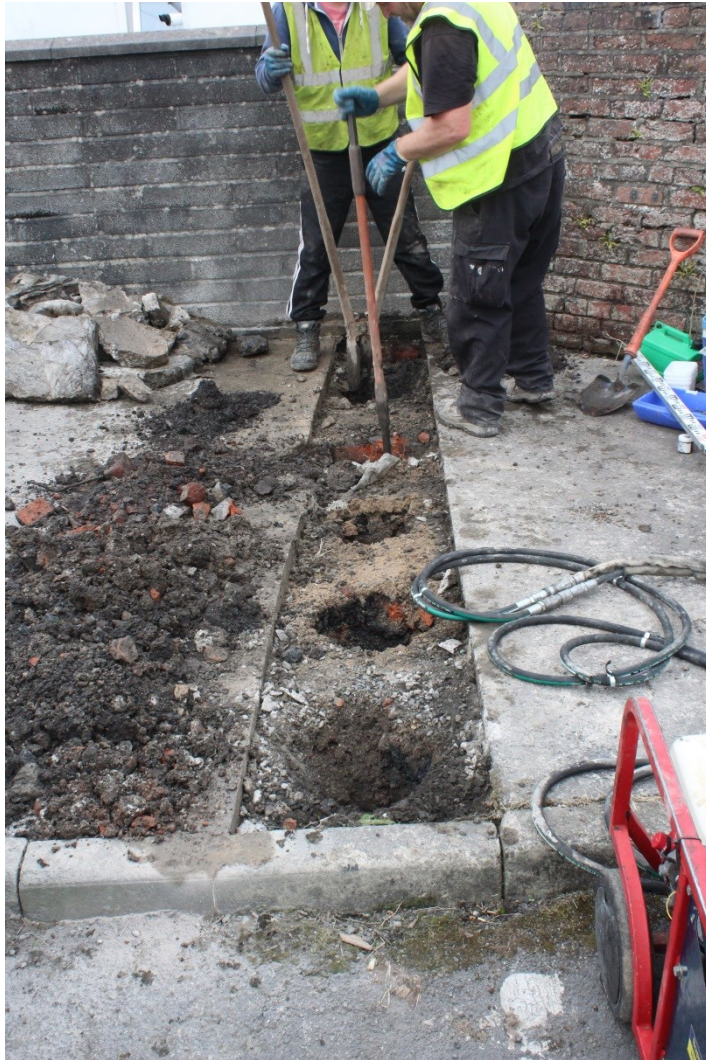
- 5.2.3 The northern trench (Photo 9) ran roughly southwest to northeast from the point where there was a kink in the retaining wall to the edge of the kerbed area. The southern trench was located some 4.5m to the southeast on the same alignment, dug from the retaining wall to the edge of the kerbed area (Photo 10).

**Photo 9:** Excavation of northern trench  
for percussive sampling

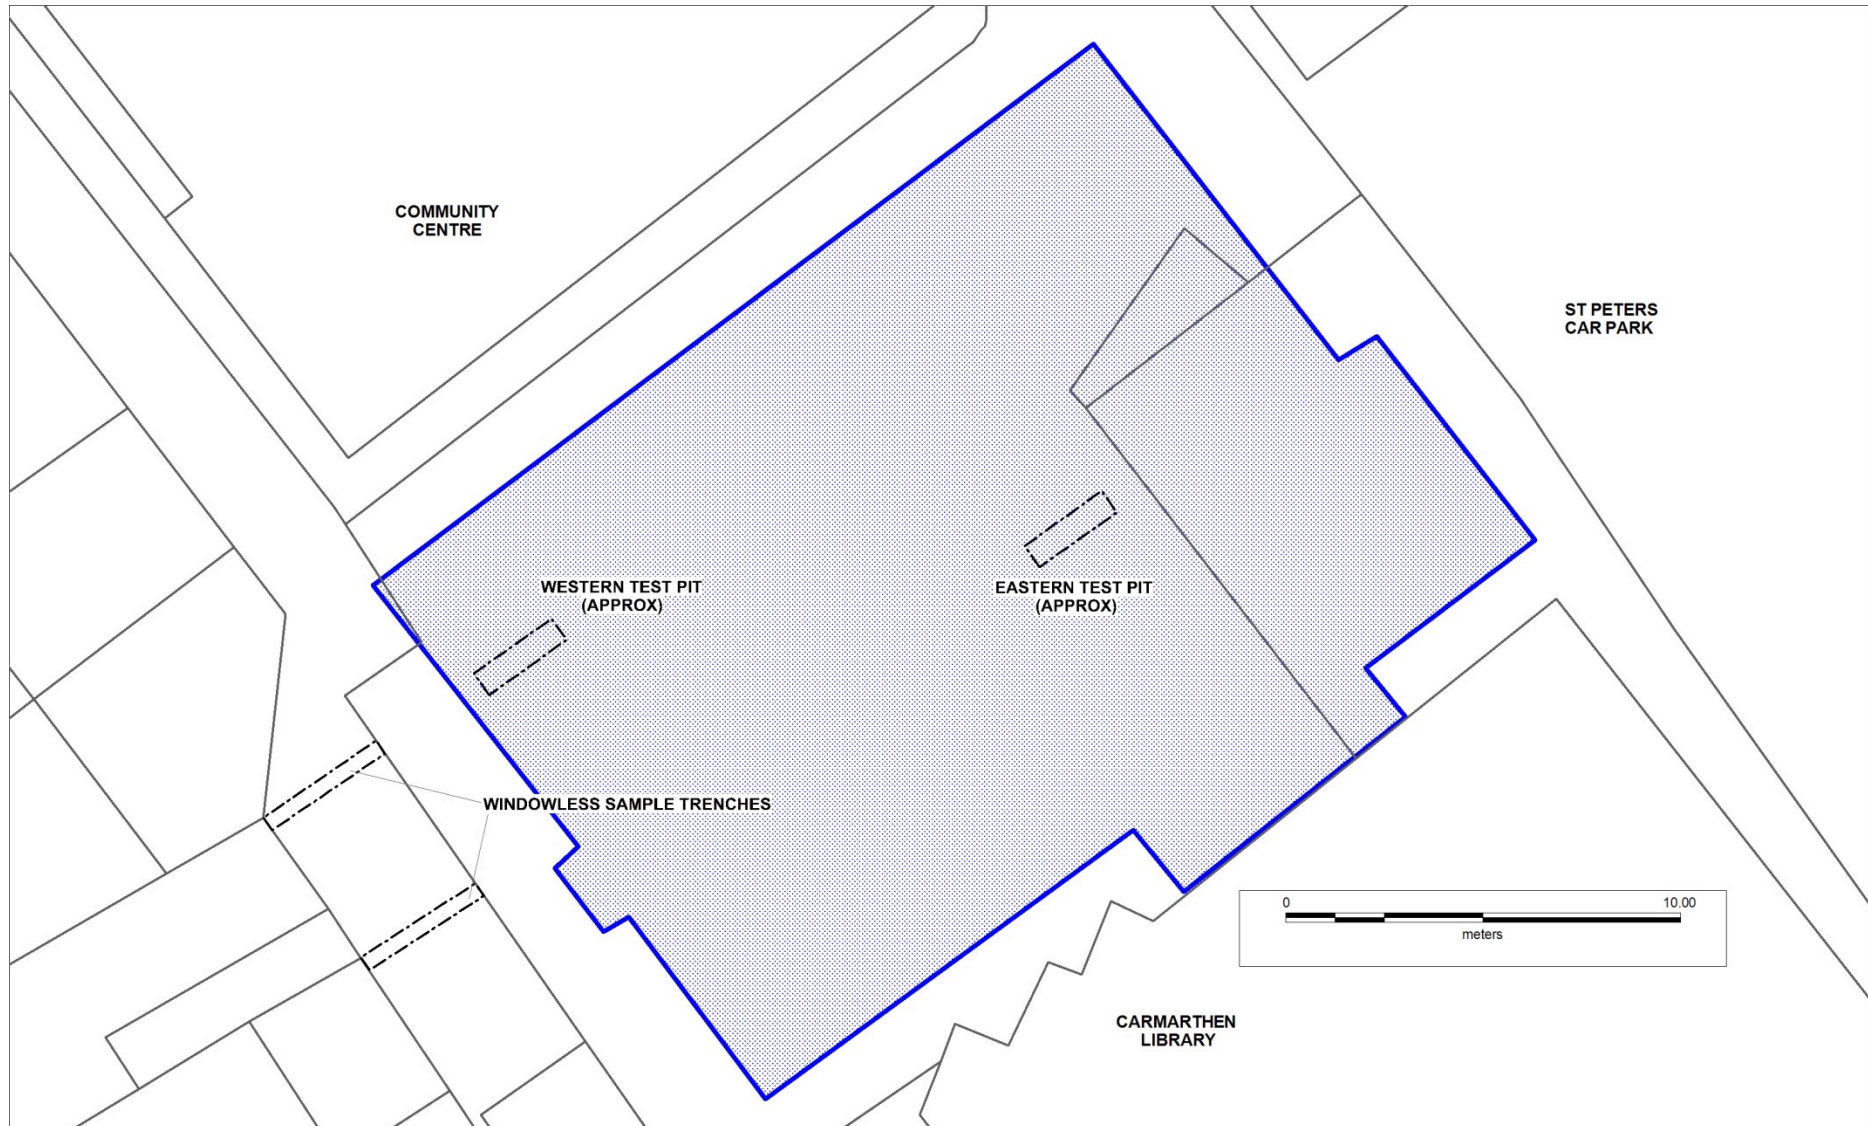
- 5.2.2 Two hand excavated trenches were opened against the retaining wall to the properties on Little Water Street (Figure 7). These ran perpendicular to the wall covering the width of the kerbed area and were excavated initially as a roughly 3.5m long trench some 0.40m in width and around 0.30m depth. The locations of the 5 proposed percussive sampling points in each trench were then excavated to a total depth of around 0.90m using a post-hole digging tool (Photo 9).

**Figure 7:** Location of test pits and windowless sample trenches

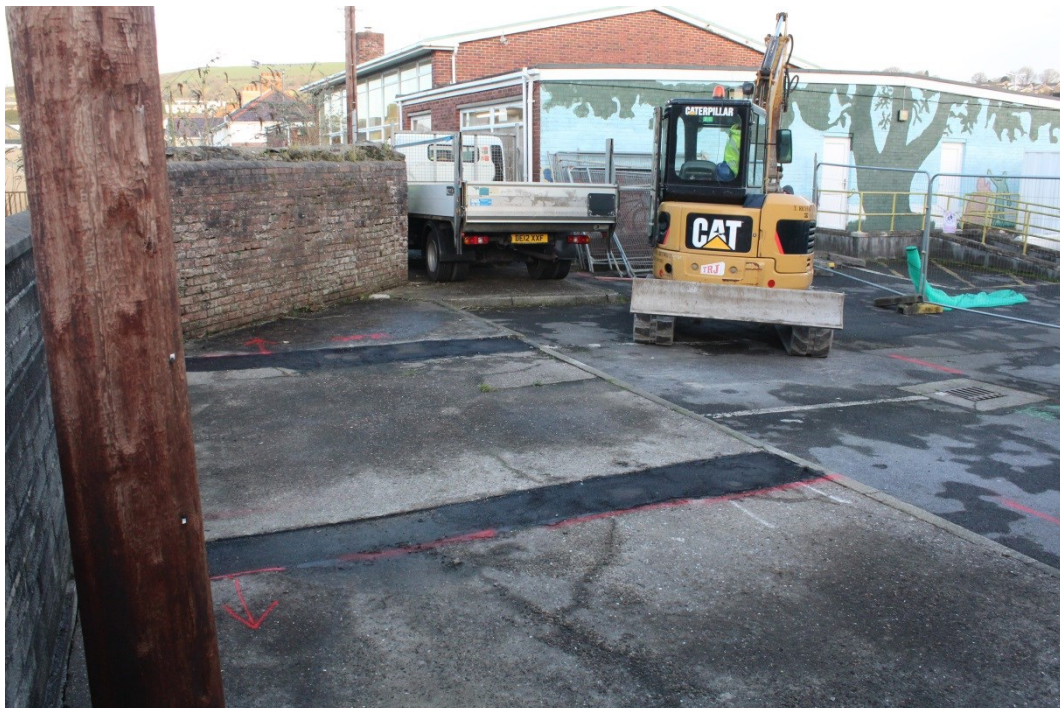
**Photo 11:** Site area prior to start of works showing the two backfilled trenches from the percussive sampling

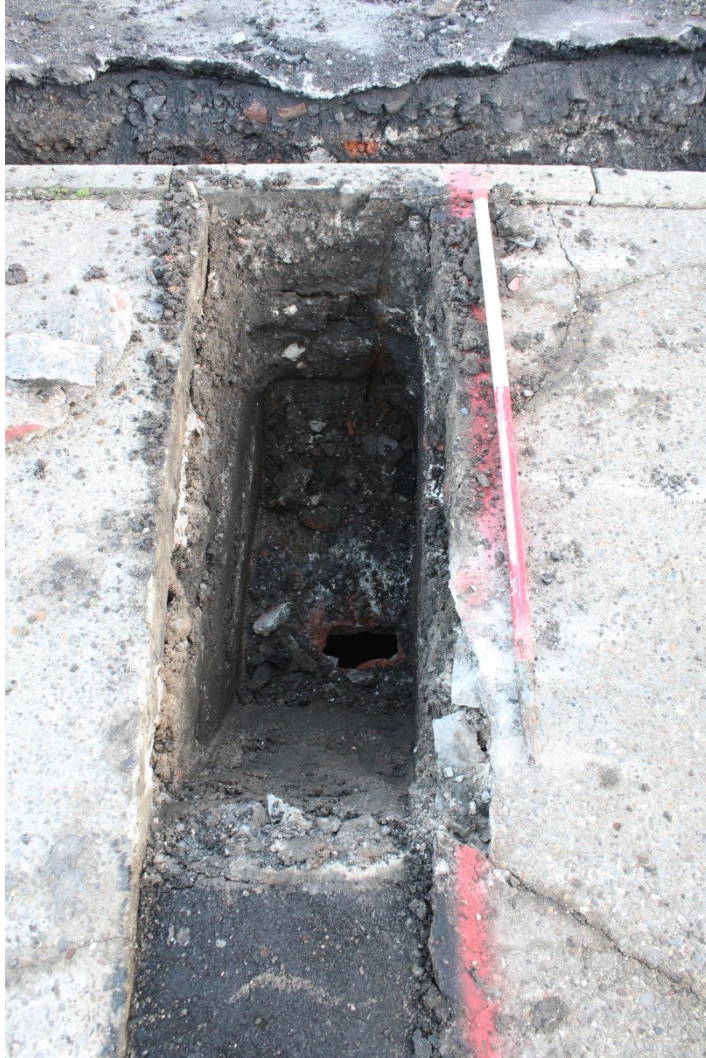
- 5.3.1 On the 17<sup>th</sup> January a small mechanical excavator was used to machine down to the top of the void identified by the percussive sampling under constant archaeological supervision. The trench was initially located over the southwestern of the two percussive sampling trenches with a perpendicular one running on the northeastern side of the kerb (Photos 12 and 13; Figure 8).

**Photo 12:** Initial machined trench through former percussive sampling trench, with hole visible

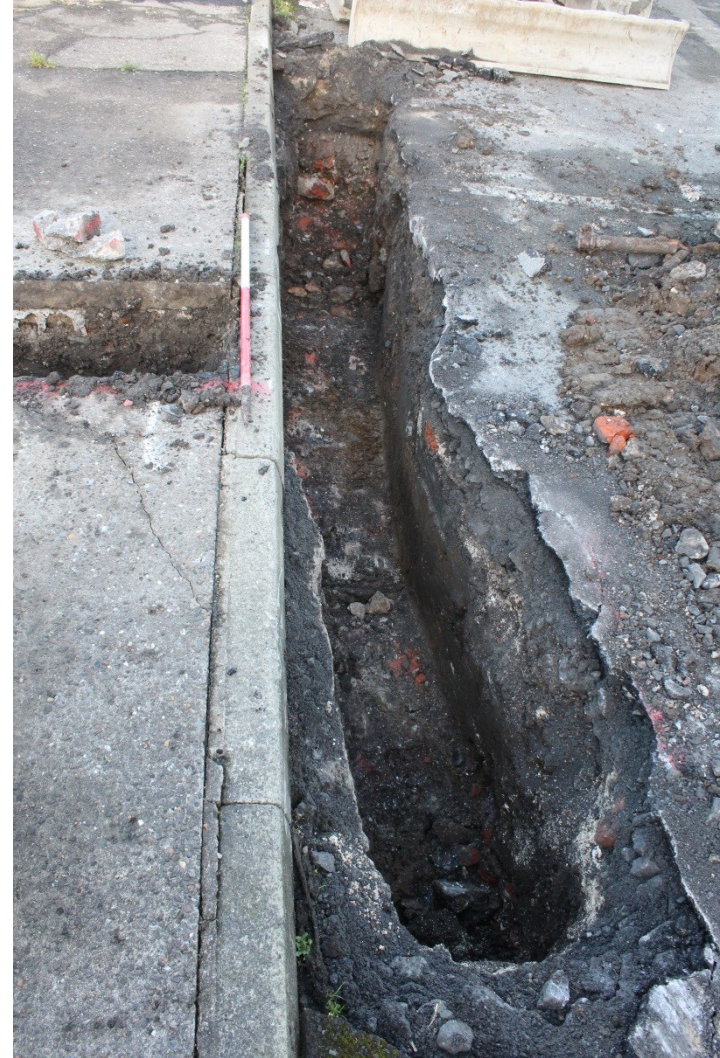
**Photo 13:** Trench excavated along the northeastern edge of the kerb

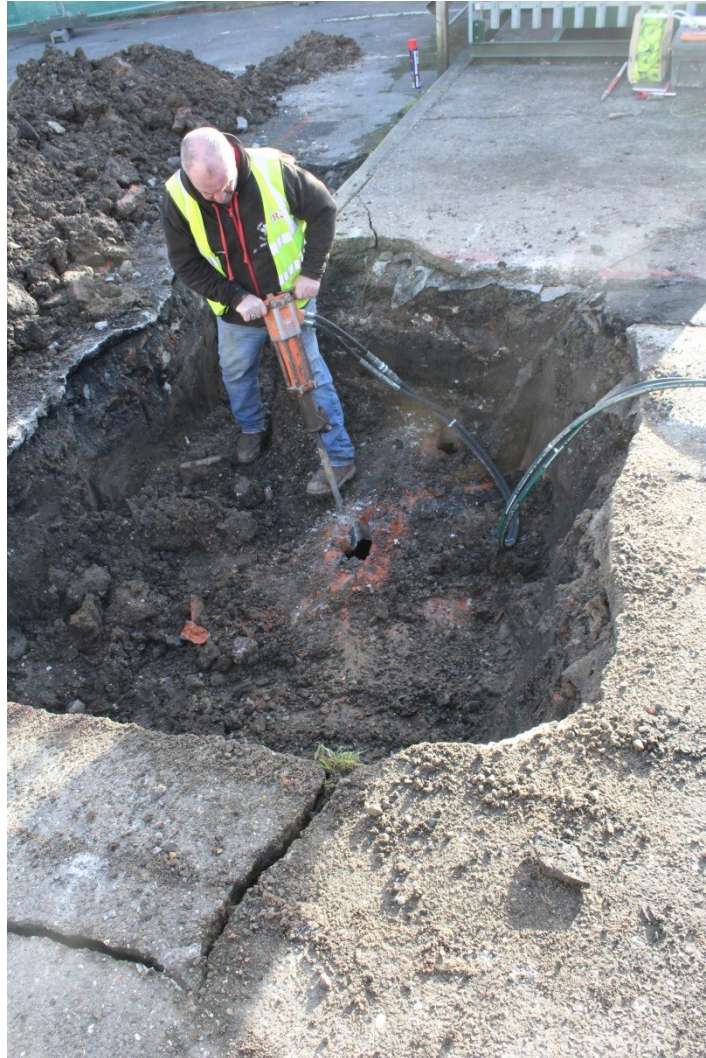
- 5.3.2 This initial T-shaped trench demonstrated the presence of a brick vaulted structure at around 1m depth and its southeastern end appeared to have been identified. The area was then extended to expose the width of the brick vault and a hole was drilled into its top to view inside the structure (Photo 14).

**Photo 14:** Drilling into the top of the vault within the extended trench area

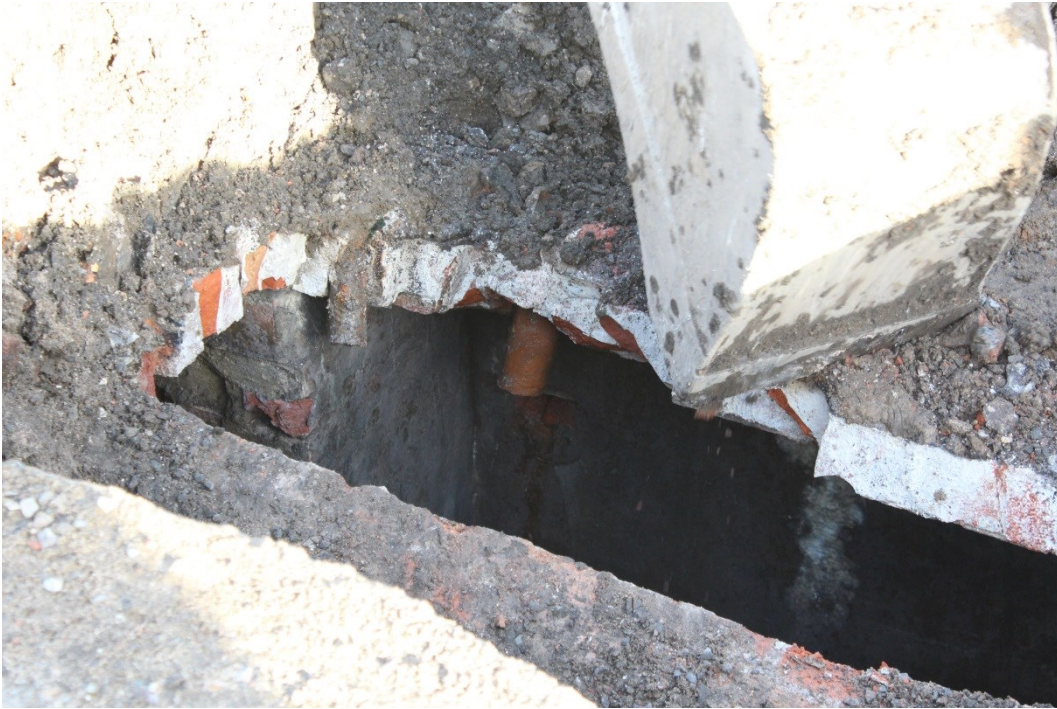
- 5.3.3 Once it was determined that the structure was apparently quite small and evidently structurally sound, a larger hole was created in the vault to enable access into the void.

**Photo 15:** Machine breaking into the vault

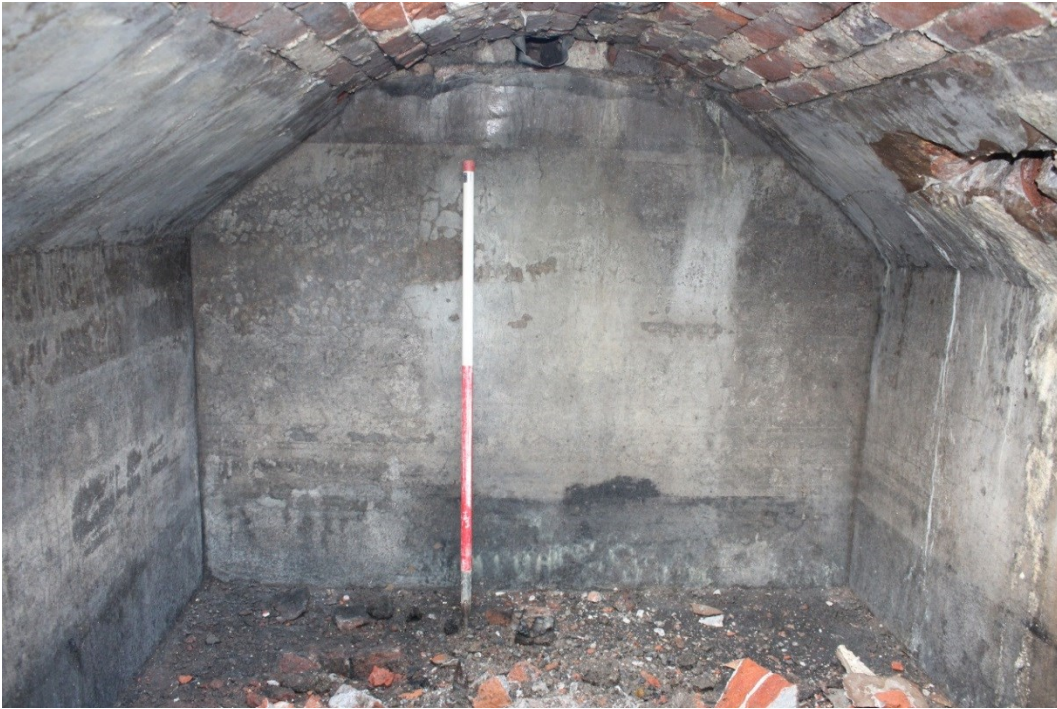
- 5.3.7 There was no further chamber identified to the southeast. The chamber was divided from that to the northwest by a brick wall 0.36m in width. An access between the two chambers was centrally placed at a height of 0.96m from the floor, with the access 0.72m in width (Photo 16).

**Photo 16:** View southeast of southeastern chamber, with drain entrance at apex

- 5.3.10 A possible breach in the roof of the vault was noted in its northeastern corner although this couldn't be confirmed as the chamber could not be accessed. The southeastern chamber was backfilled with concrete.

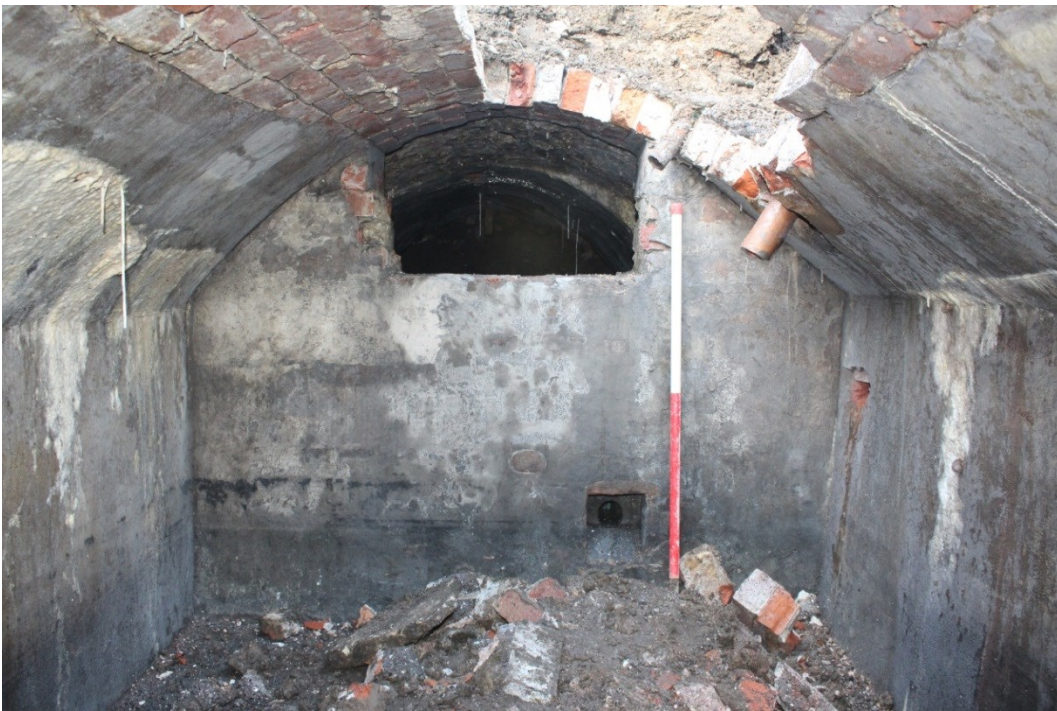
**Photo 17:** View northwest of southeastern chamber to dividing wall, with pipes accessing through roof of vault and through dividing wall

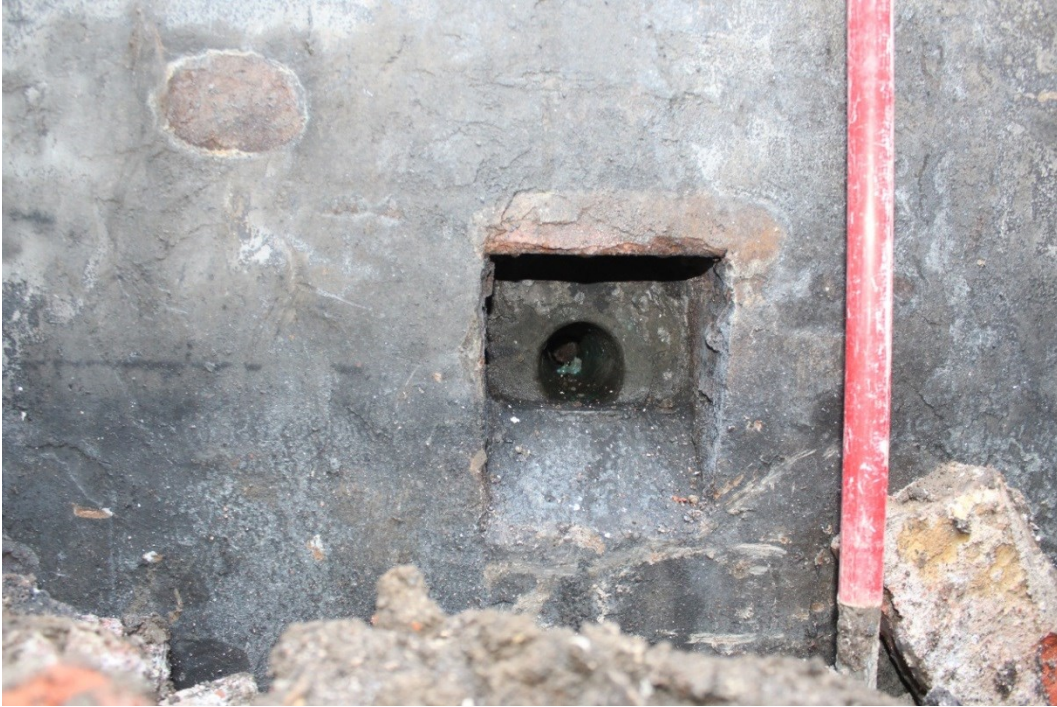
**Photo 18:** detail of pipe leading through wall between the two chambers

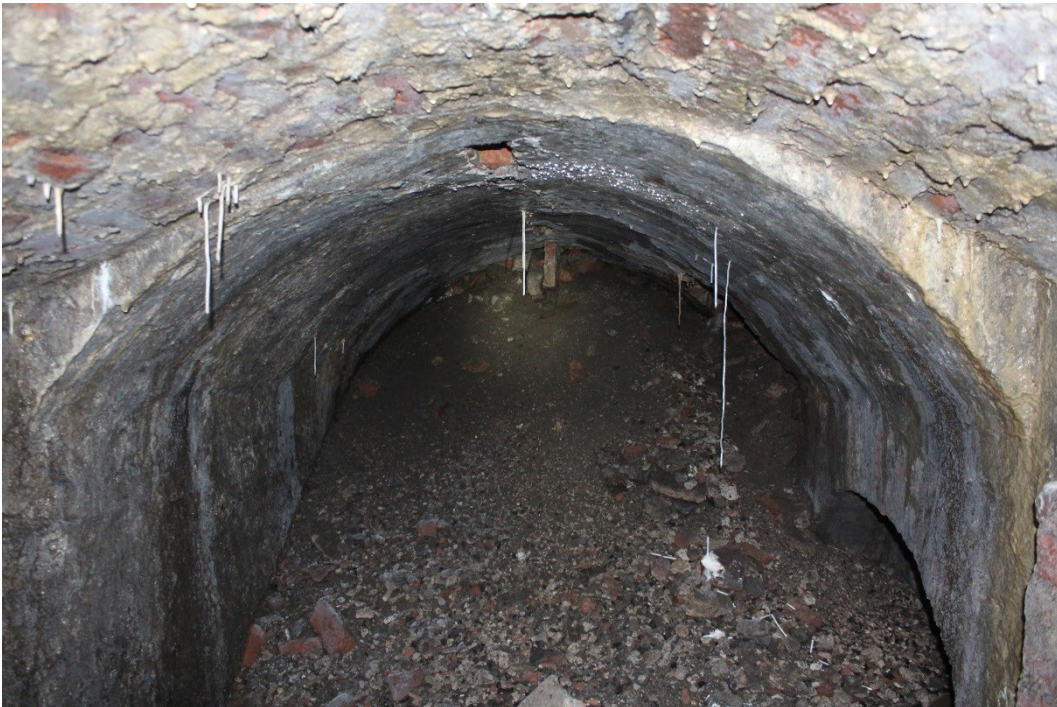
5.3.8 The northeastern chamber was not accessed, but it was possible to create a record of the structure. It was of at least 3.85m in length and of the same 1.79m internal width (Photo 19). The vaulted roof was at the same level as that for the other chamber although the floor was lower, covered in silts which may have hid an underlying brick floor. The northwestern end of the chamber was obscured by silts and rubble that sloped downwards towards the southeast.

**Photo 19:** View into northwestern chamber, with sloping deposits of silts and rubble and arch on eastern side

- 5.3.9 A brick arched recess was visible on the eastern side of the chamber of around 1m width, lying 1.4m north of the dividing wall. It was not tall and the apex was below the spring of the vault above. The back of the arch could not clearly be seen, but was thought to only have been the width of the wall/length of a standard brick.

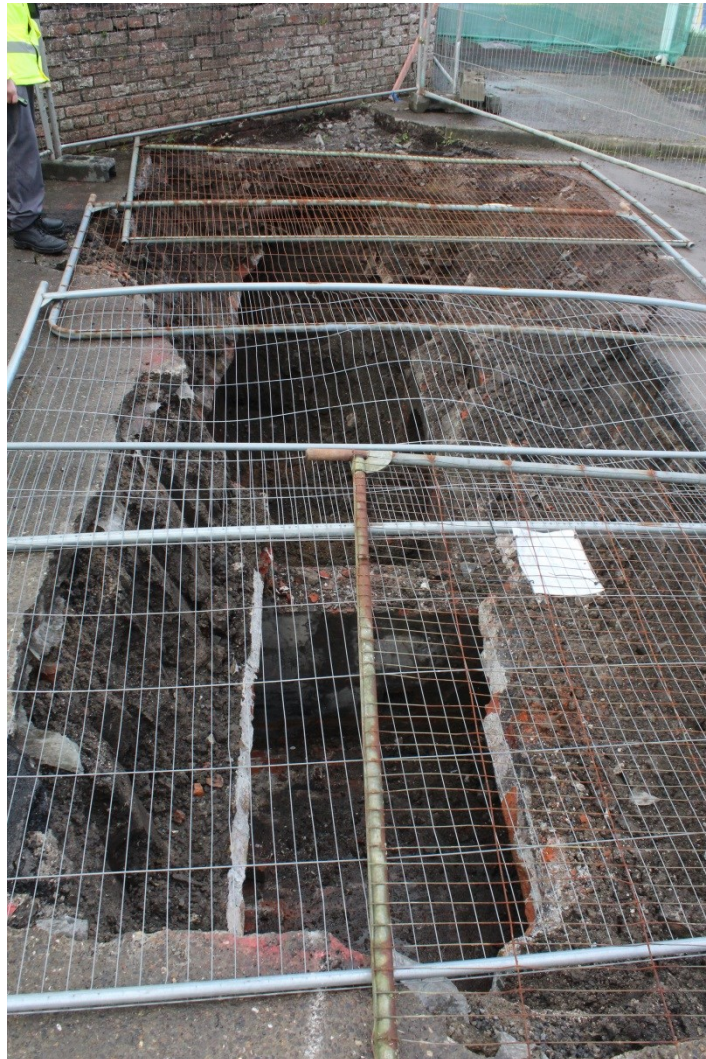
- 5.3.12 The northwestern chamber could be seen to run almost up to the retaining wall to the gardens of Little Water Street (Photo 20). No northwestern end to the chamber was confirmed, but it would appear that the silts and rubble that were present in that chamber had been deposited in from that end.

**Photo 20:** View northwest along chambers on 18<sup>th</sup> January 2018 following exposure and opening of northwestern chamber

- 5.3.11 On the 18<sup>th</sup> January it was agreed with the site contractors that they could excavate down to the top of the northwestern chamber and open it as they had done on the one to the southeast. This was not monitored but a site visit was carried out to view what had been found. The chamber had been covered in fencing before the site visit due to the potential health and safety risks of leaving it open (Photos 20 and 21).

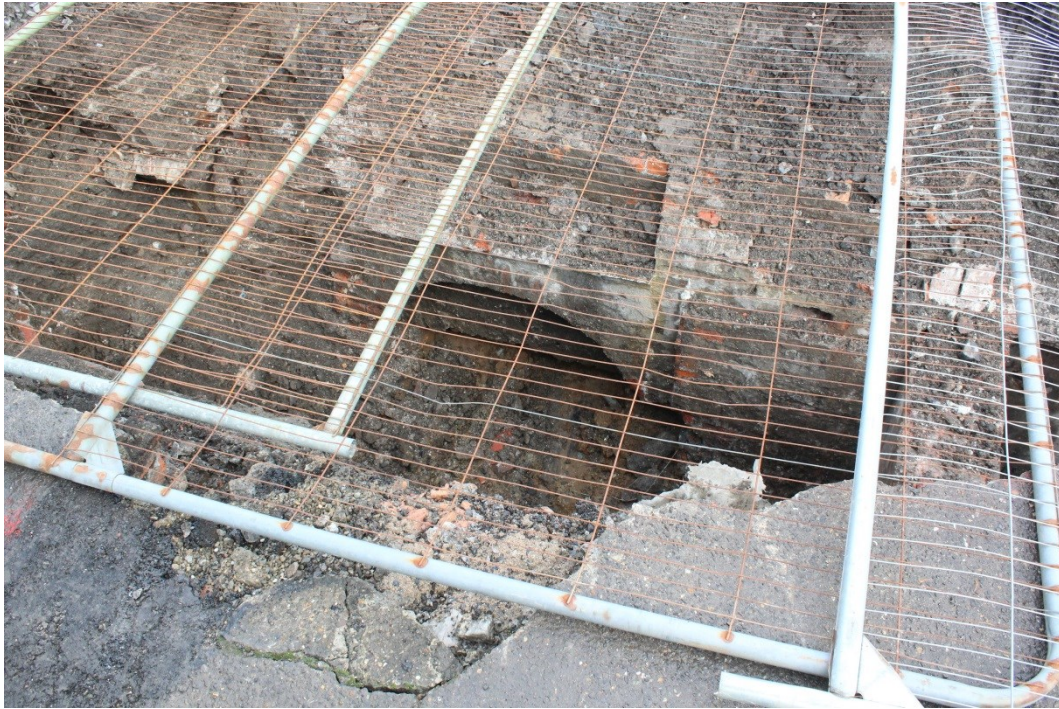
**Photo 21:** View northeast across brick arched opening in wall of northwestern chamber

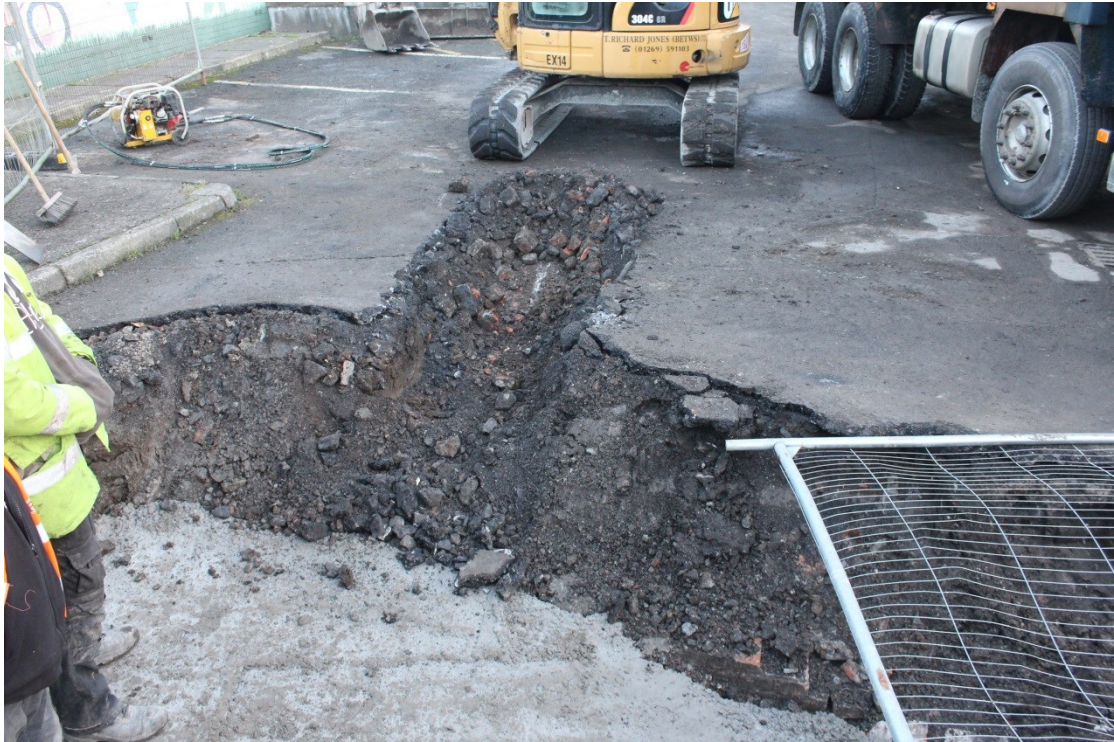
- 5.3.13 The arch in the eastern brick wall of the northwestern chamber could be quite clearly seen below the covered area (Photo 22) confirming that it was only as deep as a single length of brick. What was not clear was whether a wall was present on its eastern side or whether the archway led to a further chamber to the east. The upper part of the back of the arch appeared to be closed off, but sands and silts were present slumping in to the chamber below this. It was thus determined on-site that further investigations were needed on the eastern side of this arch to confirm whether another void was present. The chamber itself was then backfilled with concrete to stabilise it and for safety reasons.

**Photo 22:** Excavation of trench to the east of the archway, showing concrete backfill of northwestern chamber

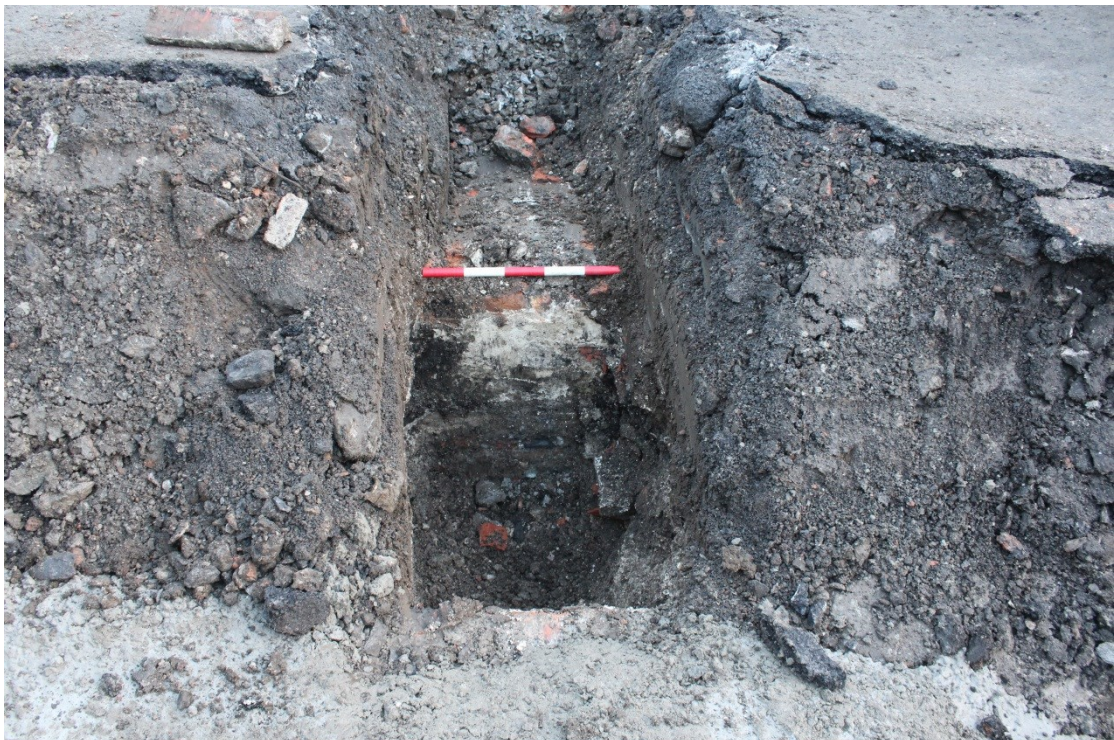
- 5.3.15 A second brick wall was identified c.0.65m to the east of the eastern wall of the chamber (Photo 23; Figure 8). This was of at least one brick thickness, but was not investigated further to the east. Excavation of the area between the two walls was then carried out to determine if there was indeed a void leading east from the chamber. A 1.30m depth of mixed rubble and soil containing bricks and ceramic pipes, as well as a few larger rounded stones was removed from the area between the two brick walls exposing an apparent large cobbled surface set in a very tough soil matrix (Photo 24).

**Photo 23:** Brick wall revealed to the east of the eastern chamber wall just visible on edge of concrete
