**CARMARTHEN LIBRARY  
PROPOSED ARCHIVES BUILDING,  
CARMARTHEN:  
ARCHAEOLOGICAL  
WATCHING BRIEF  
(SN 4145 2026)**

Prepared by DAT Archaeological Services  
For: Carmarthenshire County Council

RHIF YR ADRODDIAD / REPORT NO. 2018/05  
RHIF Y DIGWYDDIAD/ EVENT RECORD NO. 111238

# CARMARTHEN LIBRARY PROPOSED ARCHIVES BUILDING, CARMARTHEN: ARCHAEOLOGICAL WATCHING BRIEF

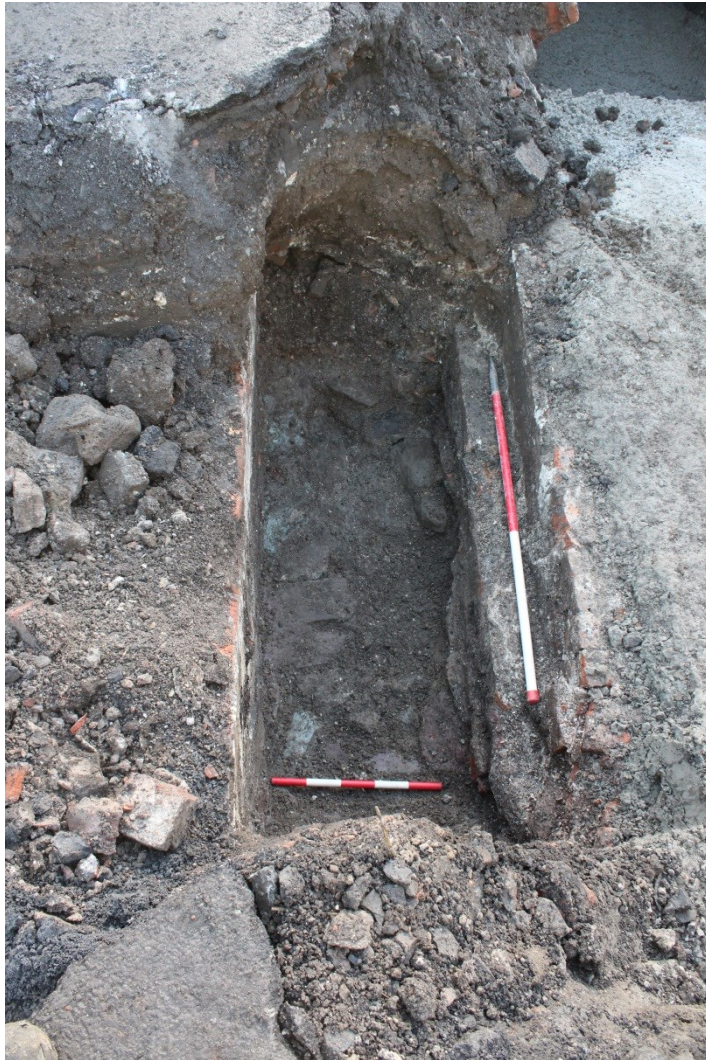
- 5.3.15 A second brick wall was identified c.0.65m to the east of the eastern wall of the chamber (Photo 23; Figure 8). This was of at least one brick thickness, but was not investigated further to the east. Excavation of the area between the two walls was then carried out to determine if there was indeed a void leading east from the chamber. A 1.30m depth of mixed rubble and soil containing bricks and ceramic pipes, as well as a few larger rounded stones was removed from the area between the two brick walls exposing an apparent large cobbled surface set in a very tough soil matrix (Photo 24).

**Photo 24:** Apparent cobbled surface recorded directly east of the northwestern chamber

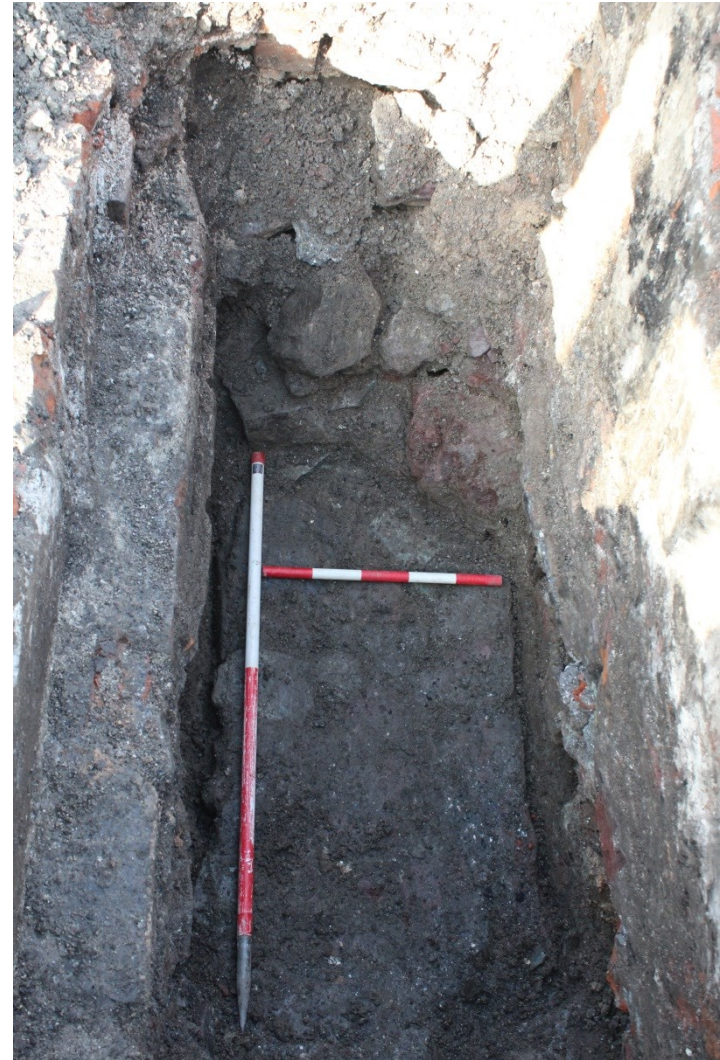
- 5.3.16 It was agreed that part of this possible surface should be removed to confirm it was not sealing a vault over another void and a 0.40m depth was removed revealing that it was actually the remains of a mortared stone wall. It was possible to see that the wall was faced on both sides and had a width of 0.60m. A total length of 2.20m of the wall was exposed in the trench (Photo 25; Figure 8).

**Photo 25:** Clearly defined mortared stone wall in the base of the excavated area to the east of the chamber

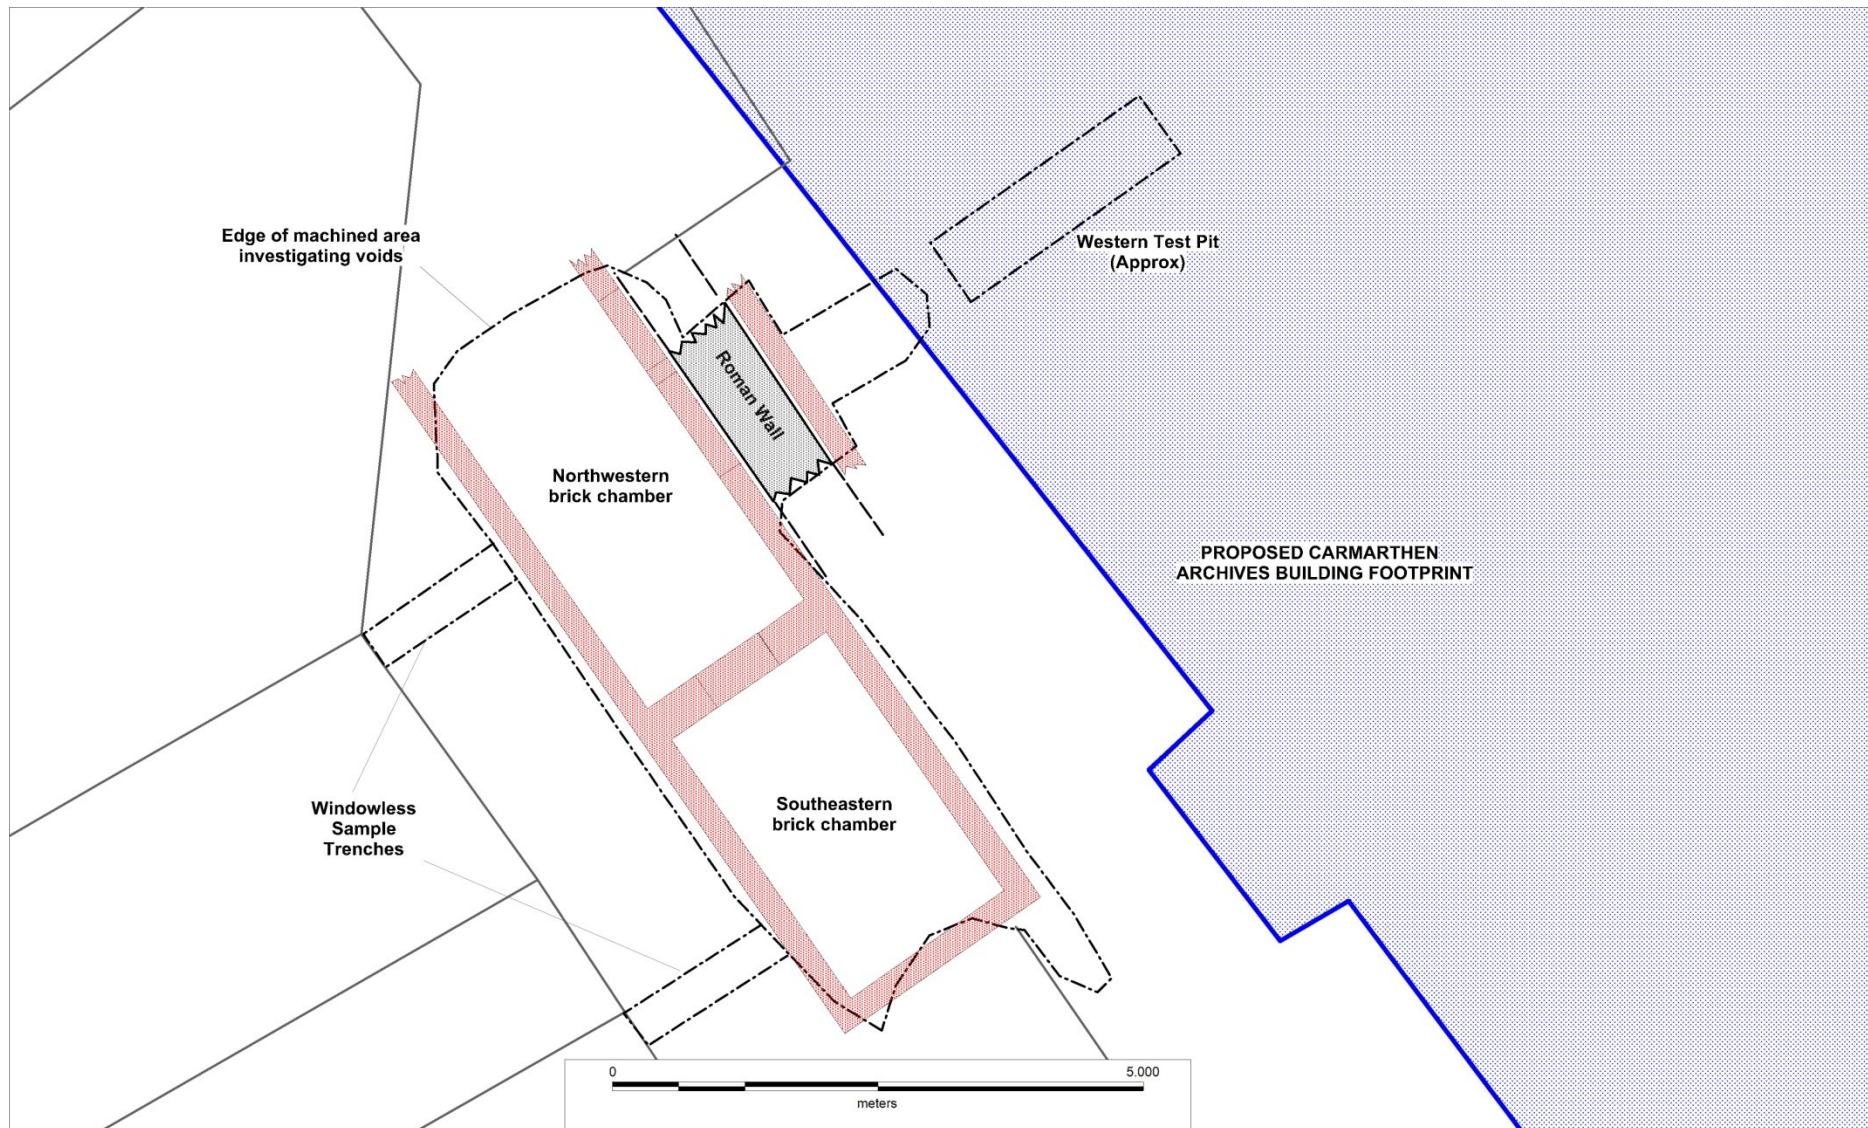
**Figure 8:** Detailed plan showing location of brick built chambers and Roman wall

- 5.3.17 During the above investigations the top of a substantial mortared wall was revealed at a depth of around 1.30m below the ground surface directly behind the northeastern wall of the northern chamber. The wall was partially removed to a depth of 0.40m but could be seen to be continuing down below this level. It was aligned roughly northwest to southeast, parallel to the retaining wall to Little Water Street. It had been well-faced on both sides and measured 0.60m in width. A length of 2.20m of the wall was exposed, but the wall definitely continued beyond the edges of the exposed area. It is considered that the wall would be of Roman date. Its location would have been on or within the ramparts of the town defences. The character of the wall would suggest it formed part of a building and the fact that it was apparently faced on both sides indicates that it is part of the superstructure rather than just foundations. The wall lay directly southeast of one of the test pits excavated in 2016, indicating that the test pit would have been located within and through the Roman building.
