ZION GARDENS, TENBY, PEMBROKESHIRE: ARCHAEOLOGICAL WATCHING BRIEF (SN 13046 00864)

RHIF YR ADRODDIAD / REPORT NO. 2018/07
RHIF Y DIGWYDDIAD/ EVENT RECORD NO. 111366

ZION GARDENS, TENBY, PEMBROKESHIRE: ARCHAEOLOGICAL WATCHING BRIEF

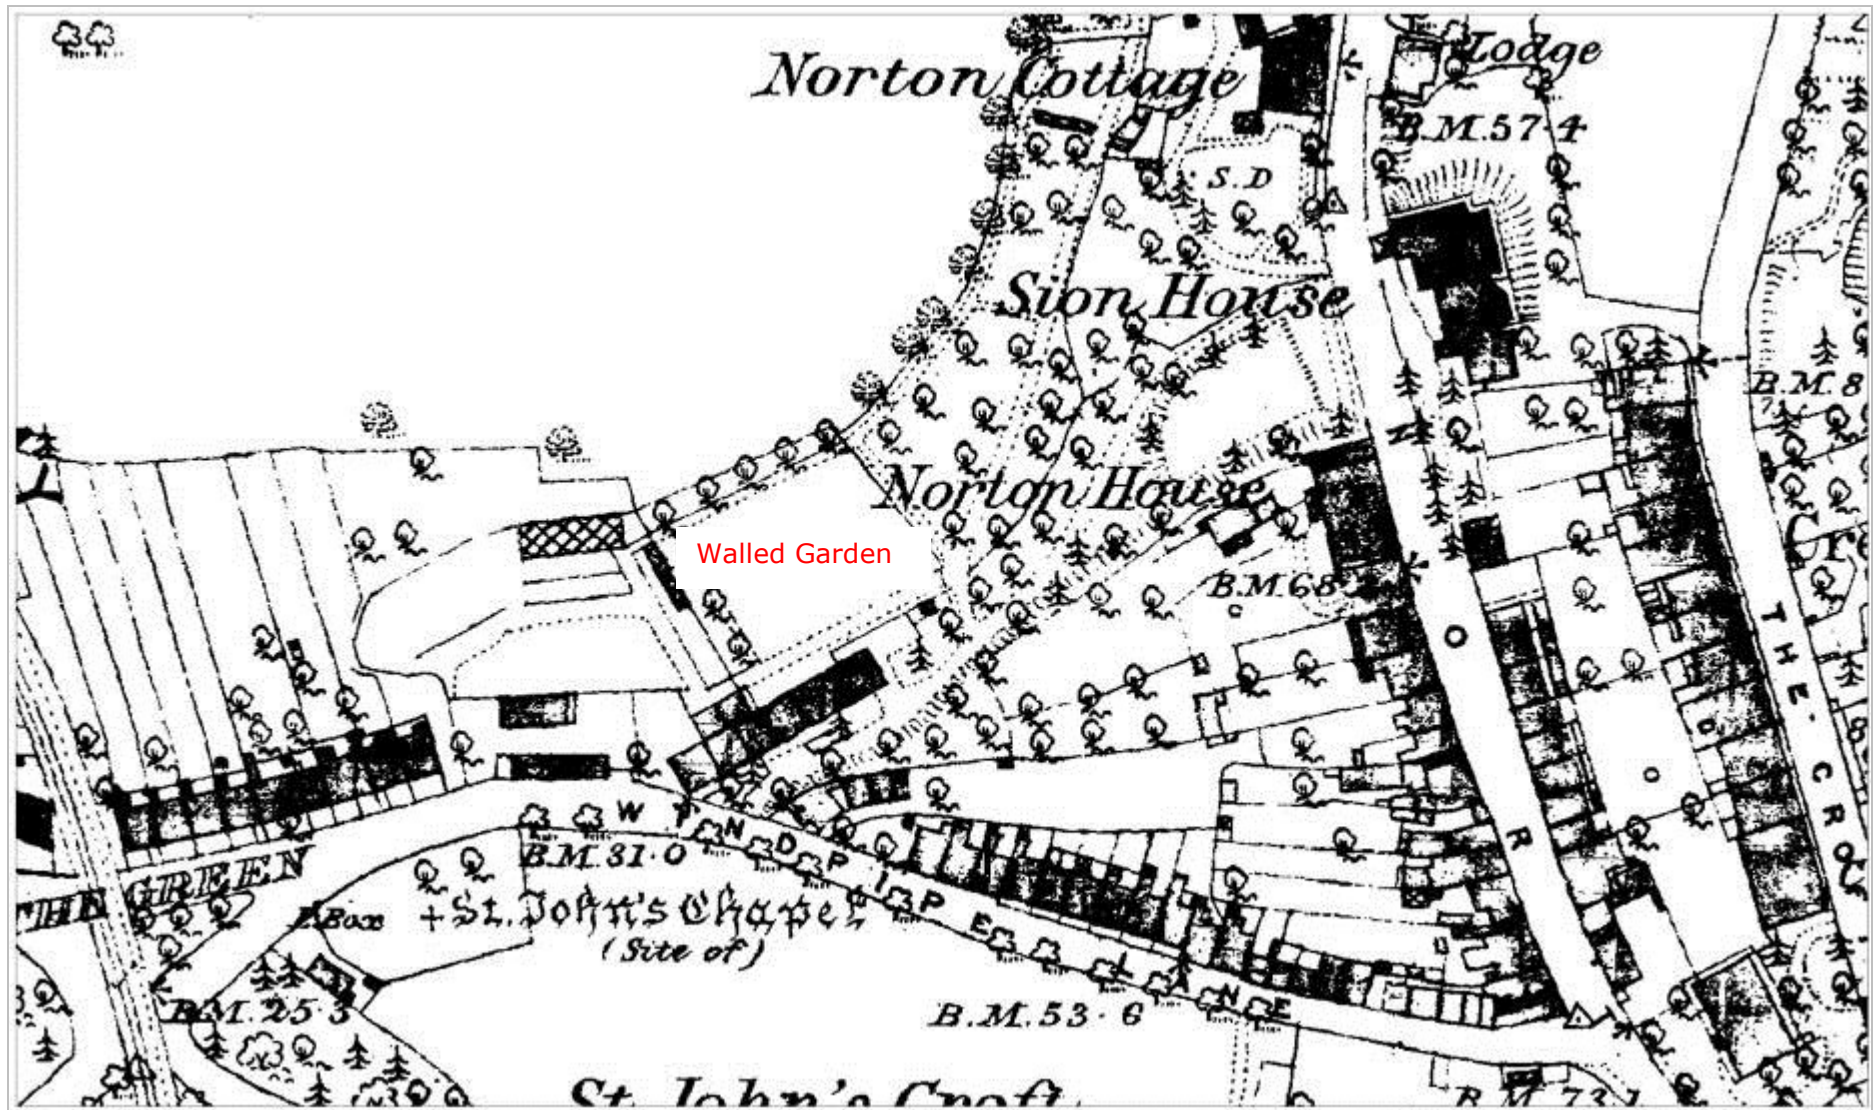
Figure 5: Extract of the 1890 1st edition OS map, showing the walled garden

- 2.2.8 Figure 4 shows the OS 1:500 map of 1889, and Figures 5 and 6 show the 1890 and 1907 OS historic 1:2500 maps respectively. They show the area when Sion (Zion) House was still a residence with terraced pleasure gardens, glasshouses and the walled garden. The location of St John's Chapel (Figure 5) and St John's Well (Figure 6) are also indicated. The 1889 map is the first known map to show the walled garden and associated outbuildings of Sion House.

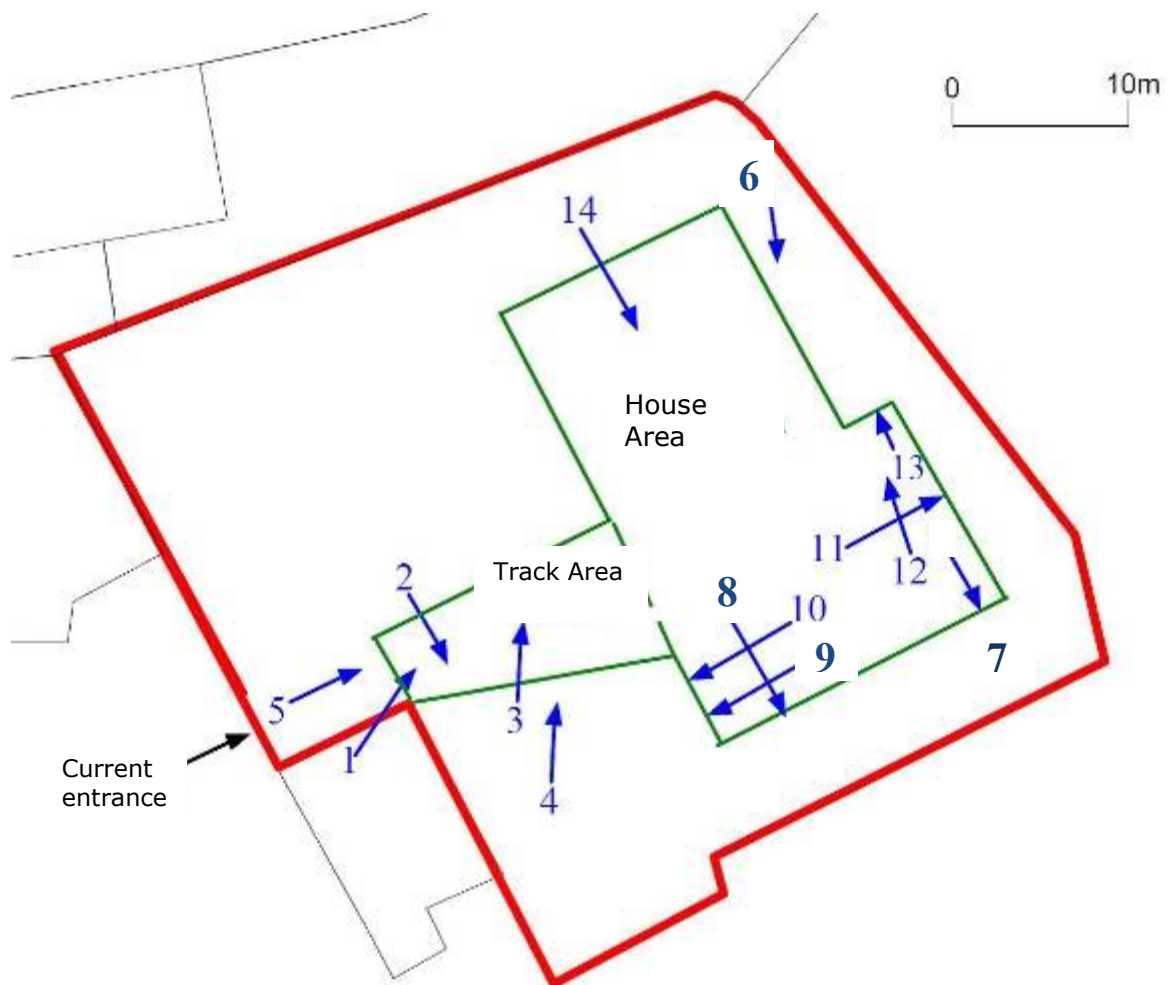
Figure 7: Plan showing the walled garden outlined in red (excluding the house and garden at its southwest corner), the approximate position of the machine excavated areas outlined in green, and photo locations and directions in blue.

- 4.1 A description and photographic record of the works is given here, with Figure 7 showing the positions from which each photo was taken and the direction of the shot.
- 4.2 The current entrance, created to enable caravans to be taken into the walled garden, is halfway along its southwest side, with a short length of tarmac drive extending northeast into the interior. Beyond the entrance machine excavations commenced with the creation of a trackway to give better access to the site. Photos 1-5 illustrate the watching brief in this area.

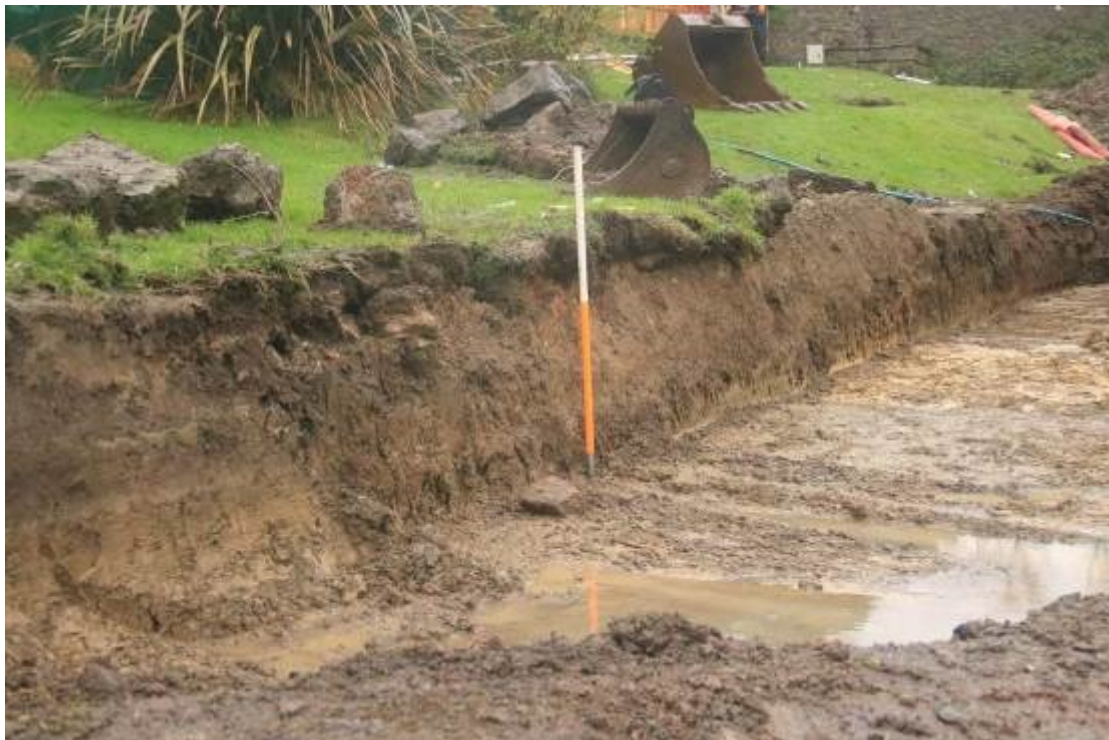
Photo 1: Looking north-northeast at south-facing section of track area east of the current entrance. 1m scale

- 4.4 The first phase of watching brief was undertaken on 29th January 2018 during machine excavations to extend the current entrance and create a levelled track into the site (Figure 7). The excavations for the track cut into the NW-SE slope (Photo 1) revealed the 19th century terracing had been formed from re-deposited layers of sand and clay, above which lay silty loam topsoil. Revealed within this re-deposited material were darker areas of soil that are likely a result of activities that post-date the terracing. A small rectangular shaped soil mark (Photo 2) was observed at the southwestern edge of this area. Photo 3 shows a circular area where burnt material had been deposited; that included unburned and discarded oyster shell and disarticulated bird bones. This circular area lay 2.0m northeast of the rectangular soil mark, and further northeast were further circular and sub-circular soil marks of unknown origin (Photo 4). There was no requirement to investigate these features as it was not proposed to excavate levels any deeper in these areas.

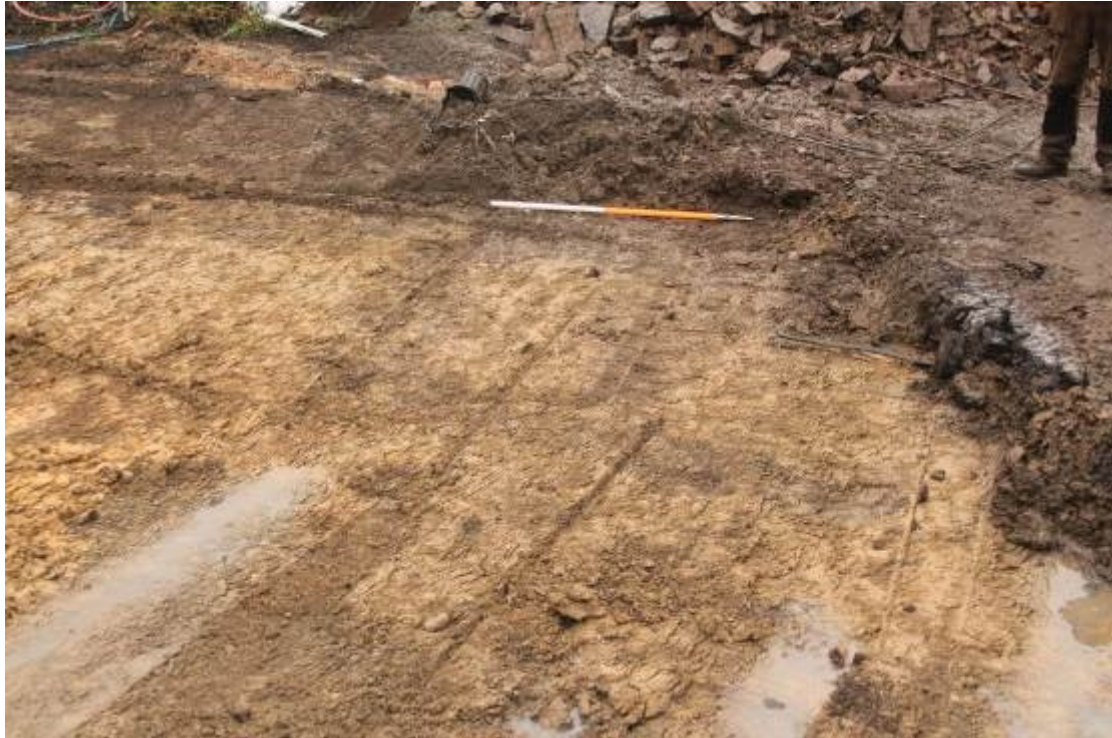
Photo 2: Looking southeast at rectangular soil mark revealed in the track area east of the current entrance. 1m scale

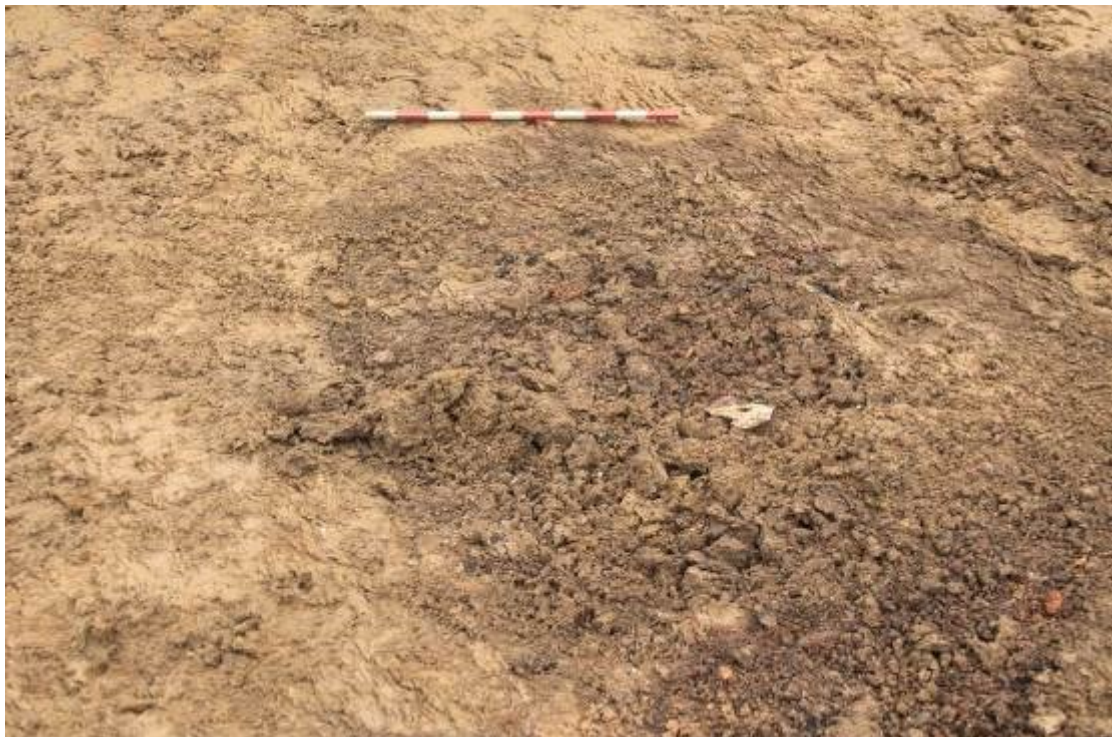
Photo 3: Looking north at a circular area of burnt material in track area east of the current entrance, including unburned oyster shell and bird bones. 0.5m scale

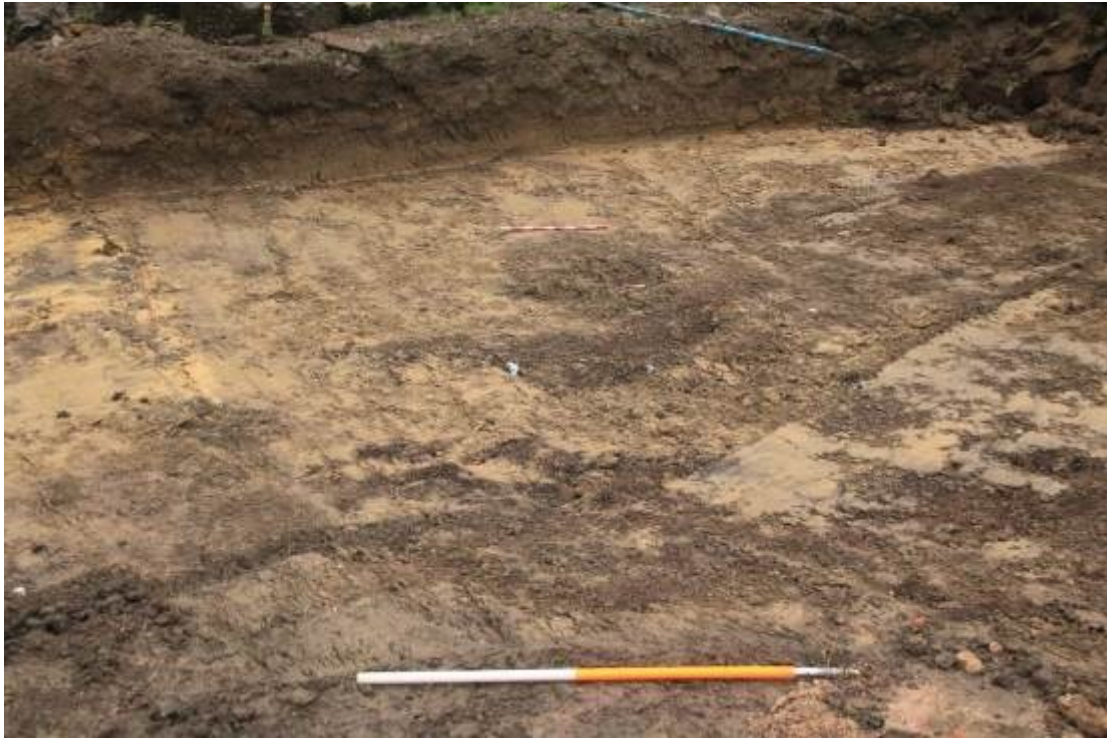
Photo 4: Looking north at areas of burning and soil marks in the track area east of the current entrance. 0.5m and 1m scales

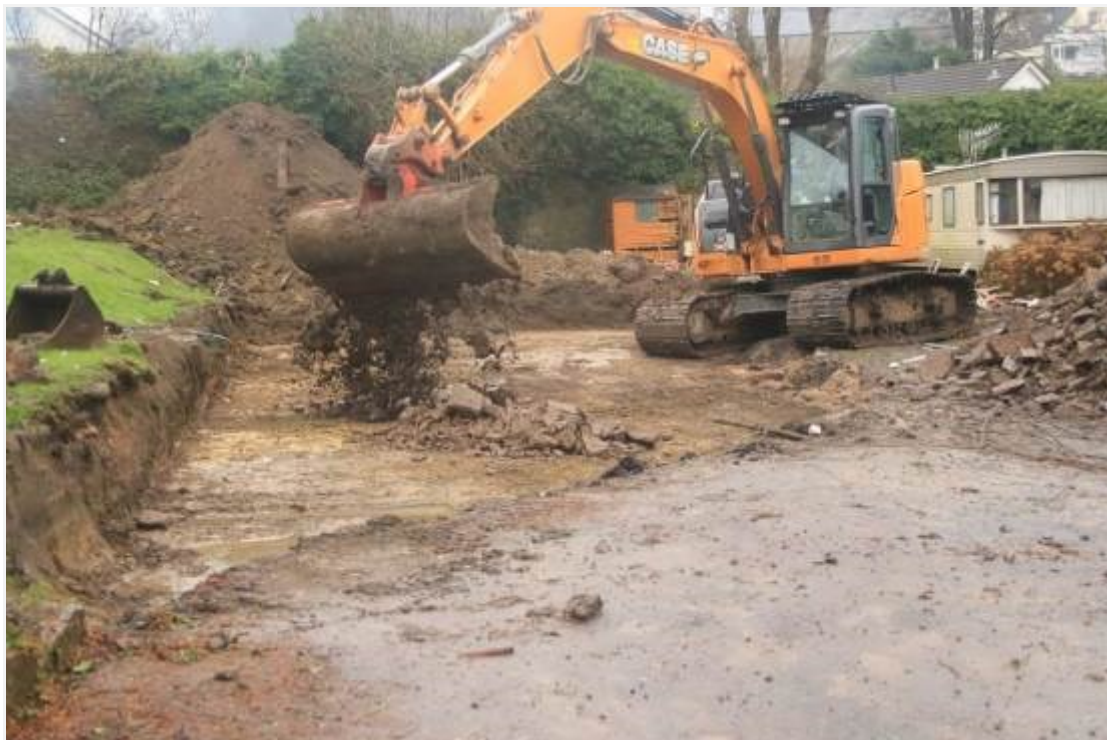
Photo 5: Looking northeast at the track area east of the current entrance, after excavation and with re-surfacing commencing

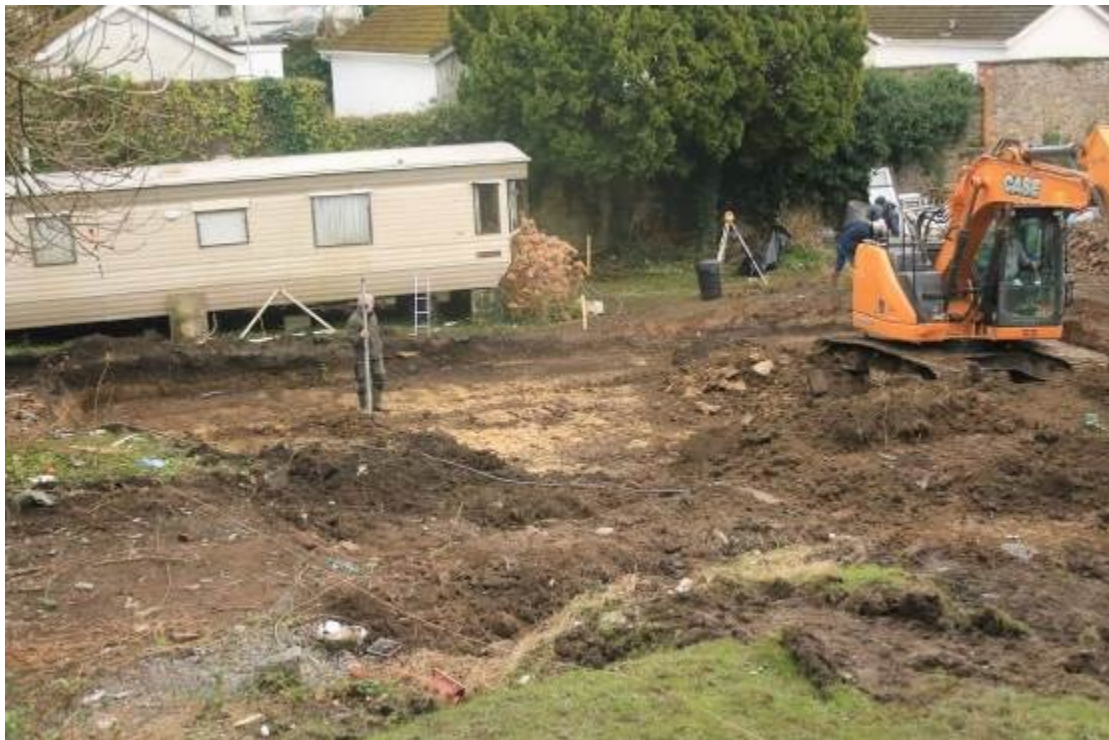
- 4.5 On January 30th 2018 machine excavation of the house area began at the south-eastern end of the garden (Photo 6). Approximately 0.5-0.6m of soil was machine excavated to reach the required levels. A number of soil sequences were revealed. In general the machining removed a layer of loamy topsoil approximately 0.15m deep, which in the east of this area lay above sandy clay subsoil (Photo 7), but in many other places covered various layers that appear to have been deposited to make up the ground; presumably during landscaping for the caravan park. For example photos 8 and 9 illustrate a sequence, from the top, of loamy topsoil above a layer of yellow/brown clay above a very dark buried soil layer; suggesting that the clay had been deposited above the then existing garden soil of the walled garden. In some areas, particularly in the southeast corner of the house area natural clay and shale bedrock were revealed below the sandy clay subsoil.

Photo 6: Looking south-southeast at the lower third of the house area showing the natural yellow clay revealed after excavations to required depth.

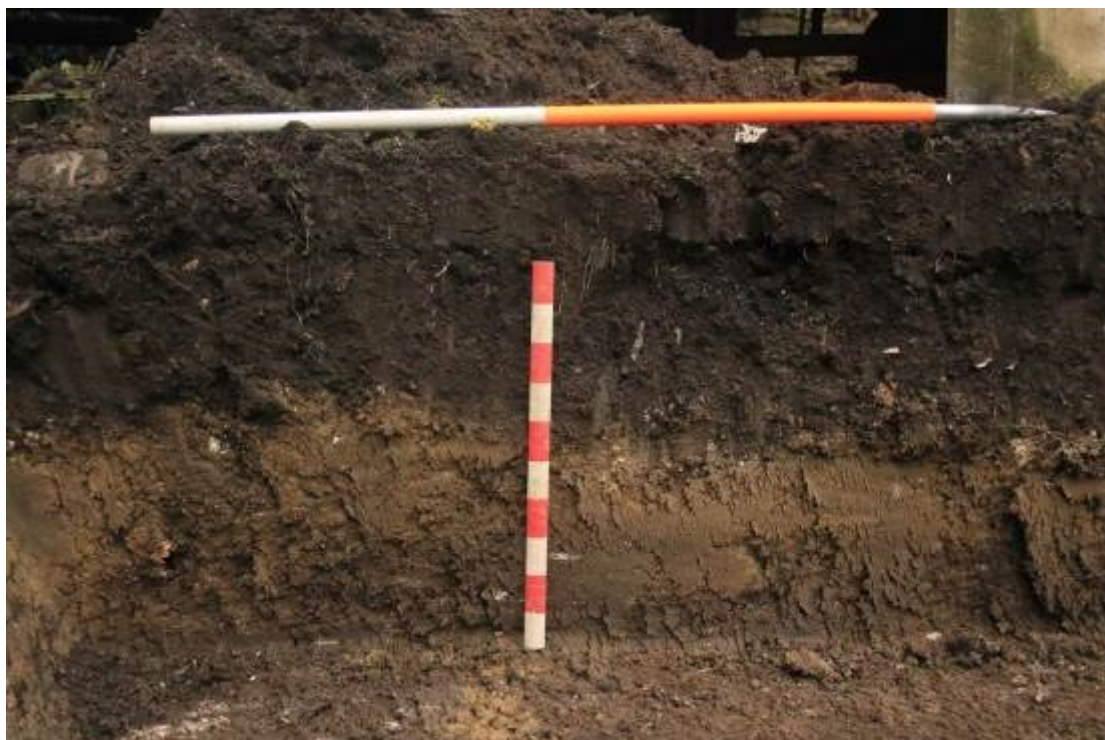
Photo 7: Looking southeast at the northwest-facing section revealed at the east corner of the house area, showing loamy topsoil over sandy clay subsoil. 0.5m and 1m scales

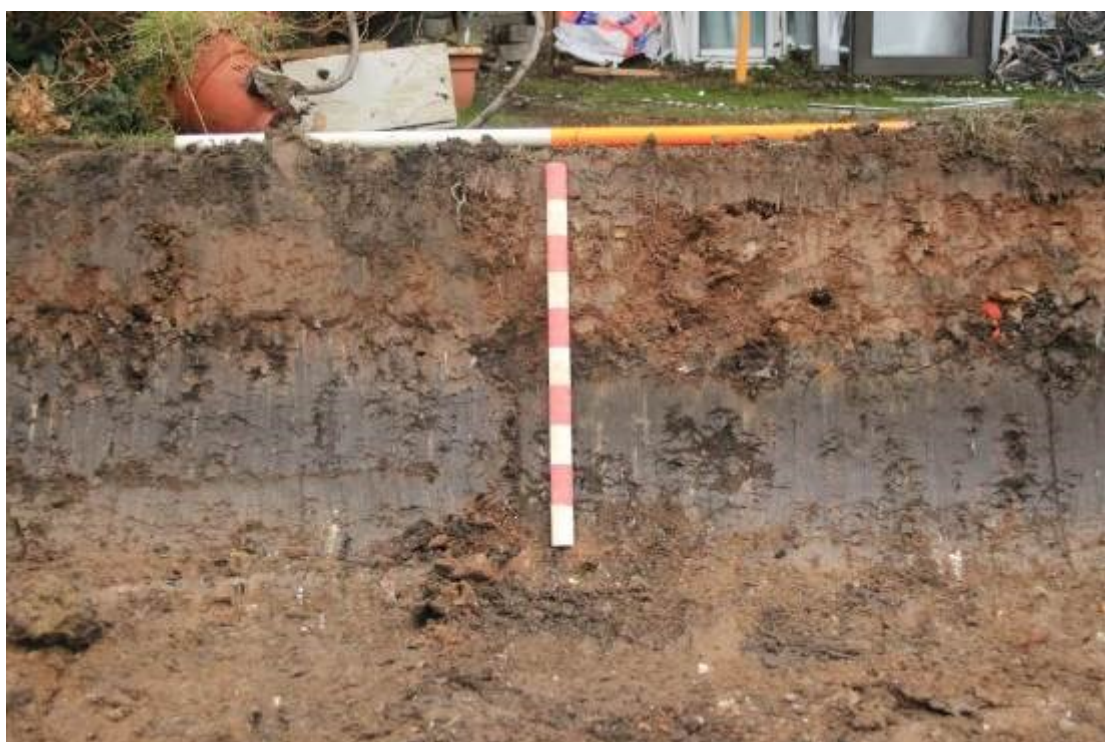
Photo 8: The northwest-facing section revealed along the southern edge of the house area, showing a sequence from the top of topsoil, clay, buried soil and subsoil. 0.5m and 1m scales

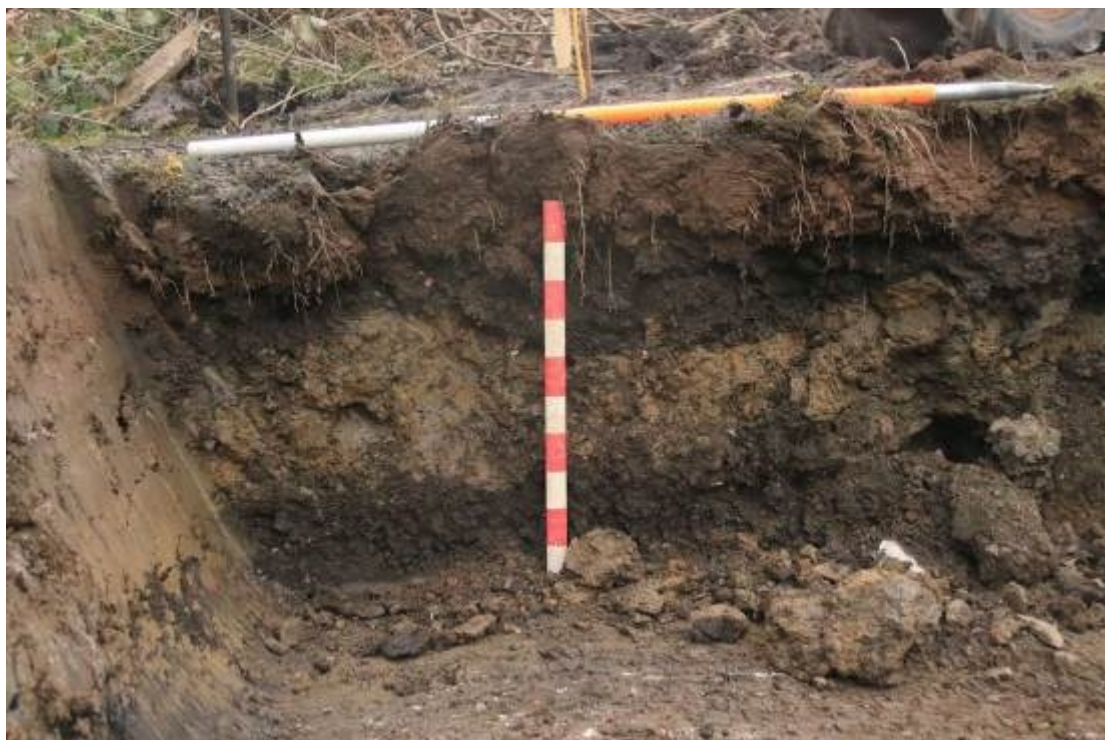
Photo 9: The northeast-facing section at the south corner of the house area, showing from the top a sequence of topsoil, clay, buried soil and subsoil. 0.5m and 1m scales

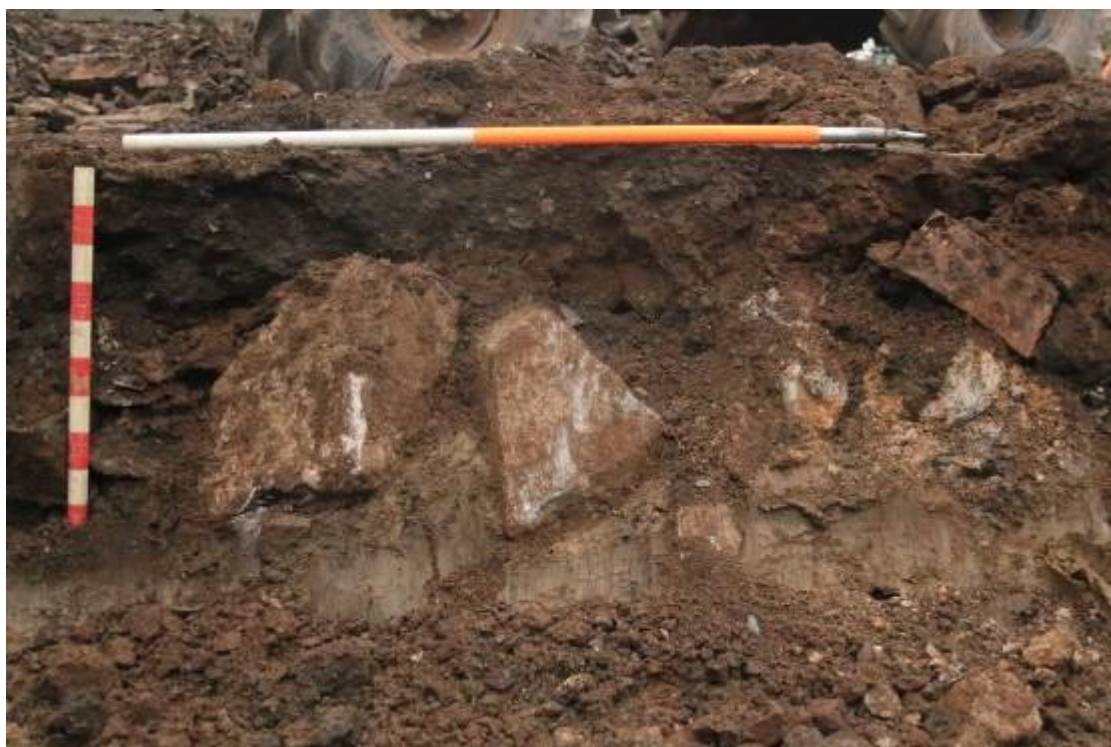
- 4.6 Photo 10 demonstrates that building rubble was also used in some places to build up the ground.
- 4.7 A small exploratory pit c.0.6m deep was excavated in the south-eastern corner of the walled garden in an attempt to find a cess pit that was thought to be there. The cess pit was not found (it was recalled that it lay further to the south). No significant archaeological deposits were observed during these excavations.

Photo 10: The northeast-facing section, 3.0m northwest of the south corner of the house area, showing a layer of large stones and rubble between the topsoil and subsoil. 0.5m and 1m scales

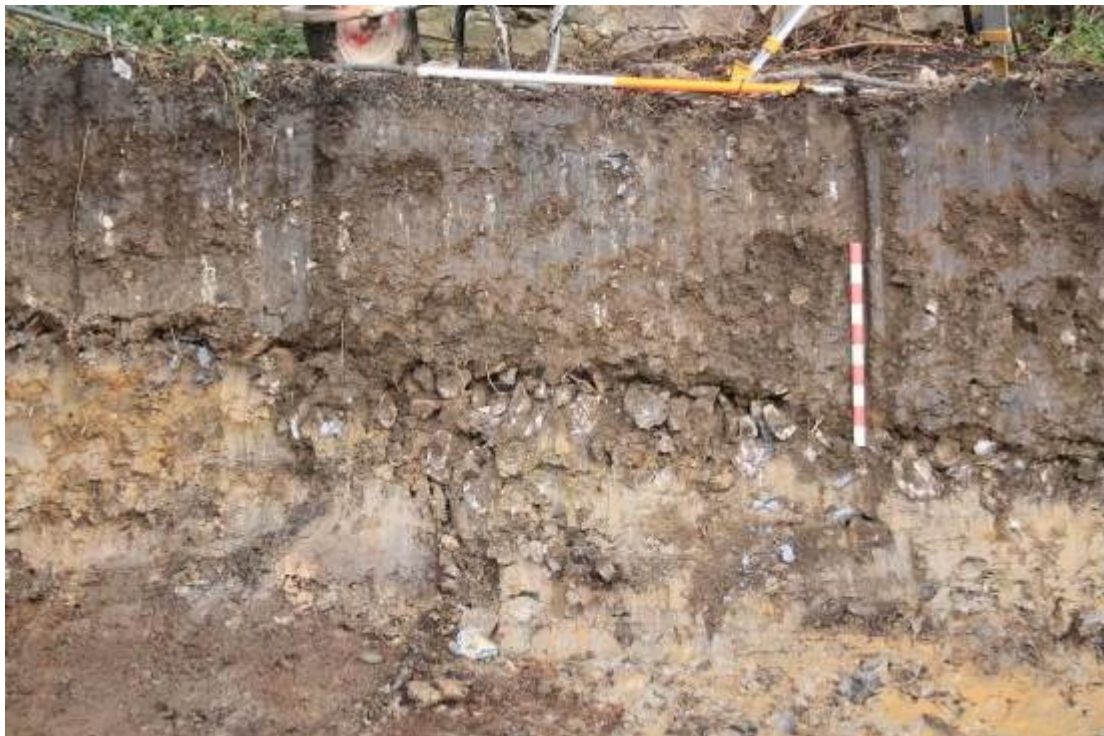
- 4.8 On 31st January 2018 the house area was extended slightly to the northeast and two archaeological layers were recorded at the interface between the subsoil and the natural clay. A layer of stone rubble, measuring 7.5m long was exposed between the subsoil and the natural clay in the section near the east corner of the walled garden (Photo 11). Photo 11 shows clearly the nature of the subsoil deliberately enriched with lumps of lime and charcoal to improve the soil, probably when the walled garden was in use. This subsoil lies above a c.0.15m thick layer of stony rubble containing mortar, slate and ceramic drainpipe fragments. It might well have been deposited during the creation of the walled garden in the later 19th century and could represent vestiges of a small building demolished nearby during the development of Sion House and grounds.

Photo 11: The southwest-facing section near the east corner of the walled garden, showing layer of stone rubble between the subsoil and clay.
0.5m and 1m scales

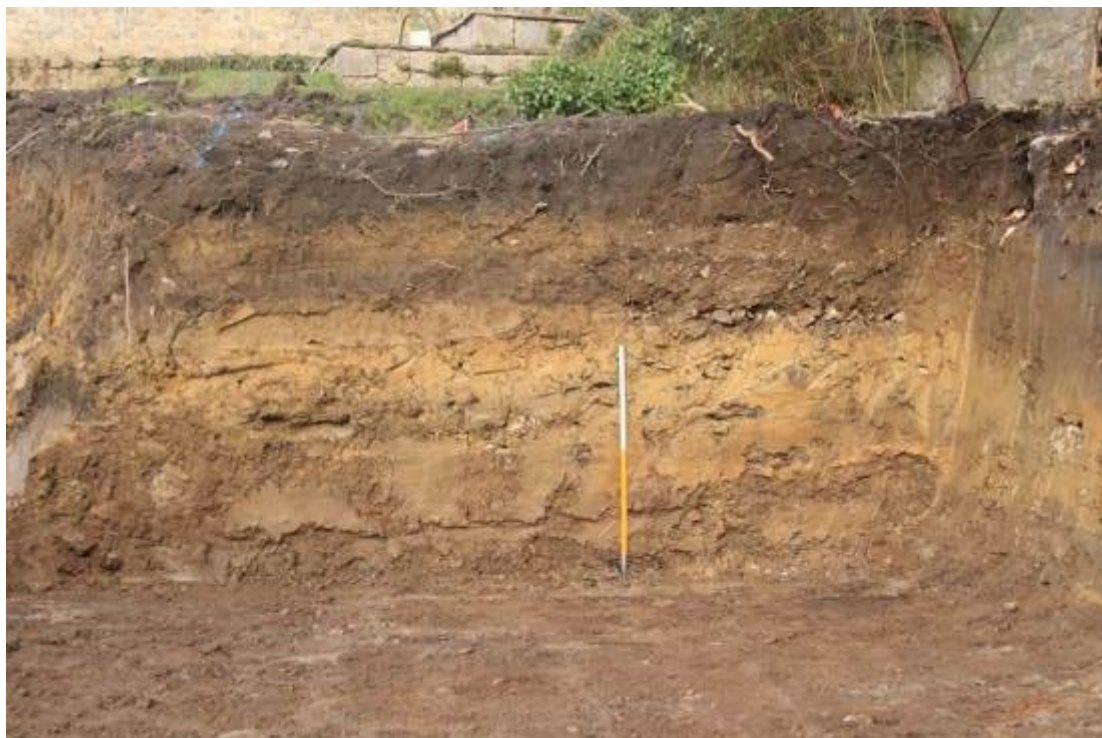
- 4.9 Approximately 3.0m northwest of the rubble layer, in the southeast-facing section of the dog-leg on the northeast side of the house area, a layer of small stone pebbles was recorded (Photos 12 and 13). This again lay at the interface between the subsoil and the natural clay and hence probably coincides with the creation of the walled garden. The layer was 0.10m thick and 1.0m wide and likely represents the remains of a pathway that once traversed this area before the walled garden was constructed in the late 19th century.

Photo 12: The southeast-facing section of the house area showing the layer of pebbles between the subsoil and clay. 1m scale

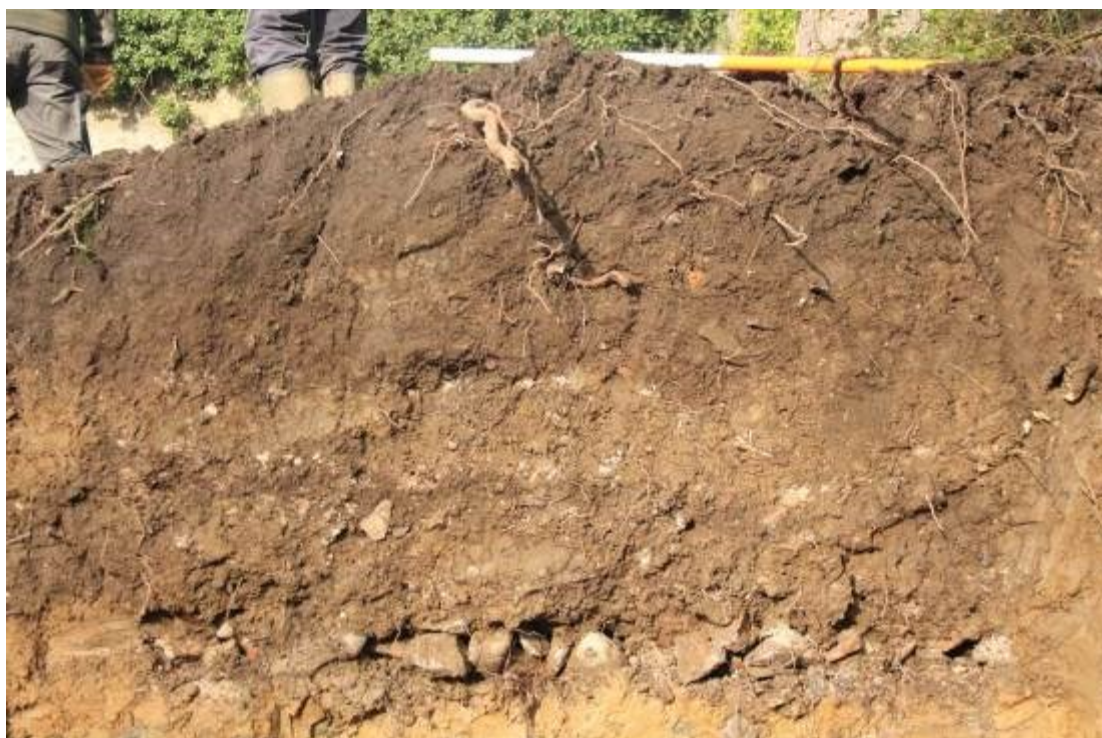
Photo 13: The southeast-facing section of the house area showing the pebble layer. 1m scale

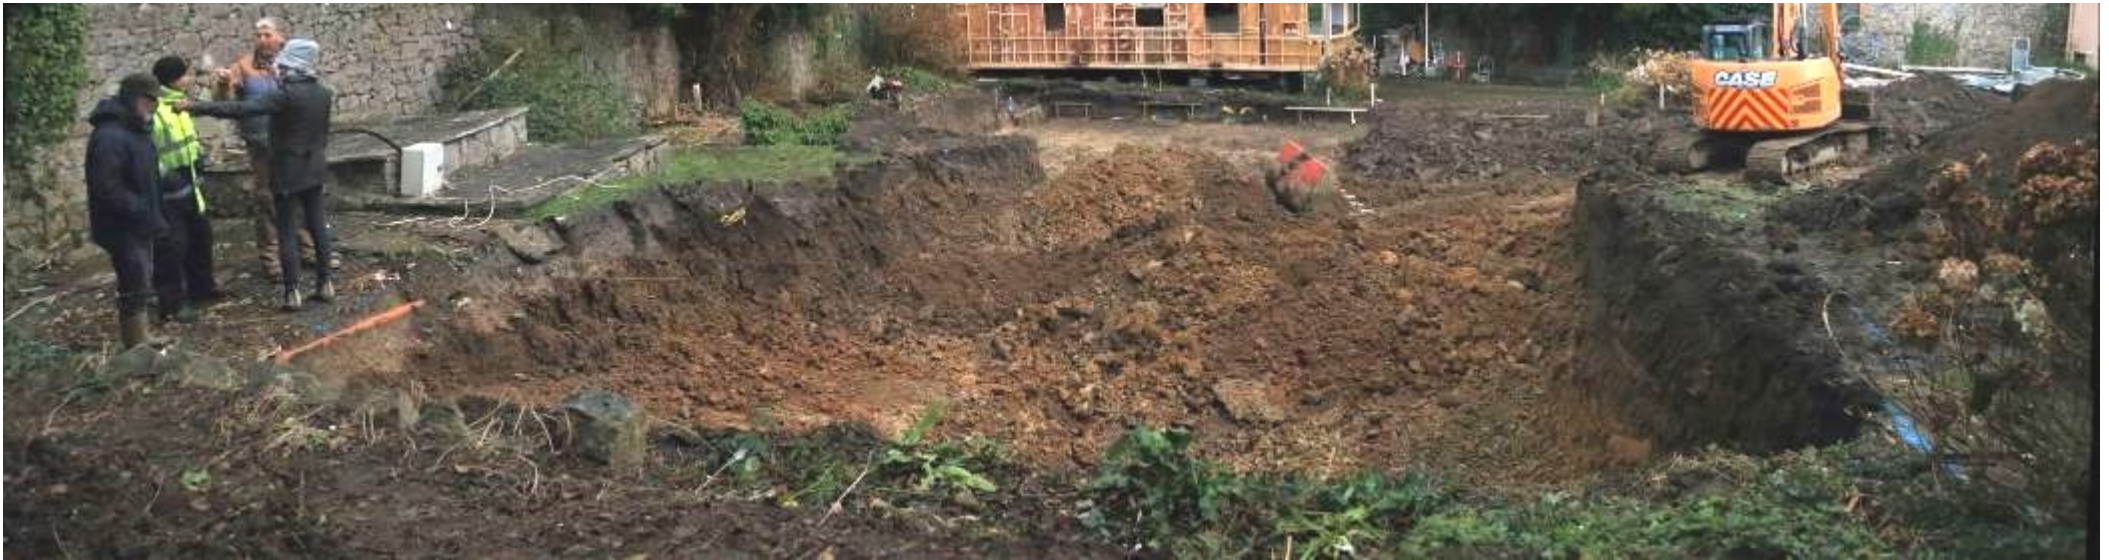
- 4.10 Photo 14 shows the whole of the house area after the machine excavations were completed.

Photo 14: Looking south-southwest at the house area after completion of machine excavations through potential archaeological layers.
