WOODLANDS, PARSONAGE LANE, BEGELLY, PEMBROKESHIRE: ARCHAEOLOGICAL WATCHING BRIEF

Prepared by DAT Archaeological Services
For: Sarah Lewis

RHIF YR ADRODDIAD / REPORT NO. 2018-10
RHIF Y DIGWILLIAD / EVENT RECORD NO. 111392

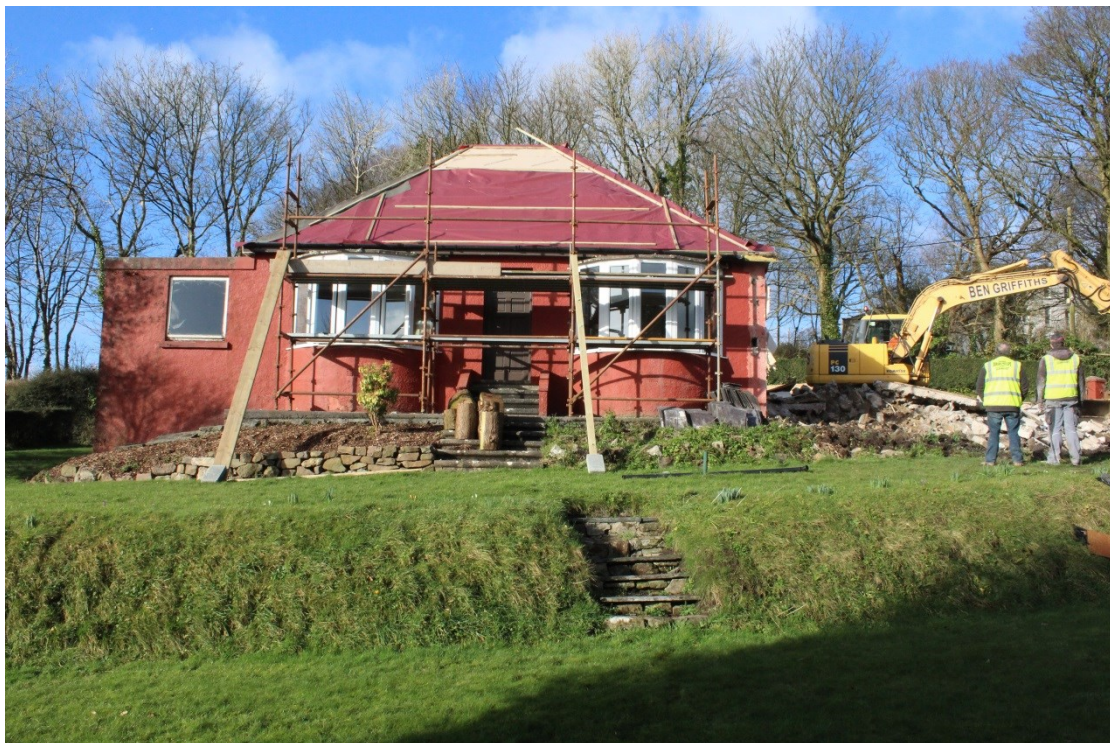
Photo 1: View north showing the original property of Woodlands and the raised landscaped platform on which it stands. The proposed extension lies to the right.

- 2.2.7 The Woodlands property is located on a fairly steep south facing slope. It is evident that significant landscaping was carried out prior to the construction of Woodlands as the building stands on a raised platform (Photo 1). The extent of this landscaped platform covered half of the eastern side of the proposed new extension.

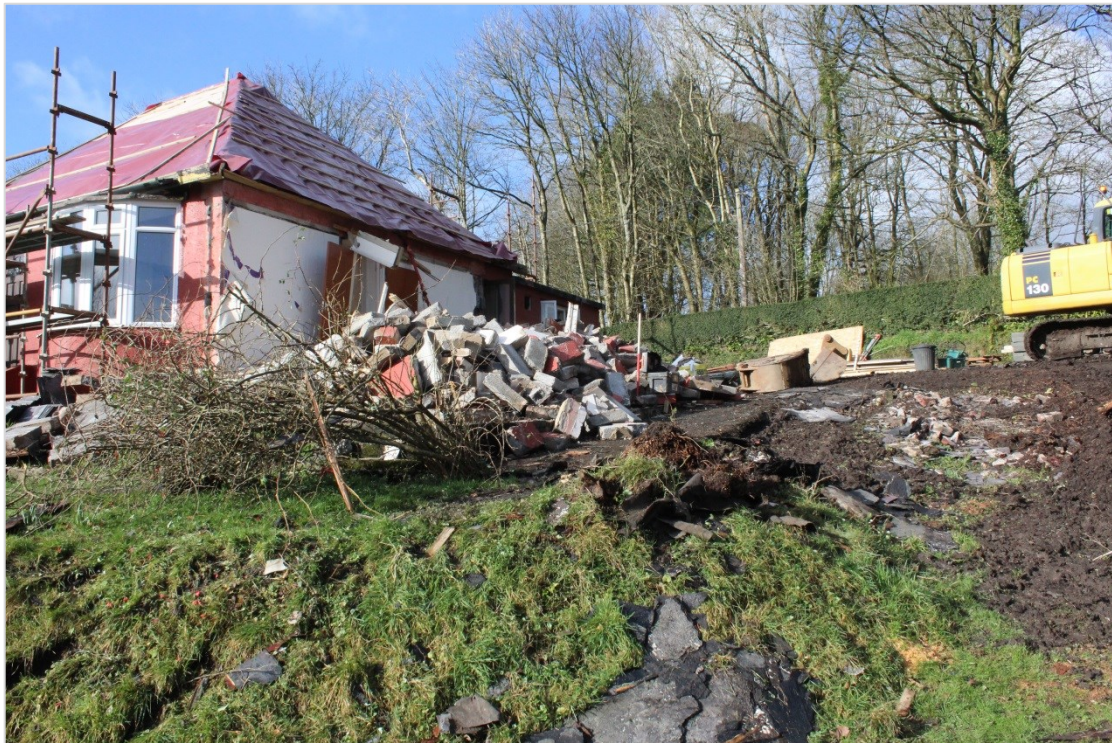
- 4.1 Prior to the arrival of the archaeologist, the previous extension had been demolished and the resultant material stockpiled on the concrete slab for the extension (Photo 2; Figure 5).

Photo 2: View northwest across development area towards Woodlands, showing demolition material for former extension on western side of site.

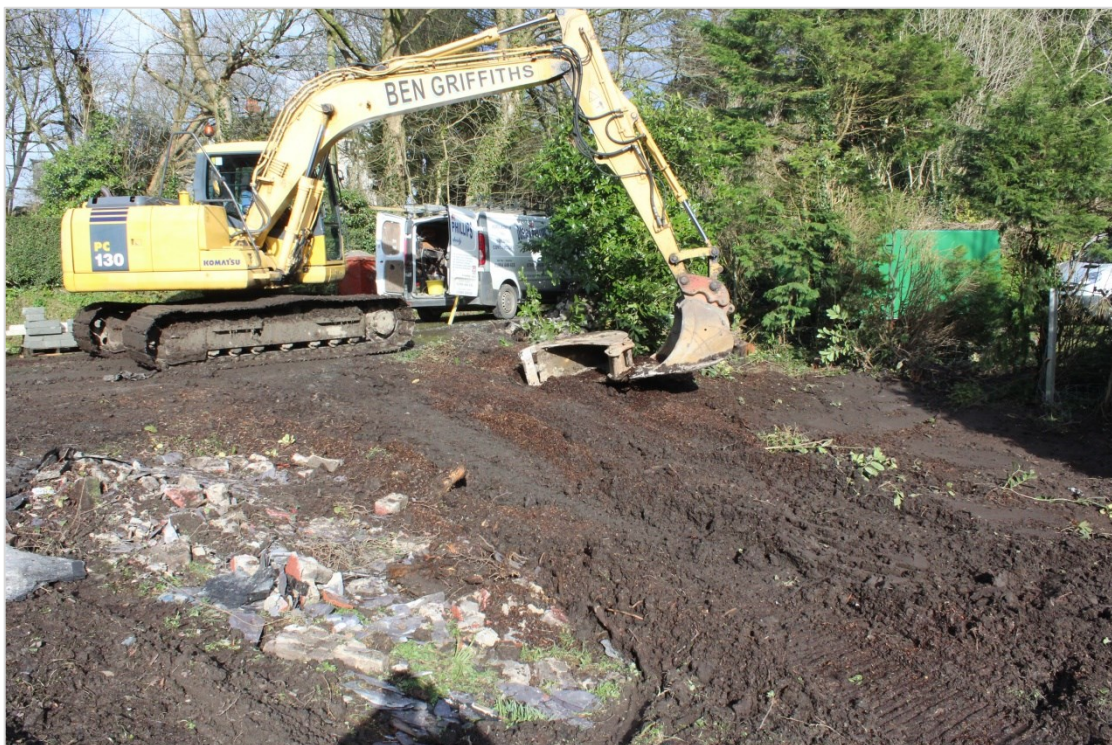
Photo 3: Area of the previous garden of Woodlands. The area had been de-vegetated and tracked over prior to the arrival of the archaeologist.

- 4.2 The eastern half of the development site (previously the garden for Woodlands) had been stripped of vegetation and partially tracked over by machinery (Photo 3; Figure 5).
- 4.3 The eastern (former garden) side of the proposed extension was machine stripped under archaeological supervision to the level of the top of archaeology (Figure 5). A series of irregular shaped features were identified cut into the underlying natural geology, which comprised a mix of orange and grey clay / stony rab (Photos 4 and 5).

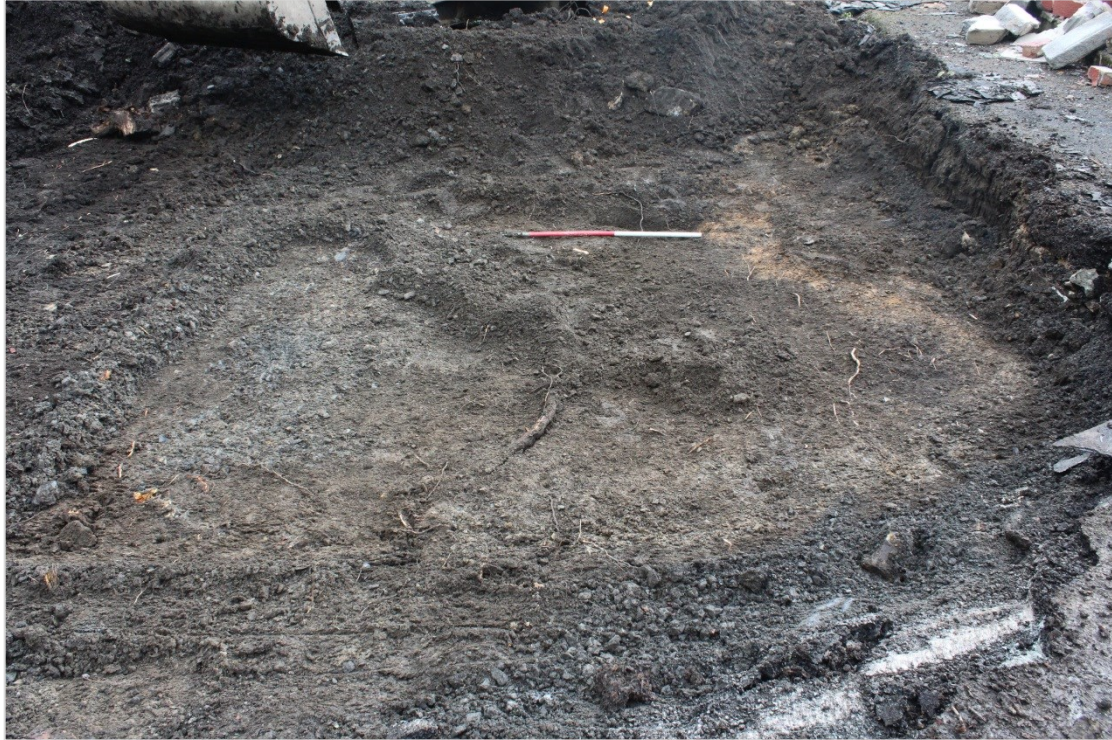
Photo 4: View south across the stripped and hand cleaned area showing natural soils and irregular shaped features.

- 4.4 Sample excavation of these irregular shaped features indicated that the fills comprised very friable dark grey brown silt clay soils with humic material and lots of roots (Photos 4 and 5). The edges and bases of the features were discernible, but they were irregular shaped and contained roots running into the natural soils. The features would appear to have been caused by vegetation and most likely tree throws (root bowls of former trees that stood in the area).
- 4.5 Fragments of 18th century Devon Gravel Tempered ware pottery were found during hand cleaning of the area, but it was definite which deposit or feature they originated from.

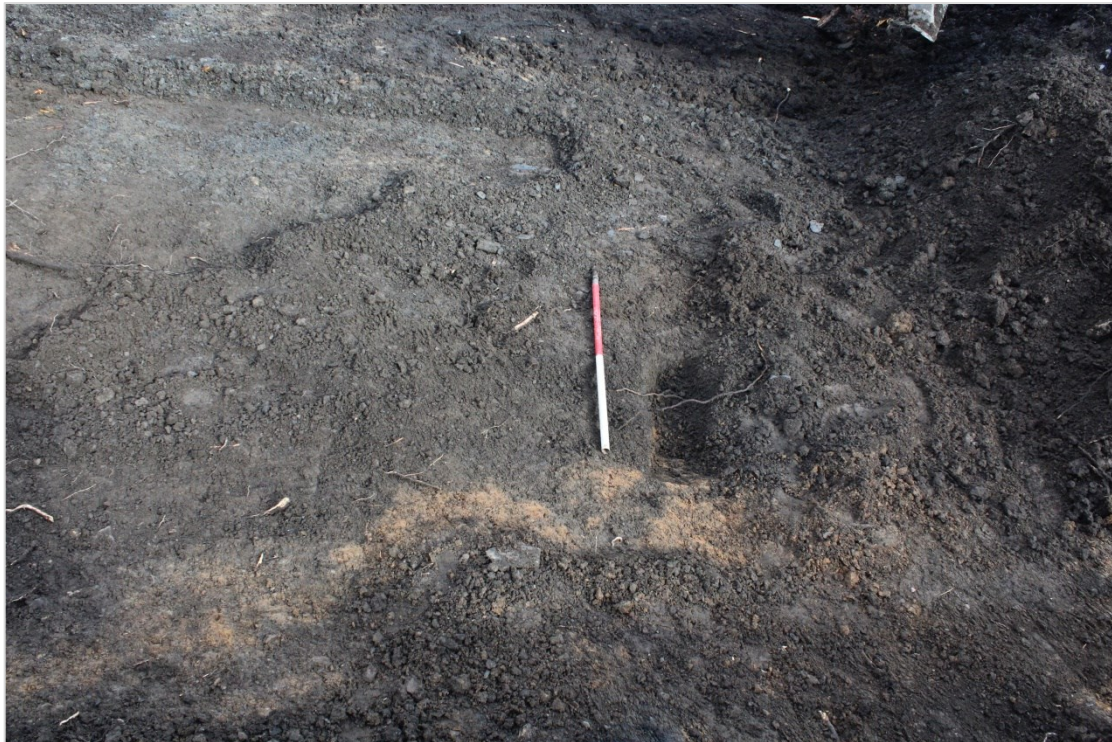
Photo 5: View east across the stripped and hand cleaned area on the eastern side of the development area showing irregular features and roots.

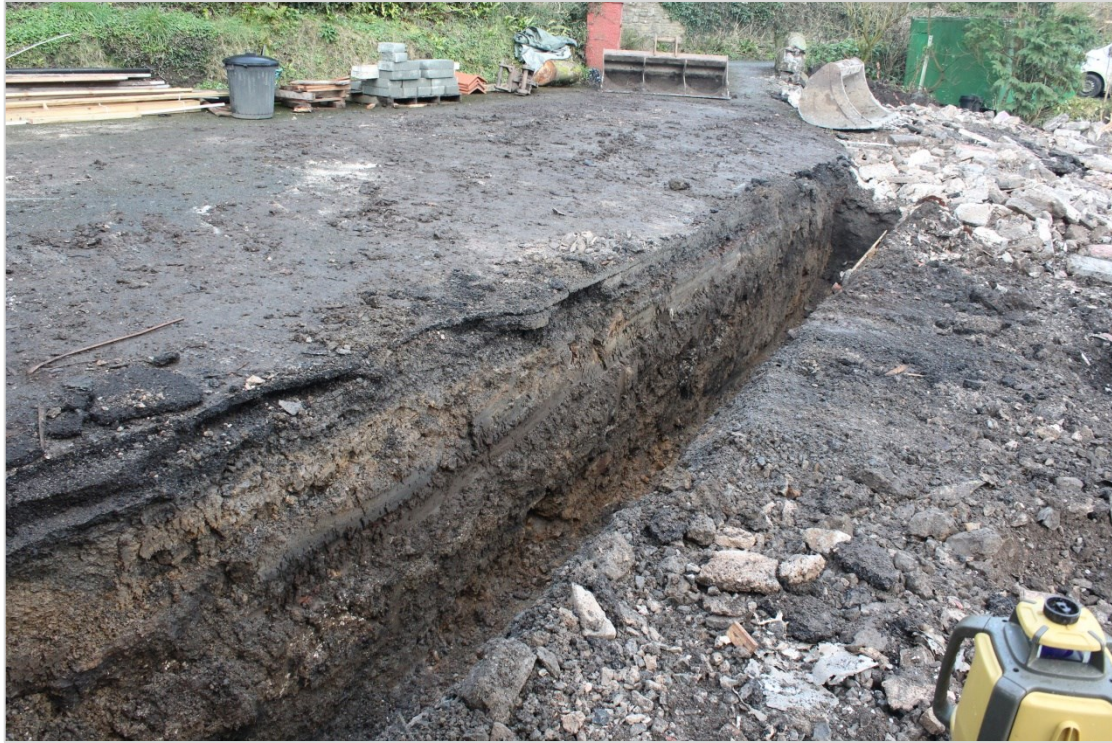
- 4.7 Each of the three observed foundation trenches were excavated through made ground associated with the former extension and landscaping associated with the original building of Woodlands (Photos 6 and 7). At the base of each trench natural ground was exposed, consisting of a mix of grey and orange clay/rab with distinct bands of fine coal material, believed to be natural as opposed to redeposited (coal deposits are known in the area).

Photo 6: Northern foundation trench excavated along the length of the extension showing layers of redeposited material above natural subsoils.

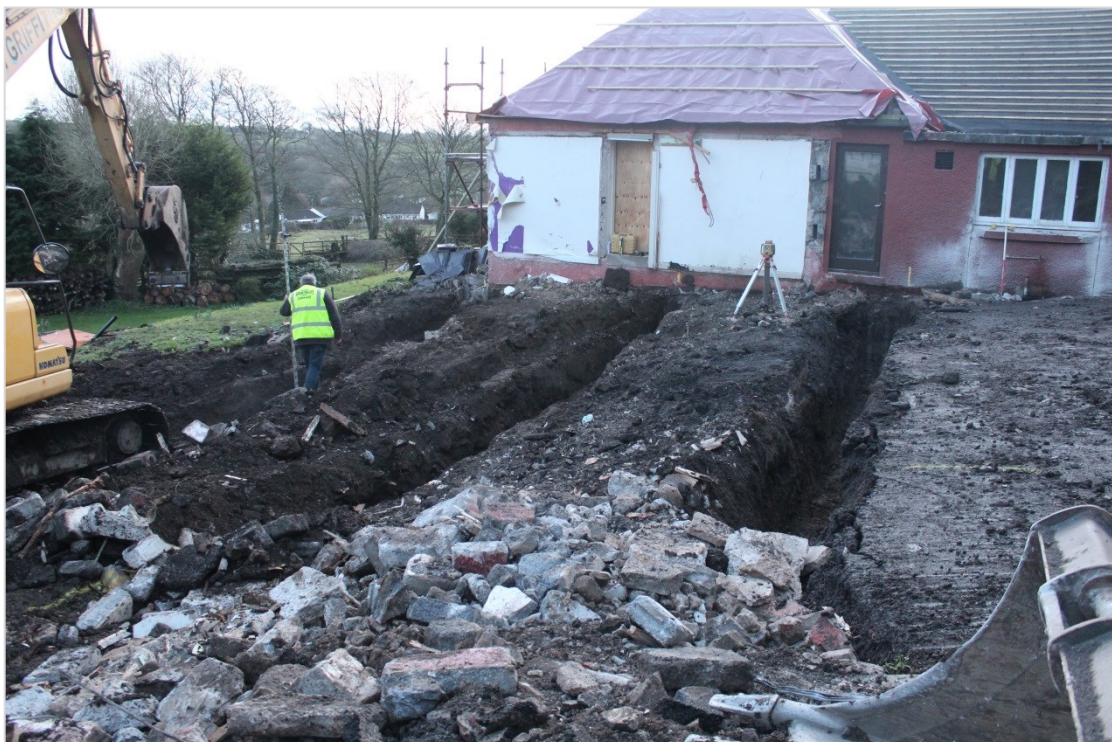
Photo 7: View roughly west-southwest across the footprint of the proposed extension following the excavation of the three foundation trenches.

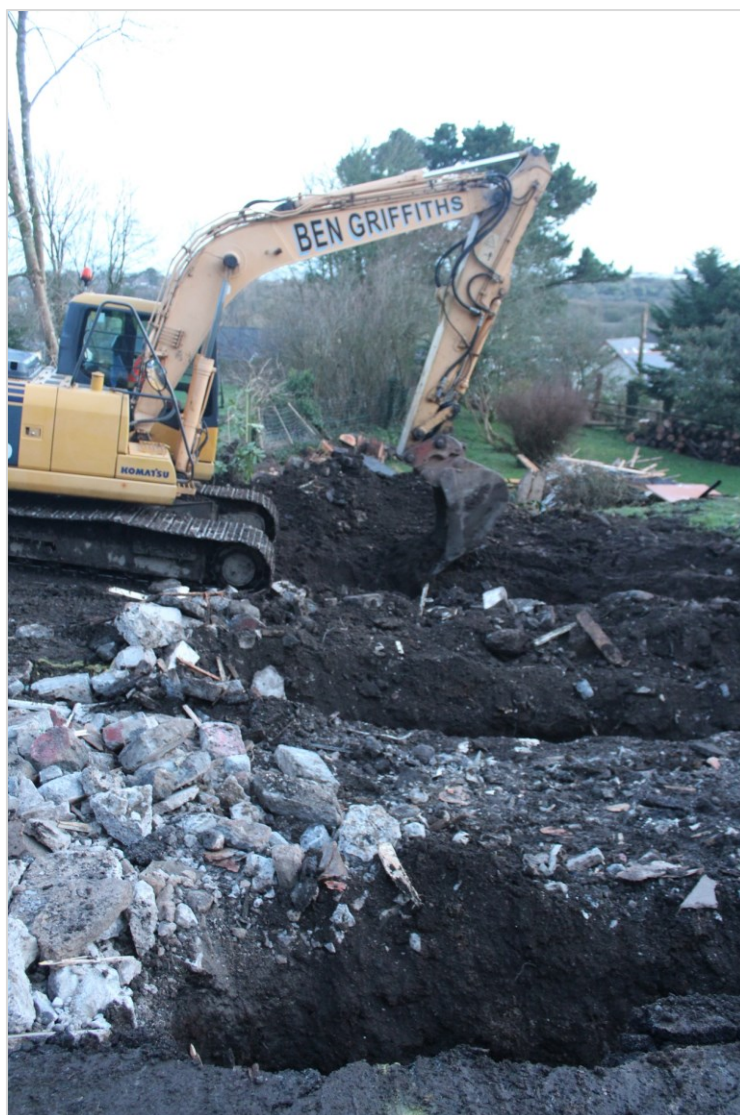
- 4.9 The three trenches were excavated deeper to the east to compensate for the sloping ground level on this side of the site and the softer nature of the underlying natural subsoils. The rubble from the former extension was gradually moved eastwards as the foundation trenches were excavated (Photo 7). The final foundation trench that would have run north to south at the eastern end of the three foundation trenches was not observed as it lay within the area previously stripped and recorded (Photo 8).

Photo 8: View south at eastern end of the three foundation trenches along the area where the eastern foundation trench was to be located.
