# **CHURCHVIEW, WHITCHURCH, SOLVA, PEMBROKESHIRE ARCHAEOLOGICAL WATCHING BRIEF**

RHIF YR ADRODDIAD / REPORT NO. 2018/16  
RHIF Y DIGWYLLIAD / EVENT RECORD NO. 112038

Mawrth 2018  
March 2018

**Hubert Wilson**

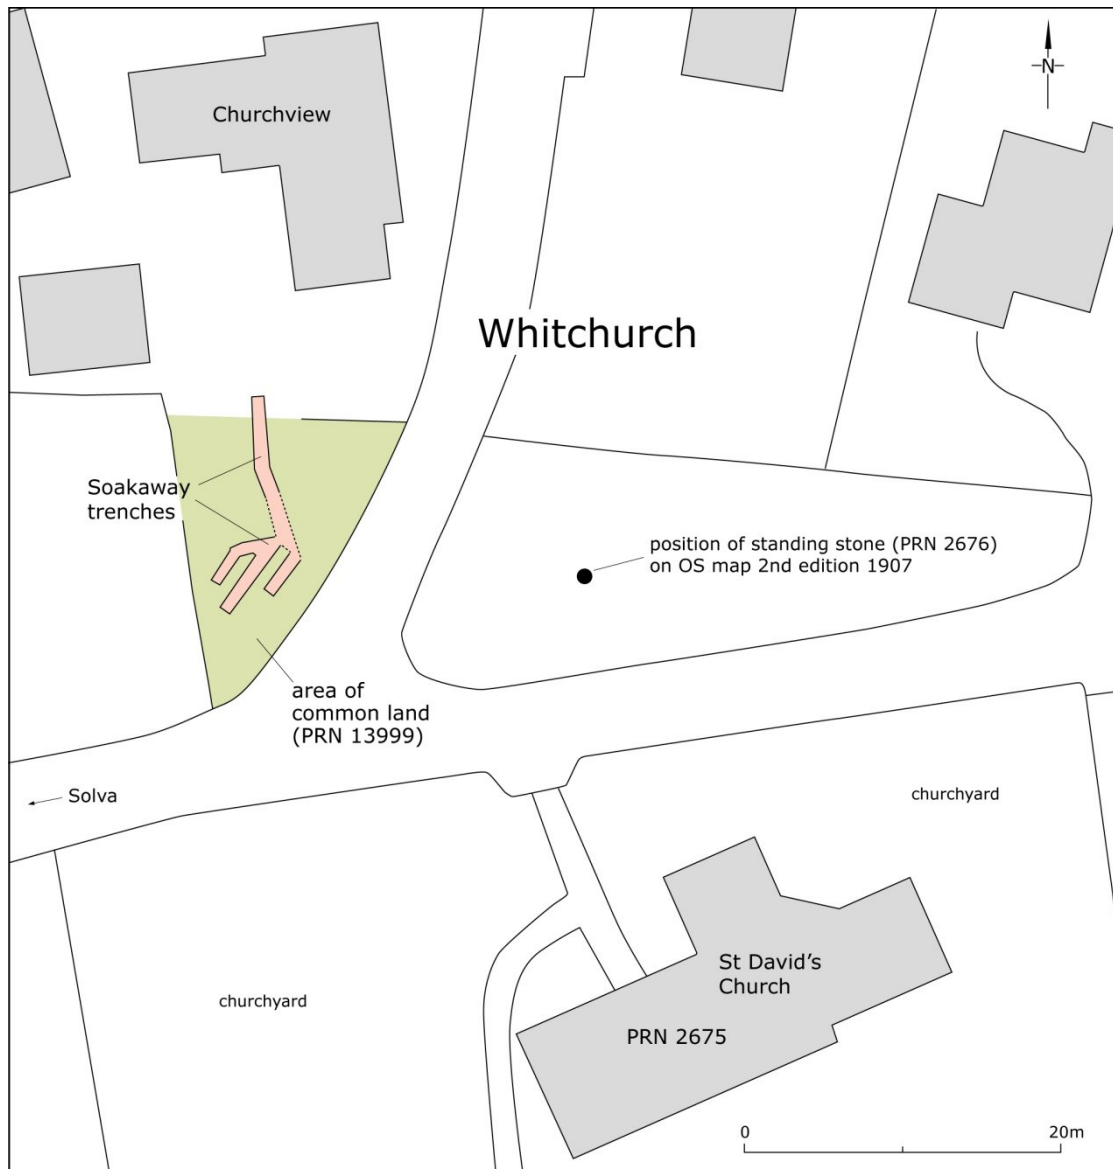
**Figure 6:** Location of soakaway trenches on common land south of Churchview, Whitchurch.

- 3.1.1 A watching brief was undertaken during groundworks at the site which had the potential to expose, damage or destroy underlying archaeological remains. This comprised a series of investigation trenches opened across the northern half of the development site (Figure 6; Photos 1-6).

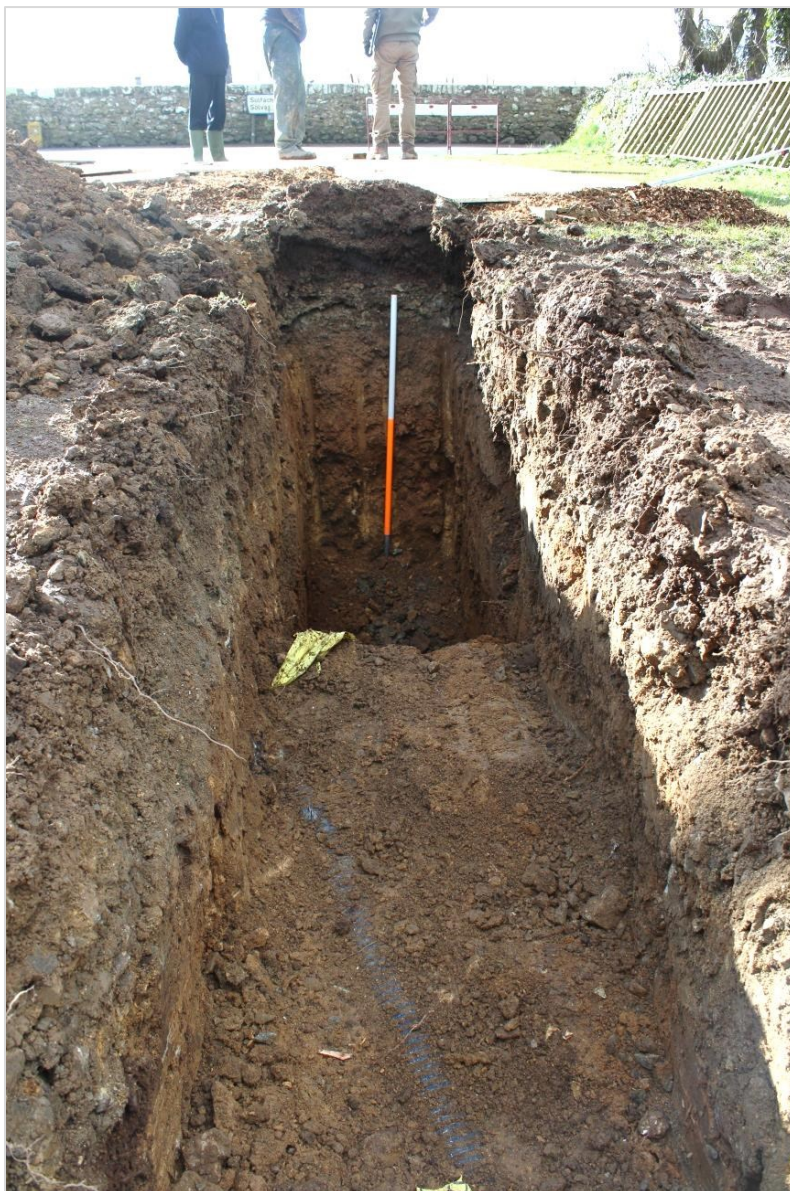
- 4.2 Trench 1 was 6.3m long and 0.7m wide and at least 1.6m deep. The topsoil (01) was a medium brown, silty-clay and 0.3m deep. Below this stood a 0.2m thick layer of mixed sandy-clay (02), with small to medium stone inclusions. The natural geology (03), which stood 0.5m below the surface, consisted of an orange-brown, sandy-clay with the odd stone inclusion (Photos 1 and 2).

**Photo 1:** View south along Trench 1. Deposit (02) (modern track) visible in facing section. 1m scale.

- 5.3 The watching brief identified a 0.2m thick deposit of mixed clay and stone (02) directly below the topsoil. This layer was visible in all of the trenches. The deposit is modern in date and is possibly material used to construct a temporary track when the first septic tank was installed sometime in the 1980s.

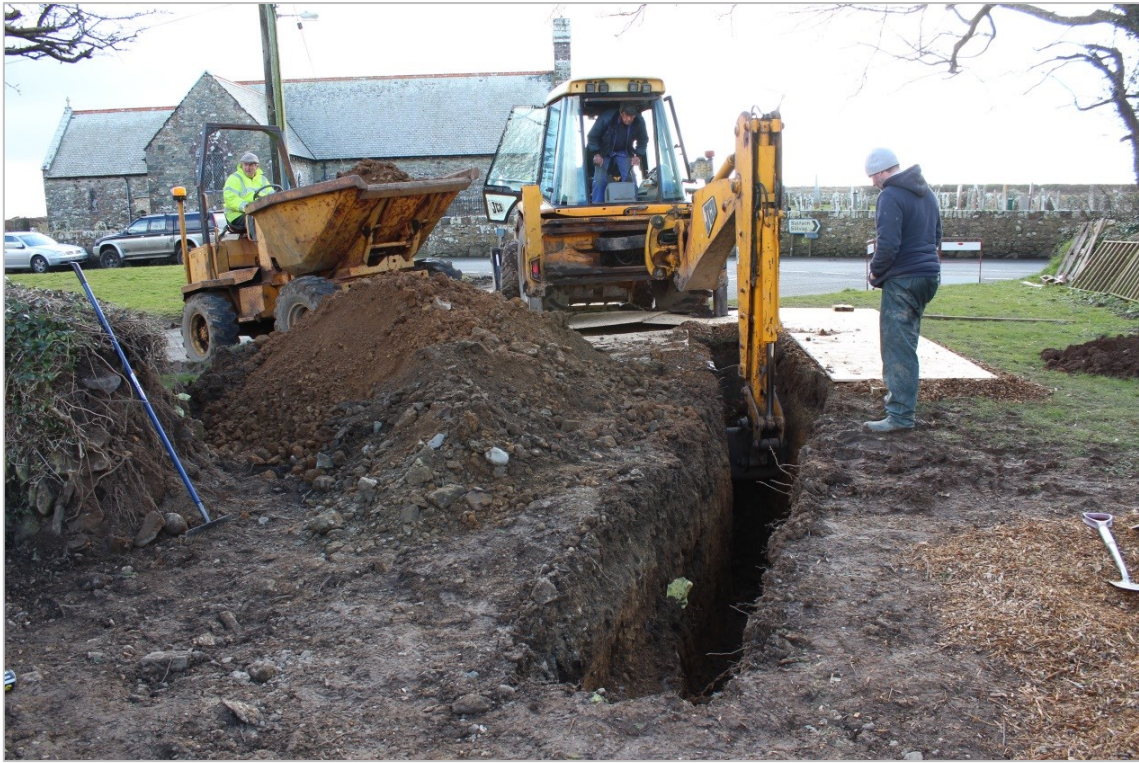
**Photo 2:** View south along Trench 1 excavated within common land.

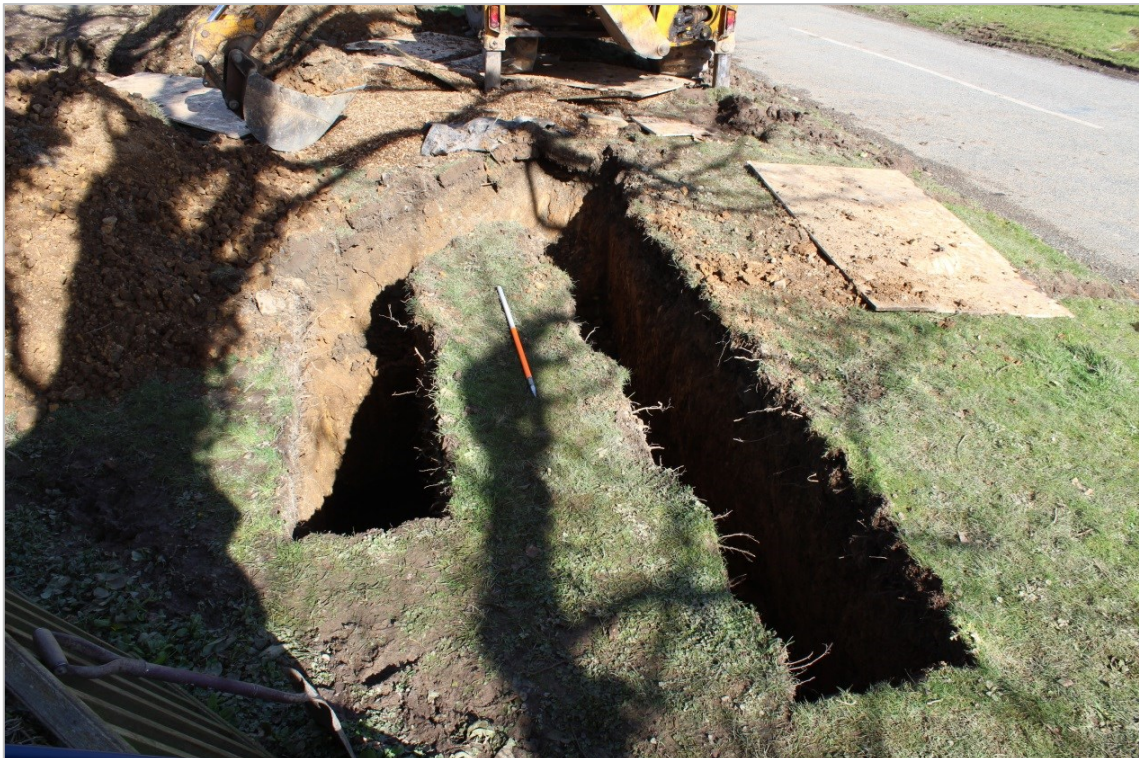
- 4.3 Trench 2 was approximately 5.2m long, 0.7m wide and 2.3m deep. The soil profile consisted of a medium brown, silty-clay (01) below which stood the natural geology (03). At the northern end of the trench the deposit (02) was visible between (01) and (03) (Photos 3, 4, 5 and 6).

- 4.4 Trench 3 was 5.2m long 0.7m wide and 2.2m deep. The soil profile consisted of topsoil (01), a medium brown, silty-clay below which stood the natural geology (03). At the north end of the trench the modern deposit (02) was visible between (01) and (03) (Photos 3, 4 and 6).

**Photo 3:** View northeast along Trenches 2 and 3. 1m scale

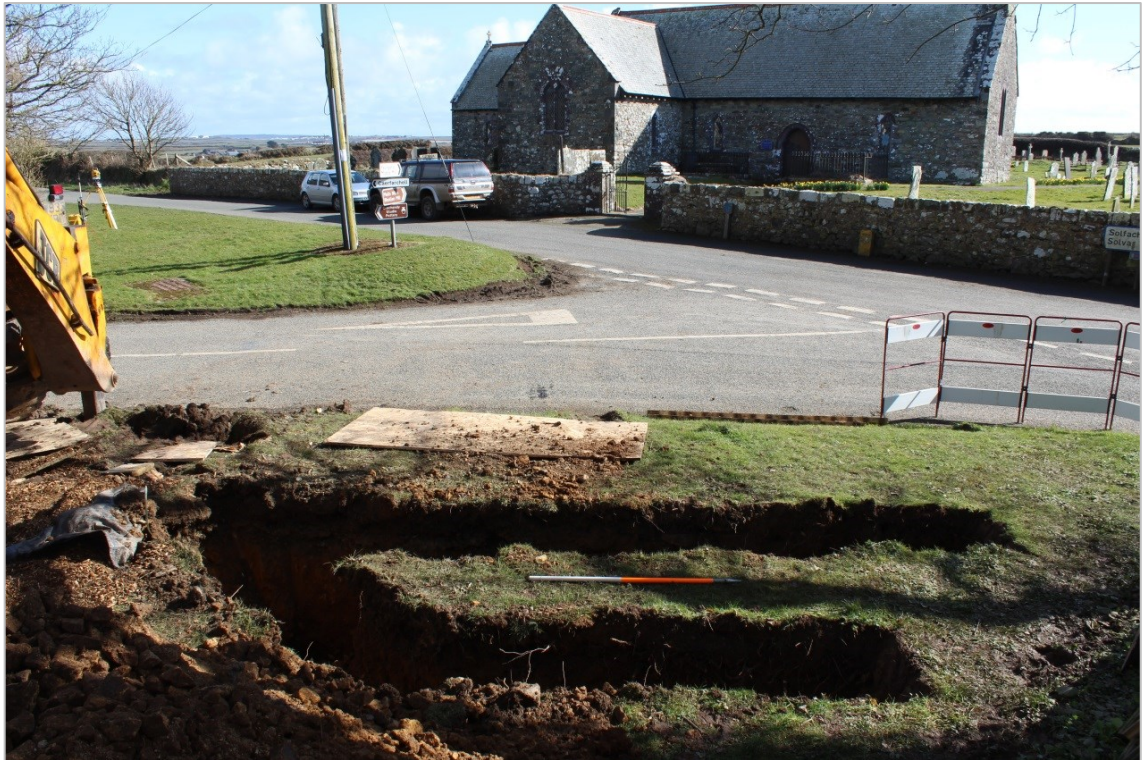
**Photo 4:** View southeast showing Trenches 2 and 3 and St David's Church.  
1m scale

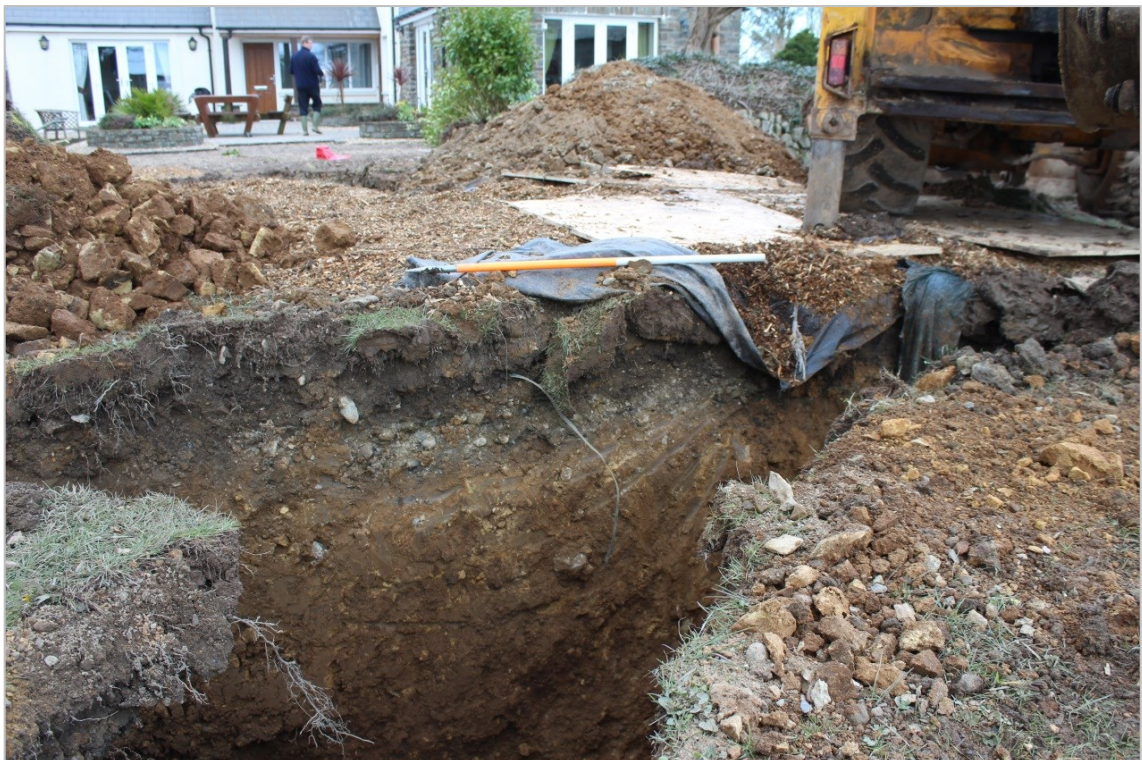
**Photo 5:** View north showing deposit (02) (modern track) in section. 1m scale

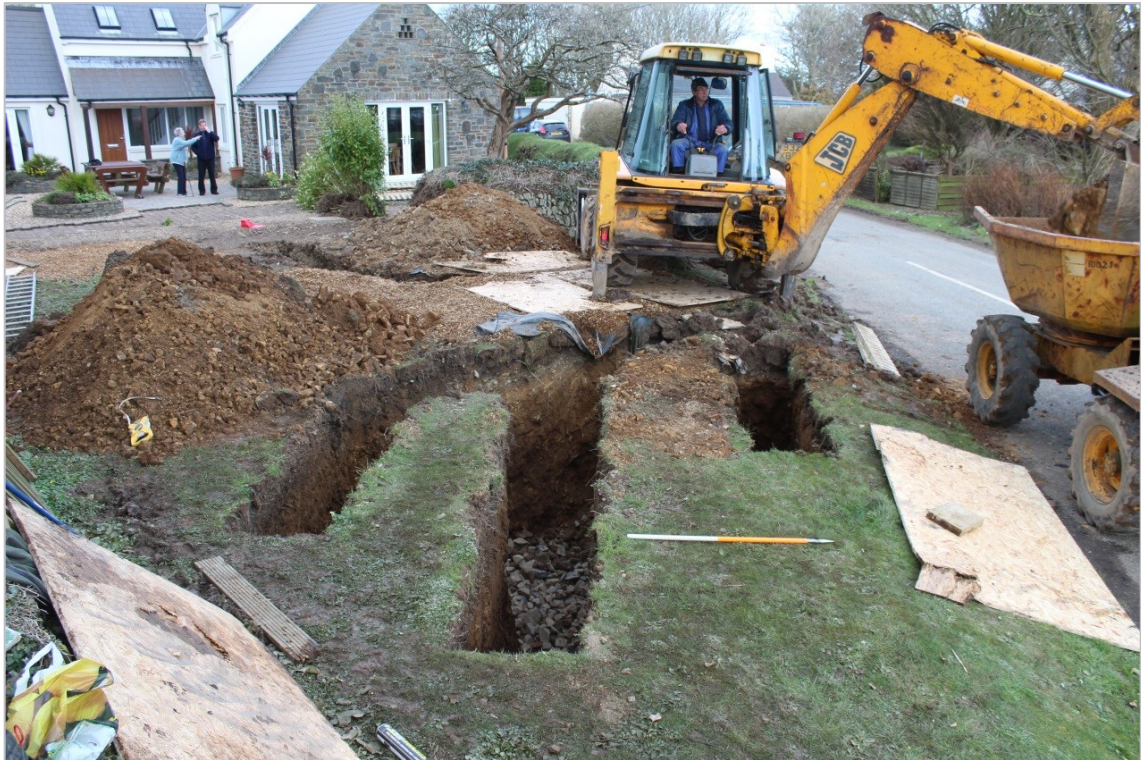
- 4.5 Trench 4 was 2.9m long, 0.7m wide and 2m deep. The soil profile consisted of topsoil (01) which stood directly upon the natural geology (03). The deposit (02) was visible in the northern half of the trench section situated between (01) and (02) (Photo 6).

**Photo 6:** View northeast showing herringbone arrangement of trenches.  
1m scale
