# LLWYN, LLANFAIR ROAD, LAMPETER, CEREDIGION: ARCHAEOLOGICAL WATCHING BRIEF

RHIF YR ADRODDIAD / REPORT NO. 2018-20  
RHIF Y DIGWILLIAD / EVENT RECORD NO. 112096

**LLWYN, LLANFAIR ROAD,  
LAMPETER, CEREDIGION:  
ARCHAEOLOGICAL WATCHING BRIEF**

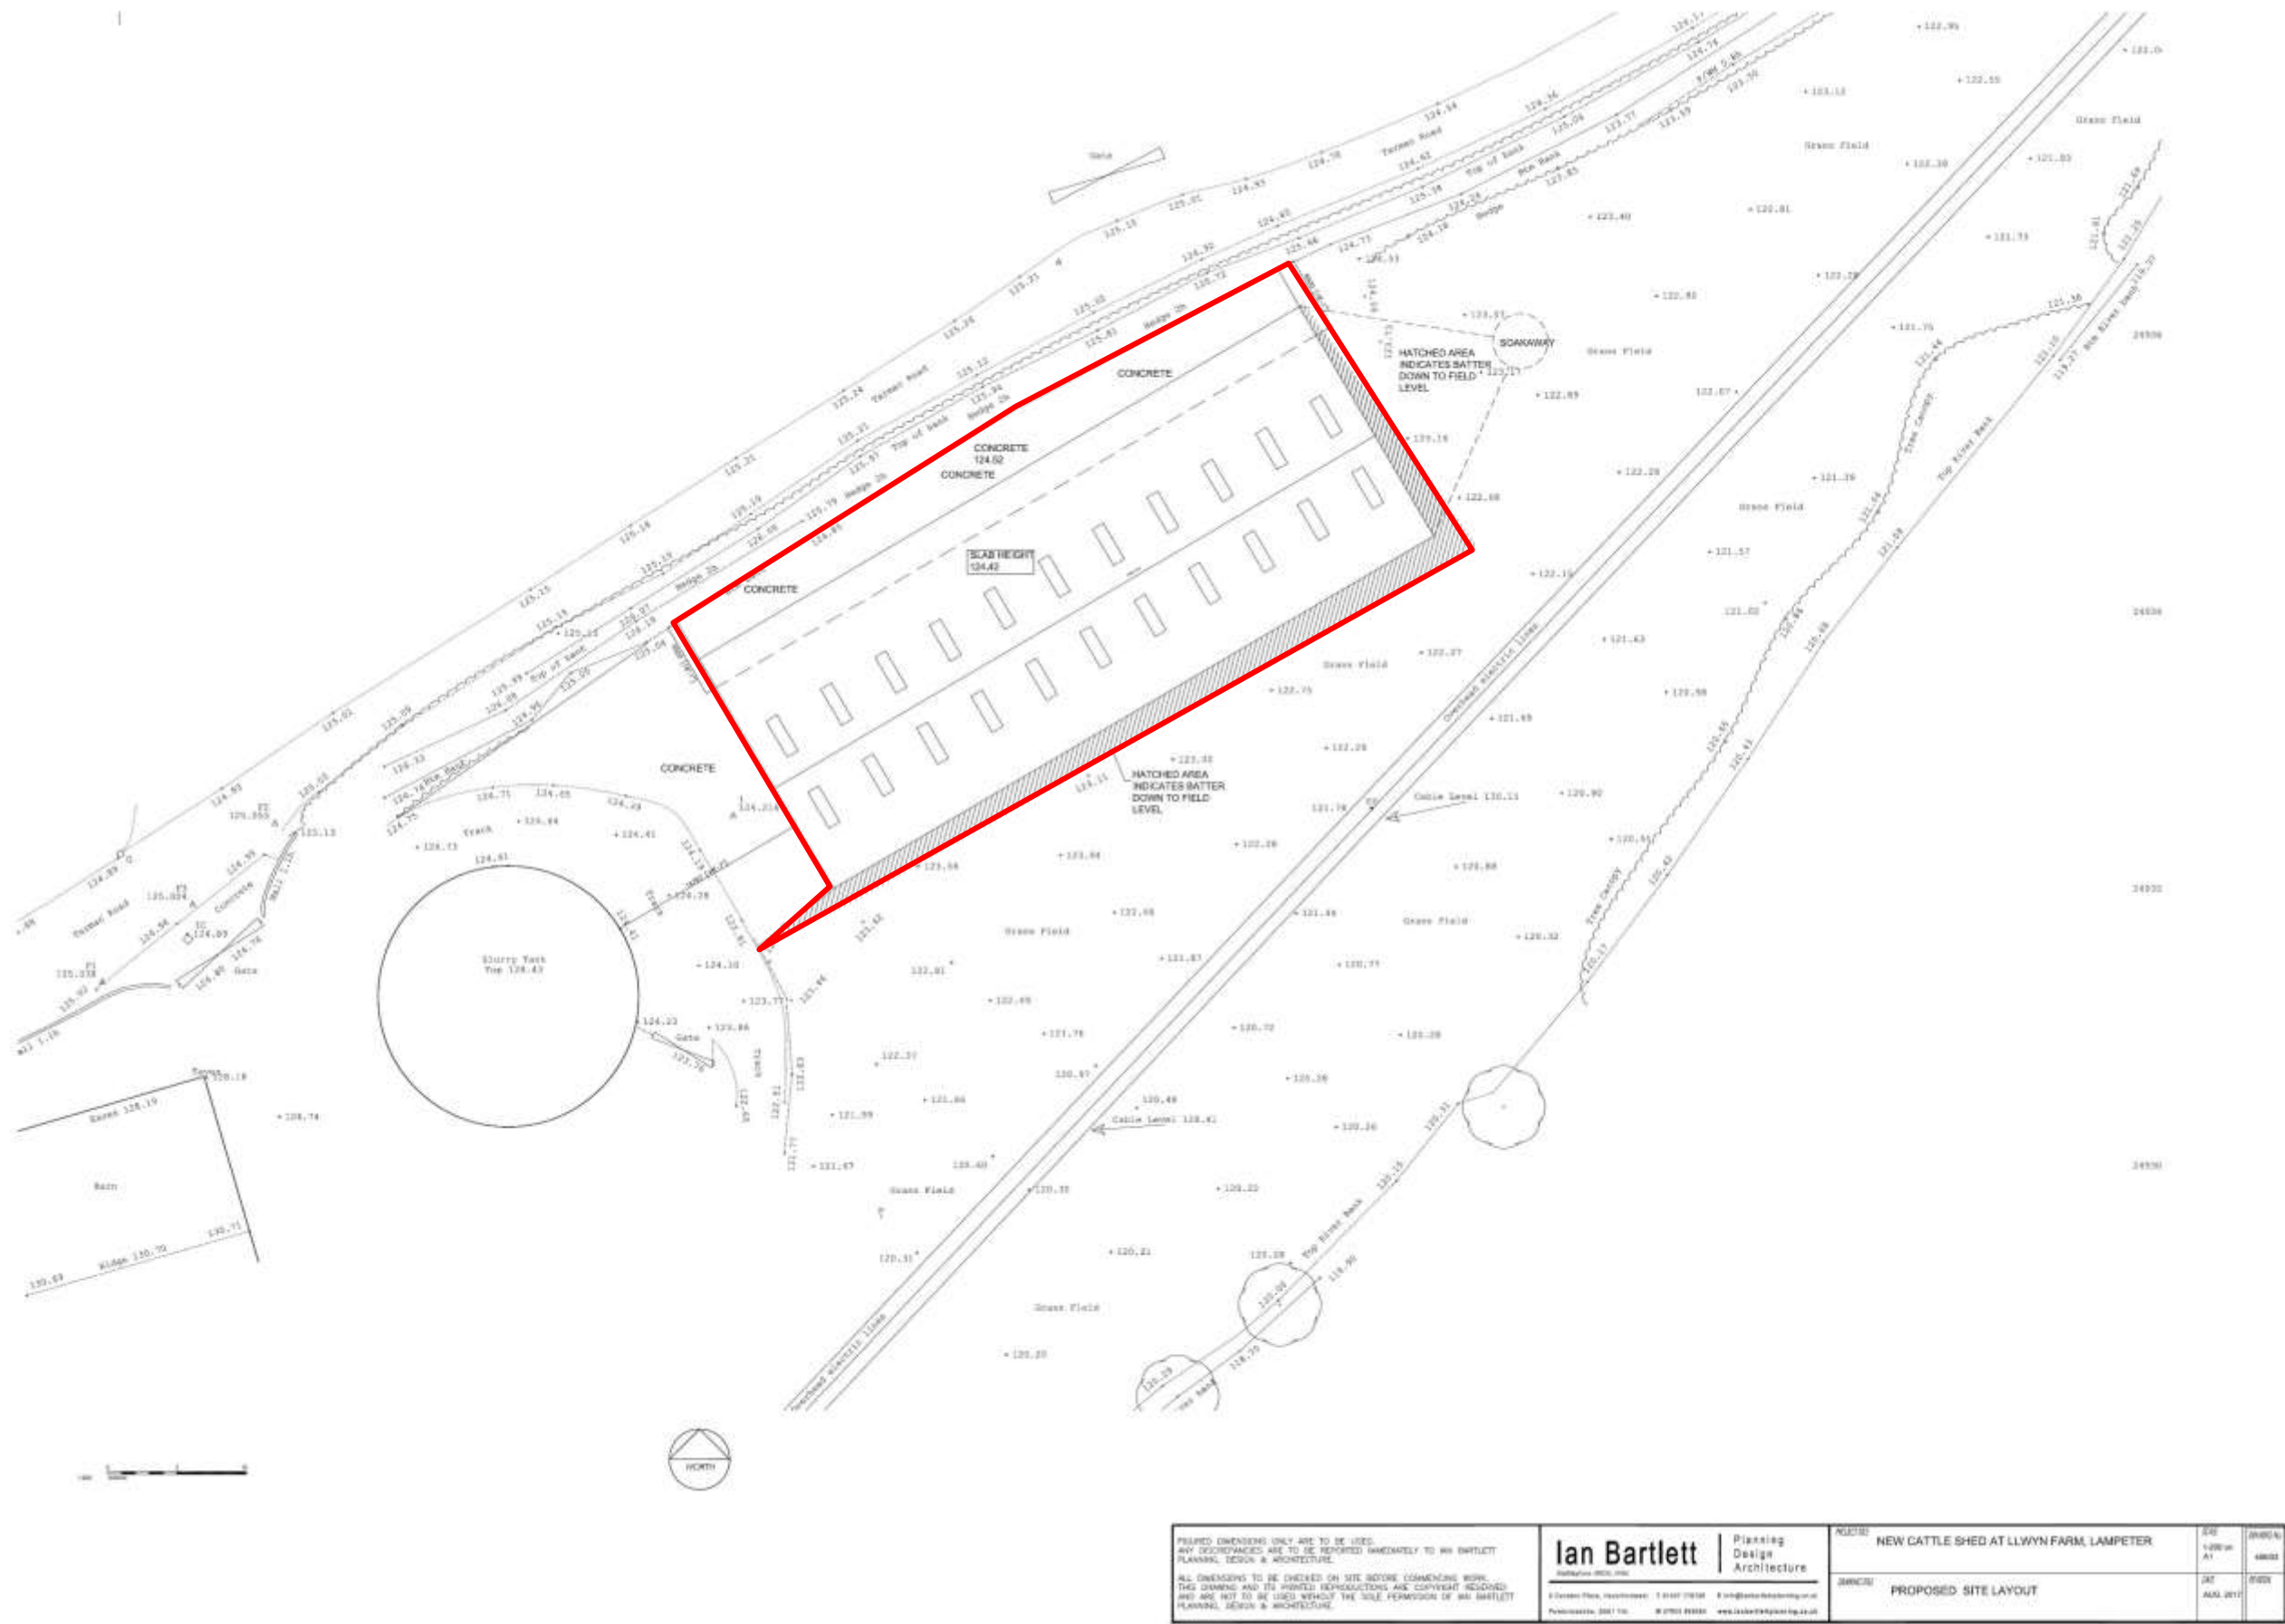
**Figure 2:** Development proposals plan showing footprint of proposed new agricultural building (red outline) at Llwyn Farm, Llanfiar Road, Lampeter (supplied by client)

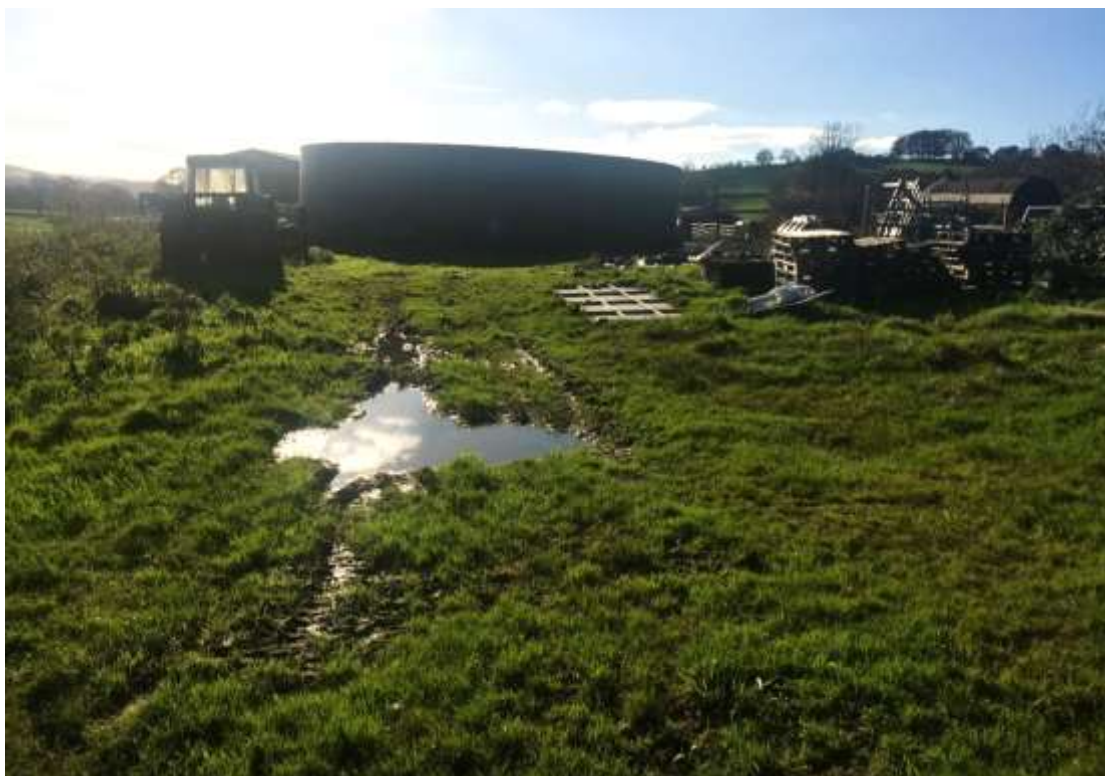
Photo 1: View southwest across site area towards Llwyn Farm  
during site visit 27.10.18

- 2.1.1 Llwyn Farm is located on the southern side of Llanfair Road midway between Lampeter to the west and Llanfair Clydogau to the east in Ceredigion (SN 6015 4934). It lies on a river terrace above the Afon Teifi.
- 2.1.2 The site area itself sloped down quite steeply from Llanfair Road to a relatively level area within which the proposed agricultural building will be placed. The land then drops down to the south onto a further gravel terrace above the Afon Teifi. A general slight drop in ground level was also noticed to the west towards the existing farm buildings of Llwyn Farm.
- 2.1.3 The area was previously used for storage, farm machinery and equipment (Photo 1), with piles of hardcore and rubble which was mostly moved during the watching brief (for use as a base for the new building).

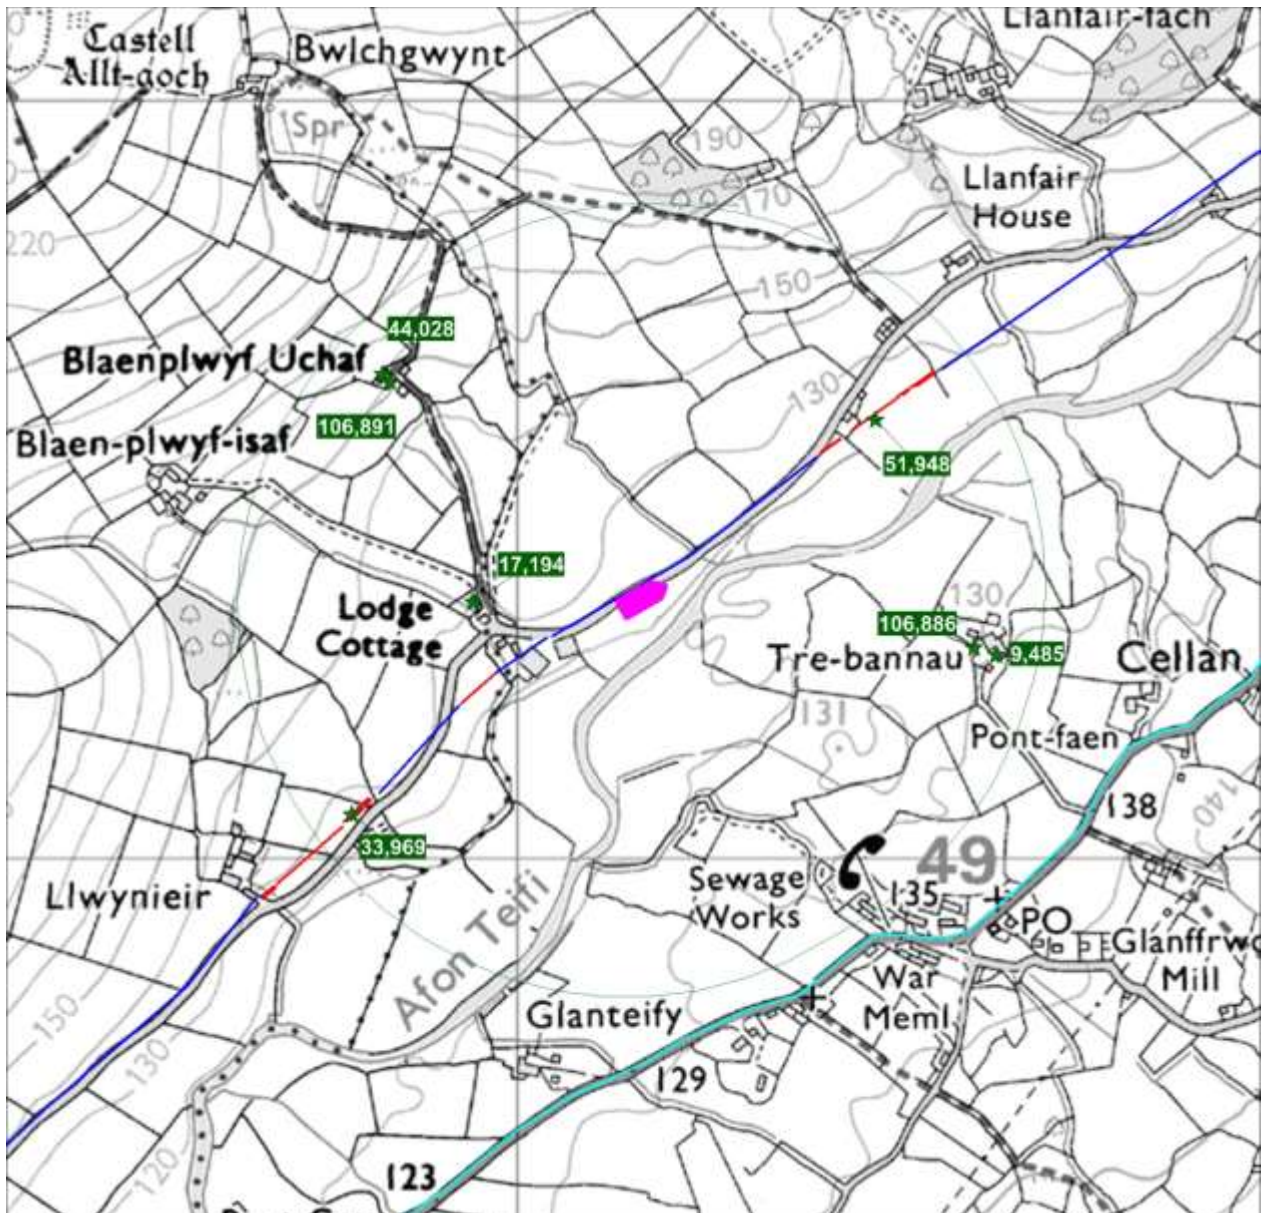
**Figure 3:** Map showing known archaeological sites recorded on the Dyfed Historic Environment Record within 500m of the proposed development (magenta area).

The Roman road is shown as a blue line where it is projected and red where it has been confirmed by cropmark evidence

- 2.2.3 Historic farmsteads are also recorded at Trebrennau (Tre-Bannua) to the east (PRN 106886) and at Blaenplwyf Uchaf to the northwest.
- 2.2.4 Of most significance to the development site are two records relating to a Roman road line leading northeast from Carmarthen, through Lampeter and on towards Bremia Roman Fort, south of Tregaron. The line of the Roman road has been previously confirmed through cropmark evidence to the northeast (PRN 51948) and southwest (PRN 33969) but runs below the existing road line along the northern edge of this development site. Figure 3 shows the road line running as a blue and red line, where blue represents the projected road line and red the areas which have been confirmed through cropmark evidence.

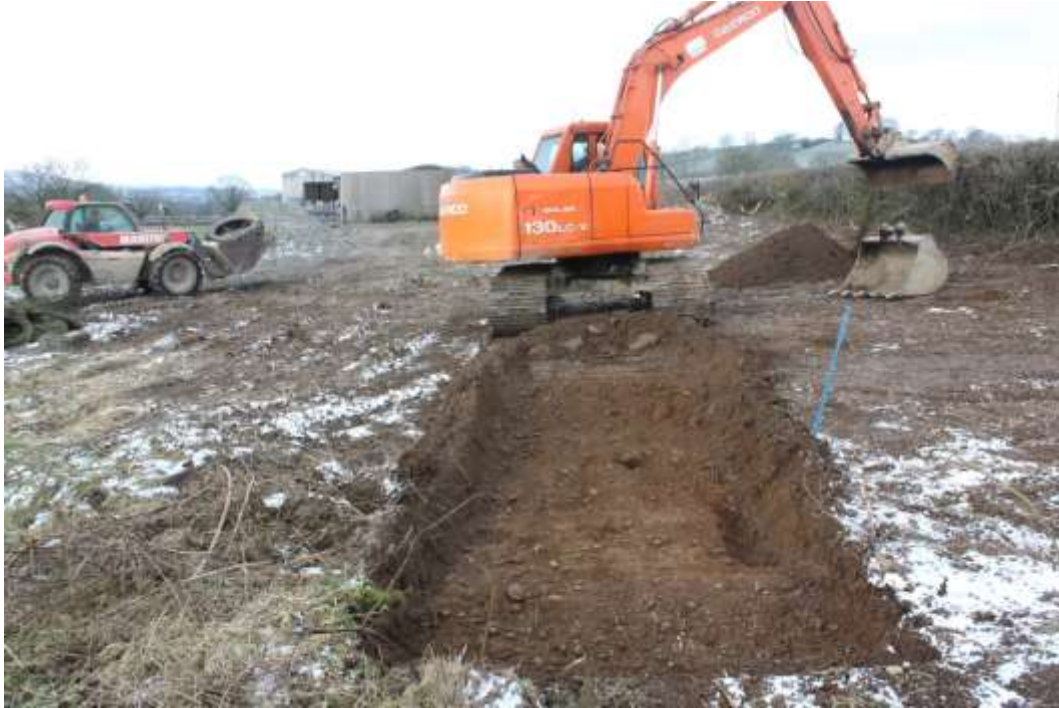
Photo 2: Start of topsoil strip

- 4.1 A single visit to the site was required to observe groundworks, undertaken during topsoil stripping of the footprint of the proposed new agricultural building.
- 4.2 A 13 ton 360 machine (Daewoo 130 LC-V; Photo 2) was used with a toothless ditching bucket to remove topsoil across the site area, which included the footprint of the proposed agricultural shed with an additional c.2m strip around its edges.

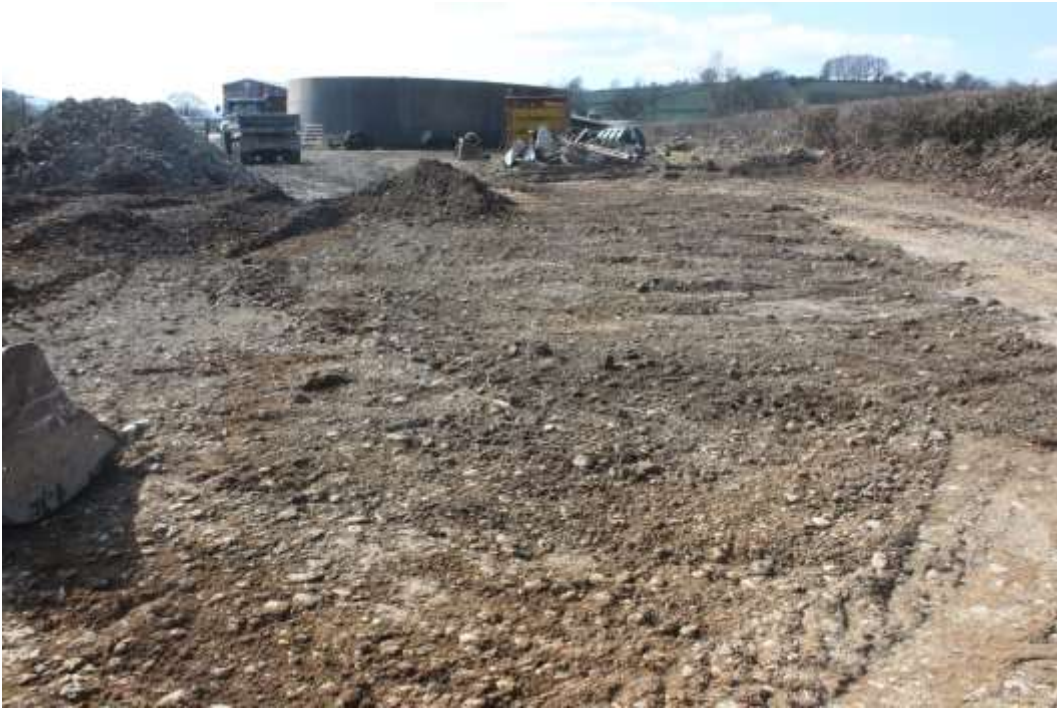
- 4.3 The topsoil comprised a reddish brown to dark brown clayey sand silt soil, with common small gravels and pebbles. The topsoil was generally thicker towards the northern edge of the site and at its eastern end, with a maximum depth of 0.30m. Towards the south it was around 0.15m. On the western side of the site it was even shallower in places.
- 4.4 It was known that the majority of the site area, excluding the eastern end, had previously been used as a silage clamp. It was thought likely that the topsoil had been removed before this was located here and it was evident that an imported layer of stones had been laid down (Photo 3). In this area topsoil was patchy and thin.

Photo 3: View southwest across western side of site area showing thin topsoil and remnants of stone levelling layer for former silage clamp

- 5.2 It was evident that the majority of the western side of the footprint of the proposed agricultural building had been previously disturbed through topsoil stripping and the laying of stone for the base of the former silage clamp that was located in the area. This had clearly disturbed the top of the natural ground surface and no archaeological remains were identified in this area. Potentially no archaeology was ever present or alternatively was removed by these previous groundworks.

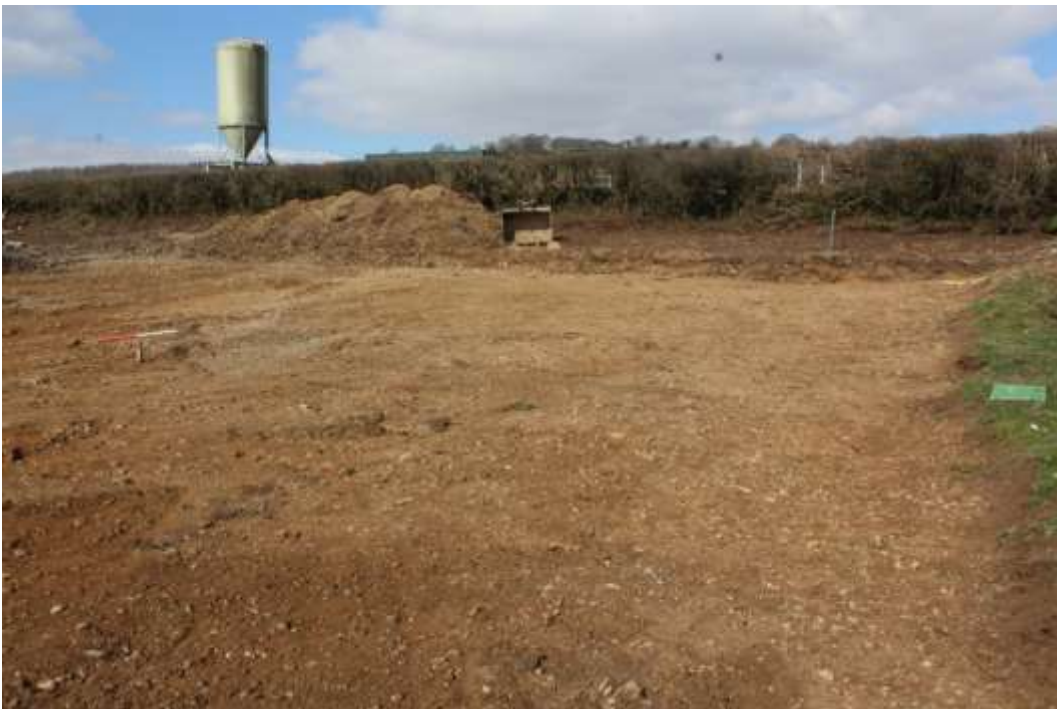
- 4.5 At the eastern end of the site clear areas of natural sands and gravels were exposed (Photos 4, 5 & 6). These ranged from mid brown or brown fine sandy silts with mineralisation mottles; finer gravels and small pebbles in a brown sand clay silt matrix; larger gravels and pebbles in a greyer silt sand matrix; orange or reddish brown sands and gravels. These were visible in irregular bands across the site. Cleaning and partial excavation confirmed that they were of natural origin.

Photo 4: View north across eastern side of site area

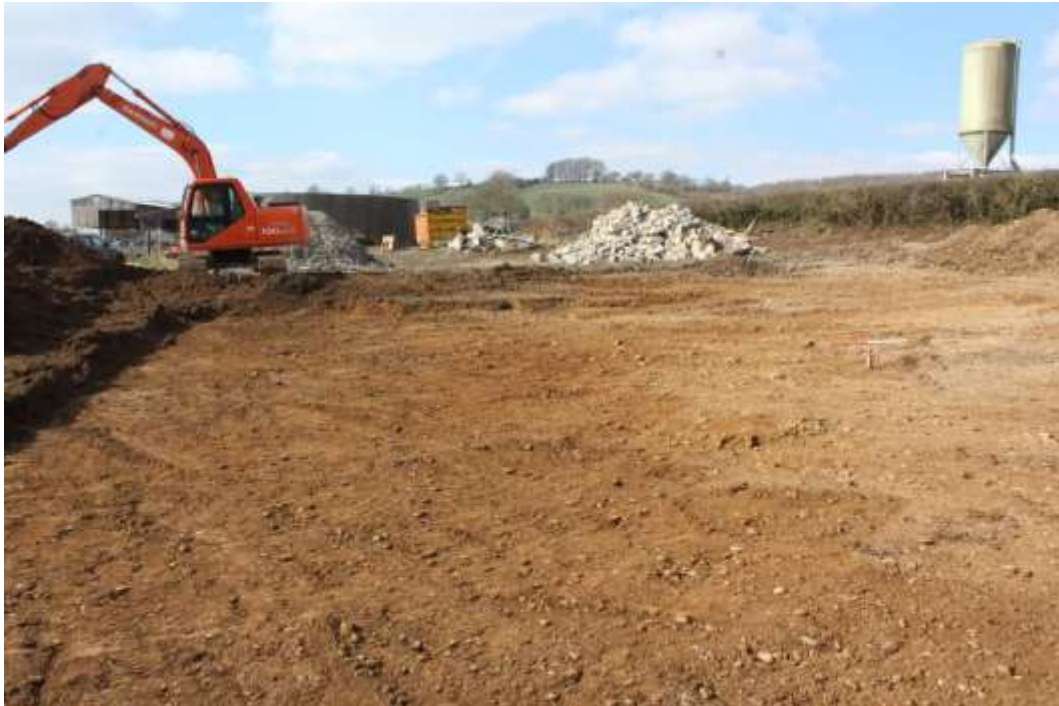
Photo 5: View southwest across eastern side of site area

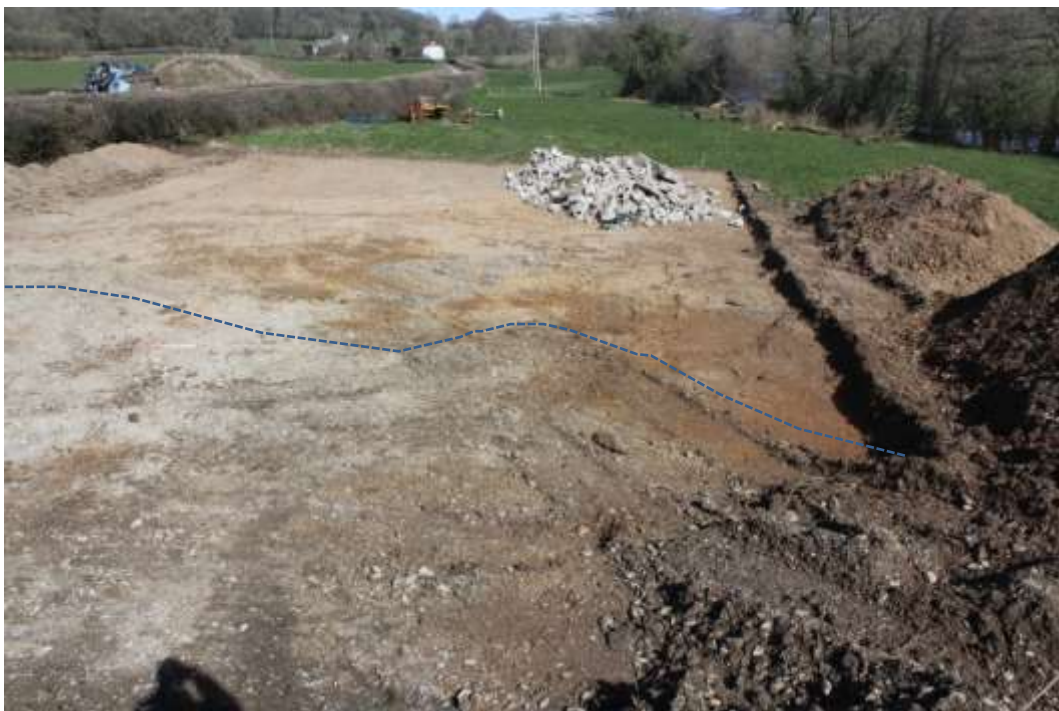
Photo 6: View northeast across site area showing change from former silage clamp area and stone in foreground to natural sands and gravels beyond (blue line)

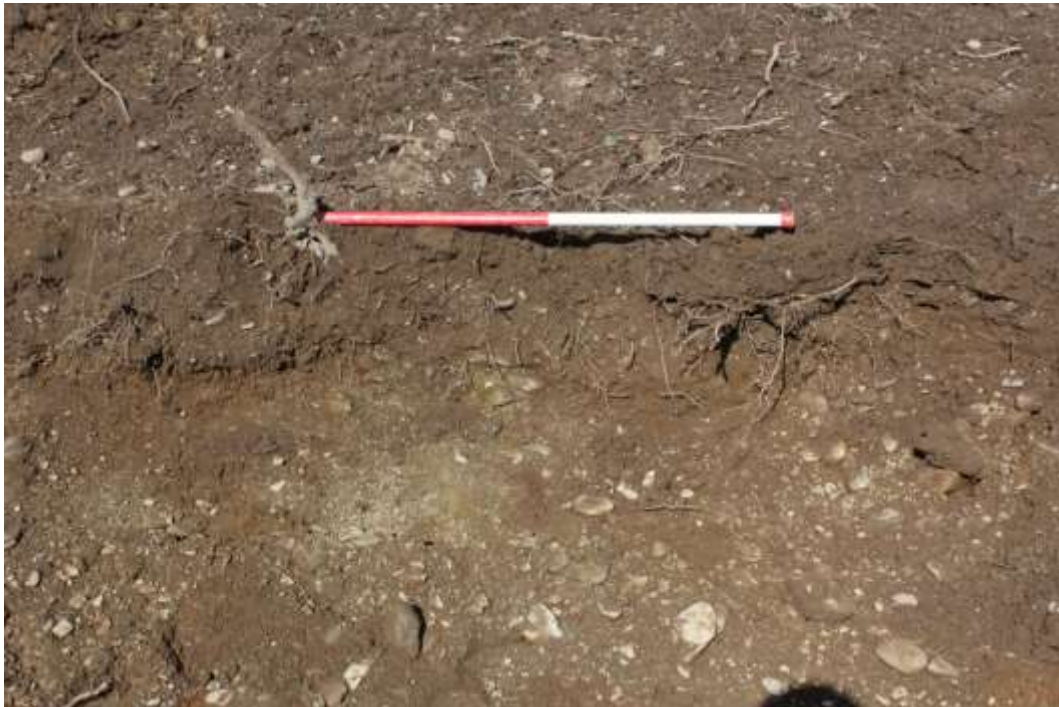
- 4.7 Excavation along the northern edge of the site indicated that the layer of hardcore did not extend this far and again natural sands and gravels were exposed. At 1m in from the eastern end, a patch of gravels was exposed within 0.10m of the ground surface (Photos 7 & 8).

- 4.8 It was considered possible that this could represent the remains of part of the Roman road due to the gravels being of slightly different character to those around and so the area was cleaned and recorded. The patch ran for around 1.5m in length and 0.5m in width. It did merge with surrounding gravel layers to the south and west and so is probably most likely of natural origin. The potential that this could form the edge of the Roman road or an area of slumping from it could not be discounted, although is probably unlikely based on the surrounding natural sands and gravels.

Photo 7: View of northeastern part of site showing small area of raised gravels in trench edge.

- 5.4 The possible area of gravels seen on the northeastern edge of the site area were tentatively suggested to represent gravels associated with the adjacent Roman road, which is thought to lie below Llanfair Road in this location. The gravels survived at a higher level than the surrounding natural sands and gravels, suggesting they may have been imported. The small area visible is such that this interpretation cannot be confirmed but does indicate the raised possibility of Roman road remains surviving below the existing hedge line and potentially the road line also. The potential road remains to the north of the trench will remain unaffected by the proposed works.

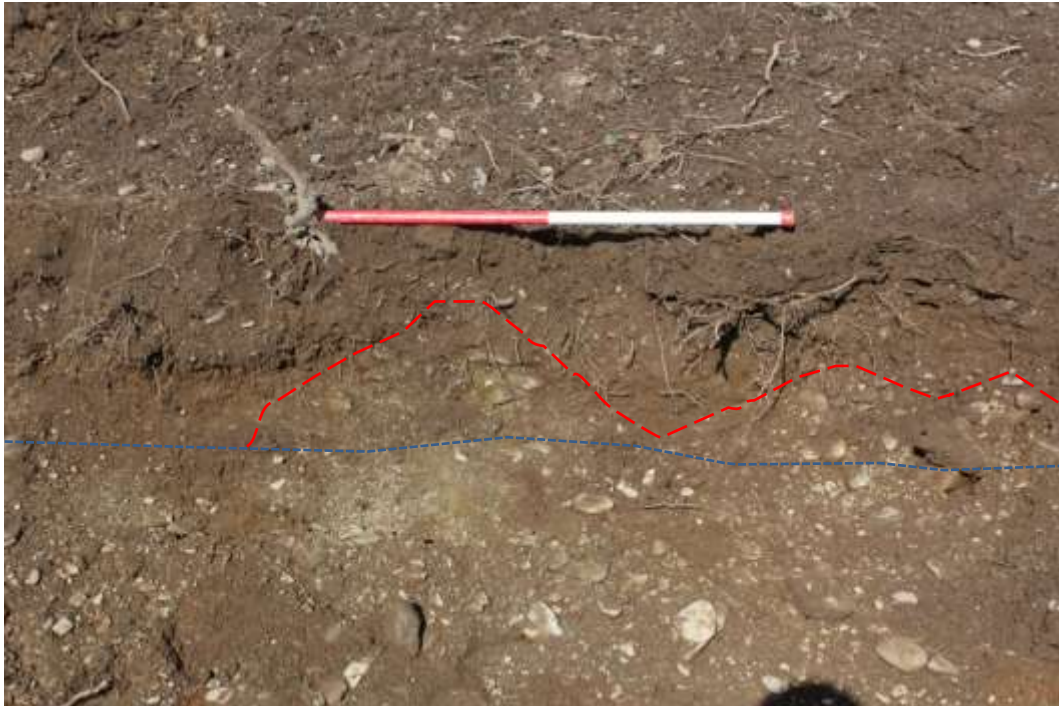
Photo 8: View of northeastern part of site showing small area of raised gravels in trench edge. Red line shows top of gravels, blue line shows base of trench
