# **BLUESTONE SKY DOME, BLUESTONE RESORT, PEMBROKESHIRE: ARCHAEOLOGICAL WATCHING BRIEF (SN 06710 12926)**

RHIF YR ADRODDIAD / REPORT NO. 2018-24  
RHIF Y PROSIECT / PROJECT RECORD NO. 112144

# BLUESTONE SKY DOME, BLUESTONE RESORT, PEMBROKESHIRE: ARCHAEOLOGICAL WATCHING BRIEF 2018 (SN 06710 12926)

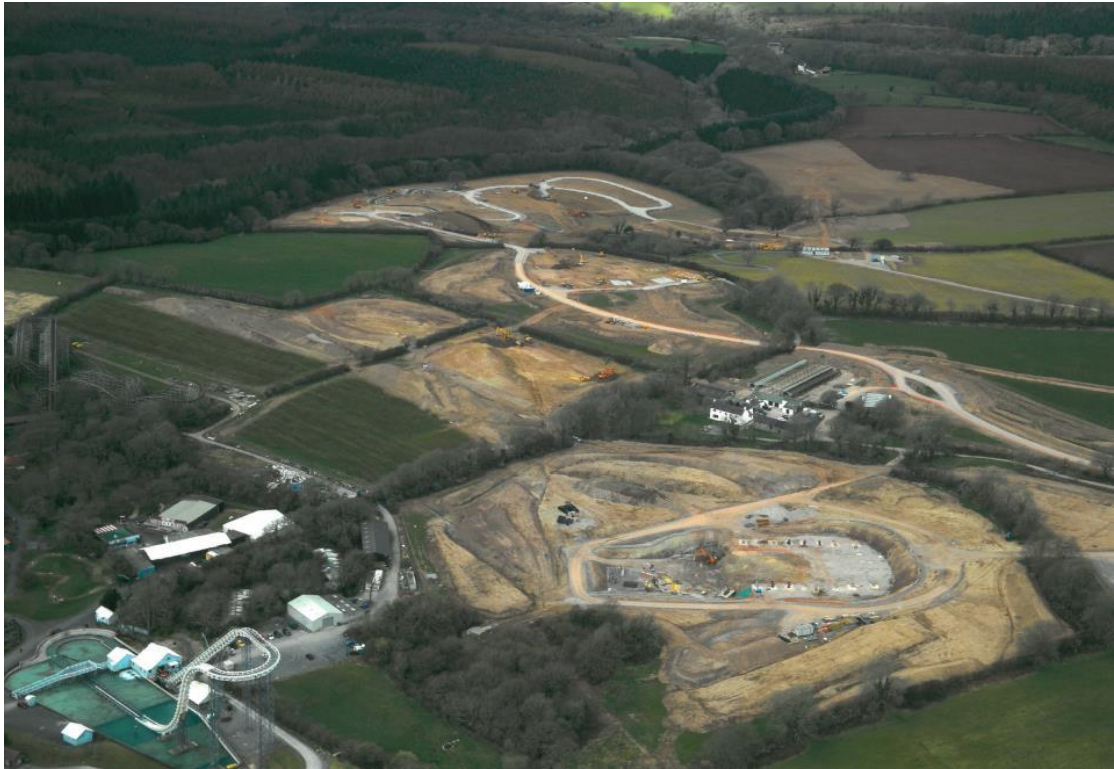
**Photo 1:** Aerial photograph of the Bluestone resort in march 2007 looking roughly northwest, with area of Blue lagoon during construction and widespread landscaping works evident (Photo supplied by Bluestone Resort Ltd)

- 2.2.7 A construction access route is planned for the Sky Dome development, which will run to the east of the development site, around the southern side of the Blue Lagoon to join with the main entranceway into the site east of the Blue Lagoon. This access road will pass through land which was significantly landscaped when the Blue Lagoon was built as has been confirmed through consultation of numerous aerial photographs taken of the development in 2007 and 2008 as supplied by the Bluestone Resort (Photo 1 shows an example of these photos and Photo 2 is annotated to show the site area and rough location of proposed construction access, Figure 3).

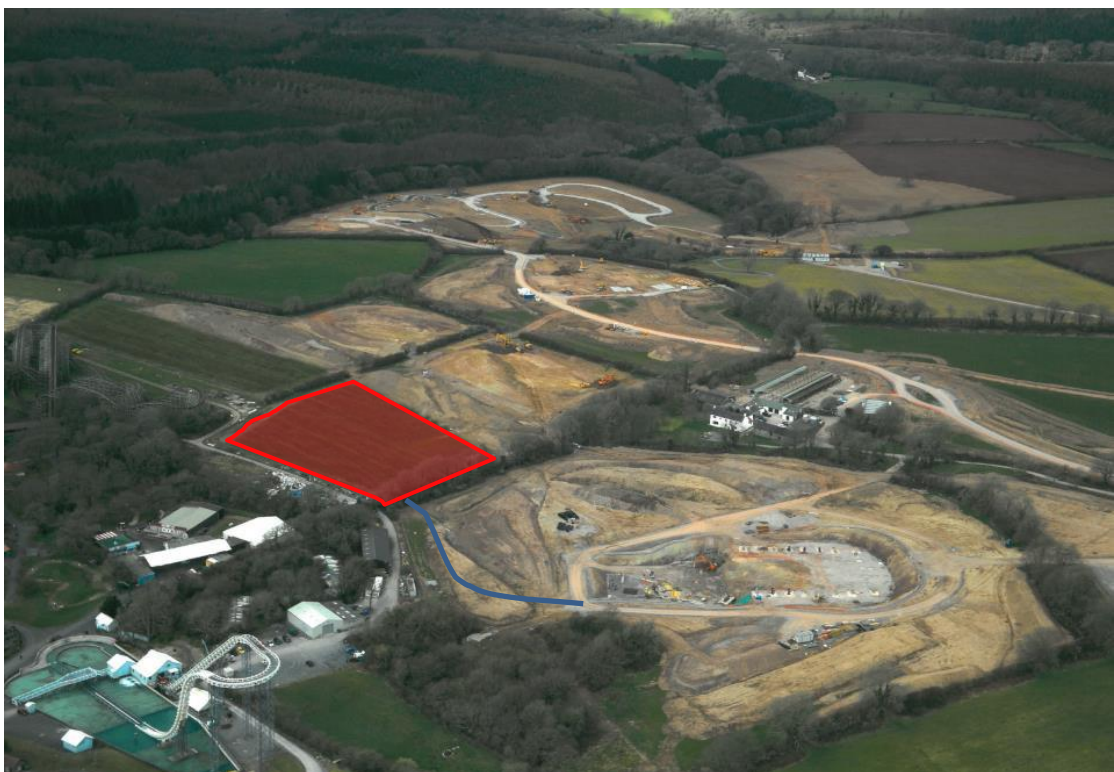
**Photo 2:** As above, but with area of Sky Dome (red) and approximation of construction access (blue) annotated (Photo supplied by Bluestone Resort Ltd)

- 1.13 A construction access route is planned for the Sky Dome development, which will run to the east of the development site, around the southern side of the Blue Lagoon to join with the main entranceway into the site east of the Blue Lagoon. This access road will pass through land which was significantly landscaped when the Blue Lagoon was built as has been confirmed through consultation of numerous aerial photographs taken of the development in 2007 and 2008 as supplied by the Bluestone Resort (Photo 1 shows an example of these photos and Photo 2 is annotated to show the site area and rough location of proposed construction access, Figure 3).

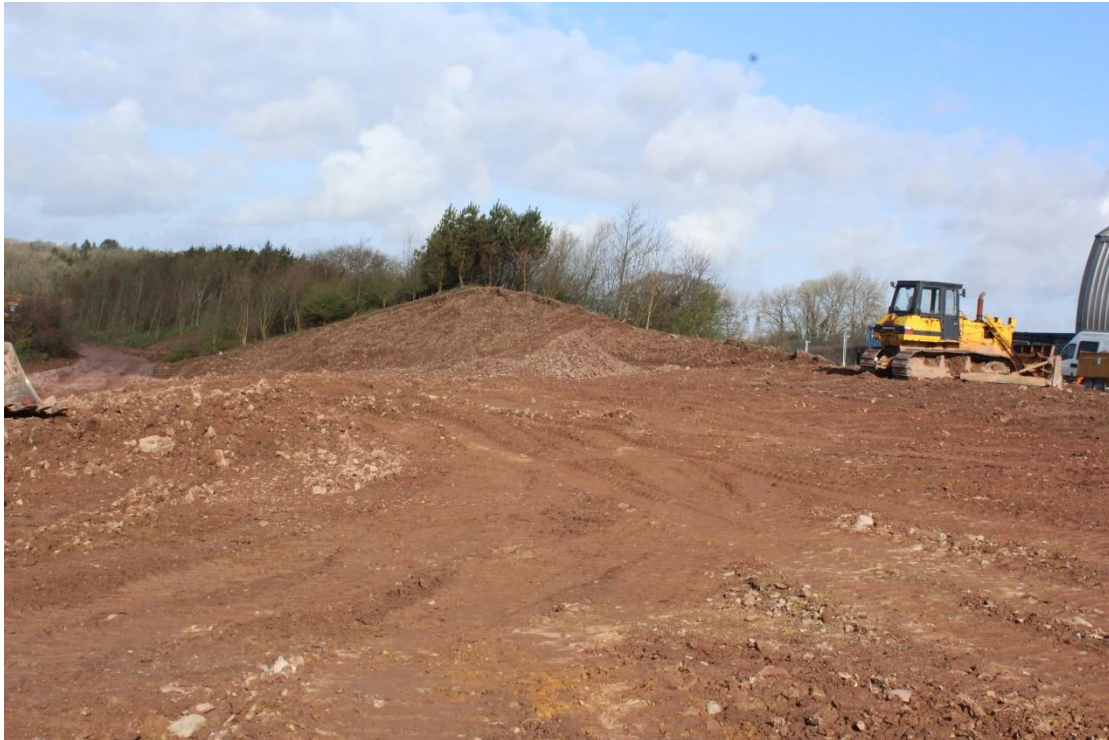
- 4.1 The watching brief started in the northeastern corner part of the Sky Dome development area nearest where medieval and post medieval archaeology had been identified in a previous evaluation near to Newton Farm. Prior to the current groundworks a significantly large soil bond was present here as part of previous landscaping of the resort. This was removed down to ground level (as agreed) before the archaeological watching brief commenced (Photo 3).

**Photo 3:** View east along the northern part following the removal of the soil bond (visible in the background).

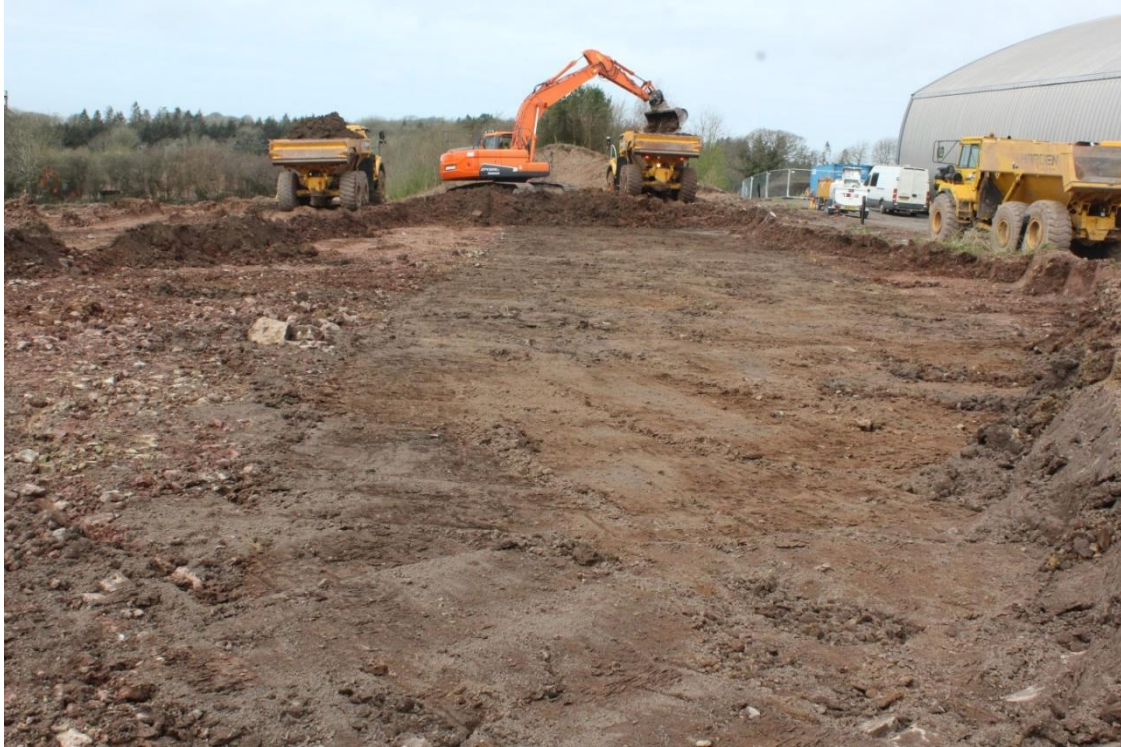
- 4.3 Beneath this landscaping material two parallel strips of buried topsoil were observed (Photos 4 and 5). These were approximately 5m wide and ran east to west across the stripped area in the northeastern part of the site. The buried topsoil was very shallow, at only c.0.05m thick and it contained no artefacts. It is assumed that these strips represent remnant topsoil that had accumulated in trackways or machine stripped areas of the site which were slightly deeper than the land either side. They were definitely modern in date and associated with previous groundworks for other phases of development at the Bluestone site.

**Photo 4:** Example of strip of buried topsoil observed in northern part of development area, viewing west-northwest

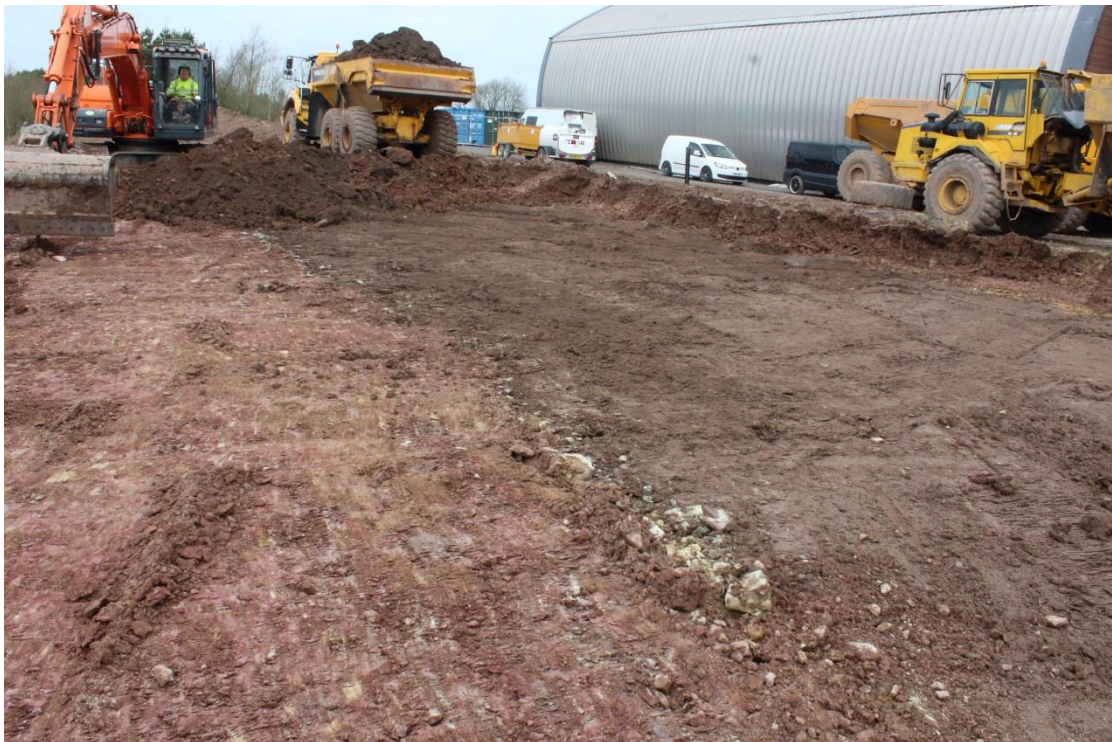
**Photo 5:** Example of strip of buried topsoil observed in northern part of development area, viewing west-northwest

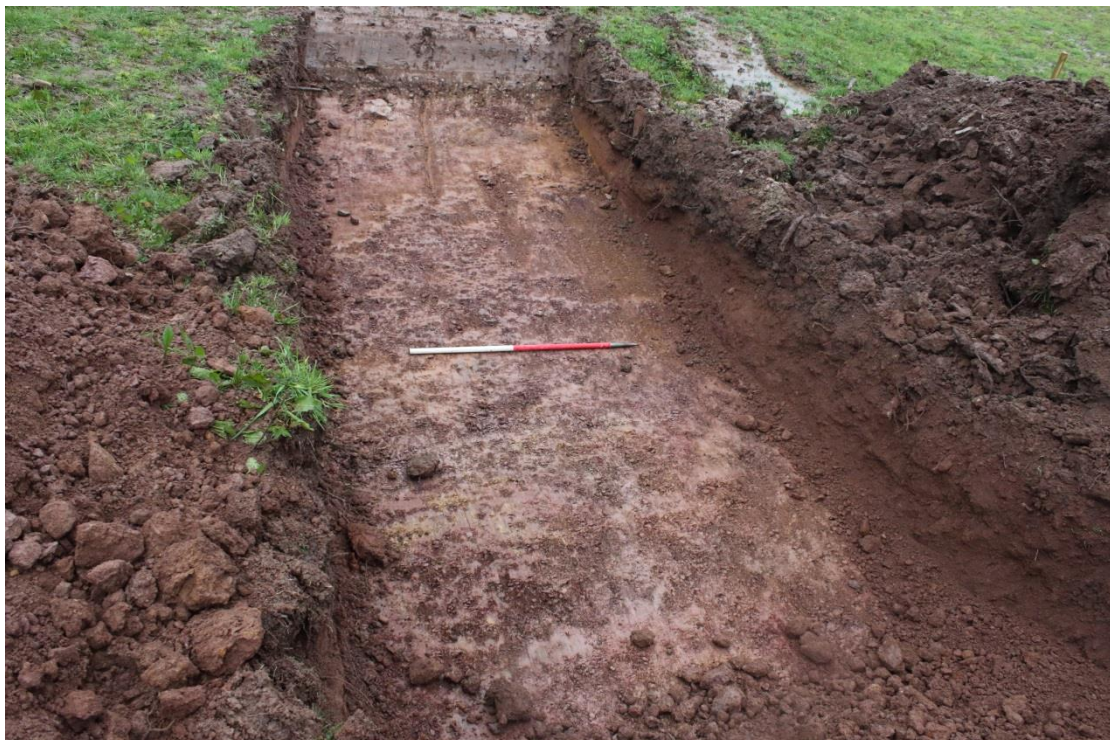
- 4.5 It was agreed with the site contractors that a trial trench would be excavated to the south of this initial stripped area to determine the depth of the topsoil and the extent of disturbance from the former willow crop. This trench was excavated to a depth of approximately 0.55m and

**Photo 6:** Excavation of evaluation trench showing topsoil containing broken 'rab' overlying natural clays

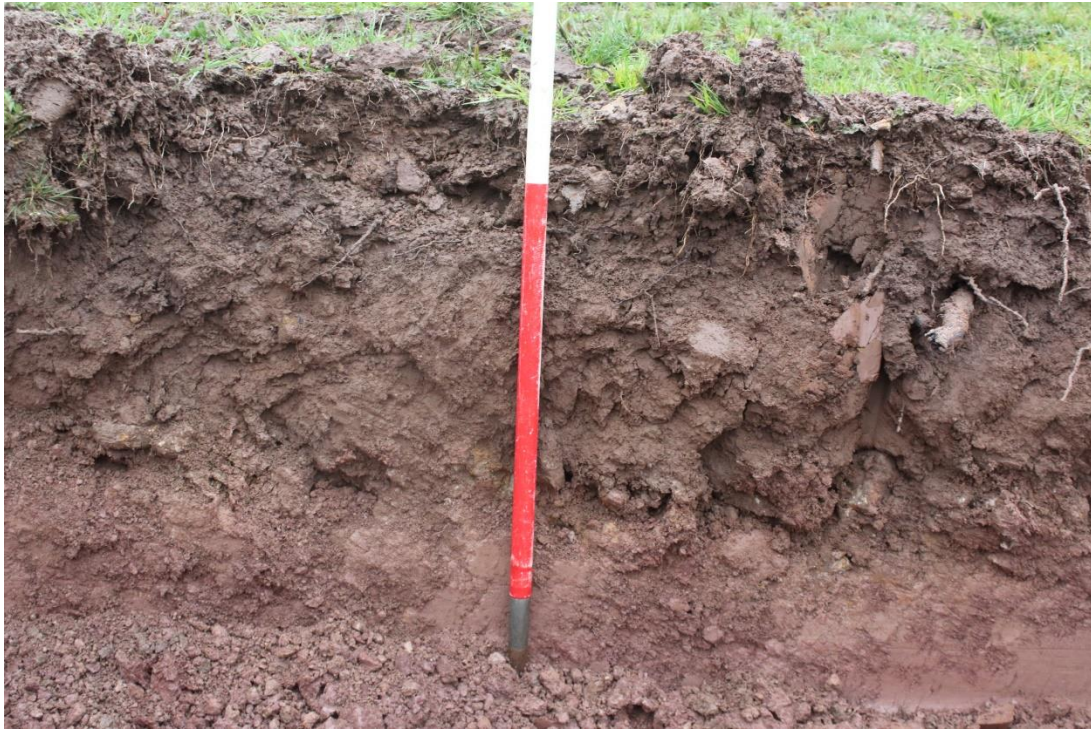
**Photo 7:** East facing section of evaluation trench showing topsoil containing disturbed 'rab' overlying natural clays.

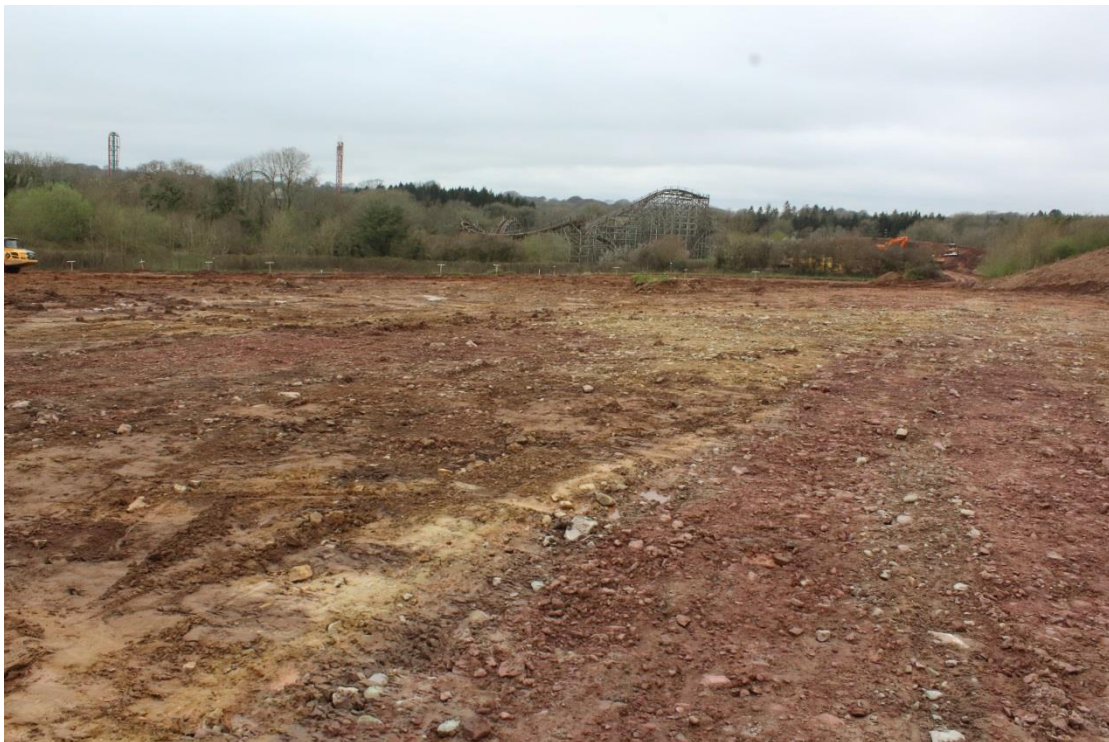
- 4.6 Across the remainder of the site an intermittent watching brief was conducted (Photos 8 and 9). The works involved both the removal of the roughly 0.50m deep topsoil and also around a further 0.50m of subsoil/natural geology to reach formation depth for the Sky Dome structure (Photo 10). The topsoil contained numerous roots and quite a lot of broken up 'rab'.

**Photo 8:** View southwest across Sky Dome area towards Oakwood showing exposed natural geology, comprising pink clay and 'rab'

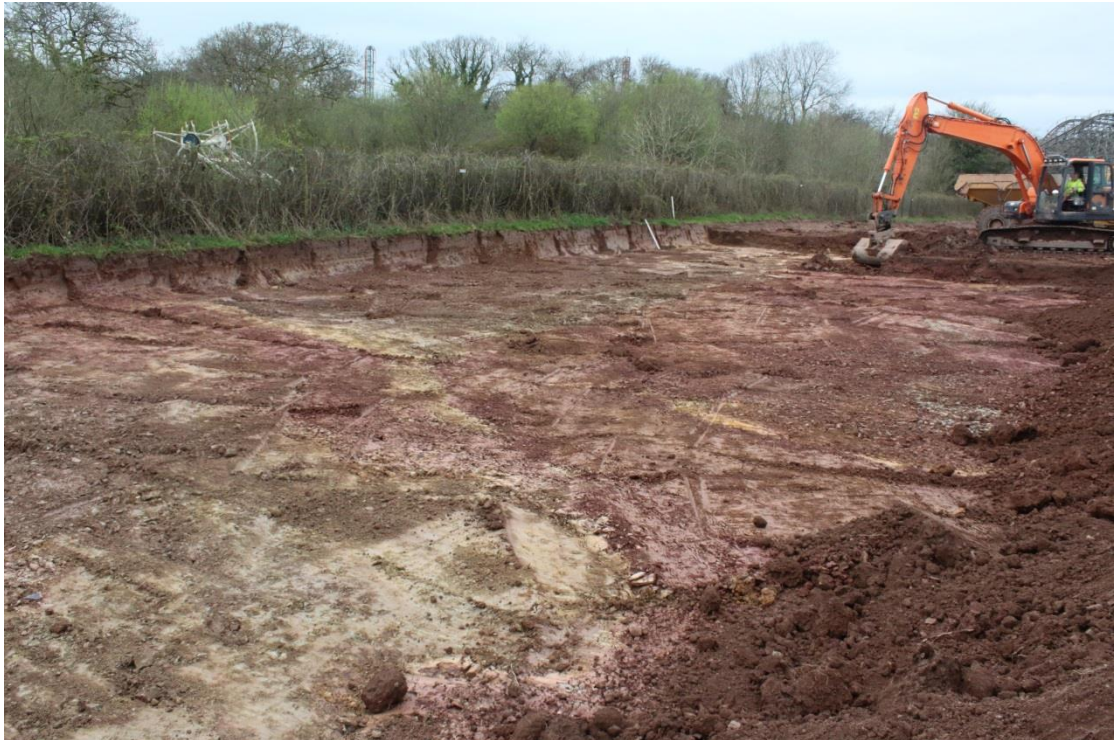
**Photo 9:** View southwest across southern edge of Sky Dome area showing exposed natural geology, comprising pink clay and 'rab'

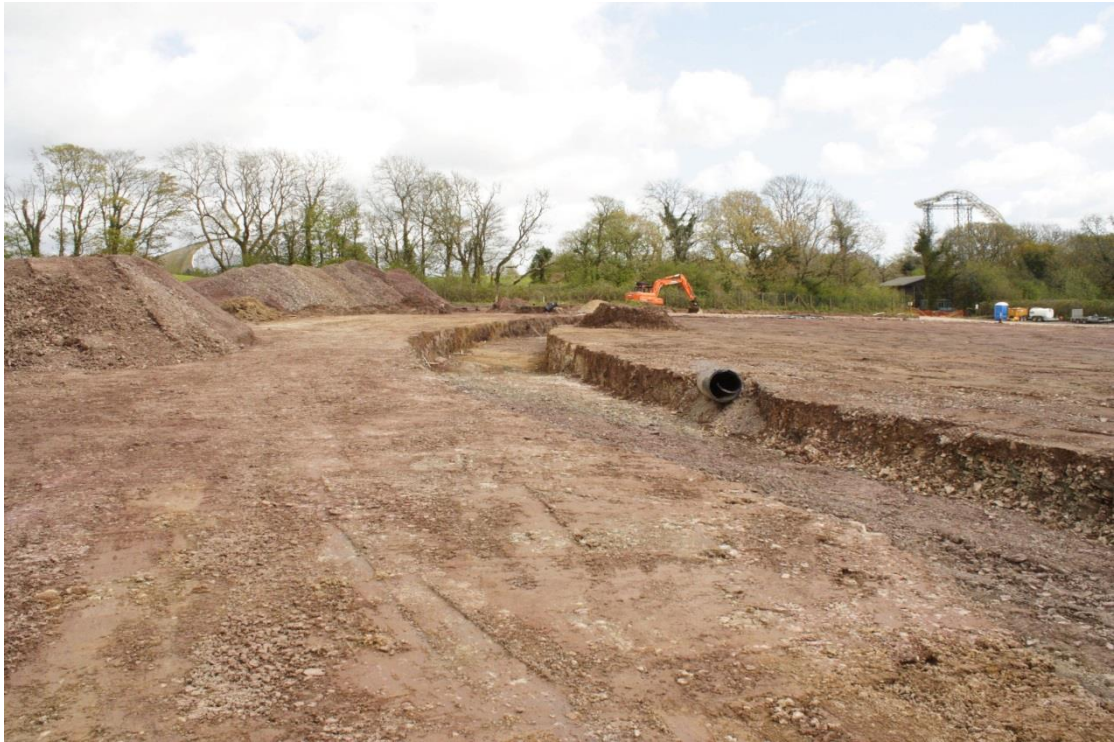
**Photo 11:** View east across the northern part of the Sky Dome footprint, showing the remains of the former diverted drainage pipe

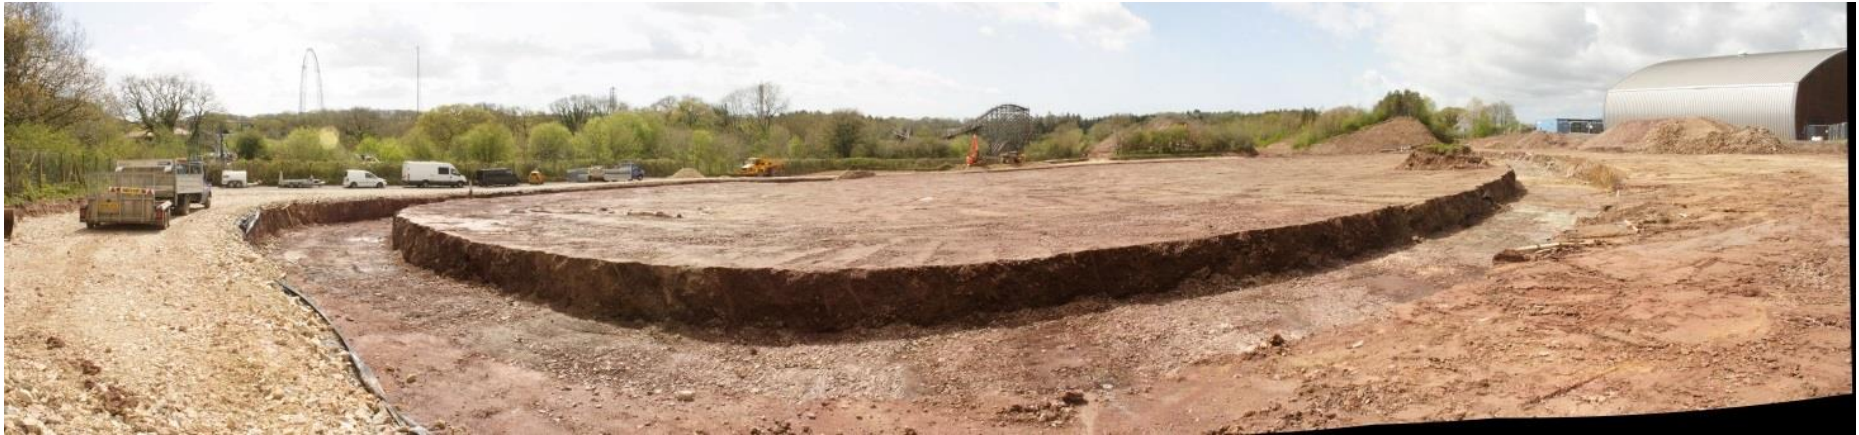
**Photo 12:** Stitched photographs of the excavated footprint of the 'Dome' showing the underlying natural geology. View southwest.

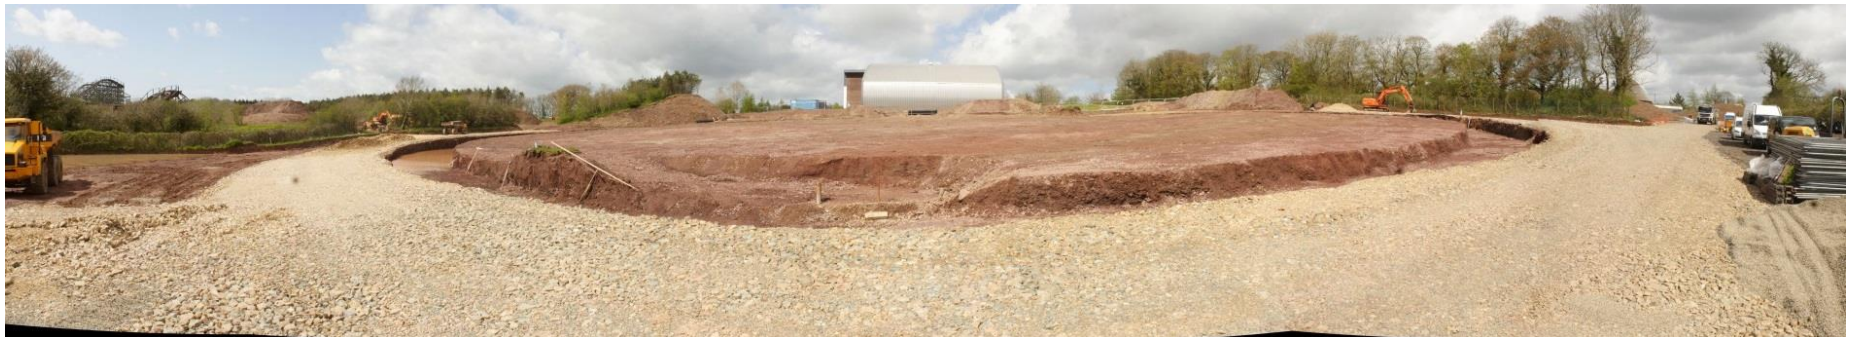
**Photo 13:** Stitched photographs of the excavated footprint of the 'Dome' showing the underlying natural geology. View north..
