DYFED ARCHAEOLOGICAL TRUST
GLASTIR ADVANCED TARGETED ADVICE

New Shipping Farm AO030819

DAT REPORT NO. 2018-34

Glastir Advanced Historic Environment Feature (HEF) Management Plan

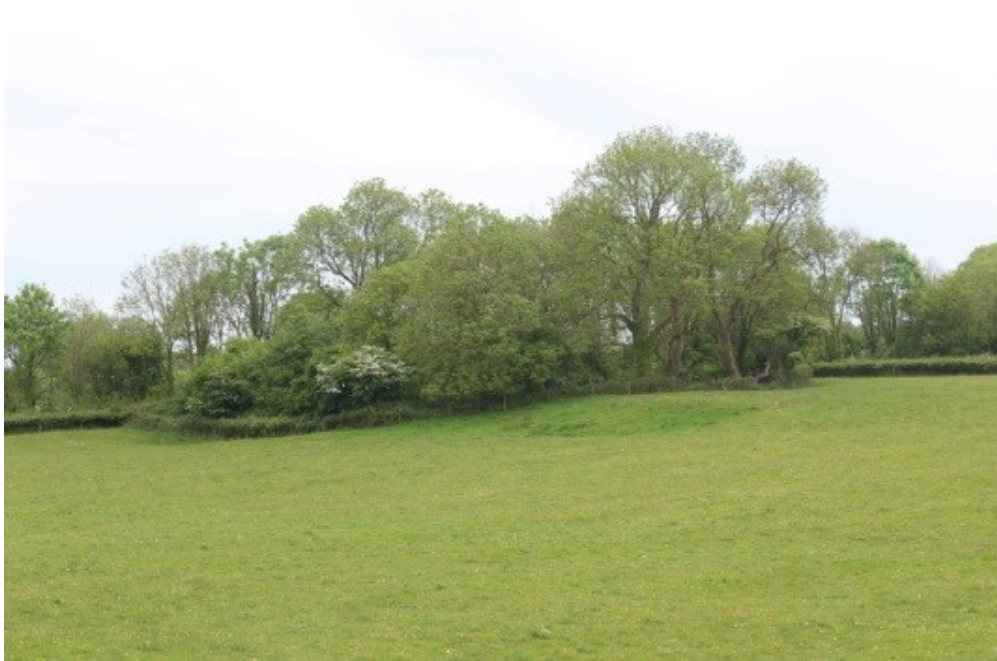
The quarry is under dense scrubby woodland. Due to the dense vegetation it was not possible to get access to the lime kiln, so its condition is unknown.

Figure 1. Long view of the quarry showing its overgrown character.

As the condition of the lime kiln is unknown then it is not possible to offer specific management advice.

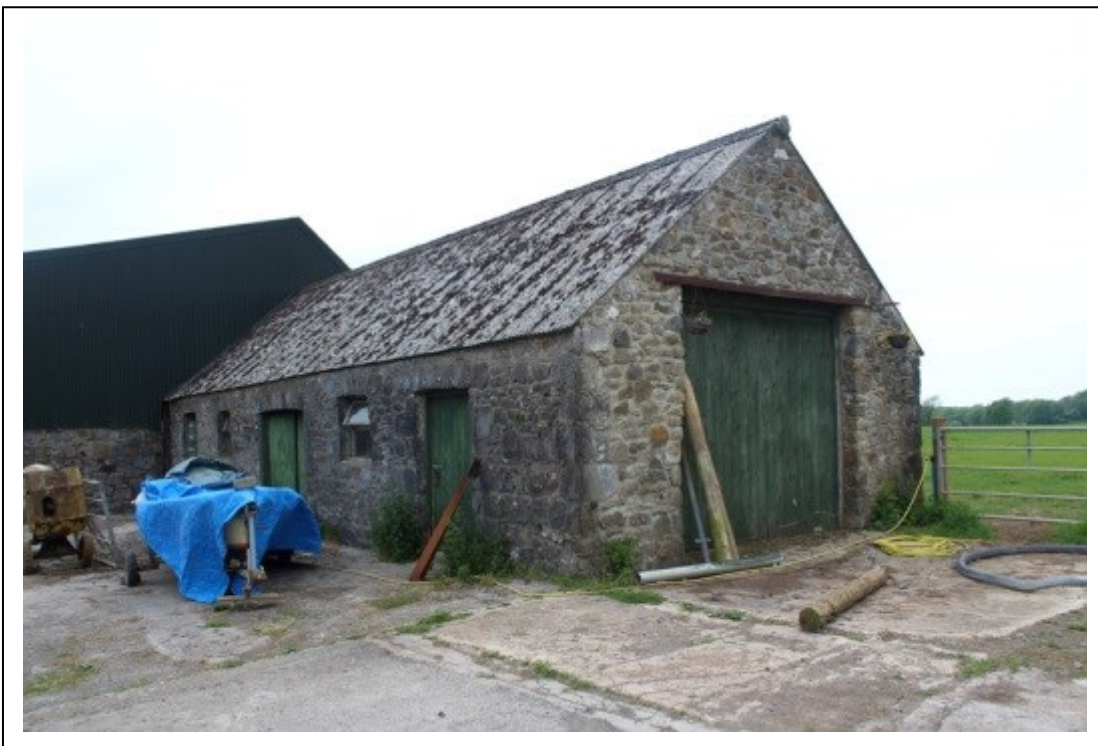
The historic farm out building is in good condition, stone built with an asbestos sheet roof. It is used as a workshop.

Figure 1. Historic Farm building looking NW.

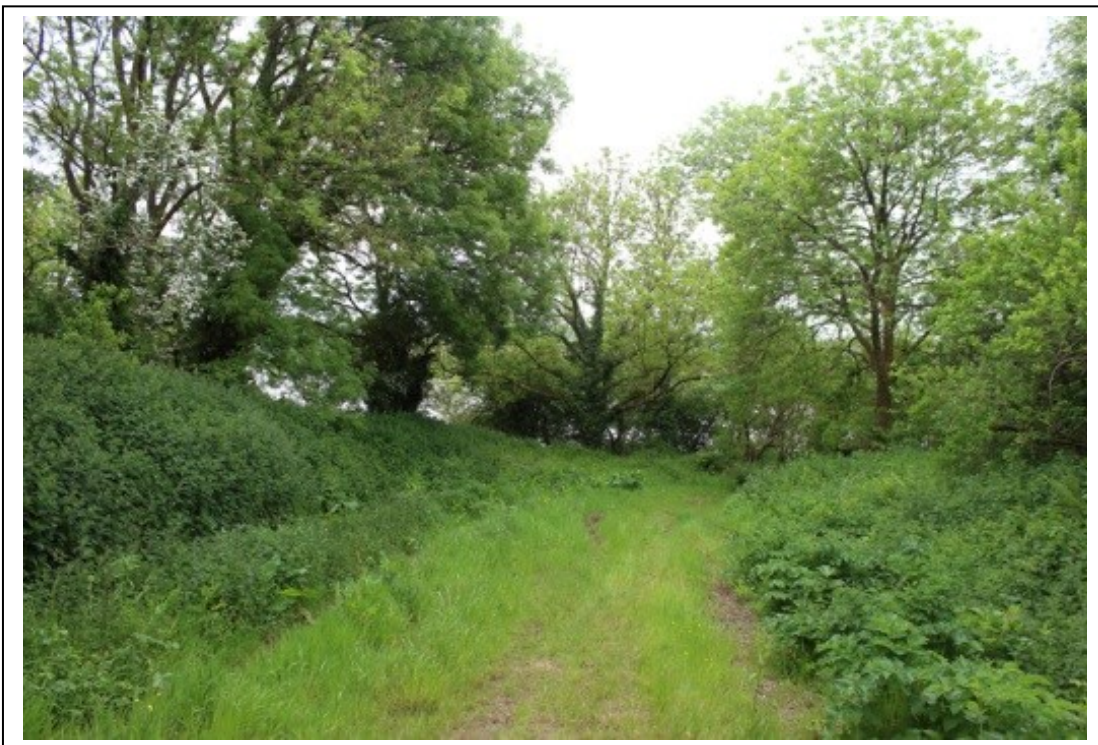
The main threat to the building remains is root damage caused by the trees and scrub. Several dying or dead ash trees occupy the site – root throw could cause problems in the future if these trees fall.

Figure 1. Site of the farmstead looking south.

Care should be taken to avoid damage to building standing remains during removal of larger trees.

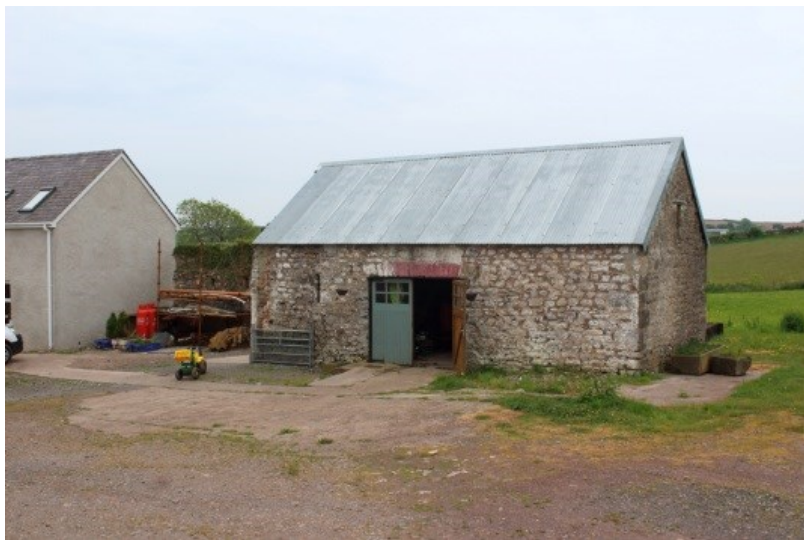
Figure 2. The restored barn.

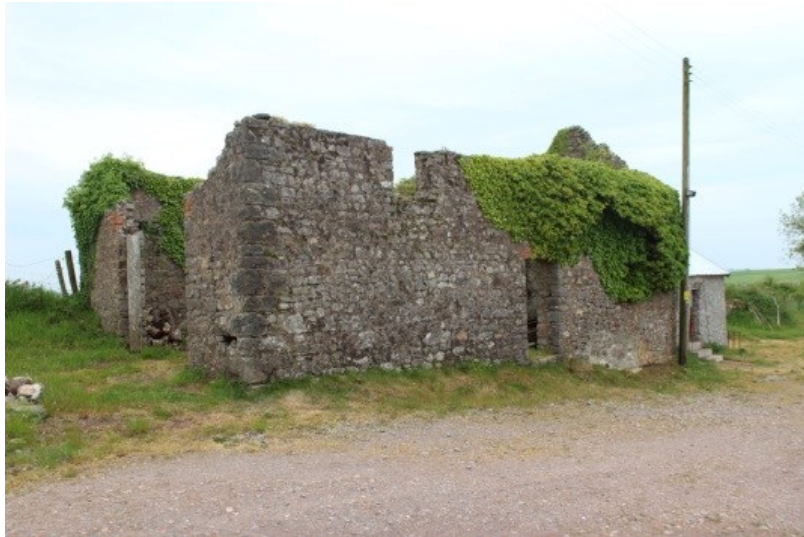
Two of the farm out-buildings have recently restored. The third, see photos below, is roofless and lintel over the main entrance in the pine end has collapsed. The tops of the walls are in poor condition and there is some ivy cover.

The main issue is the dereliction of the roofless out-building.

Figure 3. The derelict out-building.

Repoint walls of derelict building, restore failed lintels, provide new doors and windows and reroof.

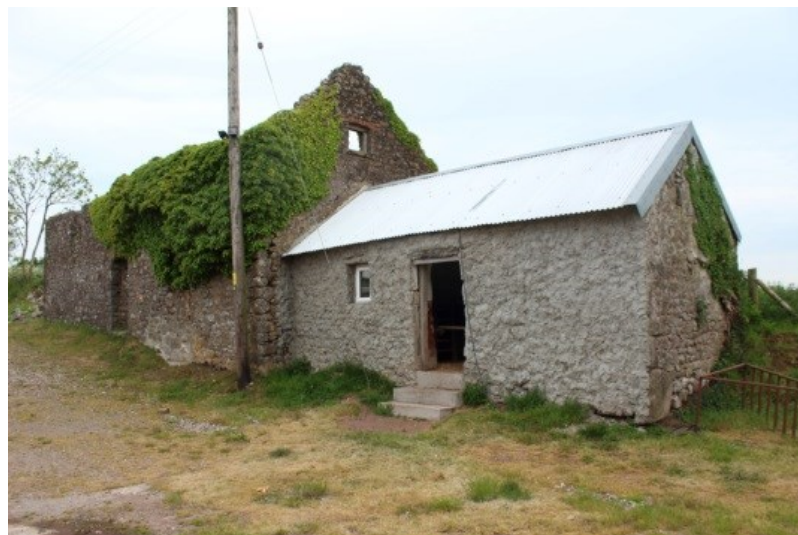
The derelict out-building with restored building at east end.

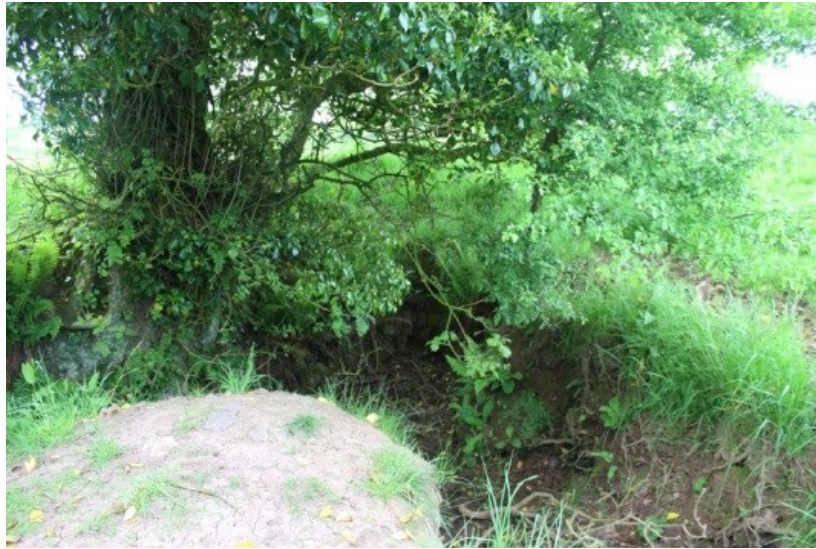
Dry stone walls in fair condition, water still flowing. Bushes and other low vegetation are beginning to choke the spring.

Figure 1. The spring.

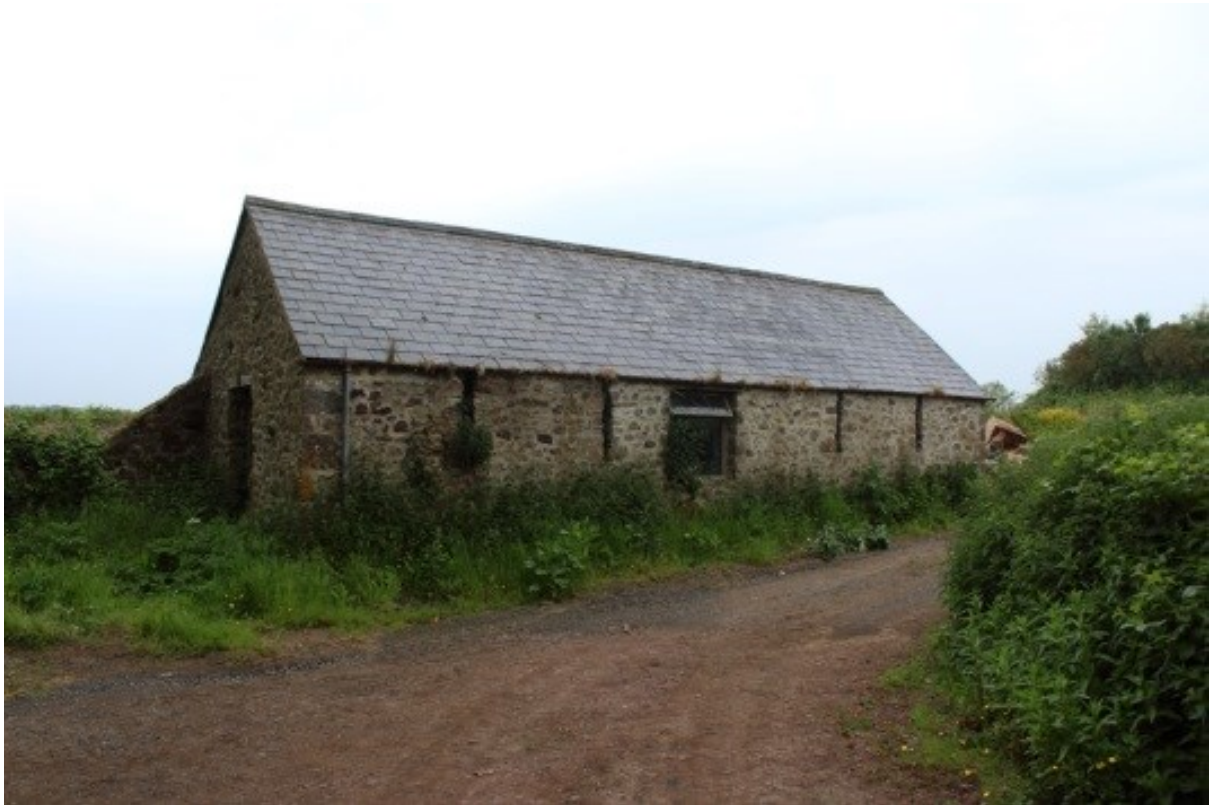
Good condition, used for storage.
