THE OLD MOAT HOUSE, 2 CASTLE ROAD, KIDWELLY: HERITAGE IMPACT ASSESSMENT

RHIF YR ADRODDIAD / REPORT NO. 2018/37
RHIF Y DIGWYDDIAD / EVENT RECORD NO. 112736

HERITAGE IMPACT ASSESSMENT

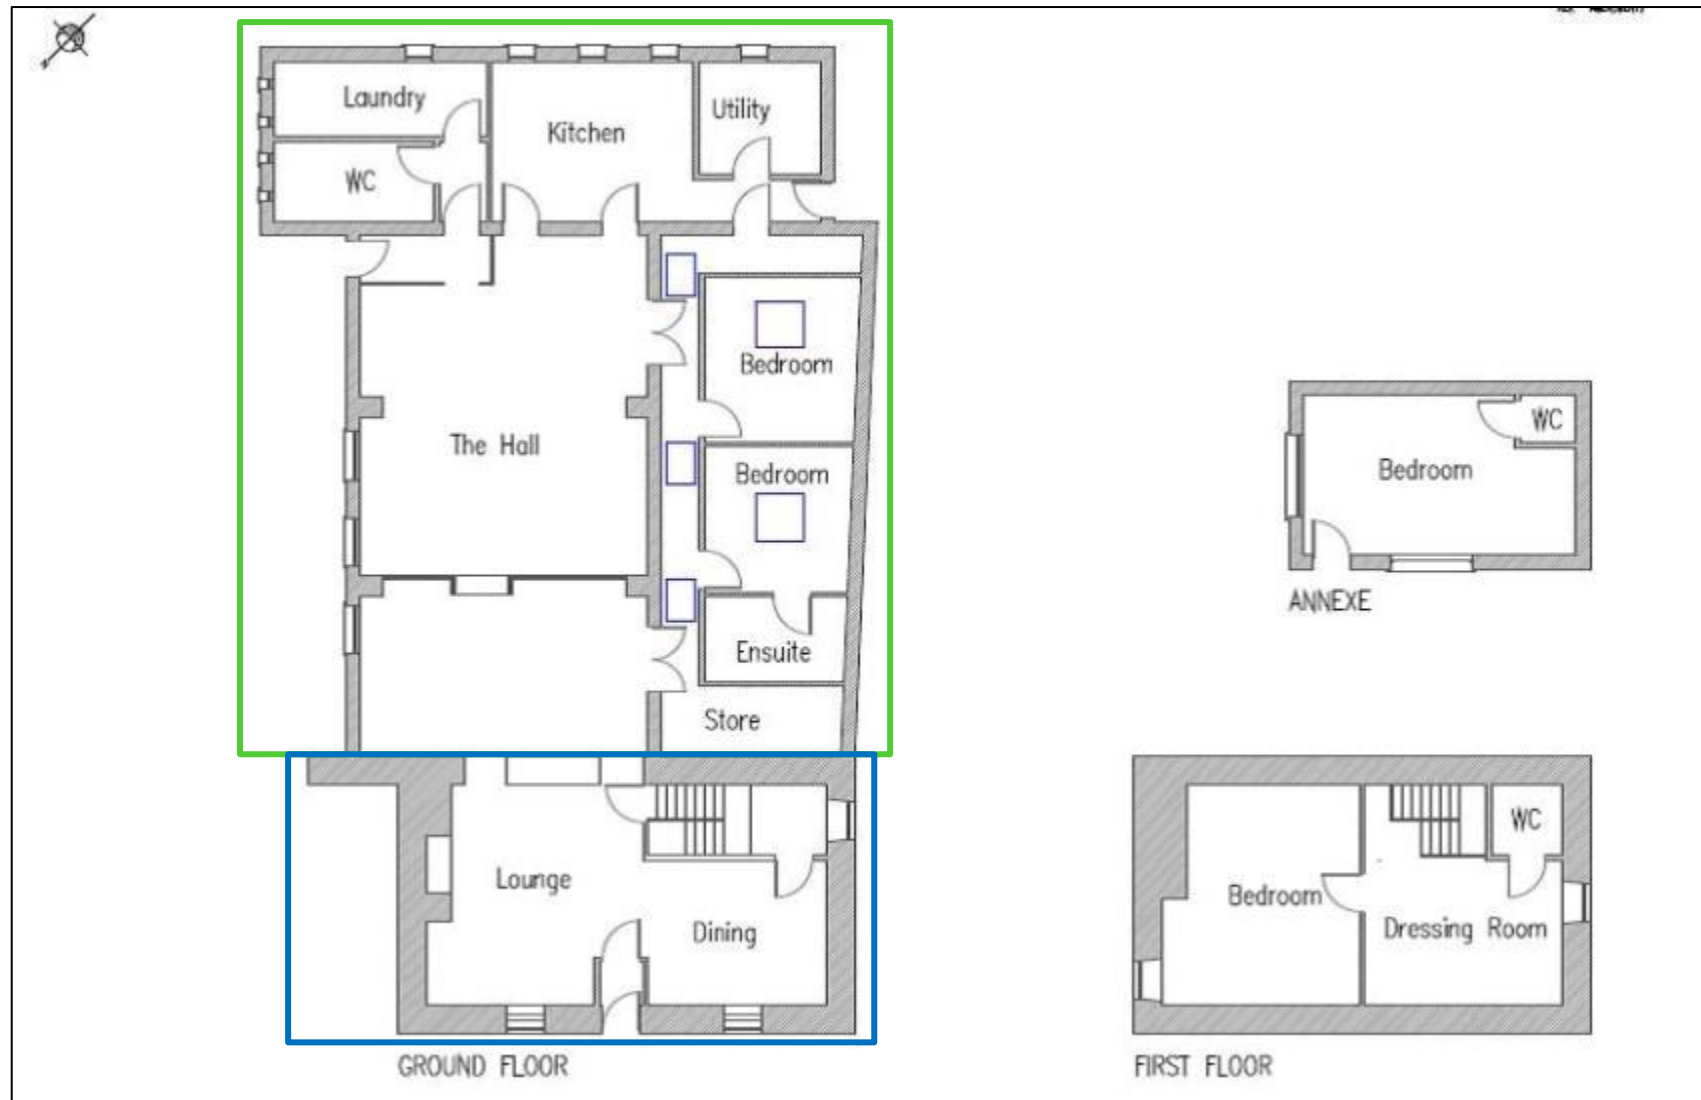
Figure 4: Existing plan layout of the Old Moat House and its annexe, supplied by the client. The blue box outlines the 18th century building and the green box outlines the 20th century extension.

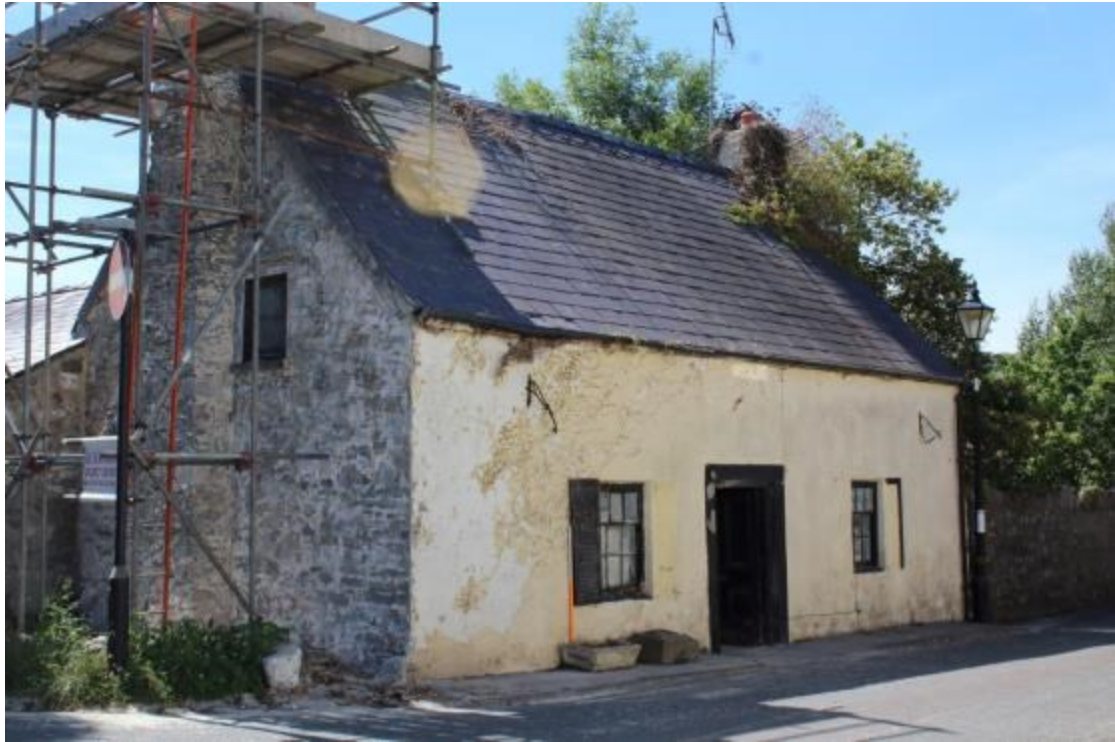
Photo 1: Looking west at the front of the original 18th century building.

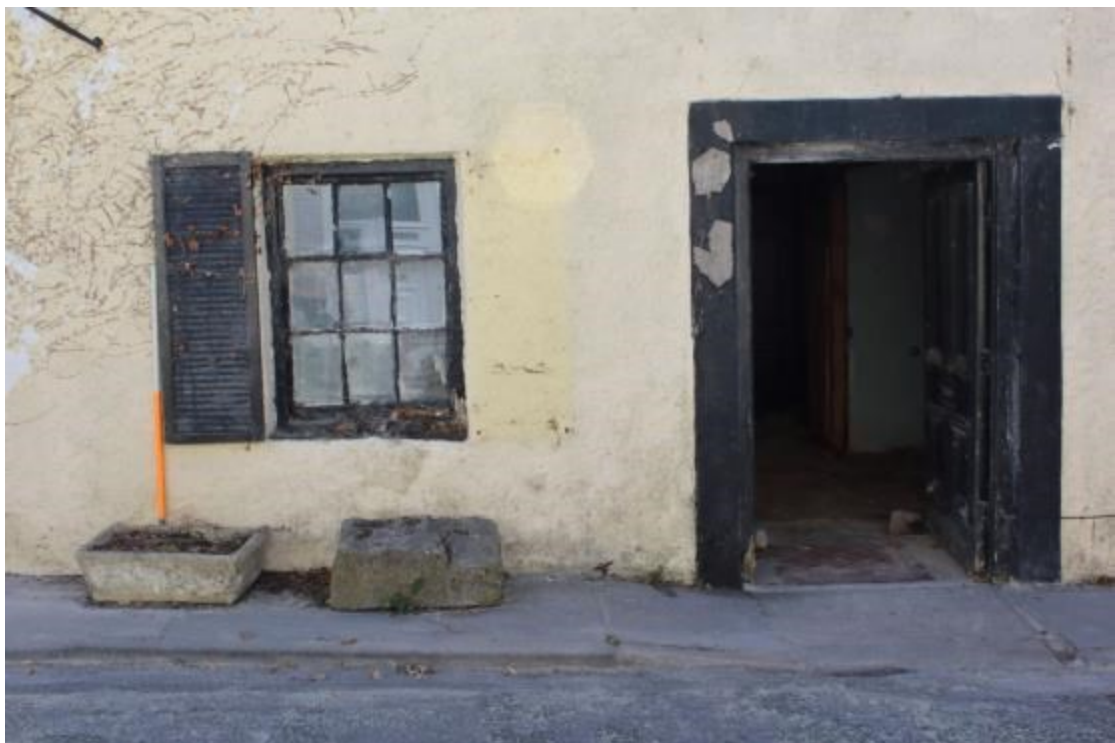
Photo 2: Close-up of the door and one window at the front of the original 18th century building.

7. External four panel door fronting Castle Road to be replaced. Door is made of low quality materials and beyond repair. The door is noted in the listing but not believed to be original door; it was possibly replaced at the same time as the extension work in the 1970s. Replace door and frame with new four panel door using British Hardwood, most probably oak, overpaint in black to match existing.

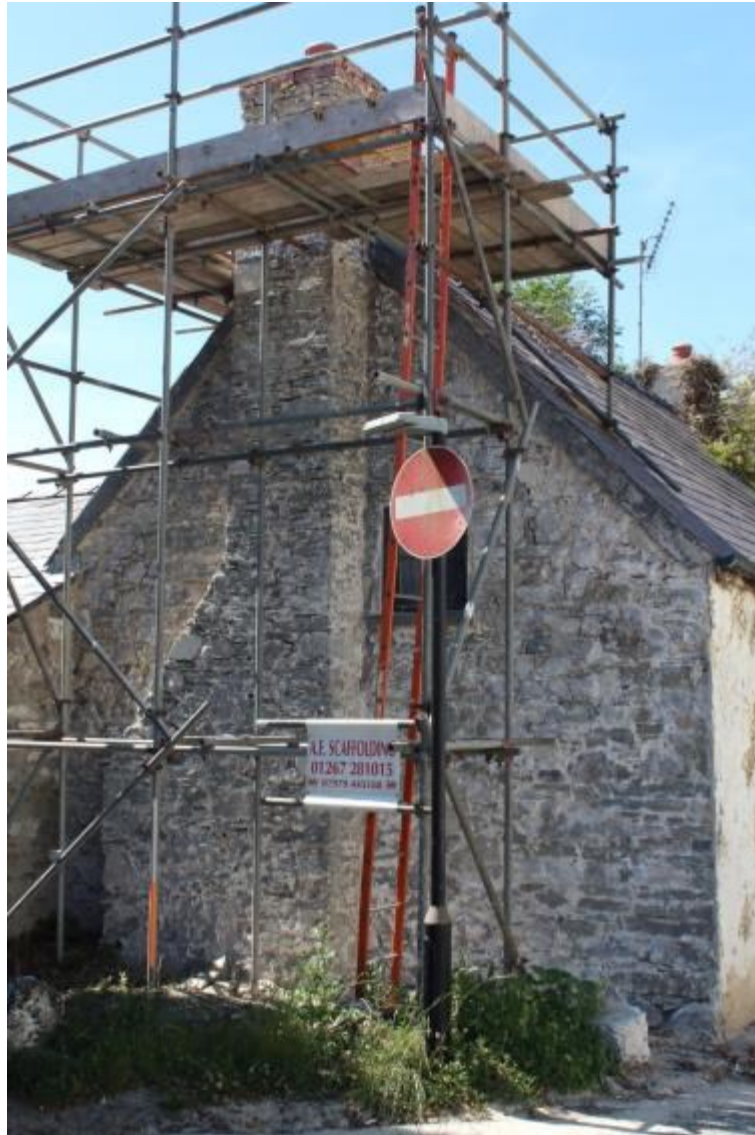
Photo 3: The southeast-facing end of the original 18th century building, with its large chimney.

3. Repair damage to northwest chimney stack caused by excessive ivy growth and repoint/ plaster as required
4. Southwest chimney stack - badly damaged by ivy growth - carefully dismantle to ridge line of existing roof and set aside existing stone work. Insert lead tray and new lead flashing to ridge line, rebuild chimney with set aside stone. The top two courses of the chimney are made of red brick with cement render - replace damaged bricks with like-for-like replacements (believed to be Emlyn bricks). Replace damaged chimney pot with like-for-like replacement (circular terracotta pot)

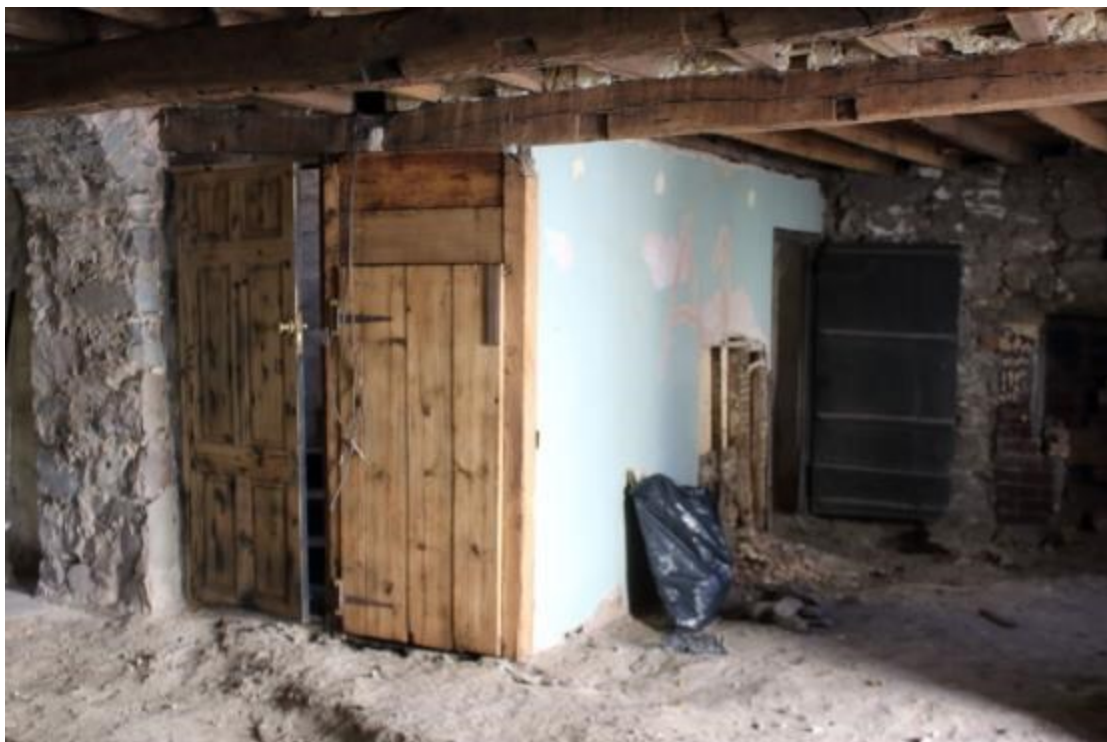
Photo 6: Looking west-northwest at the staircase enclosed by doors and an internal wall, in the west corner of the ground floor of the original 18th century building

8. Remove damp and damaged plasterboard from the internal wall that boxes in the staircase, clad with timber paneling and paint white to match existing wall colour.
9. Make good other walls with similar materials, and paint white or lime-wash as required.
10. Remove dangerous electrical fittings and rewire throughout.
11. Remove paint from stonework at western fireplace and repoint with lime mortar if required.
12. Strengthen stairs with timber supports and paint to match existing colour
13. Remove existing plasterboard and door at inner door entrance, rebuild with timber paneling, and install new timber door with glass paneling to allow sufficient access for disabled persons (the outer door is already wide enough).

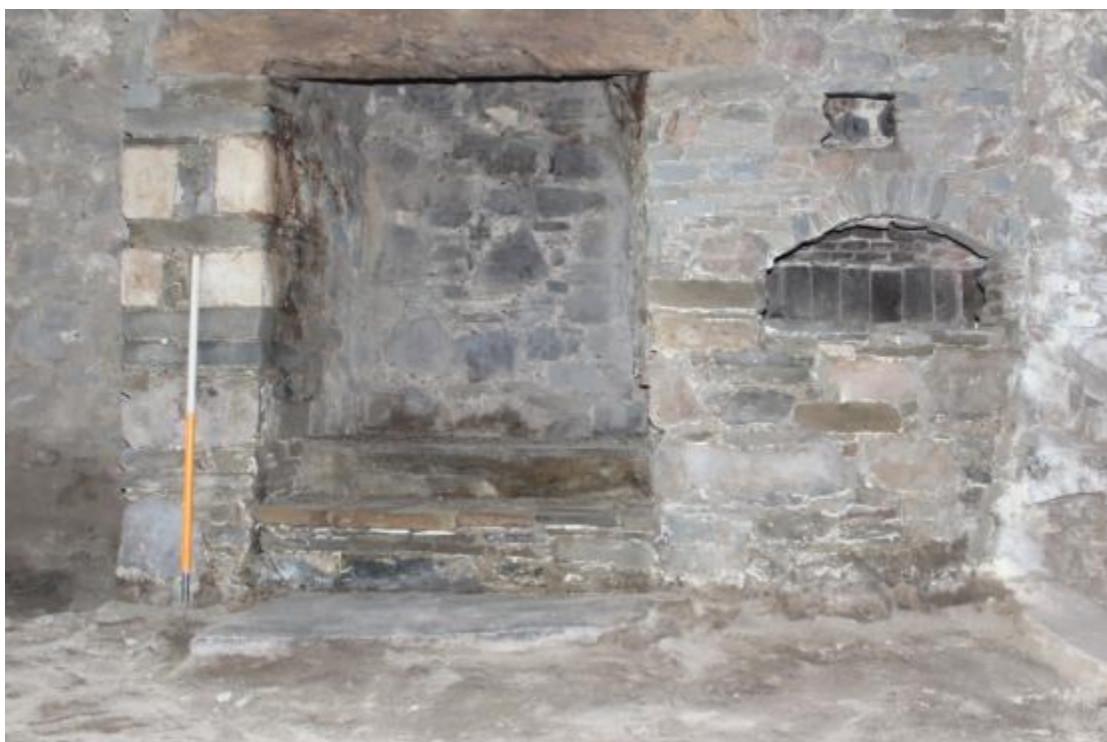
- 3.7 At the southeast end of the ground floor there is a large open stone fireplace and chimney stack with an adjoining stone bread oven (Photo 7). This fireplace was hidden by timber cladding until recently. At the northwest end is a smaller fireplace with a small chimney stack above. Recent removal of the ornate 1970s fireplace at this end has exposed a smaller Victorian glazed-brick fireplace. The bricks appear to have been damaged during the construction of the later fireplace (Photo 8).

Photo 7: The large fireplace and bread oven at the southeast end of the original 18th century building

6. Remove existing cement render from wall around eastern fireplace, and make good the damaged rough stone wall with stone lime mortar pointing. Cover with lime plaster.

7. Install a reclaimed slate hearth in front of eastern fireplace. Make good eastern fireplace - reinstate damaged Victorian fireplace using reclaimed glazed firebricks

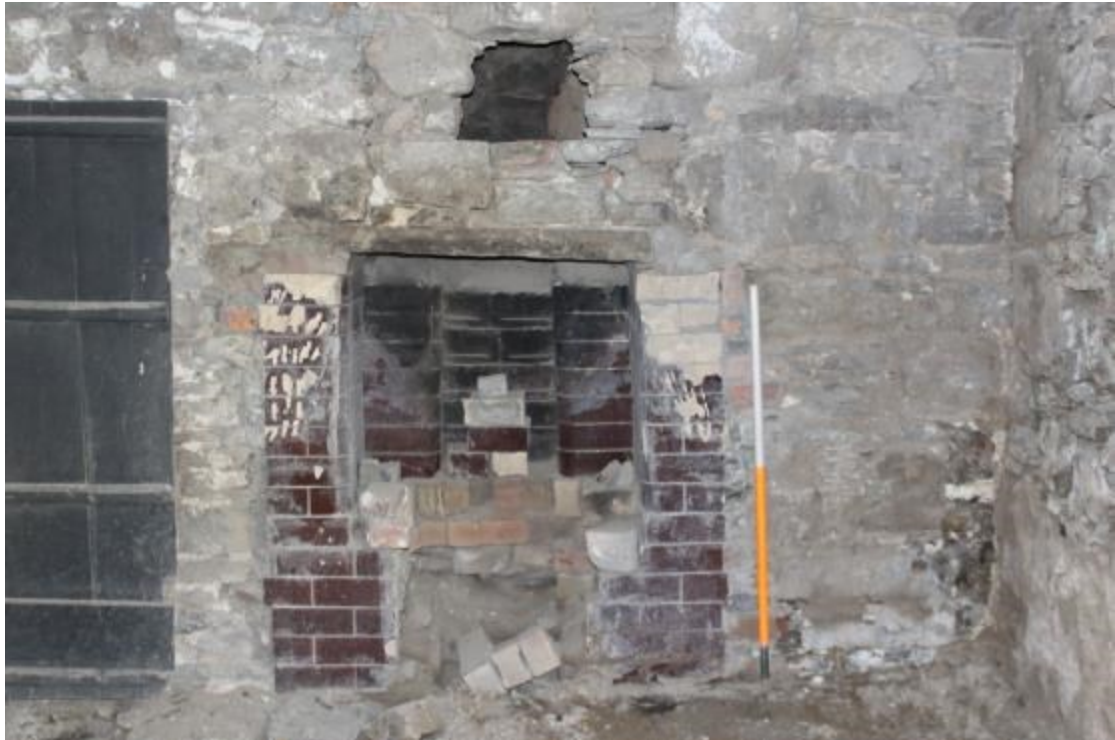
Photo 8: The smaller fireplace at the northwest end of the original 18th century building

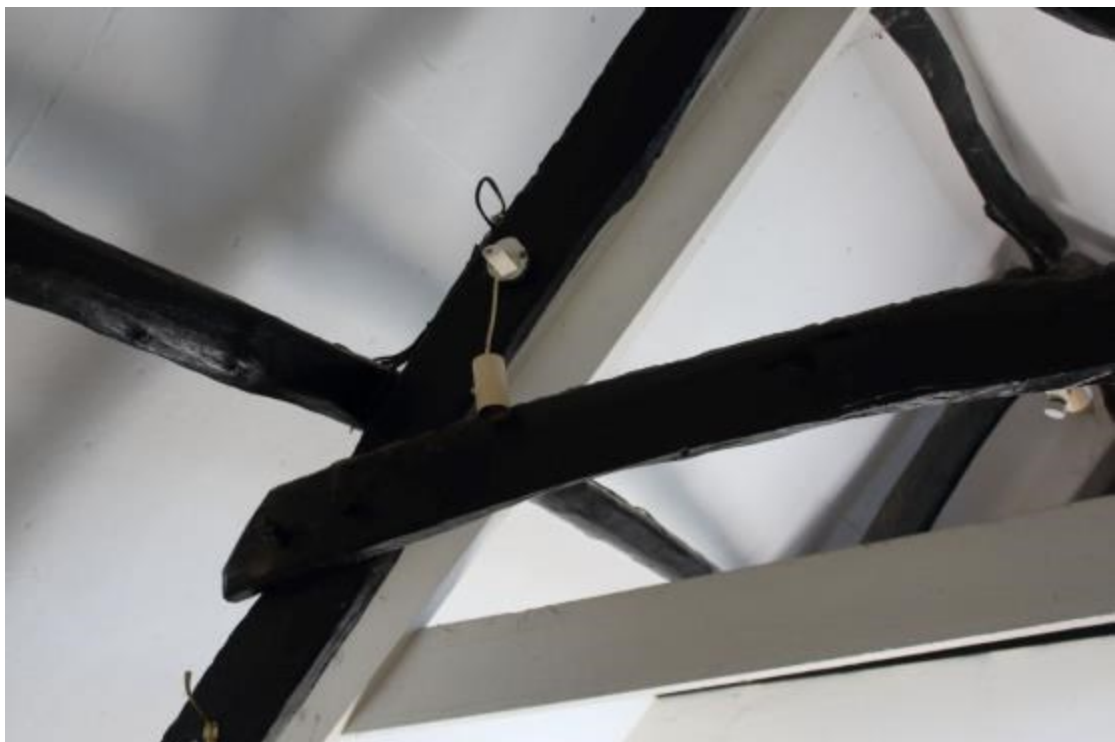
- 3.8 At the same time as the works were carried out on the ground floor, the roof structure was extended upwards and replaced with slate. The original A-frame timbers were retained (Photo 9). Two small windows (of uncertain date) light the loft - one at each end (Photo 10). A WC was installed in the northeast corner of the enlarged roof space adjacent to the switchback stairwell. An internal north-to-south wall divides the loft space in two. A fold-away shower and sink unit sits against the chimney breast at the west end of the loft space (Photo 11).

Photo 9: Both original and modern timber A-frames can be seen in the loft of the 18th century building.

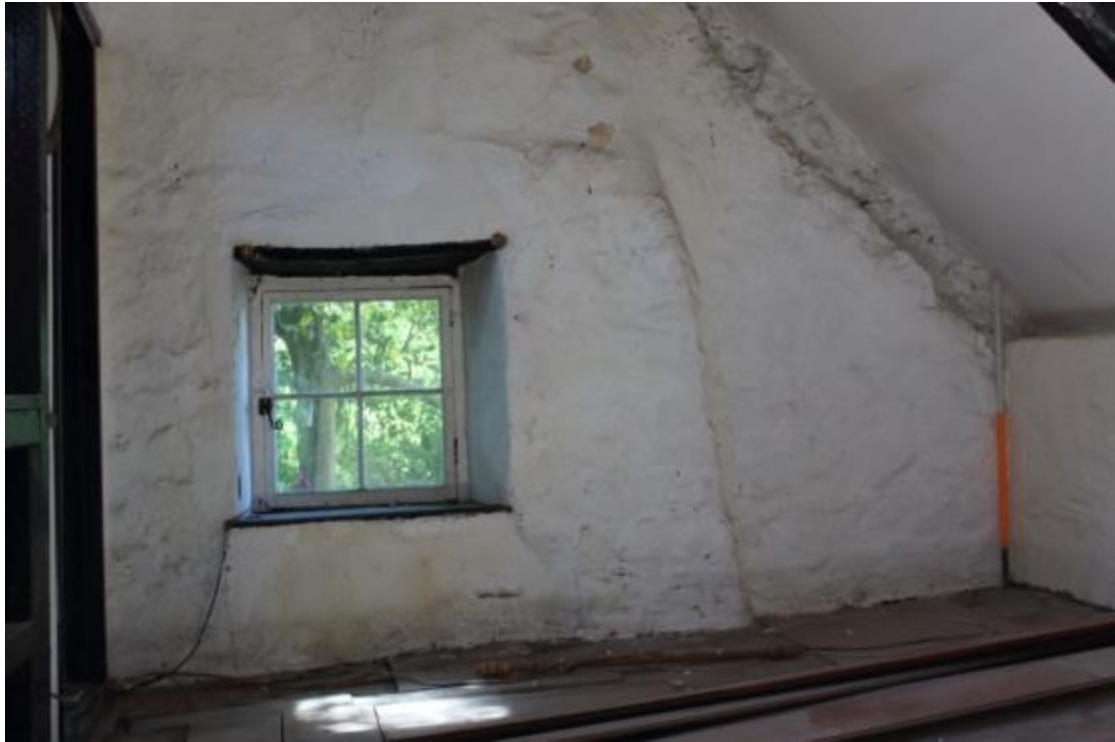
Photo 10: The northwest end of the loft of the original 18th century building, showing a window and the chimney stack. The WC cubicle is left of the window.

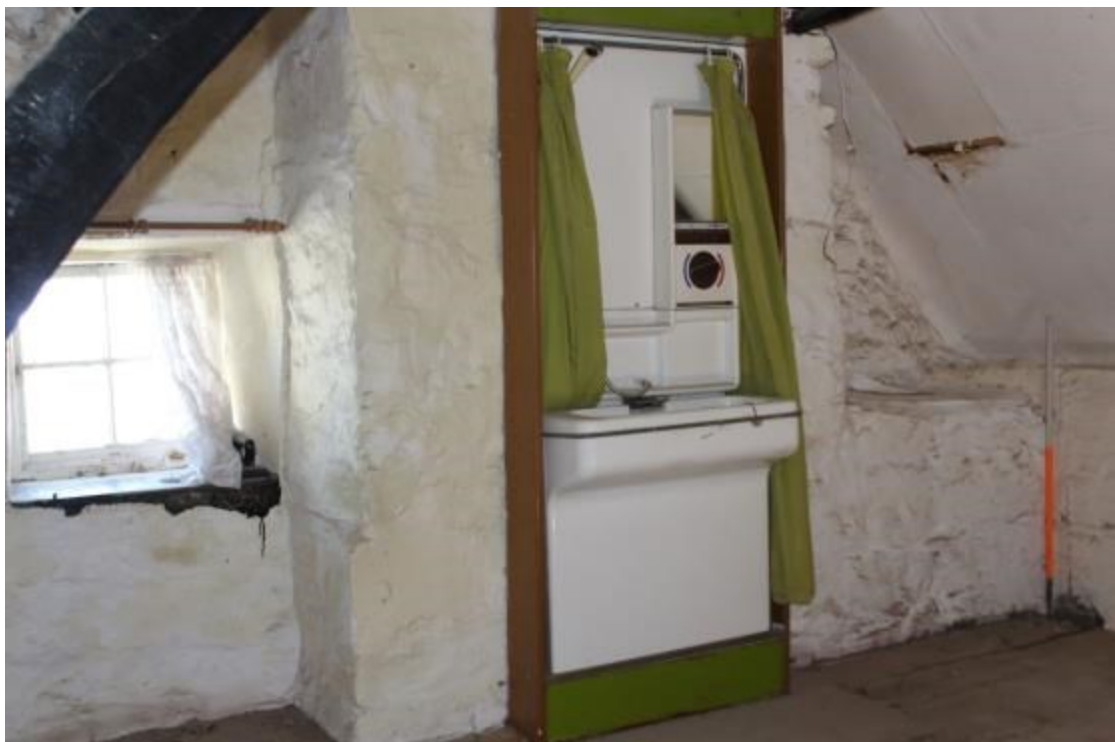
Photo 11: The southeast end of the loft of the original 18th century building, showing a window, the chimney stack and the fold-up shower and sink unit.

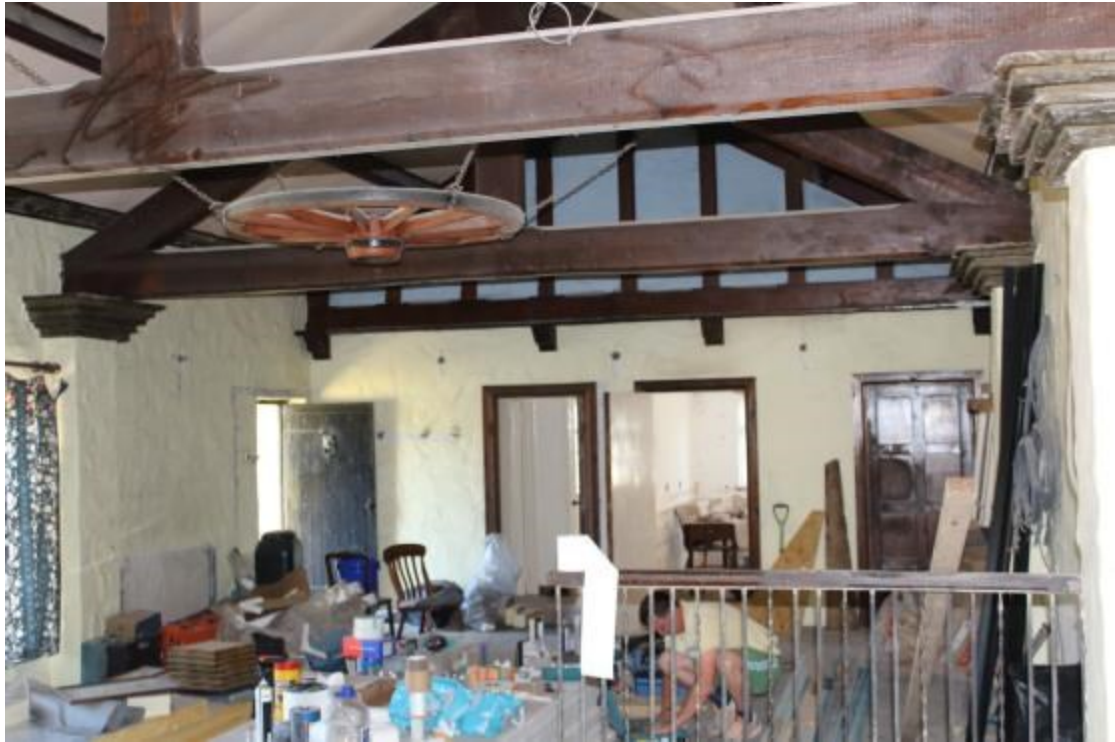
- 3.10 The large room on the ground floor is known as the main hall (Photos 14-15). At its northeast end is a raised dais, and this is the only part of the floor in the 20th century extension that is at the same level as the floor in the late 18th century part of the building. Adjacent to the main hall to the north is the kitchen area with adjoining utility room, laundry room and WC. To the rear of the building adjoining the main hall is a narrow corridor leading to two bedrooms and a small storeroom. The corridor also provides access to the kitchen, and the rear courtyard.

Photo 14: Looking southwest at the main hall in the late 20th century extension

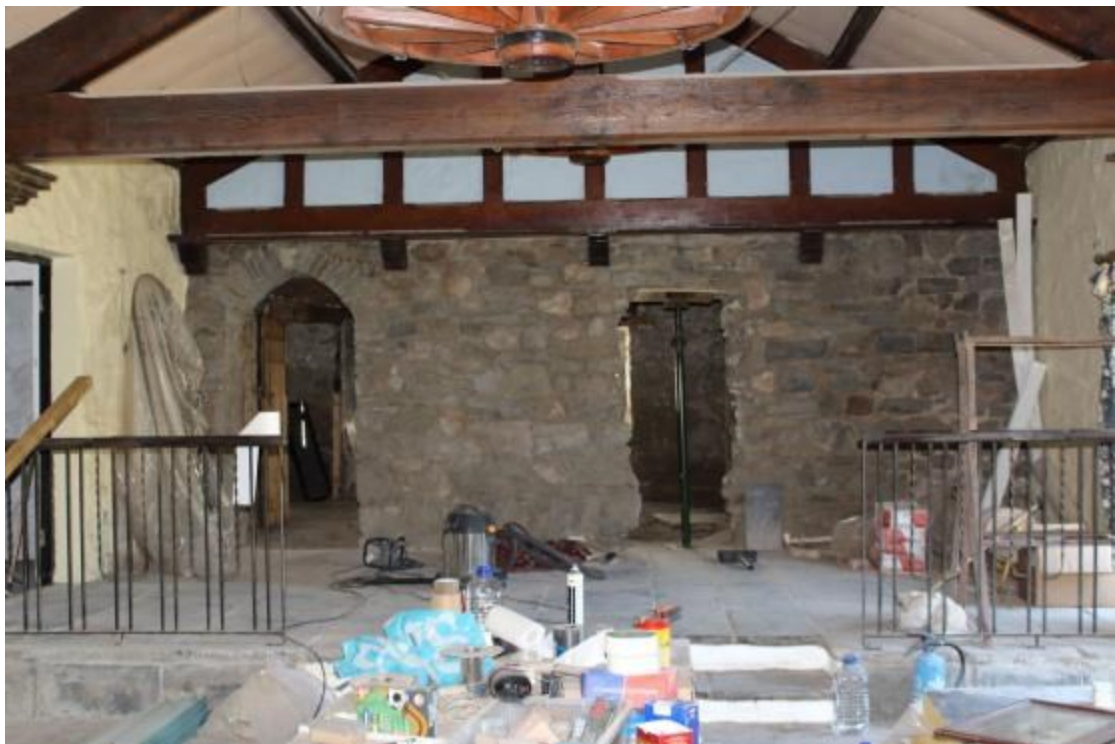
Photo 15: Looking northeast at the main hall in the late 20th century extension

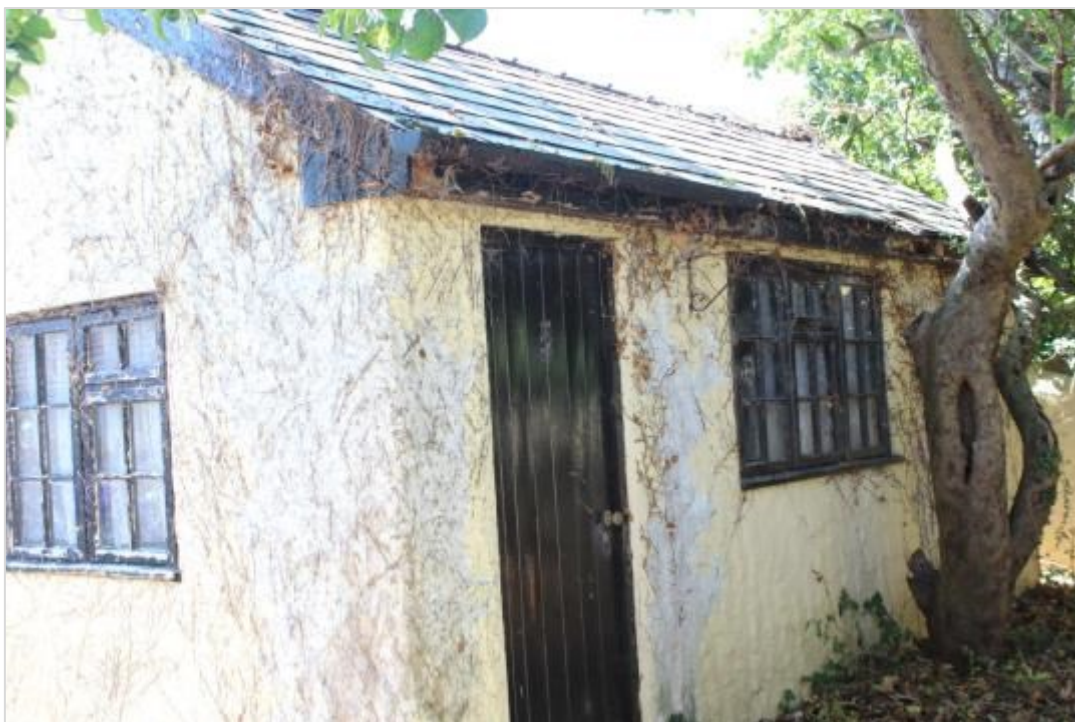
- 3.11 The outbuilding to the rear of the Old Moat House is currently a bedroom with WC. It is of block cavity wall construction with painted cement render, a composite slate roof, timber windows, doors and fascias, and black plastic guttering (Photos 16 and 17).

Photo 16: Looking northwest at the outbuilding at the rear of the Old Moat House

- 4.15 ***The 20th century outbuilding***
 1. Clear plant overgrowth make good roof, guttering and fascias, replacing as required.
 2. Replace deteriorated doors and windows with new hardwood like-for-like replacements.

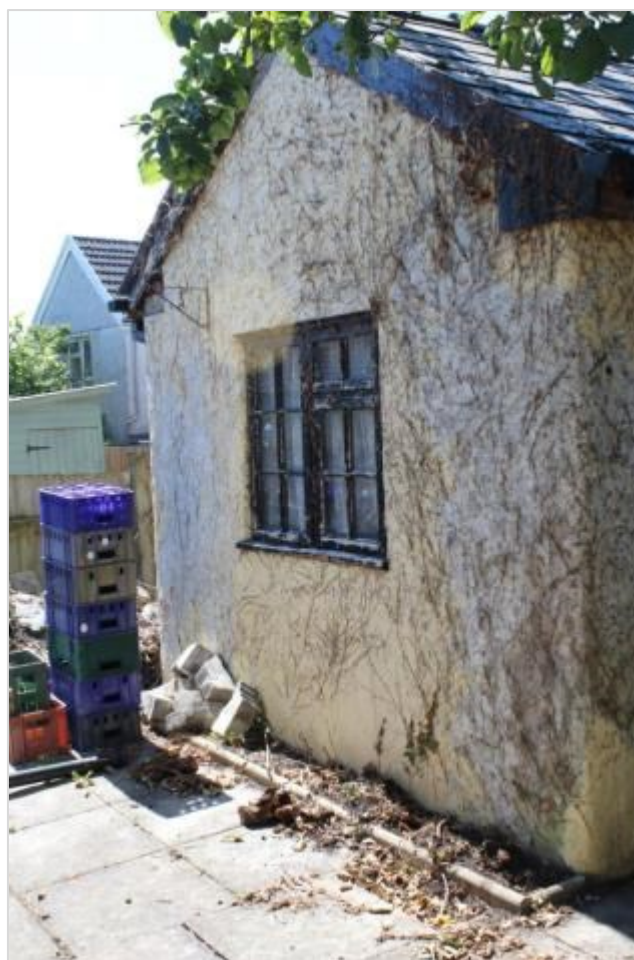
Photo 17: Looking northwest at the outbuilding at the rear of the Old Moat House
