CARMARTHENSHIRE ARCHIVES BUILDING, CARMARTHEN: ARCHAEOLOGICAL WATCHING BRIEF 2018 (SN 4145 2026)

RHIF YR ADRODDIAD / REPORT NO. 2018-38
RHIF Y DIGWYDDIAD/ EVENT RECORD NO. 112744

CARMARTHENSHIRE ARCHIVES BUILDING, CARMARTHEN: ARCHAEOLOGICAL WATCHING BRIEF 2018

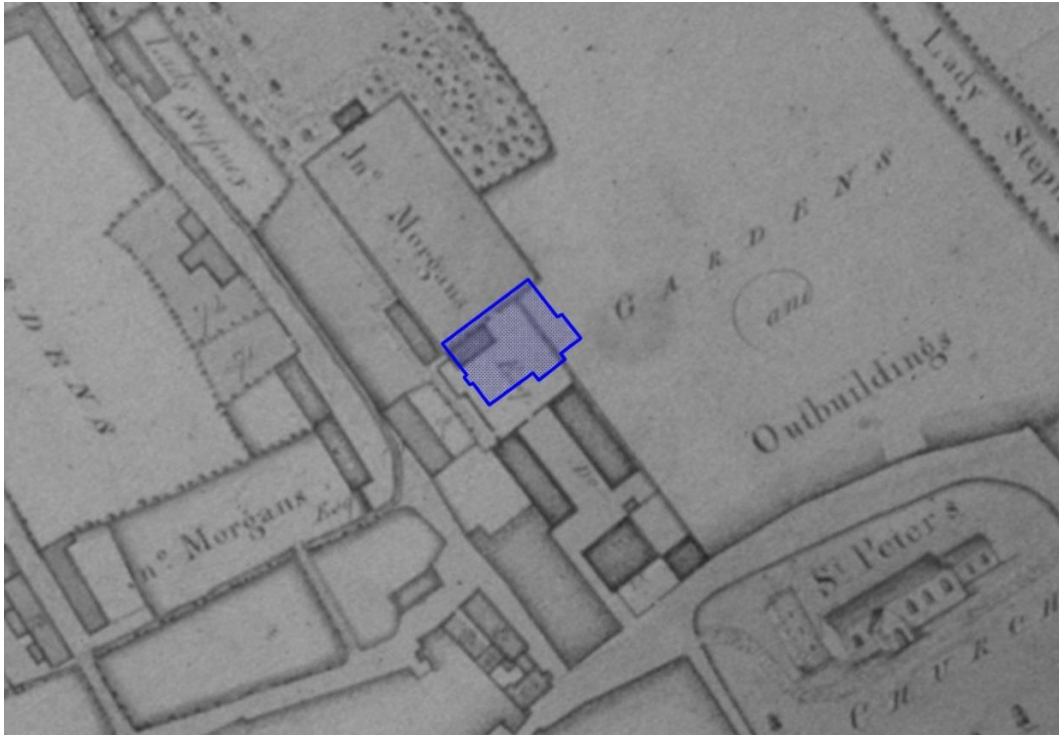
Figure 4: Extract of 1786 Golden Grove Estate Map showing approximate footprint of proposed Carmarthen Archives

- 2.2.8 The earliest map consulted was the 1786 Estate map of Carmarthen (Figure 4). This shows that the proposed location of the archives store was mostly undeveloped at this time, forming part of the area of gardens to the north of Furnace House. A structure lies within the northwestern part of the development site and a garden plot boundary runs through the eastern side.

- 4.2.2 The location of these walls; [1], [2], [8] and [9], within the NW quadrant of the development, suggested they are related to a structure which can be seen in various historical maps of Carmarthen, standing outside the walled garden of Furnace House (see Figures 4, 5 and 6). This had been interpreted as a simple glasshouse.
- 4.2.3 In order to achieve the required ground level to build upon and characterize the wall lines, it was agreed that the deposits within the bays would be excavated to leave the walls upstanding to enable detailed recording.

- 5.2.2 Only the southern wall of the walled garden was revealed during the archaeological watching brief.
- 5.2.3 A structure is shown corresponding with the area of 'Bay 1' recorded during the watching brief on earlier maps of the area: 1786 Golden Grove Estate map; Wood's 1834 map of Carmarthen and the 1888 1:500 Ordnance Survey map (Figures 4, 5 and 6).

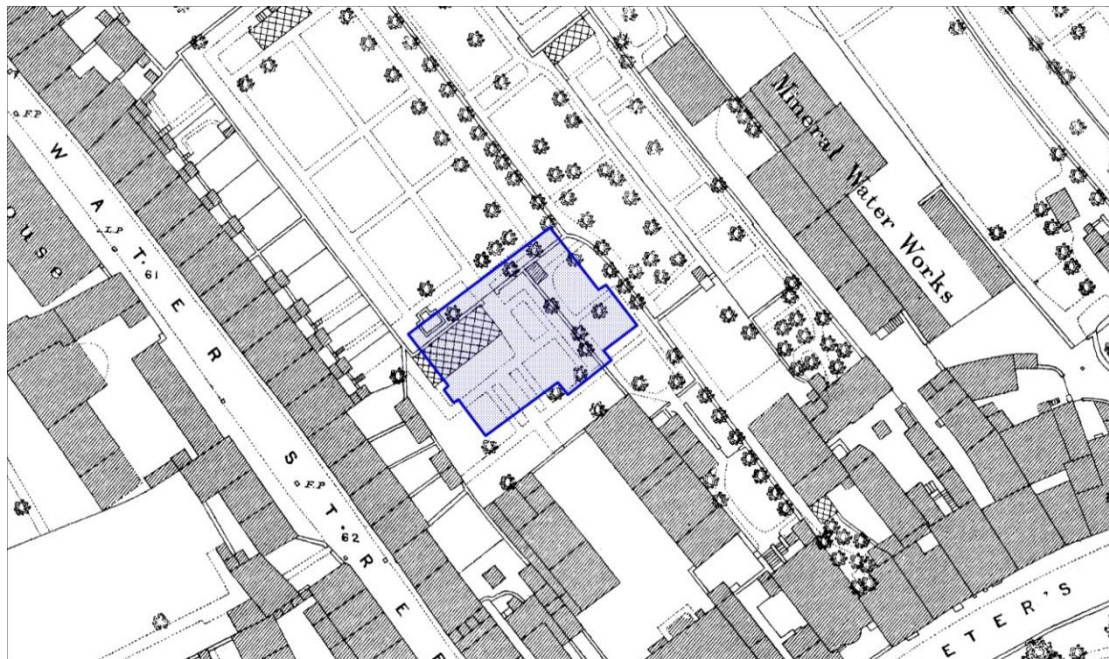
- 2.2.10 The 1888 1:500 scale Ordnance Survey map (Figure 6) shows a more accurate representation of structures on King Street, including Furnace House, adjacent structures no longer present and a formalised garden layout to the north. This covers the area of the proposed archive store and includes a structure shown as a cross hatch, which would indicate a glass house within the northwestern part of the site area. It is possible that this is the same structure as shown on the 1786 and Woods map of 1834, although this could not be confirmed.

Figure 6: Extract of 1888 1:500 Ordnance Survey Map with approximate footprint of proposed Carmarthen Archives building overlaid.

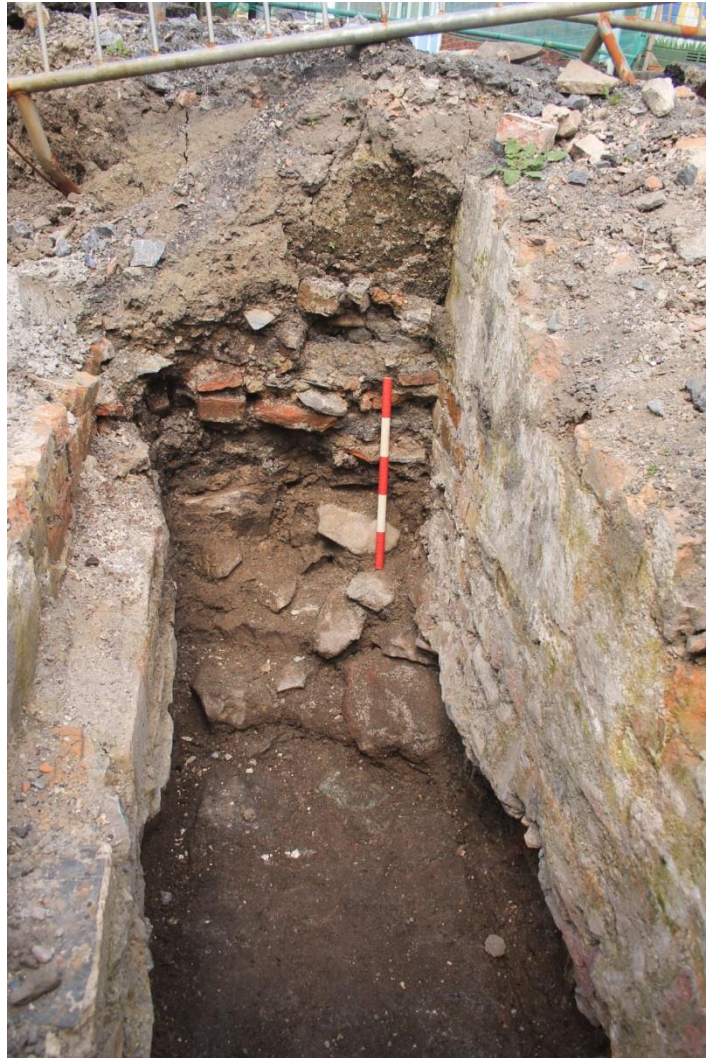
Photo 1: Remains of possible Roman wall at bottom of trial pit.
Looking west; 1m scale

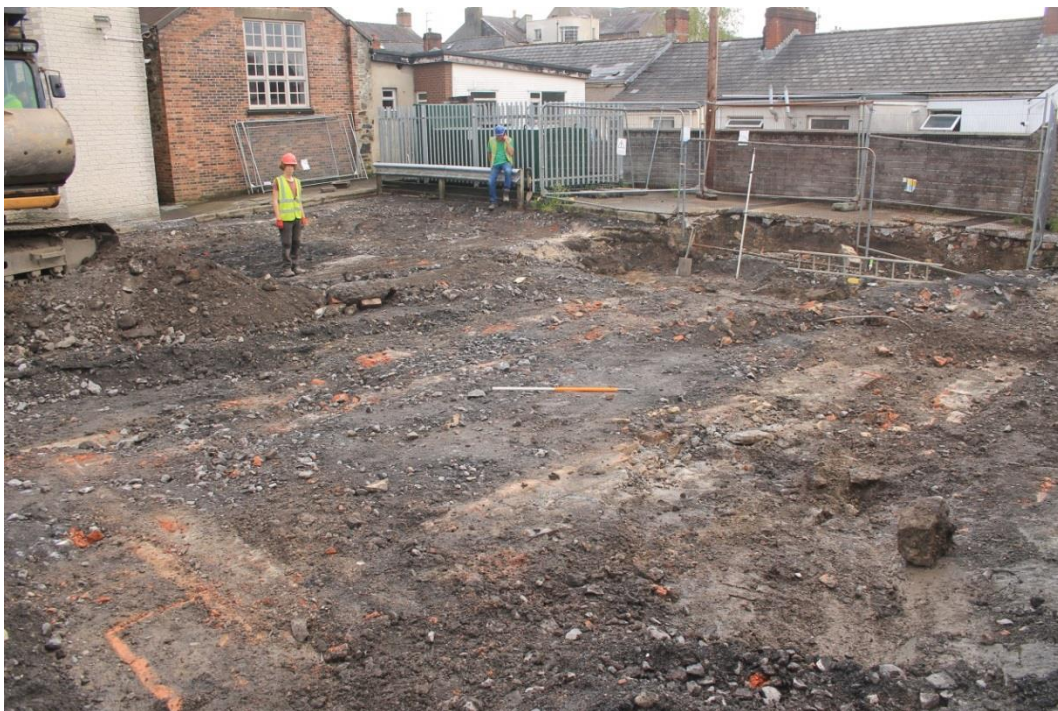
- 4.2.1 Following the removal of tarmac and ballast from the western half of the site, a sequence of wall lines creating a number of 'bays' was uncovered emerging from mixed, dark brown, garden soils (Photo 2).

Photo 2: Wall lines visible after removal of tarmac and stone ballast.
View south; 1m scale

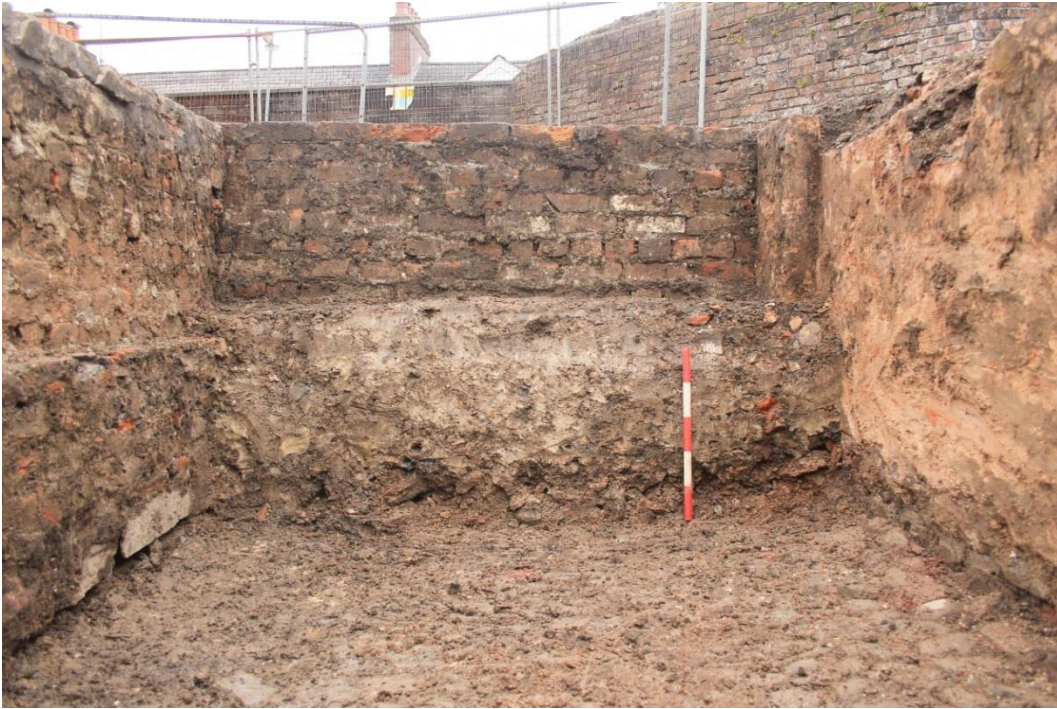
- 4.2.4 The deposits within Bay 1 consisted of 0.35m of dark garden soils (1), beneath which stood approximately 0.4m of mixed silty clays containing fragments of brick, slate and lime mortar (2). This stood upon a 0.3m thick deposit of stone and broken brick (3) (Photo 3).

Photo 3: Deposits (2) and (3) within Bay 1. Garden soils have been removed.
View west; 1m scale.

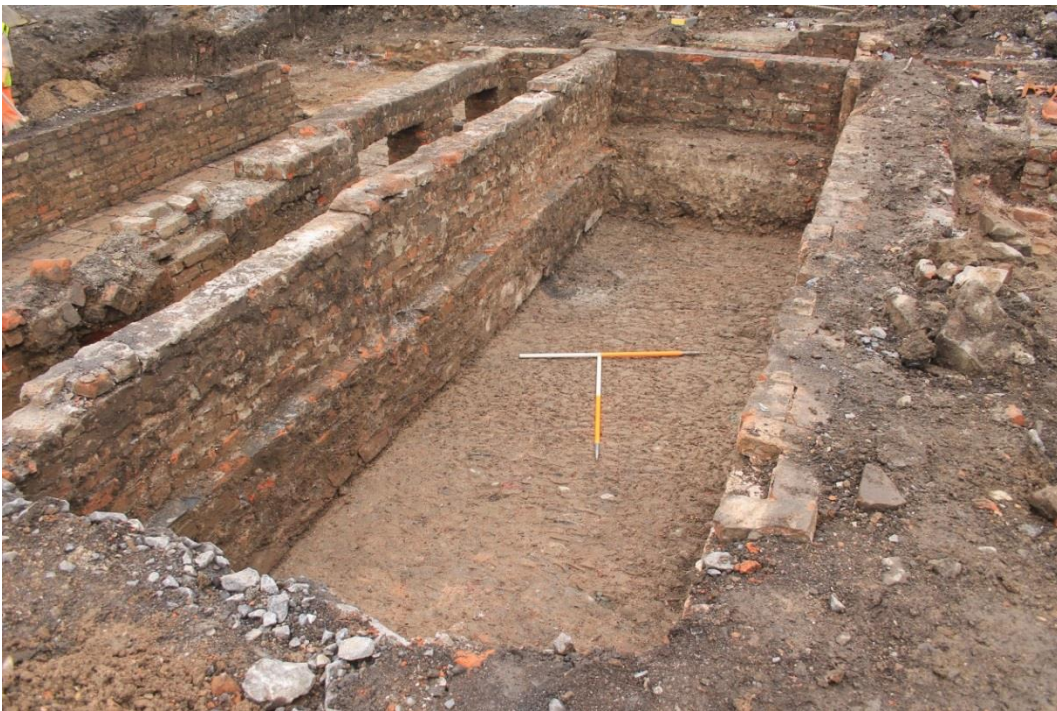
- 4.2.5 The removal of deposits within Bay 1 revealed a cobbled surface [5] which covered the whole of the bay and measured 8.1m by 1.9m (Photos 4 & 5). It butted up to wall [2] but extended beneath wall [7].

Photo 4: Cobble floor [5]. View west; 2x1m scales

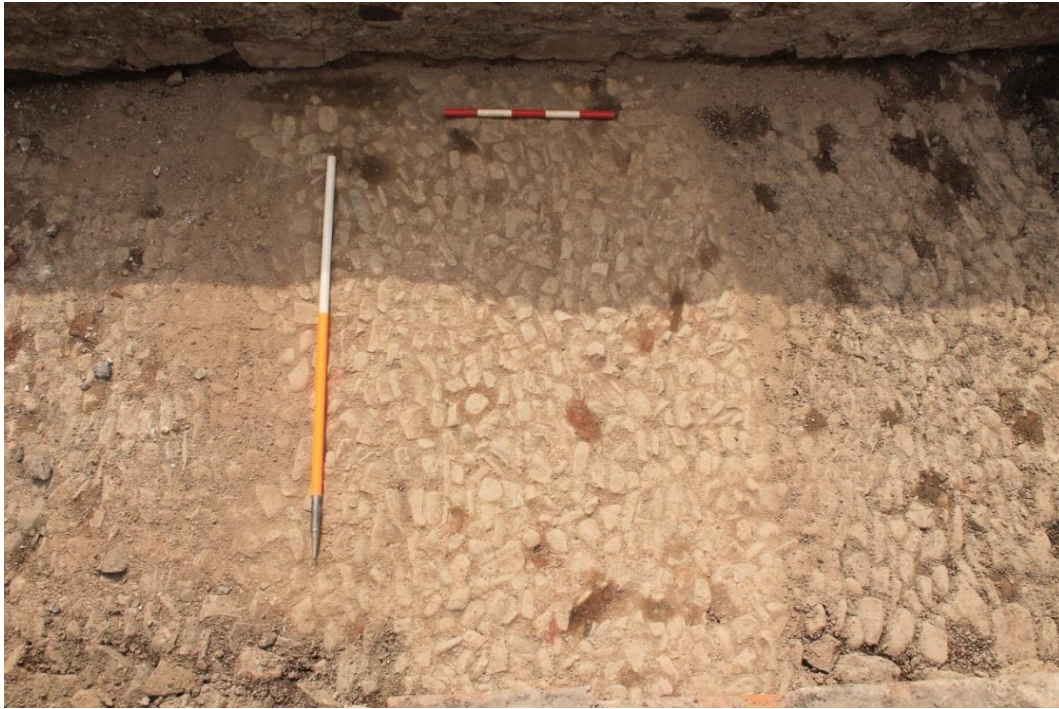
Photo 5: Detail of cobble floor [5]. View north; 0.5m and 1m scale

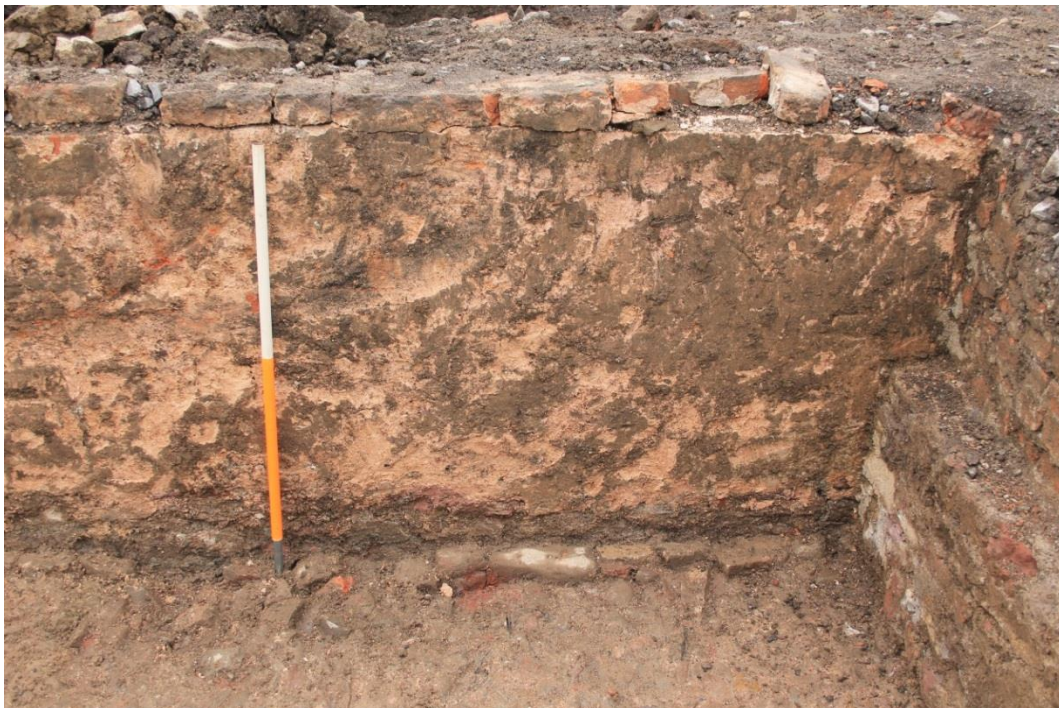
- 4.2.6 Wall [2] was approximately 9.1m long, 0.35m wide and x 1.1m high (Photo 6). Its southern elevation was brick with a pink plastered face, whilst its northern (hidden) face was a mixture of brick and stone. It formed the northern side of Bay 1.

Photo 6: Plastered face of wall [2] and cobble floor [5]. View north; 1m scale

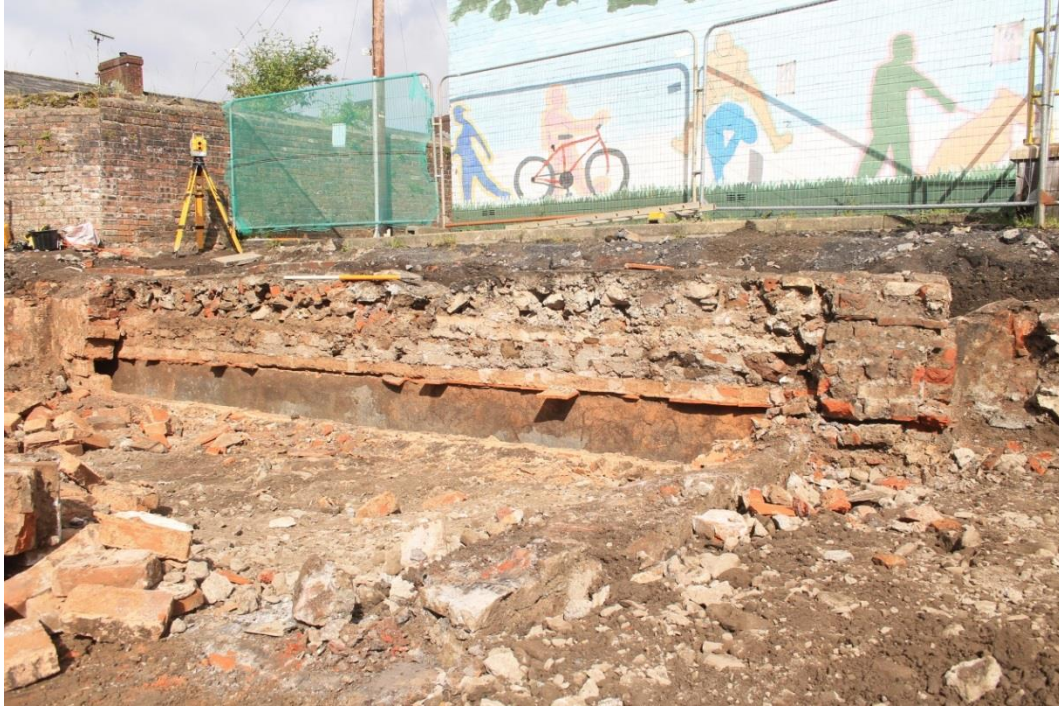
- 4.2.7 When wall [2] was demolished an internal flue [6] (which enabled the wall to heat up) was revealed (Photos 7 & 8). It was 0.2m wide, 0.4m tall, capped with thin brick tiles and ran the length of the base of the wall. At its western end it curved northwards (Photo 9) into the trench baulk. At its eastern end (its original chimney having been blocked and the flue extended through wall [9]) it exited via a chimney flue adjacent to the outside of wall [9] and cut slightly into wall [1] (Photo 10).

Photo 7: Flue [6] exposed within wall [2]. View NW; 1m scale

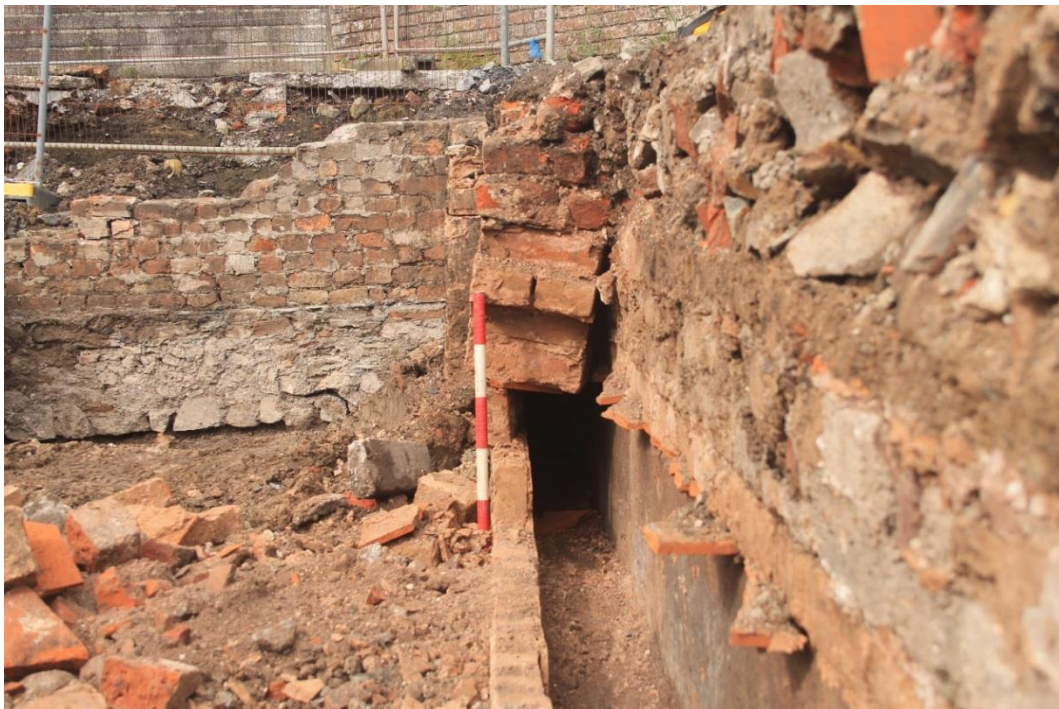
Photo 8: Detail of flue [6] within wall [2]. View west; 0.5m scale

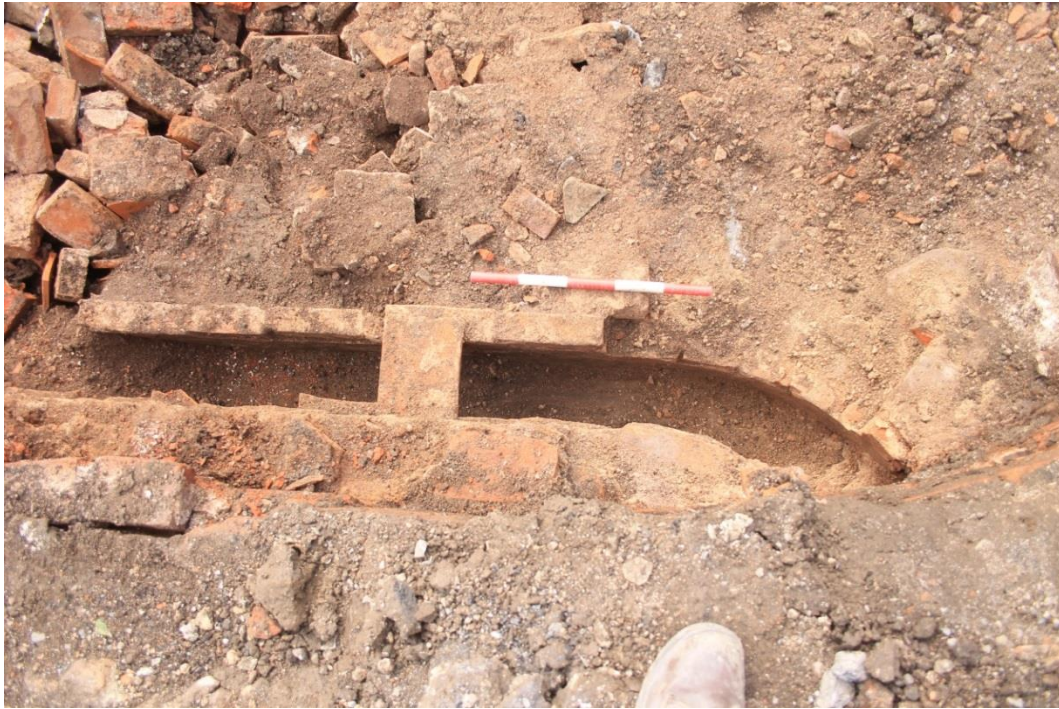
Photo 9: Flue [6] turning NW at west end of wall [2]. View south; 0.5m scale

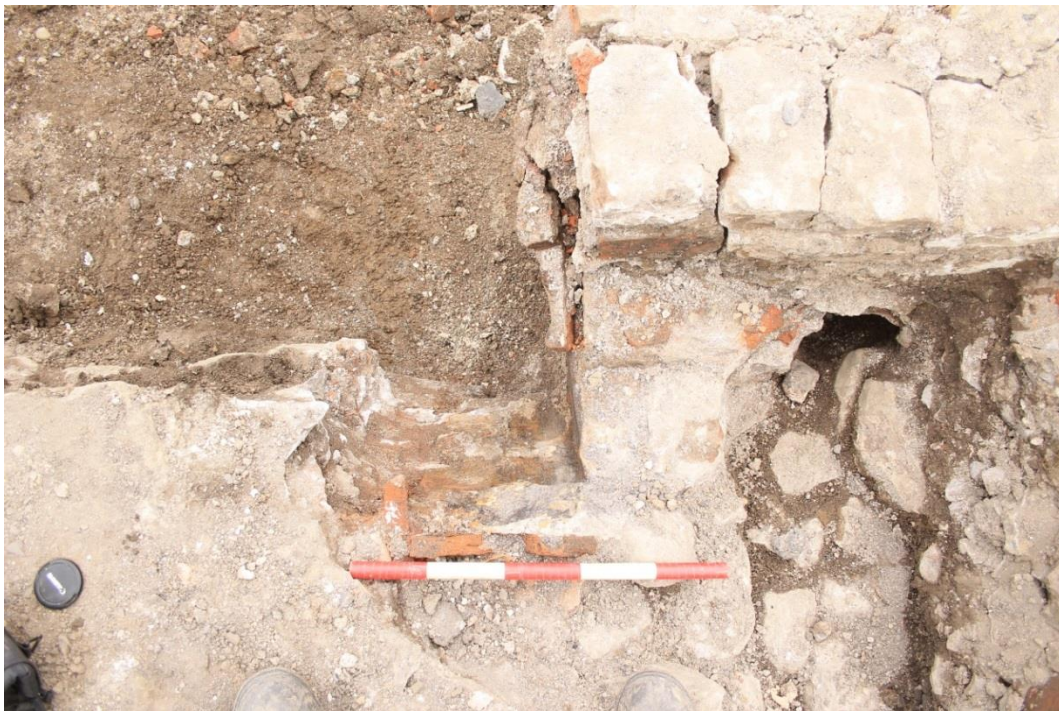
Photo 10: Blocked chimney flue [3] on the right; chimney flue [4] on the left.
View south; 0.5m scale

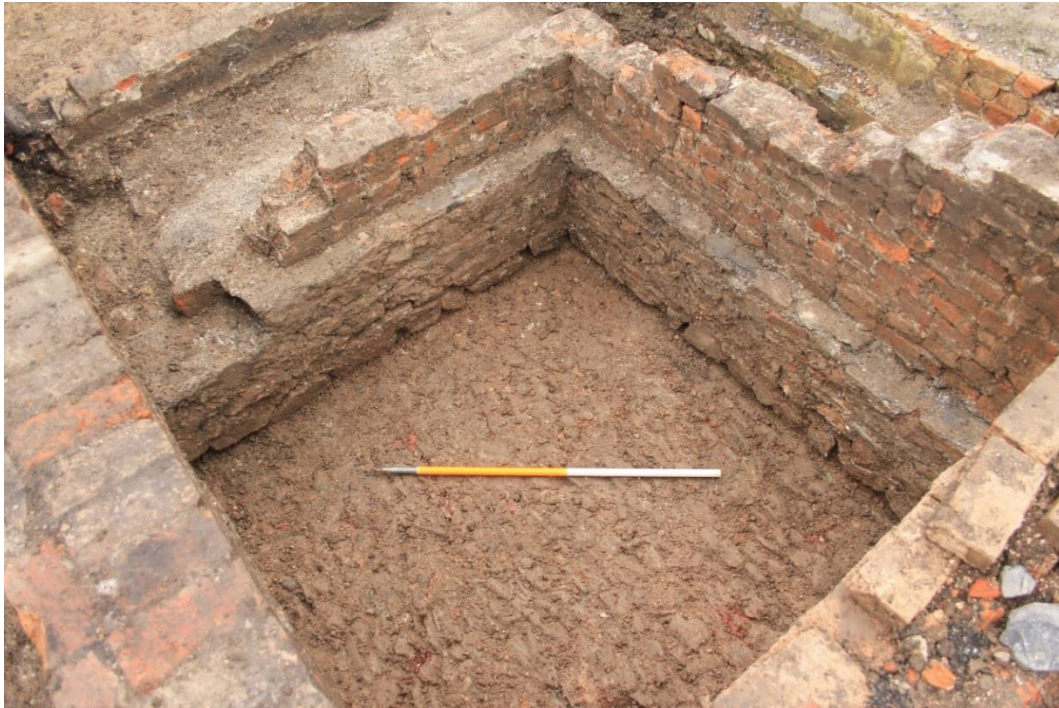
10, 11 & 12). It was brick built 0.25m wide and 0.6m high. Its outer face was flush with the outer face of wall [7] and had been plastered. Its inner face was approximately 0.1m back from the inner face of wall [7] creating a ledge (Photos 10 & 12) that encompassed three sides of the bay. The original length of the Bay had been divided on its western side by the later construction of brick wall [9] (Photos 11 & 12).

Photo 11: Stone wall [7] in lower part above cobbles, with brick wall [8] above and later brick wall [9] to left. View SW; 1m scale

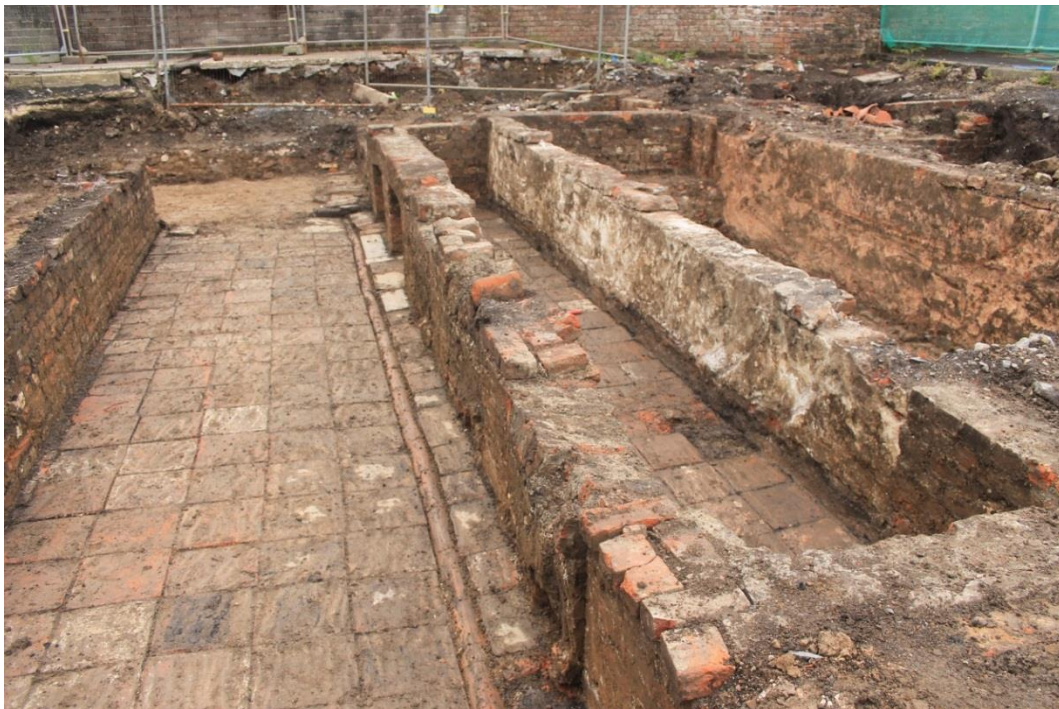
Photo 12: Wall [8] (white plaster) with walls [2] and [9] on either side. View west.

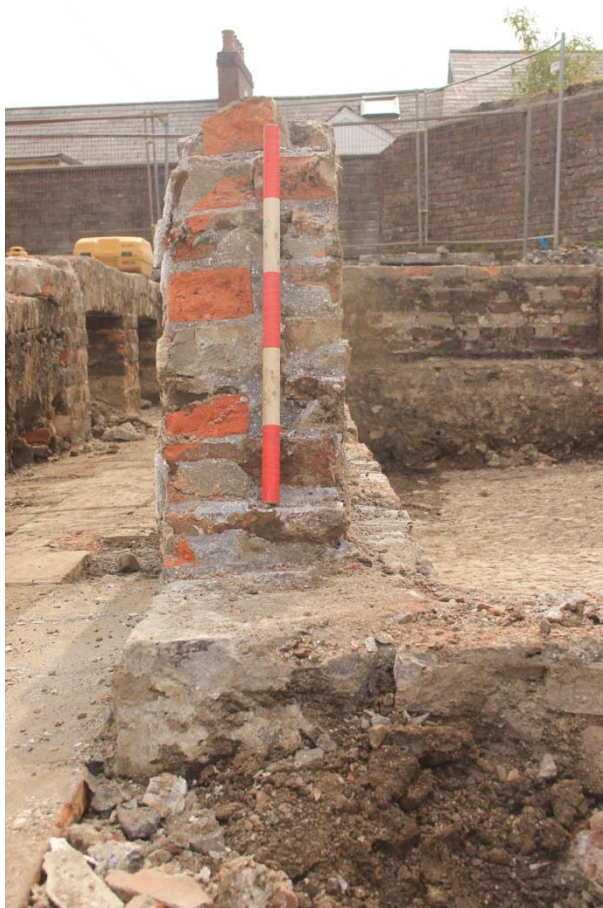
Photo 13: Section through wall [8] sitting above wall [7]. View west; 0.5m scale

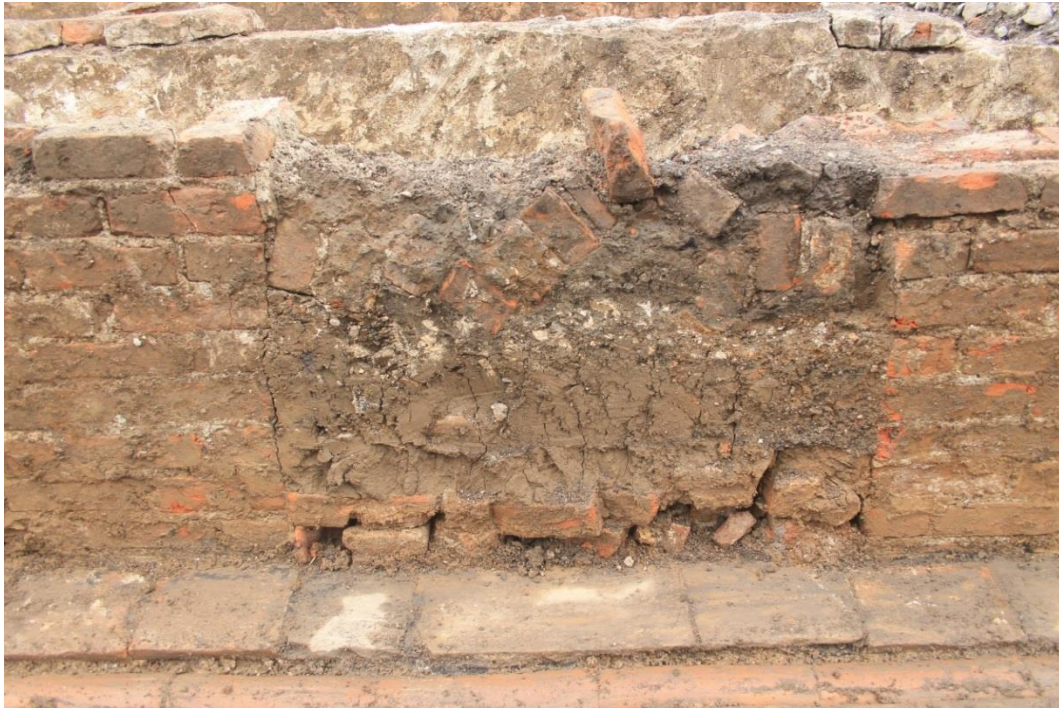
- 4.2.9 Within Bays 2 and 3, and areas to the west of these bays, the same thickness of garden soils (1) continued, beneath which stood a mid-brown, silty clay (4) with occasional brick fragments. This deposit stood upon a layer of stone and broken brick (5) similar to (3) but with larger fragments of brick (Photo 14).

Photo 14: Deposits (1), (4) and (5) beneath collapsed arch in wall [9].
View north.

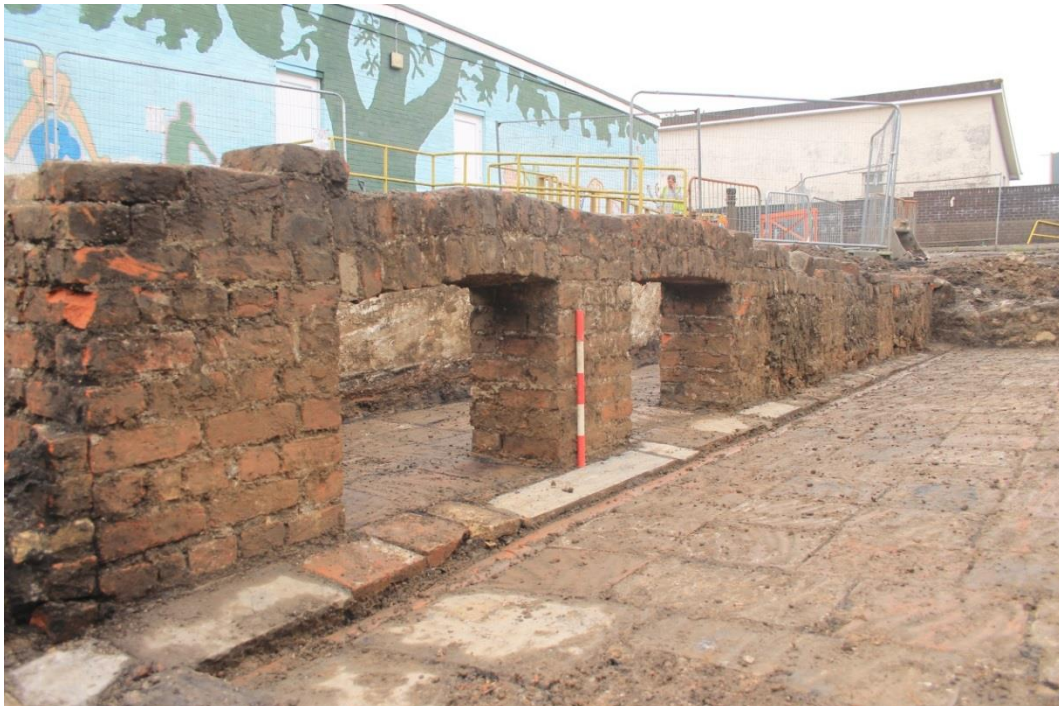
Photo 15: Southern aspect of wall [9] showing small arcade.
View NE; 0.5m scale

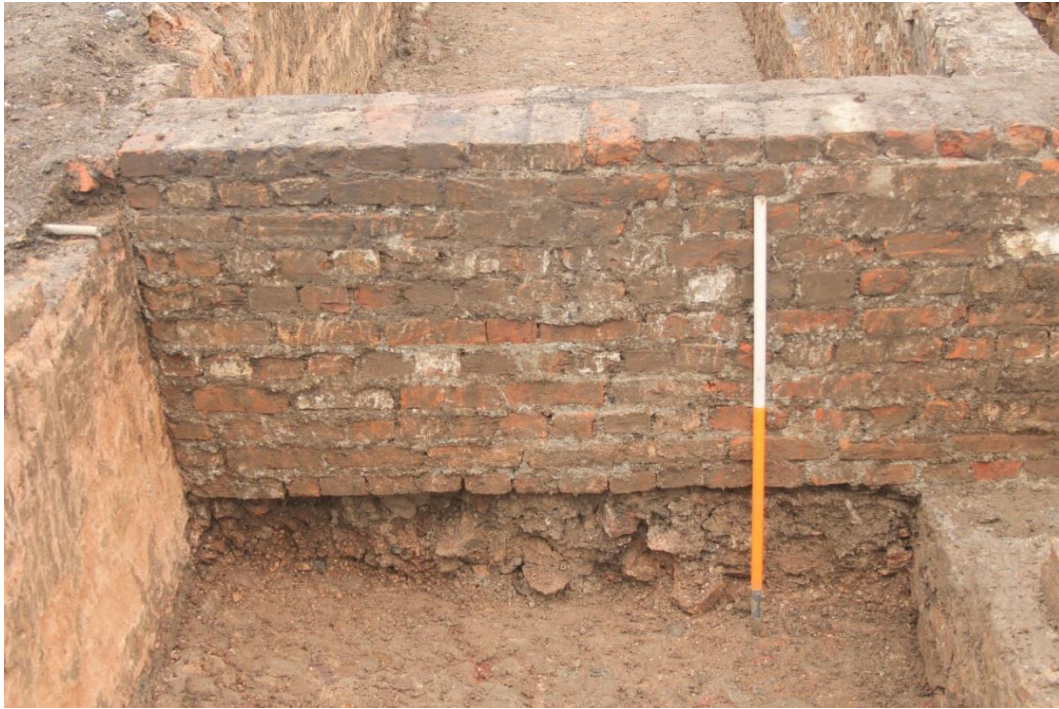
Photo 16: Wall [9] sitting on top of deposit (3) and butting up to wall [2], dividing Bay 1. View east; 1m scale

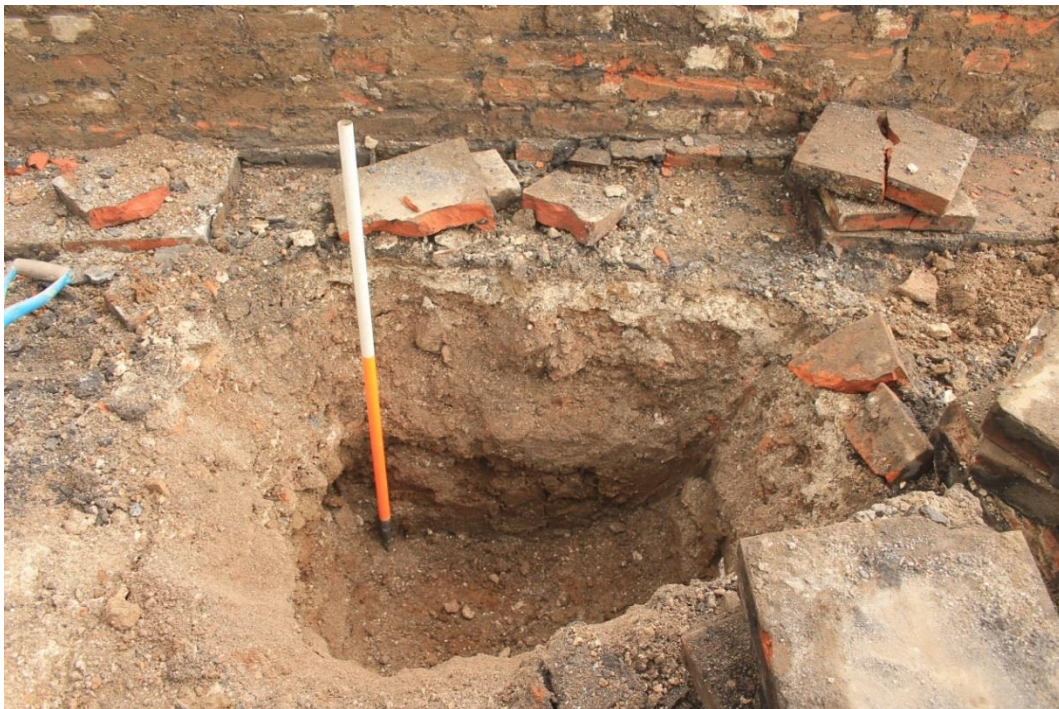
4.2.13 It was evident that the cobbled floor [5] extended beyond the edges of Bay 1 and it is likely that it extended below the area of Bay 2. As the formation depth for the new Archives Building had been reached, there was no requirement for any deeper excavation in this area and so the extents of cobbled floor [5] could not be confirmed. The small Test pit 1 excavated in Bay 3 did not show the cobbles in section, only demolition and levelling layers were revealed (Photo 17).

Photo 17: Test pit 1 showing demolition and levelling deposits. View south; 1m scale

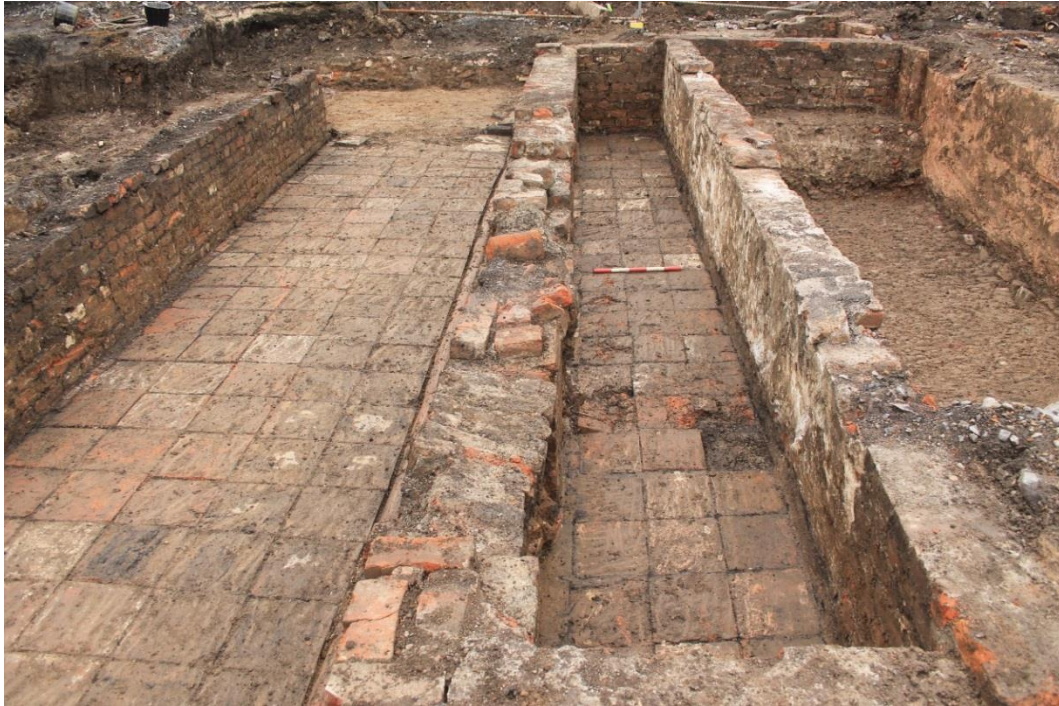
- 4.2.14 Floor [10] lay between the arched section of wall [9] and wall [8], which formed a corridor 7m long and 0.75m wide. The floor comprised unglazed earthenware tiles, each measuring 0.28m by 0.24m (Photos 18 & 19). It appeared to extend just beyond the arches of wall [9] by one row non-continuous row of tiles.

Photo 18: Tiled floor [10] bounded by walls [8] and [9] in Bay 2 (centre). Floor [15] is on the left in Bay 3. View west; 0.5m scale

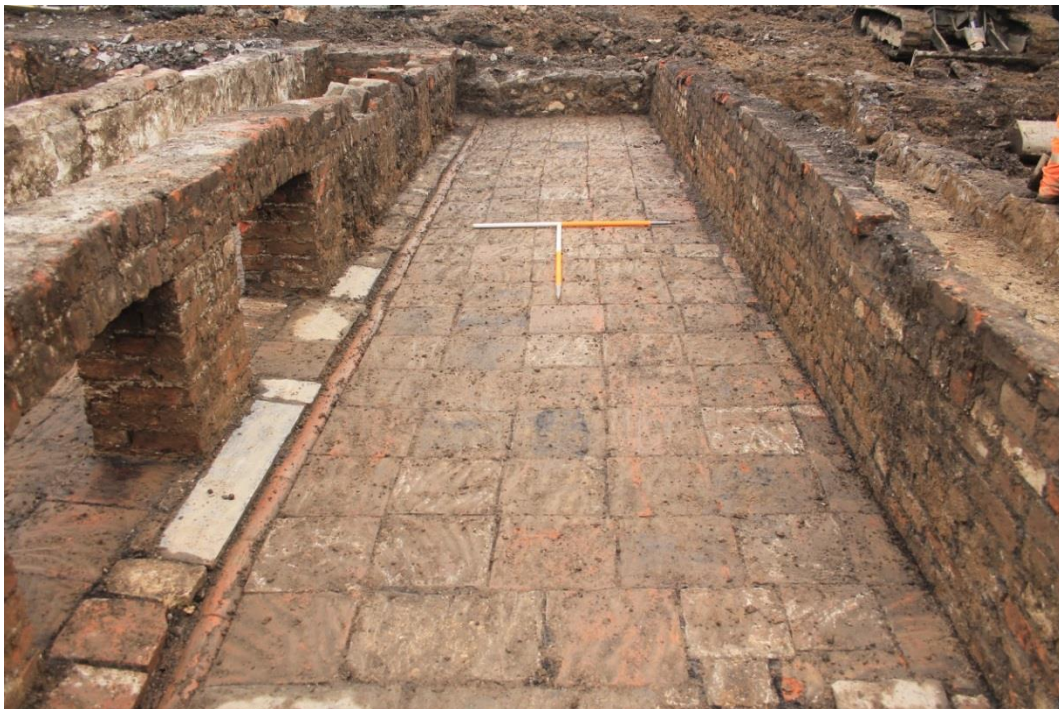
Photo 19: Tiled floor [15] bounded by walls [9] and [17] in Bay 3. Drain pipe [12] runs between floors [10] and [15] to the left. View east; 2 x 1m scale

- 4.2.16 Beneath drains [18] lay another unglazed earthenware tile floor [15] (Photos 18 and 19) similar to that seen at the base of Bay 2 [10]. It measured 7.85m by 1.7m and was better preserved than floor [10] with a drain pipe [12] separating both floors.
- 4.2.17 Wall [17] was a single-skinned brick wall with one good face adjacent to floor [15] (Photo 19). The wall was built against a deposit of light brown, silty clay (6) overlain by garden soil (1) (Photo 22). There is probably some significance in the fact that both floor [15] and wall [17] ended in line with wall [9]. Beneath deposits (1) and (6) a mortared surface, possibly bedding for a former tiled floor, was revealed (Photo 23).

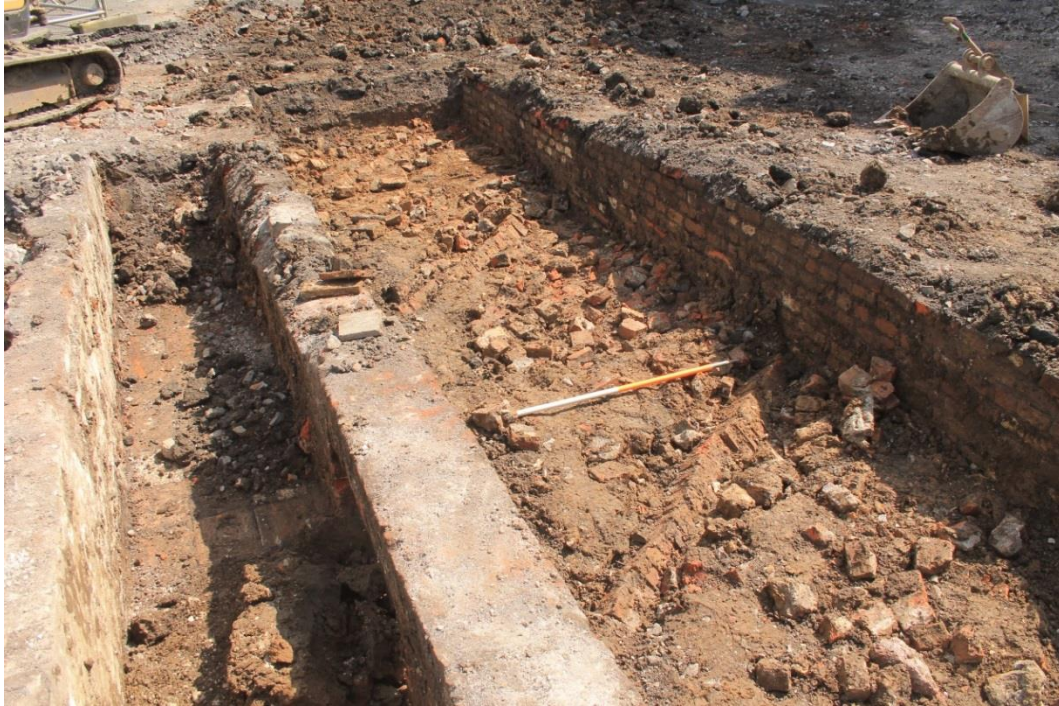
- 4.2.15 The prior removal of overlying deposits from within Bay 3 revealed a series of four parallel brick drains [18] (Photo 20) which ran into a makeshift culvert placed on top of earlier drain pipe [12], which, in turn fed a small, rough, stone-capped drain [14] (Photo 21). A lime mortar surface [11] was uncovered between walls [8] and [13]. The eastern ends of the surface and both walls had been damaged by the insertion of a modern pipe (Photo 21).

Photo 20: Brick drains [18] within Bay 3 protruding from deposit (4).
View SE; 1m scale

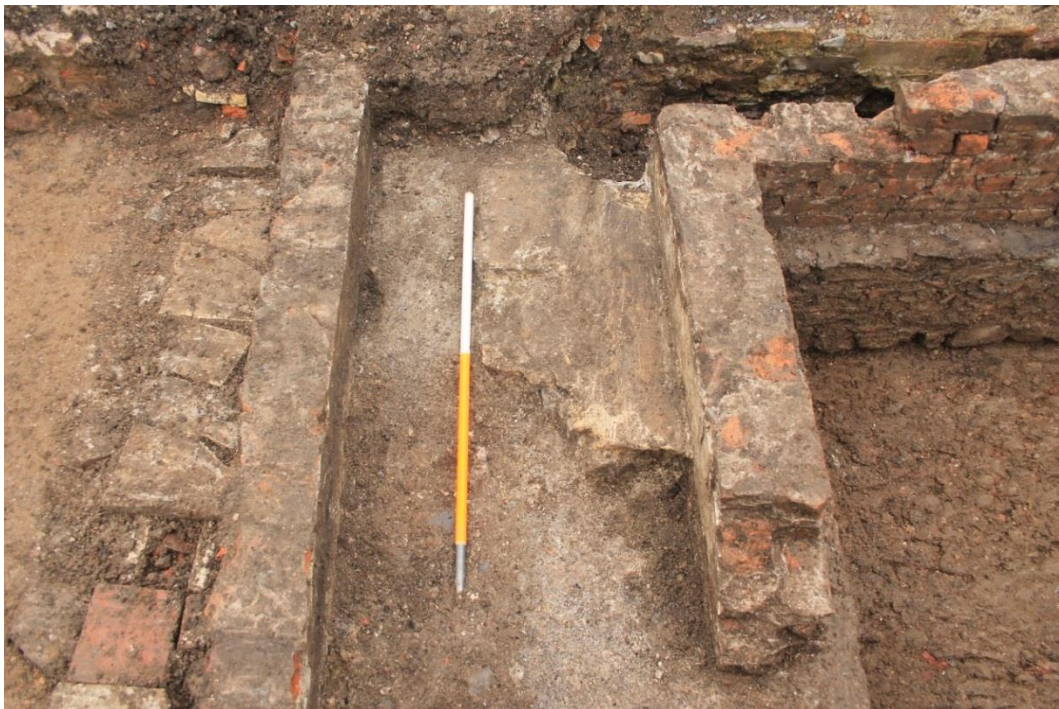
Photo 21: From left to right - stone capped drain [14], wall [13], mortar surface [11], wall [8] and cobble floor [5]. View west; 1m scale

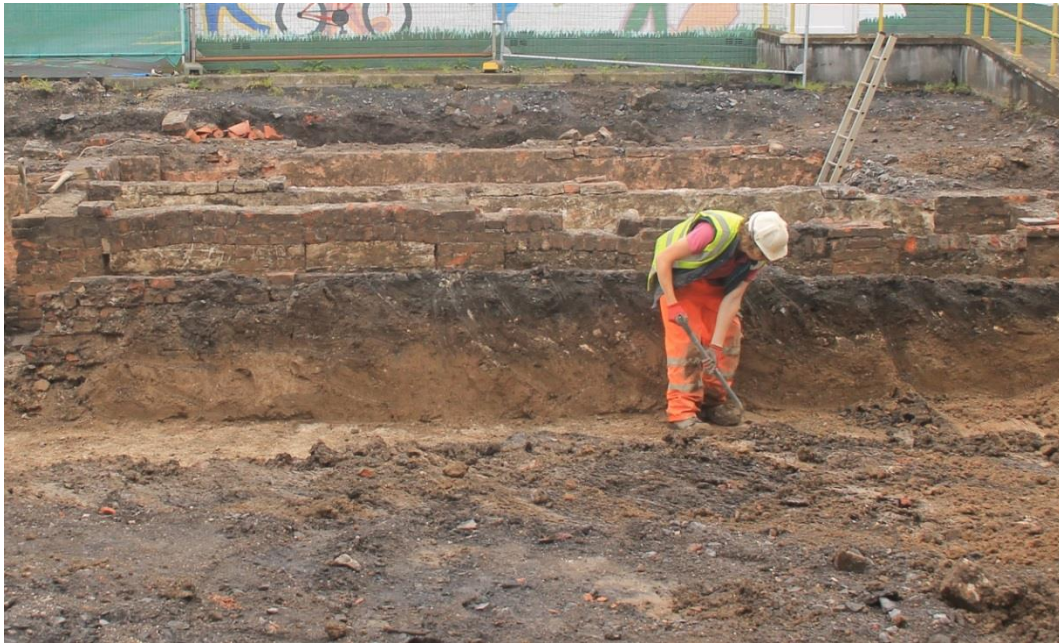
Photo 22: Deposits (1) and (6) directly south of wall [17]

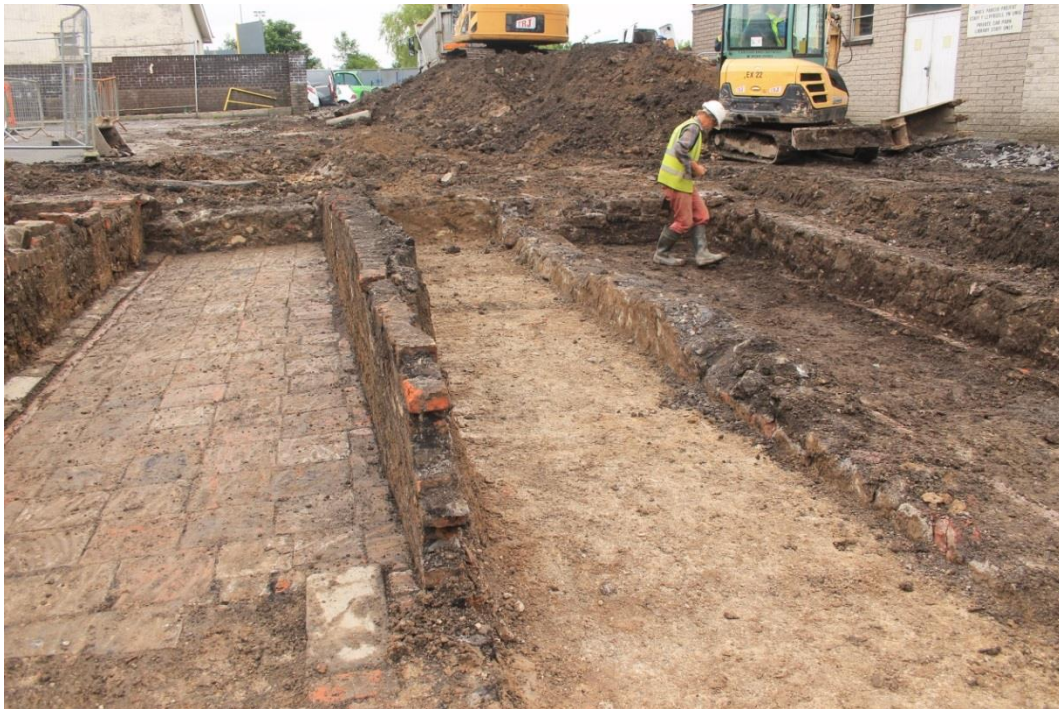
Photo 23: Mortar layer [19] between walls [17] and [20]; floor [15] on the left. View east.

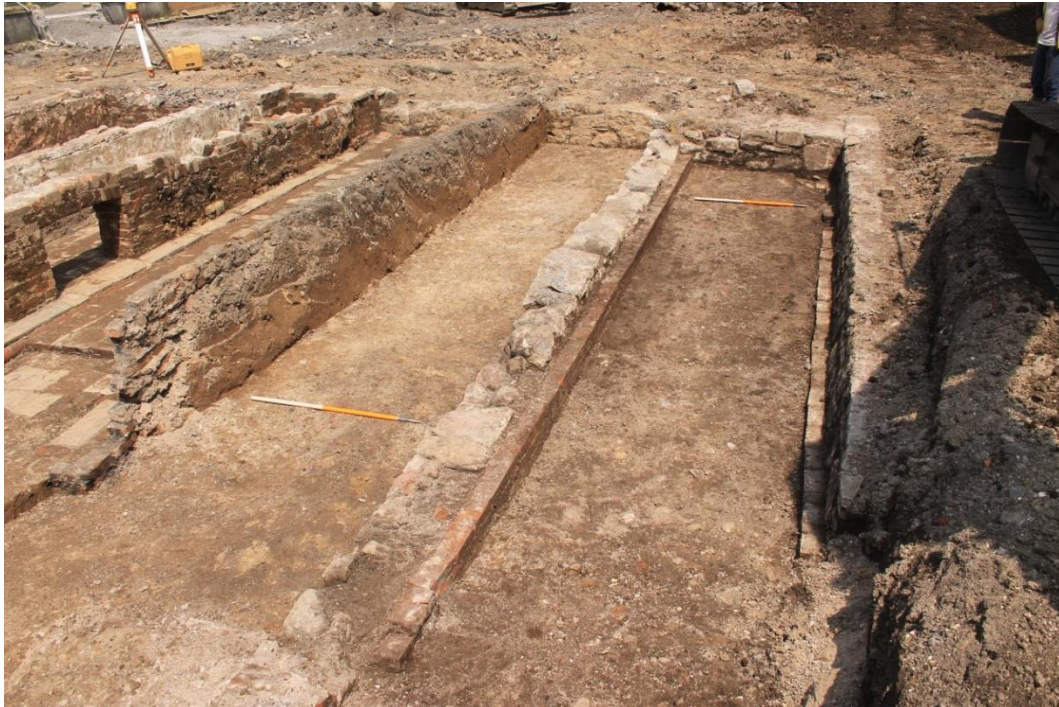
Photo 24: Walls [20] and [21] and their respective brick ledges. Cross wall [16] in the foreground. View east; 2x1m scale

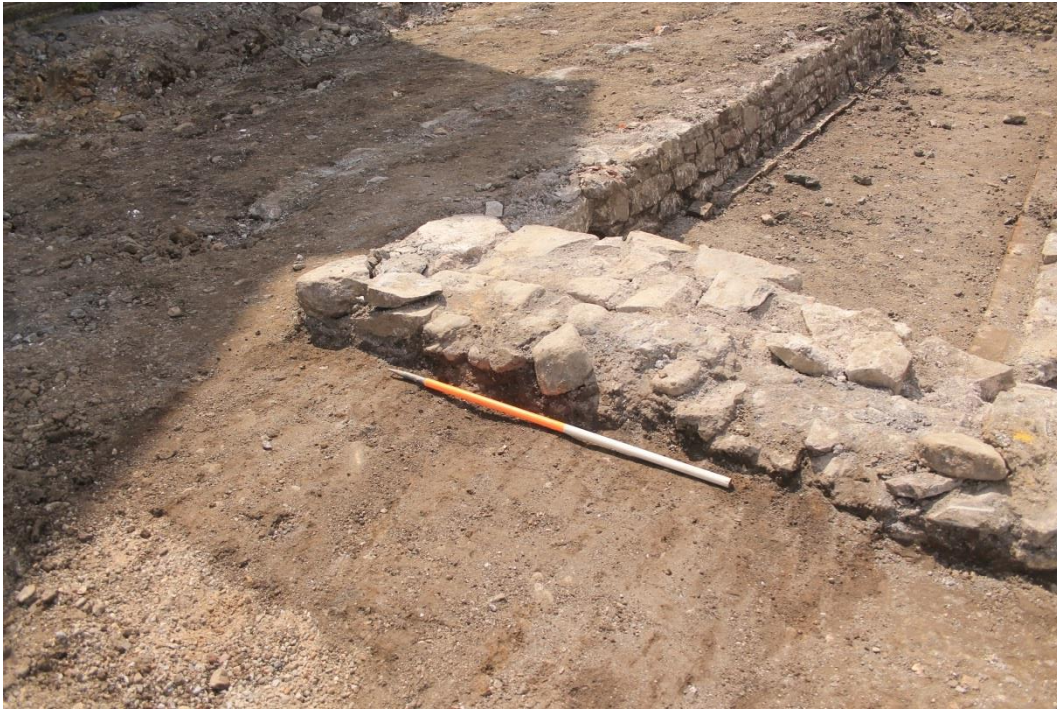
- 4.2.20 The truncated tops of three other walls [22], [23] and [24] running parallel with [21] were uncovered but the deposits between them were not excavated as the level of the walls corresponded with the required formation level for the new Carmarthenshire Archives building (Photo 25).

Photo 25: Walls [21] with the tops of walls [22], [23] and [24] just visible to the left. View SW; 1m scale
