CARMARTHENSHIRE ARCHIVES BUILDING, CARMARTHEN: ARCHAEOLOGICAL WATCHING BRIEF 2018 (SN 4145 2026)

RHIF YR ADRODDIAD / REPORT NO. 2018-38
RHIF Y DIGWYDDIAD/ EVENT RECORD NO. 112744

CARMARTHENSHIRE ARCHIVES BUILDING, CARMARTHEN: ARCHAEOLOGICAL WATCHING BRIEF 2018

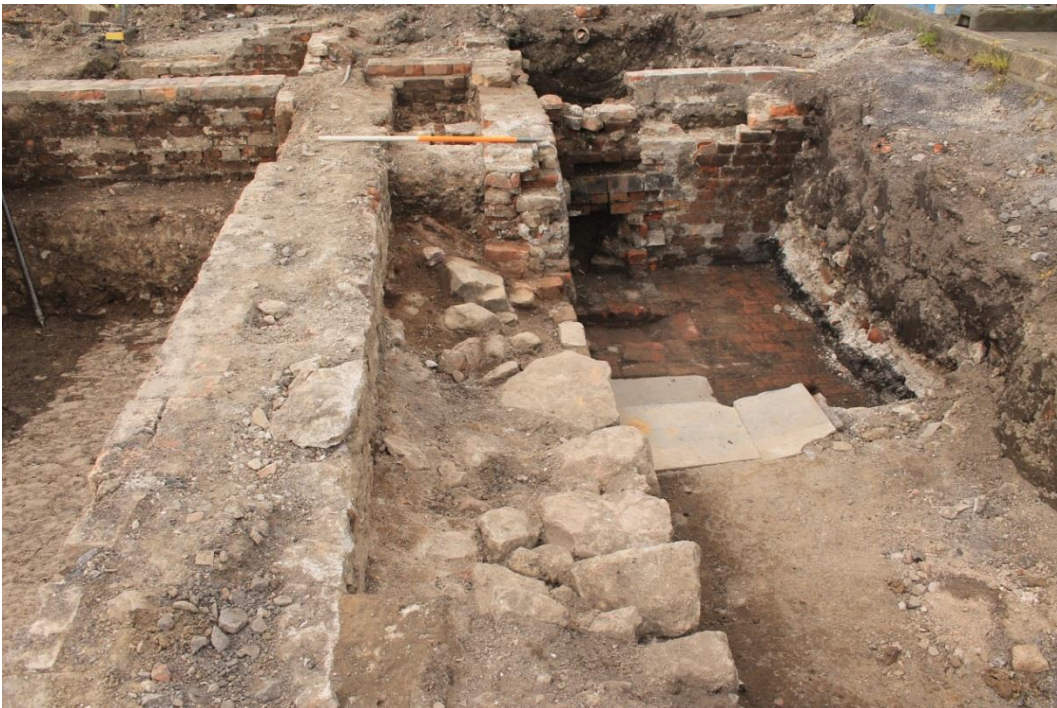
Photo 26: Wall [1] on the right, wall [2] on the left; the furnace room can be seen in the background, having been inserted into wall [1]. View west; 1m scale.

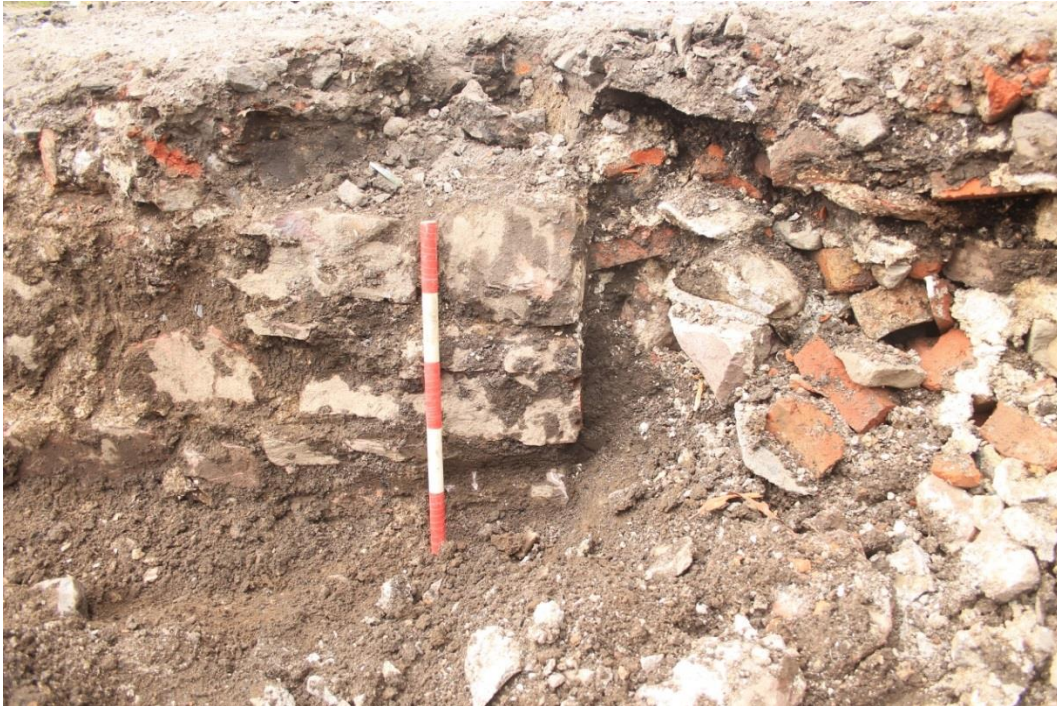
4.2.23 At its eastern end it returned north (Photo 27), whilst its western end was truncated by a modern drain. There was a gap of approximately 0.45m between walls [1] and [2], within which an iron pipe with a brick surround was uncovered (Photo 28). The remainder of the gap was filled with soils, stone and brick.

Photo 27: Southeast corner of Furnace House garden wall [1].

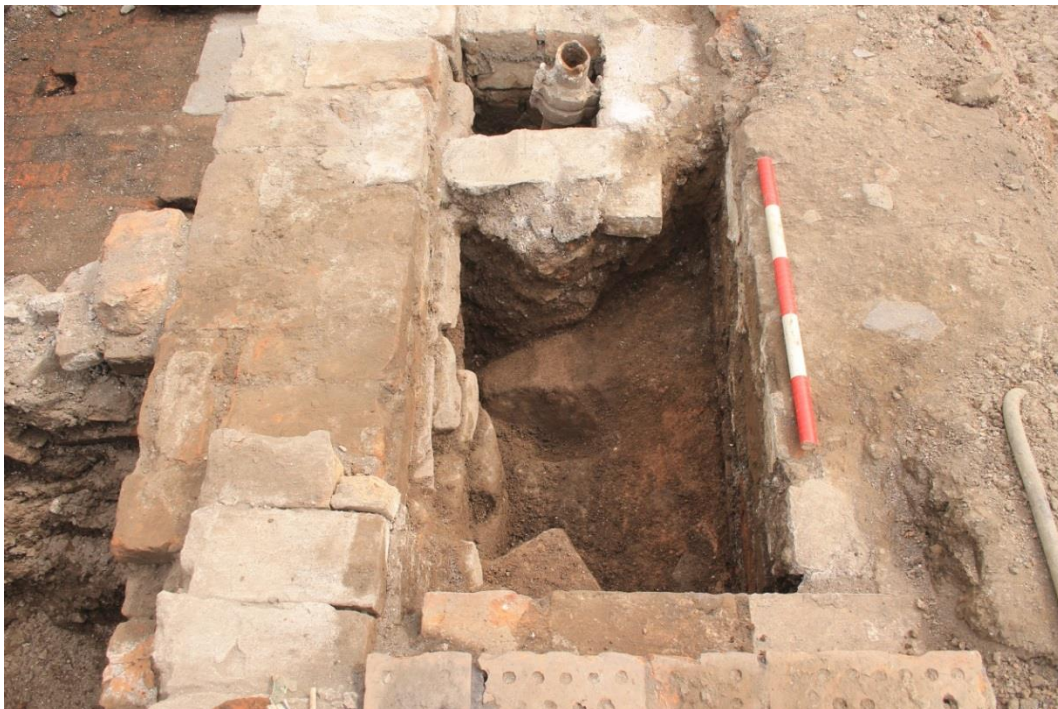
Photo 28: Gap between the furnace room section of wall [1] and wall [2], with hot water pipe and brick surround. View east; 0.5m scale

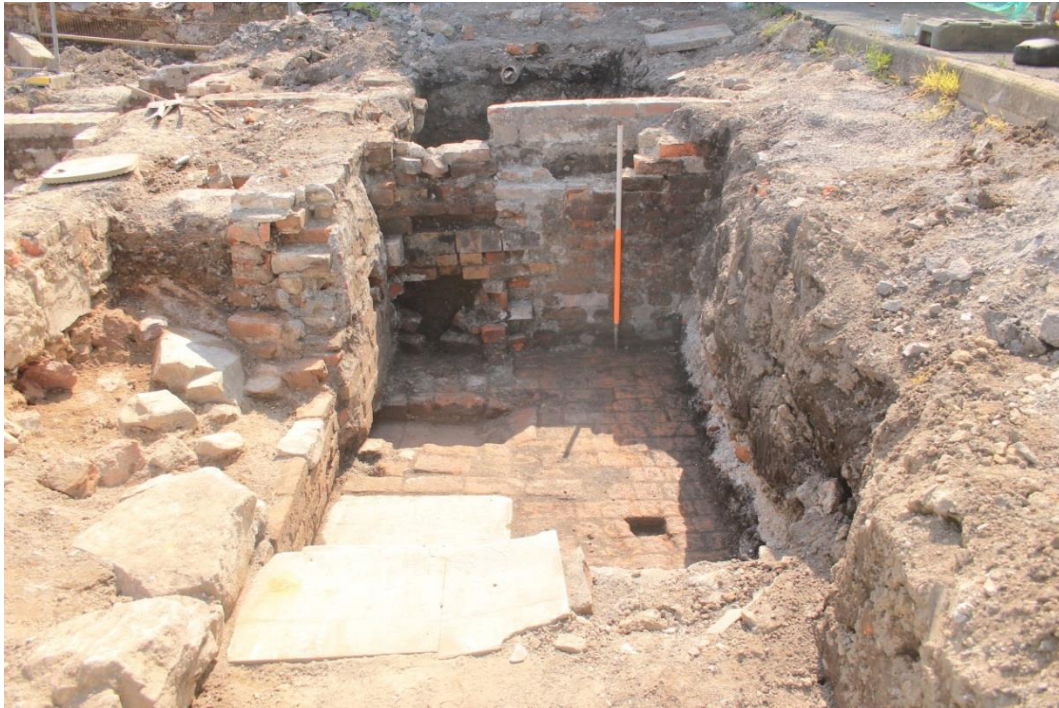
- 4.2.24 On the north side of the wall [1] (adjacent to Bay 1) its face had been removed to incorporate the construction of a brick built furnace room with a brick floor (Photos 26 and 29).
- 4.2.25 It measured 2.15m by 1.8m and was 1.05m deep. Its north wall contained a 0.95m opening and possibly the remains of an arch (Photo 30). Access into the room was via three slate steps. This structure can be seen on the 1888 1:500 Ordnance Survey map.

Photo 29: Furnace room. Brick wall on left is incorporated into Garden wall [1].
View west; 1m scale

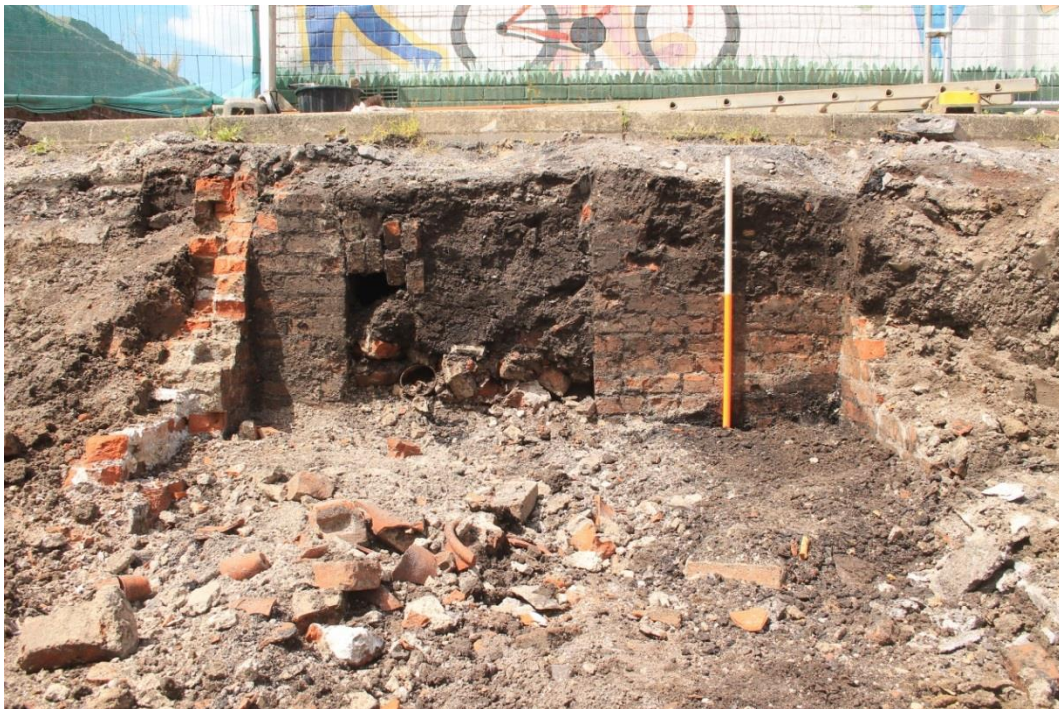
Photo 30: North wall of furnace room with possible collapsed arch.
View north; 1m scale.

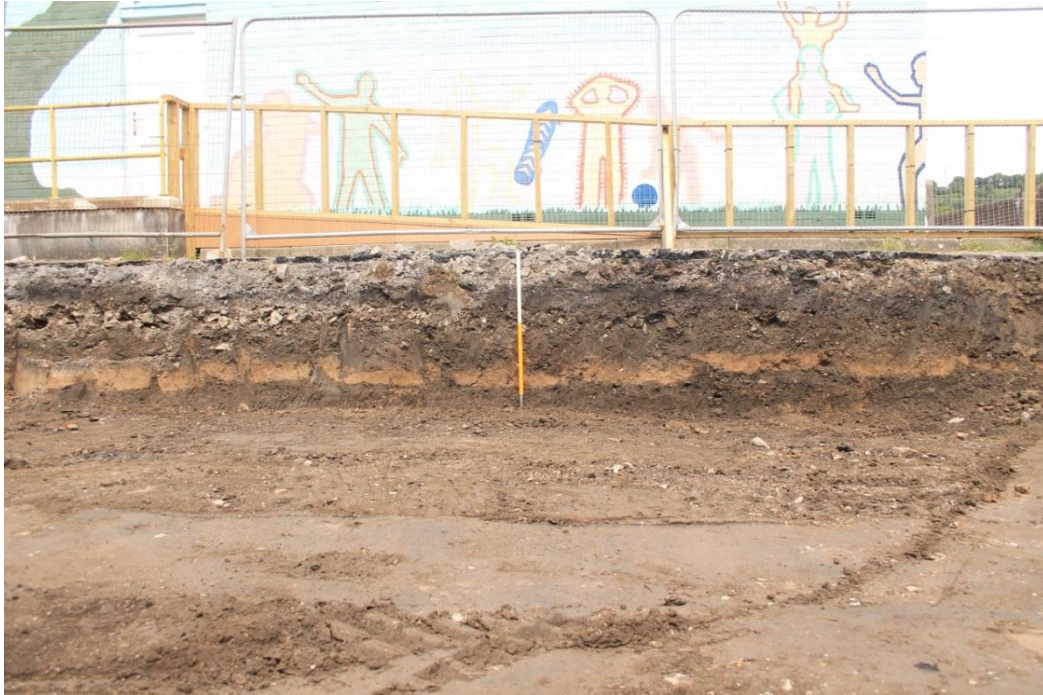
- 4.3.1 During ground reduction a number of modern land drains were removed from this half of the development. Apart from the continuation of the walled garden wall [1], no other post-medieval features were encountered. A few metres from the edge of the development, wall [1] turned north (as shown in historical maps) (Photo 27). When the wall was removed a soil profile associated with the formal gardens within the walled garden of Furnace House was exposed (Photos 31 & 32).

Photo 31: Exposed soil profile of Furnace House gardens after removal of wall [1]. View north; 1m scale.

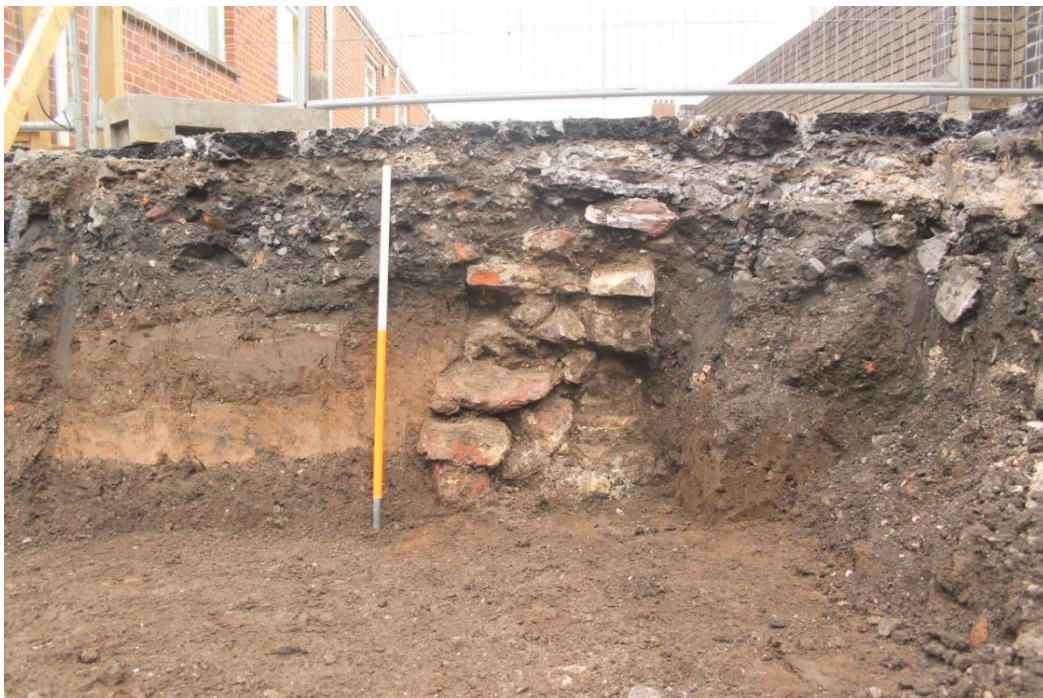
Photo 32: Wall [1] and soil profile of Furnace House garden (left) contrasting with garden soils outside the wall (right). View north; 1m scale

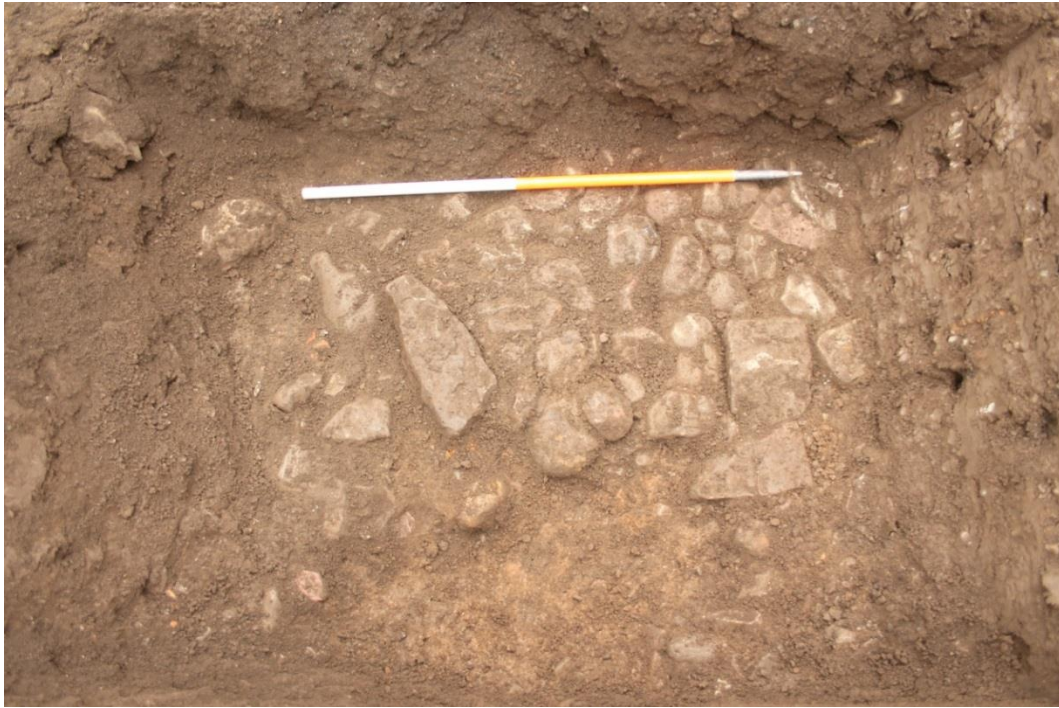
- 4.3.3 After the removal of wall [1] the rest of the site was reduced down to a compact, mid brown, silty-clay (7).
- 4.3.4 Test pit 2, measuring 1.3m by 1.1m was sunk into layer (7) to determine what lay beneath. At a depth of 0.45m a cobbled surface [25] was revealed (Photo 33). The cobbles were larger than those seen in floor [5]. A sherd of Roman grey-ware and a sherd of colour-coated ware were recovered from the surface of the cobbles (Photo 34).

Photo 33: Cobbled surface at base of Test pit 2. View north; 1m scale.

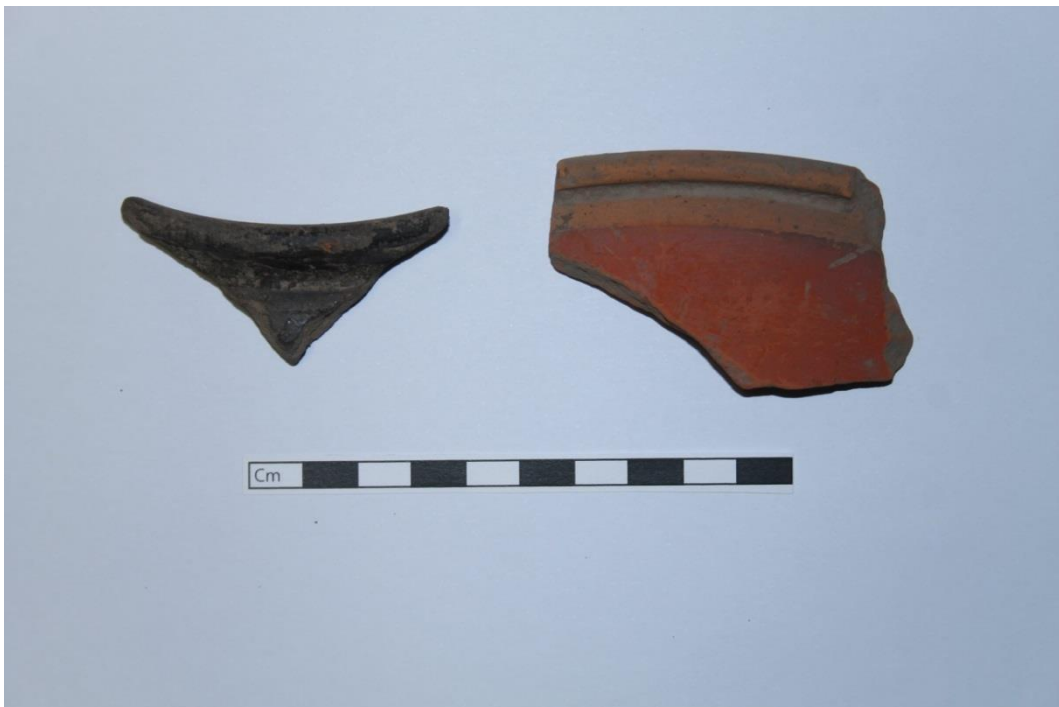
Photo 34: Roman pot sherds (grey ware and colour-coated ware) found on cobbled surface [25] in Test pit 2; 0.1m scale

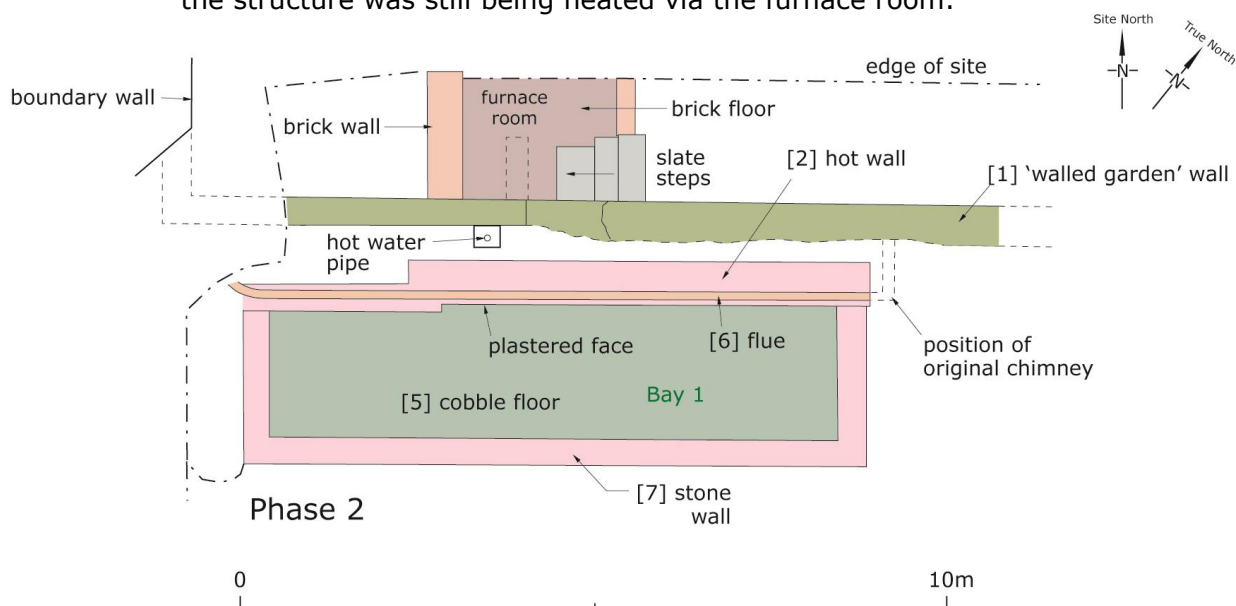
- 5.2.7 Wall [7] is built on top of cobbled floor [5], its eastern and western sides butt up to wall [2] creating an enclosed area measuring 8.1m by 1.9m and 0.5m deep (Bay 1). It is possible that tiled floor [10] constructed during this phase, butting up to wall [7].
- 5.2.8 It is possible that this is the first phase of a glasshouse being built at the site on the southern side of the walled garden wall. The likelihood is that the structure was still being heated via the furnace room.

Figure 9: Phase 2 of the structure shown on historic maps in the northern part of the site area

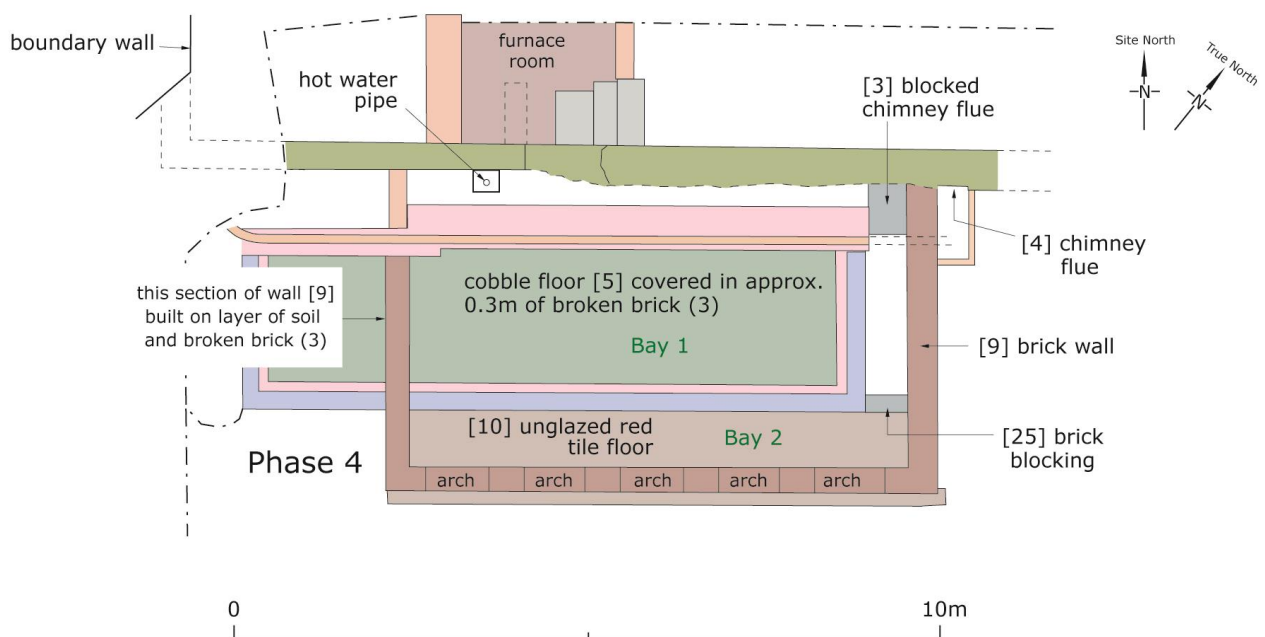
- 5.2.12 Wall [9] is latterly constructed to create Bay 2 added on to the south of Bay 1 and separating its western end. The western arm of the wall is built directly upon deposit (3) within Bay 1 whilst the southern arched section is built on top of tile floor [10].
- 5.2.13 It is possible that layer (3) within the remaining part of Bay 1 is now capped by deposit (2) and garden soil (1). Heated wall [2] is still operational during this phase because flue [6] has been extended and appears on the east side of wall [9] where it terminates as a chimney [4].

Figure 11: Phase 4 of the structure shown on historic maps in the northern part of the site area

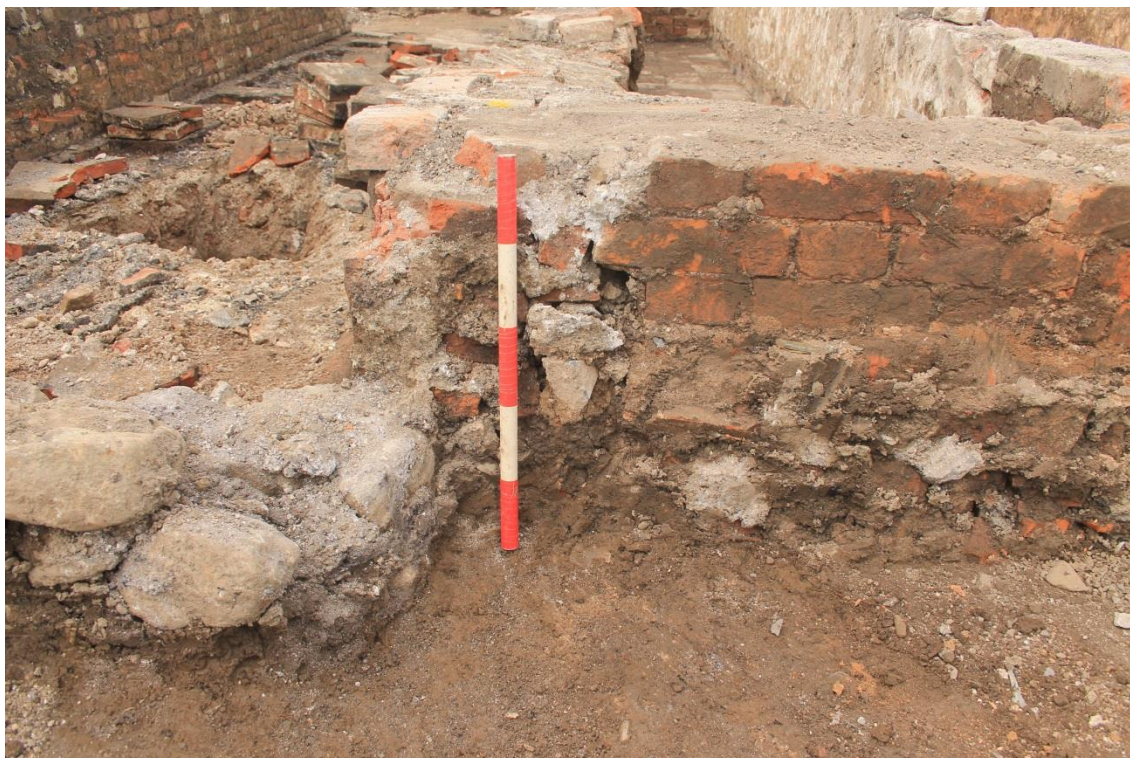
- 5.2.14 The integration of walls [16] to [24] south of Bay 3 (including Bays 4 and 5) indicate they are contemporary with each other but nevertheless probably a little later than Phase 4, based on the observation that wall [16] seems to have built against wall [9] (Photo 35).
- 5.2.15 If this is the case then Bay 3 is later than walls [16] to [24], because wall [17], the southern limit of Bay 3, butts wall [16]. This would represent a sixth phase of garden development at the site.
- 5.2.16 It must be emphasized that the amount of time that elapsed during this period needn't be very long. There may be very little time between each of the six phases identified.

Photo 35: Stone wall [16] and brick wall [9]. Note mortar scar at end of [9] derived from [16]. View west; 0.5m scale
