NRW TREE FELLING ON LAND AROUND DOLAUCOTHI GOLD MINES, CARMARTHENSHIRE: ARCHAEOLOGICAL WATCHING BRIEF

Prepared by DAT Archaeological Services
For: Natural Resources Wales

RHIF YR ADRODDIAD / REPORT NO. 2018-46
RHIF Y DIGWYDDIAD/ EVENT RECORD NO. 113514

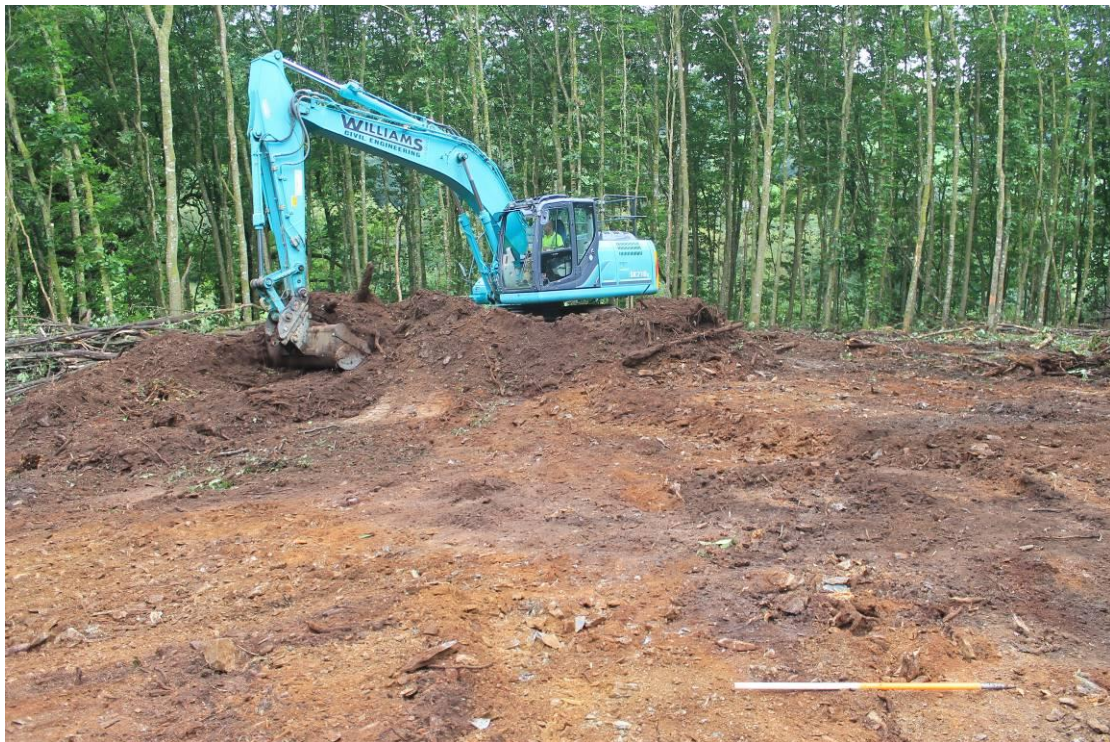
- 4.1.1 At the northern part of the site the watching brief was undertaken during construction of the access way to the main road and the log storage area (Photos 1 - 3).

- 4.1.3 The area was machine stripped and for the majority of the area revealed a thin layer of silty topsoil. Beneath this was a deep deposit of yellow/brown silts, sand and shale stones (Photo 1 & 2). Large areas of disturbed ground were present in the areas where tree stumps had been removed.

Photo 1: Mechanical excavator removing the topsoil and exposing the underlying silts and sand.

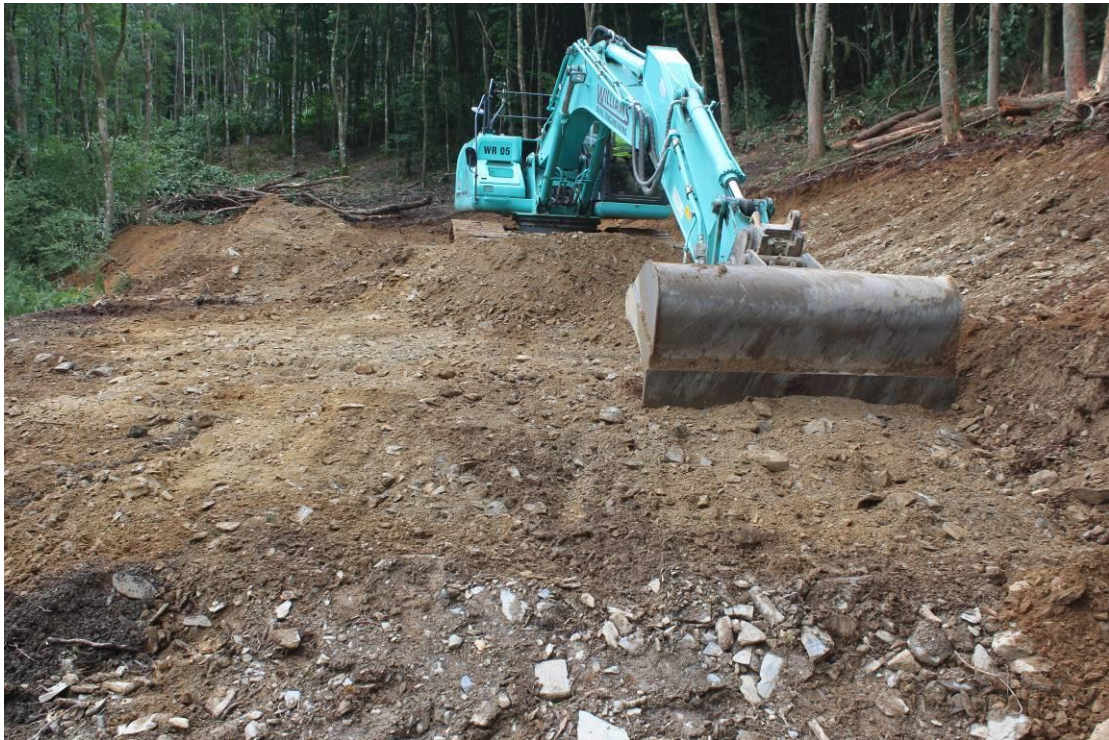
- 4.1.5 Where the access track met the road along the western side of the area the ground level was reduced quite significantly (Photos 2 & 3). It was clear that this cut into the underlying natural geology and no archaeological remains were observed.

Photo 2: Machine excavating the access road to the north of the site.

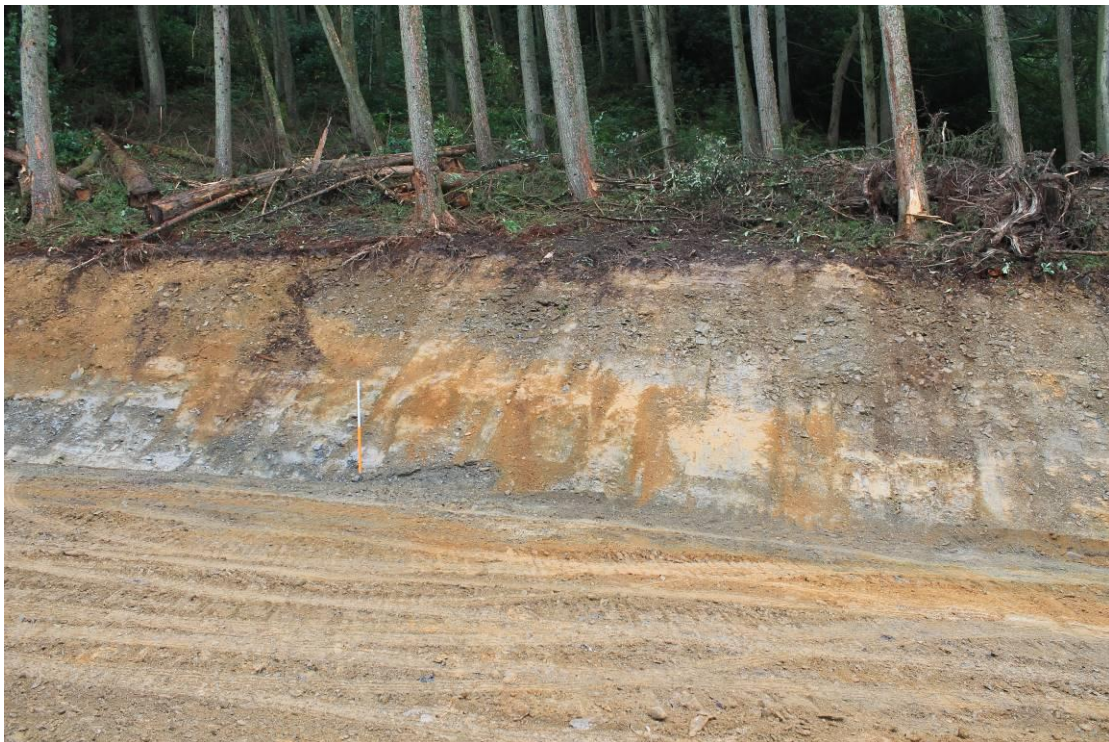
Photo 3: Representative section of access road showing topsoil and underlying sands and silts.

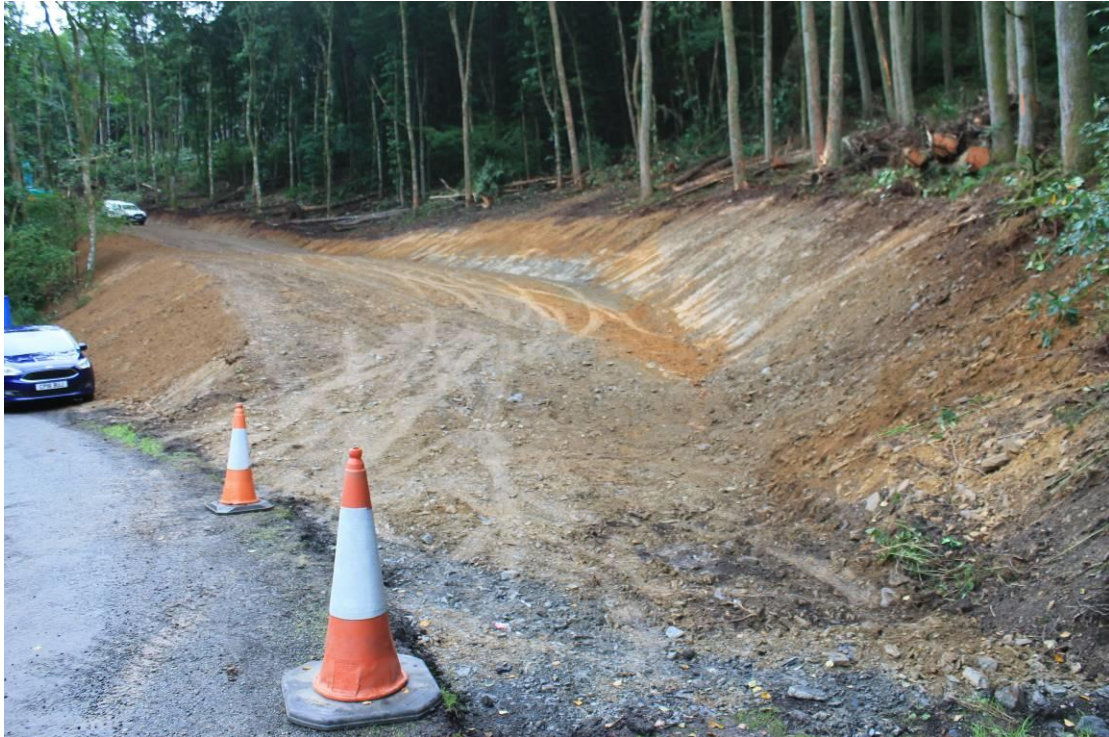
- 4.1.6 Crushed stone mostly taken from the cutting for the road was spread across the access track surface (Photos 4 & 5).

Photo 4: View from western road along access track after ground reduction

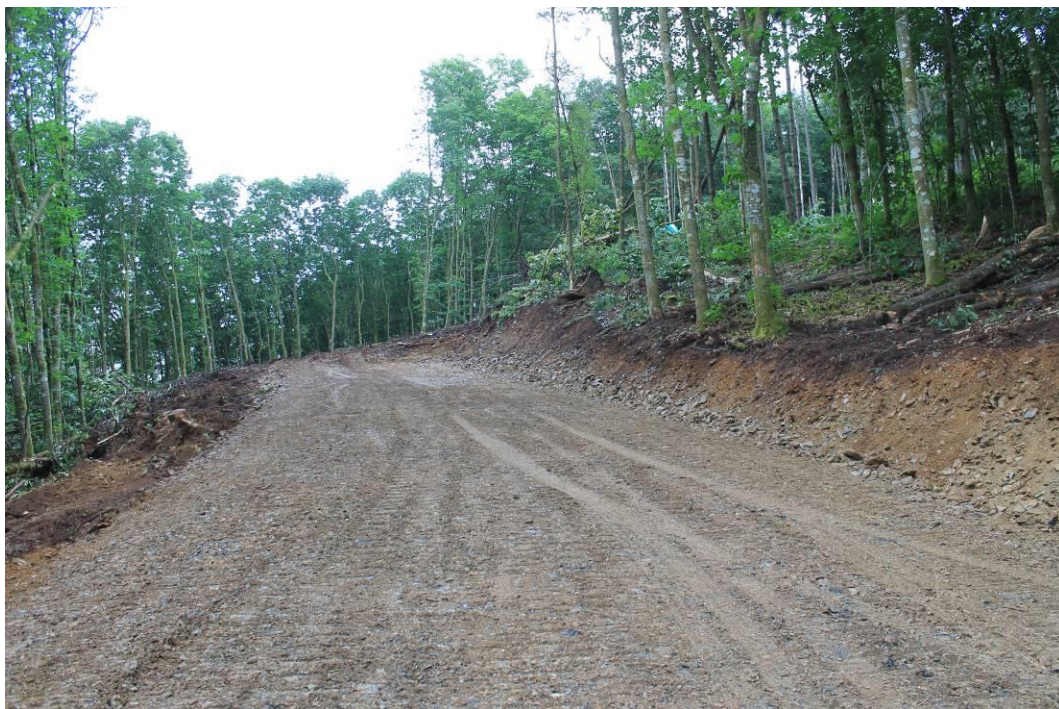
Photo 5: View along western access track towards log storage area and lower skyline base

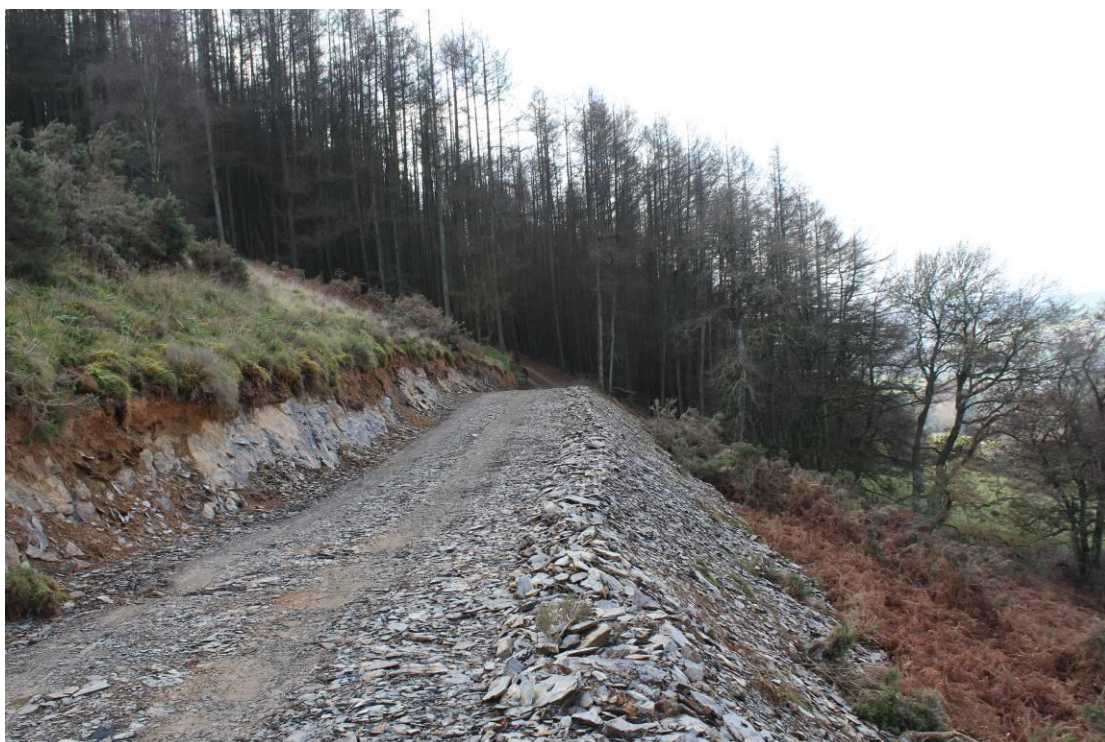
- 4.2.1 The second access road in the upper plantation (Allt Cwmhen) was also monitored through a watching brief. In this area the road was cut from an existing trackway running uphill from the western road, across a field and towards the woodland area (Figure 3; Photo 6).

Photo 6: New road entering Allt Cwmhen

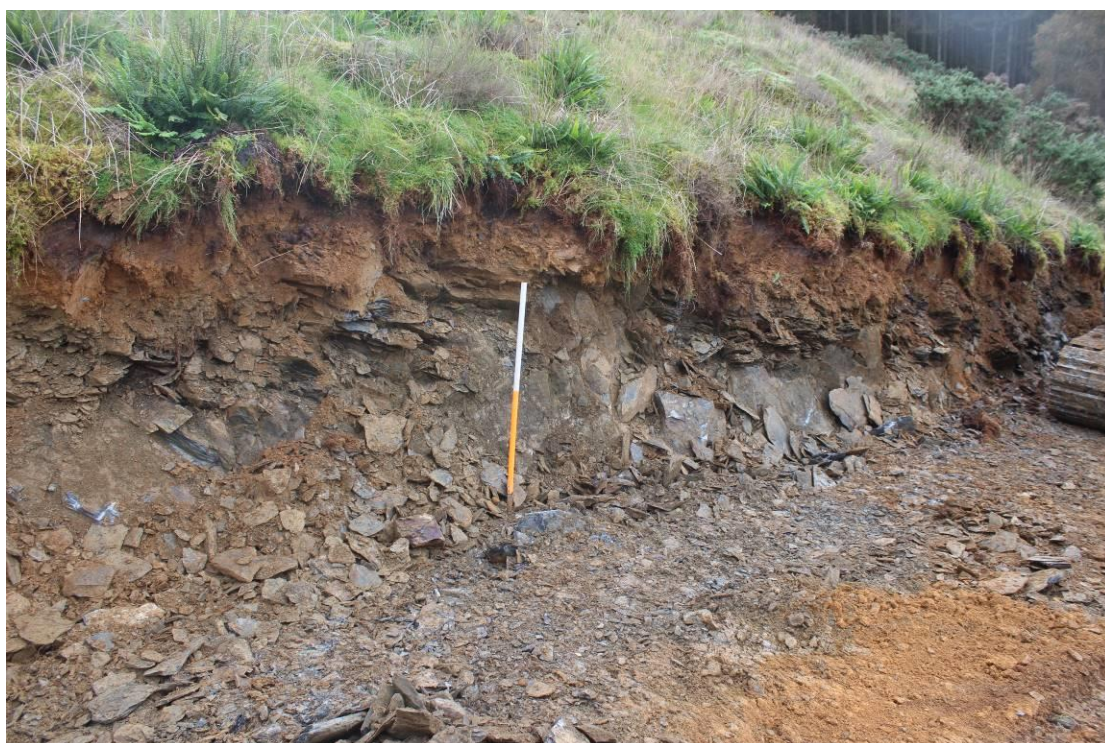
- 4.2.2 Where the topsoil strip crossed the field from the track to the woodland it revealed a yellow, sand silt, similar to that which had been seen in the previous area, directly overlying the natural bedrock geology (Photo 7 and 8). Due to the slope of the land in this area the trackway was terraced into the hill slope with stone cut from the ground upslope used to raise the side of the road on the downslope side (Photos 6 and 7). Within the field the topsoil was again quite shallow.

Photo 7: Bedrock geology revealed during road cut.

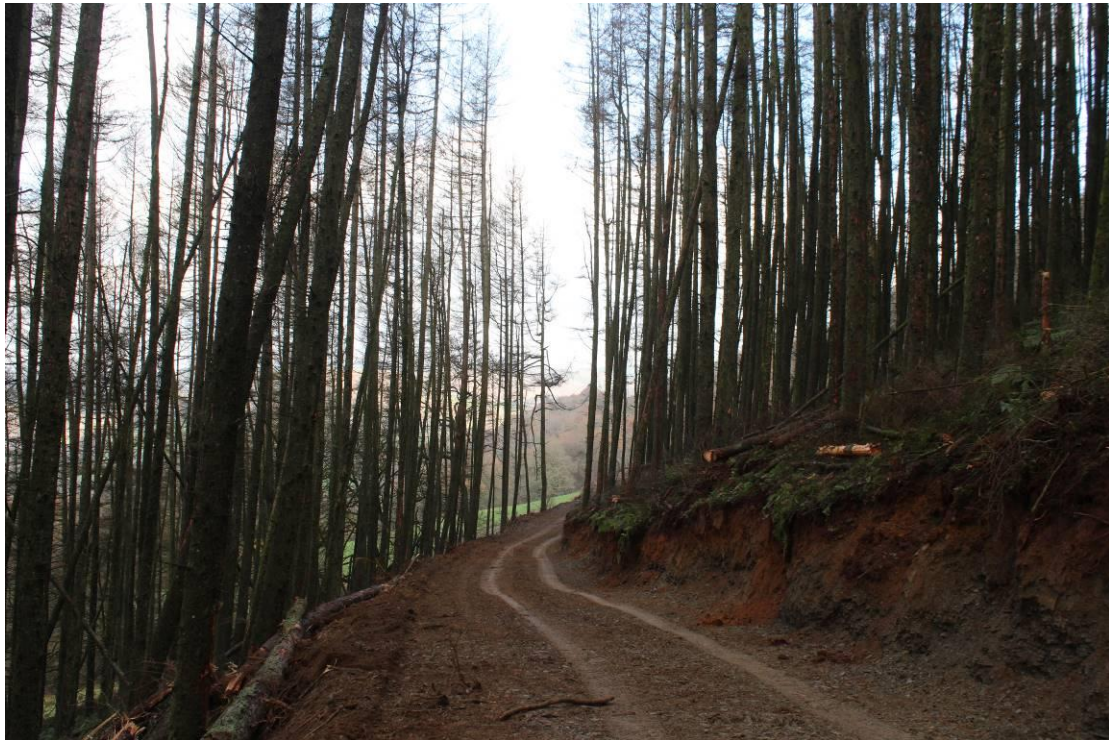
- 4.2.3 A similar method of construction was employed for the road lines within the plantation area (Photo 8). The topsoil here was again shallow and lay directly upon the bedrock. Disturbed areas were present where former trees had stood.

Photo 8: Road cut within plantation showing bedrock geology

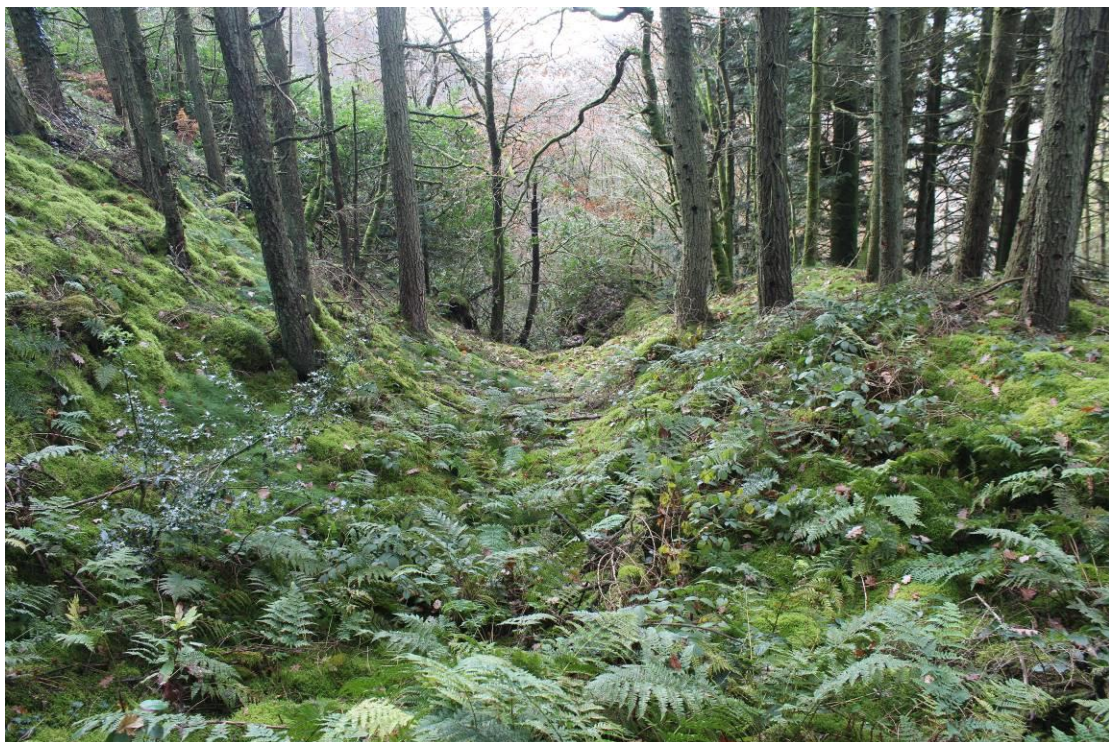
- 4.2.3 A few metres to the west of the proposed location for the upper end of the skyline, a sunken trackway was observed. This was visible on the very southern edge of the felling area and presumably lay within the scheduled area. It is uncertain if the feature was associated with the Roman goldmines or a more recent trackway. It is shown on the ordnance survey maps. The route of the sunken feature did not extend or project into the felling area as far as could be seen (Figure 4, Photo 9).

Photo 9: Looking west at sunken track located below proposed site for skyline, outside of the proposed tree felling area observed

- 5.2 Part of a track or hollow way to the southwest of the northern felling area and upper skyline base was recorded. This lay beyond the boundary of the felling area lying within a scheduled area (CM 210). The earthwork was not disturbed by the works.

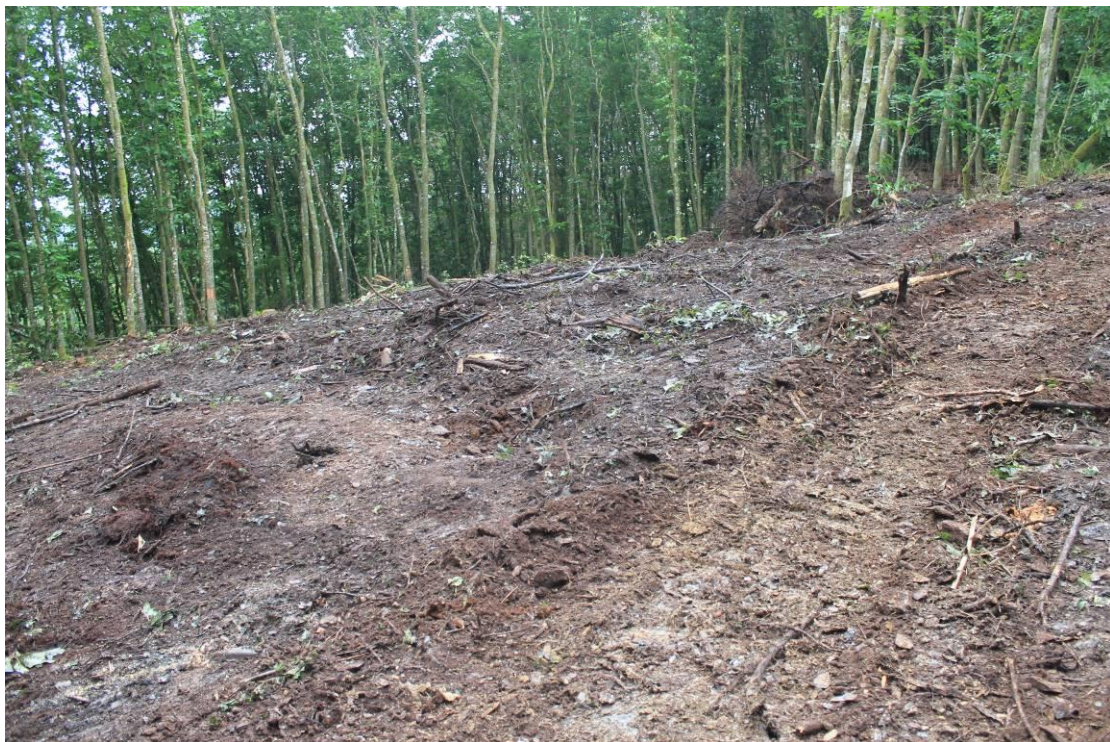
- 4.3.2 This area was again stripped with a large 360 excavator with flat bladed bucket. The surface prior to stripping was quite disturbed from the earlier felling activity, but in general little deeper disturbance had occurred (Photo 10).

Photo 10: Log storage area prior to site stripping, but after felling showing ground conditions

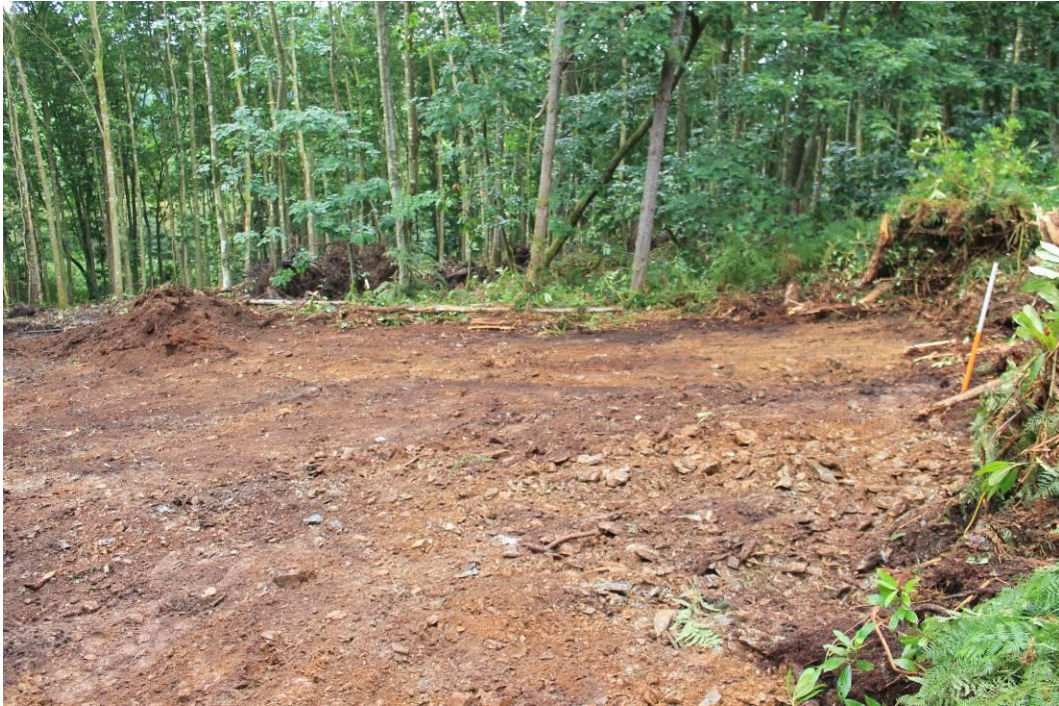
- 4.3.3 Thanks to the assistance of the site contractors a neat strip was possible to expose the entire part of this area. The topsoil was again thin overlying a orange yellow sand clay and stone natural geology layer (Photos 11, 12, 13 & 14).

Photo 11: View east across upper part of log storage area in the vicinity of the skyline base showing stripped surface

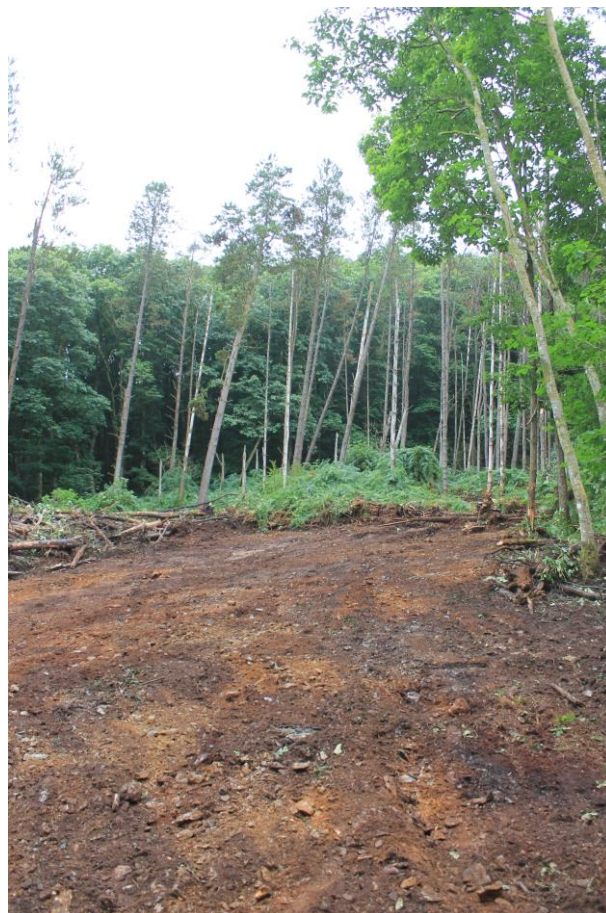
Photo 12: View northeast across upper part of log storage area in the vicinity of the skyline base showing stripped surface

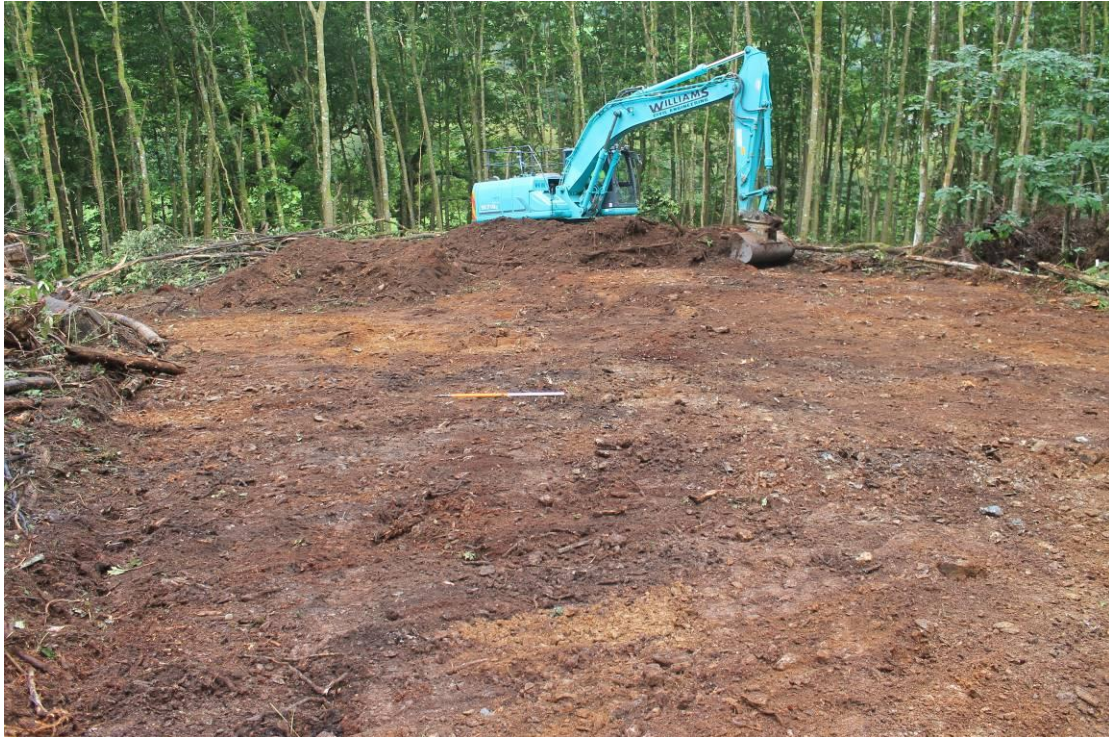
- 4.3.3 Numerous hollows from former tree roots were noted across the stripped area, a number of tree roots were also removed during this part of the watching brief (Photos 13 and 14). Some were fairly small and self-contained (Photo 14) whereas others were far larger combining roots systems from several trees (Photo 13).

Photo 13: View northwest across storage area showing large area of tree root disturbance in foreground.

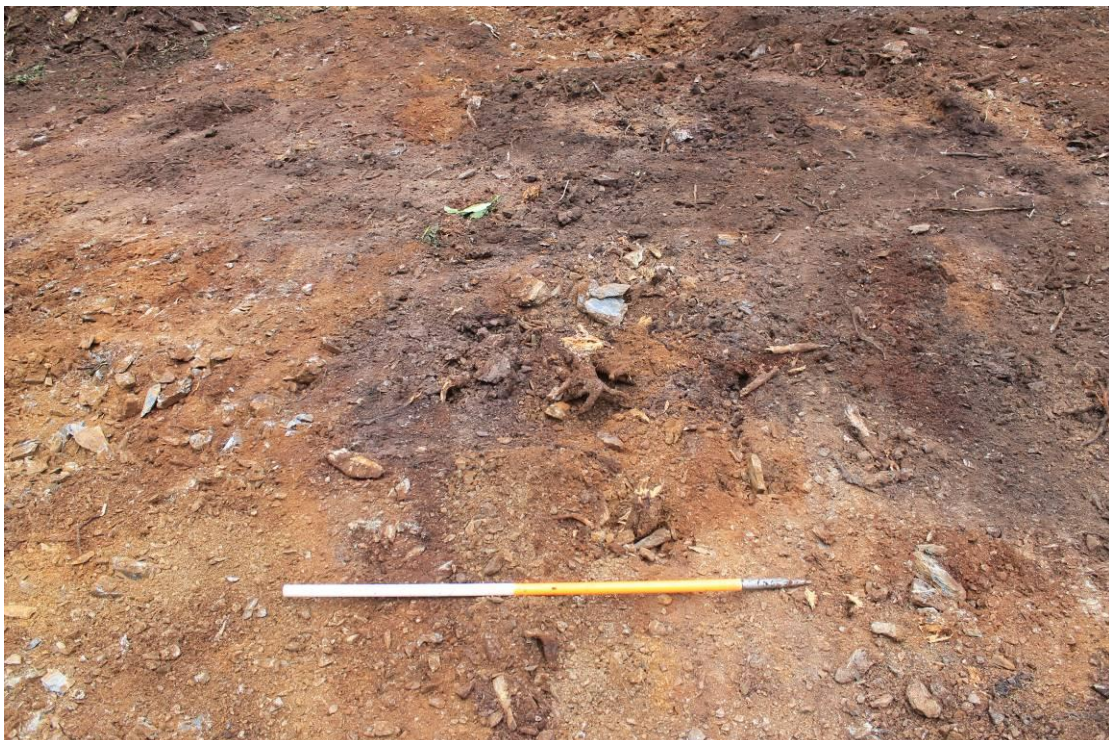
Photo 14: Smaller area of tree root disturbance seen within log storage area during topsoil stripping.
