CADW SCHEDULED ANCIENT MONUMENTS PCNPA AREA 2013-14

RHIF YR ADRODDIAD / REPORT NO. 2014/14

Pete Crane FSA

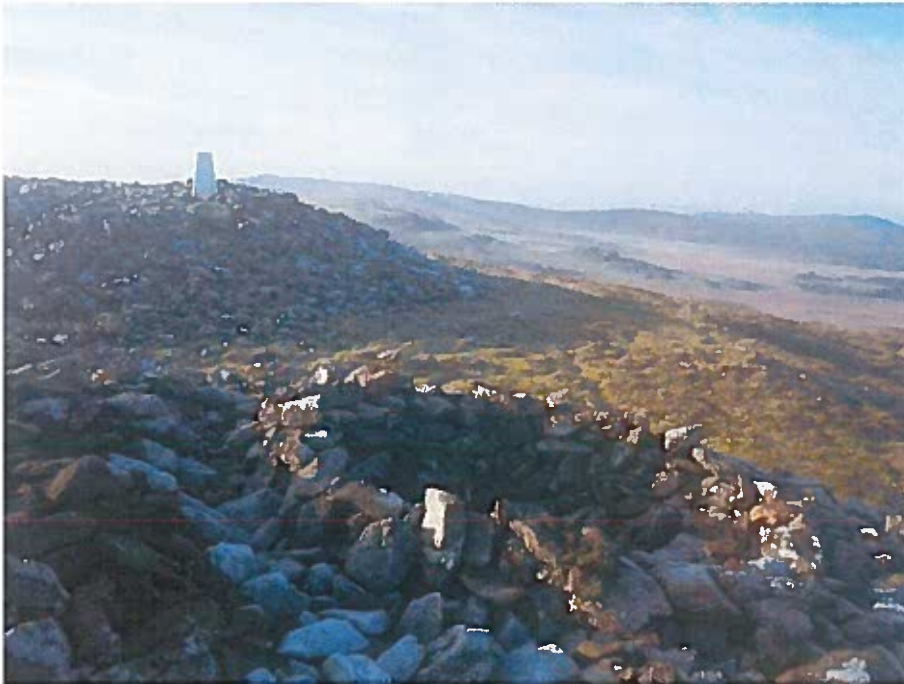
Visitor damage had been caused by visitors making a hollow in the stones of the NE cairn. This hollow has been further disturbed and the slight depression recorded previously has now turned into a shelter. This shelter has been constructed in the SW side of the cairn and is c.3m in diameter and up to 1m deep (see photos below).

Foel Drigarn: Damage to north cairn. Scale 0.5m View S. 11/12/2012 (freezing temperatures at the time of the visit caused the camera to mist up)

The damage to the north cairn was repaired 09/01/2014 as part of a programme for BBC Countryfile program that was shown nationally on 26/01/2014 (see photos below).

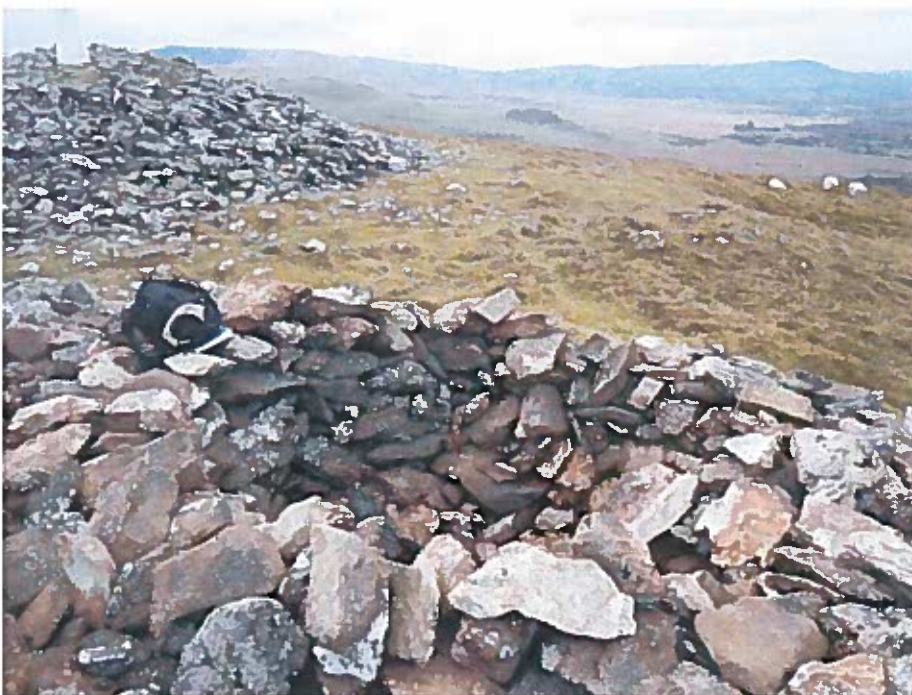
Foel Drigarn: Damage to north cairn. View S. 13/11/2013

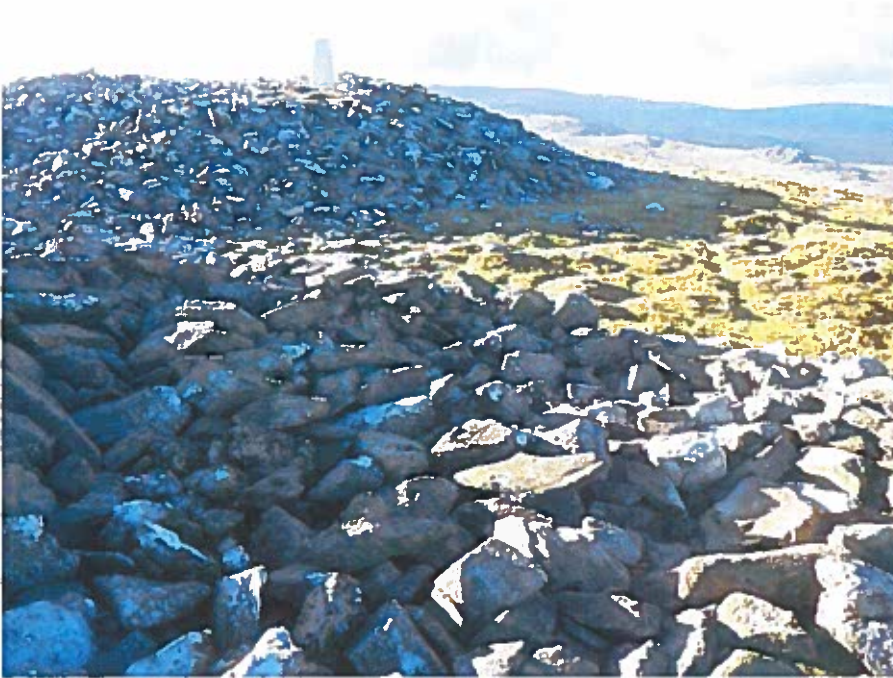
Foel Drigarn: Repaired damage to north cairn. View S. 09/01/2014

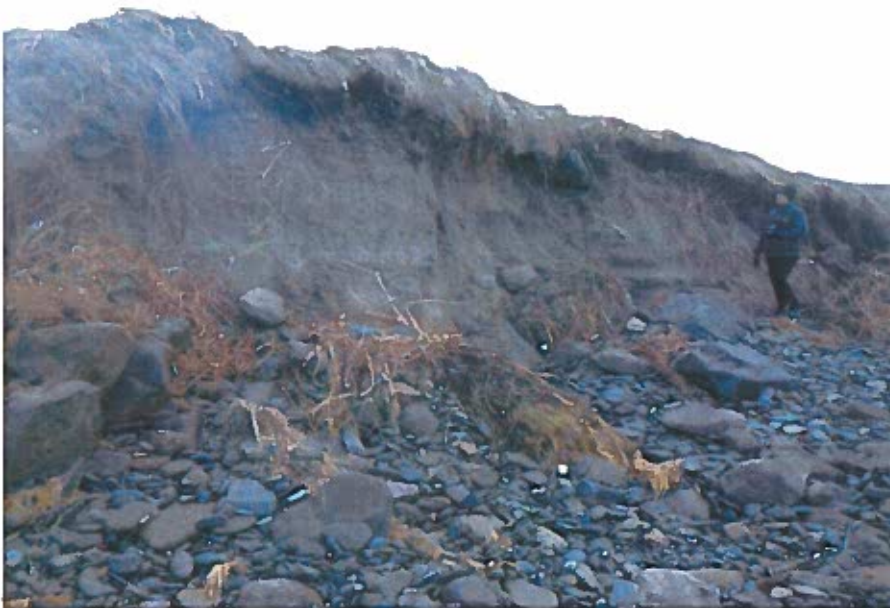
The site was visited early on 03/01/2014, while on holiday, to observe the site after the first winter storms: there had been erosion of the cliff edge but no archaeological features were visible. However, parts of a buried soil horizon were showing. Returned to the site on 07/01/2014, more erosion had taken place but still no features had been revealed.

St. Patrick's Chapel: eroded edge (no graves visible). View SE. 03/01/2014

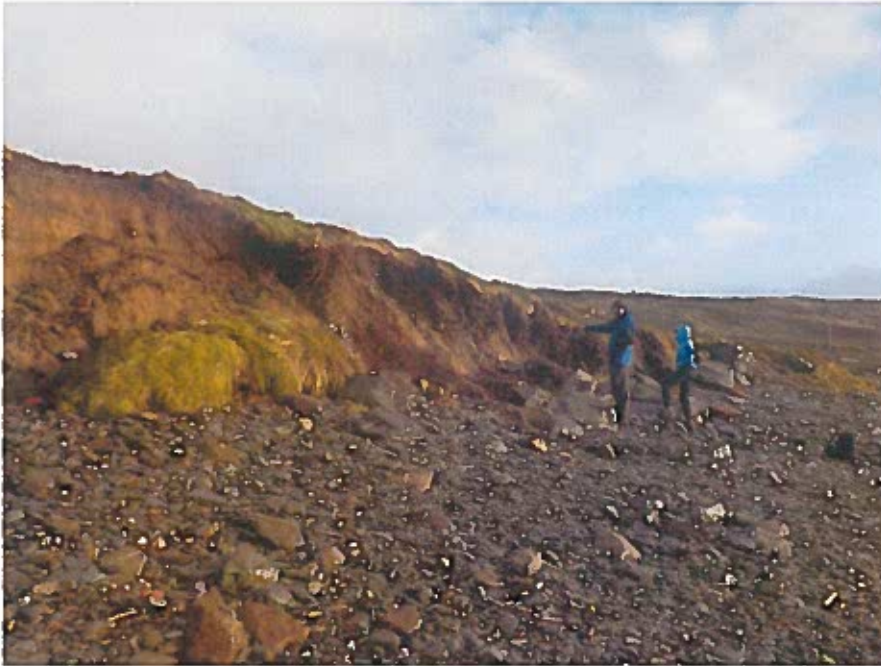
St. Patrick's Chapel: eroded edge (no graves visible). View SE. 07/01/2014

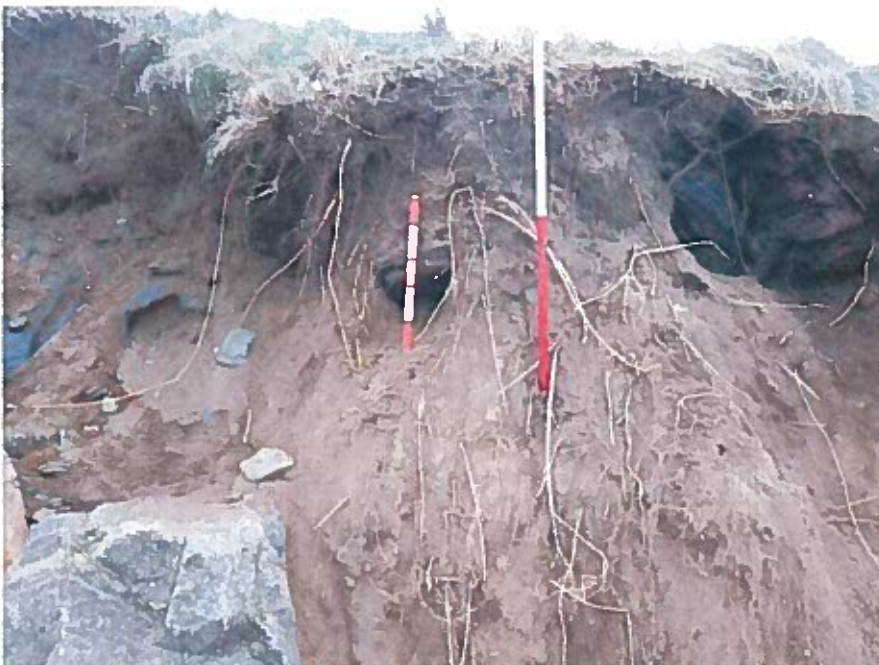
On Sunday 12/01/2014 I received a phone call to contact the police who had recovered a skull from the site the evening before. I met the officer soon after on site who handed over the skull and said that he would contact the coroner. The skull had been taken from a cist that was just showing in the eroded cliff face. Several hours were then spent building a sand and stone revetment to protect the revealed grave.

St. Patrick's Chapel: cist (later recorded as burial 4), car "burial" top right. Scales 0.5m and 1m. View E. 12/01/2014

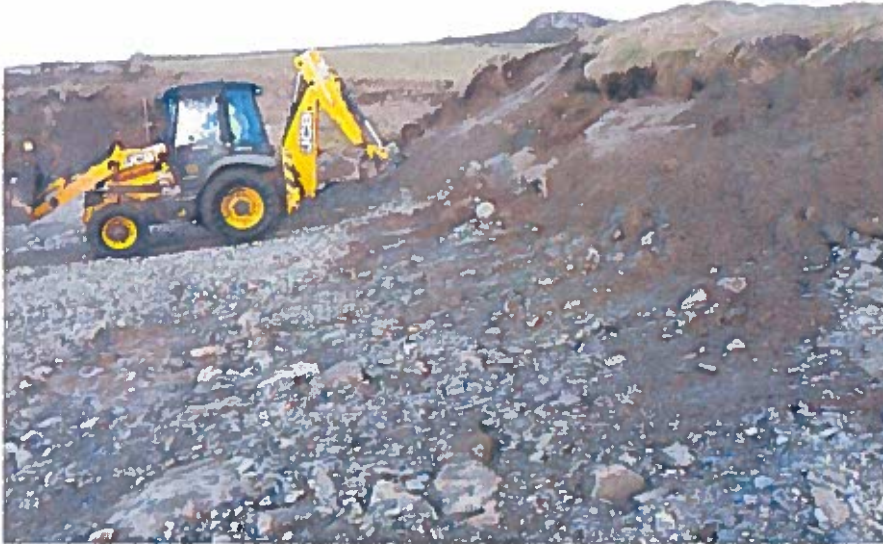
St. Patrick's Chapel: eroded edge repairs. View NE. 17/01/2014

Having gained permissions from CADW, PCNP and NRW, temporary sea defence repairs were made on 17/01/2013 when a JCB was used to replace boulders and sand against the exposed edge (see photo below). This work was paid for

by PCNPA and was under the direction of the area Ranger, with myself in attendance as part of my Cadw commitments.

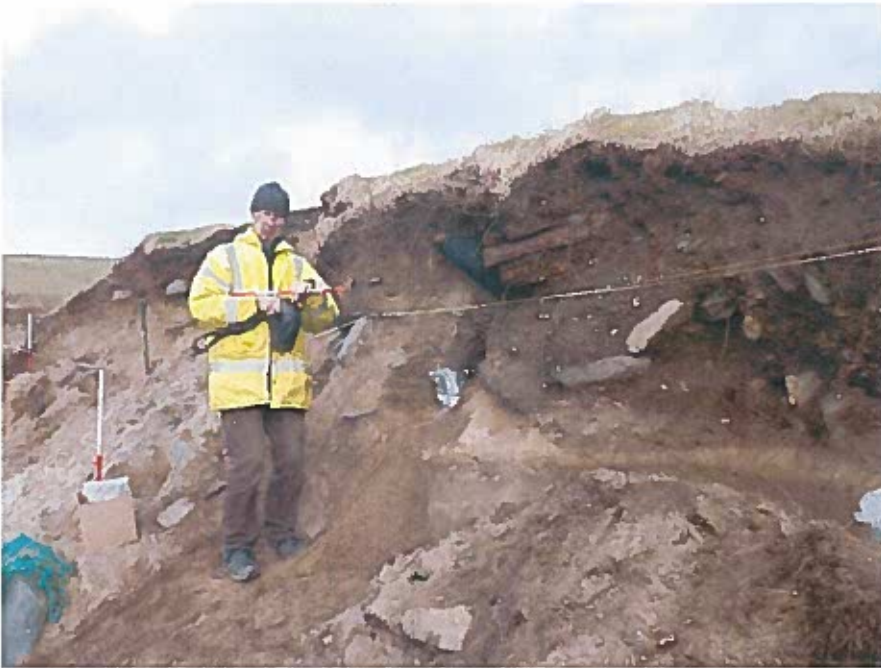
St. Patrick's Chapel: rapid recording and bone recovery. View NE. 24/02/2014

On 24/02/2014 Ken Murphy and I undertook rapid recording and recovery of the exposed bones: this work was an emergency Cadw contingency funded DAT project and will be reported on separately. Three further visits have been made to monitor the erosion on the site along with a couple of locals who will continue to regularly monitor the site and report if anything is revealed.

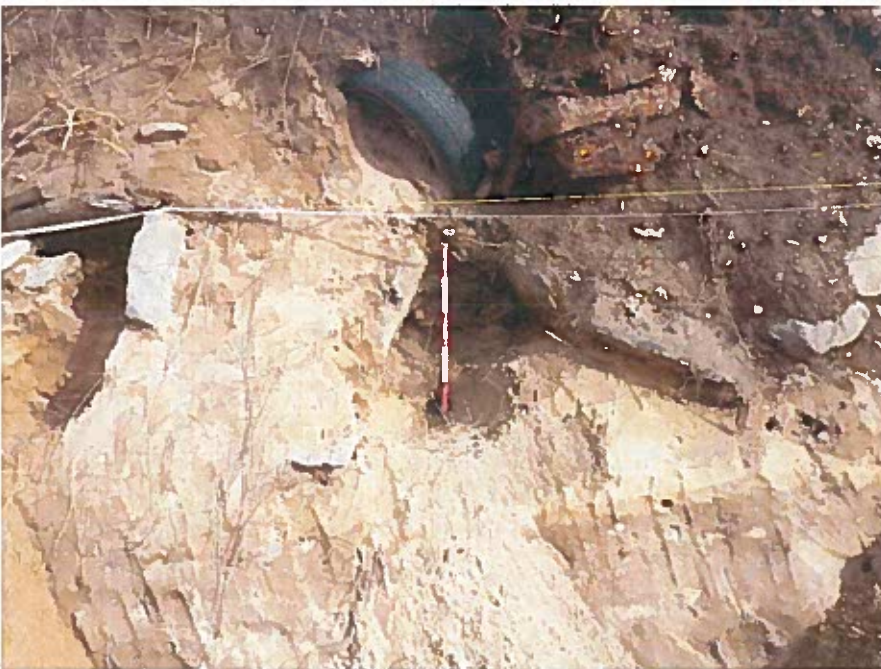
St. Patrick's Chapel: two cist graves each with a further grave below. View E. 24/02/2014

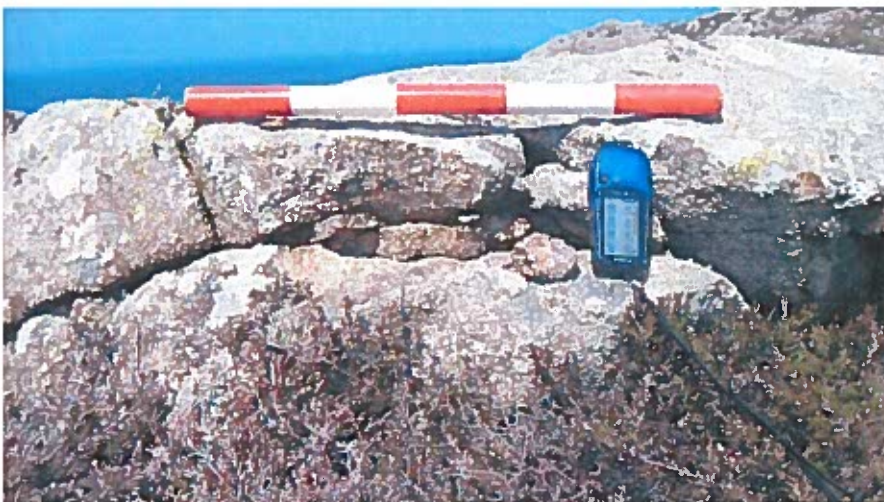
Damage was reported to stones on the site on 17/03/2013. On investigation, no damage had been done to the hut circle stones but some natural rocks had large chips up to 200mm: this damage could be to "geologist" but it appears to brutal and simple vandalism seems more likely.

St. David's Head Camp: Chipped stone. GPS SM7229327943. Scale 0.5m View N. 17/05/2013

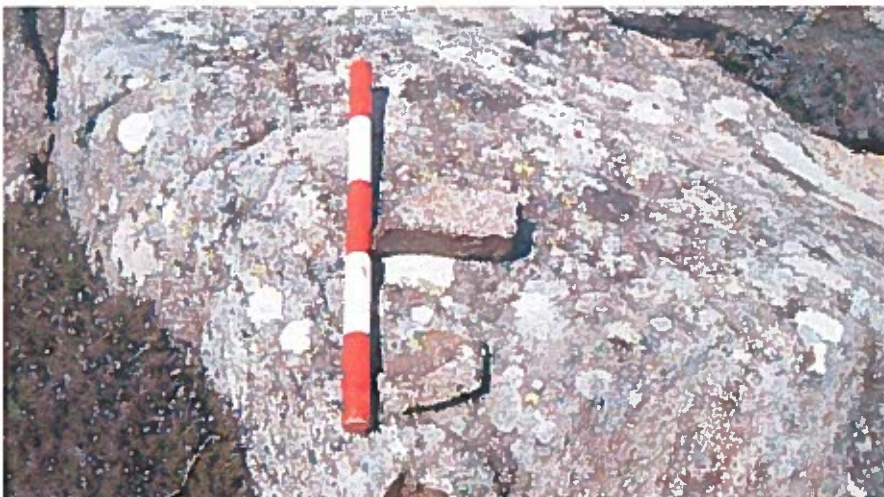
St. David's Head Camp: Chipped stone. GPS SM7229427932. Scale 0.5m View N. 17/05/2013

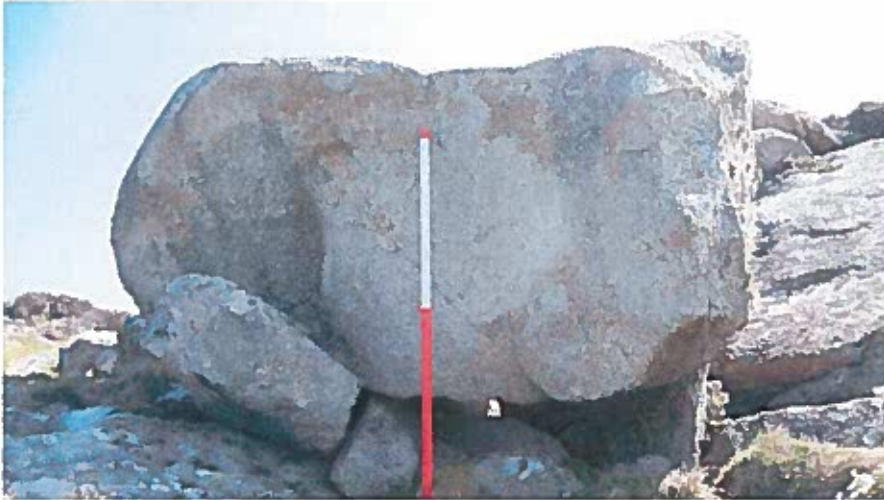
A potential propped stone or fallen cromlech was noted on the north side of the promontory at GPS SM7221727914. It was not that easy to obtain a decent photo of this. A geologist Steve Drinkwater confirmed that this does not appear to be a natural arrangement of stones.

St. David's Head Camp: propped stone. Scale 1m. View S. 17/05/2013

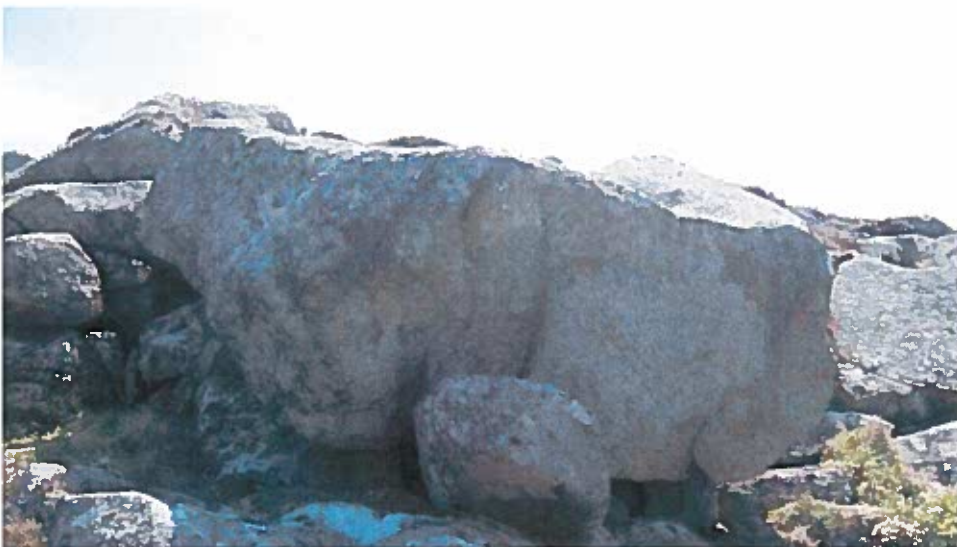
St. David's Head Camp: propped stone. View SW. 17/05/2013

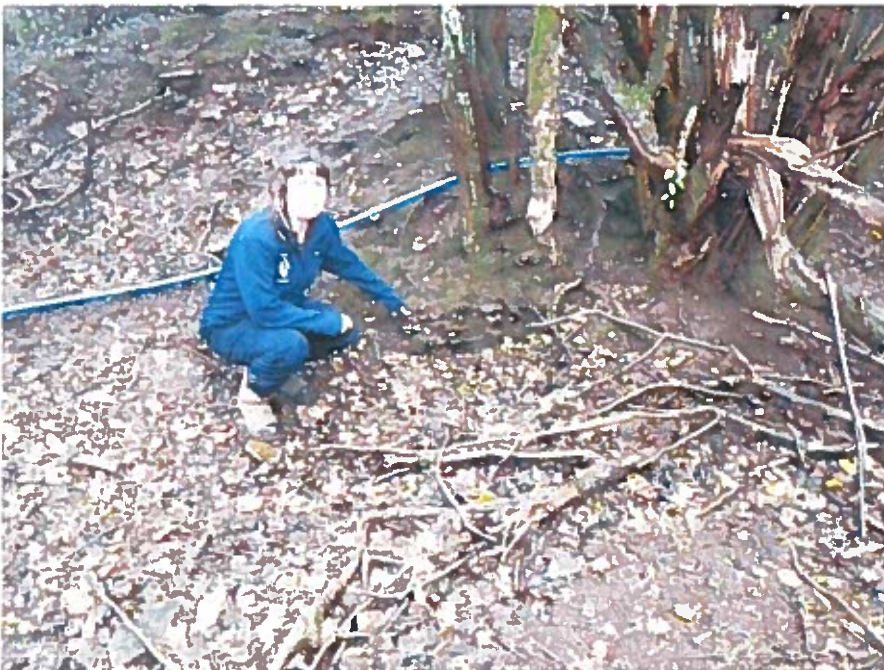
Capestone Rath: Wall face? in bank. 11/11/2013

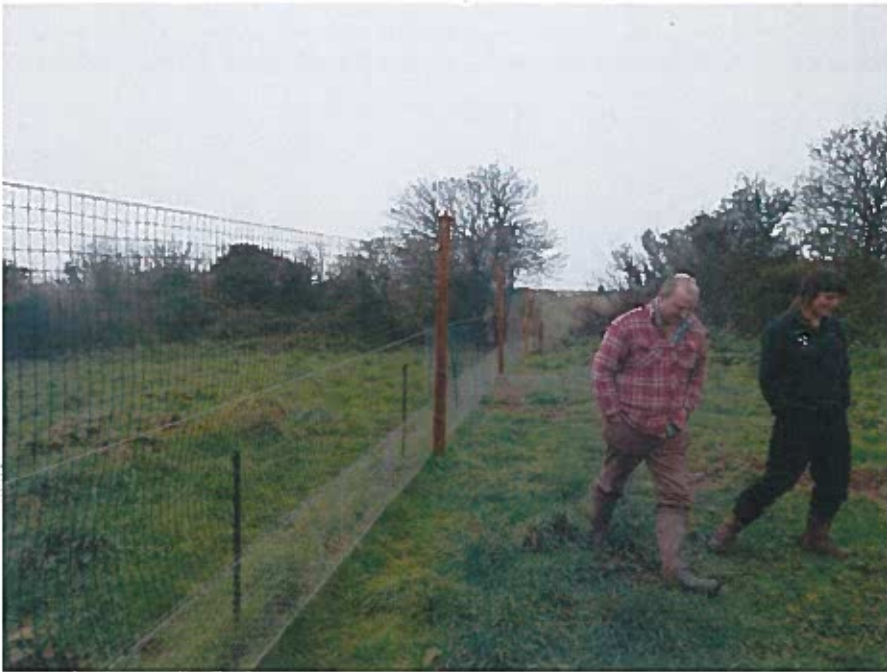
Capestone Rath: New fence across interior of fort. View S. 11/11/2013

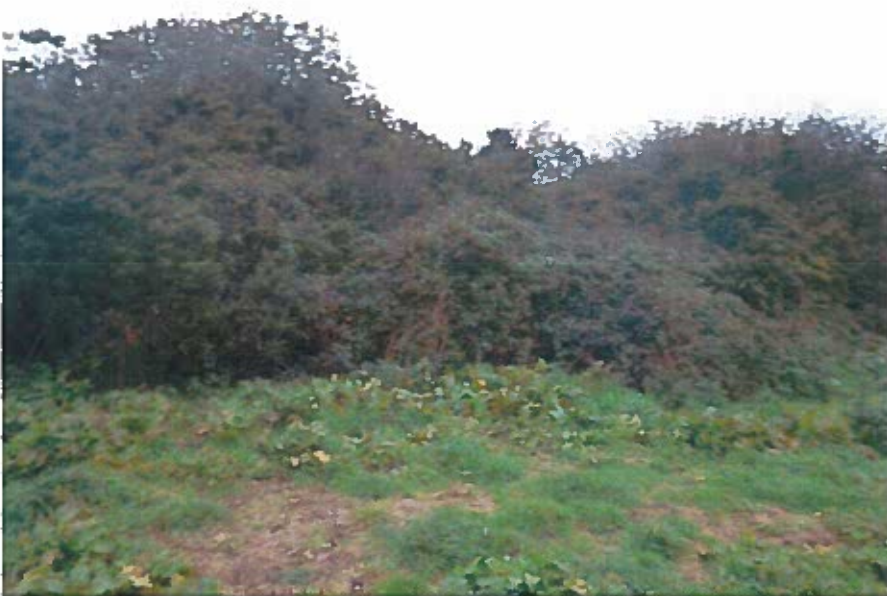
Capestone Rath: vegetation on bank. 11/11/2013

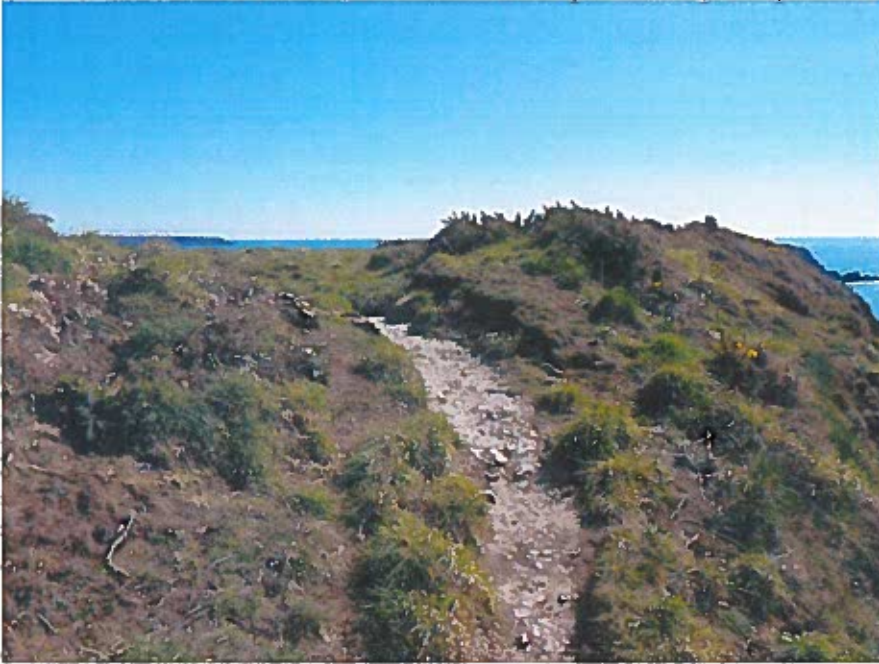
better signage or fencing is needed to the south. This partial re-routing has taken pressure off the path through the interior and the site of the Time Team cut in the north bank, has much improved (see photo below).

Watery Bay Rath: modern entrance through northwest bank, Time Team consolidated trench now looking much better. View S. 13/04/2013

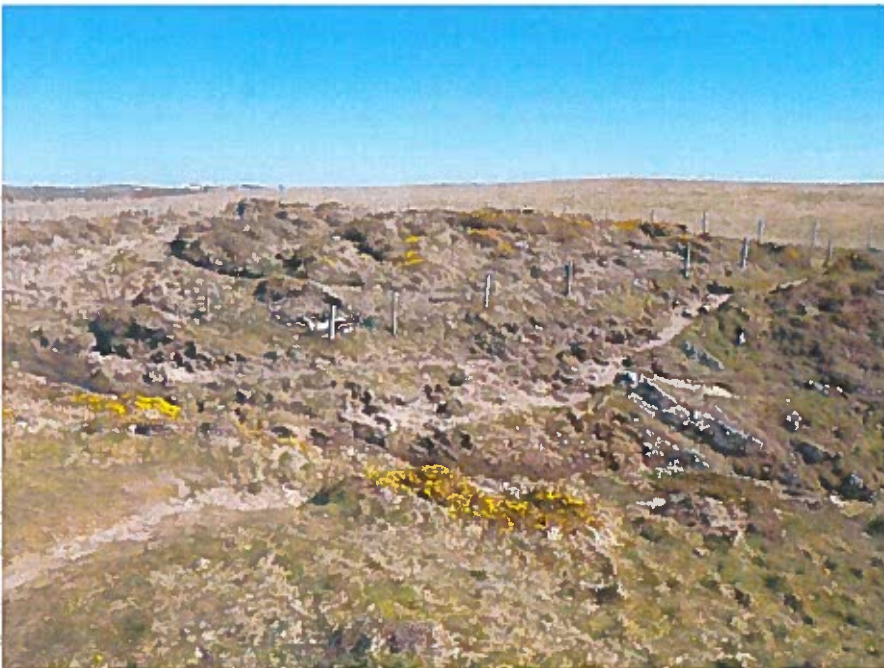
However, there is still considerable erosion on either side of the stream to the south of the fort's inner entrance; while this is visually unattractive there does not seem to be any significant archaeological damage (see photo below). Fresh rabbit holes were noted in the bank to the east of the entrance. Gorse has taken quite a hold on the outer banks and to the east of the entrance: Cadw may wish the National Trust to reduce this in the near future?

Watery Bay Rath: footpath erosion to the south of the inner entrance. View S. 03/04/2013

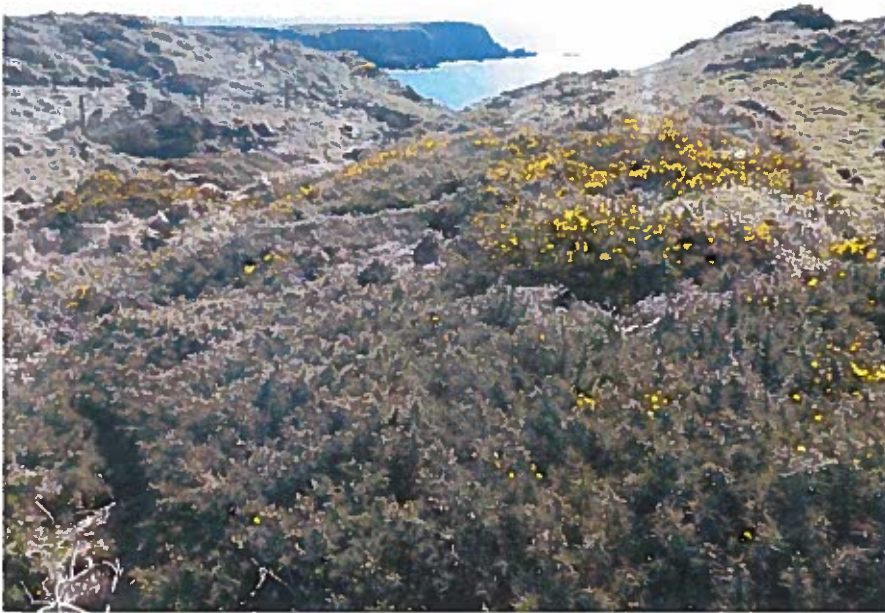
Watery Bay Rath: Gorse to the east of the inner entrance. View W. 03/04/2013

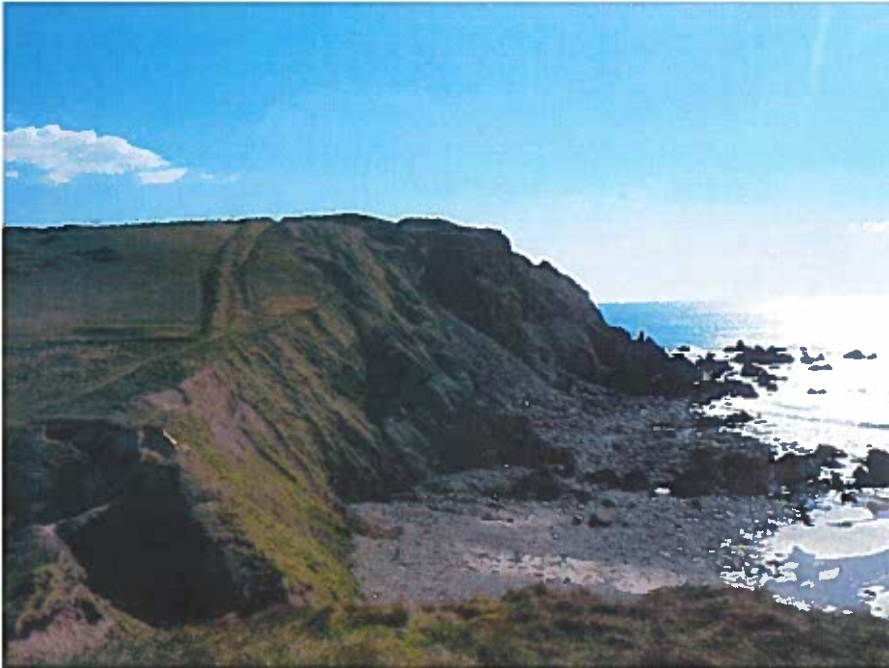
The site was visited in May 2013 and January 2014. Recent cliff erosion was noted in 2013, along with a fissure just north of the inner bank, but there did not appear to be any significant new land slips after the severe winter storms just prior to the visit in January.

Great Castle Head, Dale: landslip/cliff fall. View SW. 03/04/2013

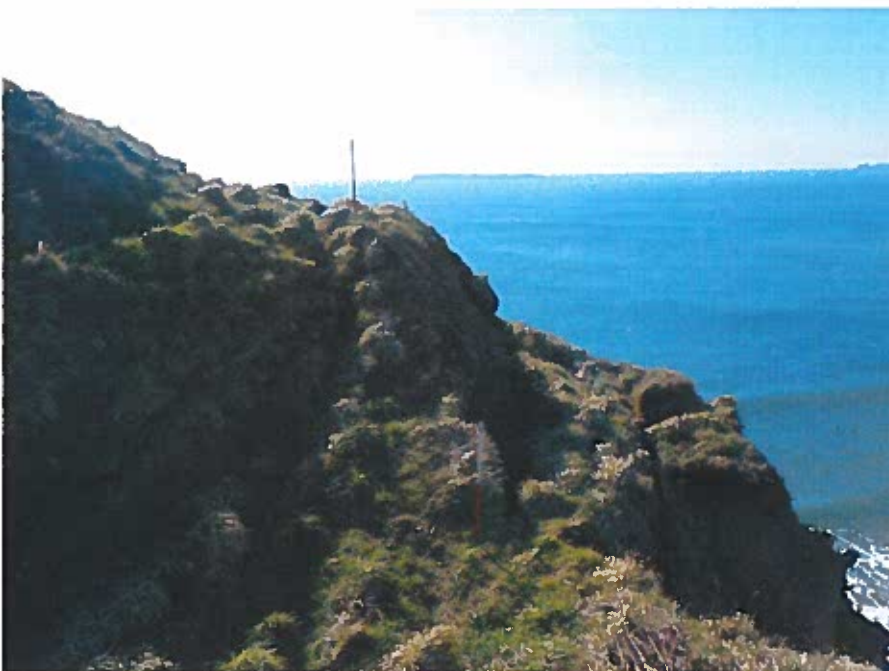
Great Castle Head, Dale: Fissure and landslip. Scales 1m. View W. 03/04/2013

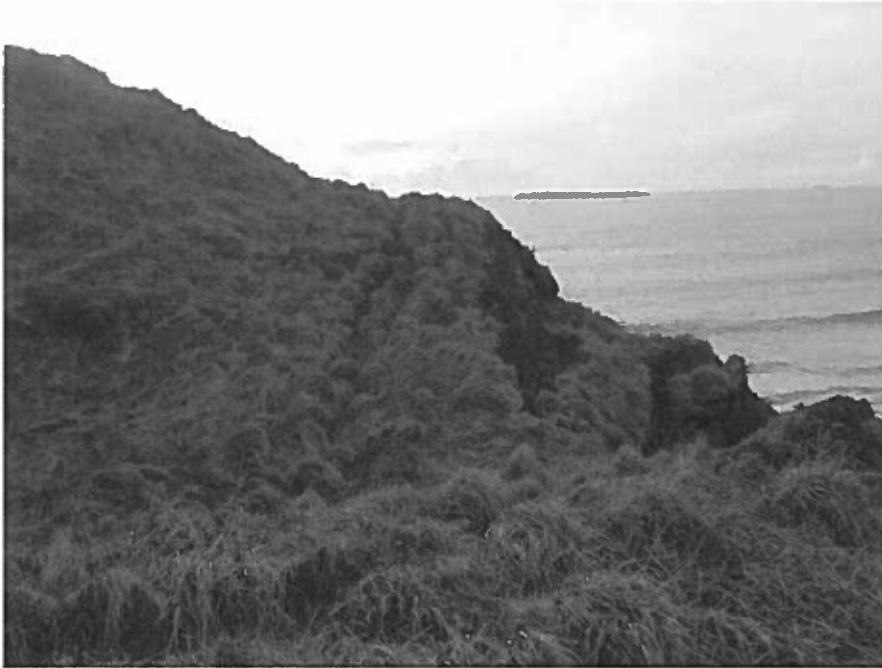
Great Castle Head, Dale: Fissure and landslip, little changed from May 2013.
View W. 17/01/2014

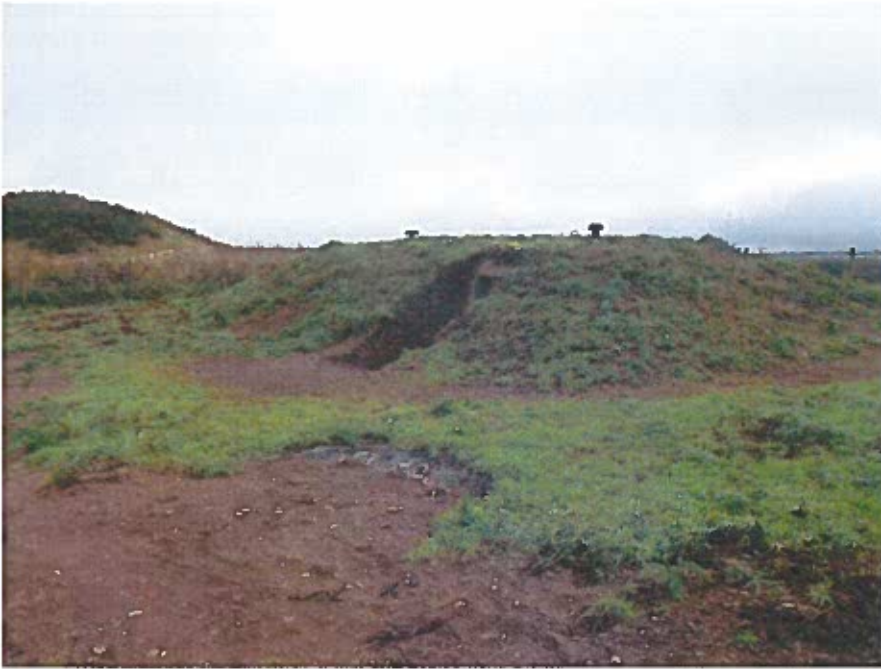
Crugiau Cemmaes: clearance and conversion of the old reservoir. View NE.
04/10/2013

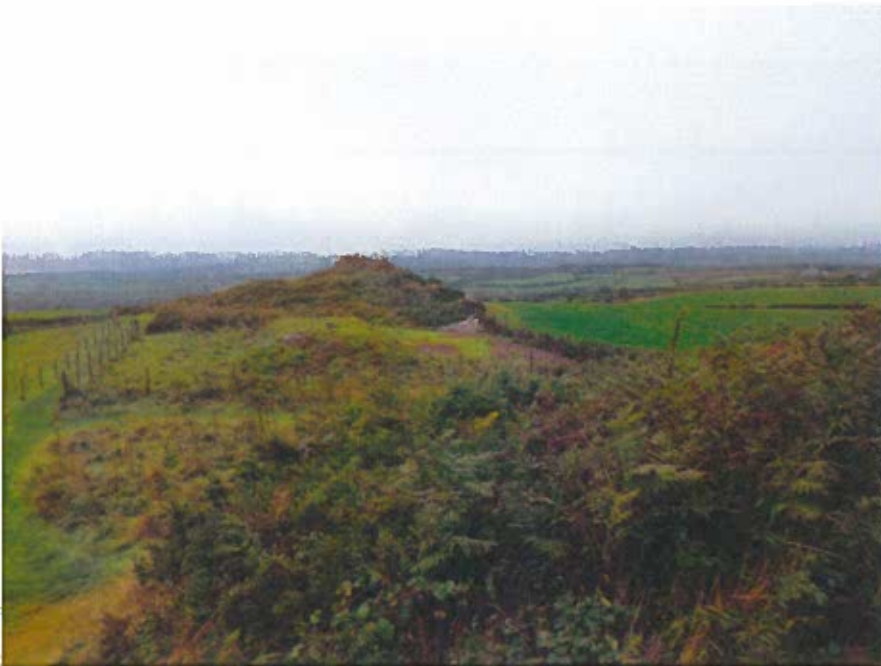
Crugiau Cemmaes: clearance and conversion of the old reservoir between the southern two barrows, note the bracken growth on both of these. View S.
04/10/13

- PC to continue with efforts to replace and move the fencing around the southern two barrows

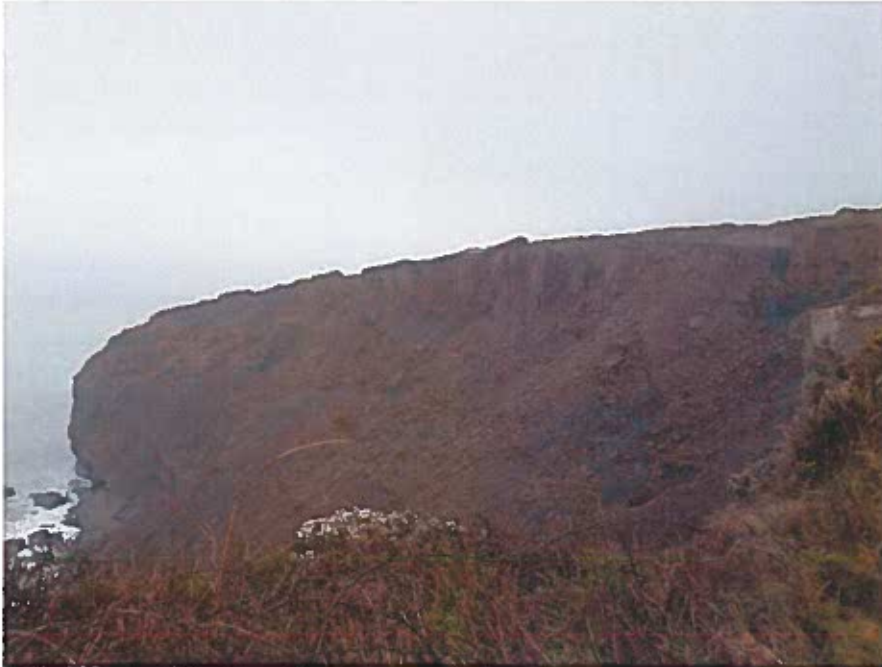
The site was visited in April 2013 with the Area Ranger who provided safety back up. The general area of the site is a little more fissured than when visited a couple of years earlier, and appears to have active erosion on the southern side of the promontory. This erosion is now also being monitored by one of the Arfordir volunteers (see photos below).

Blackpoint Rath: Southern side of promontory fort. View NW. 11/04/2013

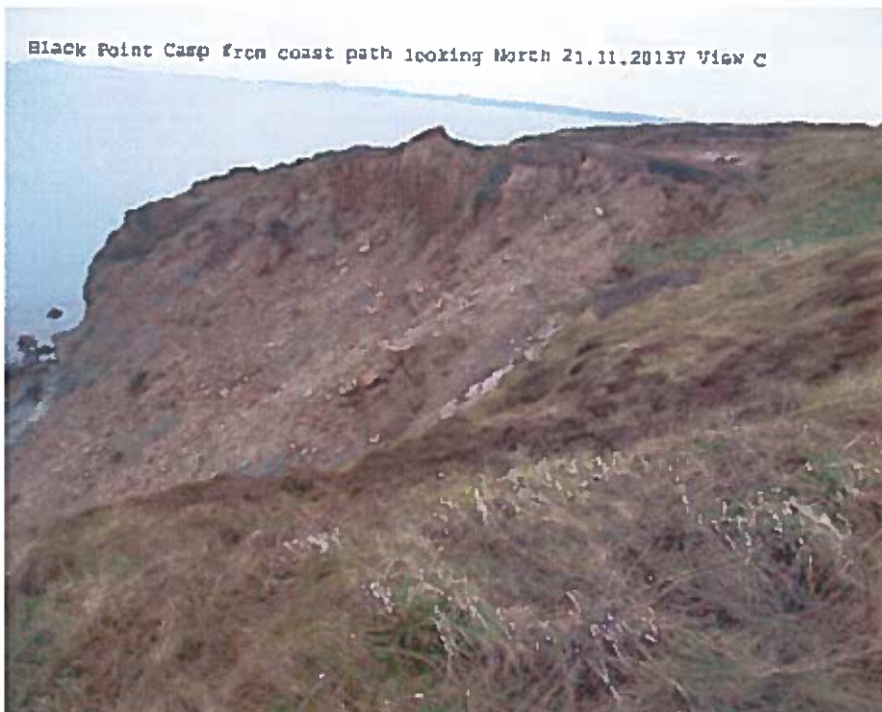
Blackpoint Rath: Southern side of promontory fort. View NW. 21/11/2013
(photo Jim Garner)

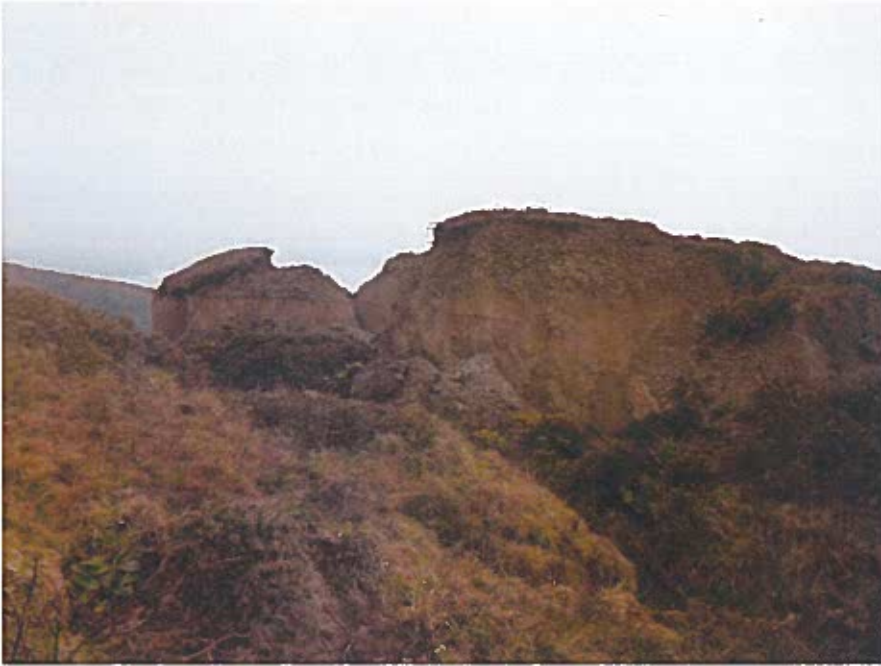
The fissured southern end of the inner bank looks to have a buried soil layer, possibly containing charcoal (see photo below).

Blackpoint Rath: Fissured inner bank with buried soil line. View S. 11/04/2013

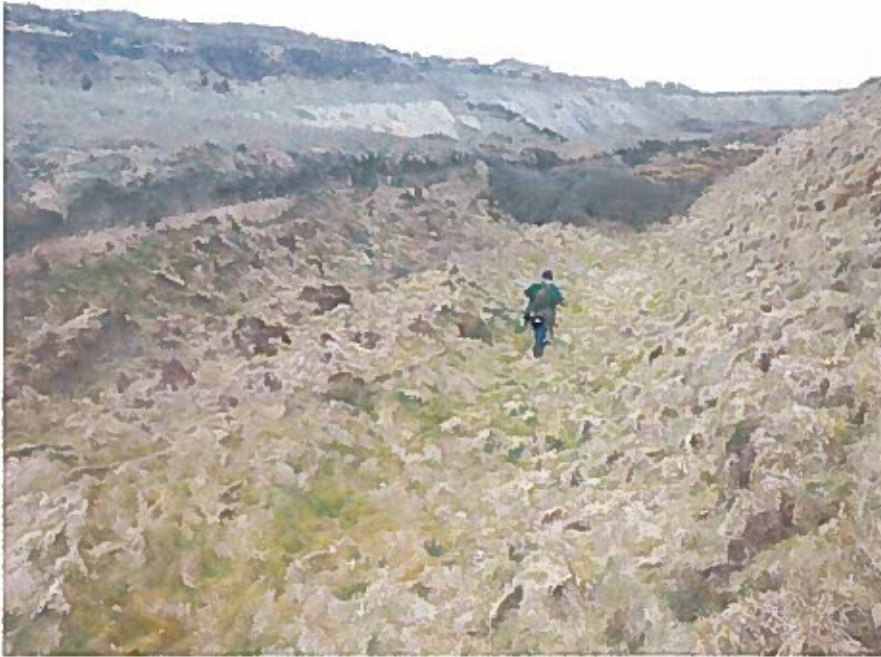
Archaeological features, possibly part of a chevaux-de-frise or postholes with stone packing as part of a palisade trench, were again recorded in part of a long east-west fissure to the north of the site (see photos below and location on sketch plan). This area has safer access and it may be possible to draw and excavate these features, but not as of volunteer training due to steep access and possible risk.

Blackpoint Rath: Fissure with archaeological features to north of inner bank.
View E. 11/04/2013

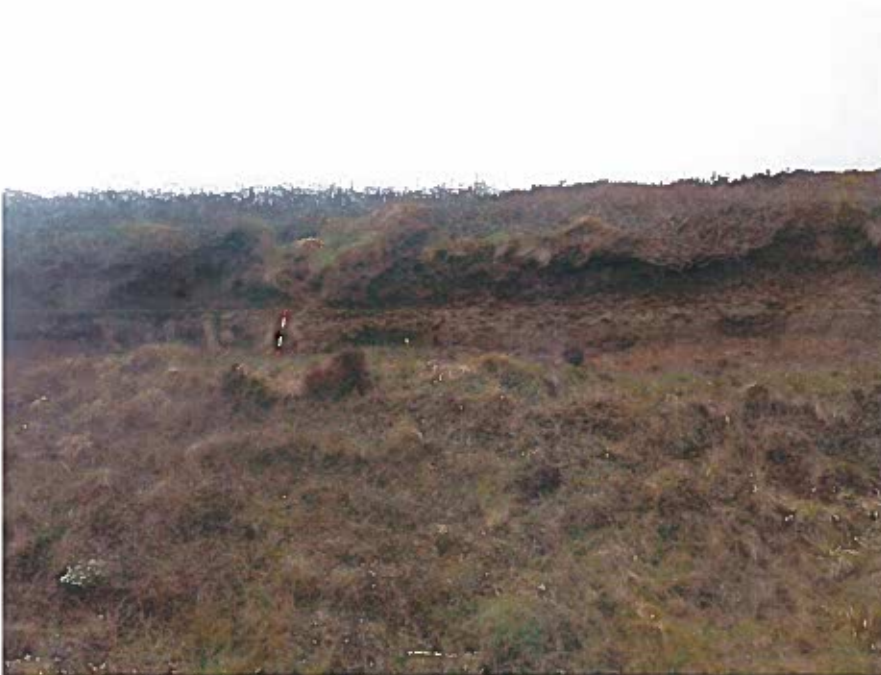
Black Point Rath: detail of archaeological features, possibly chevaux-de-frise or timber palisade trench with stone packing (left of scale), and buried soil below probable counterscarp bank. Scale 0.5m View N. 11/04/2013

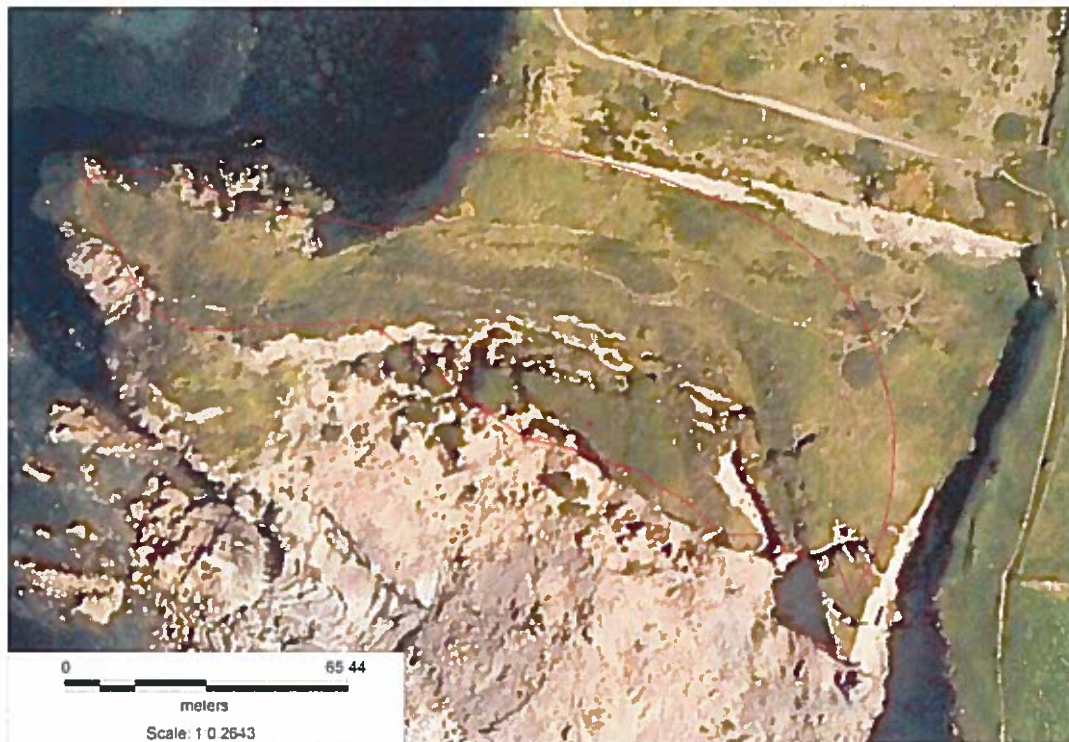
Recent aerial photographs show the continued erosion (see photos below).

Black Point Rath erosion 2006 and SAM area

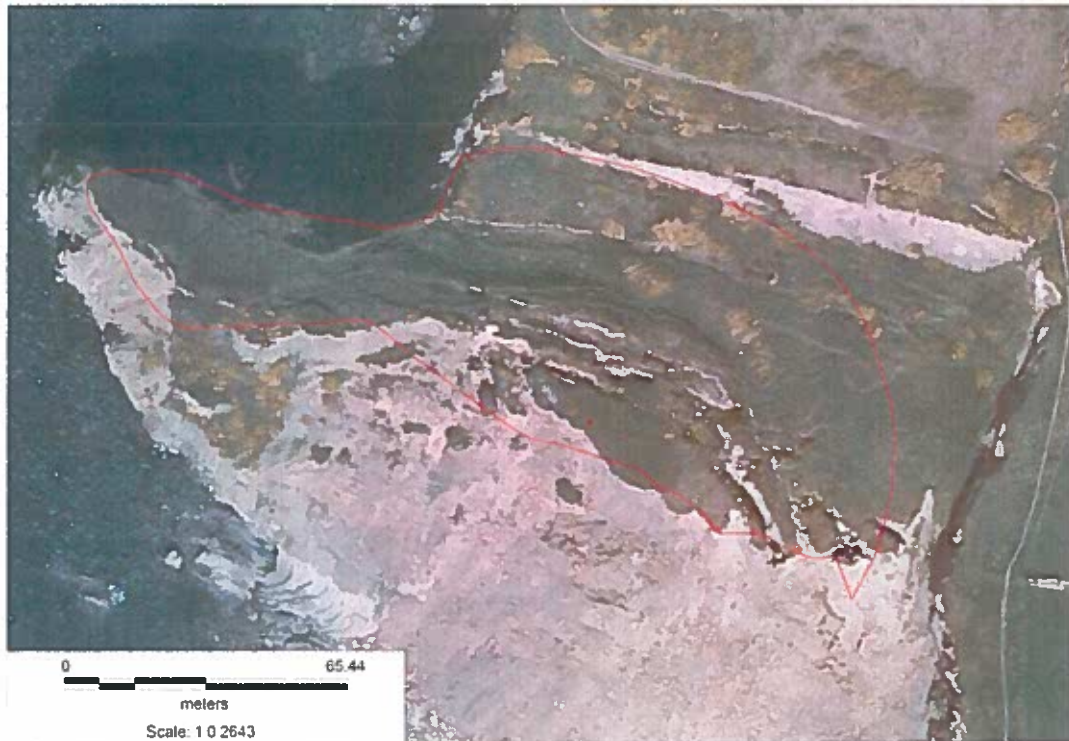
Black Point Rath: erosion 2009 and SAM area

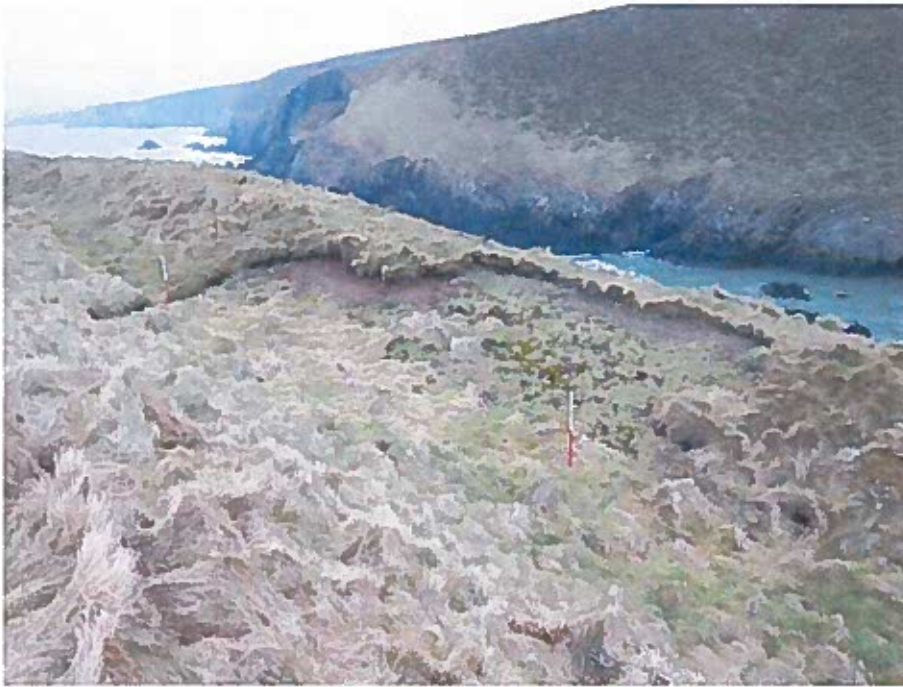
Porth y Rhaw: area of grass fire grow-back. Scales 1m. View W. 12/02/2013

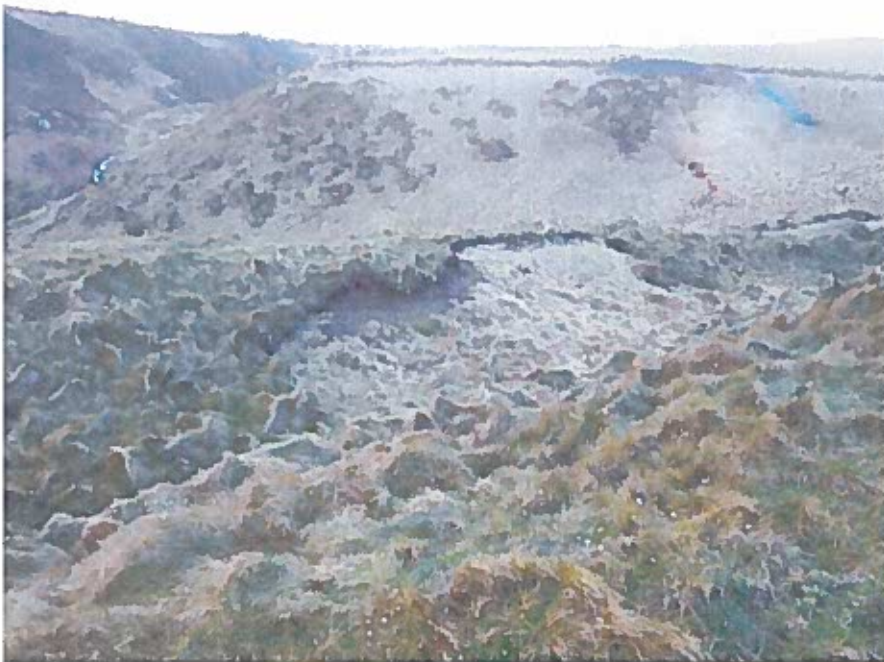
Porth y Rhaw: area of grass fire grow-back. View N. 16/01/2014

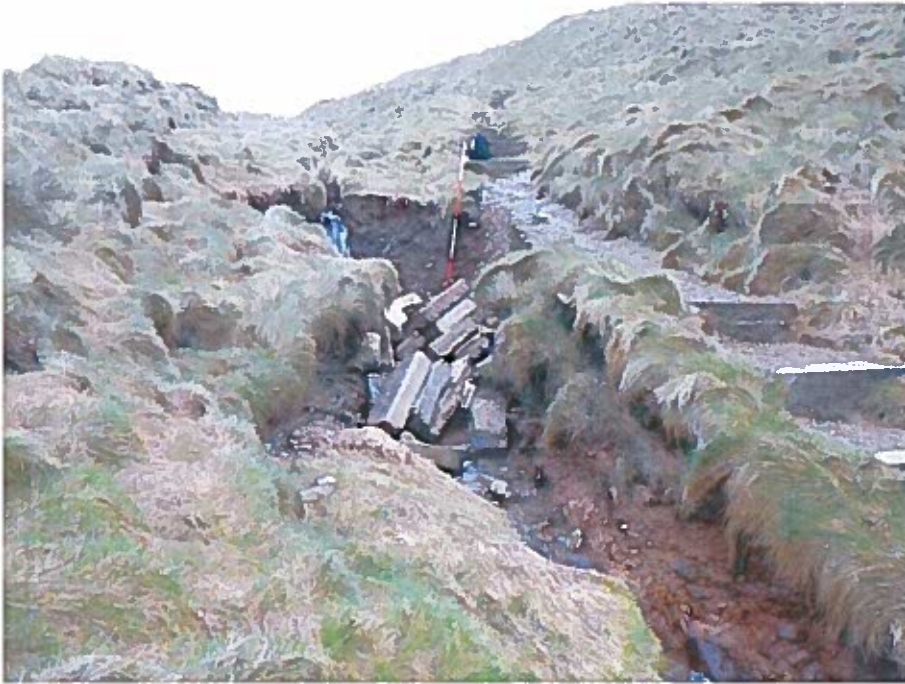
In early February 2013 torrential rain on already waterlogged ground caused localised flooding. The small stream running adjacent to the Coast Path washed away the retaining wall (see photos below) and undermined the lowest step at the west end of the outer defences of the fort. Water had also poured down the Coast Path to the east and through the new gap in the hedgebank (see photo below), just outside the entrance to the fort, and had created a new "step". Furthermore, this torrent of water also washed away most of the gravel surface of the path by the fort and caused some minor erosion at the top of the bank below. These water flows have basically undone all of the repairs undertaken by Polly Groom a few years ago, except for the stone steps. As this flooding was considered to be exceptional it is intended to re-do all of these repairs.

Porth y Rhaw: water damage to retaining wall. Scale 2m. View E. 12/02/2012

The revetment wall between the stream and edge of the Coast Path was immediately rebuilt and the "step" through the hedge bank was made good as emergency repairs, after discussion with Louise Mees (a Scheduled Ancient Monument Damage Assessment Report was sent in regarding this matter). Repairs are programmed for April 2014, with further footpath improvements and resurfacing, probably during or just after the summer. Scheduled Ancient Monument Consent will be obtained before undertaking this further work.

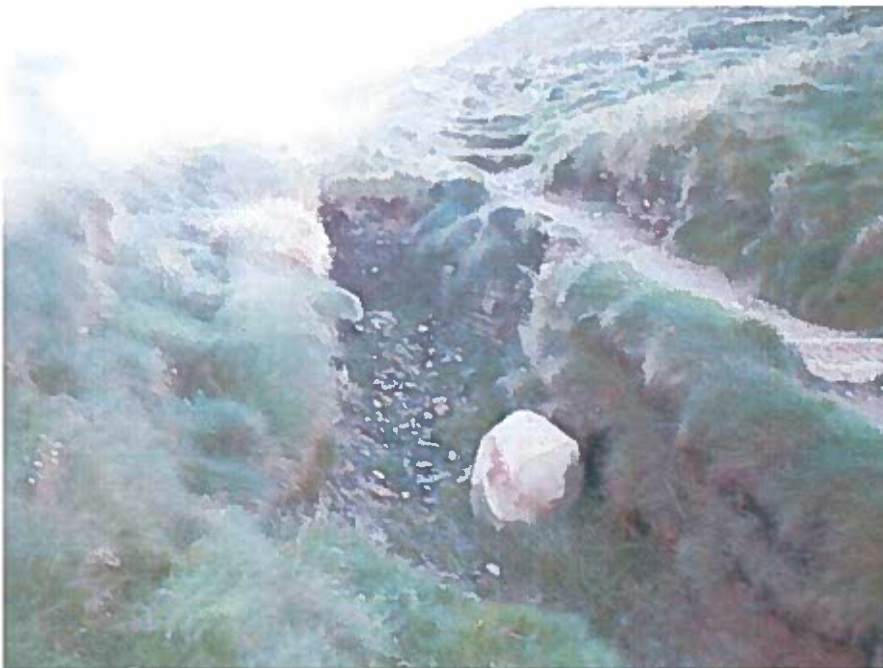
Porth y Rhaw: retaining wall as rebuilt before winter water erosion. View E. 15/10/2013
