CADW SCHEDULED ANCIENT MONUMENTS PCNPA AREA 2013-14

RHIF YR ADRODDIAD / REPORT NO. 2014/14

Pete Crane FSA

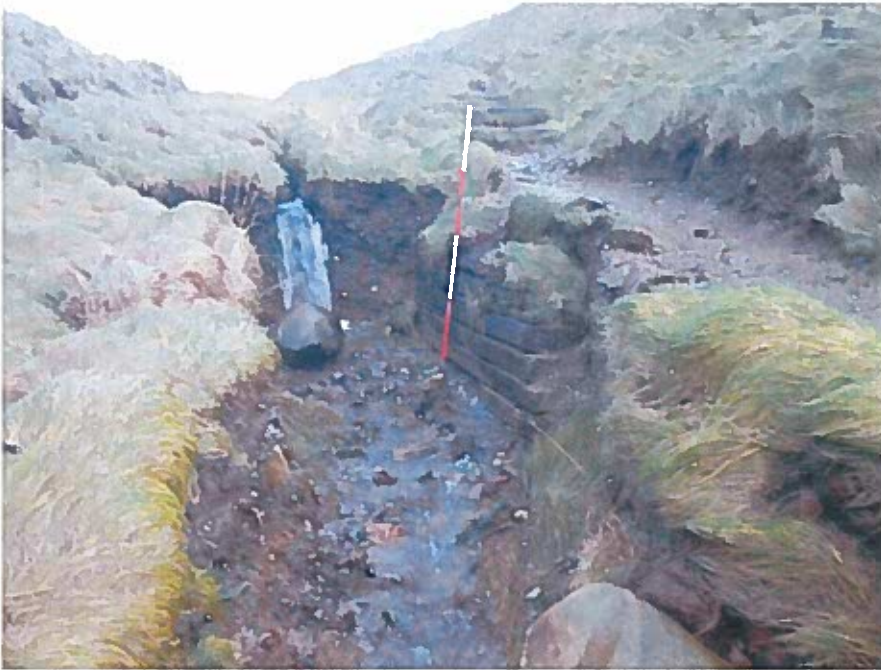
Porth y Rhaw: retaining wall as rebuilt but being undercut. Footpath above left to be cut further back into natural bank. Scale 2m. View E. 16/01/2014

- Footpath and stream edge repairs due to start on 09/04/2014
- Recommend PC to monitor erosion and record re-growth along eroding inner bank edge

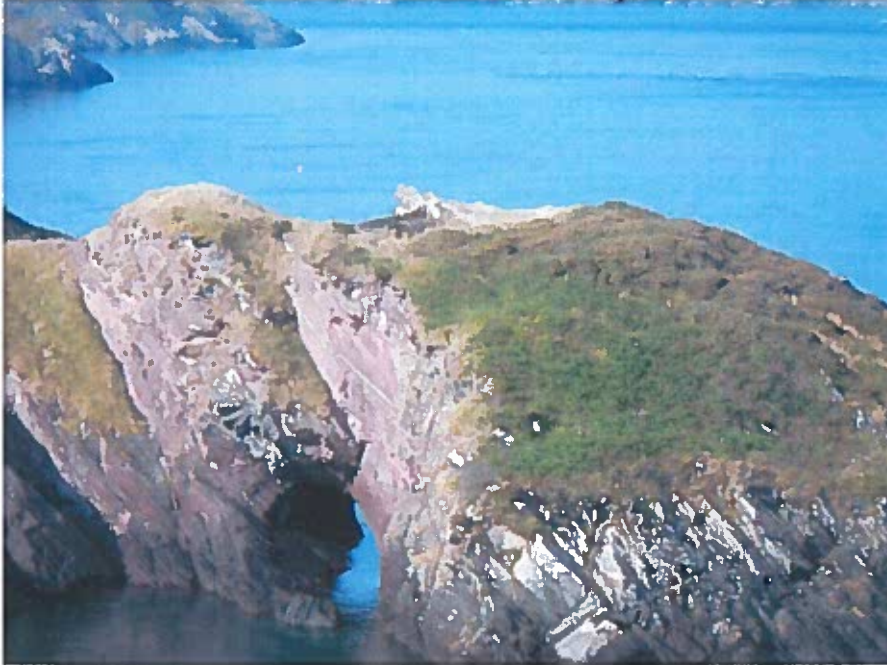
over part of the interior of the fort. It appeared that the fire was started by a campfire, located in a likely hut platform, which spread due to the very dry conditions. The area of the burn was c.15m SW-NE and c.10m NW-SE, but not all burnt (yet) on the SE side. No sign of any features on the surface. NT staff and volunteers arrived to damp down the site and PC therefore asked them to make as little soil disturbance as possible. Because of the potential erosion PC aimed to monitor the site as necessary.

Castell Heinif: General view of burnt area on promontory. View S. 10/07/2013

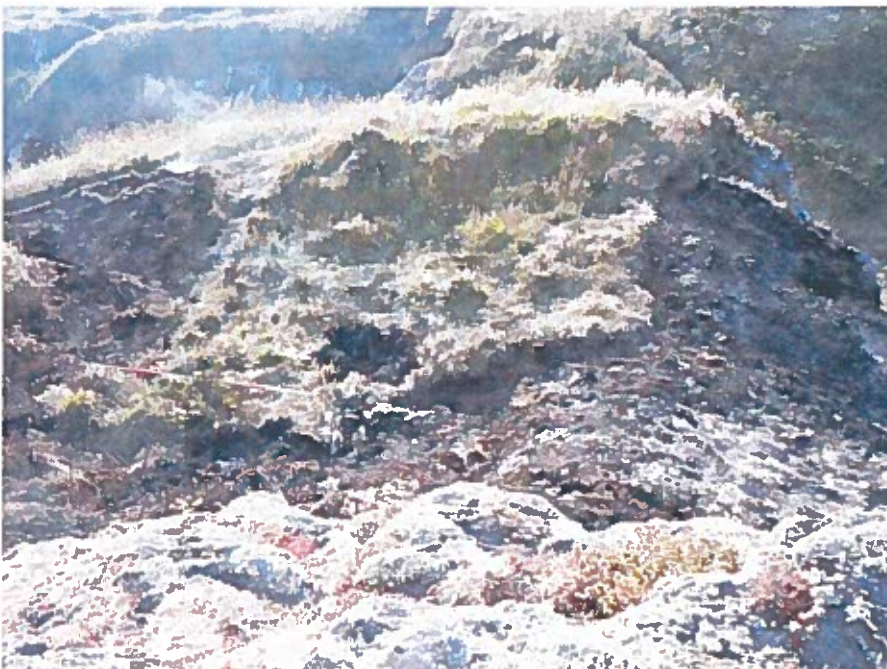
Castell Heinif: Burnt area still smouldering. Camp fire in centre. Scale 2m. View E. 10/07/2013

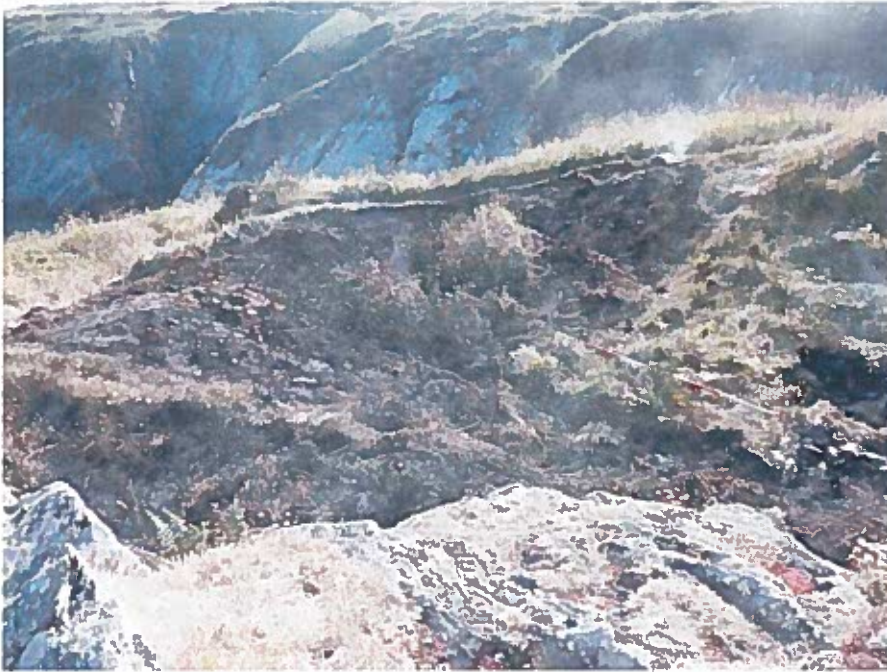
Castell Heinif: Burnt area still smouldering. Camp fire to right of scale. Scale 2m. View E. 10/07/2013

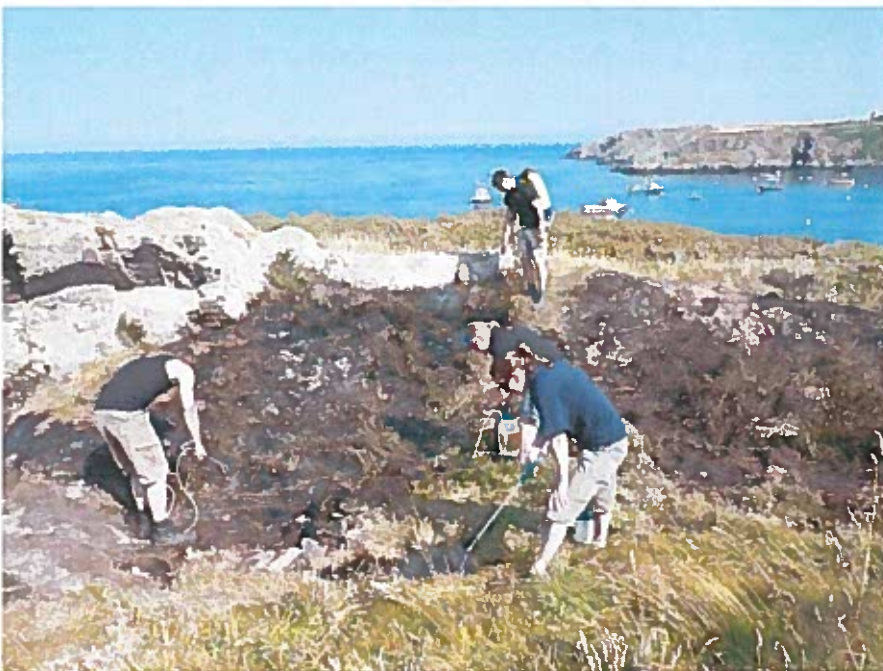
Castell Heinif: National Trust team damping down burn. View NW. 10/07/2013

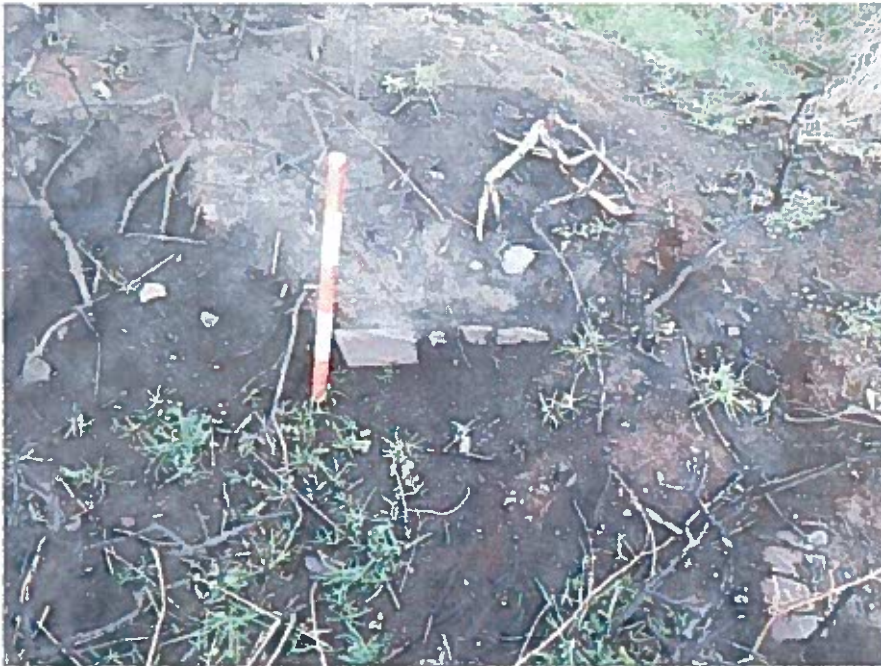
Castell Heinif: Possible stone edge revealed by further erosion. Scale 0.5. View W. 30/10/2013

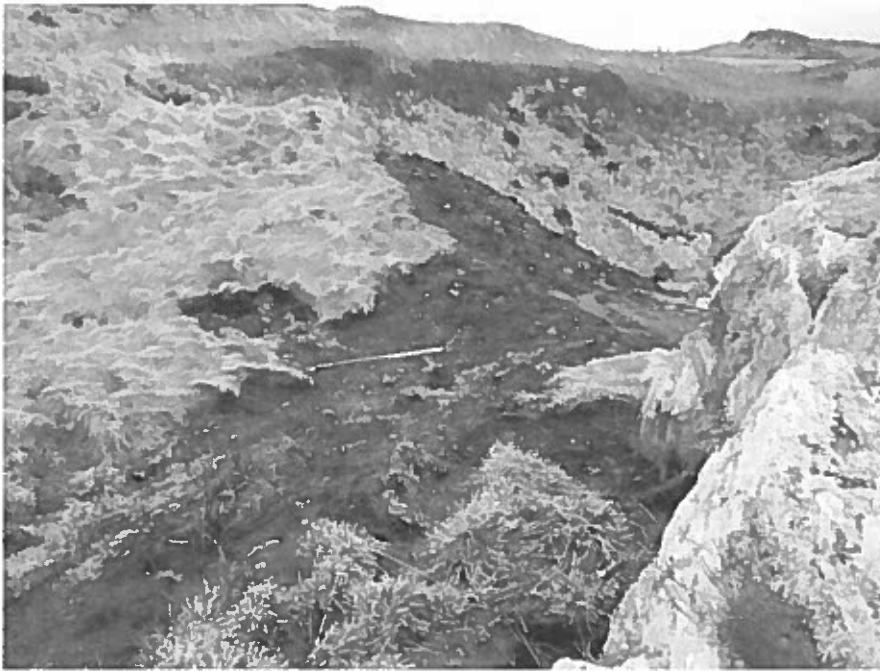
The last visit made was on 13/01/2014, there having been extreme gales and waves over the Christmas and New Year periods. No noticeable regrowth from the last visit and there had been more wash off of the topsoil on the S side but the rest of the burn area appeared unchanged.

Castell Heinif: water erosion of topsoil on south side (photo right) of burnt area. Scale 1m. View SE. 13/01/2014

- PC: To monitor any further erosion, especially to visit after any severe weather conditions

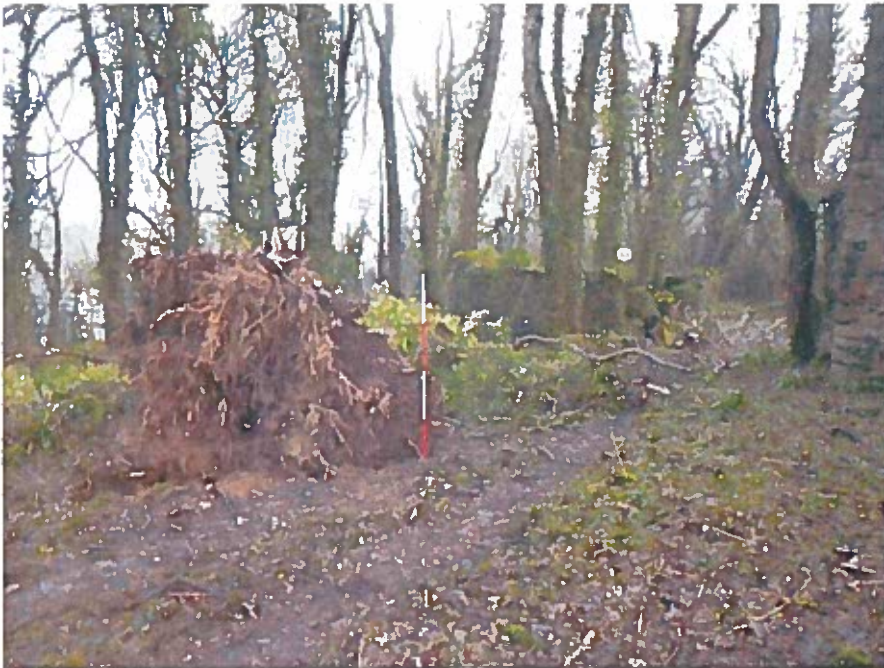
The following weeks were very wet and windy so the site was not visited again until into the New Year on 16/01/2014. Spoke to the tenant farmer who informed me that there had been no further tree cutting since before Christmas. Sketch planned the location of cut trees. One tree may have been uprooted by accident but it is probable that the winter storms may have done this (see photo below). There did not appear to be any archaeological deposits in either the tree-hole or root-ball.

Sisters House: Uprooted tree. Scale 2m. View NE. 16/01/2014

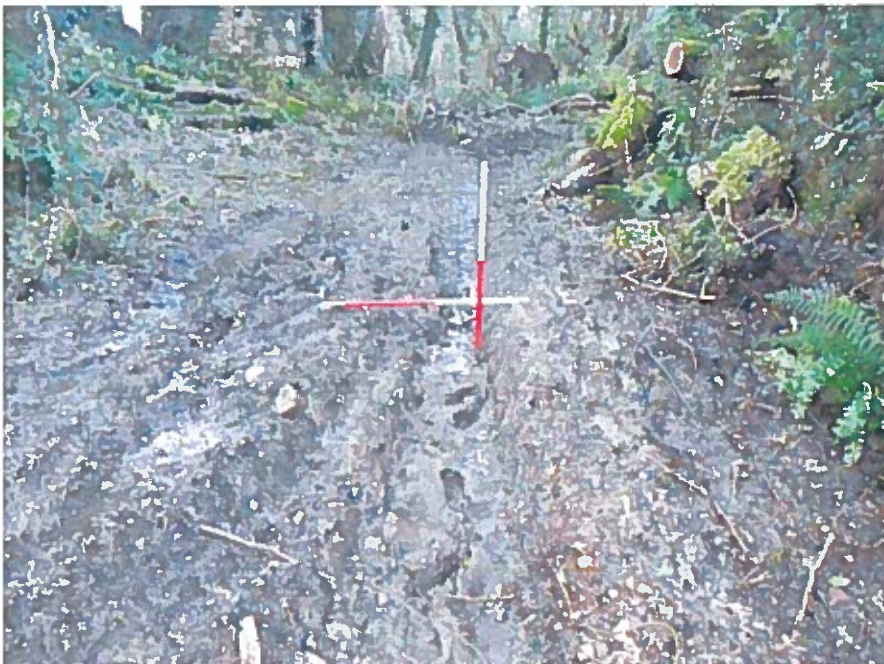
There was one new rut c.0.25m deep (see photo below), probably on the line of an original lane: the bottom of this was onto hard ground or surface, and no damage to any archaeological deposits seem likely. The conditions at the end of the year had been exceptionally wet.

Sister's House: Machine rut. Scale 1m and 2m. View W. 16/01/2014

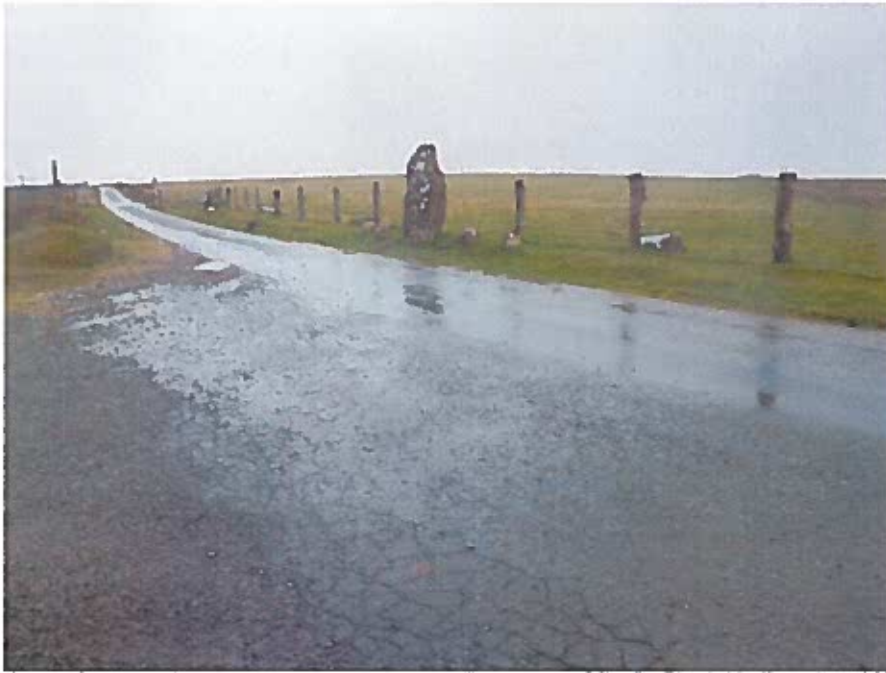
The site was visited on 30/10/2013. The fencing has been renewed behind the stone and the grass has regrown around it. Stones have been placed on the verge either side of the standing stone to try and protect it. An iron spike, part of the earlier consolidation was found to be standing above the surface and on a subsequent visit, 01/11/2013, this was hammered down well below the surface.

Bedd Morris: with protecting stones on either side. View SW. 30/10/2013

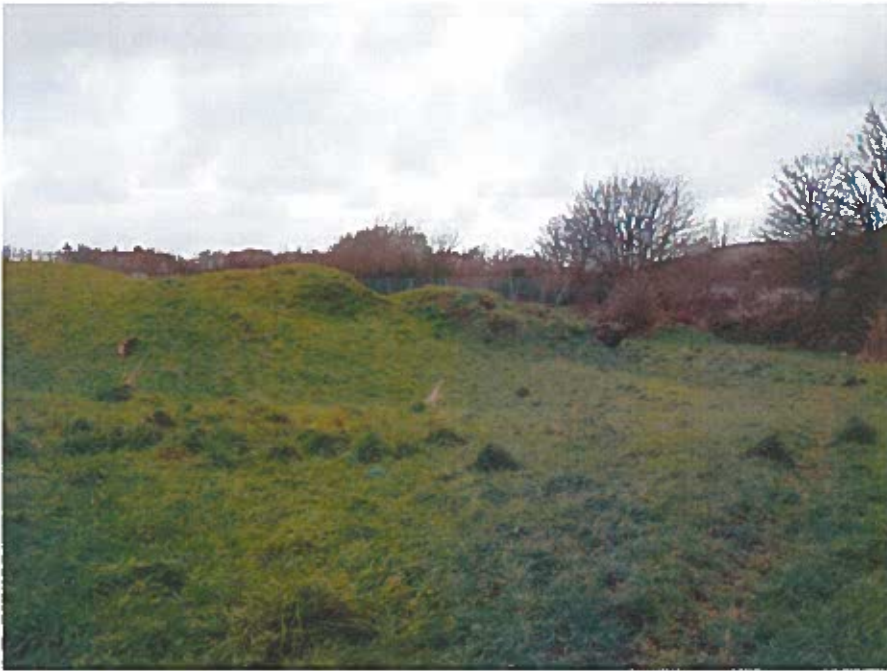
The site was visited on 16/12/2013 while looking at an adjacent problem. Some vegetation had been cleared from the banks since the last visit and there is now only a little scrub on the far north of the site. There did not appear to be any active burrows in the bank.

Newport Old Castle: Banks mostly cleared of vegetation. View W. 16/12/2013

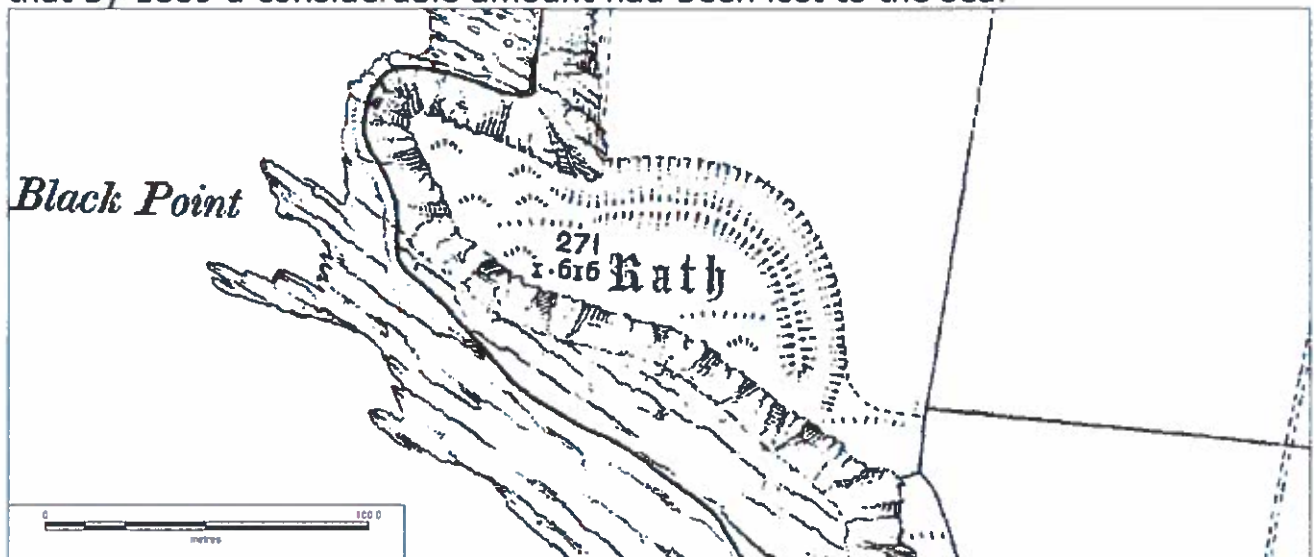
Black Point Rath is shown on the 1st Edition Ordnance Survey 1:2500 map of 1889 as a univallate promontory fort. The map shows the fort naturally defended by high sea cliffs to the west and south, and by a curving bank approximately 120m long with an external ditch to the north and east. An entrance lies between the bank terminal at the south end and the edge of the cliffs. The internal area is about 120m E - W and 35m N - S, although it is likely that by 1889 a considerable amount had been lost to the sea.

Black Point Rath Ordnance Survey 1st Edition 1889
