CADW SCHEDULED ANCEINT MONUMENTS PCNPA AREA 2012-3

RHIF YR ADRODDIAD / REPORT NO. 2013/32

This report covers visits and work to Scheduled Ancient Monuments in the Pembrokeshire Coast National Park undertaken by Pete Crane during 2012-2013, for Cadw or for PCNPA.

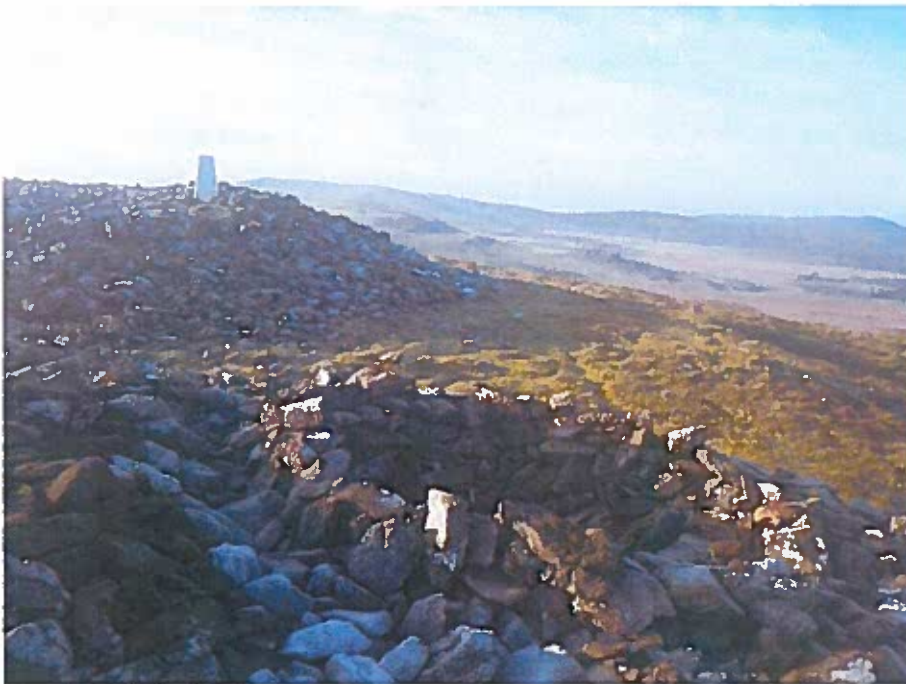
Foel Drigarn: Damage to north cairn. Scale 0.5m View S 11/12/2012 (Freezing temperatures at the time of the visit caused the camera to mist up)

The site was visited on 11 December 2012 as part of the recommended monitoring of this hillfort, mainly with regard to disturbance to the cairns by visitors building "shelters". The NE cairn had been further disturbed and the slight depression recorded previously has now turned into a shelter. This shelter has been constructed in the SW side of the cairn and is c.3m in diameter and up to 1m deep (see photo above). Slightly less disturbance was caused by a similar shelter construction in the SW side of the SW cairn (see photo below) (NGR by basic GPS grid ref. SN 15742/33585).

- Can the hollows (shelters) be repaired without further SMC?
- PC will visit the site in 2013 along with Bedd Arthur
- No action is recommended on the sheep scrapes, but these should be monitored during site visits

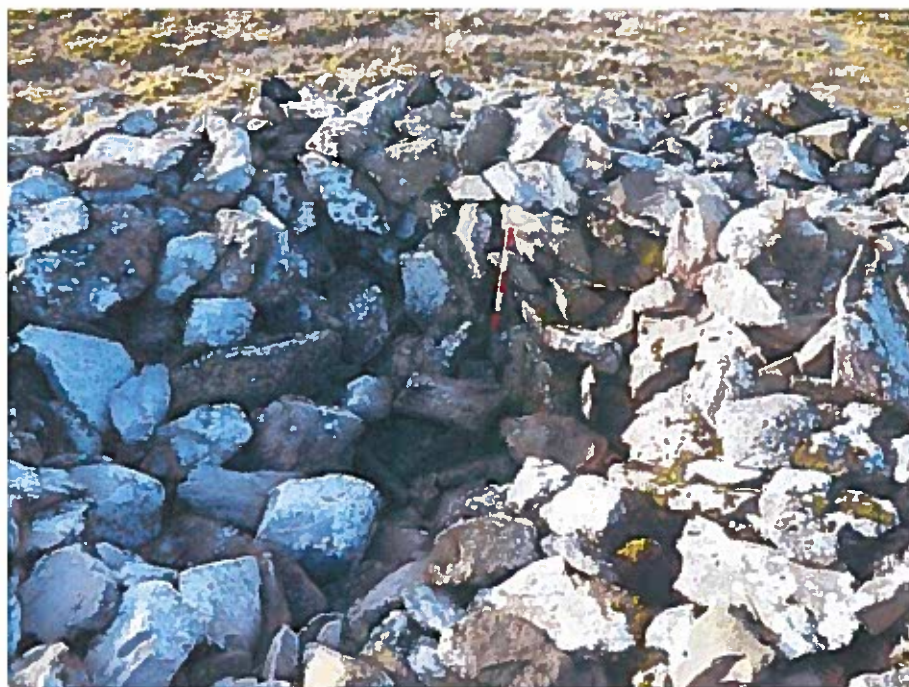
Foel Drigarn: damage to SW cairn. Scale 0.5m. View SW. 11/12/2012

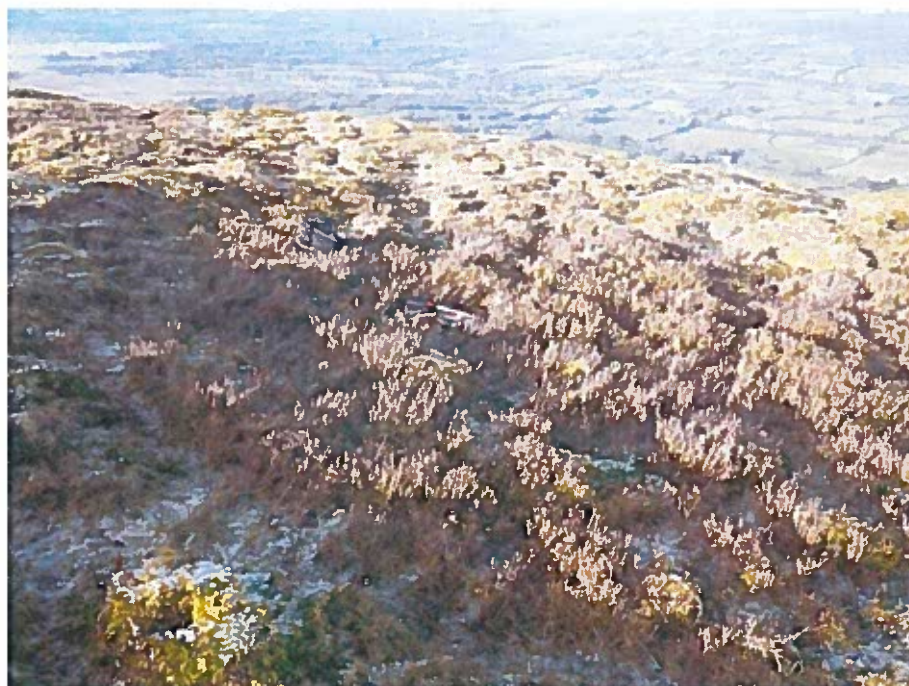
The disturbance previously noted to the centre of a hut platform just to the north east of the central cairn (NGR by basic GPS SN 15773/33624) (see photo in last report), possibly the result of metal detecting or geocache activity, was repaired. However a possible modern camp fire with stone surrounds was observed in an adjacent hut platform (see photo below) (NGR by basic GPS SN 15774/33636).

Foel Drigarn: Possible campfire. Scale 0.5m. View SW. 11/12/2012

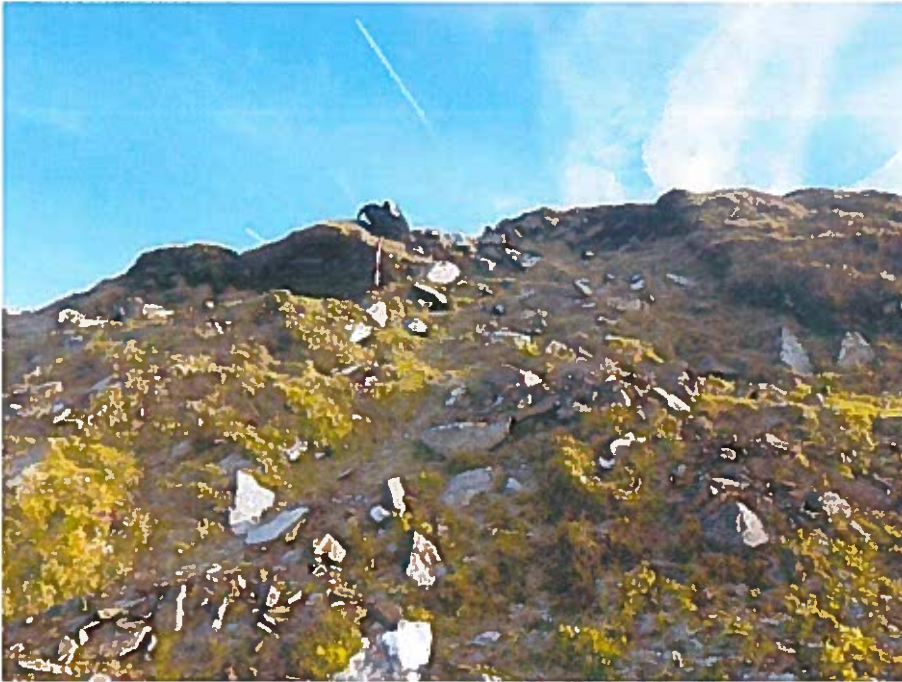
A sheep scrape was noted on the SW side of the rampart (photo below) (NGR by basic GPS SN 15681/33558)

Foel Drigarn: Sheep scrapes. Scale 0.5m. View E. 11/12/2012

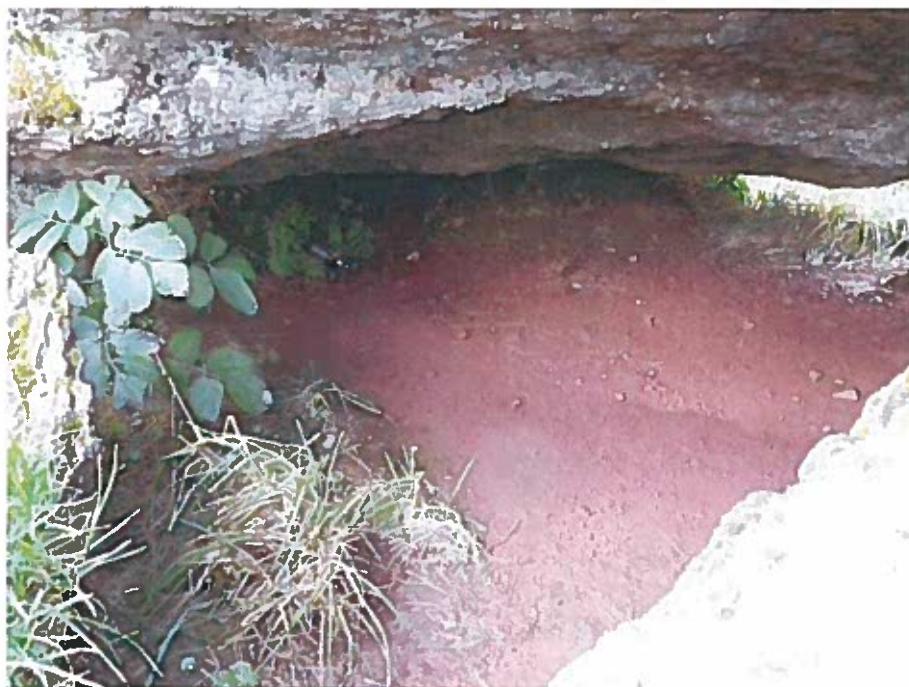
A visit was made on 6/11/2012 while undertaking a watching brief on the adjacent Coast Path. No further disturbance had taken place since last seen. There was a beer can under the capstone (see photo below).

Kings Quite Burial Chamber: under capstone. View SE 6/11/2012

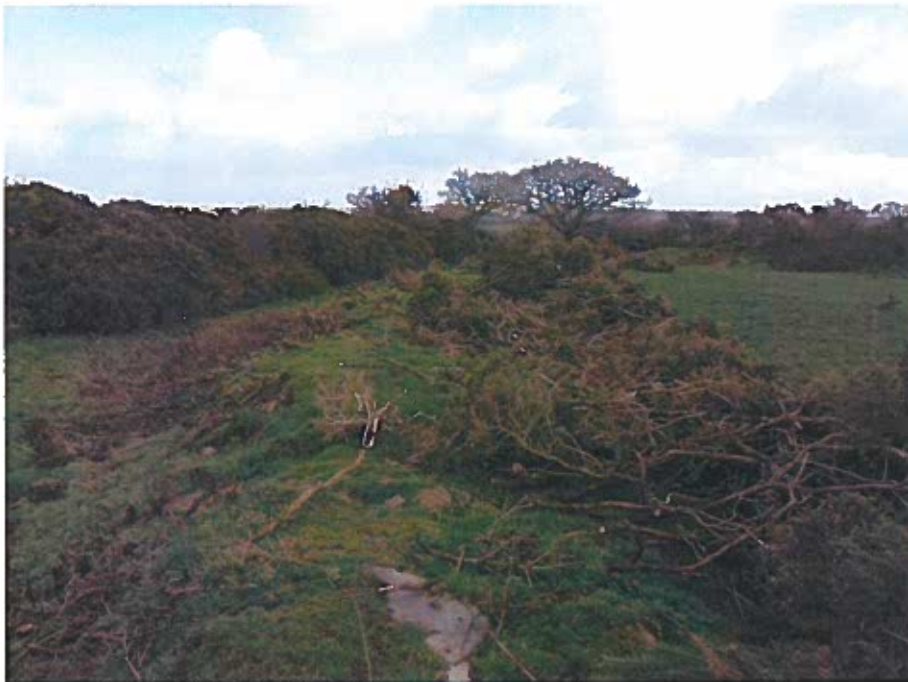
Following the work done by Mike Parker-Pearson's team in September 2012, the local PCNPA ranger and volunteers spent a couple of days clearing vegetation on the site. The site was visited on 7/12/2012 when the volunteers were due to be on site but was postponed due to poor weather. More clearance work has subsequently been done and no more is envisaged prior to the archaeological work in September 2013.

Castell Mawr: clearance underway just north of west entrance.
View N. 7/12/2012

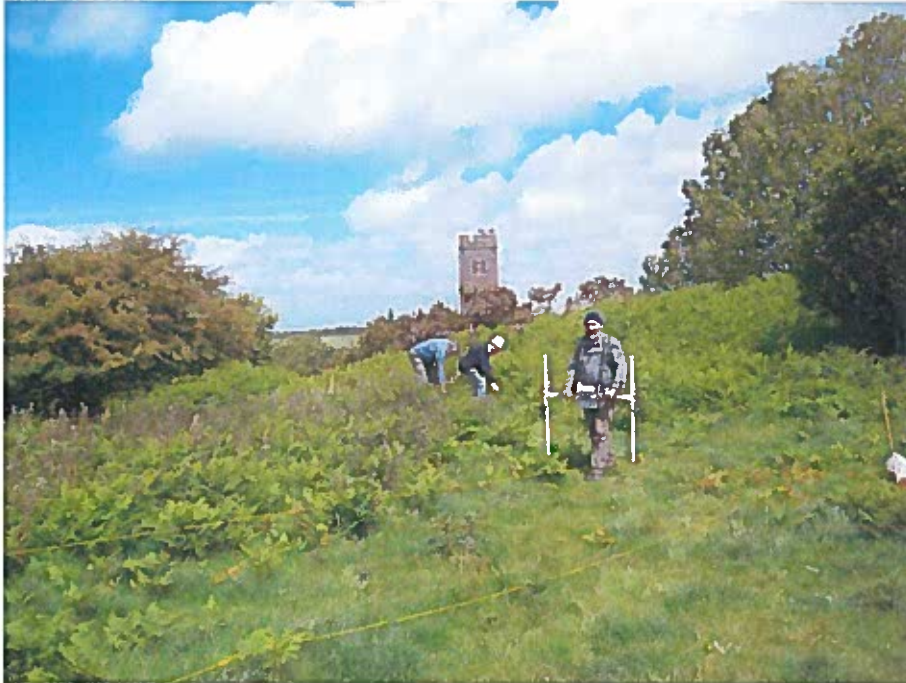
Following two separate days spent in 2011 with the Walwyn's Castle History Group undertaking a geophysical survey (see photo below), a presentation of the results (see below) and discussion was held with the group one evening in January 2013. The community are very keen to investigate some of the anomalies and involve themselves in their archaeology.

Walwyn's Castle: Undertaking geophysical survey. View N. 25/5/11

- Would Cadw be likely to grant SMC for the local community to undertake keyhole investigations with assistance from PC?
- PC to work with group to explore funding opportunities to support such investigation, as some post excavation costs such as pottery identification would be likely, plus possible help from DAT community archaeologist.

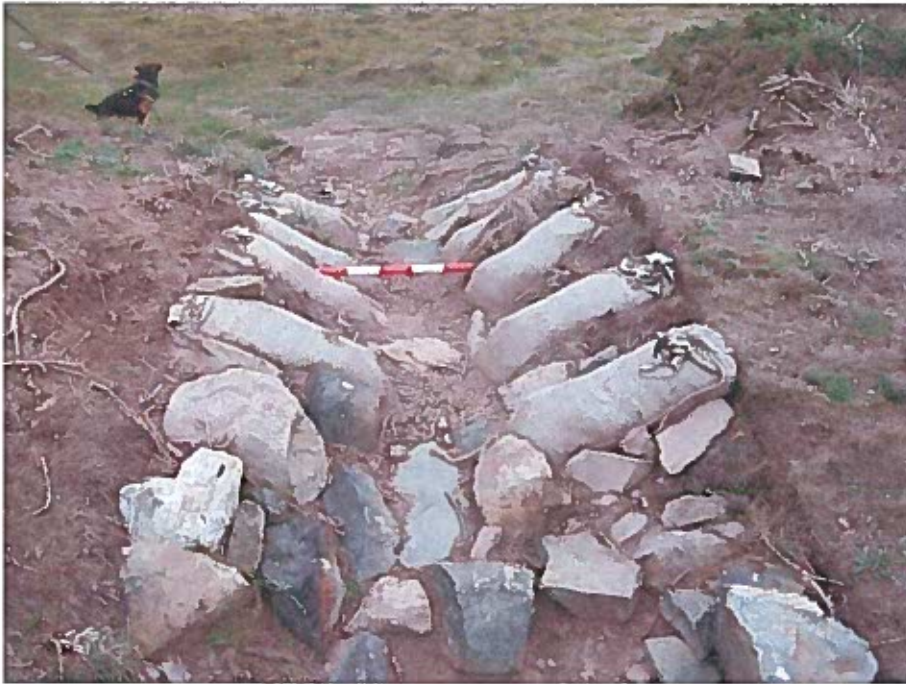
The backfilled Time Team trenches through the north bank, which is used as part of the Coast Path, were still looking very raw (see photos below).

Watery Bay Rath: modern entrance through northwest bank as consolidated by Time Team. View S, Scale 0.5m. 11/10/2011

- PC to continue monitoring consolidated footpath though northwest bank of Watery Bay Rath
- PC to visit Gateholm with National Trust Ranger to look at backfilled trenches and other erosion issues, especially near the north eastern end of the island and identify necessary remedial actions.

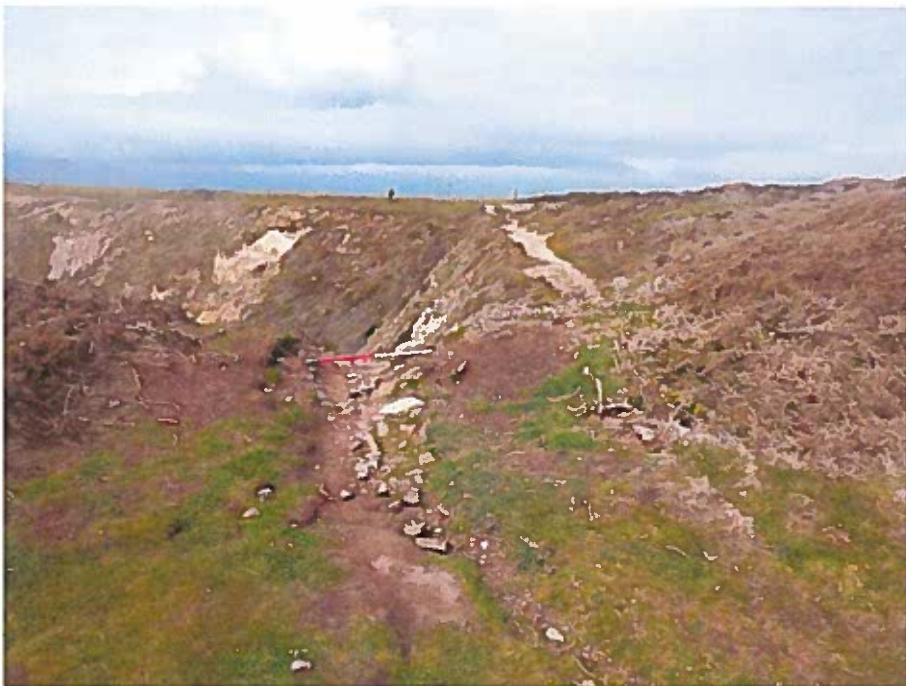
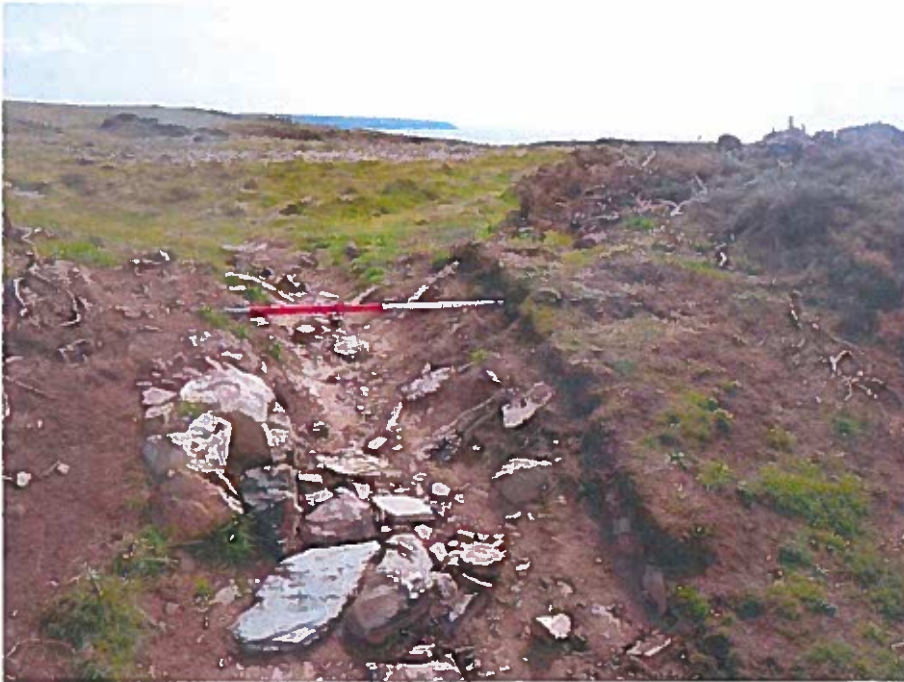
Watery Bay Rath: Time Team trench through the bank as seen in the spring. Scale 1m. View N. 13/4/2012

Watery Bay Rath: Time Team trench through the bank as seen in the spring. Scale 1m. View S. 13/4/2012

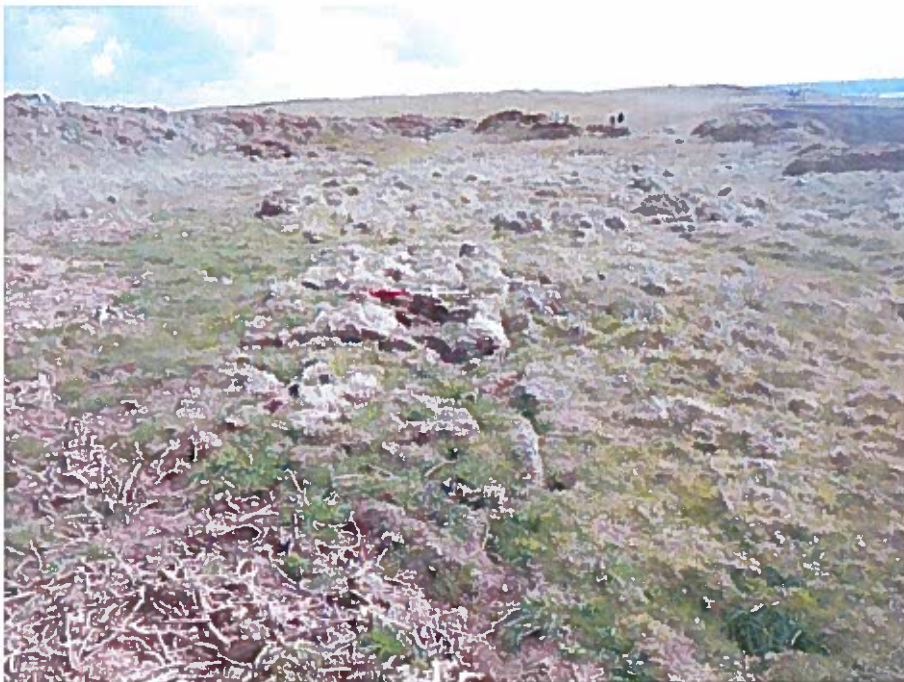
Watery Bay Rath: Backfilled Time Team Trench towards the north of the interior. Scale 1m. View S. 13/4/2012

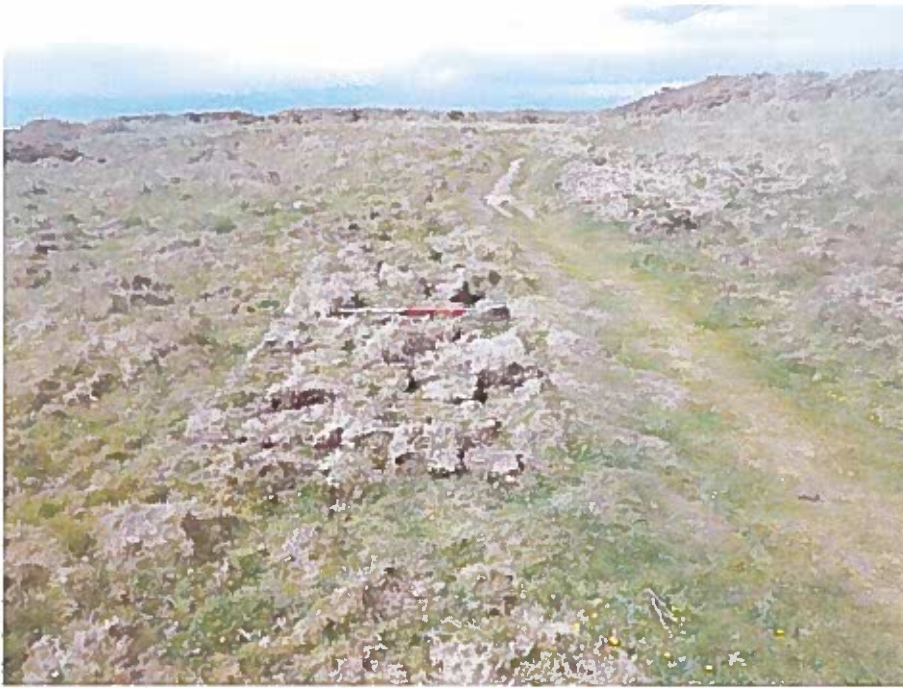
Watery Bay Rath: Backfilled Time Team Trench within fort just to the N of entrance. Scale 1m. View N. 13/4/2012

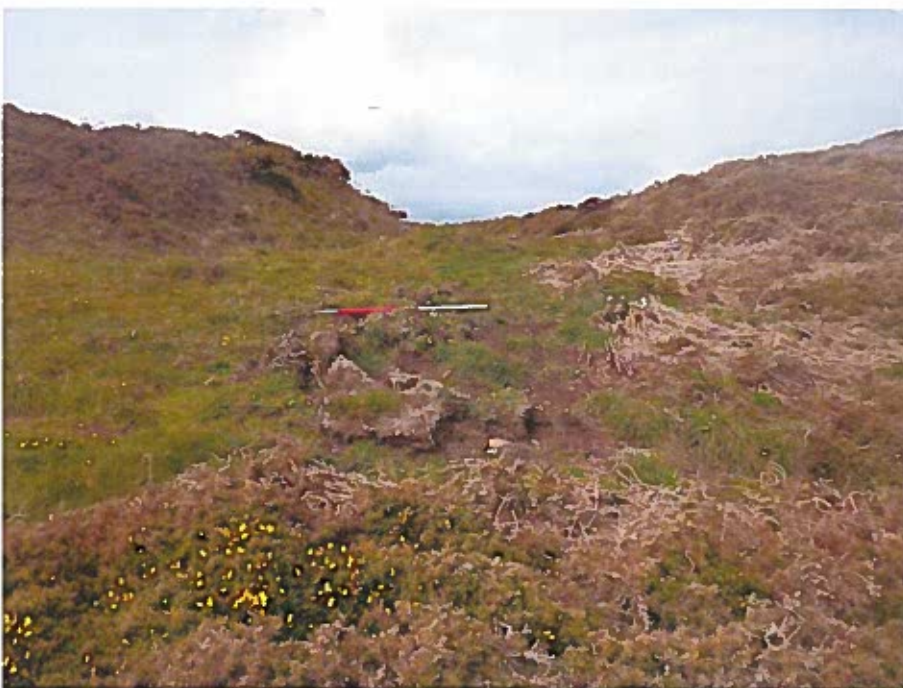
Watery Bay Rath: Backfilled Time Team Trench to the SE of entrance. Scale 1m. View N. 13/4/2012

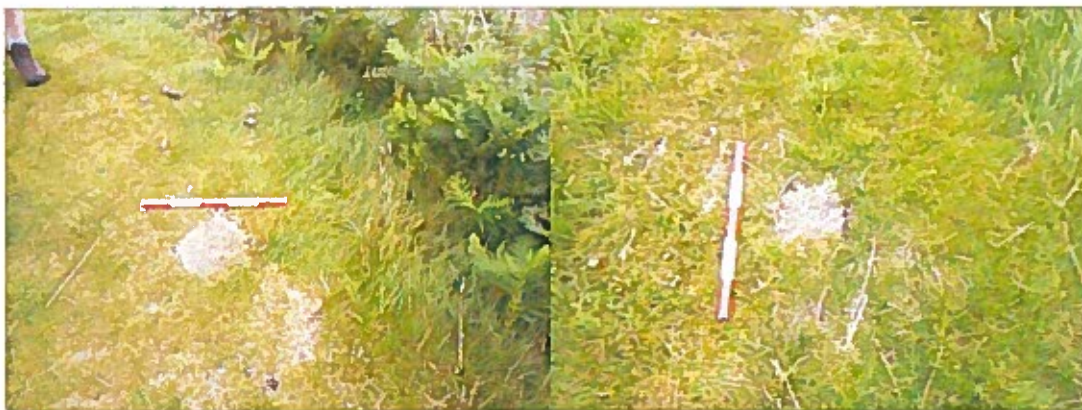
This site appears to have been discreetly metal detected as there was evidence of divots having been dug and neatly replaced on the south and east sides of the barrow which has the trig. point(see photo below). This was reported to Cadw. The possibility of PCNPA replacing and moving some of the fencing further away from the barrows, and out of the scheduled area is being pursued.

Crugiau Cemmaes: Possible damage by metal detectorist. Scale 0.5m

- PC to continue with efforts to replace and move the fencing around the southern two barrows

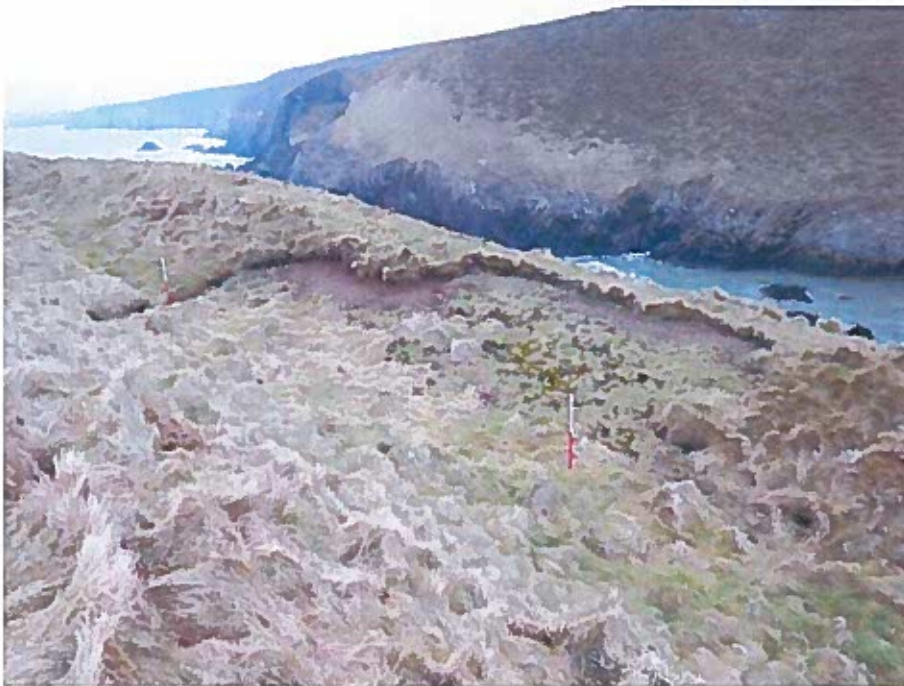
The area of the small grass fire reported last year is growing back quite well (see photo below).

Porth y Rhaw: area of grass fire grow-back. Scales 1m. View W. 12/2/2013

- Scheduled Ancient Monument Damage Assessment Report to be submitted
- SMC to be obtained for further repairs to and adjacent to the Coast Path
- Recommend PC to monitor erosion and record re-growth along eroding inner bank edge

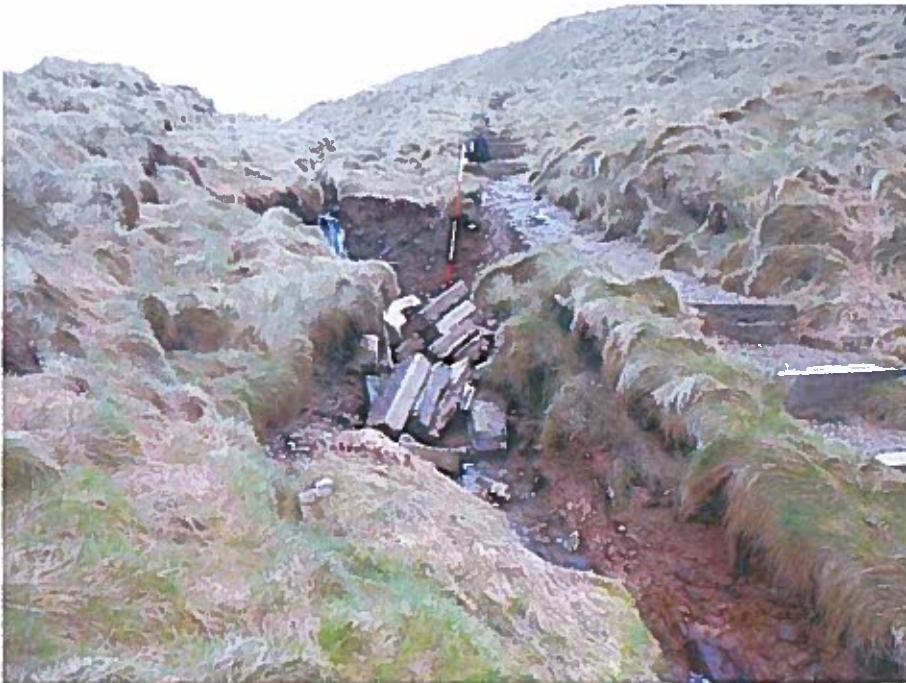
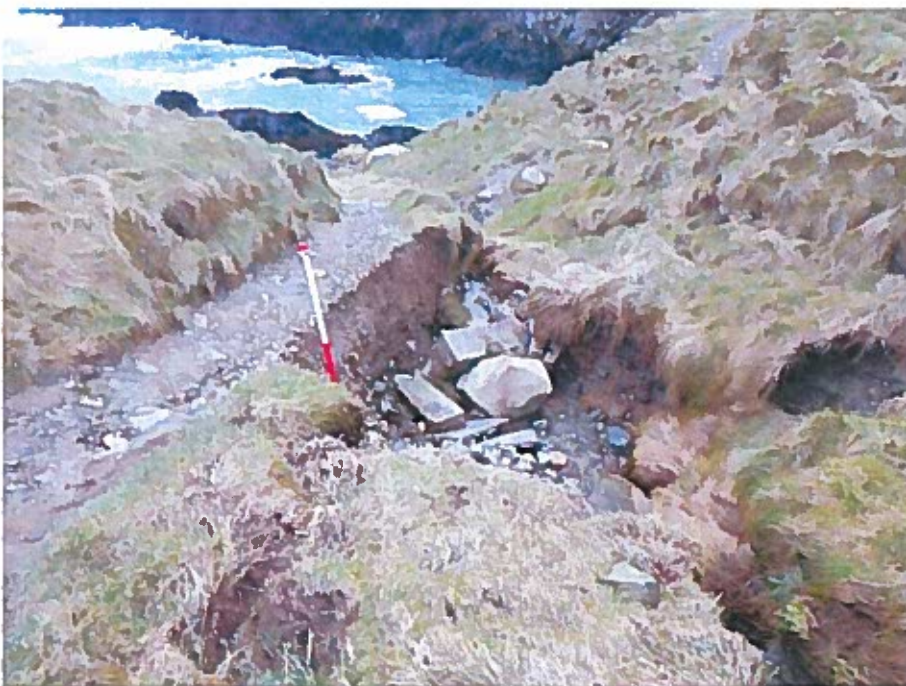
In early February 2013 torrential rain on already waterlogged ground caused localised flooding. The small stream running adjacent to the Coast Path washed away the retaining wall (see photos below) and undermined the lowest step at the west end of the outer defences of the fort. Water had also poured down the Coast Path to the east and through the new gap in the hedgebank (see photo below), just outside of the entrance to the fort, and had created a new "step", furthermore, this torrent of water also washed away most of the gravel surface of the path by the fort and caused some minor erosion the top of the bank below. These water flows have basically undone all of the repairs undertaken by Polly Groom a few years ago, except for the stone steps. As this flooding was considered to be exceptional it is intended to re-do all of these repairs.

Porth y Rhaw: water damage to retaining wall. Scale 2m. View E. 12/2/2012

Porth y Rhaw: water damage to retaining wall. Scale 2m (top). View W. 12/2/2012

The revetment wall between the stream and edge of the Coast Path was immediately rebuilt and the "step" through the hedge bank was made good as emergency repairs, after discussion with Louise Mees (a Scheduled Ancient Monument Damage Assessment Report will be sent in regarding this matter). It is intended to undertake full repairs at a later date, possibly with some footpath improvements, probably during or just after the summer. Scheduled Ancient Monument Consent will be obtained before undertaking this further work.

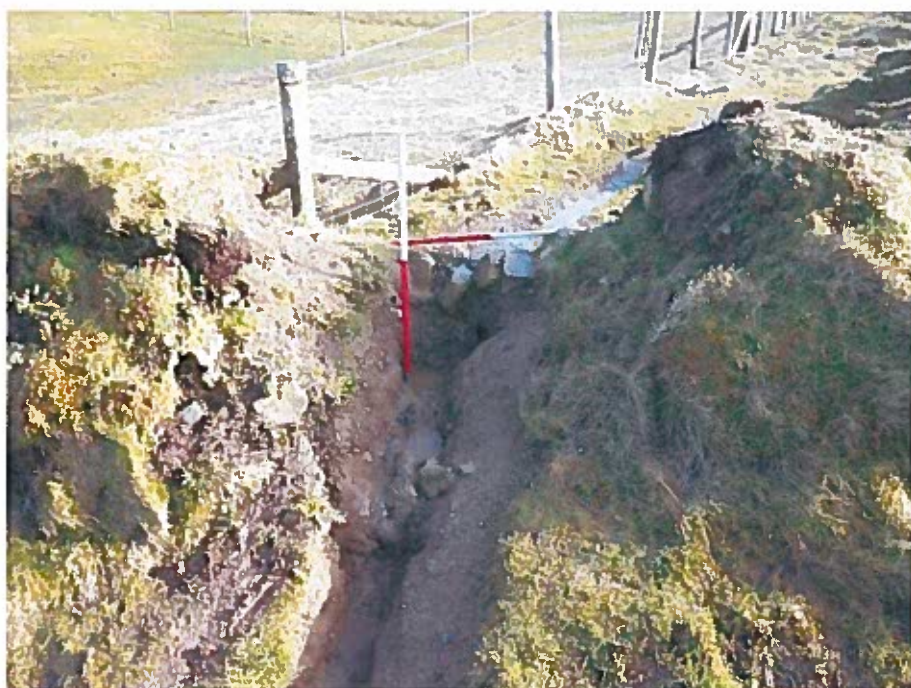
Porth y Rhaw: water damage to through hedgebank creating a step. Scales 1m. View NE. 12/2/2012

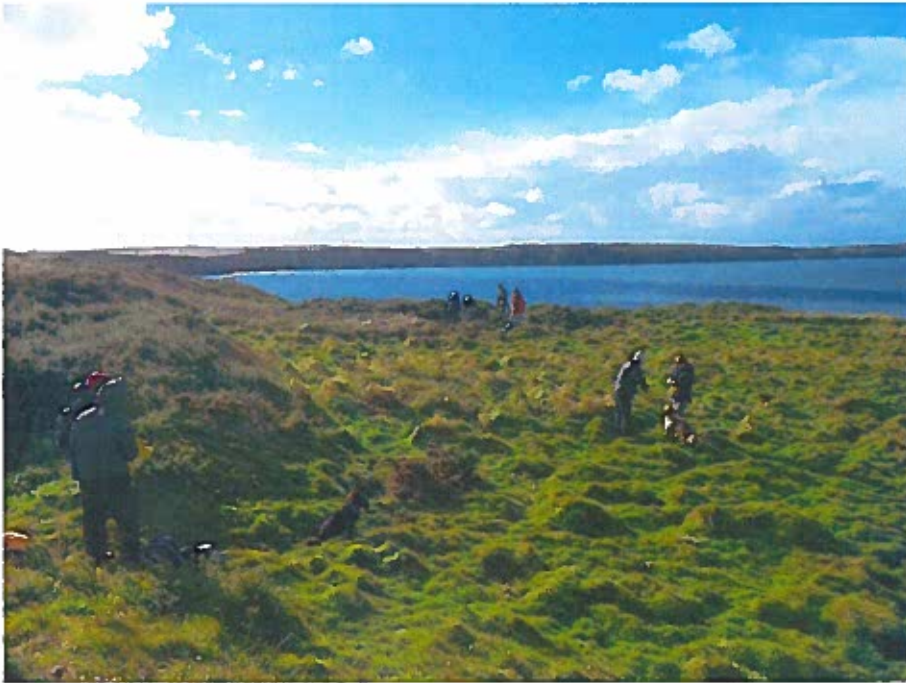
One day was spent working with the new area ranger and 8 PCNPA volunteers on further scrub clearing just inside the entrance. Subsequently the volunteers have undertaken another day's clearance. The site is now being intermittently grazed. The possibility of undertaking a geophysical survey on the interior is still being pursued along with investigating what topographic survey plans may have been done and if it is necessary to have a more detailed plan made.

Tower Point Rath: volunteers clearing vegetation on south side and interior of the entrance. View SW. 1/11/2012

- PC to visit site in 2012-13 to observe improvements and investigate the possibility of geophysical survey and if a detailed topographic survey is desirable

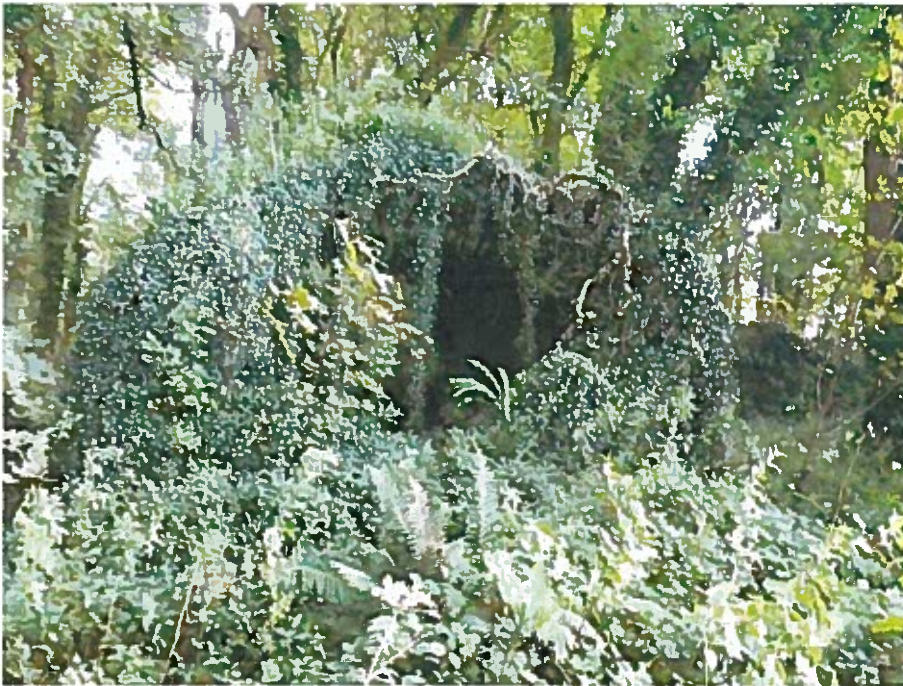
Sisters' House: "Chapel" trees causing damage to vault. View E. 11/9/2012

- PC to be on site to meet contractors at the beginning of any tree clearance
- PC to monitor during, and at the end of, each years' work on the tree clearing
- PC to make certain that any new planting is sympathetic to the monument
- Cadw are recommended to extend the scheduled area to include adjacent features, for example the walled garden and adjacent boundaries

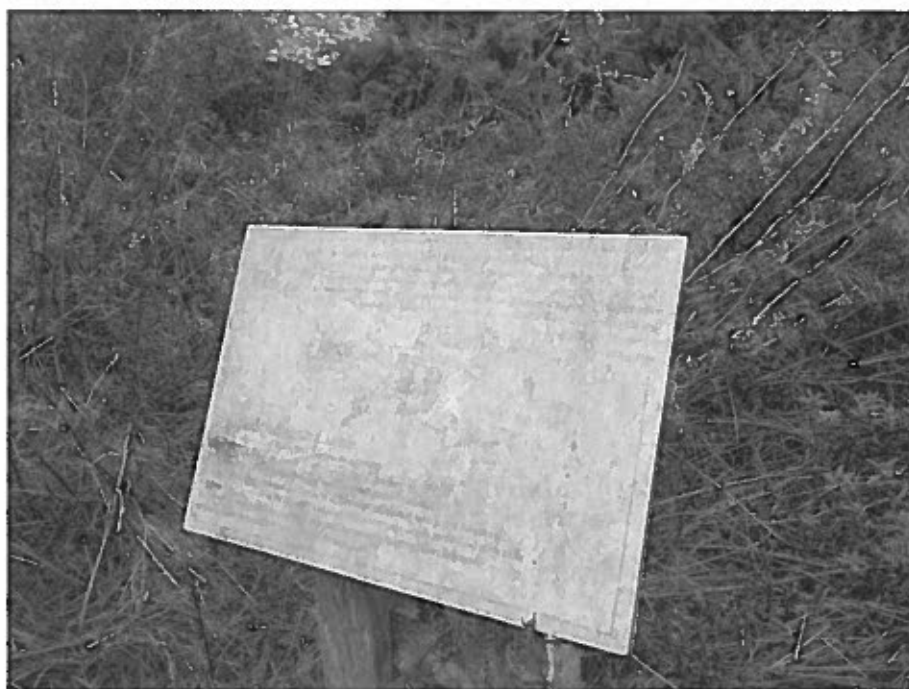
Garn Wern: information panel in need of replacement

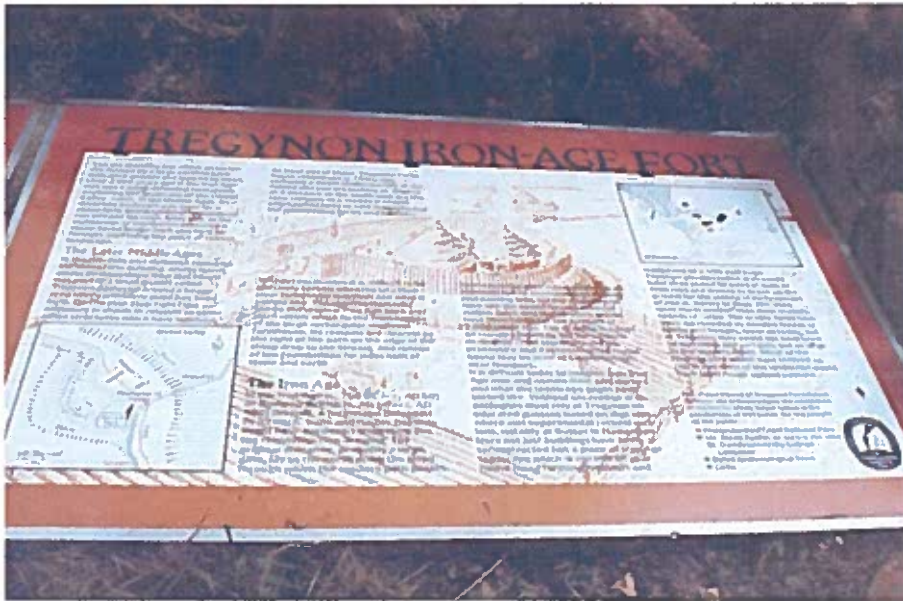
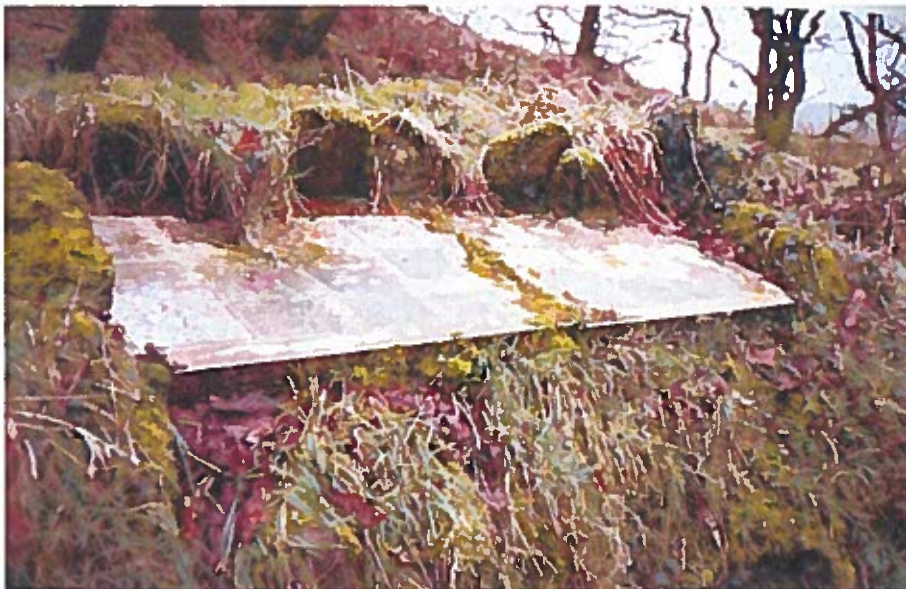
The Cadw Field Monument Warden, Louise Mees, reported in February 2013 that the information panels were in very poor condition and asked whether the original artwork could be traced. After making enquiries it was found that Brian Southern, Graphics Officer at PCNPA did the original panels, but the information is no longer held.

Tre-Gynon English panel. Photo Louise Mees

Tre-Gynon panels. Photo Louise Mees

- Try to trace original version of information panels at DAT
- Obtain costings for replacement panels and/or artwork

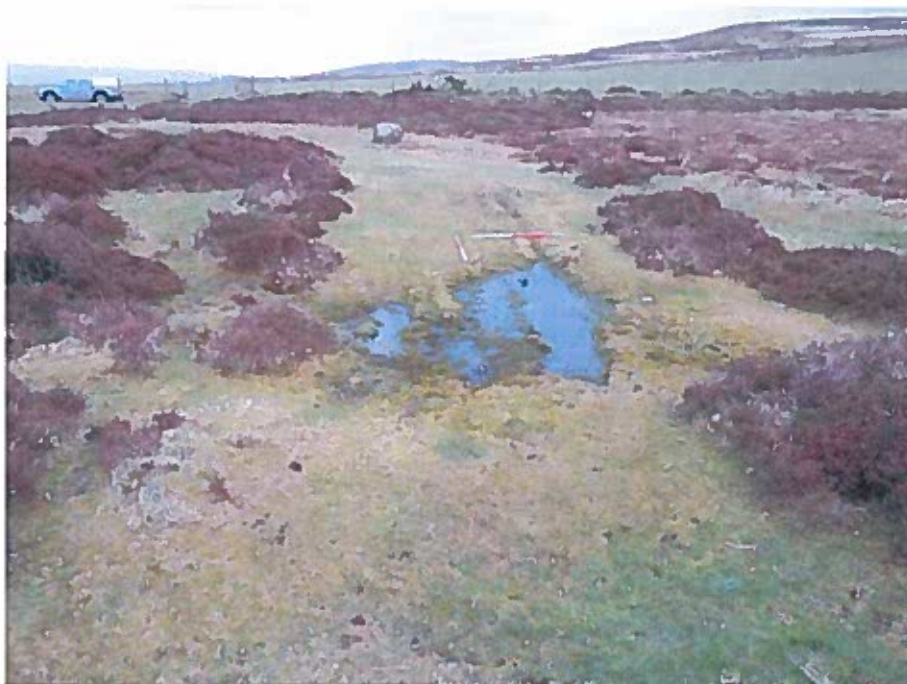
After the PCNPA ranger reported vehicle damage in January 2012, the site was visited on 17/12/2012. There were no signs of any more recent damage, but the site had obviously been part of a circular off road route. The proximity of this site to the road leaves this site vulnerable to further damage. It is not intended to undertake any action now but if it recurs then rock barriers may be necessary along the road edges, although this will not stop motorbikes.

Glyn Gath: old wheel rut damage to centre of barrow. Scales 1m. View N.
7/12/2012

- PC to visit in 2013

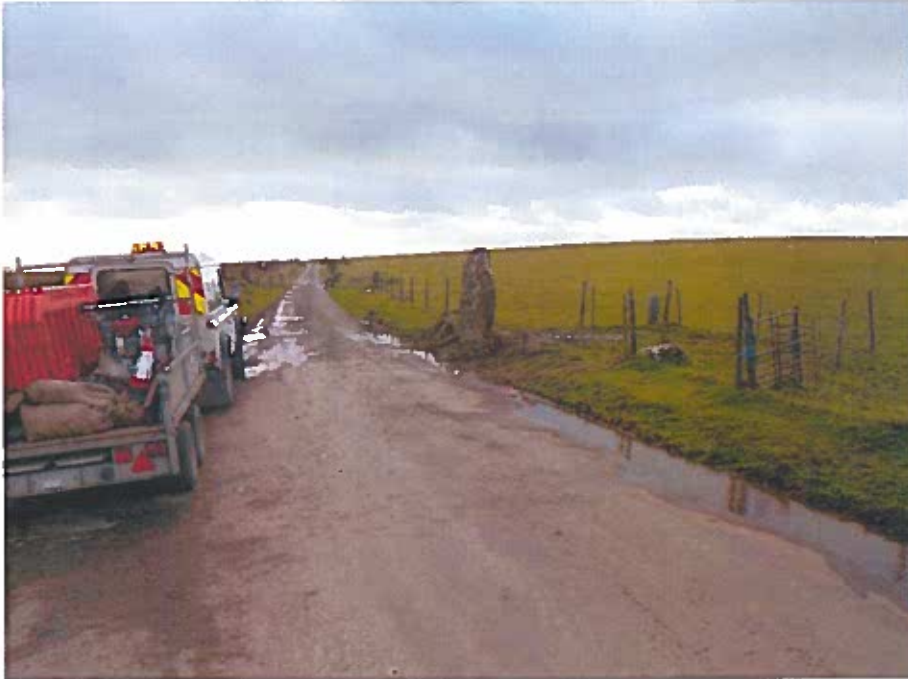
The stone was repaired and re-erected in late November 2012 and subsequently a report on the work has been sent to Cadw including the radiocarbon dates obtained from charcoal samples.

Bedd Morris: Stone re-erected and temporary barriers just removed. View S.
7/12/2012

- PC to photo again when new fencing is in place
- PC to monitor backfill and re-turfing in 2013

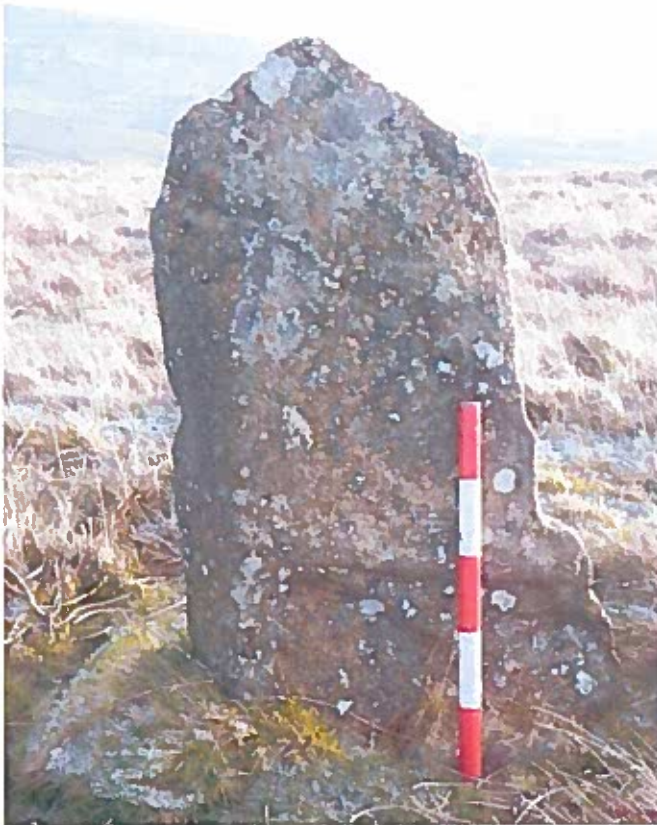
The site was visited on 11/12/2012. The graffiti reported last year was hardly visible: therefore no action seems necessary on this stone. Sheep scrapes adjacent to three of the stones continue to develop and may need re-filling in the near future.

Bedd Arthur: stone that had suffered graffiti, now almost invisible. Scale 0.5.
View NE. 11/12/2012

- PC to visit early in spring 2013 and after summer 2013
