ST ISHMAEL DESERTED MEDIEVAL VILLAGE, CARMARTHENSHIRE ARCHAEOLOGICAL INVESTIGATIONS 2018 SHORT INTERIM REPORT

RHIF YR ADRODDIAD / REPORT NO. 2018/50
RHIF Y DIGWYDDIAD / EVENT RECORD NO. 114192

CADW PROJECT NO. DAT 147

Gan / By
Fran Murphy and Alice Day

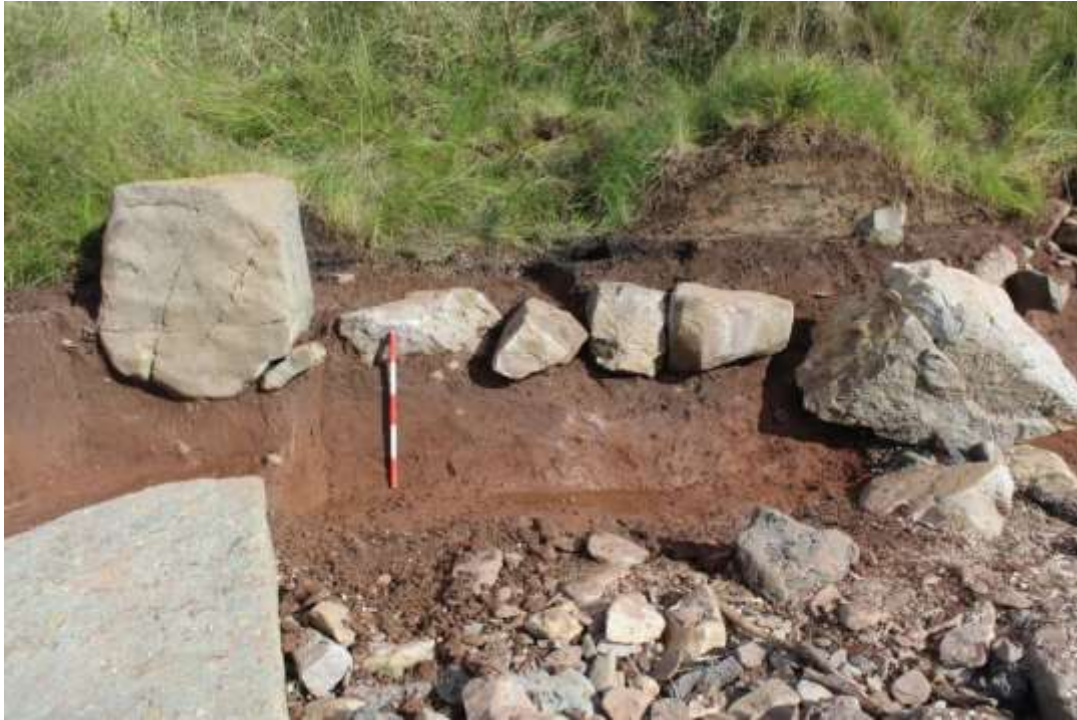
Only a remnant of the one east wall of Building 4 survives in the dune edge and it seems unlikely that this will endure another winter's storms (Photo 1). The surrounding area was cleared and a number of features cutting the red clay were revealed all of which contained medieval pottery. One of these features was a possible linear drain to the south of the building (Photo 2).

Photo 1: The remaining remnant of the east wall of Building 4

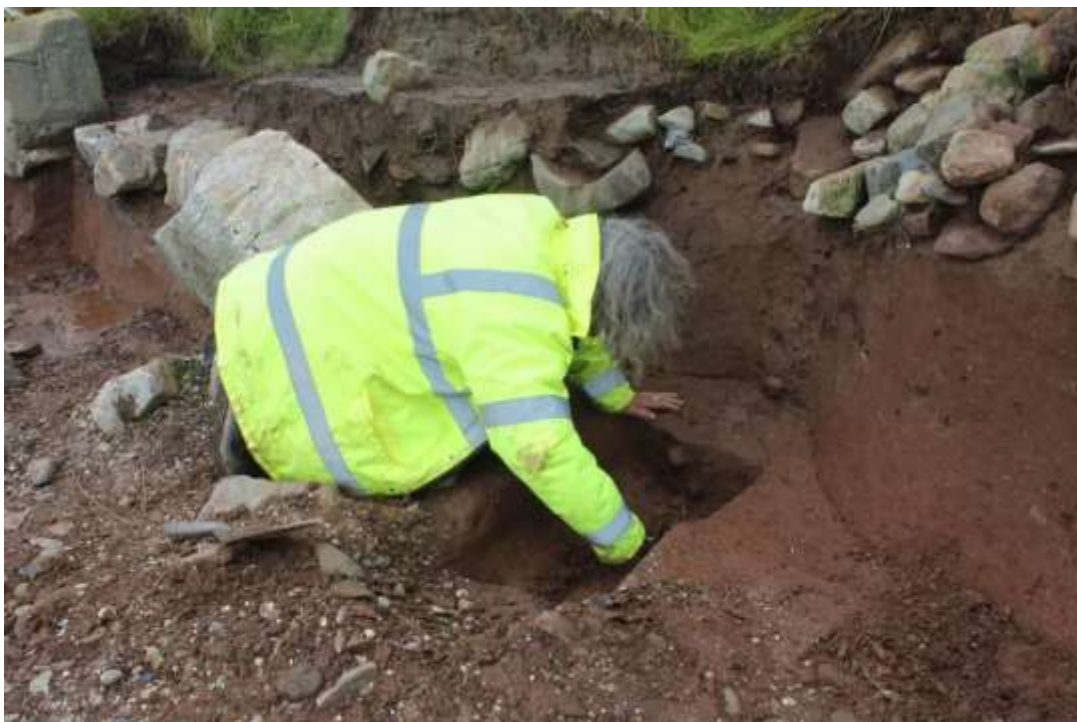
Photo 2: Nik excavating a possible linear drain to the south of Building 4

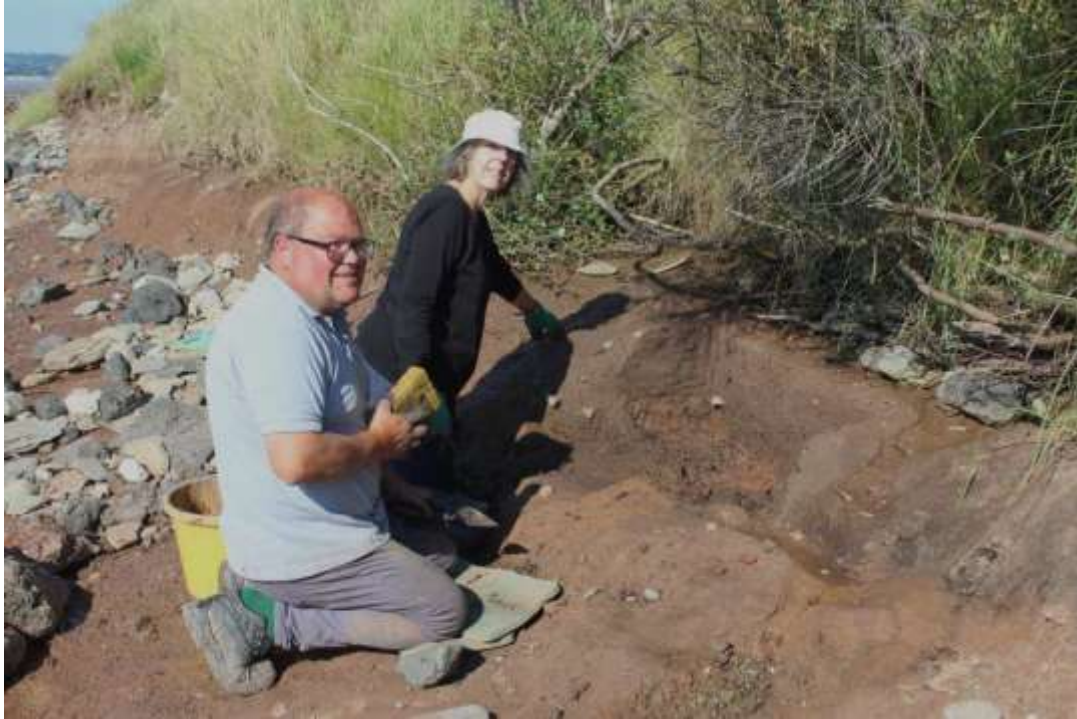
A small trench was excavated into the deposits visible on the dune edge to the north of Building 5. A number of sherds of medieval pottery were found, along with animal and fish bones (Photo 4). The individual layers all contained charcoal and samples of the deposits were taken for possible future analysis and carbon dating.

Photo 3: Rob and Ruth excavating a sample of the deposits visible on the dune edge to the north of Building 5

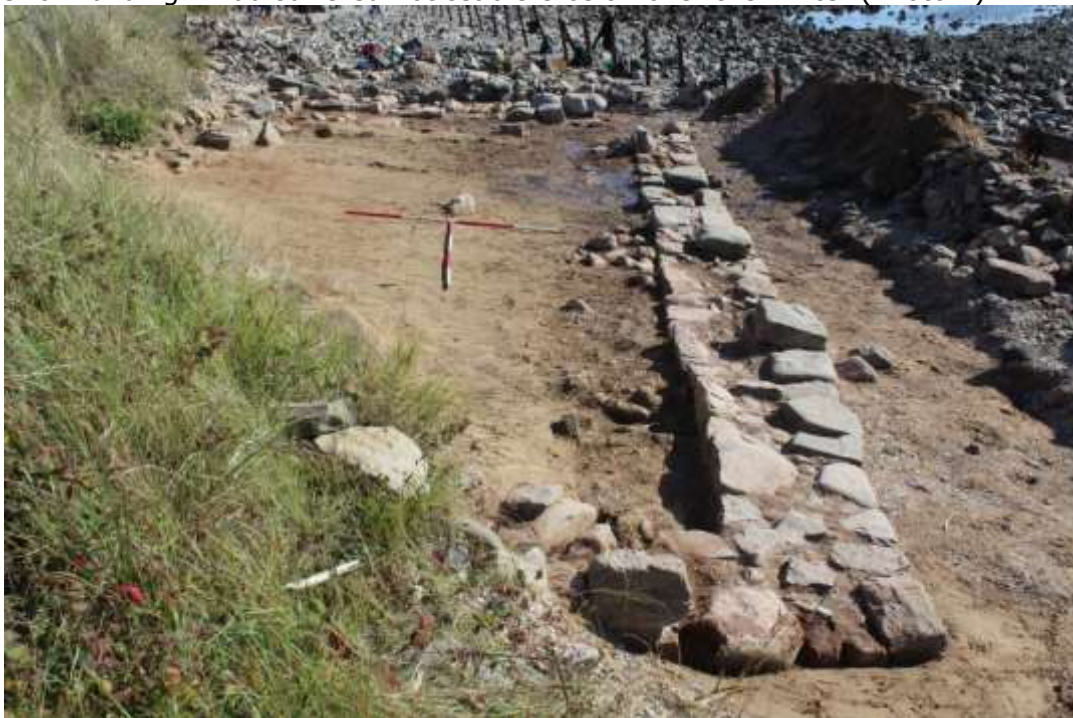
The stone and shingle covering Building 7 were removed. It was clear that the southwest corner of Building 7 had suffered noticeable erosion over the winter (Photo 4).

Photo 4: The west wall of Building 7

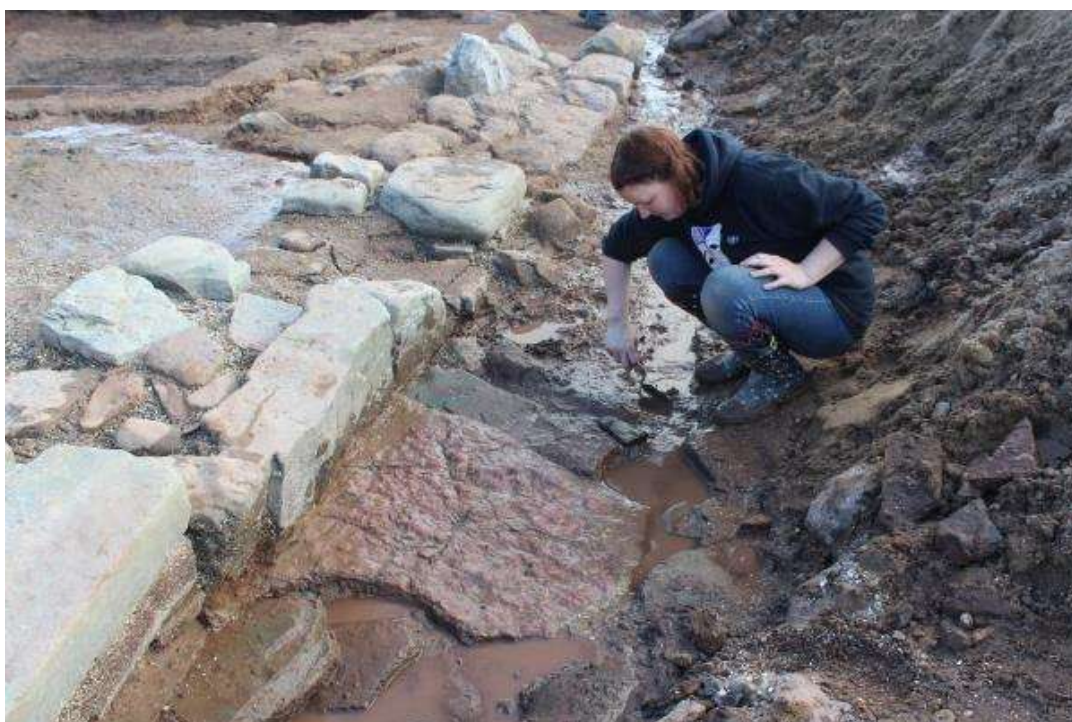
Layers of sand and clay that had built up against the outer west wall of Building 7 were removed. A blocked doorway was discovered in the wall (Photo 5), outside of which a paved area was constructed from large red sandstone slabs that ran under the stone blocking of the door. The outer face of the west wall was fully revealed and the wall was shown to have an average extant height of c.0.4m. The northwest cornerstone proved to be of substantial size (Photo 6).

Photo 5: Bryony cleans the paved area outside the blocked up doorway on the west side of building 7

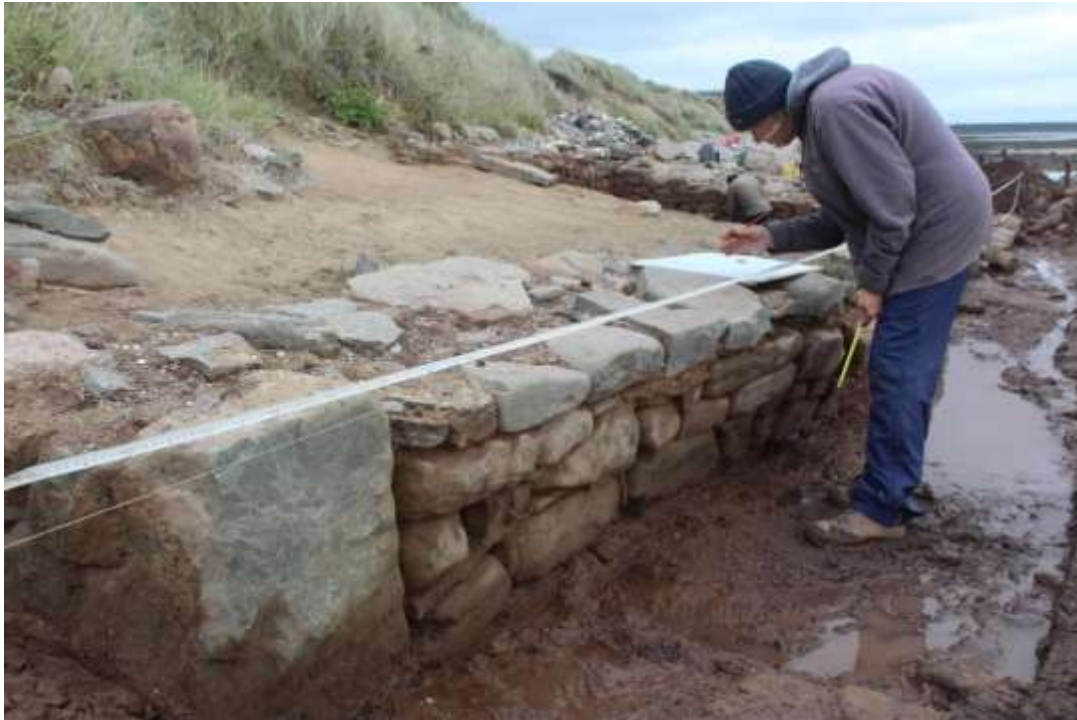
Photo 6: Jude drawing the west wall of Building 7 – note the substantial corner stone of the northwest corner of the building

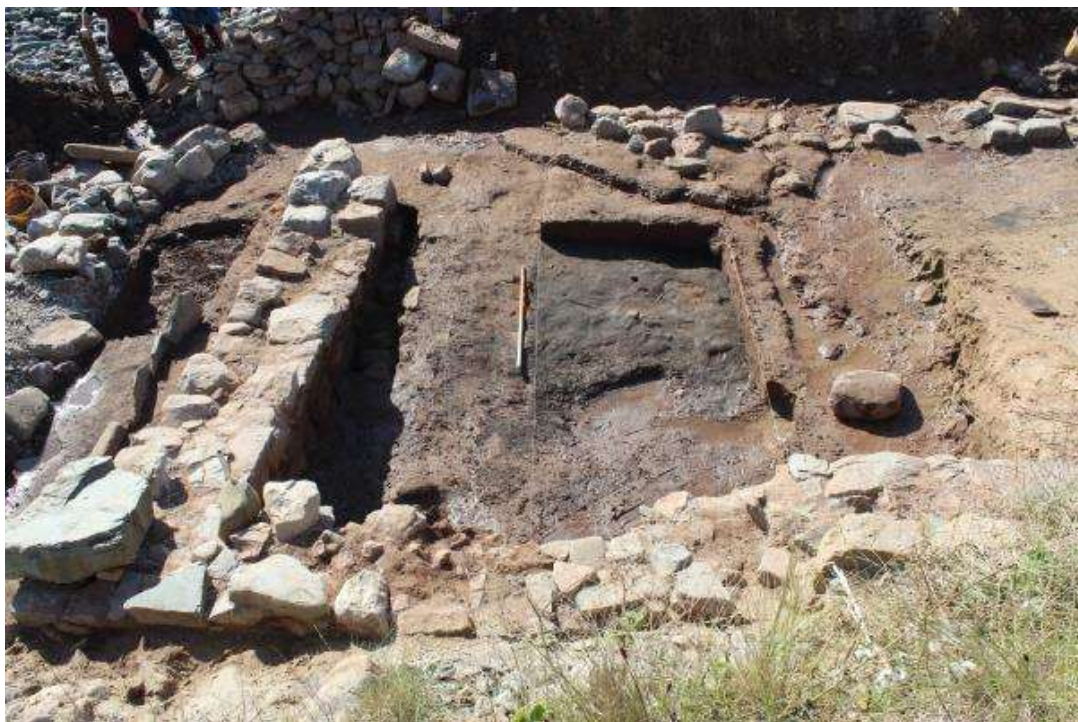
A surviving floor layer at the southern end of Building 7 was uncovered (Photo 7). As recorded in 2017, the beaten clay and ash floor contained few finds other than crushed cockle and mussel shell – it was remarkably clean. Photo 8, taken by one of the volunteers, Peter Francis, using an aerial drone, shows Building 7 at the end of the excavation.

Photo 7: The surviving dark beaten clay and ash floor within Building 7 can be seen to the right of the 2m scale; this material was removed to the left of the scale in 2017.

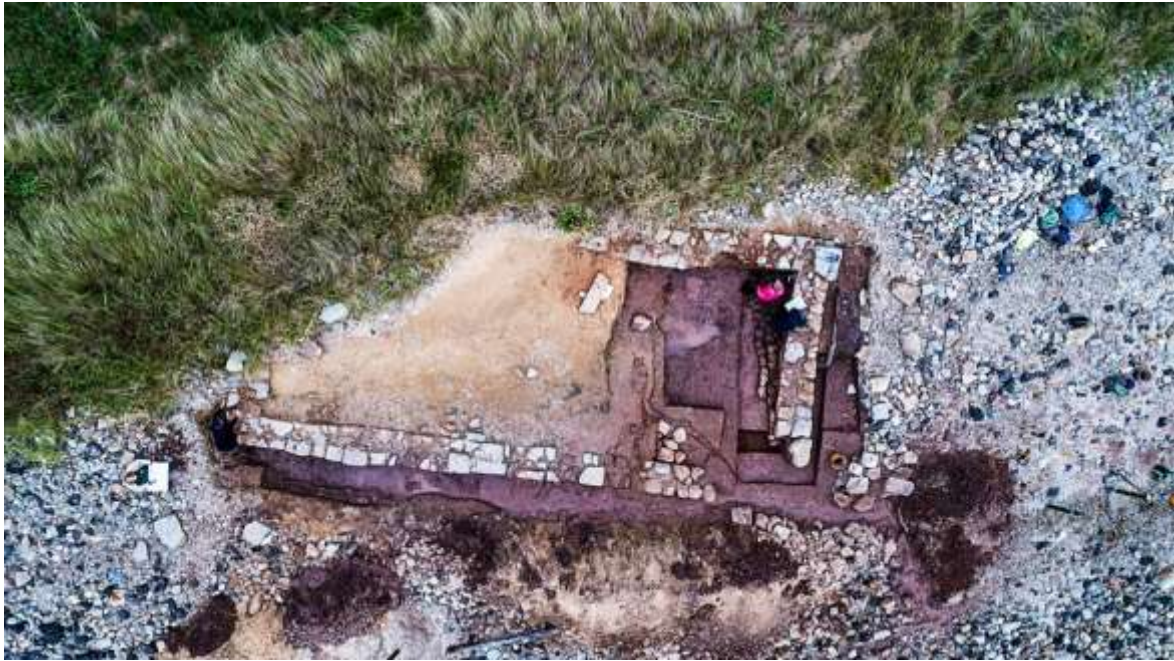
Photo 8: Aerial view of Building 7 at the end of the excavation
(photo courtesy of Pete Francis)

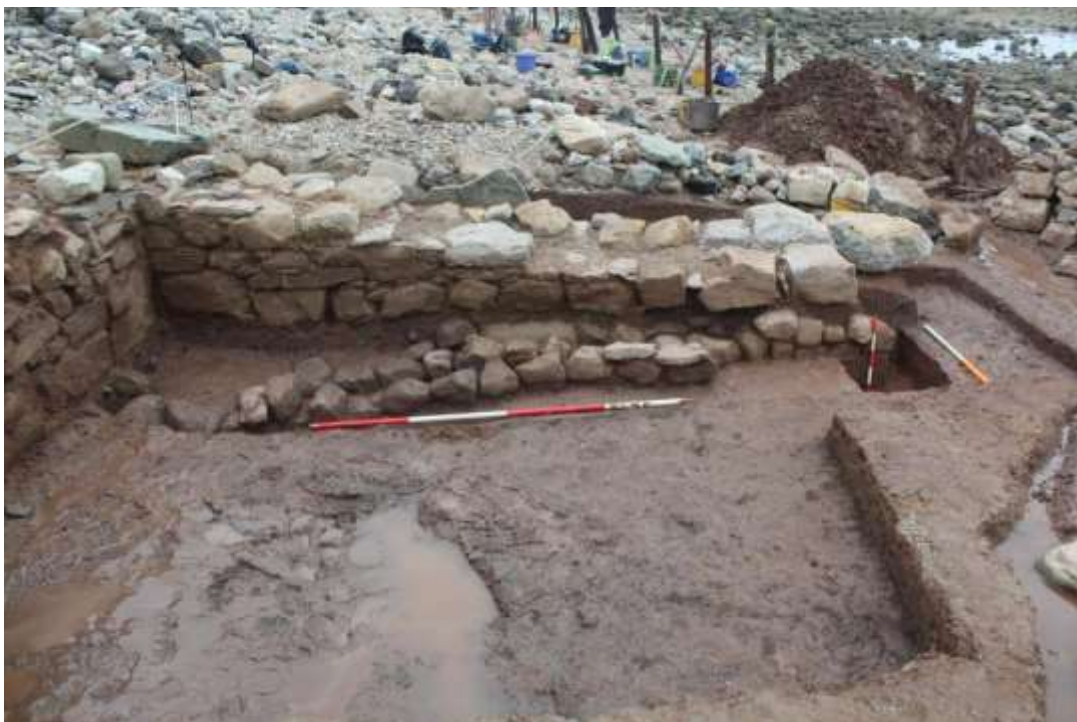
Removal of the clay floor revealed an earlier stone structure running below the south wall of Building 7 (Photo 9). It appeared that this earlier structure was completely obscured by a thick layer of clay when Building 7 was constructed, so it is unlikely that the two are related. No evidence for a date for the earlier structure was unearthed, and its function is not known. It is formed of several linear single courses of stone embedded into clay.

Photo 9: The earlier stone structure running under the south wall of Building 7

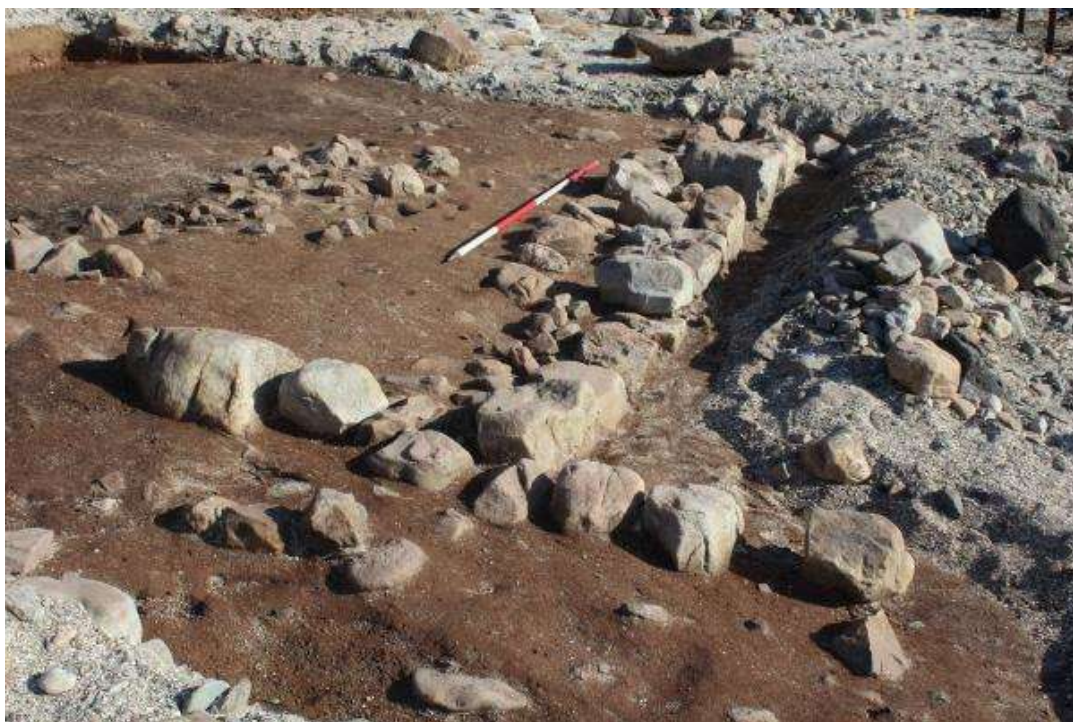
Stones and shingle were cleared from Building 8, which lies to the south of Building 7. In contrast to Building 7 the walls of Building 8 do not survive well (Photo 10).

Photo 10: The north-south (best surviving) wall of Building 8.

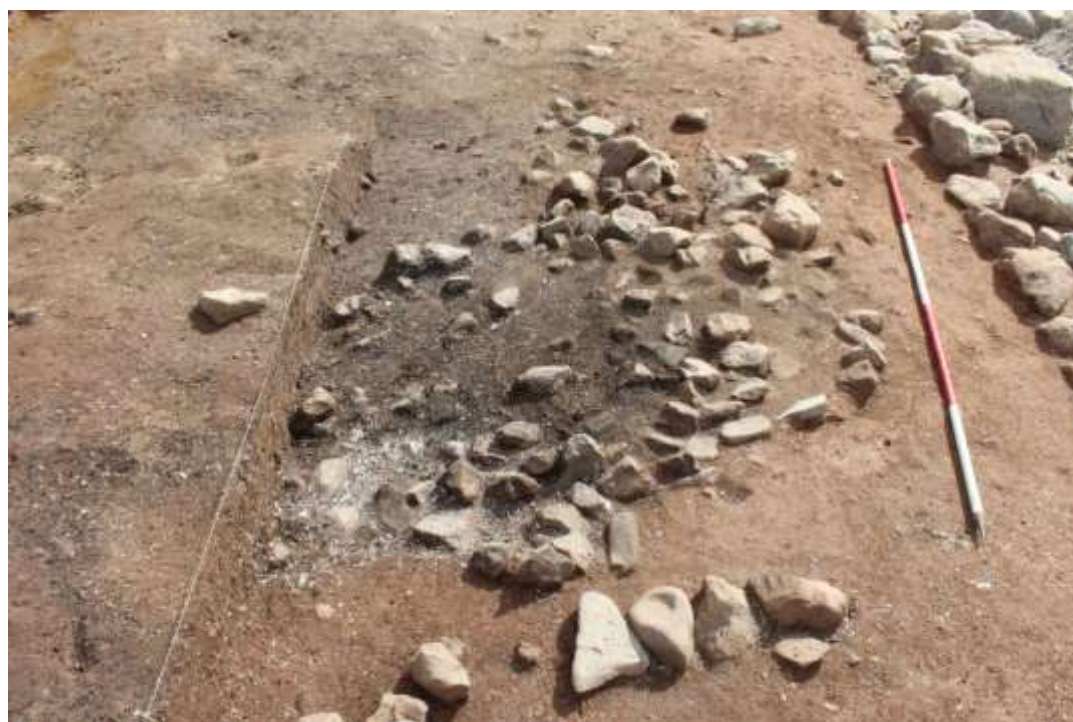
It was uncertain whether the face of this wall was the inside or outside of a building. What appeared to be the remains of a large pit were revealed to the east of the wall (Photo 11); the uppermost deposit of which contained ash, stone, numerous mussel and cockle shells, animal bone and one piece of pottery. Indications of earlier features in this area, cut by the large pit, were also revealed indicating a possible occupation sequence.

Photo 11: A large pit in the area to the east of the north-south wall of Building 8 after cleaning of overburden.
