**PENRHYN BACH, POPPIT,
PEMBROKESHIRE
ARCHAEOLOGICAL
WATCHING BRIEF
(NGR SN 14223 49040)**

RHIF YR ADRODDIAD / REPORT NO. 2018/54
RHIF Y DIGWYLLIAD / EVENT RECORD NO. 114791

PENRHYN BACH, POPPIT, PEMBROKESHIRE
ARCHAEOLOGICAL WATCHING BRIEF

DAT Archaeological Services were commissioned by Mrs Mary Mill, to undertake a watching brief during groundworks associated with building and renovation works at the property known as Penrhyn Bach, Poppit, Pembrokeshire; centred on SN 14223 49040 (Planning Application Number NP/17/0525/FUL).

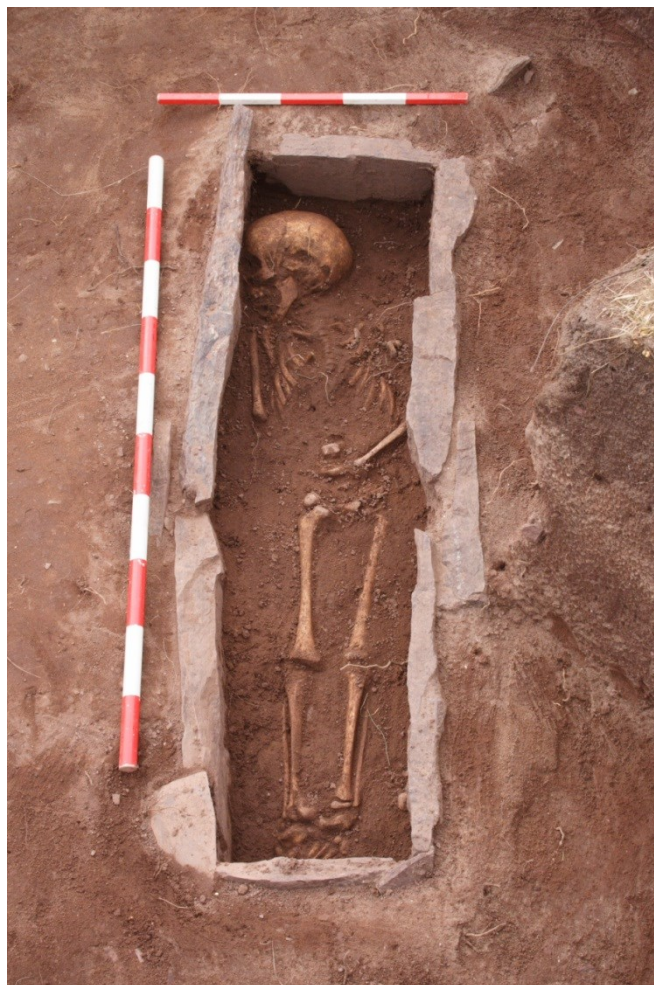
- 2.2.2 The development area lies close to the site of recorded cist graves of possible early medieval date (PRN 1058). Cist or long cist graves are stone lined graves containing an extended inhumation (Photo 1). The graves typically comprise a basal slab or slabs, side and end slabs and finally a top or 'lintel' slab covering the grave. They typically date from the 5th to the 11th century and are generally taken to be indicative of Christian beliefs. There is a marked concentration of cist graves in north-west and south-west Wales, especially in Pembrokeshire. The HER records the cemetery as having been revealed in three areas around Penrhyn Bach, but gives a single location around 15m to the west of the proposed development. Research provided by the owner of Penrhyn Bach, Mary Mill, suggests that one of these cemeteries was revealed during the mid-nineteenth century when *'the field between Penrhyn Bach and Penrhyn Castle was ploughed up, many graves or stone coffins were found'* (these would suggest stone lined cist graves). The location of these graves is thought to be some 90m to the north-northeast of Penrhyn Bach near the boundary with Penrhyn Castle; possibly revealed in 1835 when the new hedgebank was constructed dividing the field named Parc y Ceri (Mary Mill pers comm). This hedgebank division separated the land between Penrhyn Bach and the new house known as Penrhyn Castle (1835-36) (ibid). The second area of graves is believed to lie some 50m to the west near the site of the ruined cottage at Cwmclywd, where *'similar graves were found at this place; when the horse gear was fixed near Penrhyn Bach barn to work a threshing machine, a grave was discovered. In this there was a skeleton.'* (ibid). There is no known chapel or church site recorded on mapping in this area.

Photo 1: Photograph of a typical cist grave. This example is a child's burial from Porthclew, Pembrokeshire (© Dyfed Archaeological Trust)

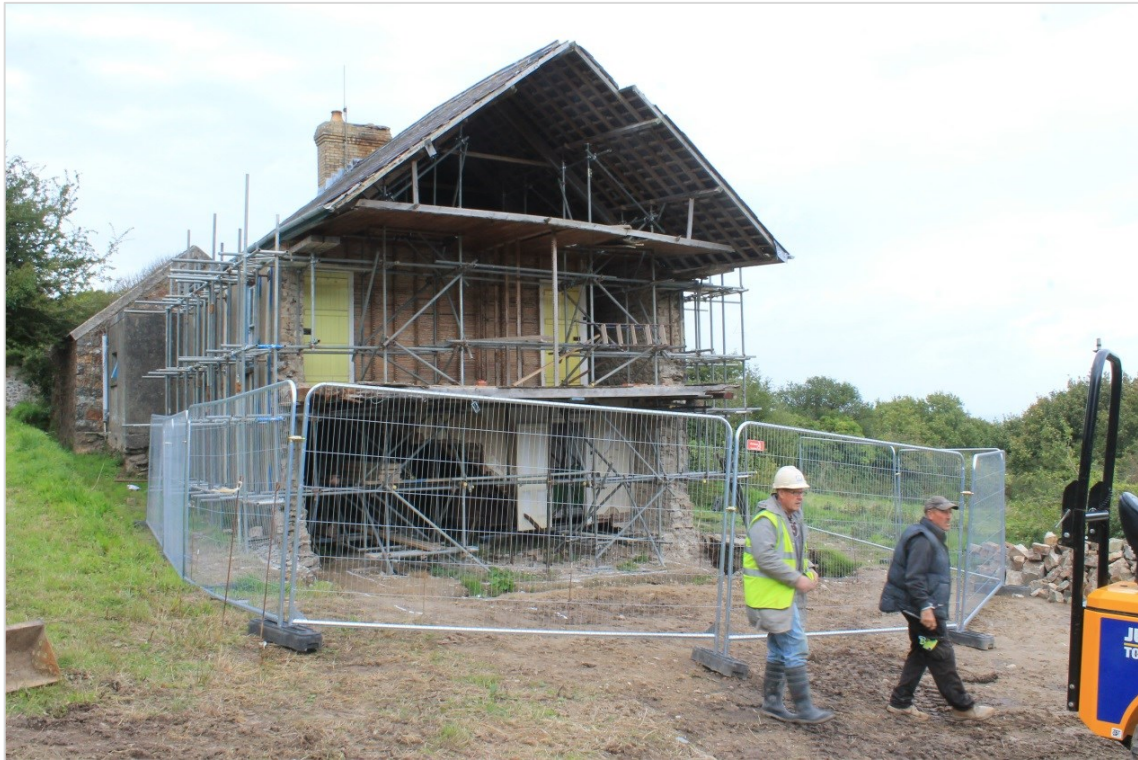
Photo 2: View north across the site towards Penrhyn Bach house. Note past terracing into hillside to provide platform for building.

- 3.1.2 Once on site it was evident how extensive the terracing into the hillside for Penrhyn Bach house (Figure 4, Photo 2) and cowshed was, and that it was highly unlikely that any archaeological remains would have survived this past disturbance. Therefore it was judged unnecessary to monitor the groundworks involved during the replacement of the existing extension between Penrhyn Bach house and the cowshed, and the rebuilding of the south wall of Penrhyn Bach house.

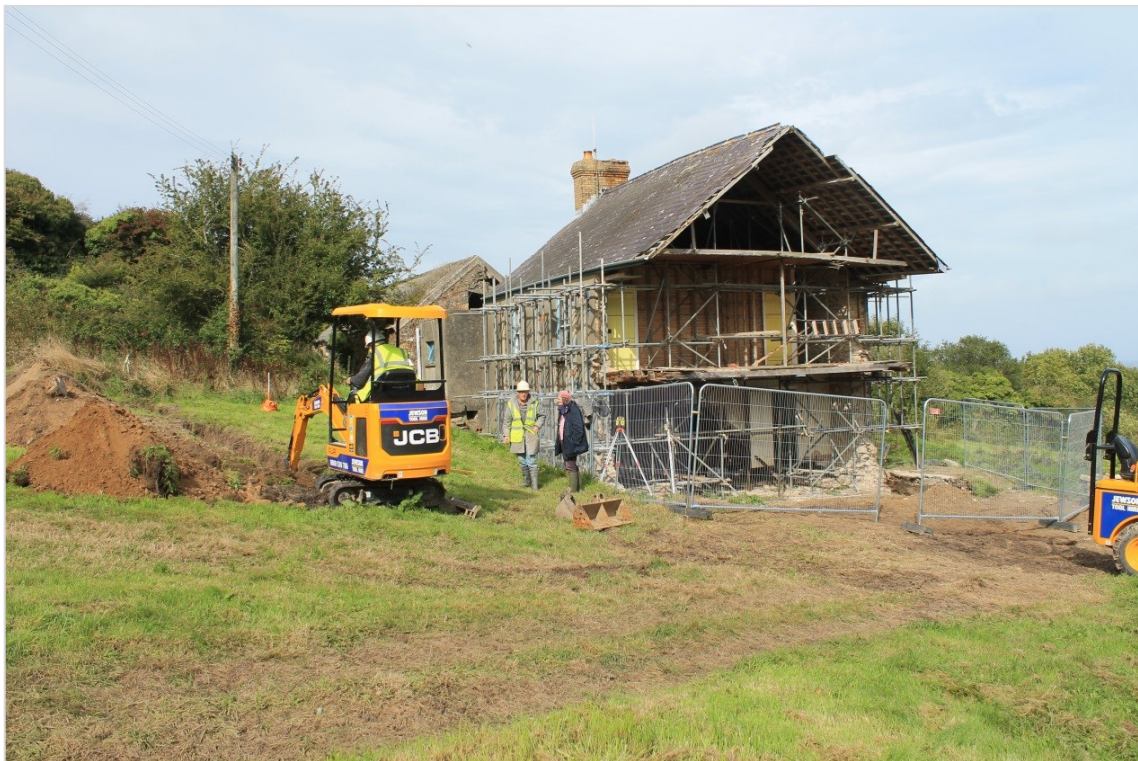
Photo 3: View north during excavation of drainage trench, showing proximity of Penrhyn Bach house.

- 4.1 The location of the monitored drainage trench was near the bottom of a moderate, grassy slope (former lawn and garden), some 9.0m to the rear of Penrhyn Bach house (Photo 3; Figure 4).

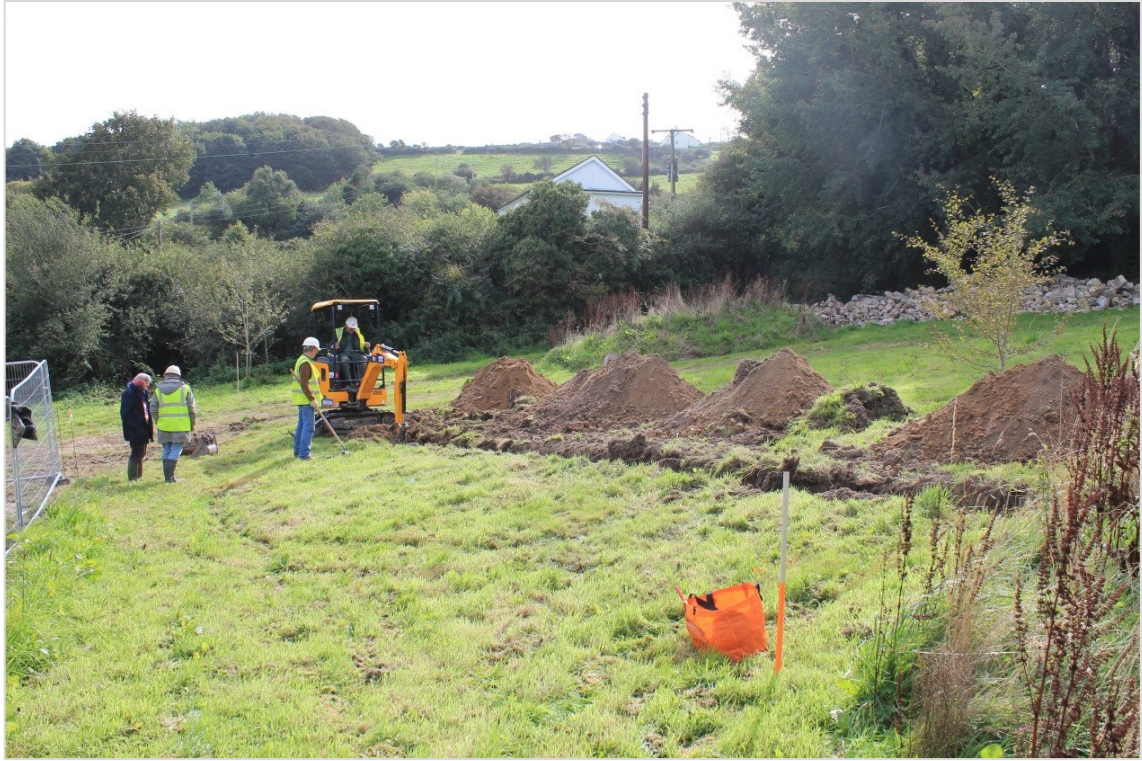
Photo 4: View south during excavation of drainage trench

- 4.2 The trench was approximately 30m long, 0.65m wide and 1.0m deep. It ran down a slight slope to a hedge bank at the southern edge of the property (Photos 4 and 5).

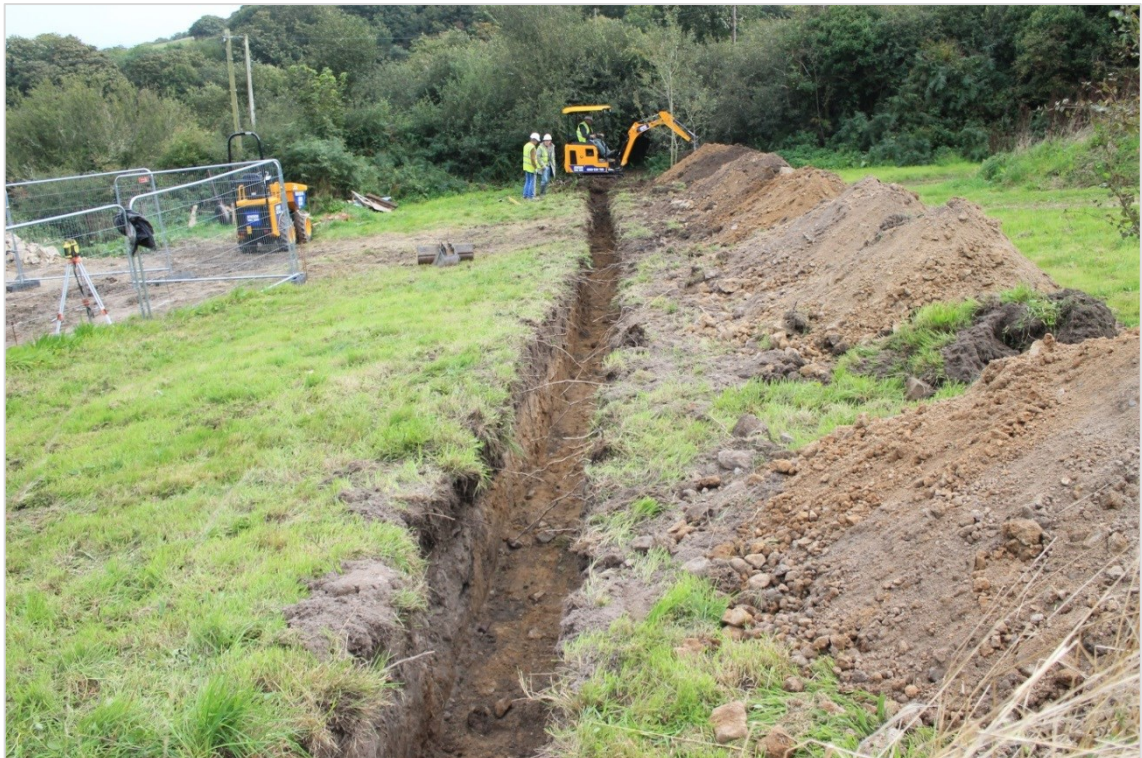
Photo 5: View south of almost completed drainage trench

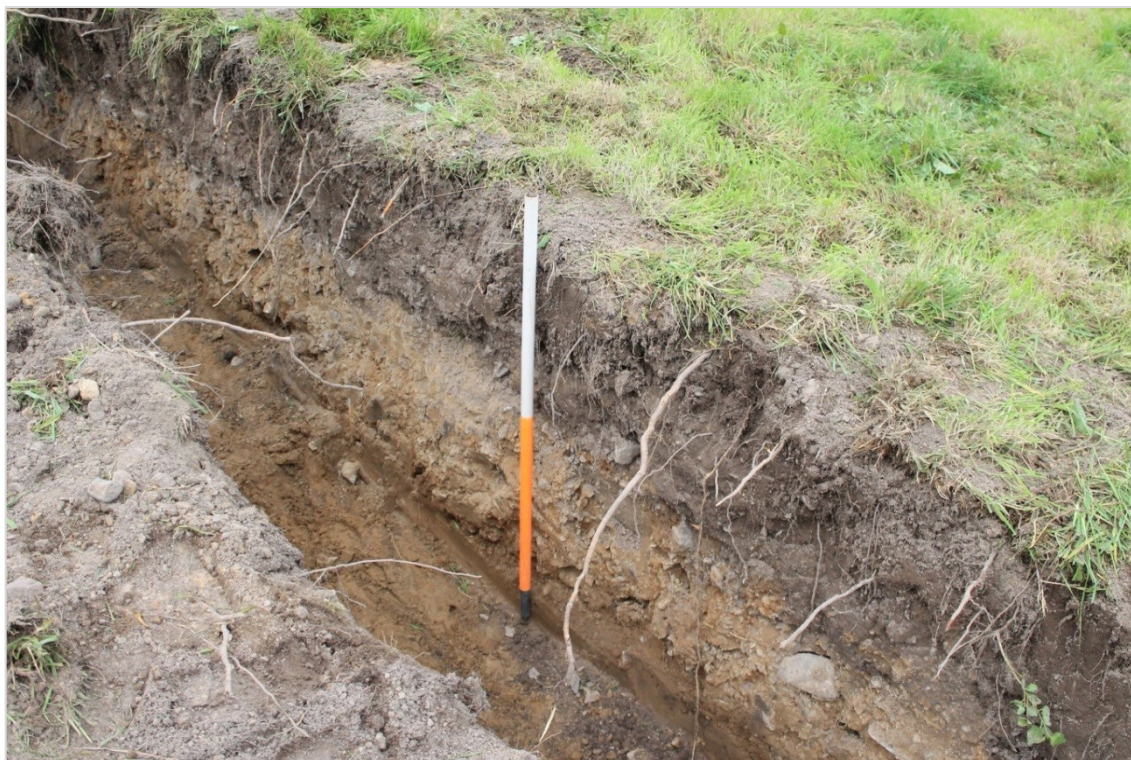
- 4.3 Apart from a slight increase in the depth of the garden soil for a metre at the north end of the trench (filling a slight depression), the trench section showed a consistent soil profile throughout the excavation (Photo 6).

- 4.4 This soil profile comprised between 0.35 to 0.4m of garden soil; friable, medium brown, sandy loam, containing no significant artefacts.
- 4.5 Below this sandy loam layer a deposit of orange-brown sand with occasional small lenses of clay was revealed. This appeared to be a wind-blown sand deposit. The base of this deposit was not reached. No archaeological features or deposits were identified in section or in plan.

Photo 6: Typical soil profile in west facing section of drainage trench (1m scale)
