FAN FOEL & TWR Y FAN FOEL BURIAL MOUNDS ARCHAEOLOGICAL SURVEYS & WATCHING BRIEF 2017

Prepared by Dyfed Archaeological Trust
For: Brecon Beacons National Park

REPORT NO. 2018/58
EVENT RECORD NO. DAT 115115

**FAN FOEL & TWR Y FAN FOEL
BURIAL MOUNDS
ARCHAEOLOGICAL SURVEYS &
WATCHING BRIEF 2017**

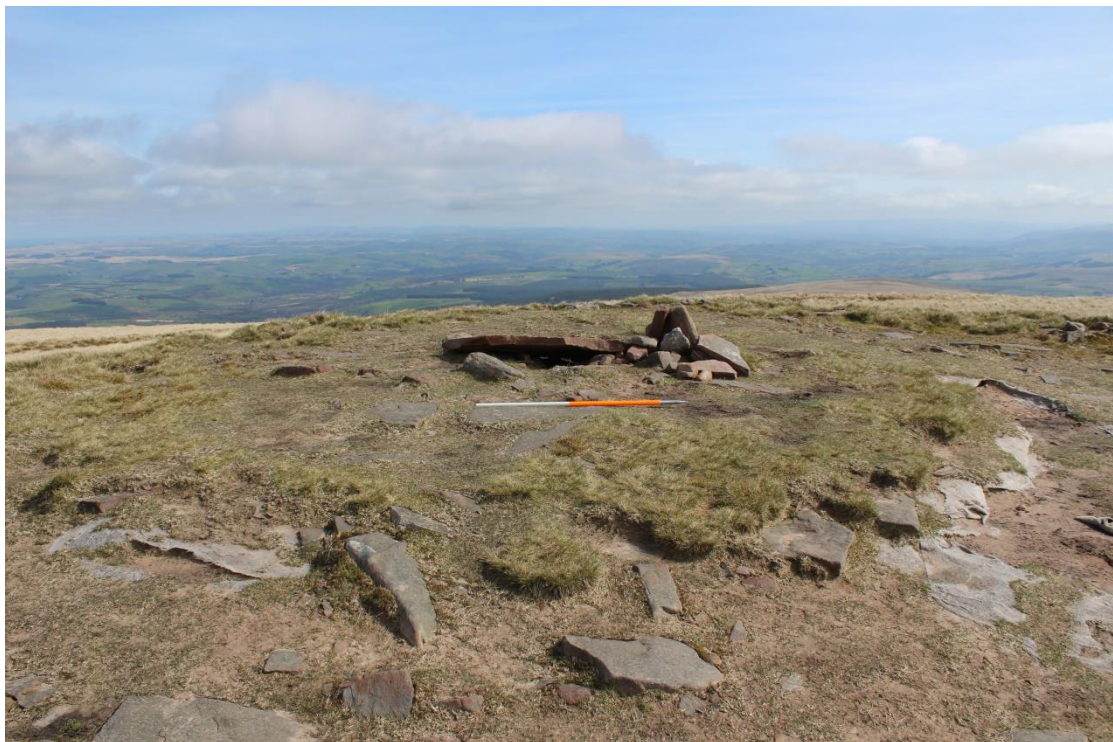
'Fan Foel is a 16m diameter up to 1m high round barrow occupying a prominent position on the Black Mountain. It is mainly earth/turf built with some stone surrounded by a stone kerb and with off-centre stone-built cist. Due to concerns about visitor erosion Dyfed Archaeological Trust partly excavated the site in 2003-04, including the burial within the cist. Following which geo-textile was laid down and the site re-turfed as best as possible using available materials. However, turf has not regenerated over the site, the geotextile is exposed over wide areas, and some disturbance to the cist is evident. Dyfed Archaeological Trust has received correspondence expressing concerns about the condition of the site.'

Photo 1: *Photograph of Fan Foel round barrow showing the damage caused to the mound by visitor erosion. Looking roughly east. 1m scale*

1.1.4 Following the excavation of the Fan Foel round barrow, the mound was reinstated, but unfortunately further erosion has continued and the reinstatement has not taken well (Photo 1). Following a recent visit to the site the following description was made by Ken Murphy, Director of Dyfed Archaeological Trust:

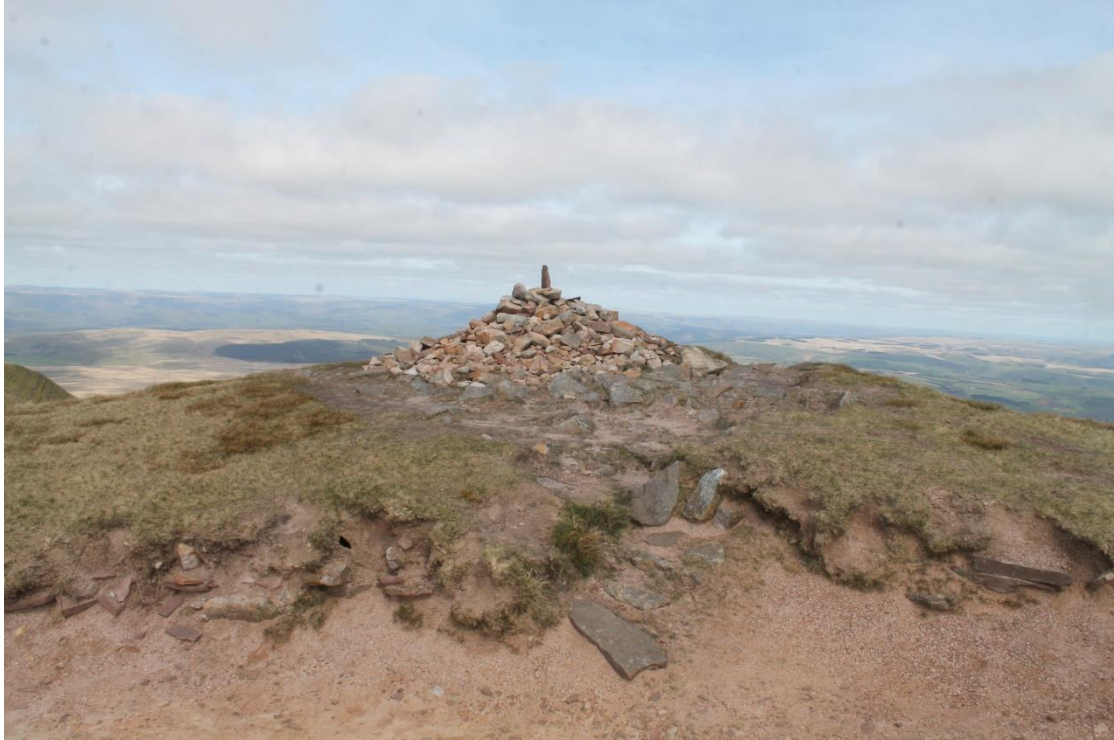
'Most of this barrow lies under thick turf and is in good condition. A walkers' cairn sits on top of the mound. However, visitor erosion has removed turf and soil to the south of the barrow, exposing bedrock, and creating a step-up from bedrock onto the turf in the environs of the barrow. This erosion is close to the barrow, and may even be affecting the south side of it.'

Photo 2: *Photograph of Twr y Fan Foel burial cairn showing the erosion of the low mound and the recently constructed walkers cairn. Looking approximately north*

1.1.5 Visitor erosion also continues at Twr Y Fan Foel (Photo 2). The description by Ken Murphy states that:

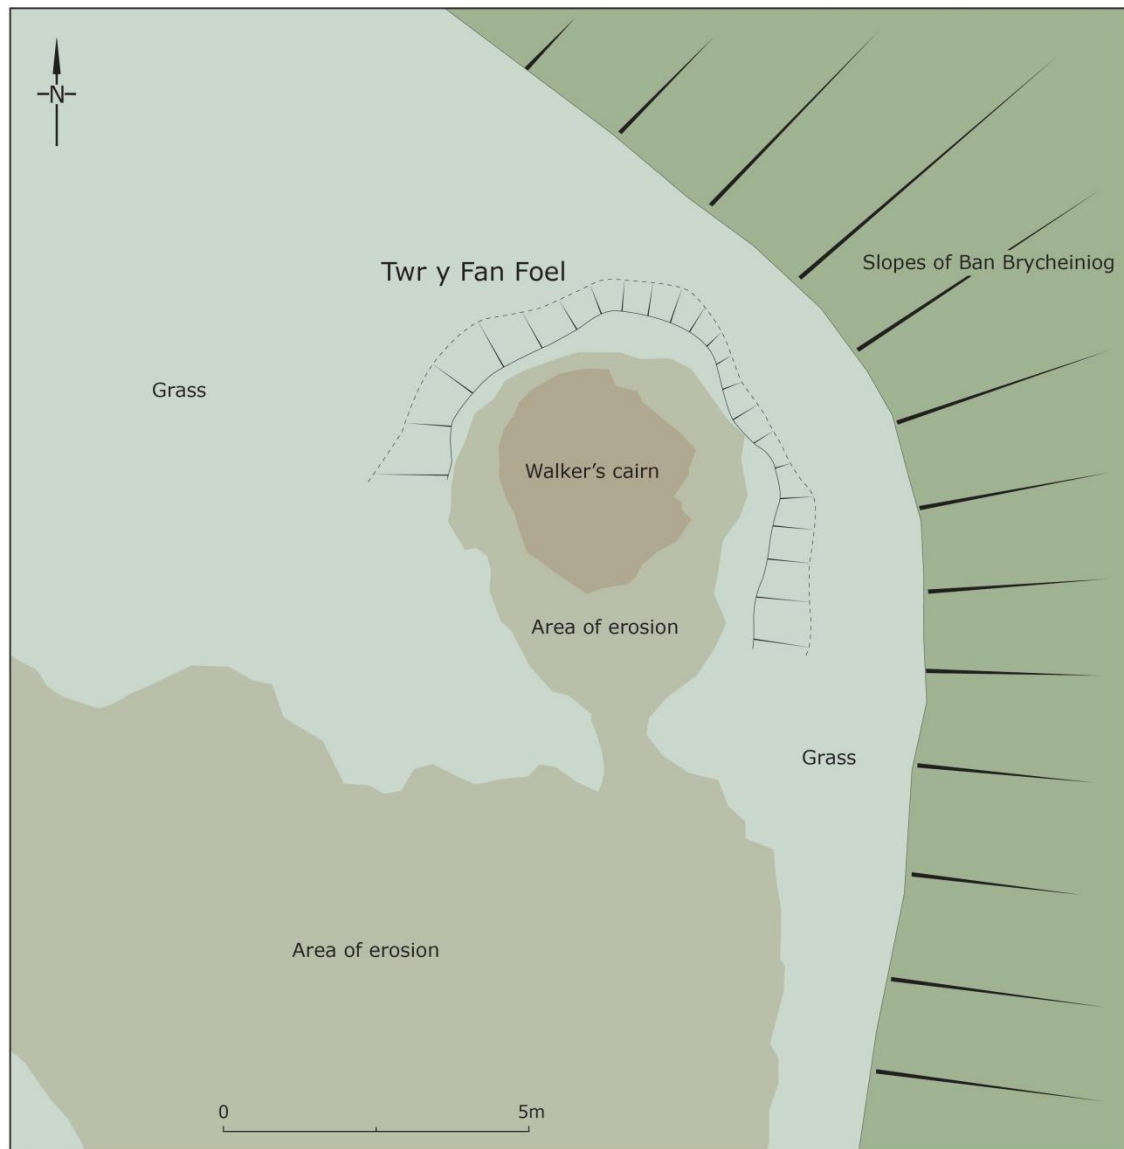
- 4.3.3 The topographic survey of Twr y Fan Foel (Figure 4) revealed the extensive erosion to the site and its surrounding area, predominantly on the southern side of the barrow, exposing bedrock and producing a step-up from bedrock onto the turf which is very close to the barrow, and may even be affecting the south side of it. A walkers' cairn has been erected on top of the barrow mound and this is accelerating the surrounding erosion as visitors remove stones from the exposed bedrock to place on the cairn.

Figure 4: Illustration of the topographic survey results of Twr y Fan Foel (PRN CPAT 1501) showing the areas of heavy erosion and walkers cairn.

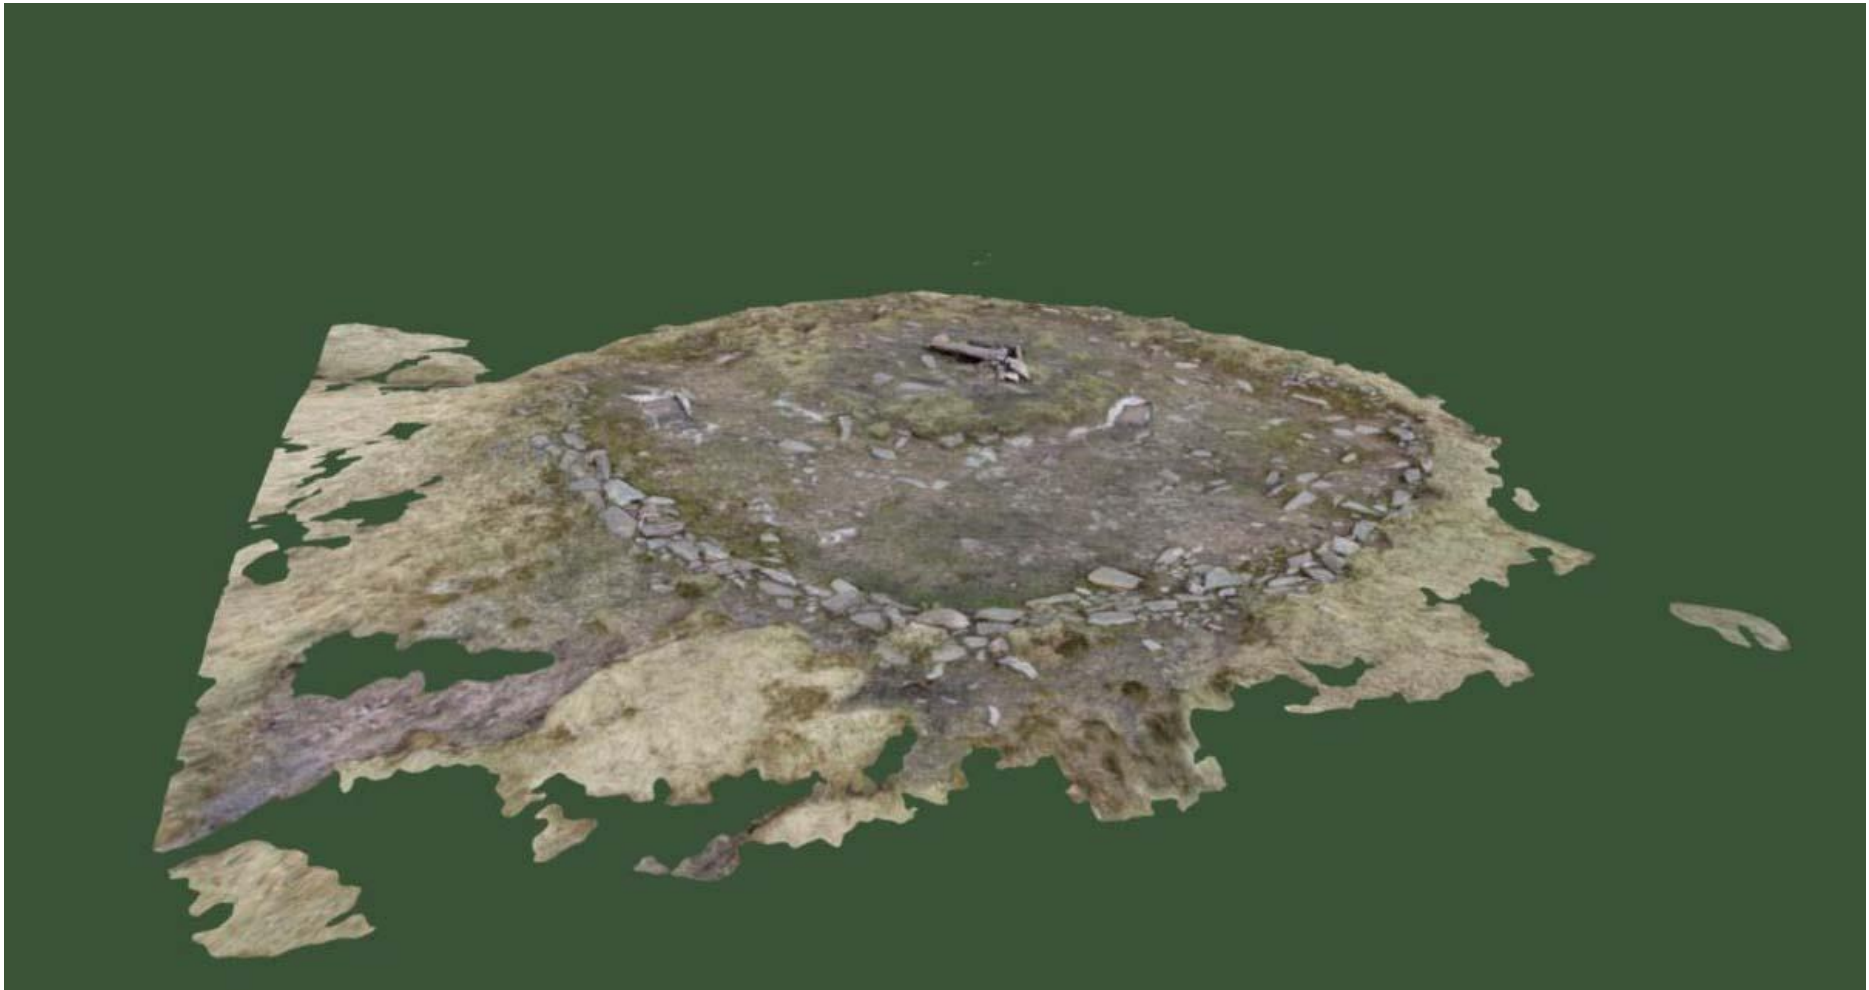
Figure 5: Image produced from the 3D photogrammetric survey of Fan Foel clearly showing the exposed stone kerb and the extent of the area where visitors have caused widespread erosion of the turf. <https://skfb.ly/6qzPx>

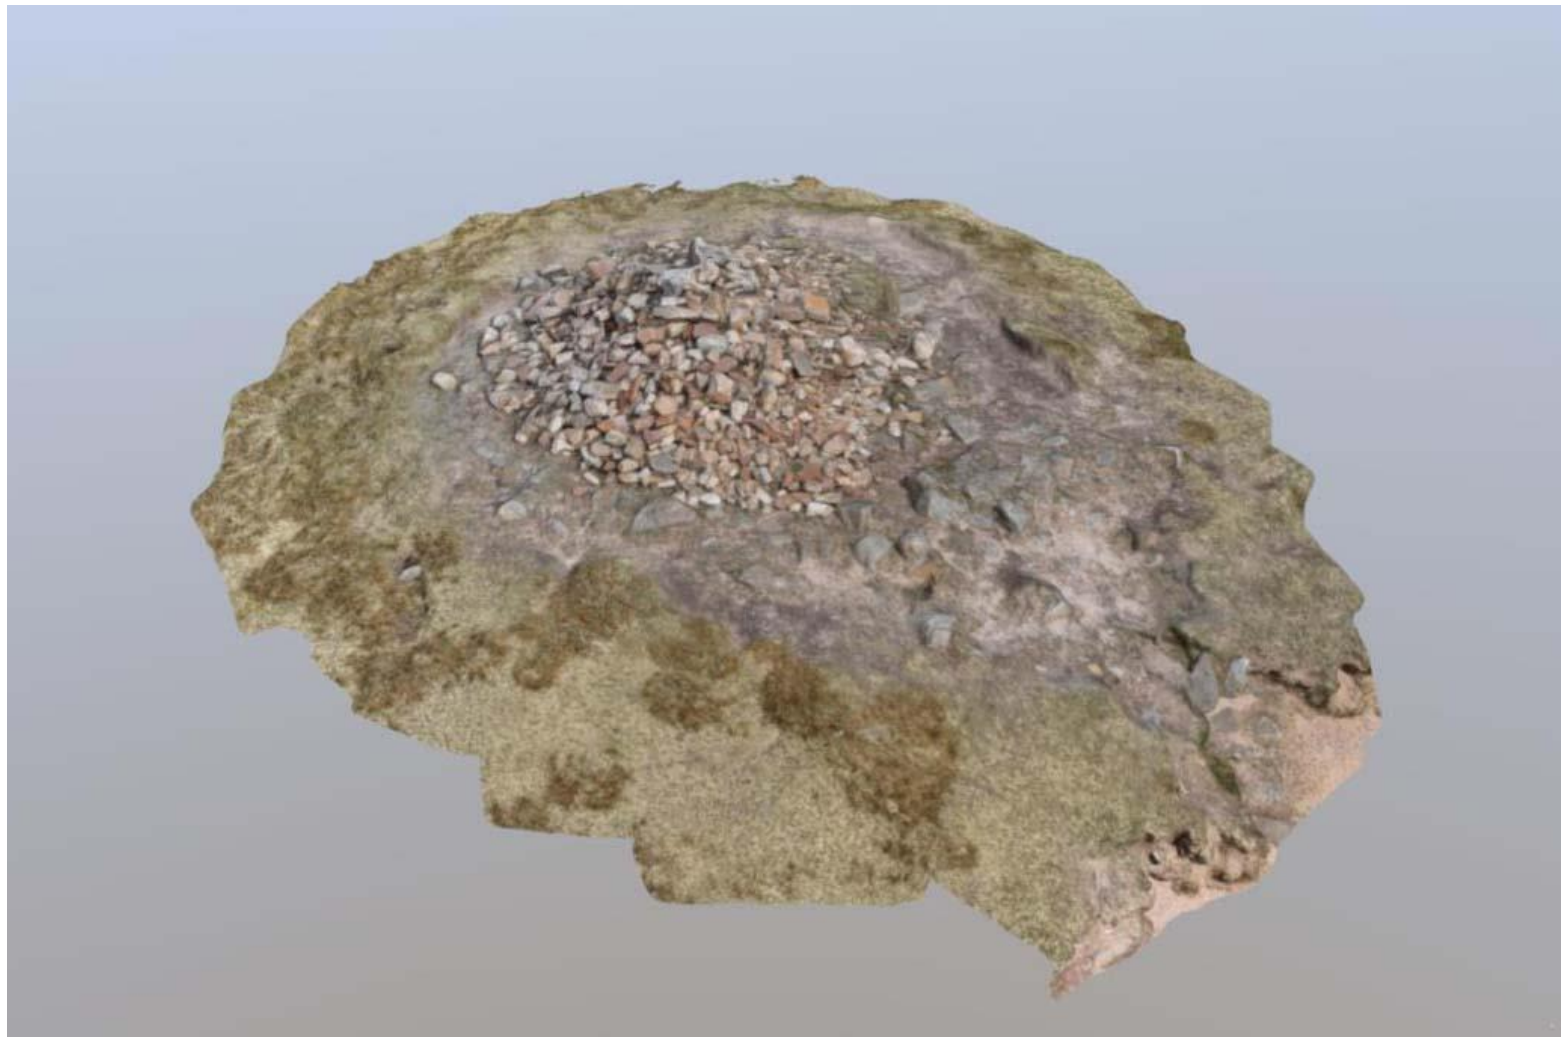
Figure 6: Image produced from the 3D photogrammetric survey of Twr y Fan Foel clearly showing the exposed stone of the barrow upon which a modern walkers cairn has been placed. <https://skfb.ly/69v9M>

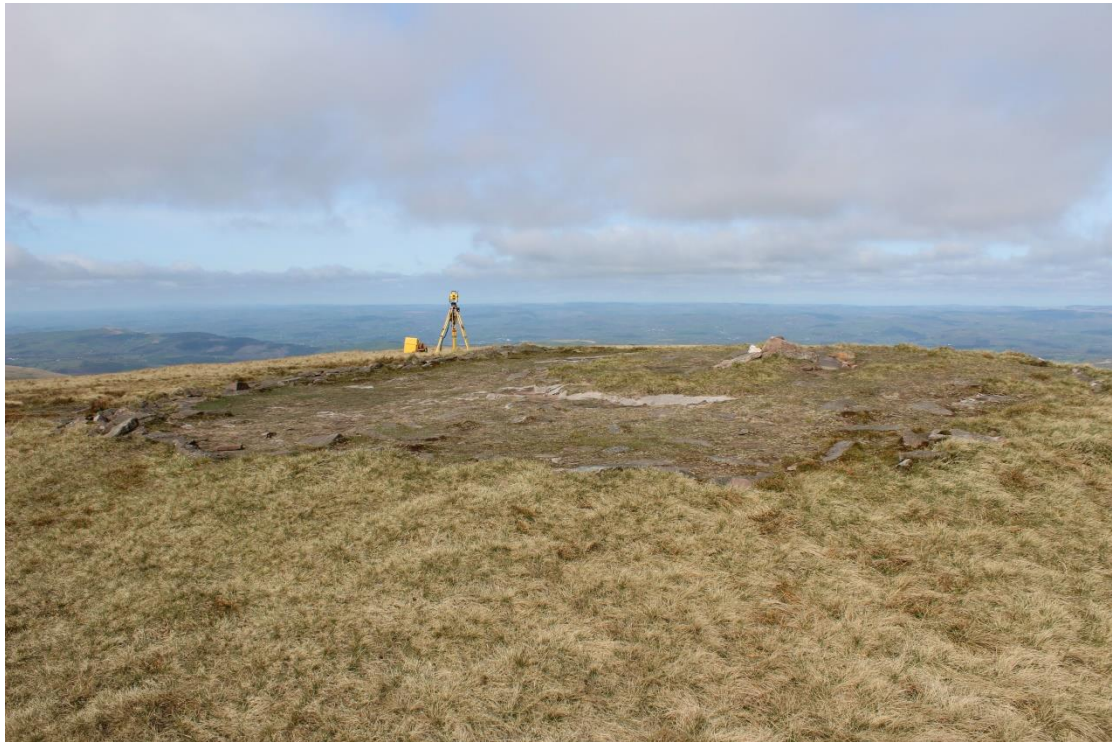
- 4.5.1 The watching brief was undertaken over several days from 8th – 15th May 2017.
- 4.5.2 A large area of the south and west of the low mound of Fan Foel, repaired in 2004, had suffered from visitor erosion (Photos 3-6). The geotextile laid in 2004 beneath the then newly repaired mound was exposed in many places. In 2017 soil was brought to the site and the eroded area built up once again, as far as the original stone kerb edging of the barrow (Photos 9-12). Once leveled and packed down, the soil was covered with turfs, again laid up to the edging of the stone kerb (Photos 13-15).

Photo 3: *Fan Foel round barrow showing the extensive erosion caused to the mound by visitors. Looking roughly north.*

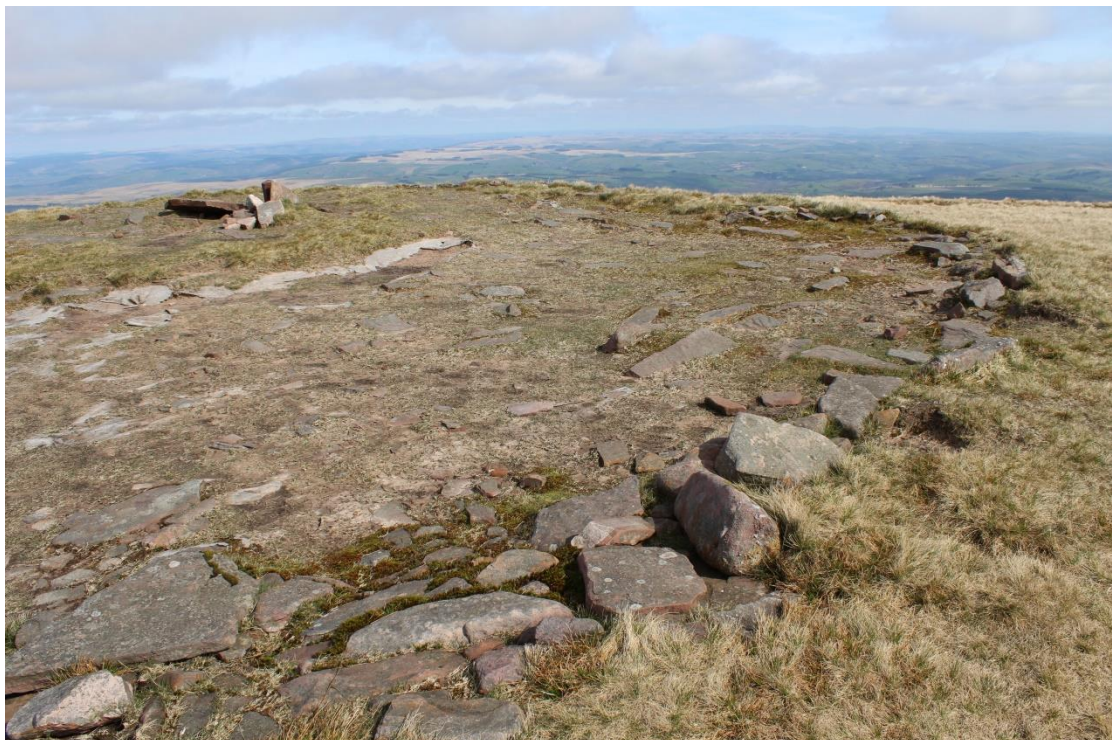
Photo 4: *Fan Foel - showing detail of the exposed stone kerb and areas of heavy erosion. Looking roughly northeast.*

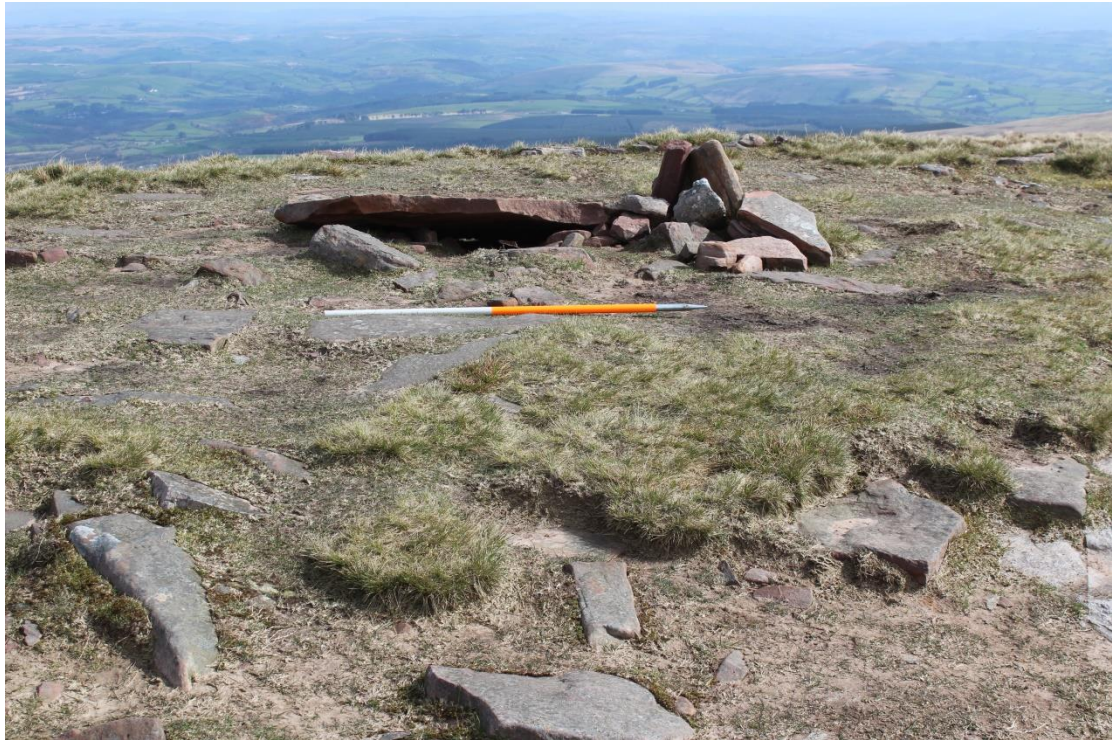
Photo 5: *Fan Foel - showing detail of the lack of turf surviving around the exposed stone cist. Looking roughly east. 1m scale*

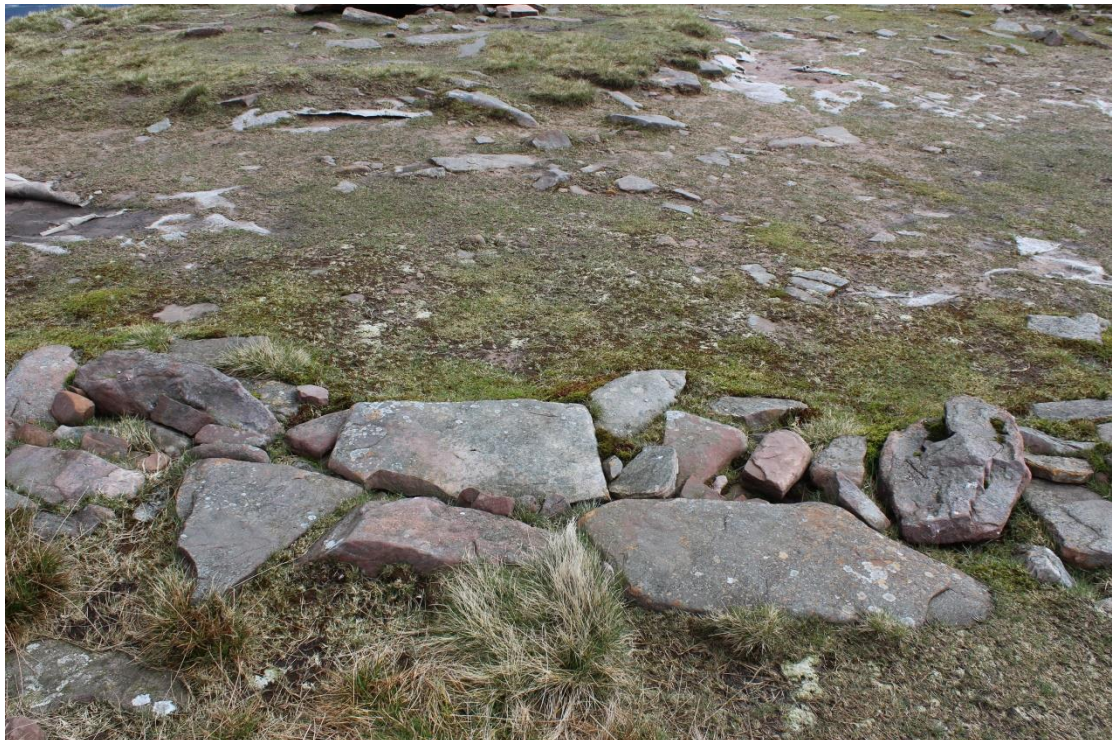
Photo 6: *Fan Foel - showing detail of the exposed stone kerb and evidence of exposed geotextile. Looking roughly east.*

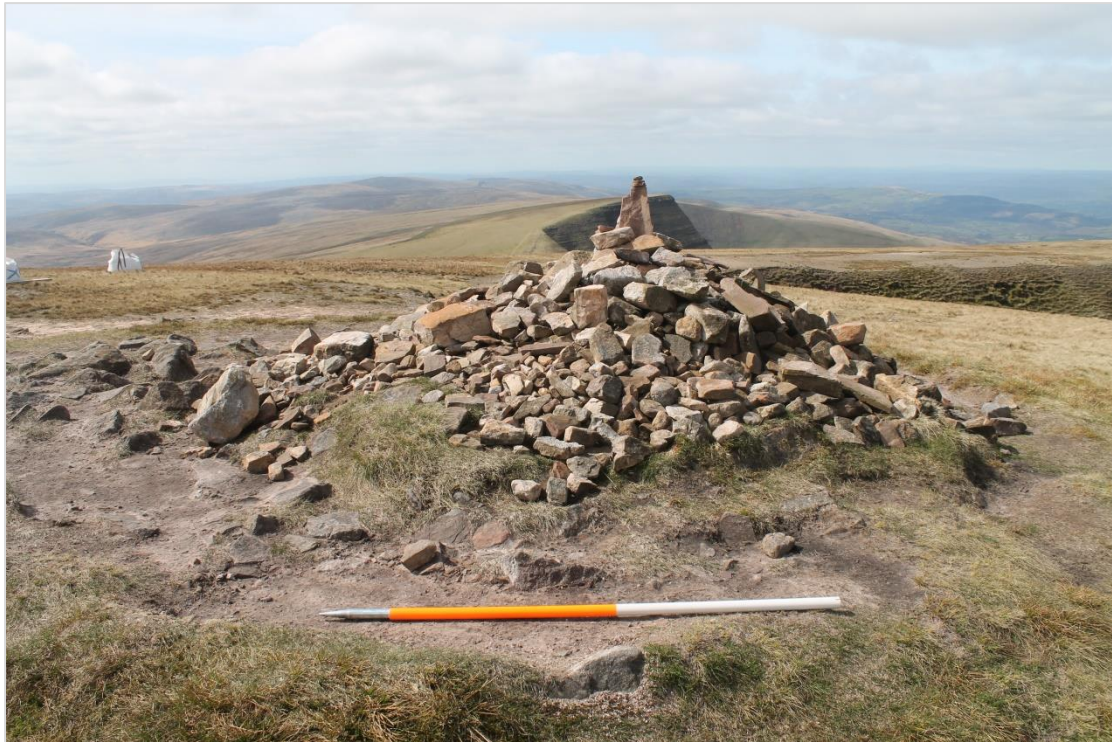
- 4.5.3 No archaeological deposits or remains associated with Fan Foel round barrow were disturbed or damaged during this repair process.
- 4.5.4 Visitor erosion has removed turf and soil to the south of Twr y Fan Foel exposing the bedrock (Photos 7 and 8). This has created a step-up from the bedrock onto the turf in the environs of the barrow. As this erosion is so close to the barrow, it is possible that original barrow material is being damaged or destroyed.

Photo 7: Twr y Fan Foel - showing detail of the damage caused to the barrow mound from visitors surrounding the walkers cairn. Looking roughly north. 1m scale

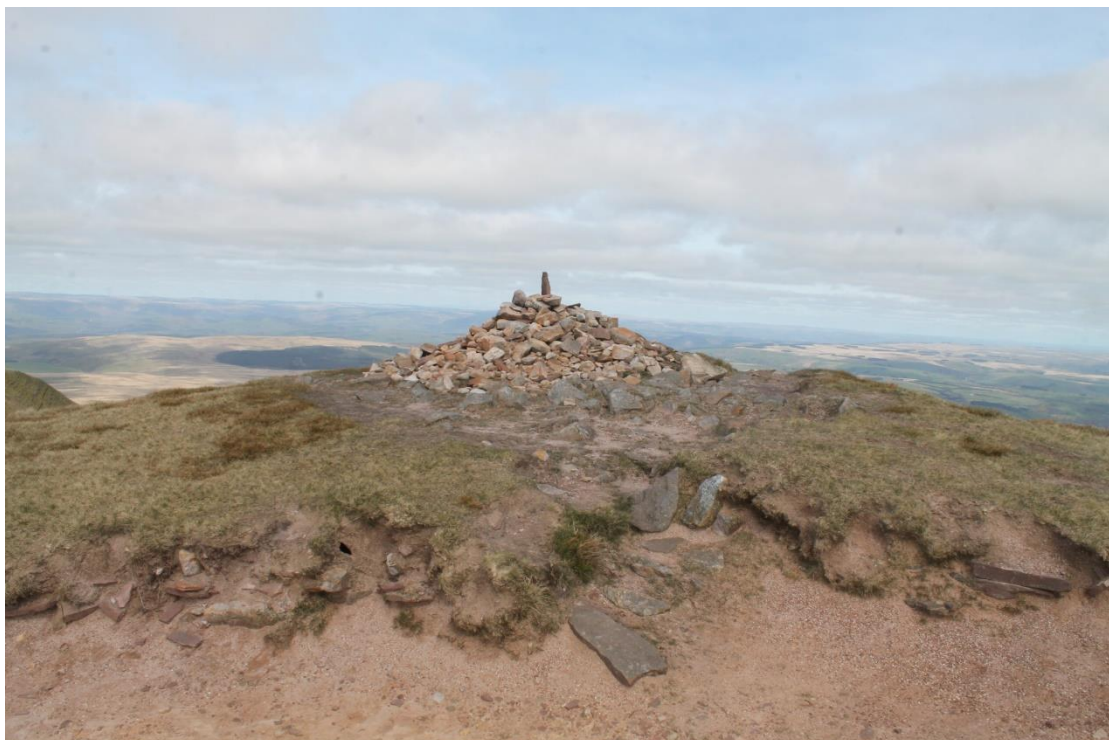
Photo 8: Twr y Fan Foel- showing detail of the extensive erosion to the south of the barrow. Looking roughly northeast.

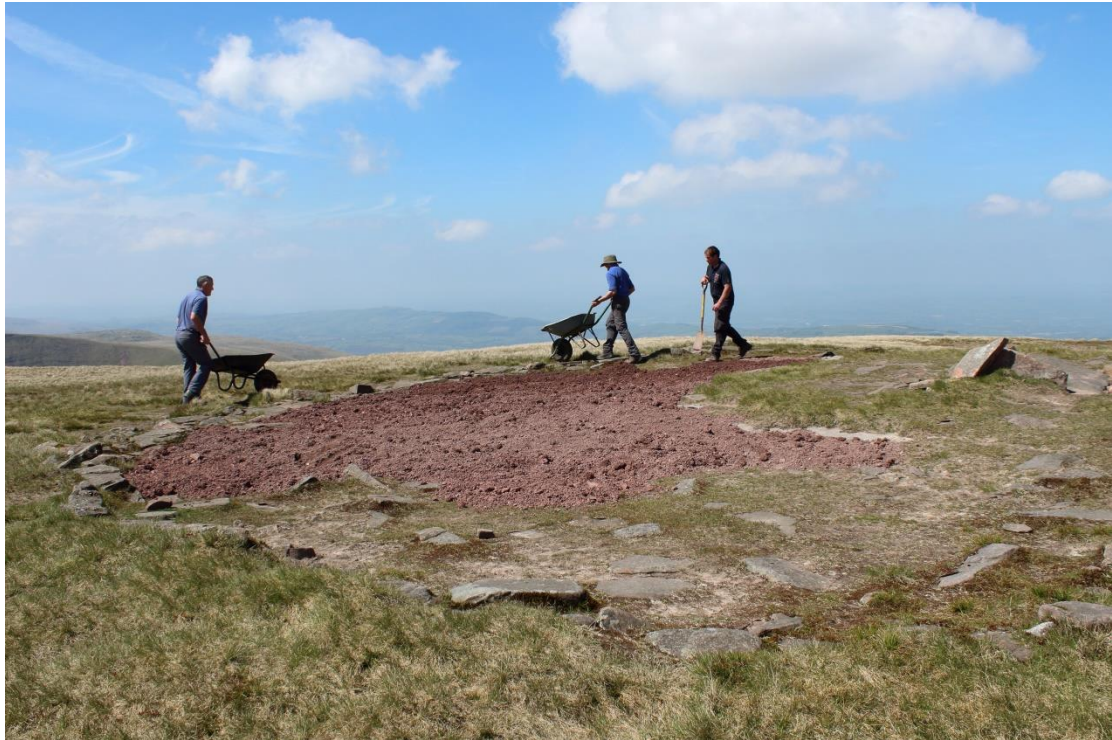
Photo 9: Fan Foel - showing the BBNP wardens replacing the soil within the eroded area defined by the stone kerb.. Looking roughly northeast.

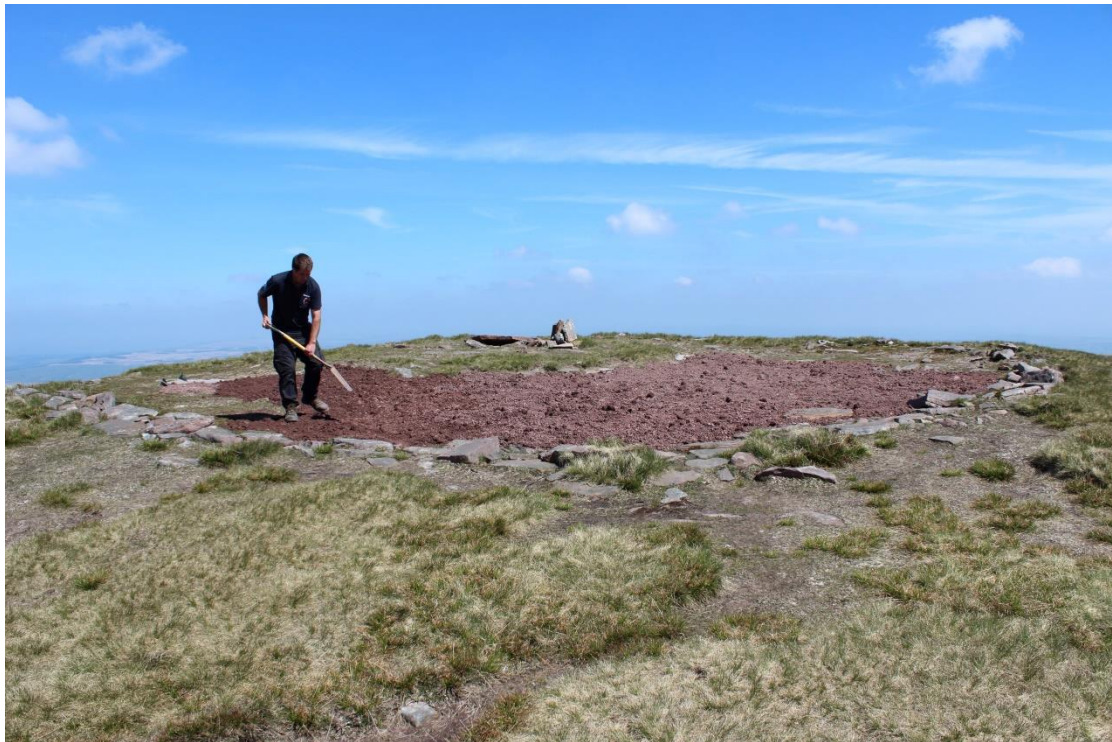
Photo 10: Fan Foel - showing a BBNP warden replacing the soil within the eroded area defined by the stone kerb. Looking roughly east.

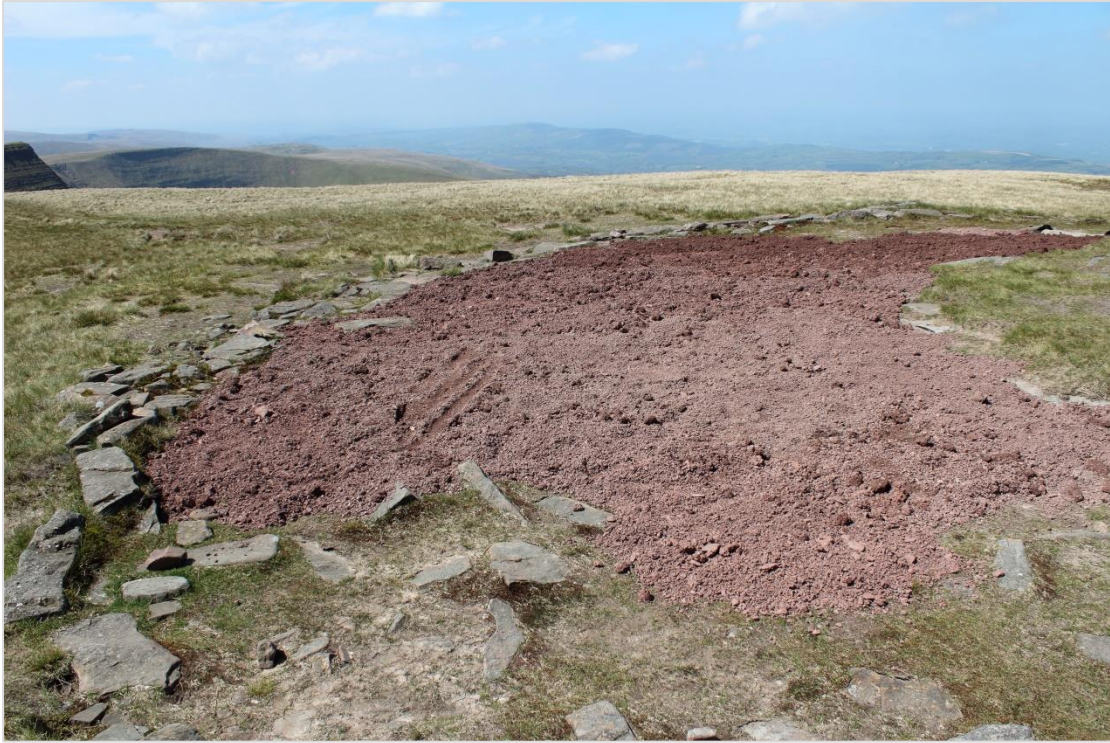
Photo 11: *Fan Foel - showing the site after all the soil had been replaced within the eroded area. Looking roughly northeast.*

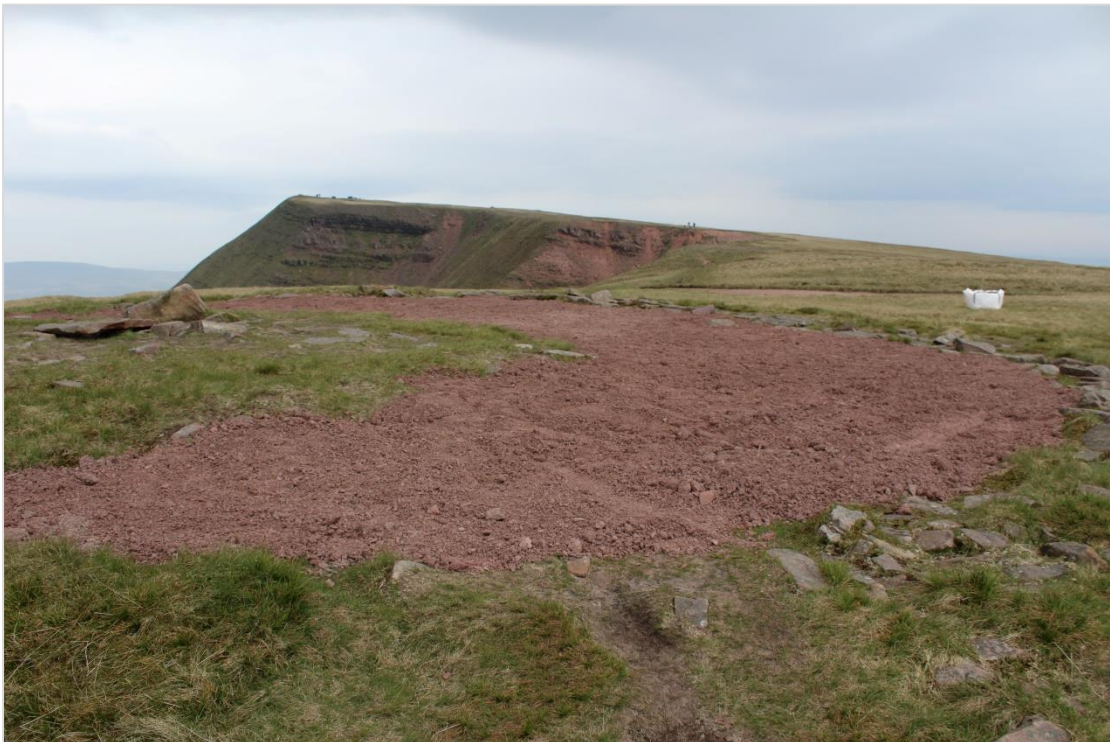
Photo 12: *Fan Foel – showing the site after all the soil had been replaced within the eroded area. In the far distance can be seen Twr y Fan Foel burial mound at the end of the promontory. Looking roughly southeast.*

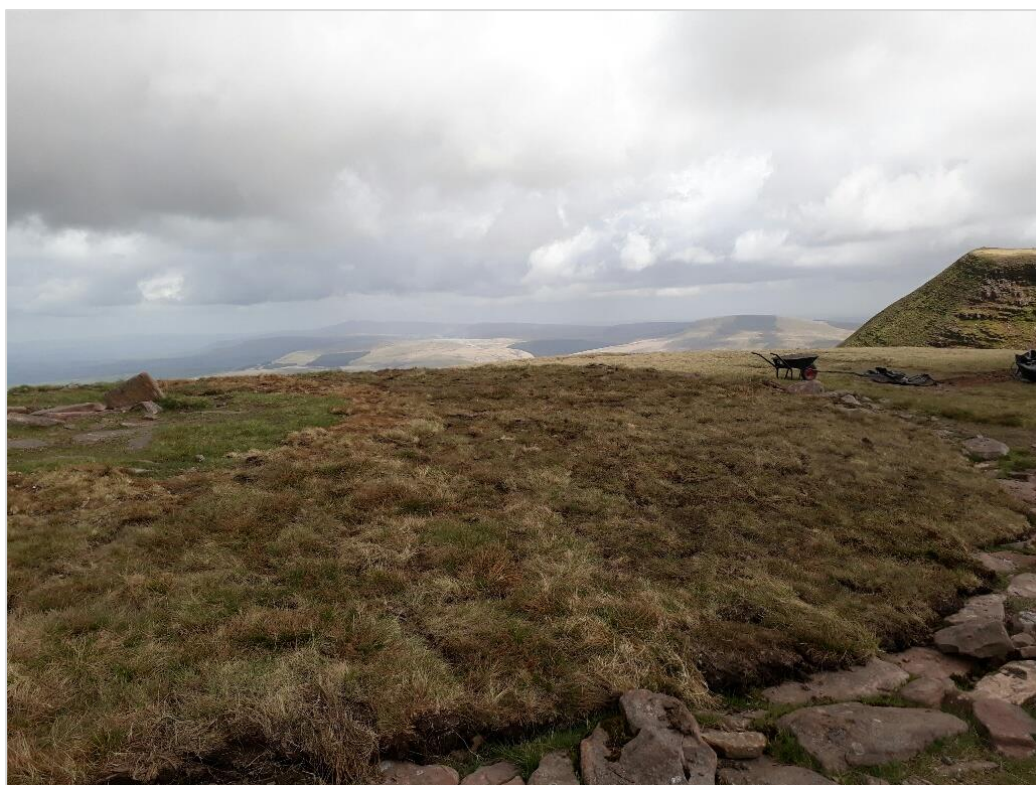
Photo 13: *Fan Foel - the burial mound after re-turfing within the eroded area. Looking roughly southeast.*

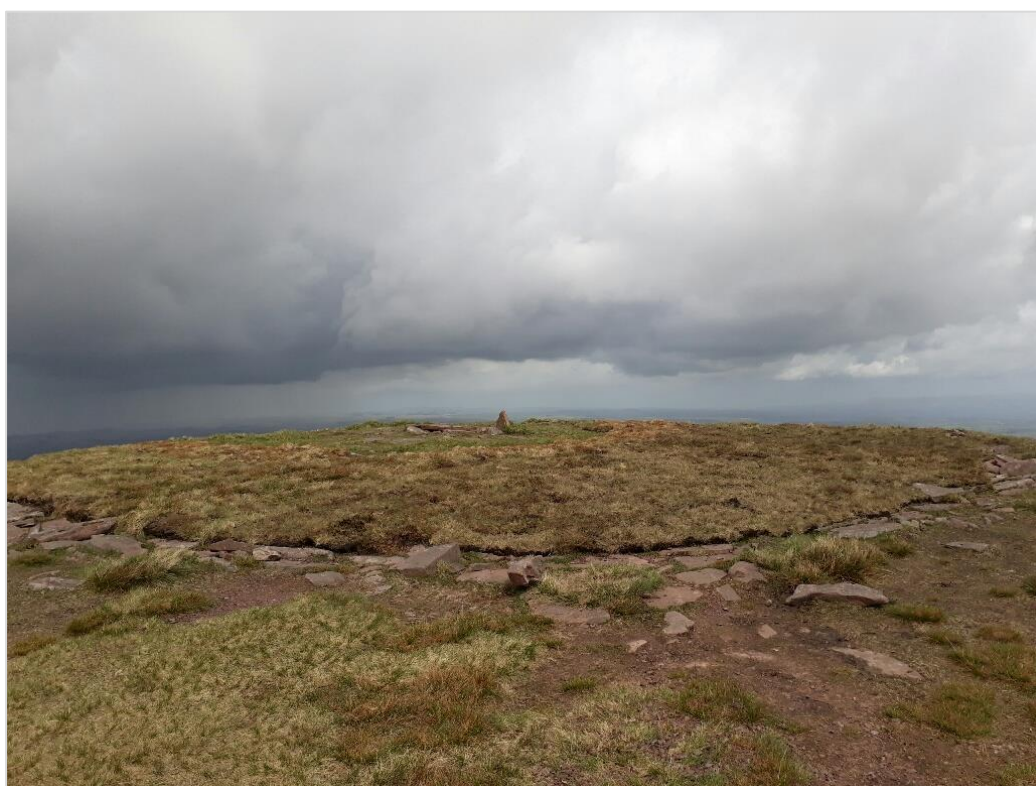
Photo 14: *Fan Foel- the burial mound after re-turfing within the eroded area. Looking roughly east.*

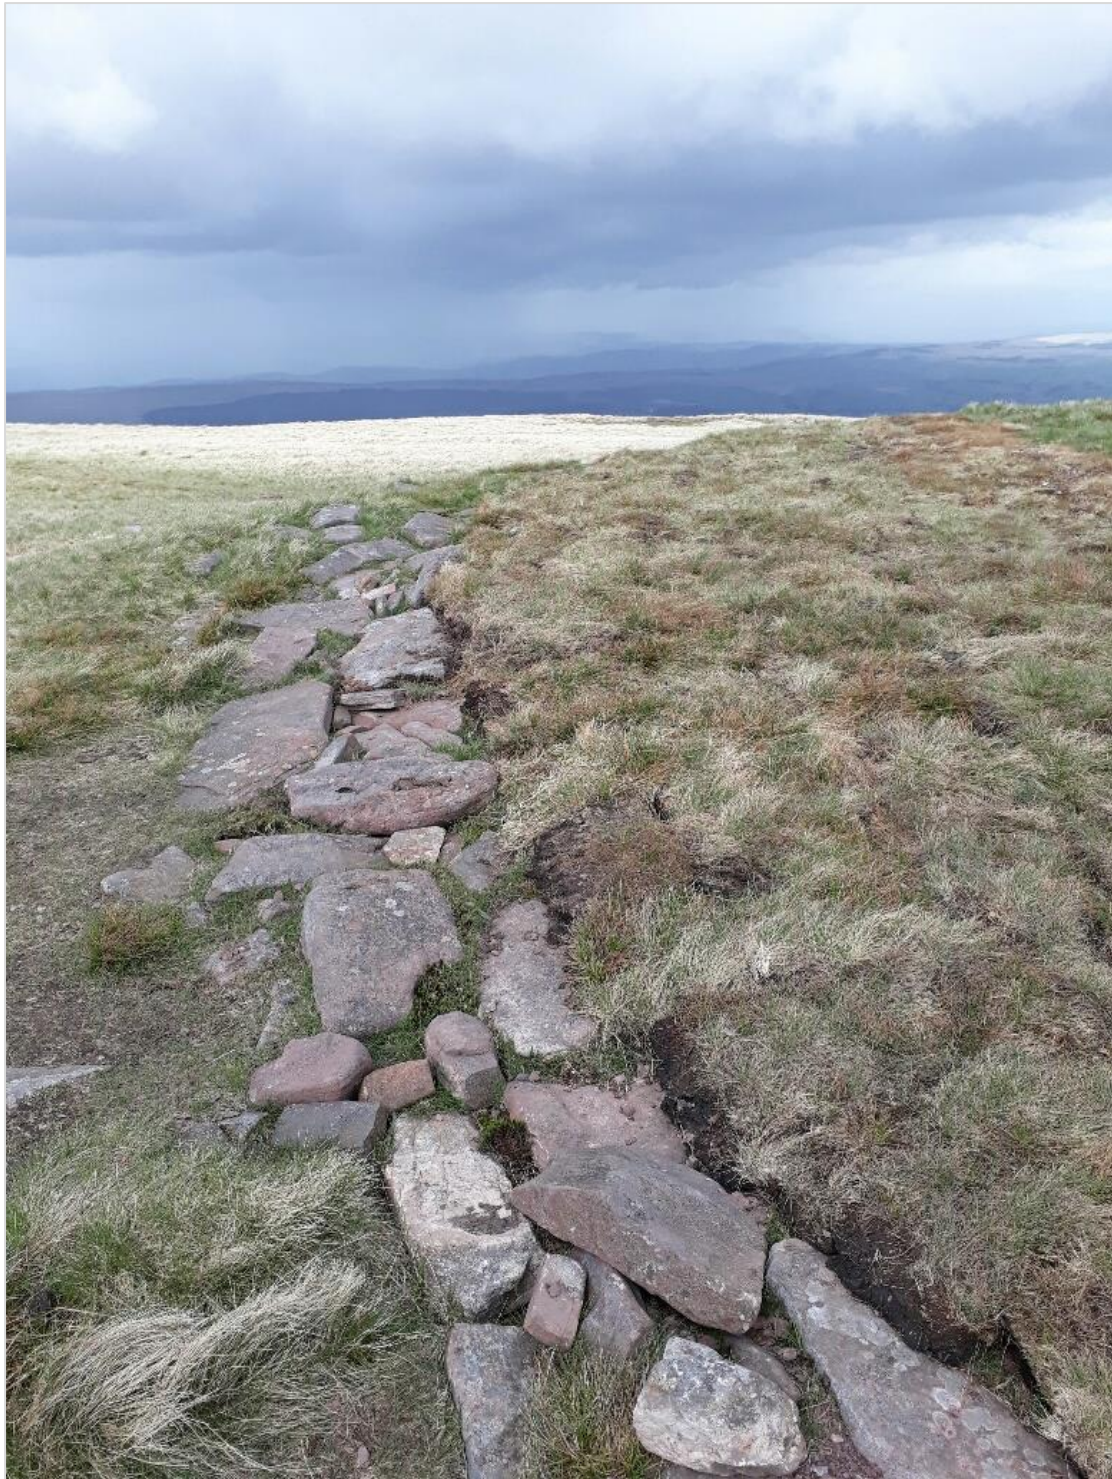
Photo 15: *Fan Foel - showing detail of the exposed stone kerb after the eroded area had been re-turfed. Looking roughly north.*

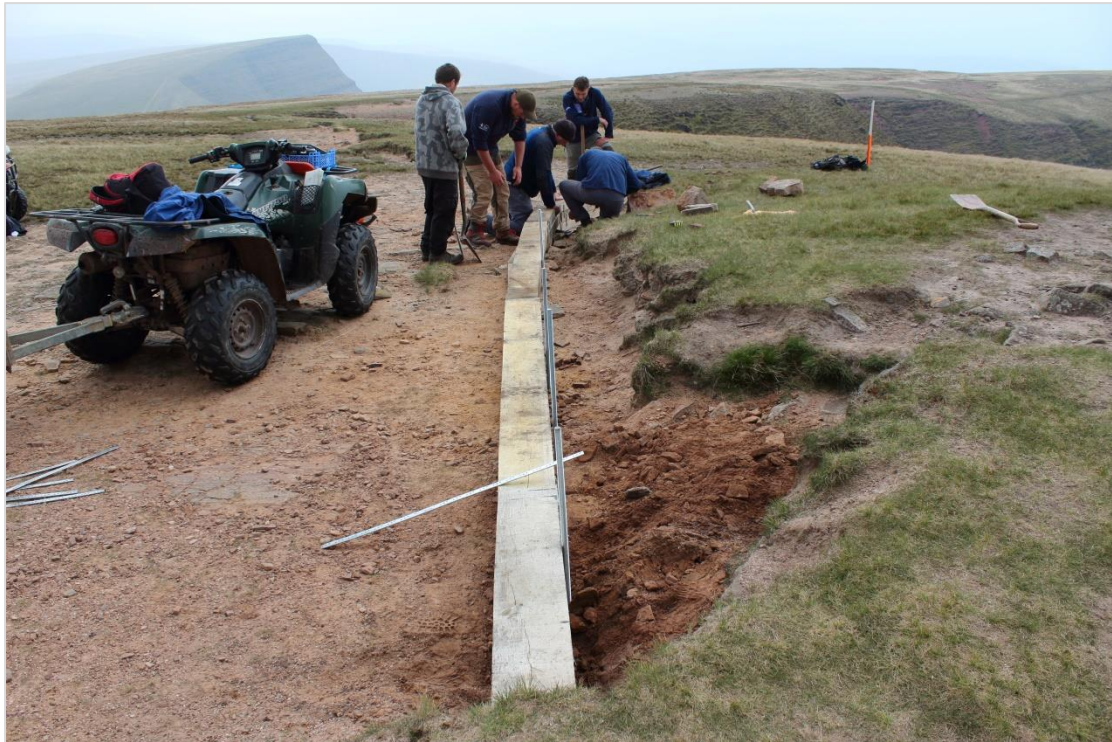
Photo 16: *Twr y Fan Foel – building a wooden revetment to the southern side of the burial cairn. Looking roughly west.*

- 4.5.5 Twr y Fan Foel burial mound had not previously been subjected to any archaeological investigation or repairs.
- 4.5.6 The repairs in 2017 comprised the construction of a low wooden retaining wall along the southern edge of the eroded area (Photo 16). The gap between the wooden barrier and the surviving mound was first in-filled with stones removed from the modern walkers' cairn (Photo 17). This removal was carried out under archaeological supervision to make sure that no stones that may form part of the underlying prehistoric cairn were inadvertently removed (Photo 19).

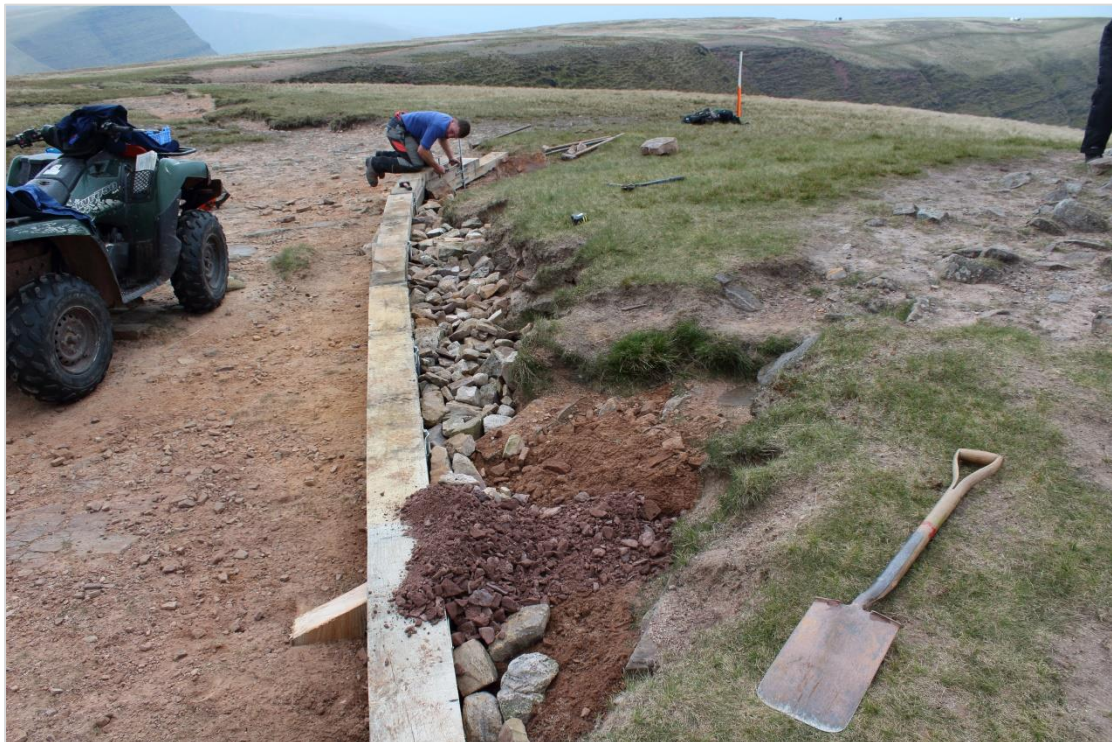
Photo 17: *Twr y Fan Foel – filling the gap against the wooden revetment with stone from the walkers cairn; followed by soil. Looking roughly west.*

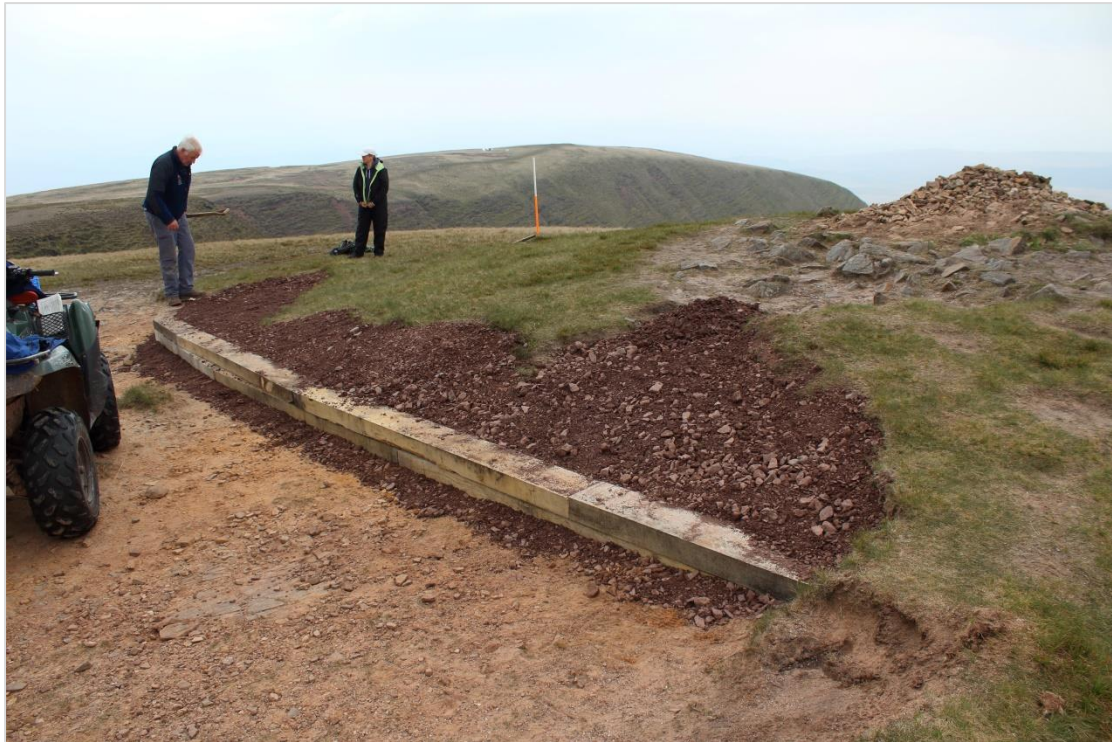
Photo 18: *Twr y Fan Foel – the completed soil packed into the gap against the wooden revetment. Looking roughly north.*

- 4.5.7 The in-filling was completed with soil that was packed down between the stones (Photo 18).
- 4.5.8 No archaeological deposits or remains associated with Twy y Fan Foel burial mound were disturbed or damaged during this repair process.
