FAN FOEL & TWR Y FAN FOEL BURIAL MOUNDS ARCHAEOLOGICAL SURVEYS & WATCHING BRIEF 2017

Prepared by Dyfed Archaeological Trust
For: Brecon Beacons National Park

REPORT NO. 2018/58
EVENT RECORD NO. DAT 115115

**FAN FOEL & TWR Y FAN FOEL
BURIAL MOUNDS
ARCHAEOLOGICAL SURVEYS &
WATCHING BRIEF 2017**

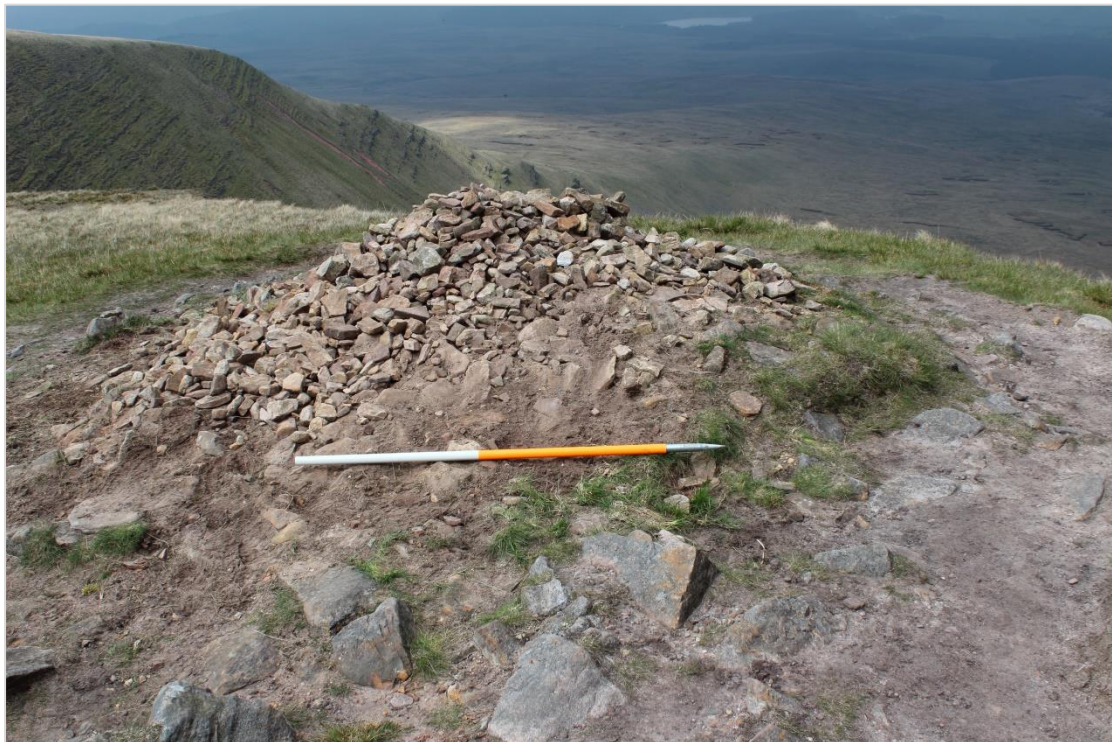
Photo 19: *Twr y Fan Foel – the walkers cairn after removal of much of the stone. Looking roughly north.*

- 4.5.5 Twr y Fan Foel burial mound had not previously been subjected to any archaeological investigation or repairs.
- 4.5.6 The repairs in 2017 comprised the construction of a low wooden retaining wall along the southern edge of the eroded area (Photo 16). The gap between the wooden barrier and the surviving mound was first in-filled with stones removed from the modern walkers' cairn (Photo 17). This removal was carried out under archaeological supervision to make sure that no stones that may form part of the underlying prehistoric cairn were inadvertently removed (Photo 19).
