LAND SOUTH OF BRONWYDD ROAD, TANERDY, CARMARTHENSHIRE: ARCHAEOLOGICAL EVALUATION (NGR SN4255 2111)

Prepared by DAT Archaeological Services

For: Pobl Group

RHIF YR ADRODDIAD / REPORT NO. 2019-01
RHIF Y PROSIECT / PROJECT RECORD NO. 115694

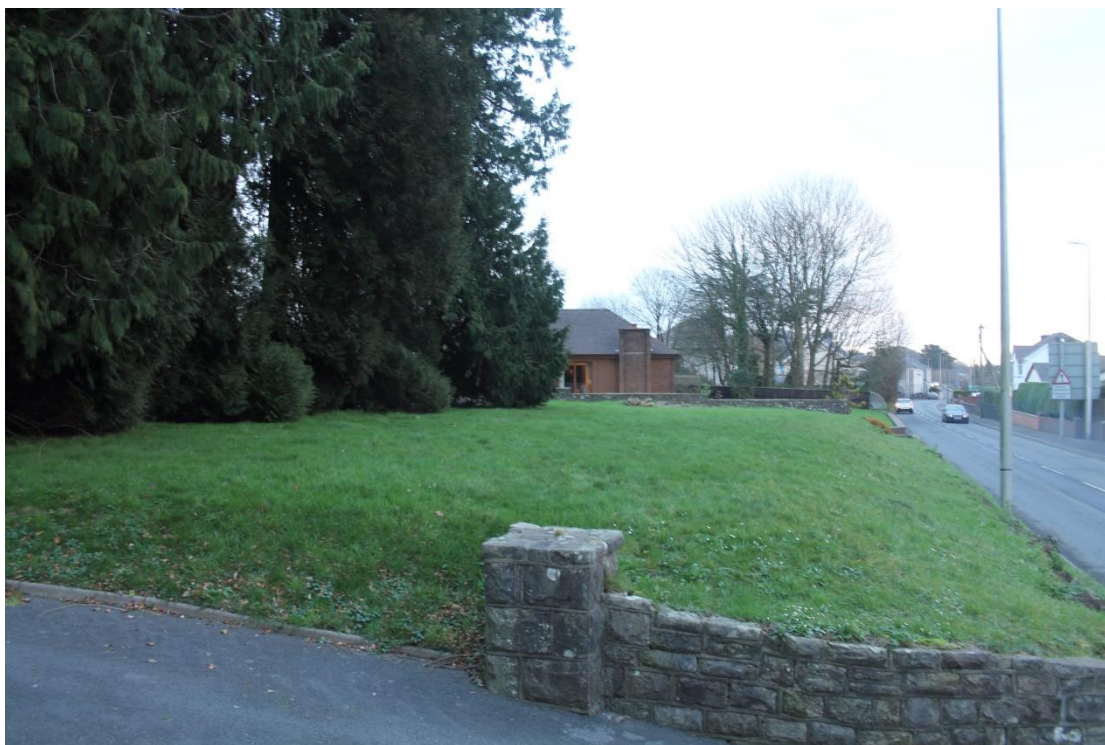
Photo 1: Area of Trench 1 prior to excavation, viewing roughly east with Abergwili road to the right and driveway leading to Ty Gwynfa in foreground

- 3.1.2 It was initially proposed to excavate two trenches, as detailed in the WSI; one located to the northeast of the driveway entrance from Abergwili Road to Ty Gwynfa (Photo 1), the second northwest of the driveway (Photo 2). Both trenches were to be dug through level, lawned areas of the site. When the works started it was noted that an area of the northeastern part of the site had been cleared of vegetation (brambles etc). It was agreed with Pobl Group that a third trench could be placed within this area to make evaluation of the area more robust (Photo 3).

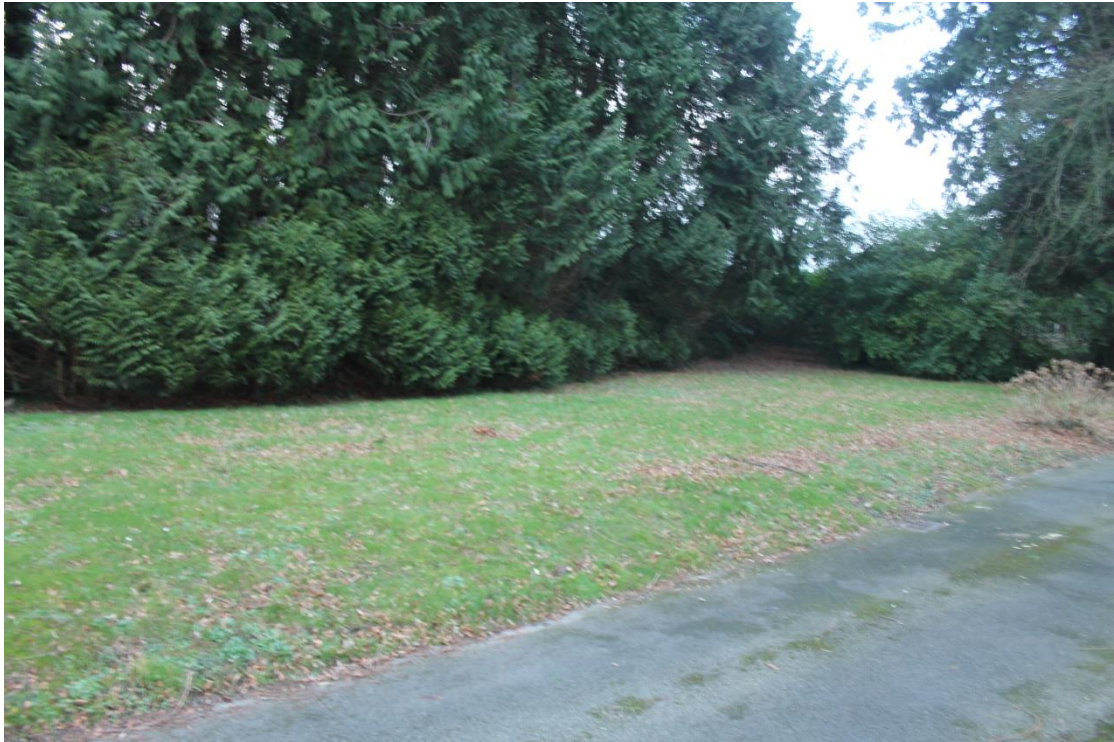
Photo 2: Area of Trench 2 prior to excavation, viewing northeast with driveway leading to Ty Gwynfa in foreground / right of photo

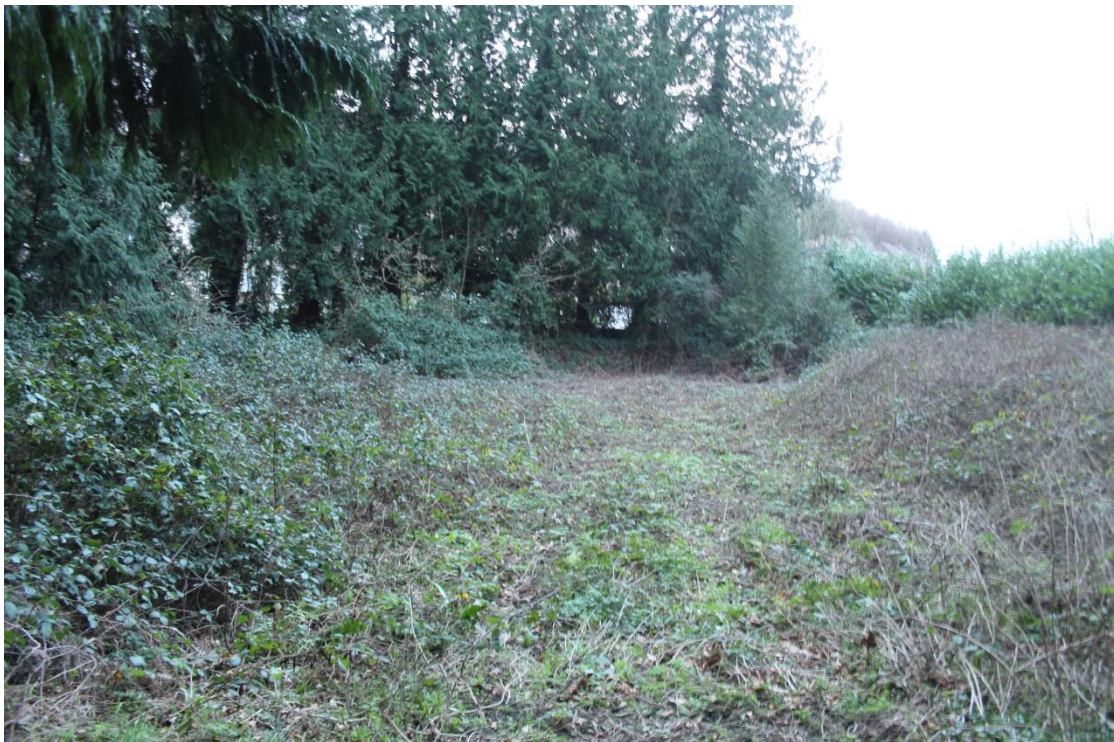
Photo 3: Area of Trench 3 prior to excavation, showing cleared vegetation strip viewing north with trees bounding Bronwydd Road to rear

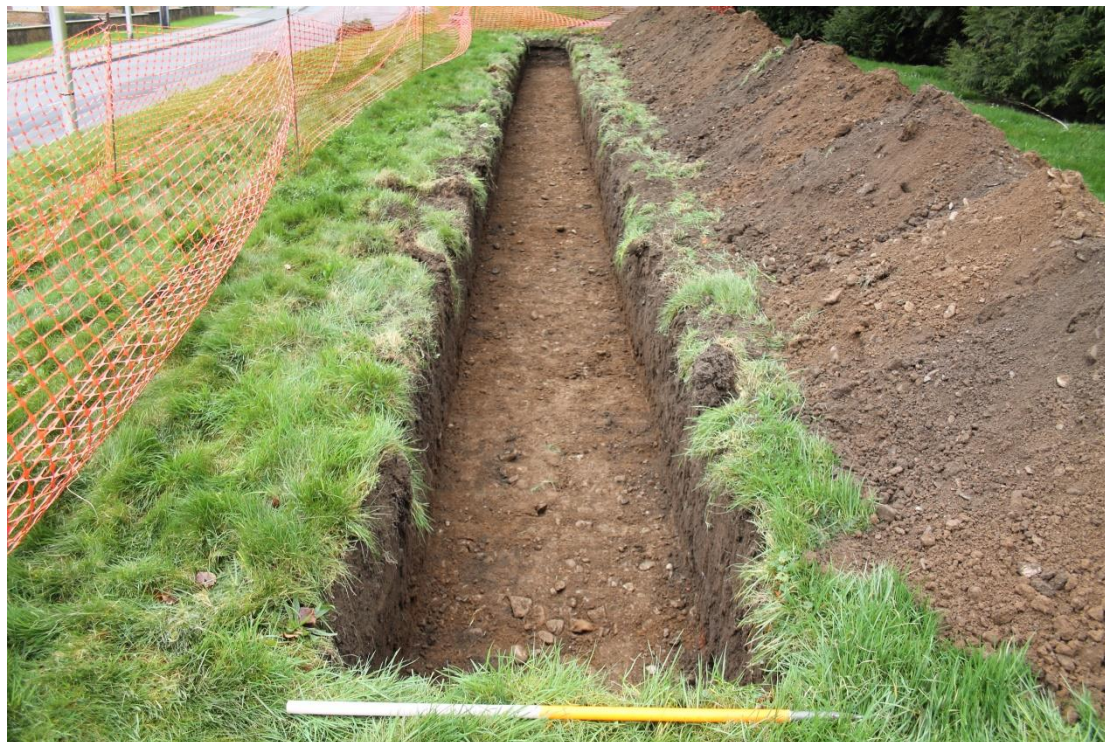
4.2.1 Trench 1 measured 20m x 1.10m and was aligned roughly east to west (Photo 4). It was located in the southwestern part of the site on the northeastern side of the driveway providing access to Ty Gwynfa from Abergwili Road.

Photo 4: Trench 1. View west, 1.0m scale.

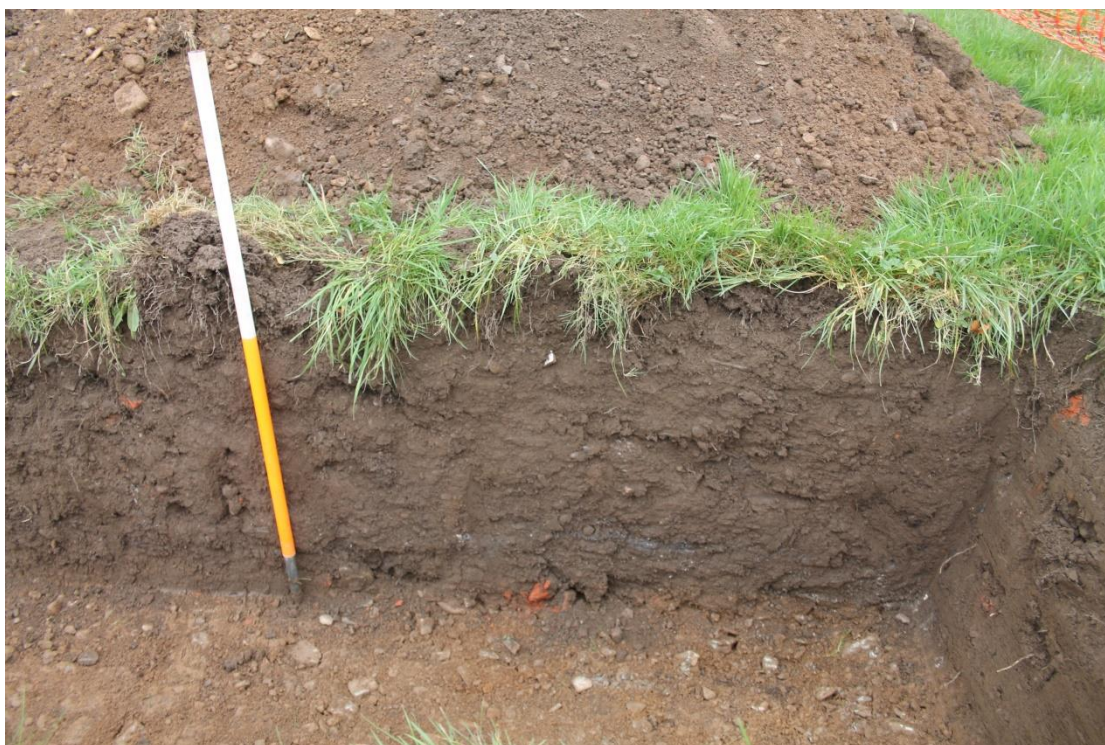
4.2.2 The earliest deposit observed within Trench 1 was (103), a firm orange silty clay interpreted as being the natural undisturbed soil horizon. Overlying this was (102), a 0.50m thick layer of loose brown silt subsoil. In turn the entire trench was overlain by a 0.10m thick layer of topsoil and turf. Photo 5 shows a representative section of the soil profile in Trench 1.

Photo 5: South facing section of Trench 1. Topsoil and turf (101), subsoil (102) and Natural horizon (103). 1.0m scale.

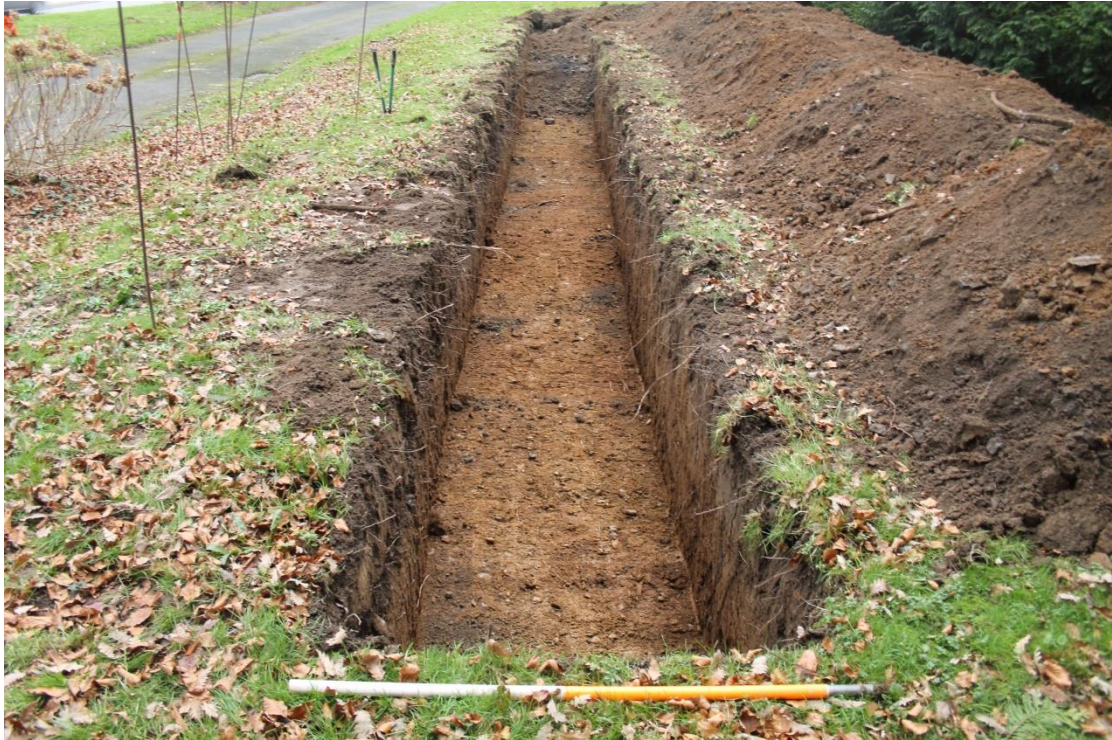
- 4.3.1 Trench 2 measured 13m x 1.10m and was orientated roughly east to west (Photo 6). The trench was located on the northwestern side of the driveway leading from Abergwili Road to Ty Gwynfa on a level grassed area.
- 4.3.2 The soil profile observed in Trench 2 was similar to that seen in Trench 1 aside from a crushed shale trackway lying beneath the topsoil and turf (202). The natural soil horizon (204) was overlaid by a subsoil (203), with the topsoil and turf above (201), excluding where the crushed shale trackway was located (202).
- 4.3.3 The trackway (202) was approximately 0.20m thick and virtually extended across the whole of the trench. It is likely that this trackway was aligned roughly east to west, perhaps an earlier driveway associated with the formal gardens. Photo 7 shows a small part of the trackway beneath the turf in the south facing section.

Photo 6: Trench 2 after excavation. View west, 1.0m scale.

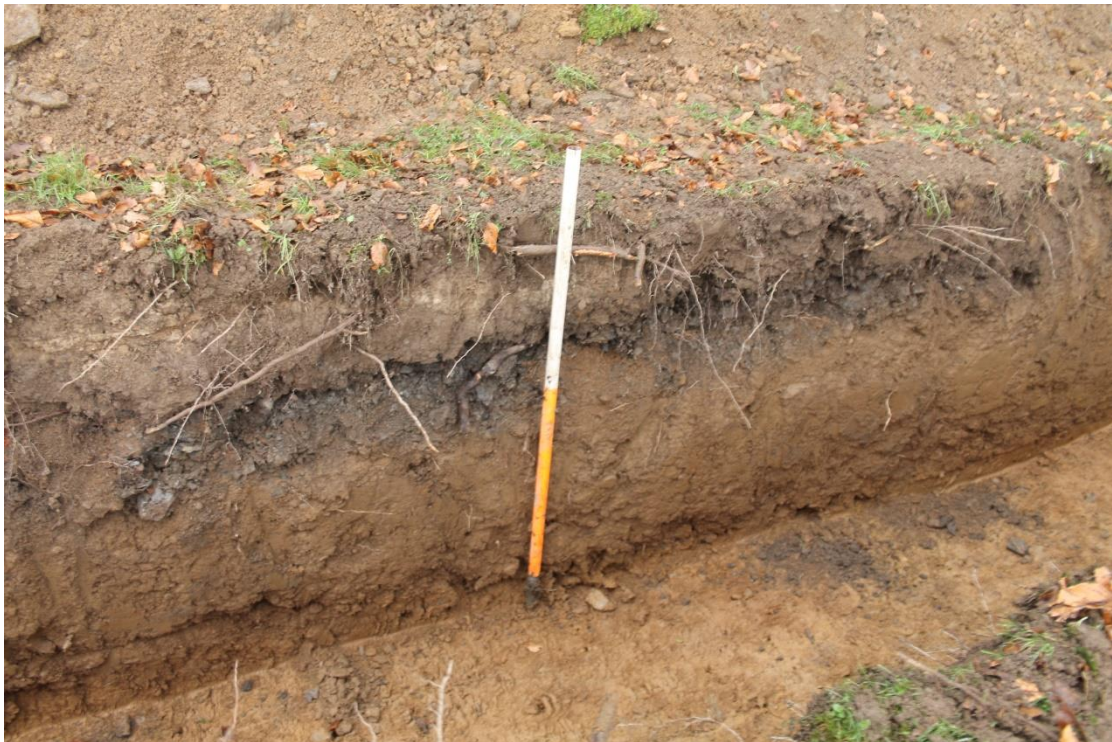
Photo 7: South facing section of Trench 2 showing turf (201), shale trackway (202), subsoil (203) and natural (204).

- 5.3 In Trench 2 a broken shale track was observed (202) which could represent a former line of the driveway leading to Ty Gwynfa. It was present directly below the turf and topsoil, overlying the subsoil demonstrating that the feature is of relatively recent date. It presumably dates from the period when the formal gardens were laid out.

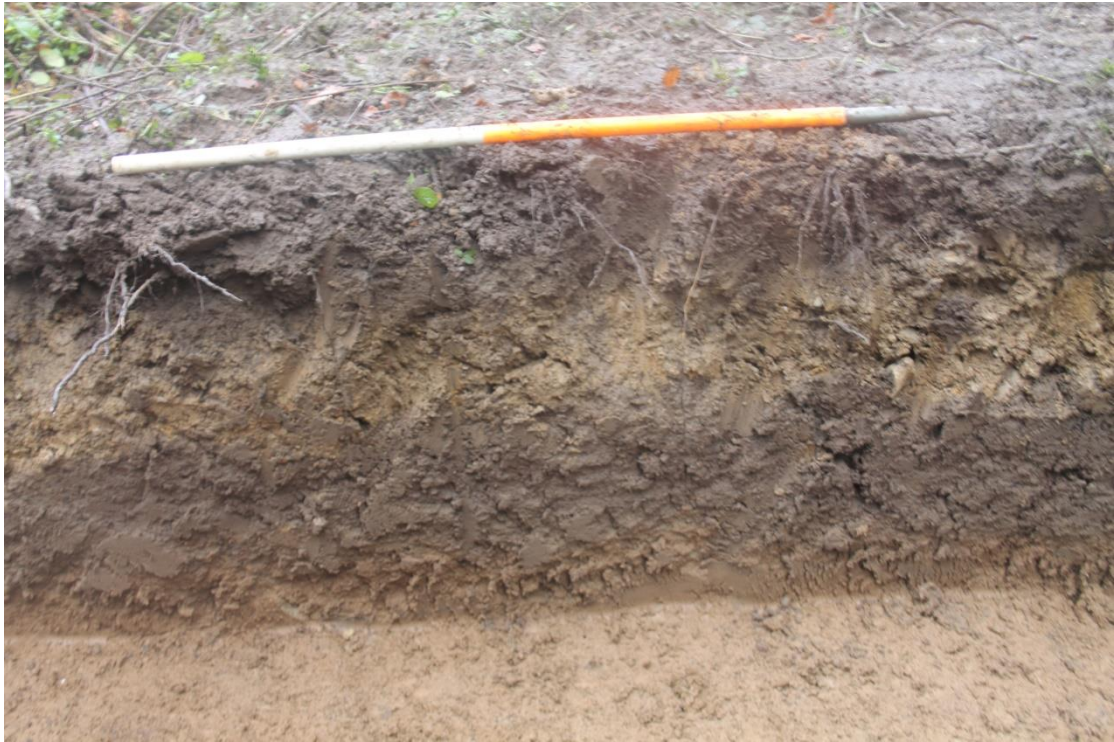
- 4.4.2 Towards the southern half of the trench beneath the topsoil (301) there was a 0.20m thick layer of redeposited natural soils (306). Beneath this was a loose brown silt, possibly a buried topsoil (307). These layers were very clean and clearly discernible, which might suggest recent activity. The buried topsoil directly overlay the natural soil horizon (305) (Photo 8).

Photo 8: West facing section in the southern portion of Trench 3, showing topsoil (301), redeposited natural (306), buried topsoil (307) and natural (305).

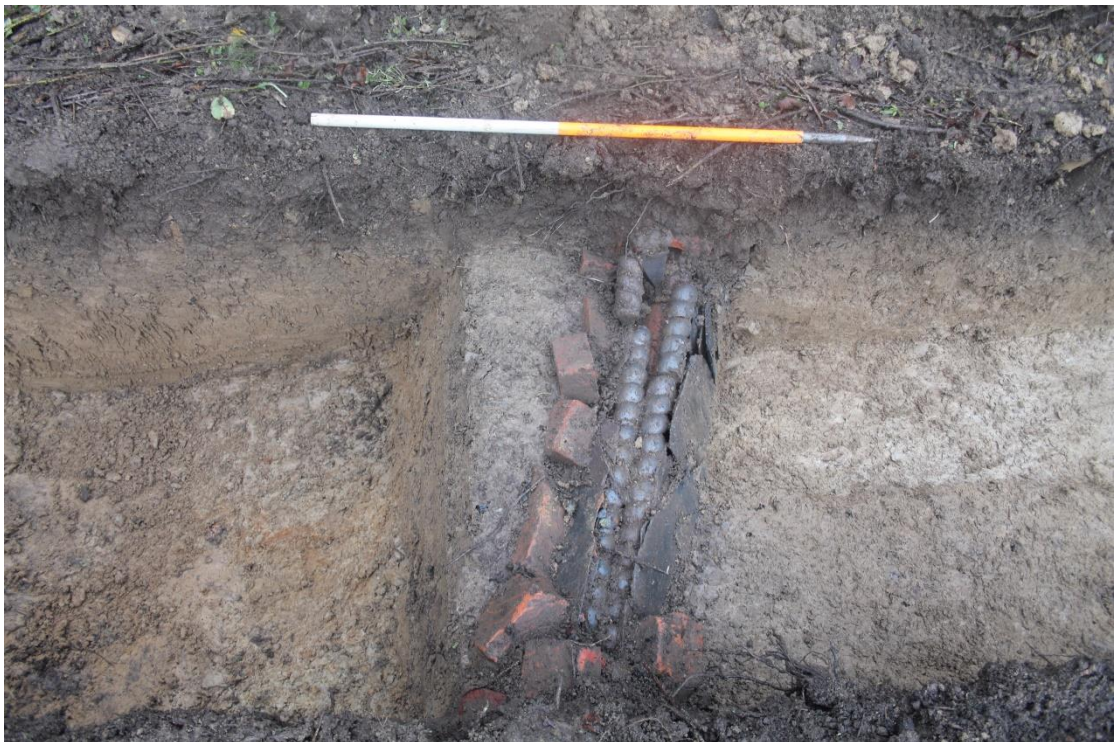
- 4.4.3 Towards the mid-section of the trench a ceramic unglazed drain pipe was observed orientated roughly east to west cut from the subsoil layer (302), this was tightly packed in with ceramic path curbing tiles, slate and bricks (Photo 9) (301), cut [311]. It extended across the trench with around 1.15m length visible, c.0.40m width and c.0.35m depth.

Photo 9: Drain (303) in Trench 3, with pale fill of feature cut [309] visible beneath.

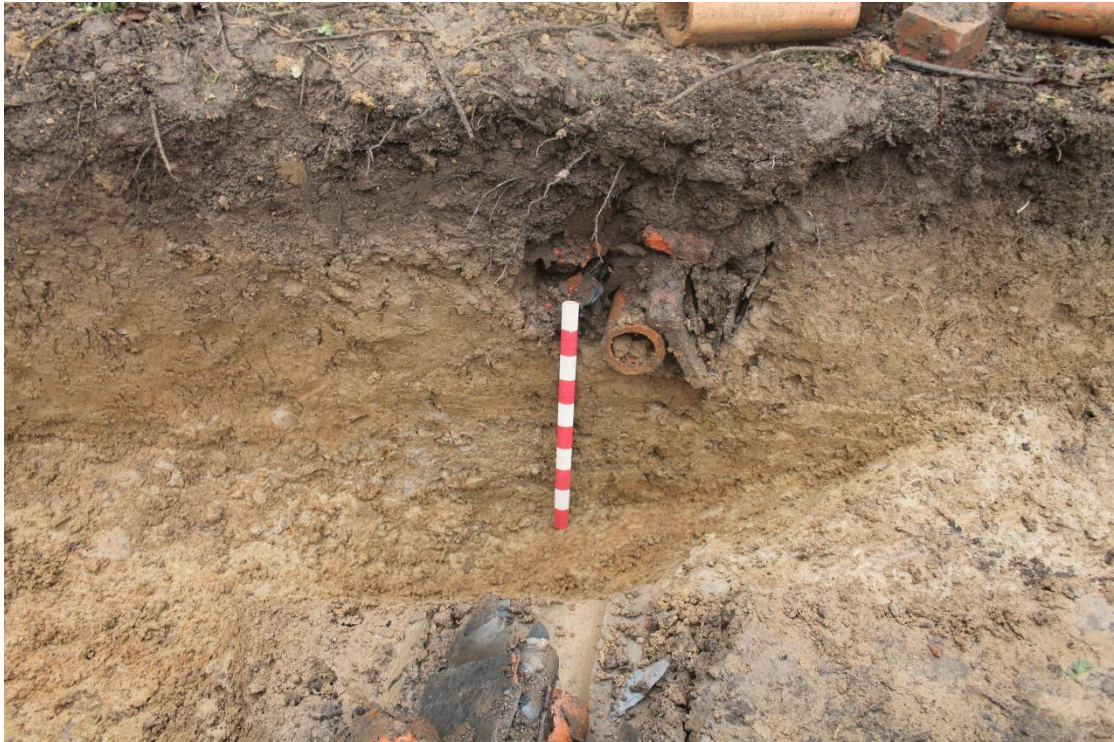
- 4.4.4 Beneath the drain was layer (303) a pale brown clay deposit, approximately 3.6m wide and present across the width of the trench, with frequent sub-rounded gravels. This was truncated by cut [309], an amorphous shaped feature, measuring approximately 1.0m long and 0.40m wide, possibly representing the terminus (end) of a gully (Photo 10). It was orientated roughly northwest to southeast.

- 4.4.5 The possible gully terminus [309] was filled by (308), an orange/brown silty clay. This was then sealed by the overlying subsoil (302).

Photo 10: Cut [309] possibly the terminus of a gully in Trench 3,
below the drainage pipe (310)/[311]

- 5.5 Below the drain in Trench 3 was the only potentially earlier archaeological feature seen in the evaluation, an amorphous cut feature [309]. This was potentially the terminus of a gully, but no artefacts or dating evidence was retrieved from the fill to help characterise or date the feature.

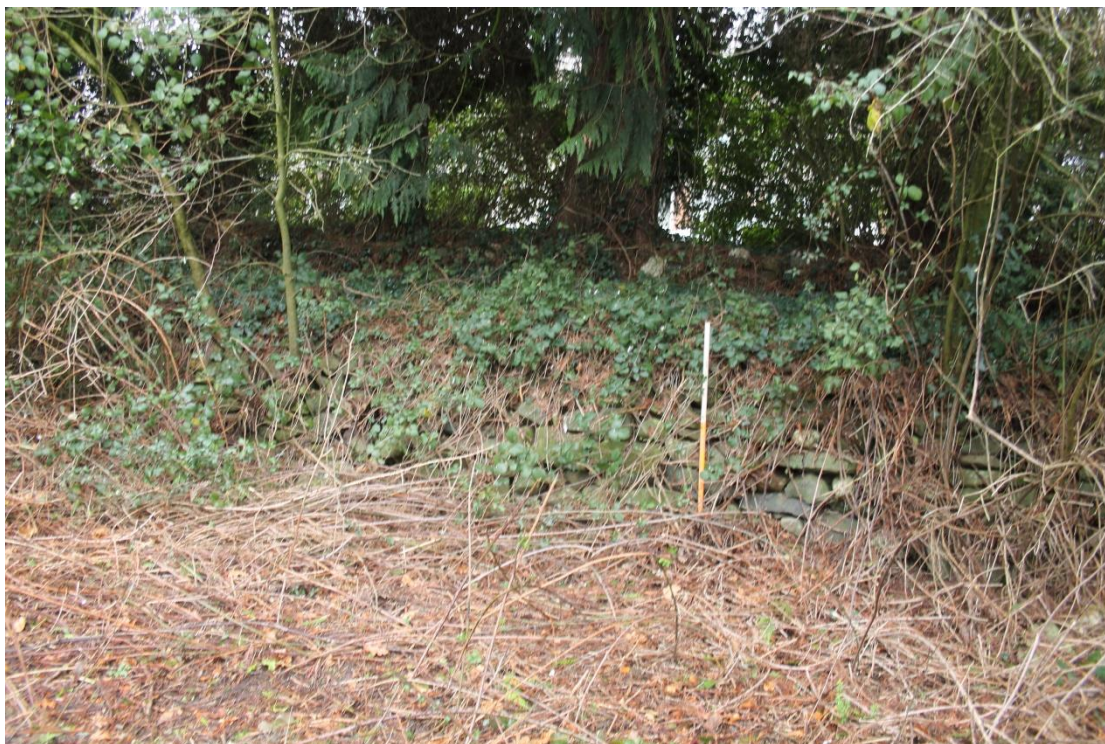
- 5.4 In Trench 3 a layer of redeposited natural was recorded overlying a buried topsoil. The buried topsoil lay directly on top of the natural soil horizon. Tied in with the shallow depth of agriculturally derived subsoil seen within the trench, it is likely that this area had been subject to landscaping in the recent past, presumably associated with the early 20th century formal gardens. This is further evidenced by the presence of a revetment wall around the higher ground level in the northeastern part of the site, where Trench 3 was located (Photo 11). Drainage as evidenced by cut [311] and the ceramic pipe (310) would also suggest landscaping and remedial drainage works. The pipe was packed with ceramic edging tiles, a typical feature of formal planting beds, also indicating the association of this area with the early 20th century formal gardens.

Photo 11: Retaining wall to the north of the site with higher ground level behind.
