# CADW SCHEDULED ANCIENT MONUMENTS PCNPA AREA 2011-2

**RHIF YR ADRODDIAD / REPORT NO. 2012/30**

**CADW SCHEDULED ANCIENT  
MONUMENTS PCNPA AREA  
2011-2**

*This report covers visits and work to Scheduled Ancient Monuments in the Pembrokeshire Coast National Park undertaken by Pete Crane during 2011-2012, for Cadw or for PCNPA. Six sites appeared to have been vandalised, remedial action has been undertaken or instigated on three of these. At least two coastal promontory forts have continuing severe coastal erosion, and another two suffered slightly from fire damage. Two sites are recommended for scheduling and another to have its protected area extended. Vegetation was cleared on two Iron Age promontory forts and on another coastal fort which has been advised for scheduling this has considerably improved their condition.*

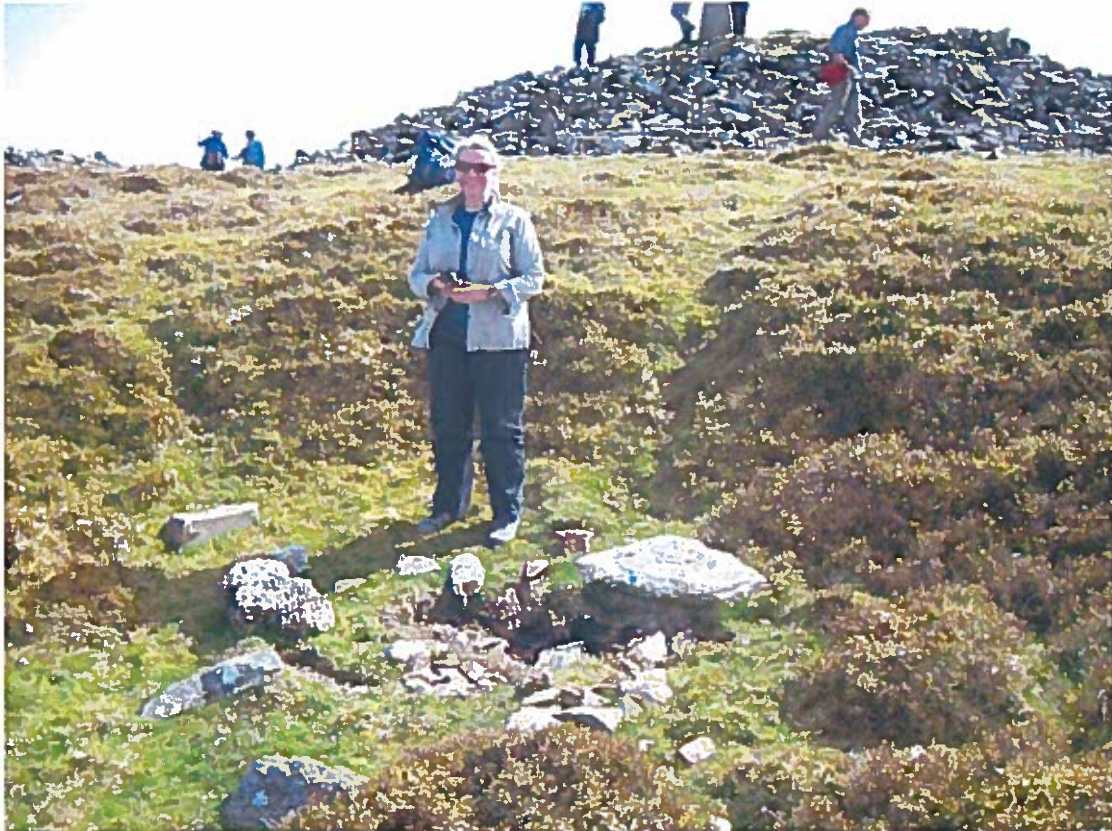
The site was visited on 10<sup>th</sup> April 2011 as part of the Hillfort Study Groups' tour of North Pembrokeshire: there was little evidence of any further disturbance to the cairns since the repairs in September 2010. However, the centre of a hut platform just to the north east of the central cairn (NGR by basic GPS SN 15773/33624) had been disturbed (see photo below), possibly the result of metal detecting or geocache activity.

Foel Drigarn hut platform disturbance 10/04/2012, View S

- PG - can I repair the hut platform disturbance or will SMC consent be required?
- Can the hollows be repaired without further SMC?
- PC will visit the site in spring 2012 along with Bedd Arthur
- PC will also visit the site twice on guided walks (7 June and 17 August)

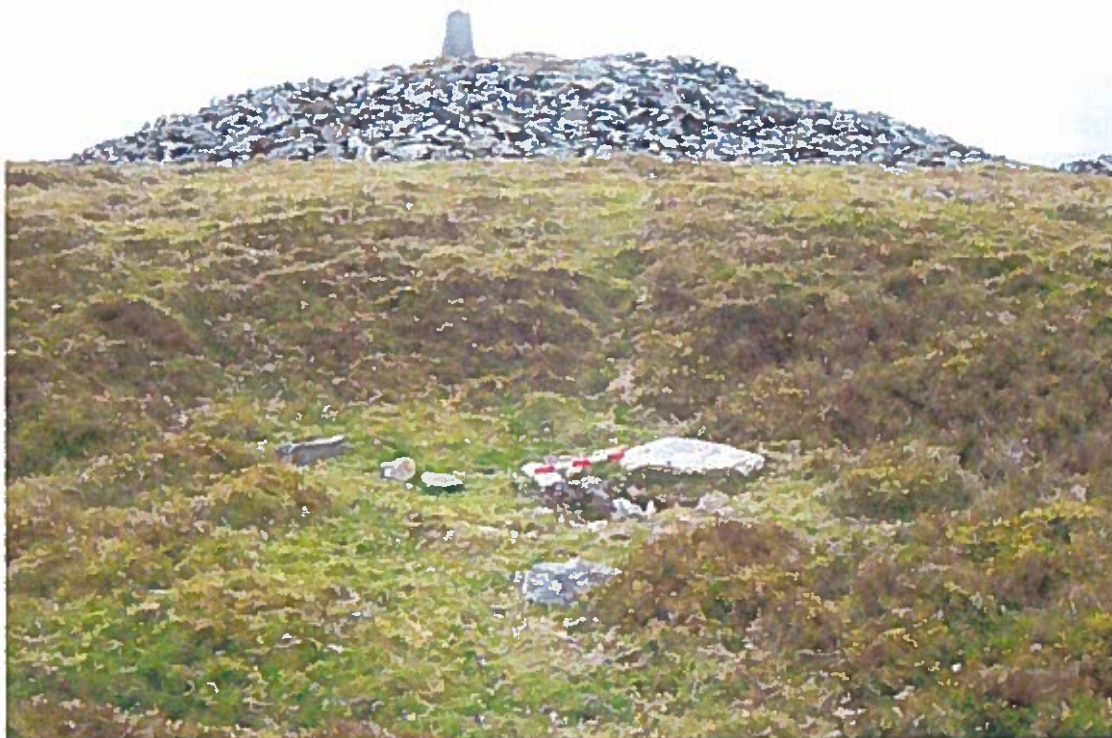
Foel Drigarn damage to hut platform 15/09/2012. View S

The site was visited again on 15/09/2012. The damage to the hut platform was as before. However, on the northwest side to the eastern cairn a slight hollow in the stones has been created. In addition more serious disturbance had been done to the west site of the west cairn (see photos below). The track scars in the turf created by motor bikes the previous year had almost disappeared.

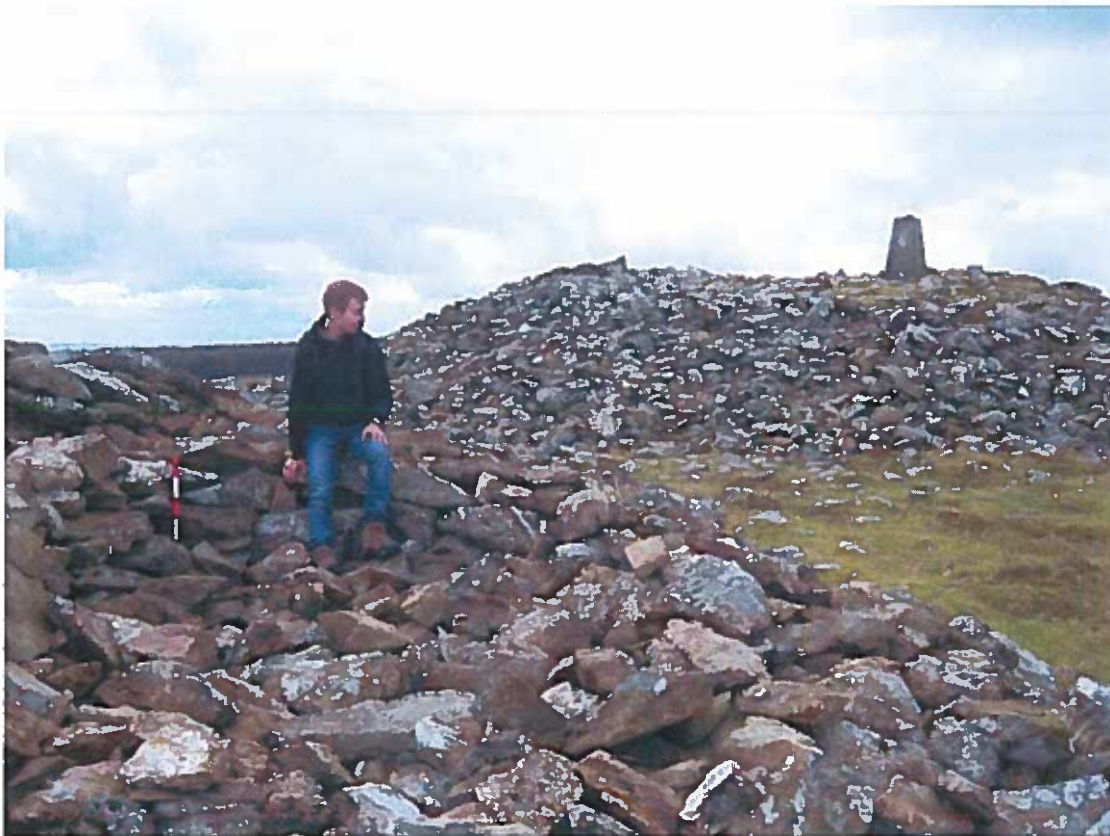
Foel Drigarn slight new disturbance in east cairn, NW side  
15/09/2012

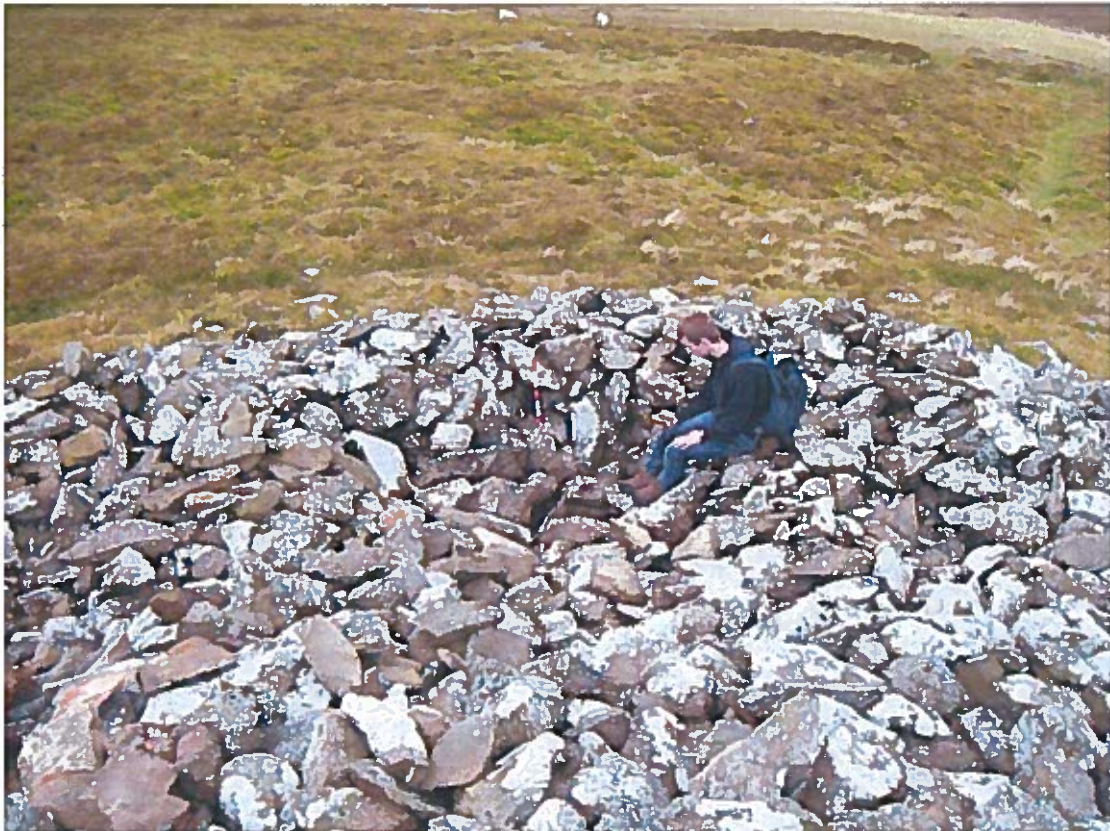
Foel Drigarn: new hollow on west side of west cairn

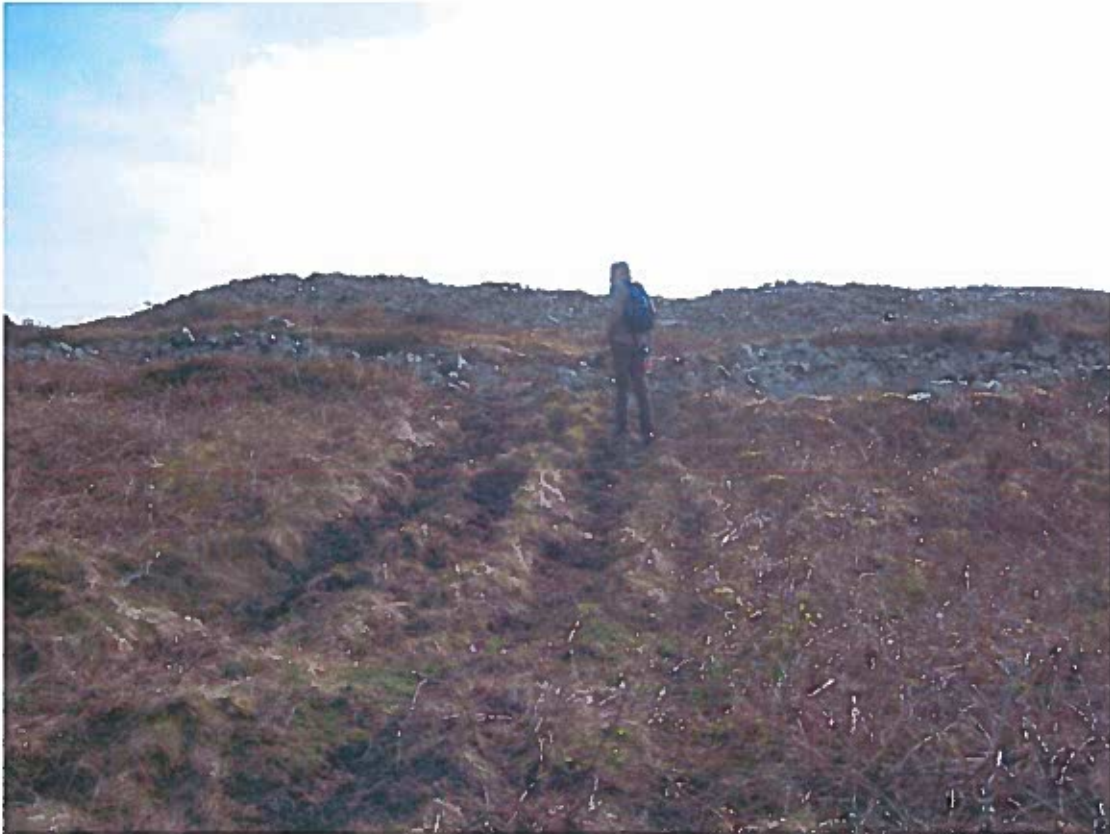
Although the 4 x 4 damage to the site was still noticeable when the Hillfort Study Group visited the site in April 2011, it was almost imperceptible by November 2011. There is a little blackthorn and some bracken on the interior. The blackthorn at this stage is not

Garn Fawr 4 x 4 damage on north side of outer rampart view S.  
09/04/2011

- PC to check with National Trust and other landowners to ascertain if the site can be grazed more.
- PC monitor site on yearly basis for the next few years?

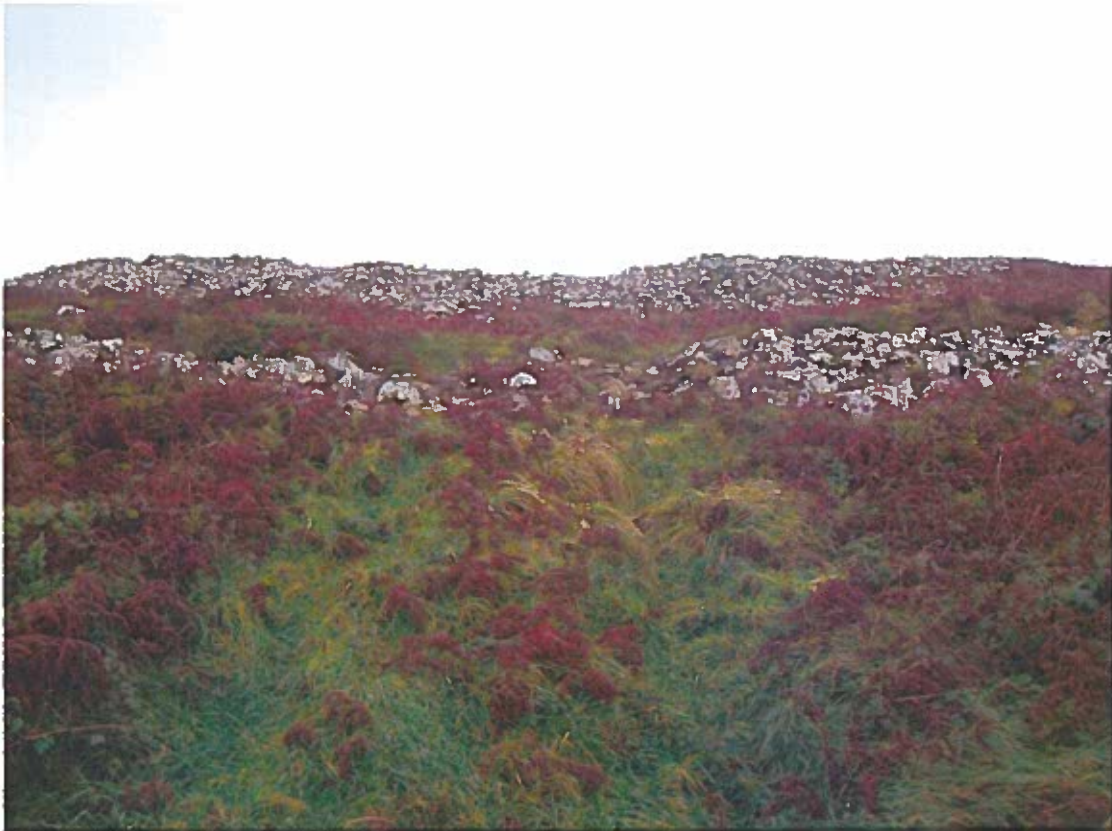
Garn Fawr 4 x 4 damage on north side of outer rampart view S.  
11/11/2011

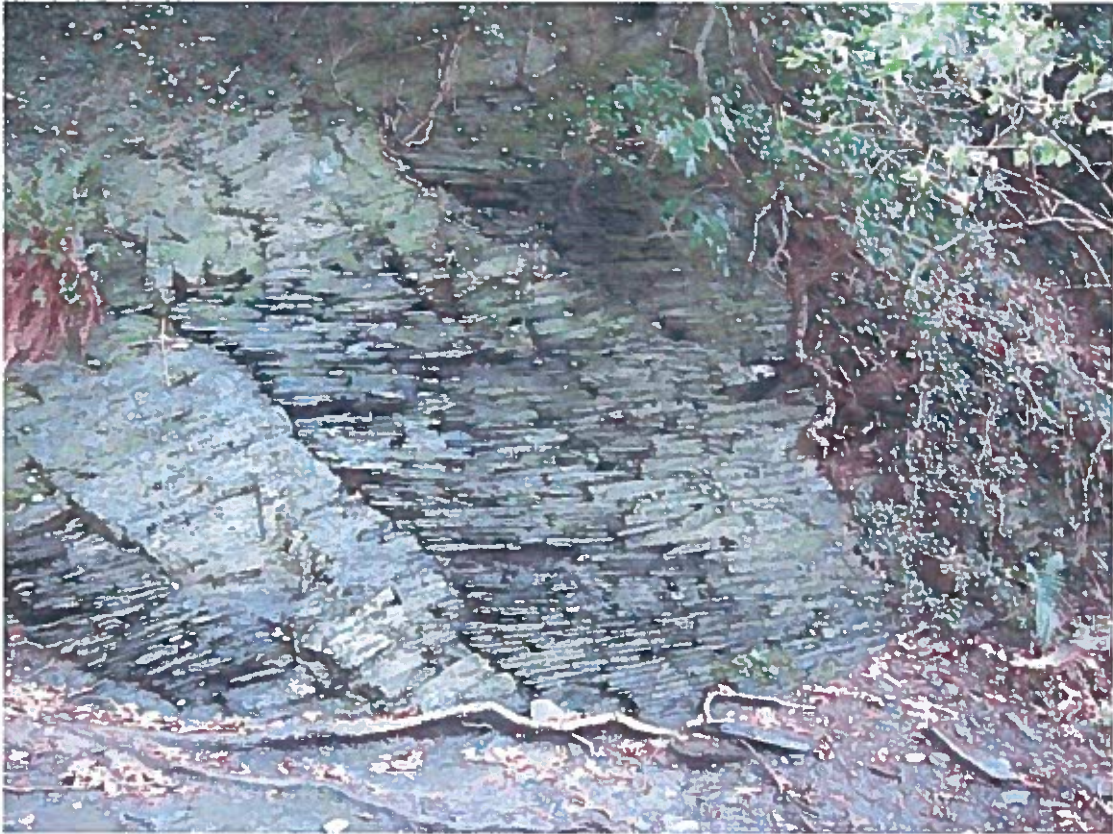
Seven small areas of damage, where some of the shale rock face adjacent to the cross has been pulled out. The damage may have occurred during the week end of 29-30/10/2011, possibly while removing coins placed between the stones. This was reported to the PCNPA by the people living in the neighbouring property, 'Nevern View'. In most places where the stones have been removed there was evidence that the rear of the stones had been bonded with mortar.

Nevern Pilgrims Cross: small areas of damage to shale face  
03/11/2011

- Mortar samples should be taken before repairs, and analysed with view to establishing date of mortar
- Repairs should be done **as soon as possible**

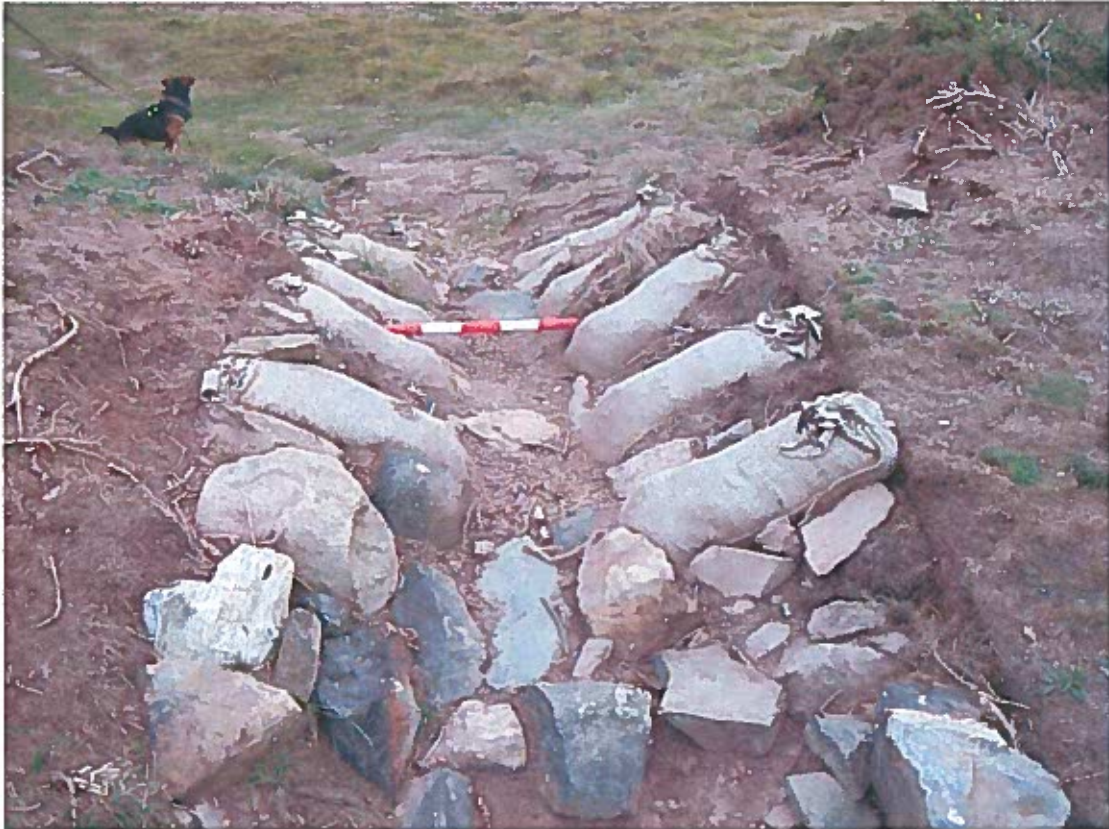
The Time Team evaluation on Watery Bay Rath and Gateholm took place in August 2011 with the programme broadcast in January 2012. It appears to have been one of their more successful endeavours and has generally been well received, although some of their conclusions have been commented on. Watery Bay Rath was visited in October with Claudine Gerrard, National Trust Archaeologist for South Wales. All of the backfilled trenches, except for the one on the footpath through the northwest bank (see photo below) were looking good. Here it may be necessary to import some turf and topsoil to improve the sides.

Watery Bay Rath, modern entrance through northwest bank as consolidated by Time Team. View S, Scale 0.5. 11/10/2011

- PC to monitor consolidated footpath through northwest bank of Watery Bay Rath
- PC to visit Gateholm with National Trust Ranger to look at backfilled trenches and other erosion issues, especially near the north eastern end of the island

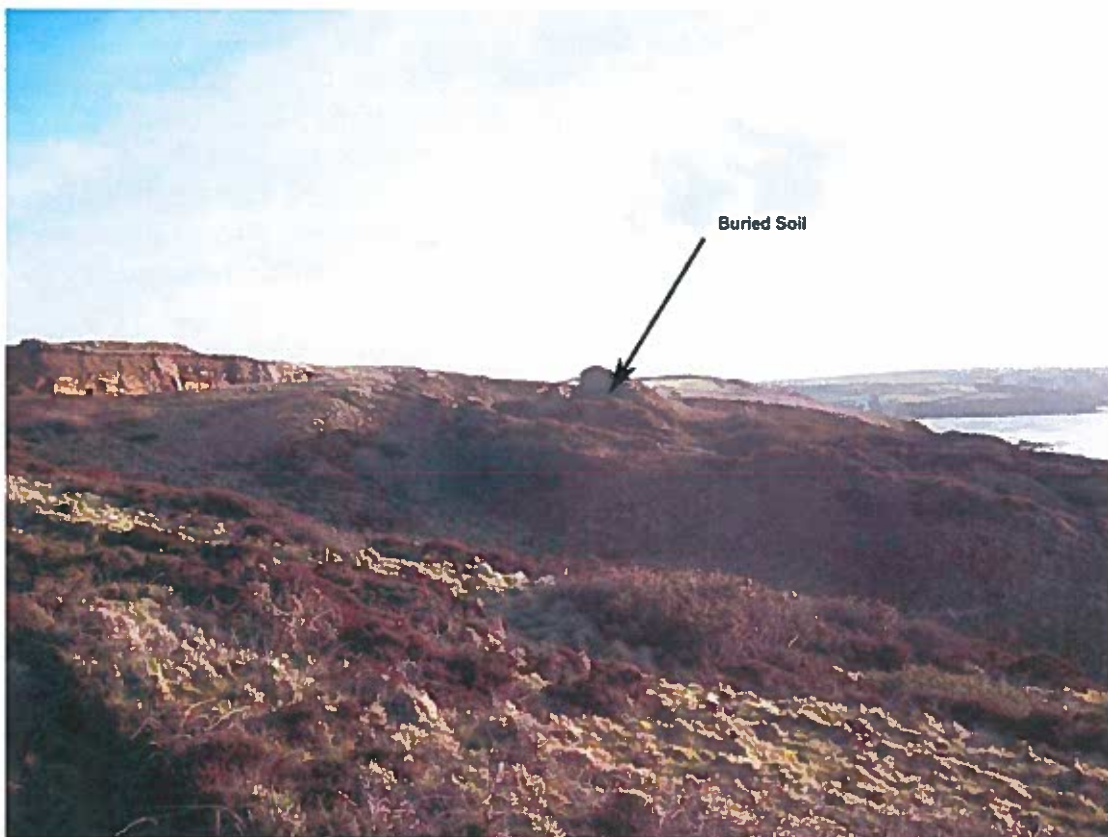
This site is one of the most seriously eroding and fractured of all of the coastal promontory forts. The site was approached on 16/01/2012, but not entered due to working alone. Unfortunately the light conditions were particularly poor. There appeared to be a buried soil, under what is believed to be the remains of the inner bank (see photo). The eroding south side of the site was also photographed. Subsequent enquires were made to see if a Ranger with climbing experience could assist with access to the site to ascertain if samples from the buried soil could be taken and to inspect some of the fissures for any other archaeological features

Blackpoint Rath. Location of possible buried soil. View S.  
16/01/2012

- PC to pursue access possibilities with a view to sampling buried soil for dating and environmental evidence and also any other recording possible
- PC to photograph site from footpath in better light (not late in the day or into the sun)
- PC to see if this site could be monitored by Arfordir Volunteer

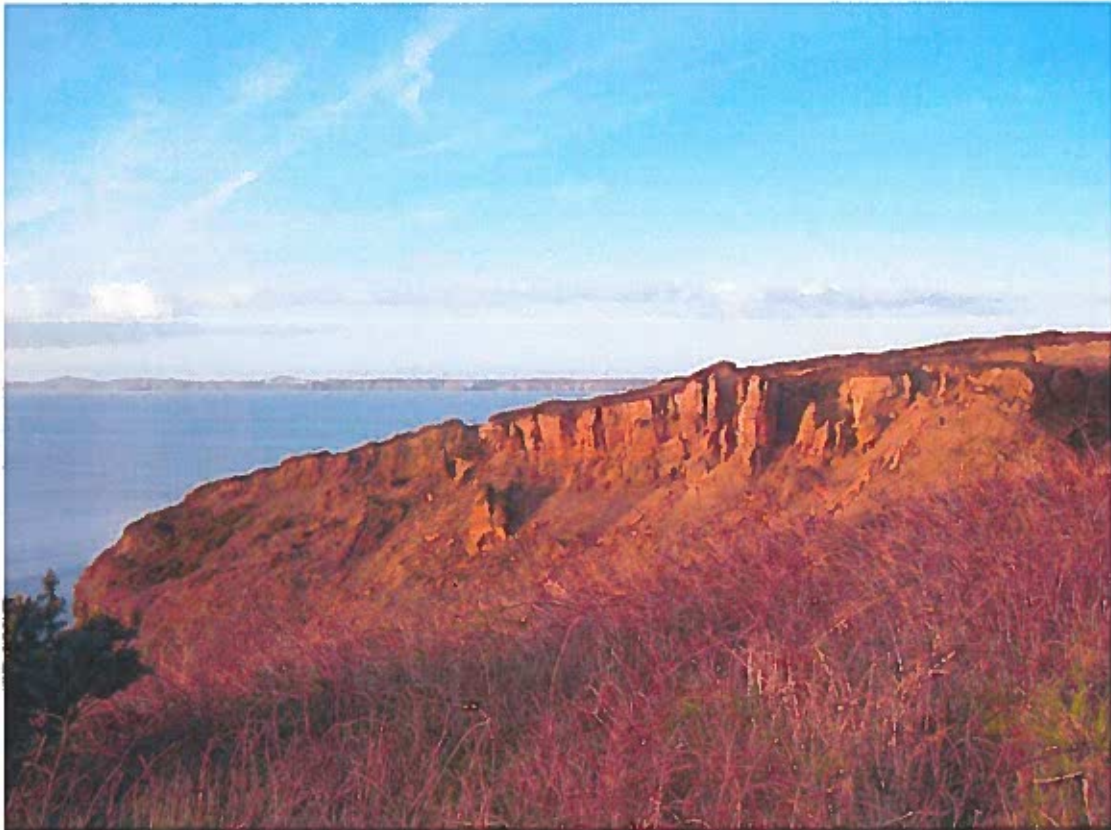
Blackpoint Rath. View N. 16/01/2012

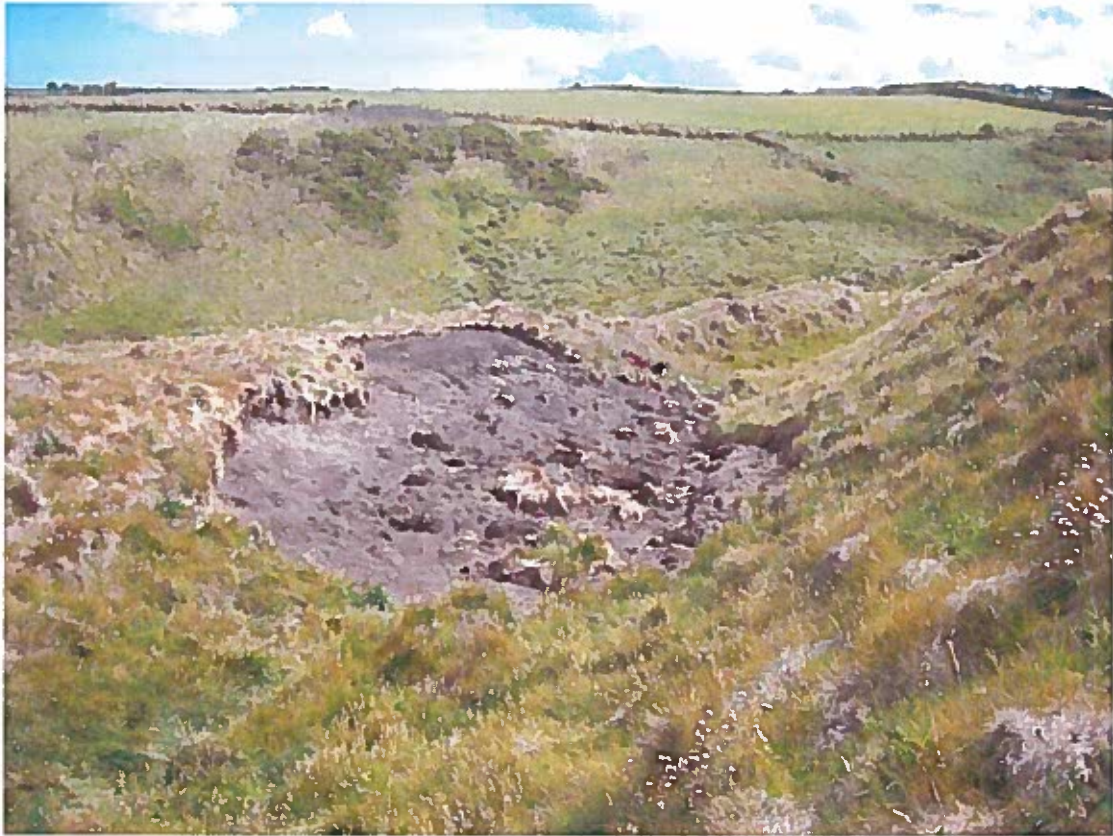
A small fire was reported to PCNPA Oriel Y Parc on 16/05/2011 and this was immediately reported to the Fire Brigade. The site was visited immediately; only a small area c. 2m by 3m had been affected at this stage. The Fire Brigade arrived and were requested to dig as shallow as possible. Unfortunately the fire was well down in the turf and could not be put out. National Trust were to visit next day. National Trust reported still burning and called in Fire Brigade again. Site revisited on 10/06/2011 to record damage. The burn area was located in the second ditch, 10m to NE of cliff edge, extended c. 12.5m along and was maximum of 6m wide. Main disturbance was at the western end and in the south side of the ditch into the second bank. Where dug c.0.3m down by Fire Brigade only in top of ditch fill and no sign of any bank structure. The remaining turf was replaced to encourage re-growth.

Porth y Rhaw: maximum burn area before turf replaced 10/06/2011

- Recommend PC to inspect and record re-growth along with eroding inner bank edge

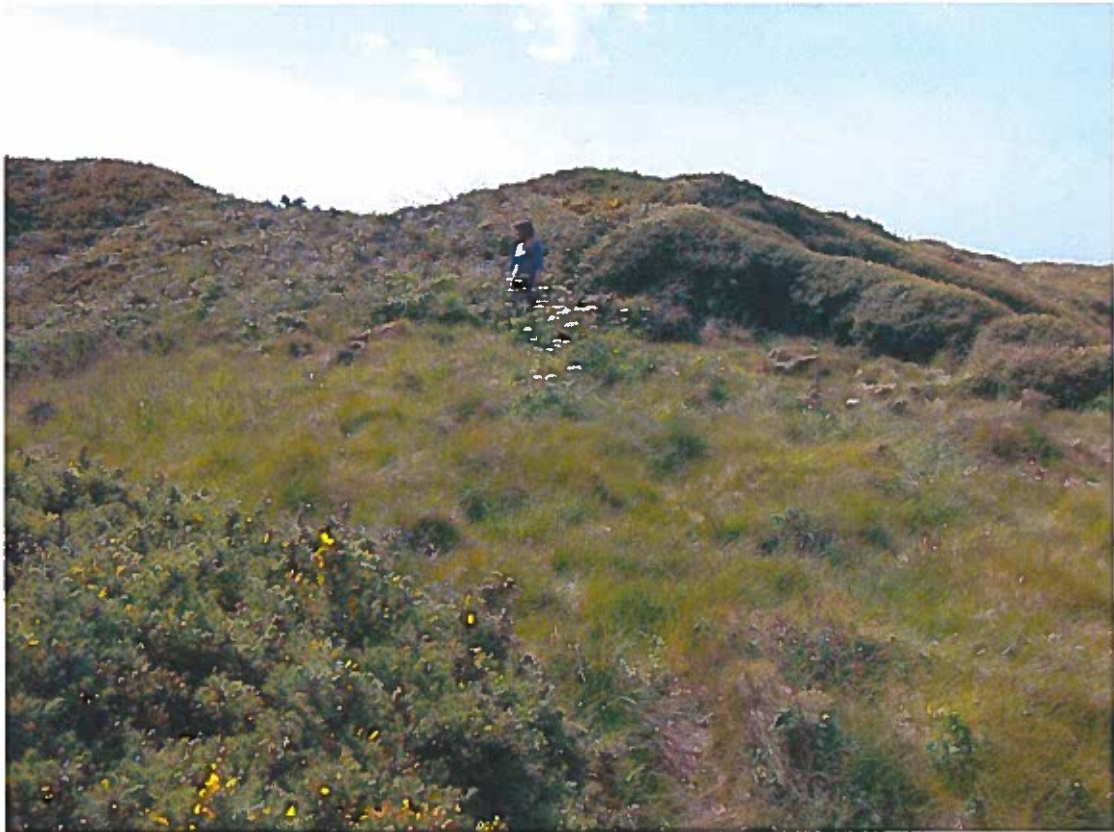
The entrance to this site had become overgrown and subsequently a footpath was being created over the bank causing minor erosion. The site was visited on 19/05/2011. Two separate days (12/10/2011 and 29/02/2011) were spent with the Ranger Haydn Garlic and 4 PCNPA volunteers to clear the entrance. Furthermore arrangements are being made by PCNPA to start grazing the site, particularly as the grass on the interior is becoming long with tussocks forming. This improvement would enable geophysical survey to be more readily carried out. More clearance of scrub on the bank and in the ditches is envisaged.

Tower Point Fort entrance before clearance. View W. 19/05/2011

- PC to visit site in 2012-13 to observe improvements and investigate the possibility of geophysical survey

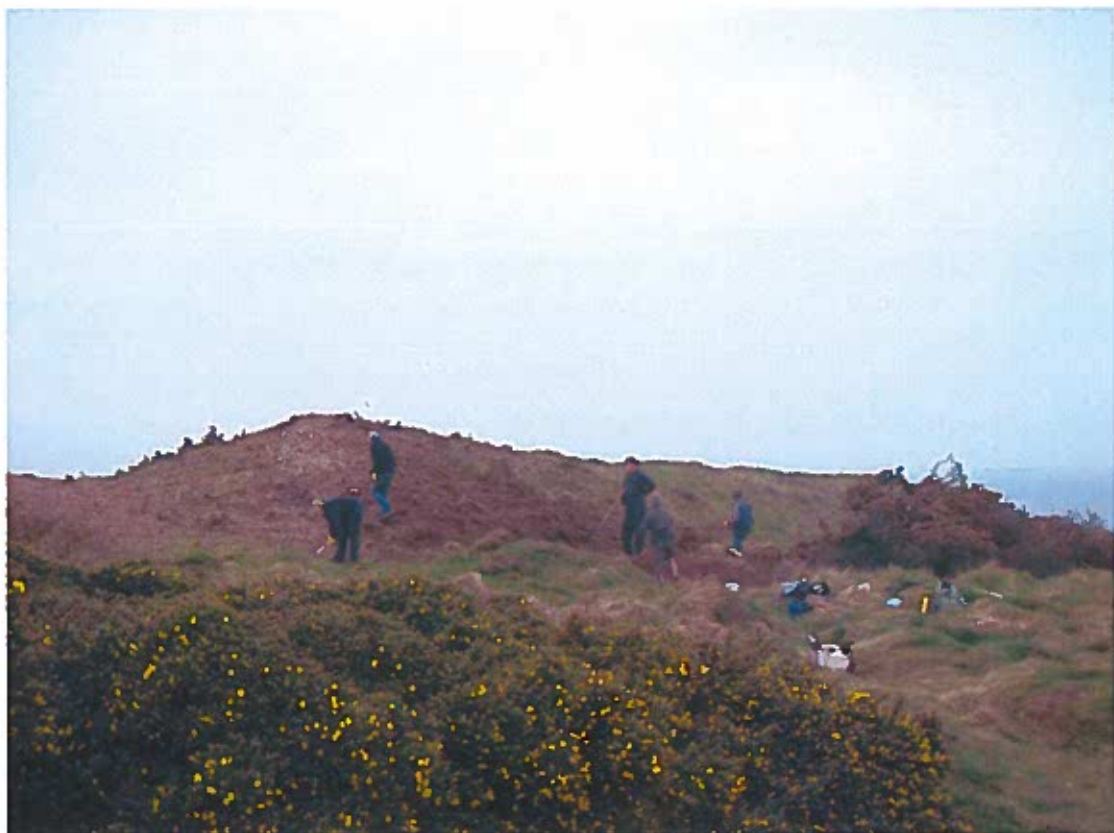
Tower Point Fort after clearing. View NW. 29/02/2012

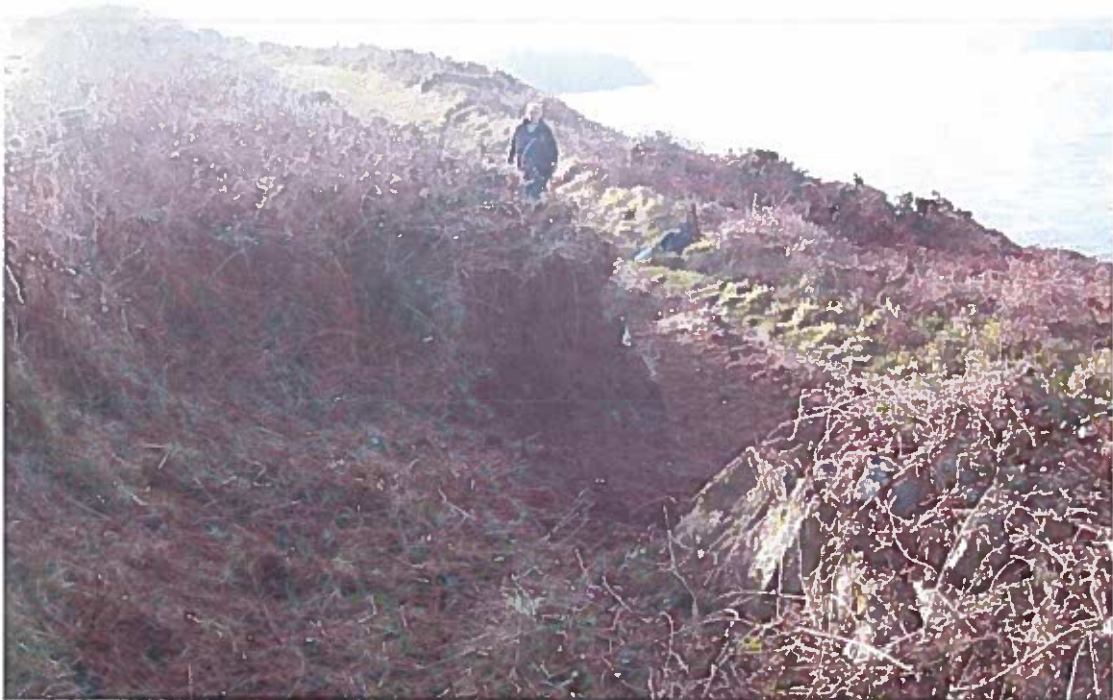
Following the site meeting the coastal path was re-routed along the inner ditch in January 2012. The hedge bank at the southern end of the defences was cut to allow the new path into the inner ditch. At the northern end there was the base of a former hedge bank which was very slightly reduced to remove a trip hazard. Postholes were dug in non-sensitive areas for direction signs at either end of the diversion. The old path has been left as it was. It is not considered that there was any disturbance to the Iron Age elements of this site.

Castell Heinif: cut through hedge banks at south end. View S.  
18/01/2012

- PC: To visit twice in 2012 to monitor new route and erosion
- PG - is a full report necessary?

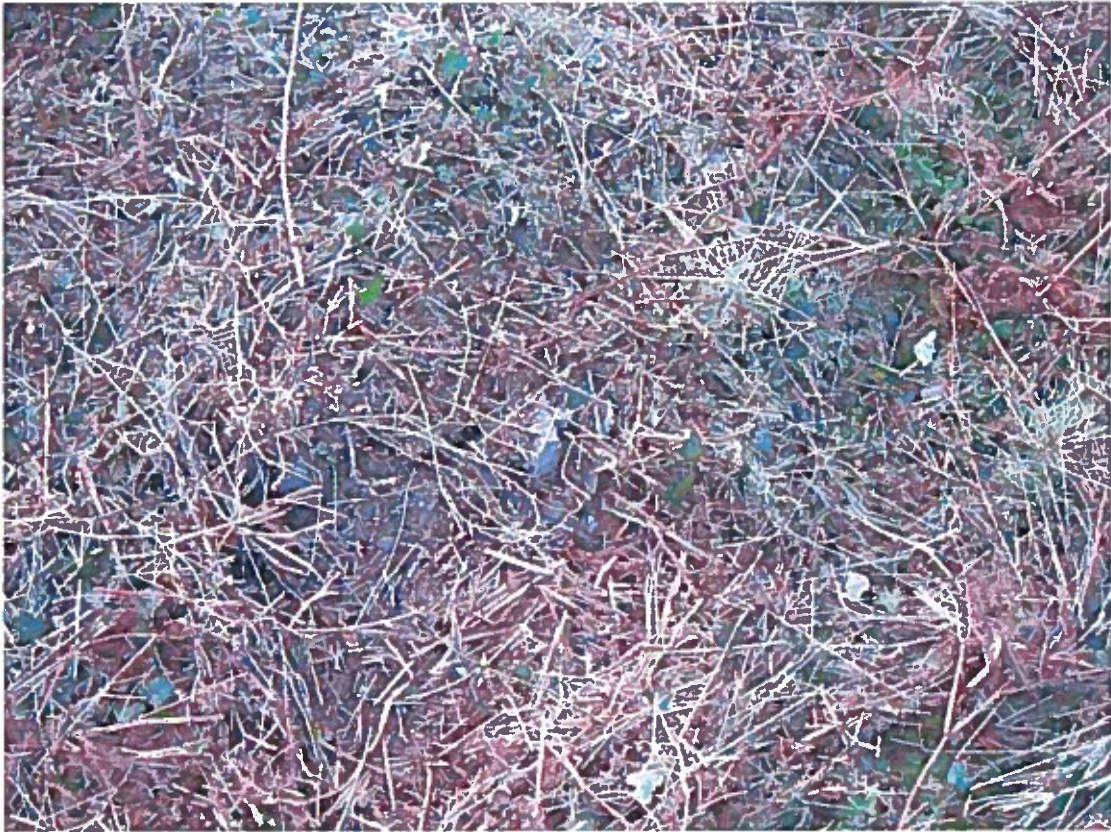
Castell Heinif: edge of hedge bank at north end of inner ditch.  
Removed as potential trip hazard. View S. 18/01/2012

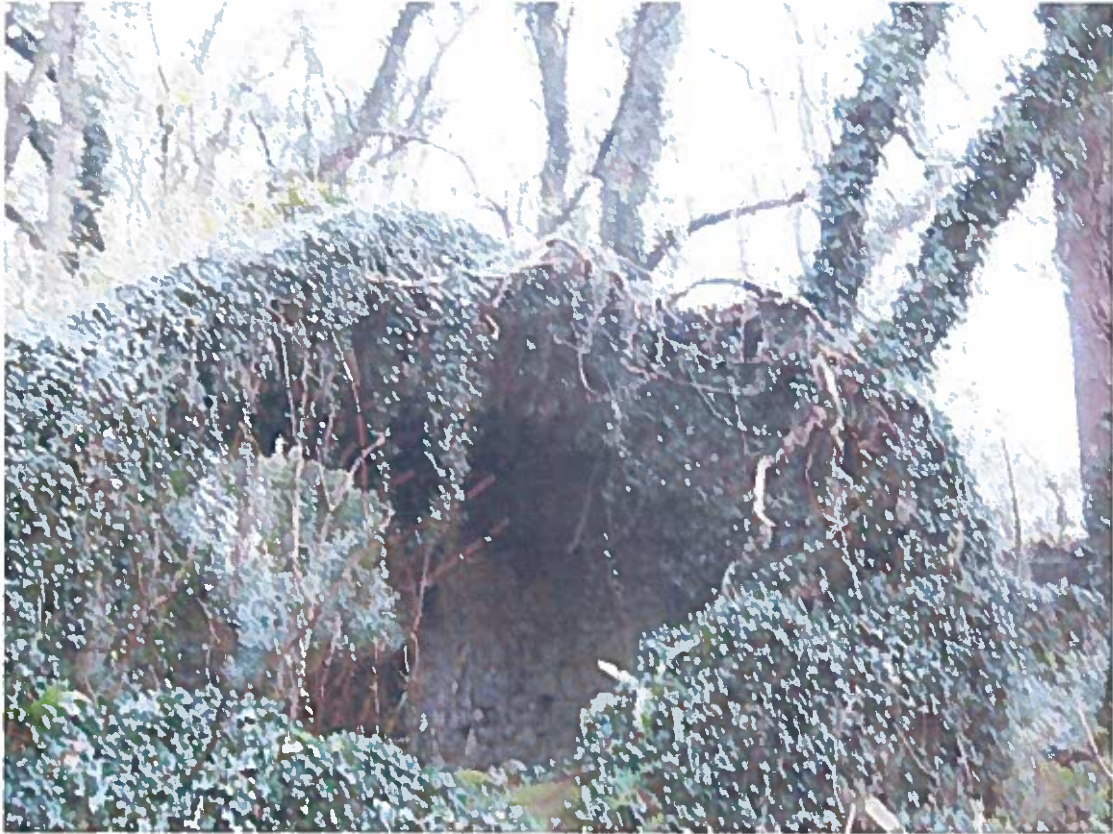
A site visit was finally made on 02/12/2011 after two attempts aborted due to extremely high winds. There was evidence that the two leaning trees on the "Chapel" vault are causing damage to the structure. A very large tree had recently come down adjacent to the south side of the house and a significant limb from a tree to the east. This is likely to exacerbate the movement of the trees on the ruins of the house.

Sisters House, "Chapel" trees causing damage to vault. View NE.  
02/12/2011

Due to continuing issues with the trees on the site and the apparent perception that little could be done, a site meeting was arranged on 20/01/2012. The conclusion was that the site should be cleared of some trees and scrub; the ruins are the most important aspect; vaults will not survive if clearance not done; this would be best for bats; owners consent necessary before any action; subject to consent, management plan to be prepared.

- PC to contact landowner concerning possible clearance and guided walks on site
- Subject to landowner meeting with PCNPA, Conservation to clear trees and vegetation

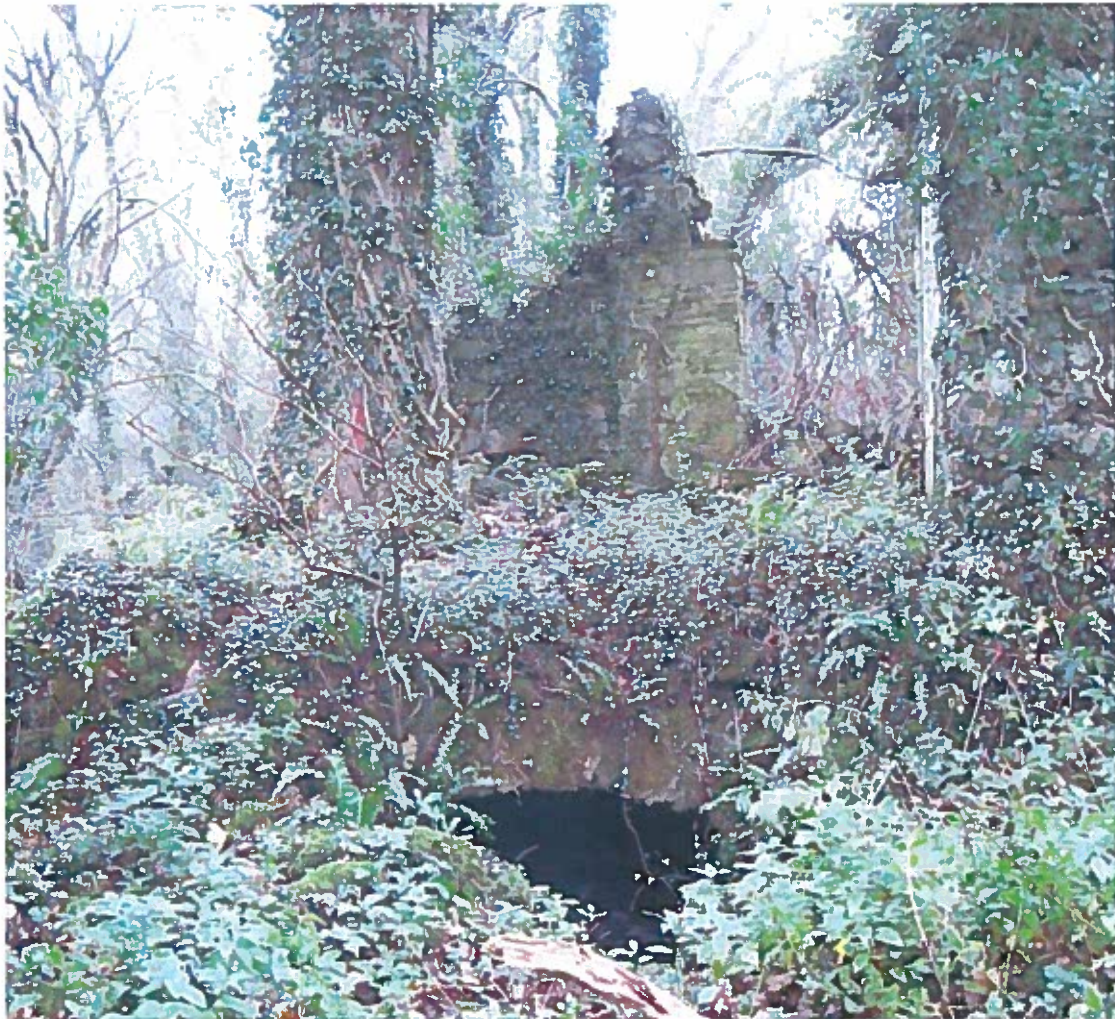
Sisters House, house ruins with large tree on vault. View E.  
02/12/12

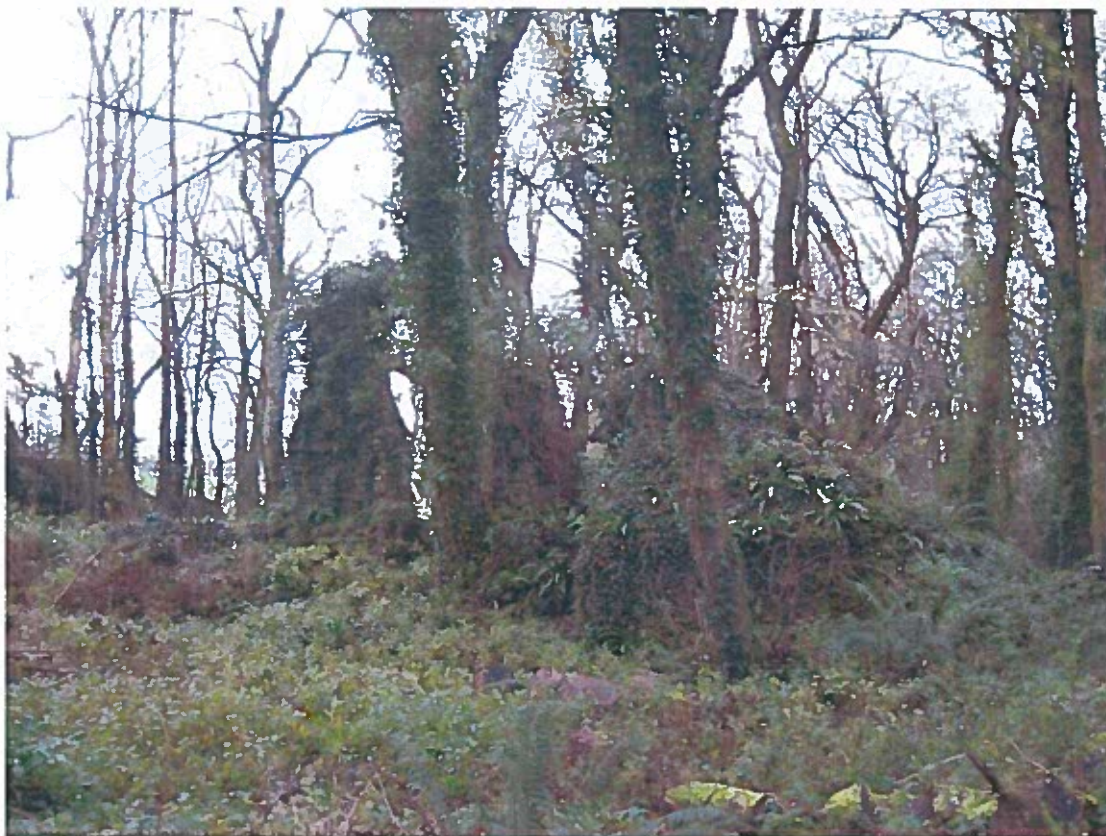
Sisters House, House ruins. View NW. 02/12/2011

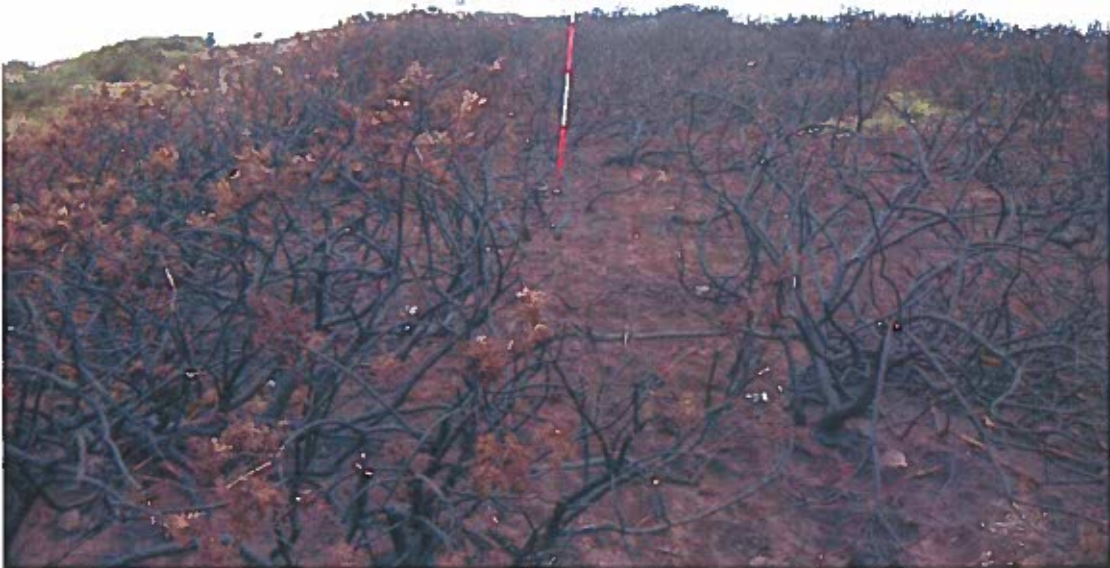
The site was visited on 5/10/2011 after a fire (seen from Solva!). An area of thorn just inside the rampart to the north of the entrance had nearly all burnt. A possible wall line was noted (4 stones in a line), and also a flint flake and a pebble, possibly a small hammer

Deer Park. Part of burnt area. View NNW. Scale 2m. 05/10/2011

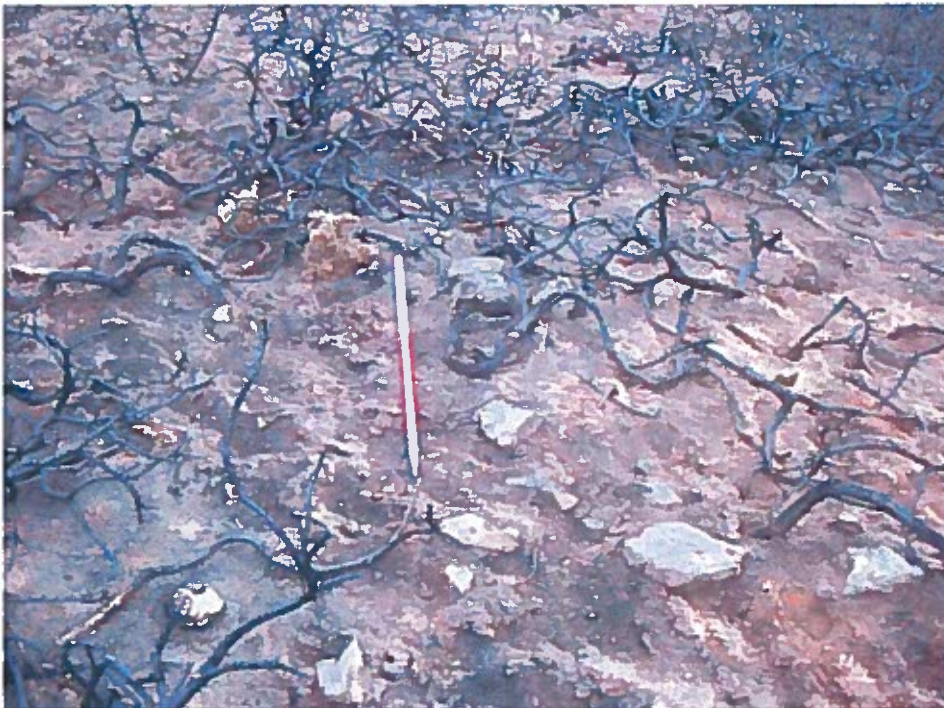
Deer Park: Possible wall in burnt area. View NW. Scale 1m. 05/10/2011

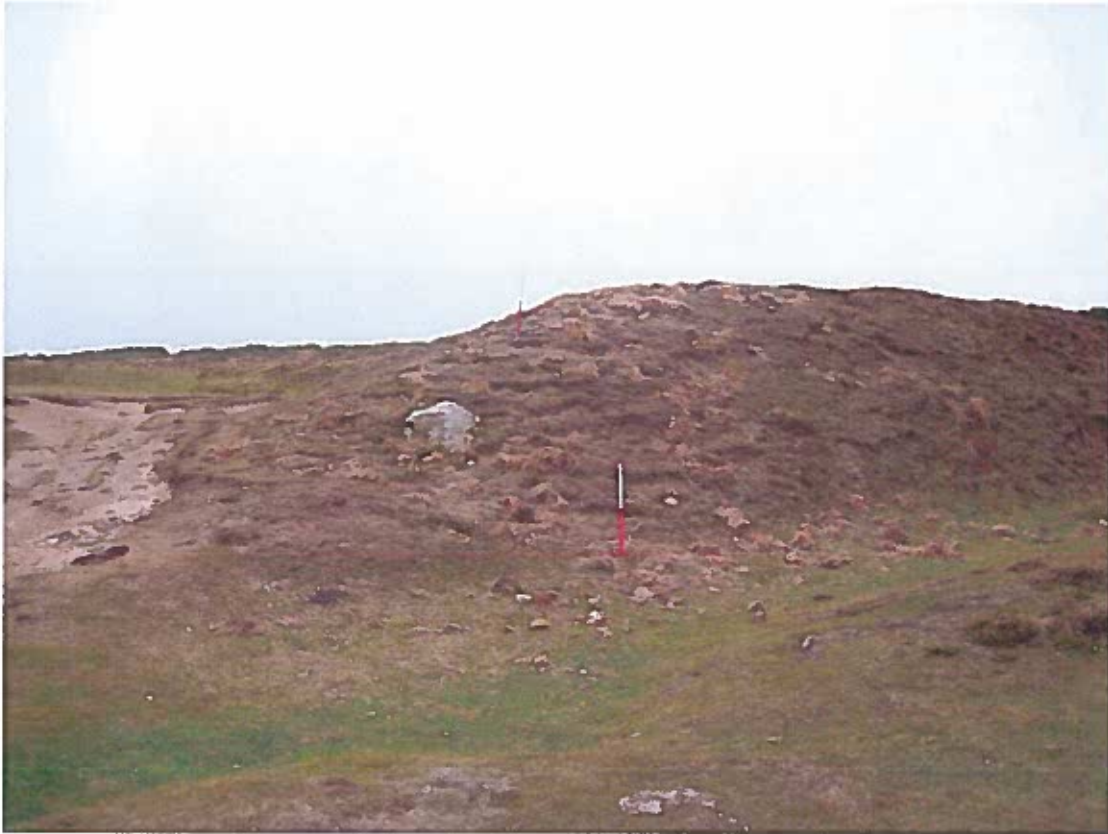
The consolidation undertaken by the National Trust at the southern end of the rampart, has not been successful, probably due to subsequent weather conditions and needs to be done again. Possibly the best time would be early spring when re-growth is likely to be more vigorous.

Deer Park: unsuccessful re-turfing of southern end of rampart. View NW. Scales 1m. 05/10/2011

- National Trust to re-do and possibly extend consolidation at south end of site

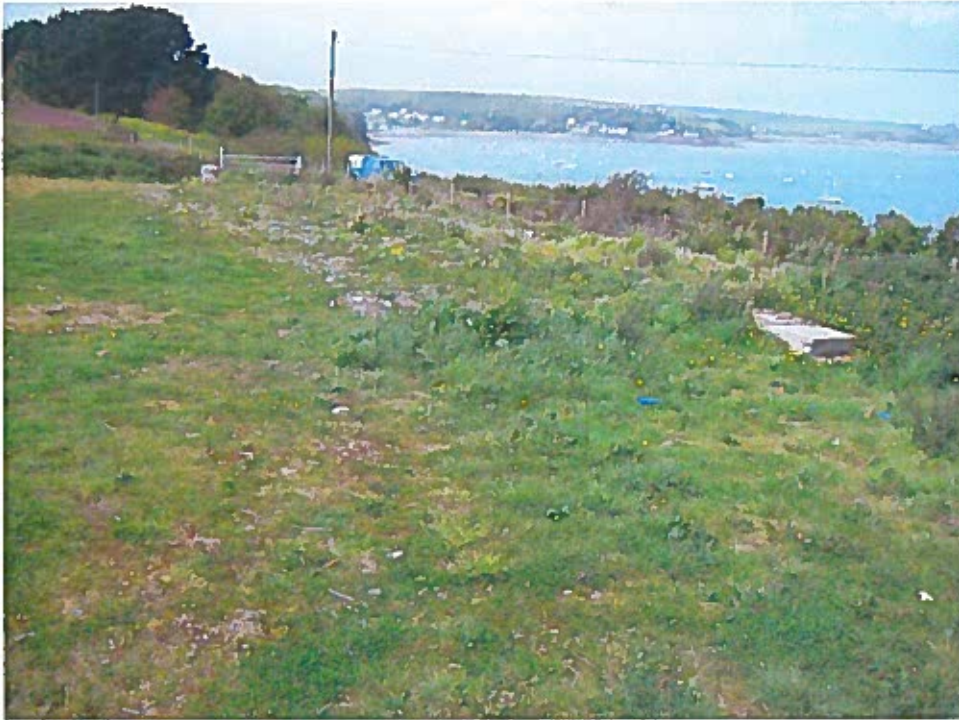
The chicken hut and old compound fencing on the adjacent non-scheduled part of the site was removed by May 2011, but the area is still a bit untidy (see photo below).

Dale Fort area adjacent to north side of SAM. View WNW  
06/05/2011

- PC and PG: A site meeting should be considered to look at possible work on the stones around the entrance and further landscaping of the spoil tip left over from the compound scrape. Possible topographic survey in the near future which could also plot the entire new fence posts and the spoil tip left over from the contractors' compound clearance.
