# CADW SCHEDULED ANCIENT MONUMENTS PCNPA AREA 2011-2

**RHIF YR ADRODDIAD / REPORT NO. 2012/30**

**CADW SCHEDULED ANCIENT  
MONUMENTS PCNPA AREA  
2011-2**

*This report covers visits and work to Scheduled Ancient Monuments in the Pembrokeshire Coast National Park undertaken by Pete Crane during 2011-2012, for Cadw or for PCNPA. Six sites appeared to have been vandalised, remedial action has been undertaken or instigated on three of these. At least two coastal promontory forts have continuing severe coastal erosion, and another two suffered slightly from fire damage. Two sites are recommended for scheduling and another to have its protected area extended. Vegetation was cleared on two Iron Age promontory forts and on another coastal fort which has been advised for scheduling this has considerably improved their condition.*

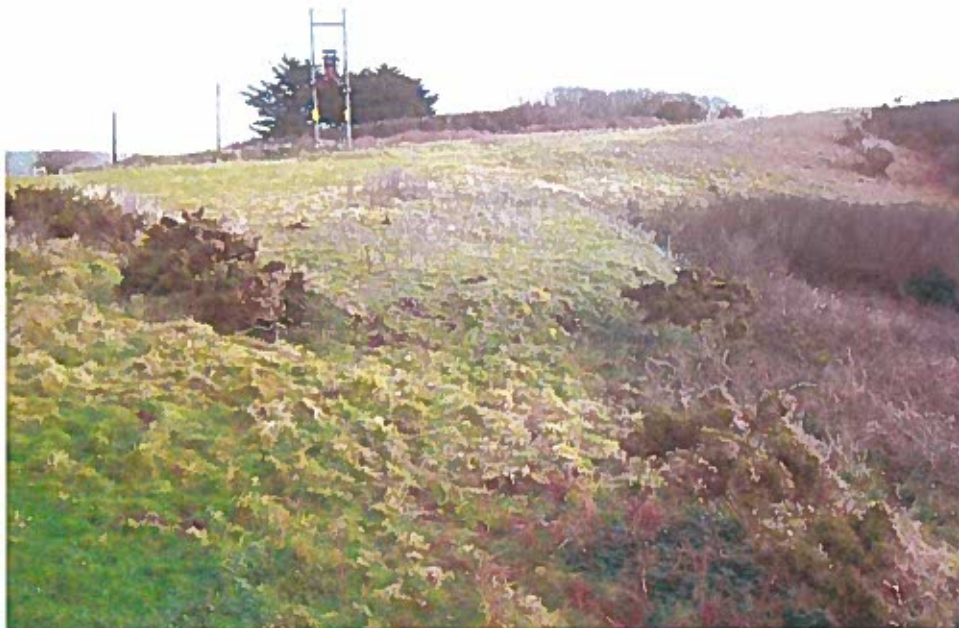
The higher part of the interior within the newly fenced area has mostly been cleared of blackthorn and the horses now grazing the site appeared to be keeping the bracken down (see photos below).

Dale Fort: Interior from bank, south of entrance, "compound clearance spoil tip in foreground" vegetation much reduced by cutting and grazing. View NE 20/01/2012

- PC and PG: A site meeting should be considered to look at possible work on the stones around the entrance and further landscaping of the spoil tip left over from the compound scrape. Possible topographic survey in the near future which could also plot the entire new fence posts and the spoil tip left over from the contractors' compound clearance.

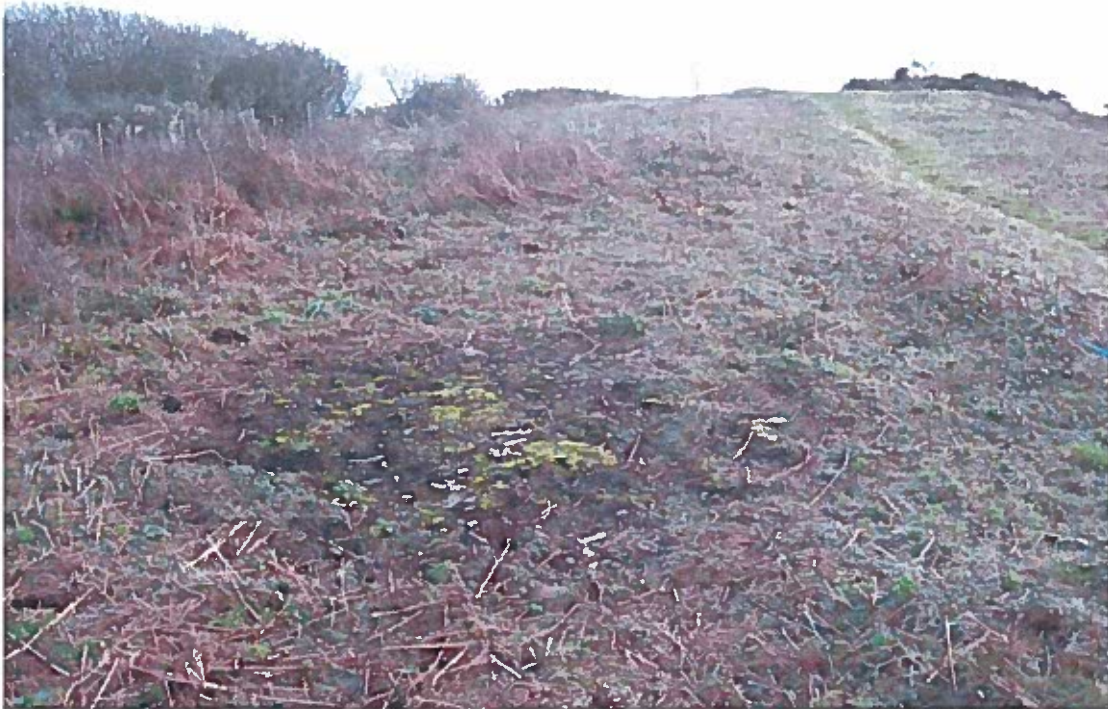
Dale Fort: Clearance on north side of interior View E 20/01/2012

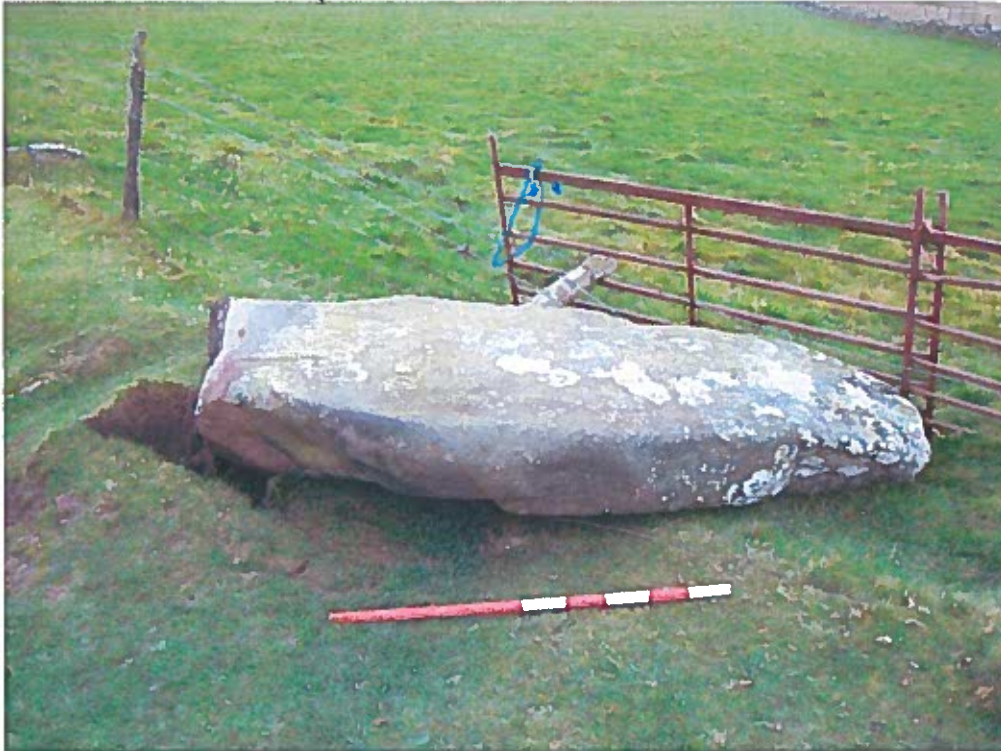
In early October, probably during the weekend of 8-9 October the standing stone was broken off just below ground level. An interview was done for HTV Wales later that week. There were some delays in undertaking the work on the site, partly due to gaining permissions from landowners and other regulatory bodies.

Bedd Morris, broken upper stone. Scale 1m. 10/10/2011

- A report for this excavation is in process
- Kieran Elliot is preparing costs for repair to the stone

- The PCNPA preference is to have the stone replaced in the same location as soon as possible
- PC to take Kieran Elliot to inspect stone to finalise costs
- Soil samples to be analysed
- Charcoal sample to be radiocarbon dated

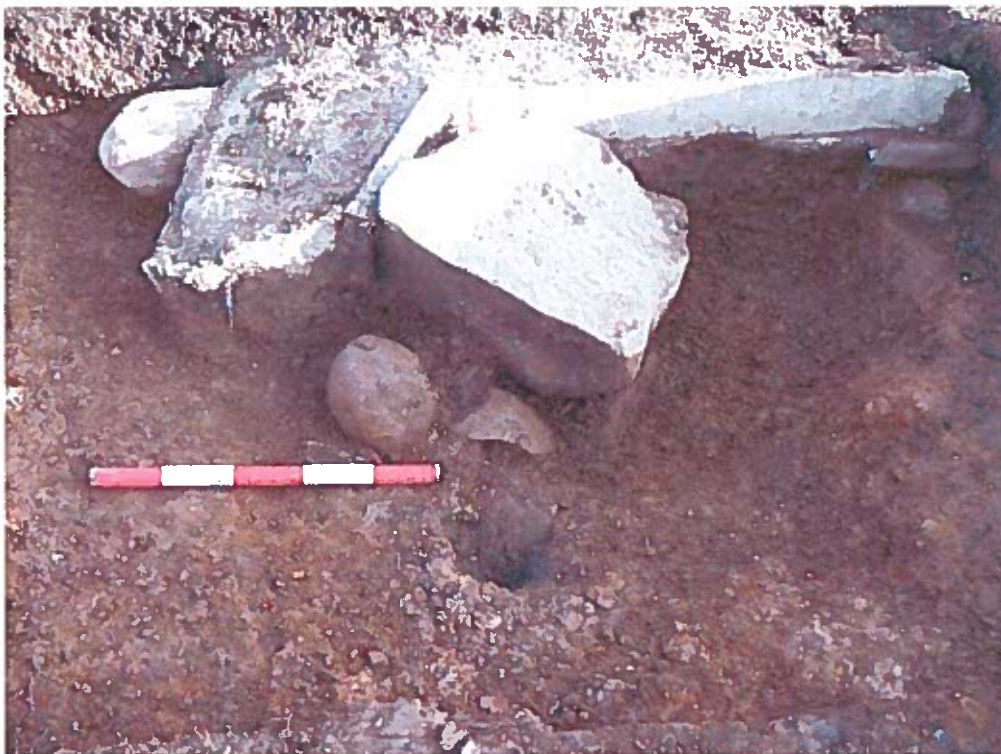
A small excavation was undertaken in early February which indicated that the bottom of the stone was *in situ* complete with hammer stones in the filled-in pit. Adjacent to the stone was a pebbled floor. The stone would therefore appear to be Bronze Age and the major damage was probably done a few years ago when the stone was hit by a lorry. Both parts of the stone are now on a nearby farm.

Bedd Morris, base of stone, hammer stone and concrete repair. View E. Scale 0.5m 08/02/2012

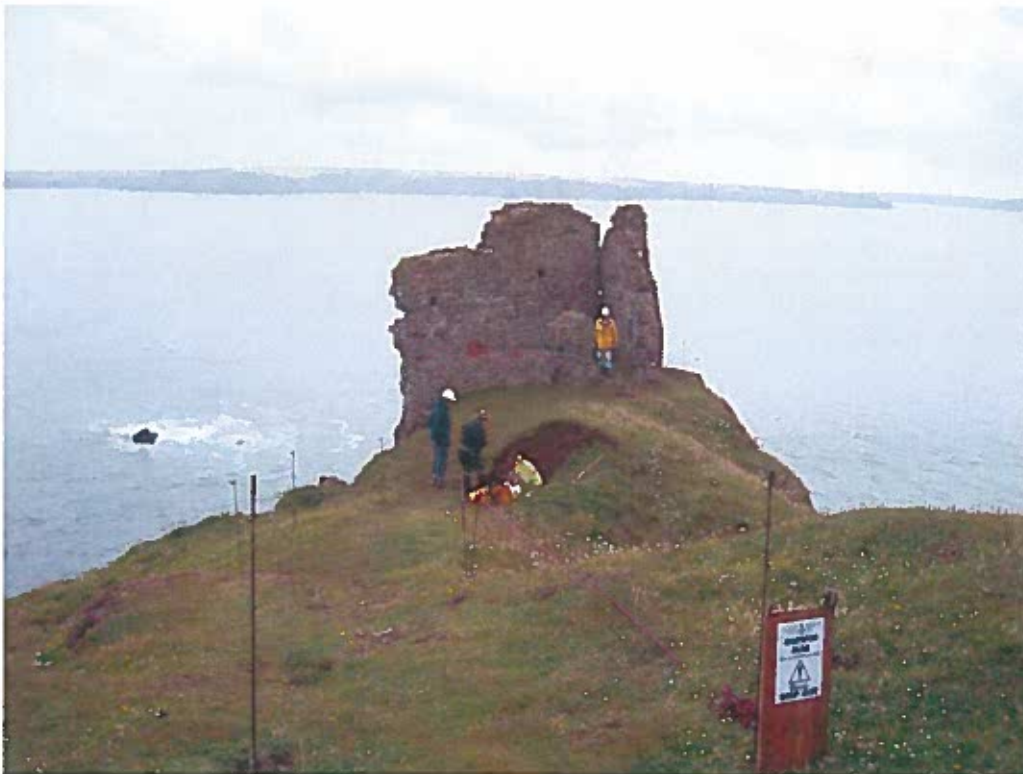
East Blockhouse Angle during excavation. WWII gun pit in front of the building being investigated.

The remains of this site are on a cliff edge which suffered a large land slip in the winter of 2010-11; when a further slip occurs it will probably render this site unsafe for further excavation, hence the necessity for this rescue dig. The work confirms the historical records that the building was never finished and furthermore that it was substantially cleared out during World War II, when it became a defended lookout. The scant remains of another building, recorded in the 1990s as already lost, were identified, but as they were right on the cliff edge it was considered too dangerous to investigate further. One WW2 gun pit was excavated together with a platform just inland that turned out to be natural. A geocache is in use within a probable putlog hole, and was the reason for three visiting groups to the site: its location is not envisaged as a problem; a short report is in progress and will be accessible via the DAT web site.

- It is recommended that this site is monitored at least once a year, preferably in the spring as landslips are more likely over the winter. Of particular importance are the scant remains of the second building, more of which may be revealed as the cliff edge erodes.

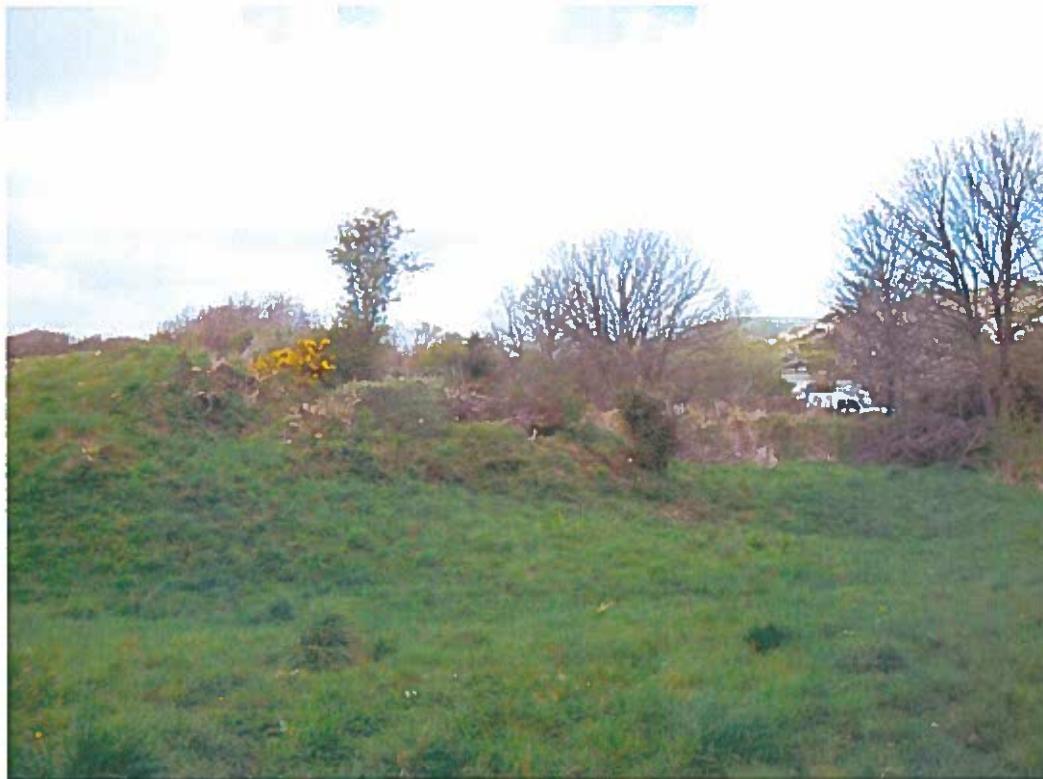
There was undergrowth over the east side of the ring work. There did not appear to be any recent badger activity, but there was some Japanese Knotweed to the north of the scrub on the bank

Old Castle, Newport, scrub on east side of ringwork. View NW  
15/04/2011

- PG: - Is a separate report required on the panel base hole?
- PC monitor scrub and burrows annually

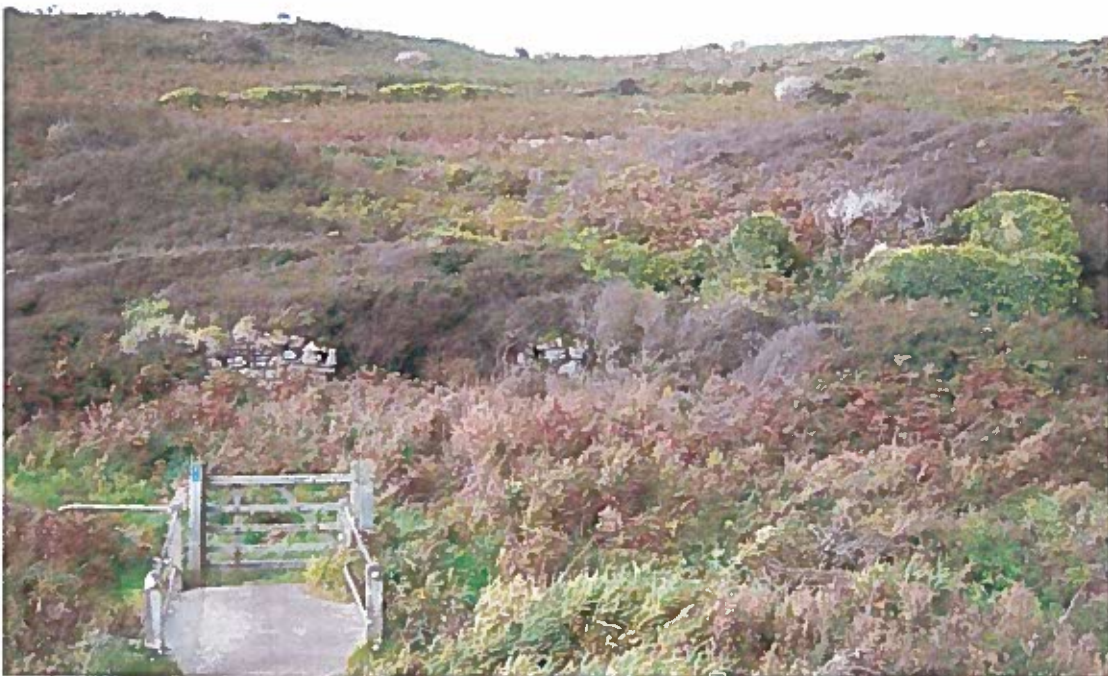
PC met with CCW officer to enquire about the Tir Gofal agreement with the landowner of Caerbwdy Mill. A site visit was made on 19/09/2011; no clearance of the site had been undertaken. Much of the machinery is still within the building. At short notice a Ranger and volunteers became available to start clearing on the site. However, the Ranger met the "owner" and evidently there is some dispute about ownership of the site and also the intentions of the current occupier may not be in keeping with PCNPA planning. Therefore after a brief discussion between the Ranger and PC it was decided that PCNPA should not be involved at this stage with any work on the site.

Caerbwdy Mill, overgrown. View W. 19/09/2011

- PC to visit the site late in 2012 to see if any work has been done to the site as part of the Tir Gofal agreement.

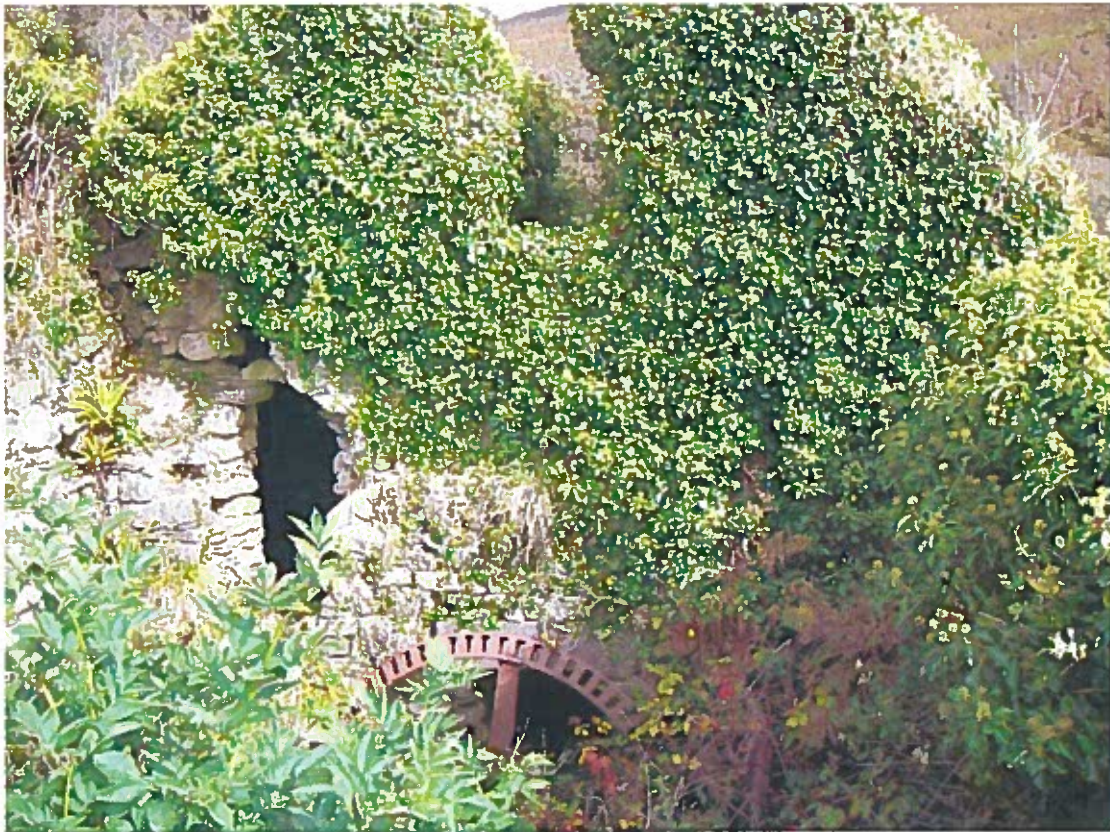
Caerbwdy Mill, remains of walls and machinery. View N. 19/09/2011

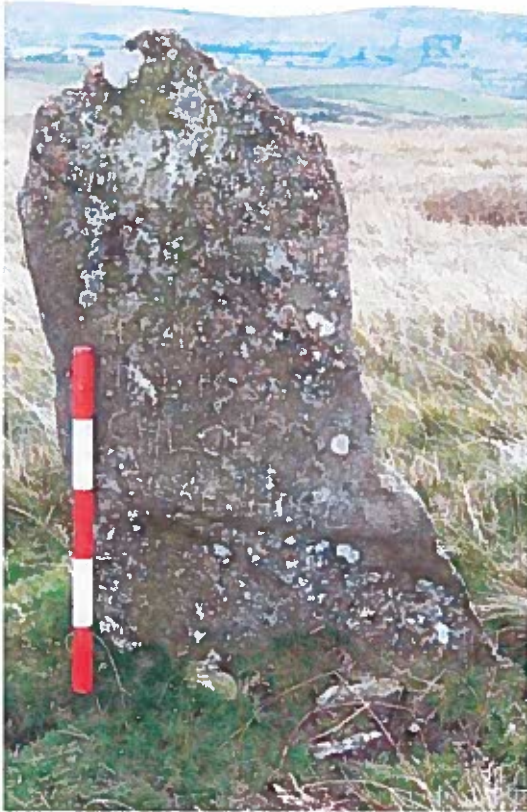
After visit on 15/09/2011: Reported graffiti on the stone re-erected previously, to Cadw, local Police and Chief Inspector Mark Harrison (English Heritage Policing Advisor, who was most helpful). Local PCNPA Ranger Richard Vaughan made a number of inquiries to trace possible suspects but no results to date. After consultation it was decided at this stage not to treat the graffiti in any way, but let nature take its course. However, it is considered that if this graffiti remains obvious it may well encourage further vandalism to the

Bedd Arthur Graffiti on stone 15/09/2011

- PC to visit early in spring 2012 and after the summer 2012

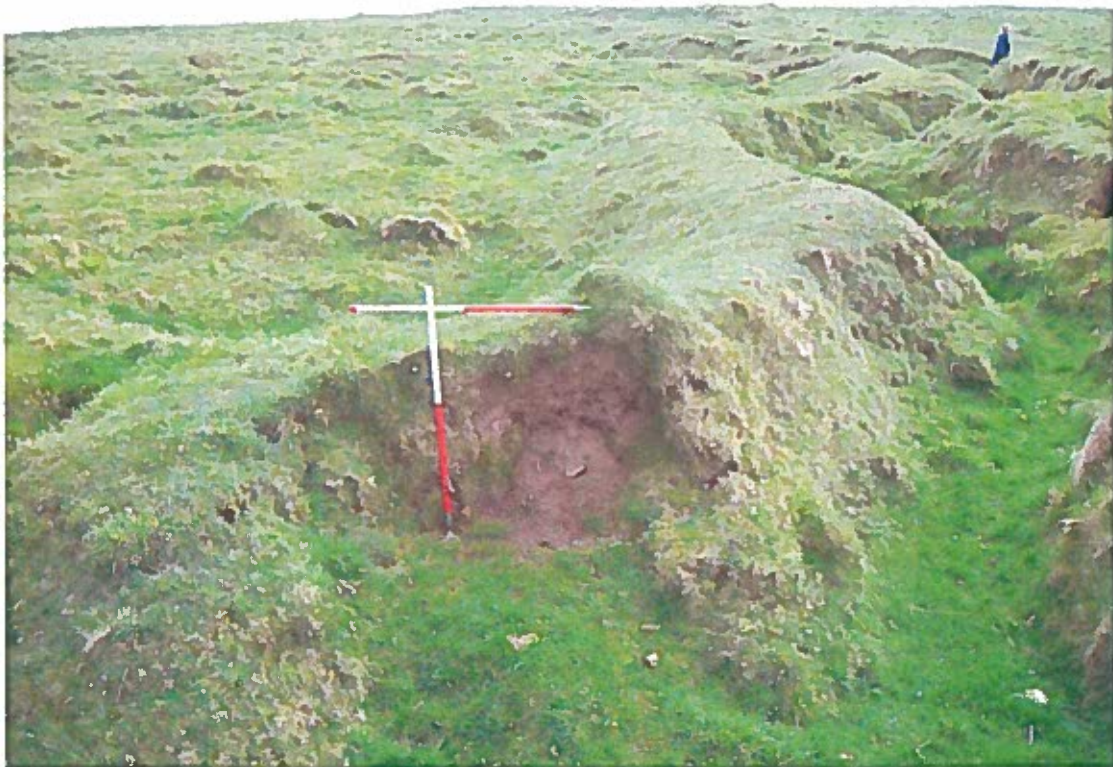
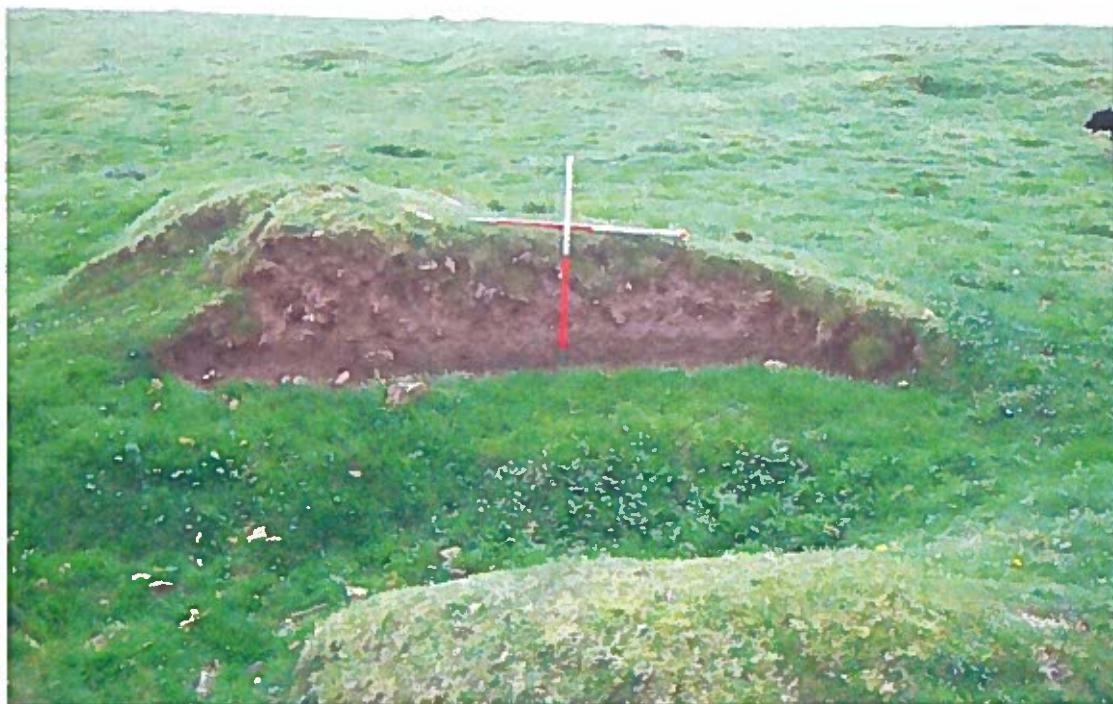
A site visit was made with Anna Sutcliffe of Landmark Trust for the MoD to look at grazing issues, notably sheep scrapes, plus some rabbit activity on 14/04/2011. The scrapes are not too bad at the moment and no action or infilling is necessary at the moment.

Penally WWI trenches, sheep scrape 14/04/2011

- Recommend detailed plot and photo of scrapes and holes then monitor at yearly intervals
- Possibly very small notices about WWI trenches could be placed on nearby Coastal Footpath gates

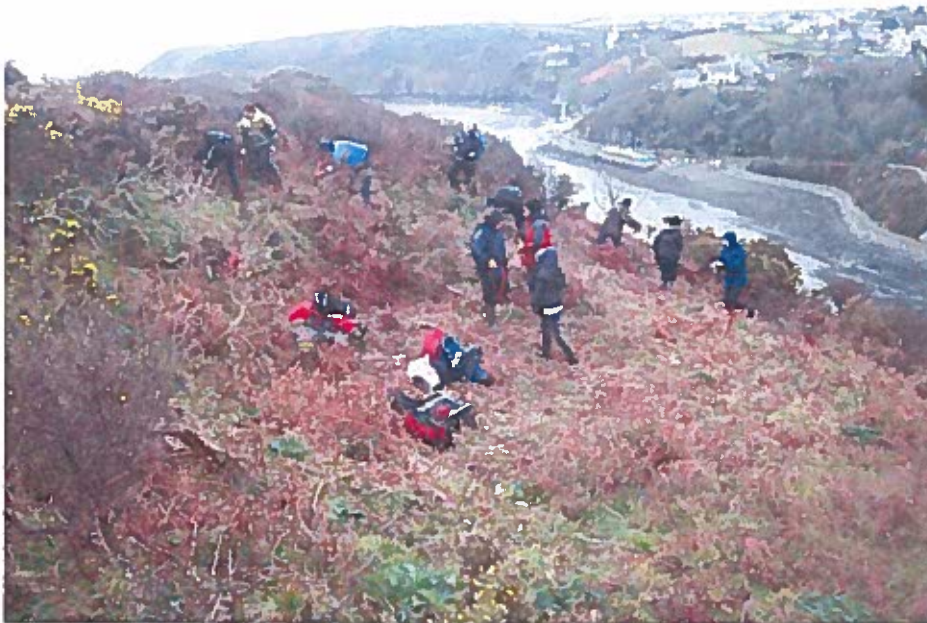
The National Trust with a little assistance from PCNPA Ranger and Portfield School pupils and PC have nearly cleared the site. The number of hut platforms visible has increased from about 8 to 15. After consideration it was decided that this site was more suitable for a professional EDM/GPS survey rather than using Arfordir volunteers due to the site's complexity and steep nature of the site: Louise Barker from RCAHMW and PC are due to undertake a topographic survey of the site at the end of April 2012.

Solva Ridge Fort: vegetation being cleared with National Trust and PCNPA plus Portfield School pupils. One of the hut platforms in foreground. 26/01/2012

- Recommend scheduling site when the site plan has been produced
