**ST MARY'S CHURCH, FISHGUARD,  
PEMBROKESHIRE  
ARCHAEOLOGICAL EVALUATION  
(NGR SM 95801 37041)**

EVENT RECORD NO. 117963  
REPORT NO 2019-18

July 2020

**ST MARY'S CHURCH, FISHGUARD,  
PEMBROKESHIRE  
ARCHAEOLOGICAL EVALUATION**

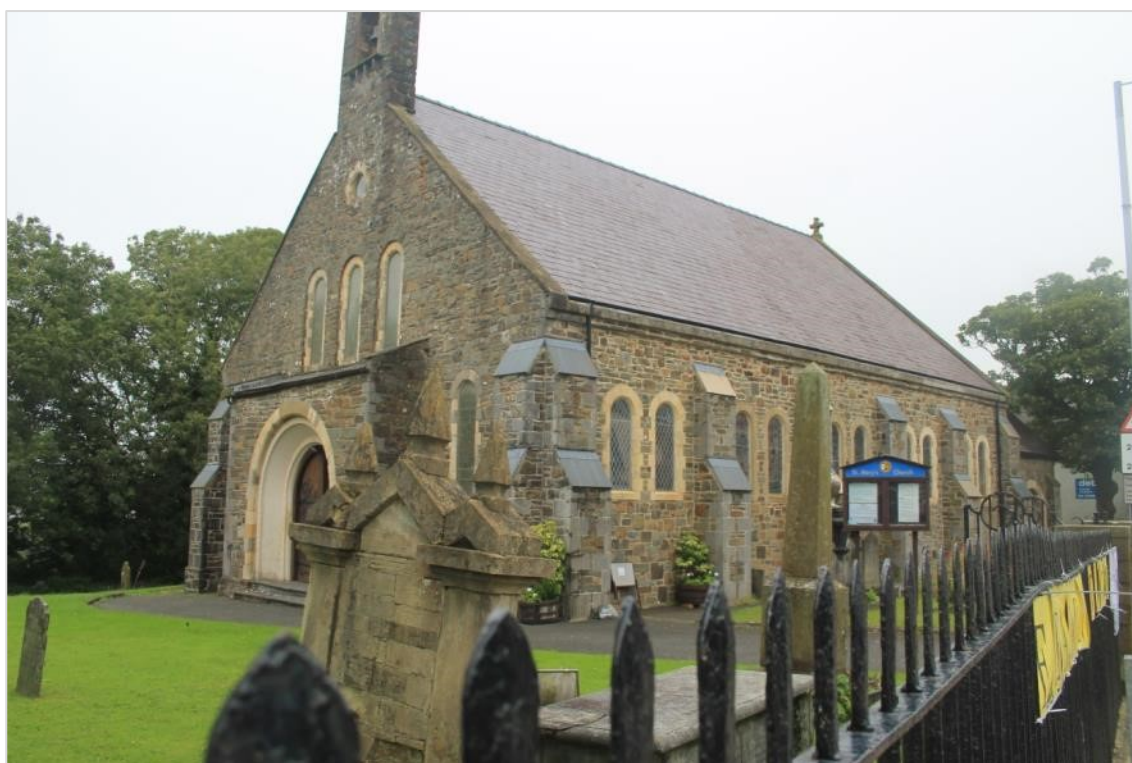
**Photograph 1:** St Mary's Church, Fishguard.

- 1.1.1 The Grade II listed current church of St Mary's in Fishguard was built in the 1850s (PRN 17326, Grade II LB 12299) (Figure 1, Photo1). However, it is believed to have been built on the same site as a medieval church (PRN 2535), recorded in the 1291 Taxatio, when it was in the possession of St. Dogmael's Abbey. Roughly 20m to the north of the church is a sepulchral stone dated to c1500 (PRN 58601).

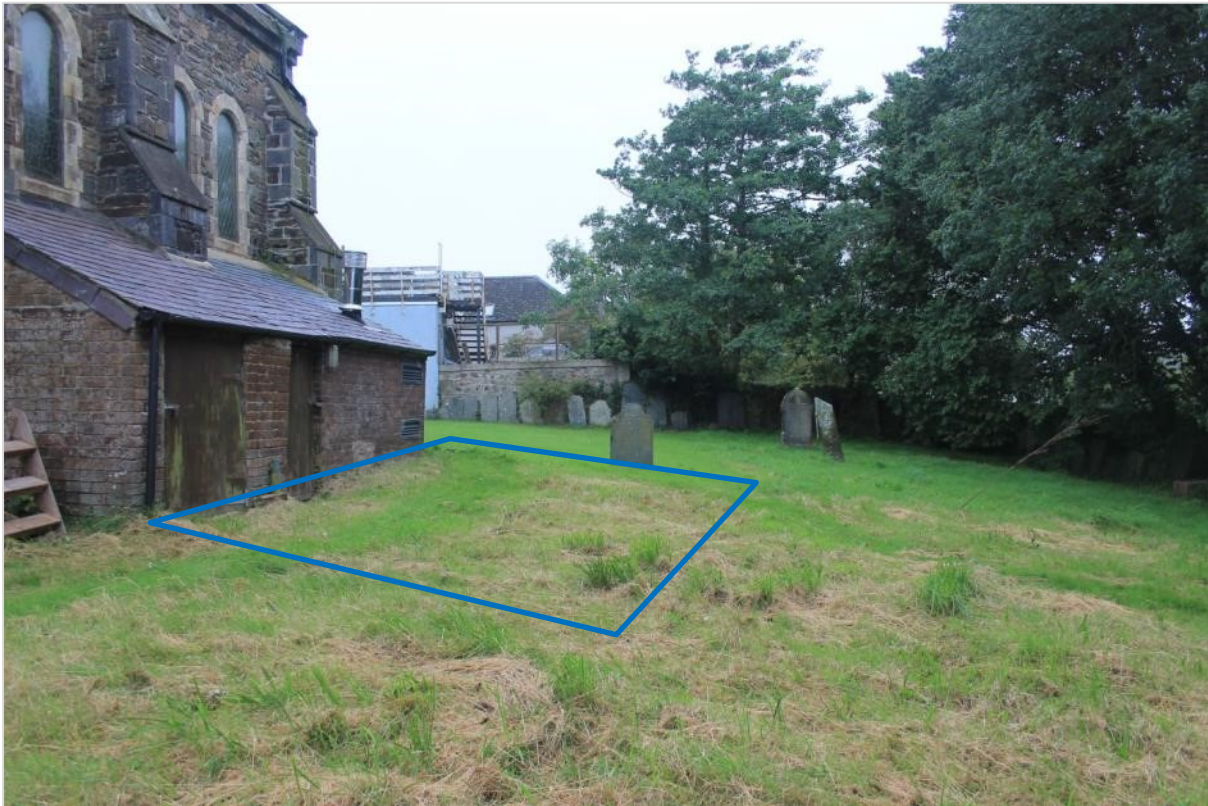
**Photograph 2:** View looking west showing the approximate position of the smaller extension proposed in April 2019 outlined in blue.

- 1.1.6 In April 2019 DAT Archaeological Services were commissioned by Bluestone Builders to undertake the archaeological evaluation. However, due to funding constraints a smaller extension was now planned measuring approximately 6.5m by 5m (outlined in blue in Figure 2, Photo 2). In addition a change had been made in the design of the building's foundations from standard excavated foundations to a raft foundation; which would require a shallower depth of only 450mm to be excavated within the footprint of the extension. The arrangement for a soakaway had also been withdrawn. Drawn plans for this change in design were not available at the time of the evaluation. The evaluation was undertaken across the whole footprint of the proposed smaller extension as shown in Figure 2.

- 3.1.1 An area approximately 6.5m by 5m (Figure 2, Photo 2) was stripped by mechanical excavator using a flat bladed bucket, under archaeological supervision. The area was machine excavated to remove all non-archaeologically significant overburden down to a depth of 600m, unless before this depth either significant archaeological levels or the underlying natural undisturbed ground surface were reached.

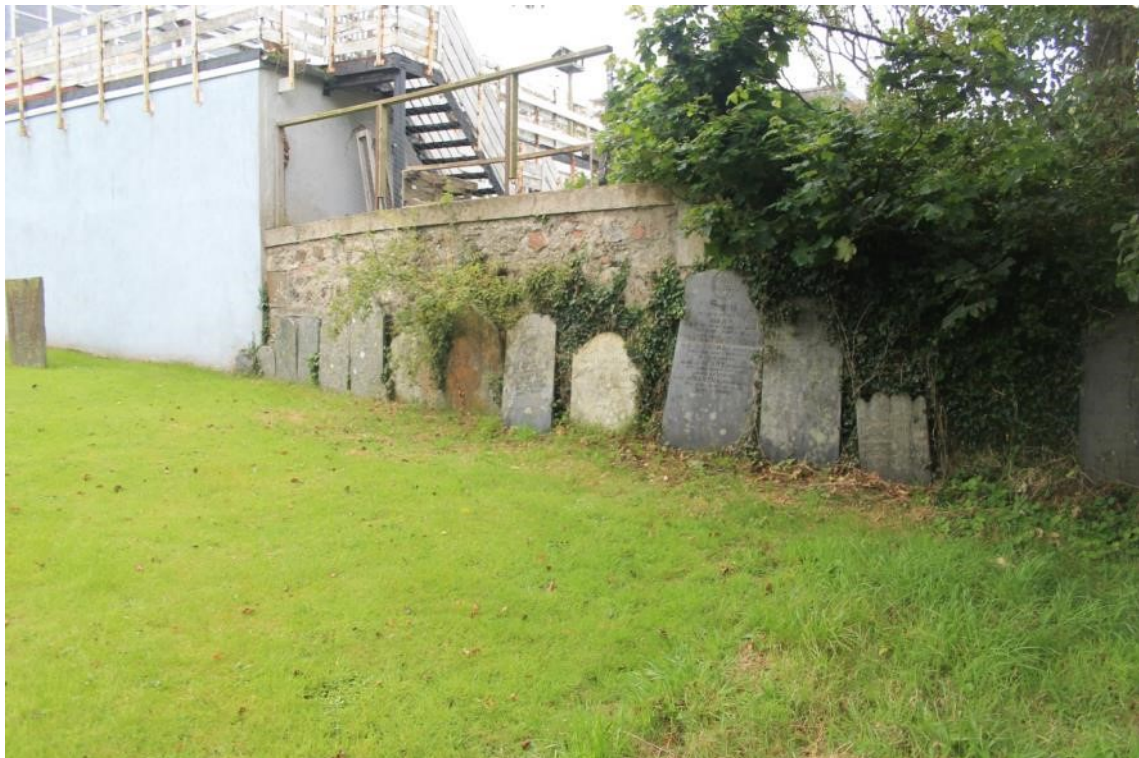
**Photograph 3:** View of St Mary's churchyard showing the gravestones moved to the perimeter of the area.

- 2.1.1 St Mary's Church lies within the coastal town of Fishguard, Pembrokeshire (centred on NGR SM 9580 3703). Modern Fishguard consists of two parts, Lower Fishguard and the "Main Town". The main town contains the parish church, the High Street and most of the modern development, and lies upon the hill to the south of Lower Fishguard which is clustered around a quay. The two areas are joined by a steep and winding road.
- 2.1.2 The church is surrounded by a small churchyard. The last burial within the churchyard took place sometime in the early 20<sup>th</sup> century. Over the years many of the gravestones have been moved to the perimeter of the churchyard (Photo 3)

- 2.3 In the churchyard many of the gravestones have been moved to the perimeter of the churchyard (Photo 3).

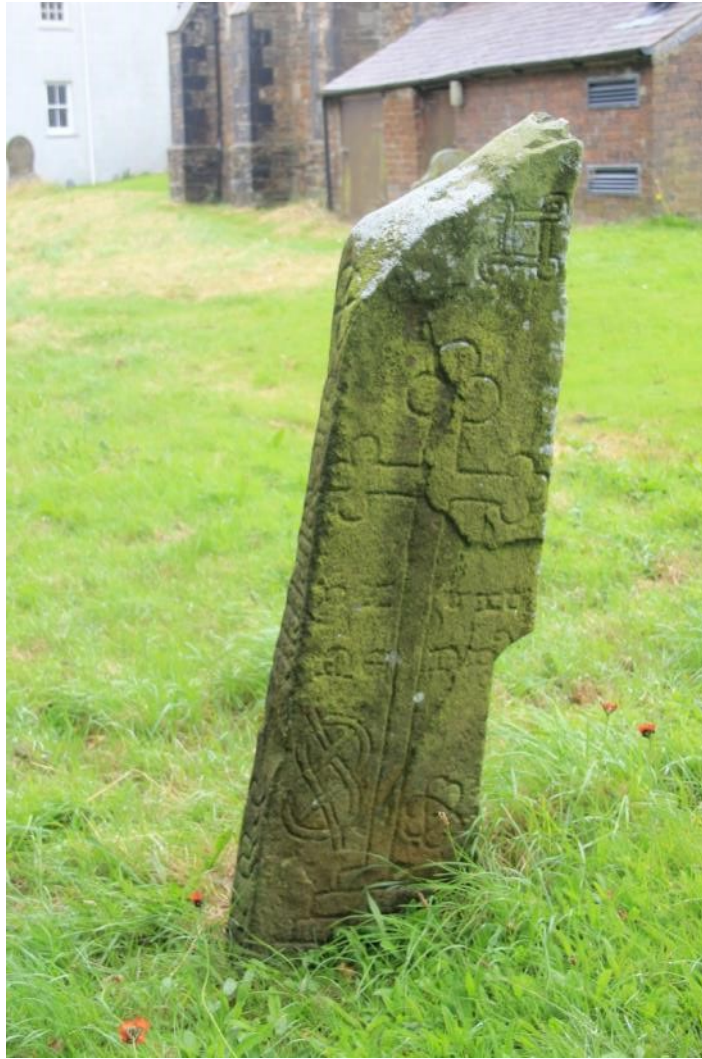
**Photograph 4:** An inscribed stone dated to c. 1500 that stands within St Mary's churchyard.

- 2.4 Standing within the churchyard is an inscribed stone (PRN 58601) situated some 20m north of the church front door (Photo 4). It is Grade II listed (LB Ref 12300), and its listing describes it thus:

*Sepulchral stone dated to c1500, but possibly of several dates. The stone was noted in the churchyard in 1856. The stone is approximately 1.5m high and inscribed with a Latin cross with trifoliated terminals on a 4-step base. Small and crude square Celtic knot above and 2-cord plait to left, trefoil to right formed of 3 interlocked hearts, and an inscription 'Dauid Medd' ', interrupted by the cross shaft. The 2 thin sides are also lettered. The left side has Gothic lettering 'dne miserere & ddme' while the right side has Celtic letters 'ihcpc a' d' m'd'i' .*

*The inscription David Medd is in letters dated to the C13-C14, the Gothic left side inscription has been read as Domine miserere me with the '& dd' representing 'uie David' or son of David, in Greek. The right side is interpreted as ihc xpc Ano Dni Mdi, or Jesus Christ AD 1501. The memorial has been linked to David Mendu, vicar in 1535, but the lettering generally looks earlier.*

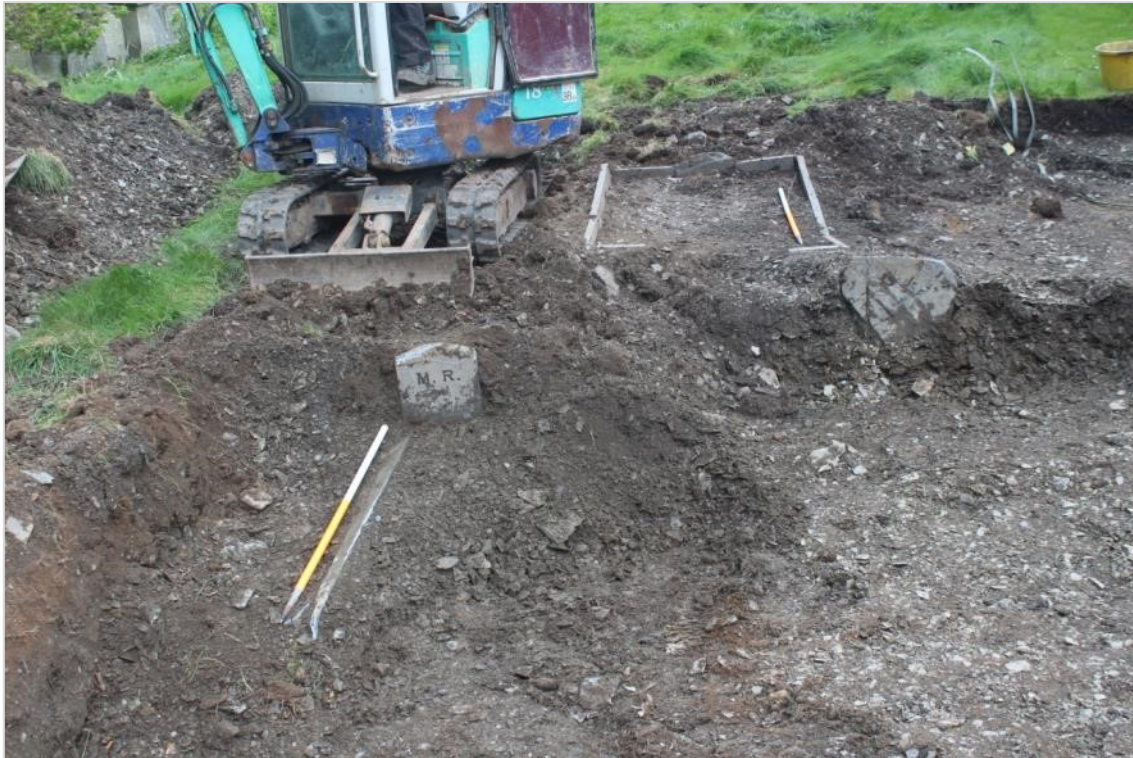
**Photograph 5:** Looking east showing 19<sup>th</sup> century foot stones and surviving grave kerb stones revealed after removal of turf and topsoil. 2 x 1m scales

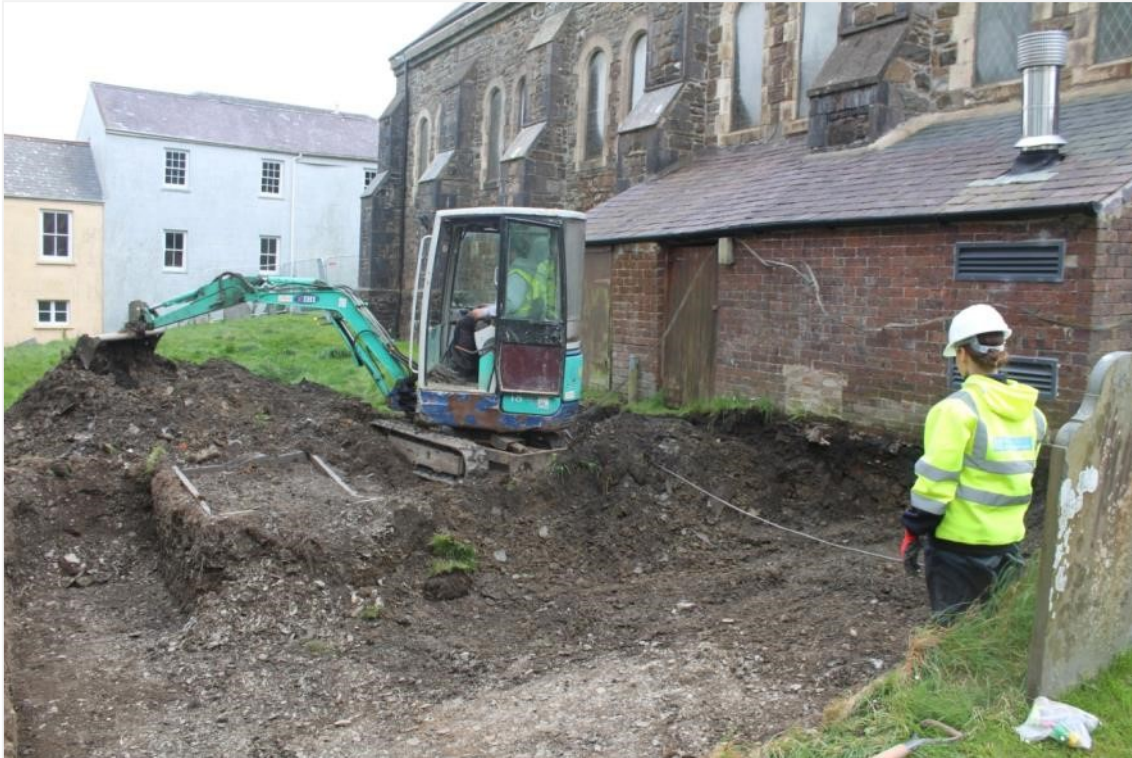
- 4.1.5 Once the grave kerb stones and foot stones had been removed deposit [102] continued to be excavated (Photo 8) until a depth of 600mm was reached across the trench; which would allow a buffer of 150mm below the required depth for foundations of 450mm. No other significant archaeological deposits or features were recorded during its excavation; although a large amount of disarticulated bone was recovered from this deposit. This bone was boxed and stored for re-burial within the cemetery at a later date.

**Photograph 8:** Looking southeast showing removal of deposit [102] across the evaluation area.

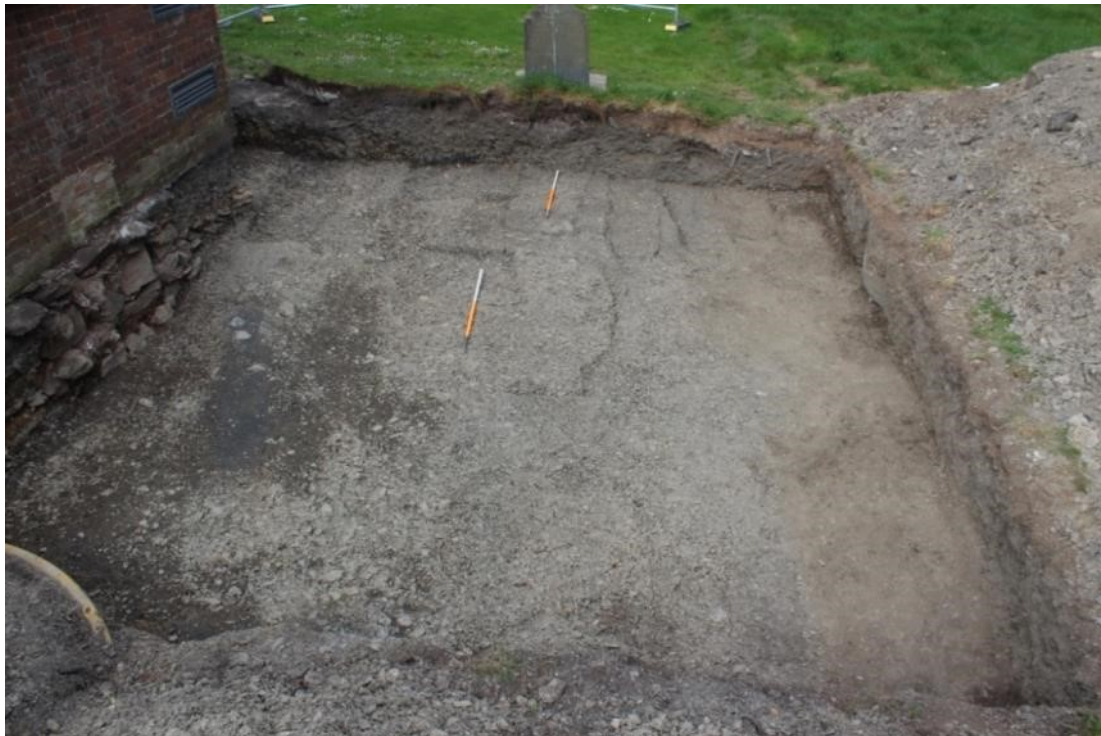
- 4.1.6 Once a consistent depth of 600mm had been reached across the evaluation trench, the trench was hand cleaned. This process enabled the identification of numerous intercutting grave cuts at the bottom of the trench (Figure 3; Photos 9 & 10). The grave cuts were filled with near identical material to that of [102] making it very challenging to see the edges of the cuts during machining.

**Photograph 9:** Looking roughly west at the evaluation trench after a depth of 600mm had been reached. Note the in-situ grave stone of Ebenezer Davies on the edge of the trench to the west. 2 x 1m scales

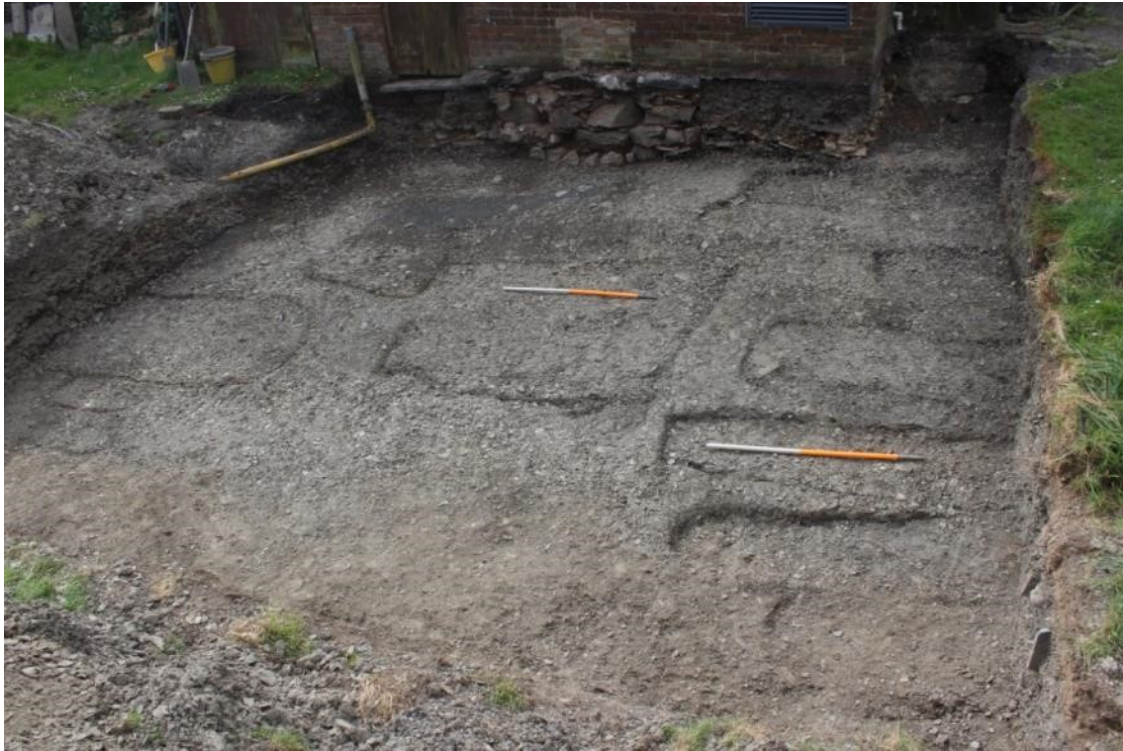
**Photograph 10:** Looking south at the evaluation trench showing a number of identified grave cuts. 2 x 1m scales

- 4.1.7 It was clear that this area had been greatly disturbed over many years by the excavation of numerous graves that had cut through earlier graves resulting in the disarticulated human bone seen throughout deposit [102].

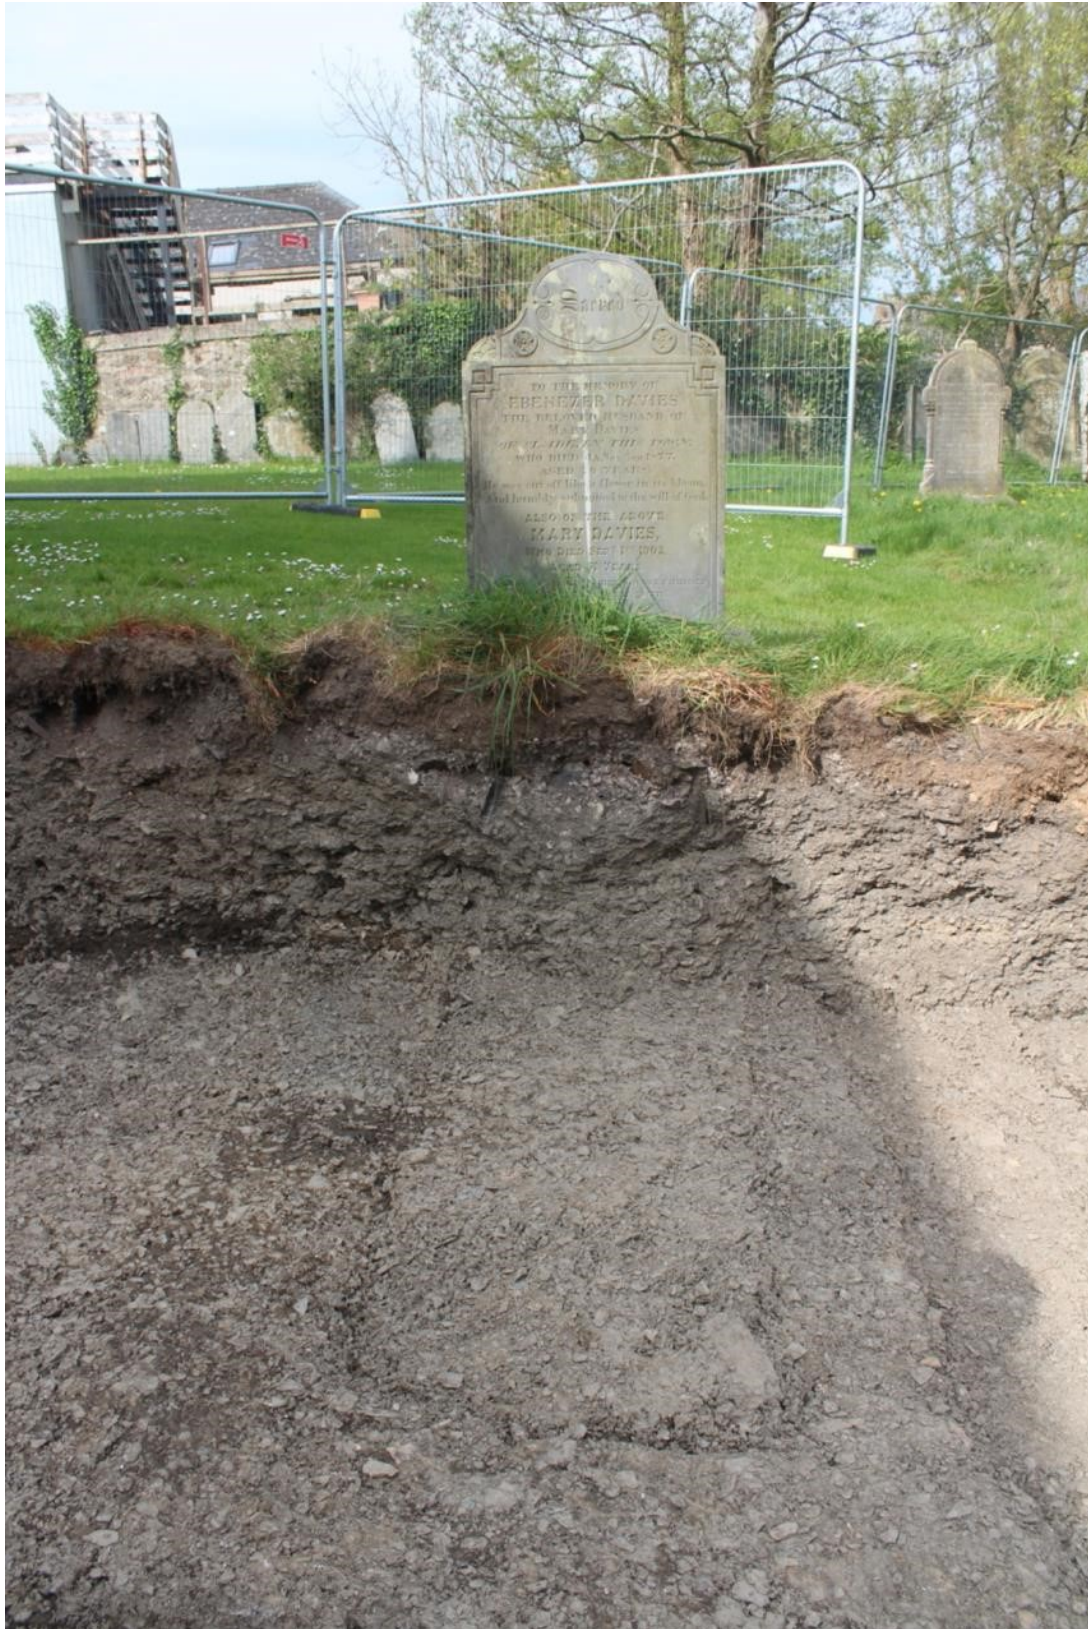
- 4.1.10 One grave could be identified as that of Ebenezer Davies who died in 1877 and whose gravestone stood outside the evaluation trench on the west (Figure 3, Photo 11).

**Photograph 11:** Looking west at the gravestone and identified grave cut of Ebenezer Davies who died in 1877.

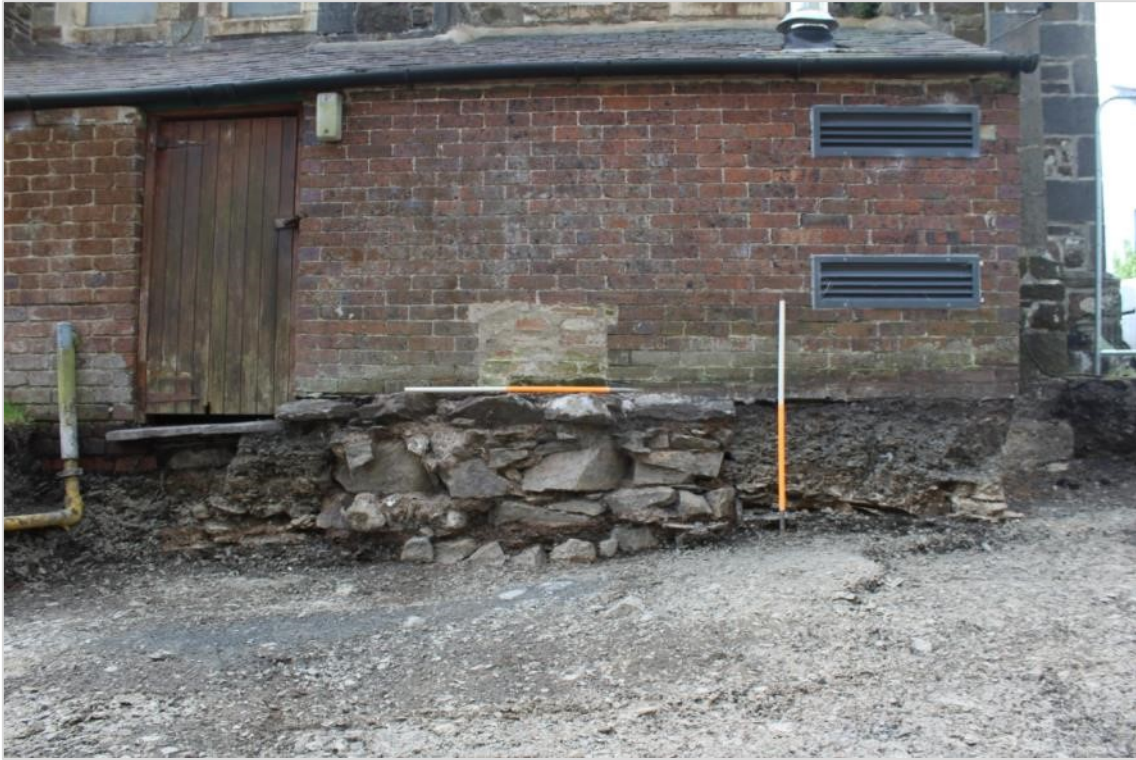
- 4.1.11 The southern edge of the evaluation trench ran along the northern wall of the existing church boiler house (Photo 12). Below this wall was a sequence of archaeological deposits including the remains of what appeared to be the foundations of a substantial stone wall or structure (Figure 4).

**Photograph 12:** Looking south at the stonework seen just protruding from under the northern boiler house wall. 2 x 1m scales

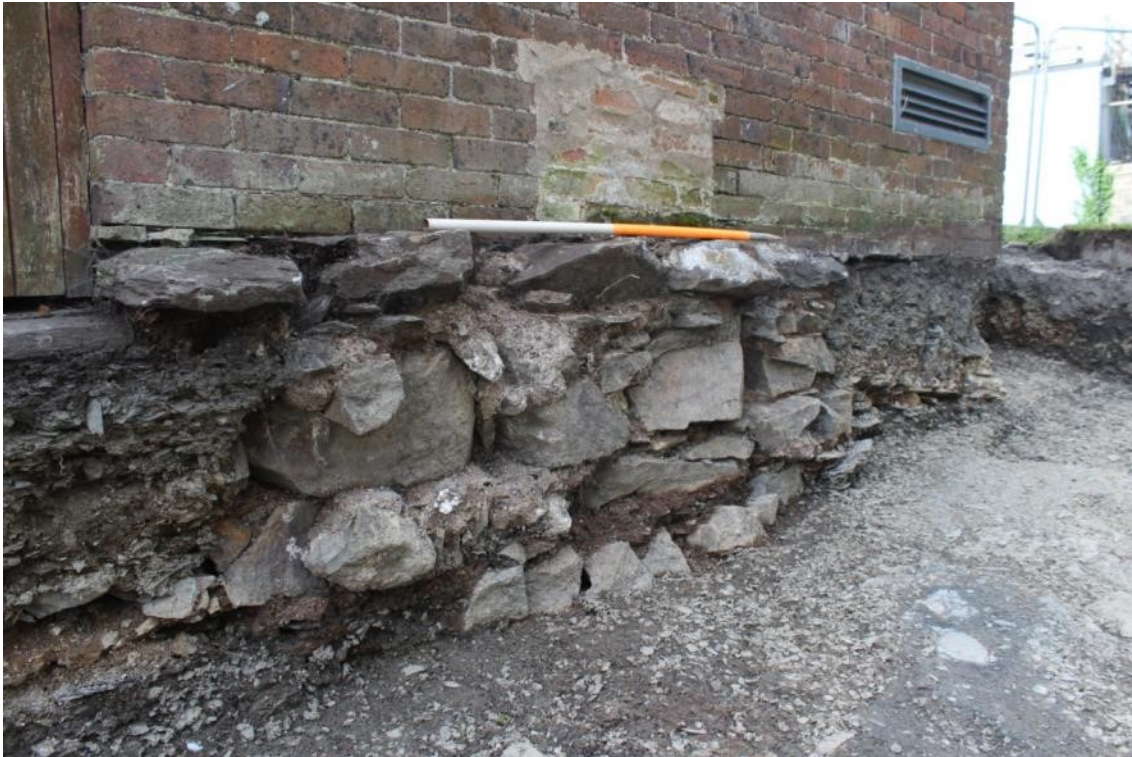
- 4.1.12 In this north facing section of the evaluation trench beneath the boiler house the substantial stone wall[108] measured c. 2.0m wide and 0.70m deep (Photo 13). The large angular stones were bonded with a hard mortar mix containing lumps of chalk, clinker and ash, fragments of broken slate, as well as dark reddish brown silty clay. The top course of large flatter stones appeared very level.

**Photograph 13:** Looking roughly southwest at the substantial stone work seen protruding from under the northern boiler house wall. 1m scale

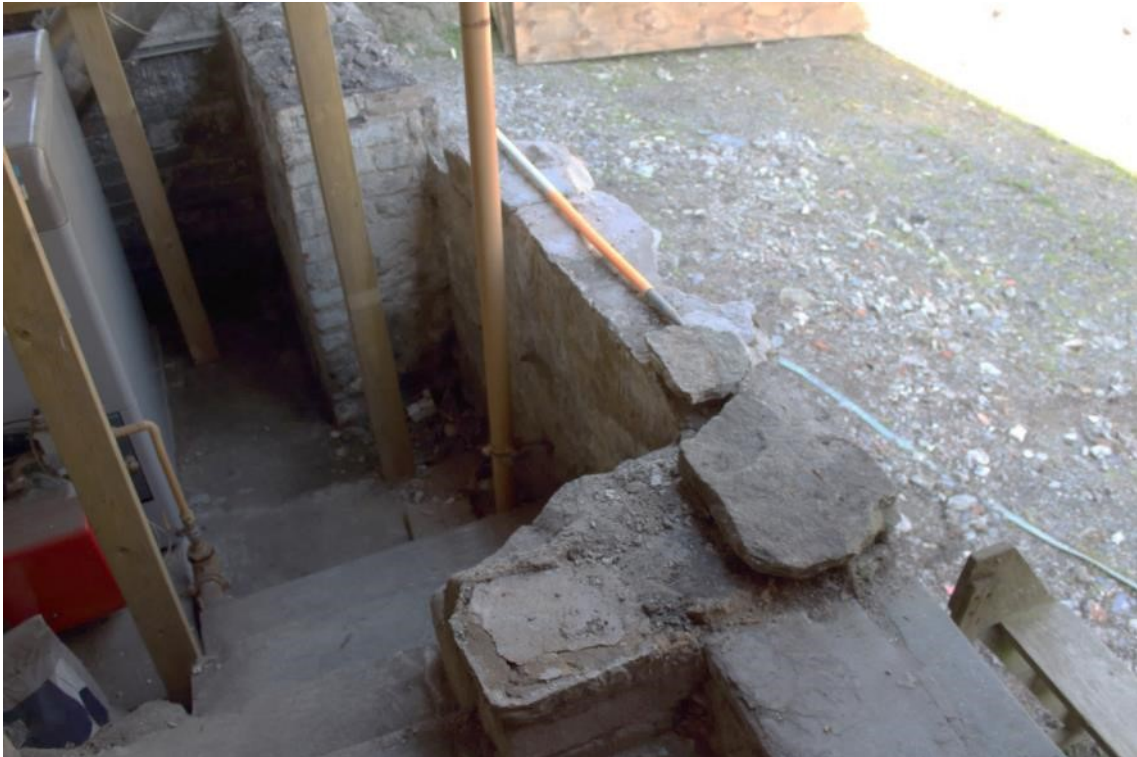
- 4.2.2 Following the dismantling of the brick walls of the boiler house a site visit was made on 21st April 2020.
- 4.2.3 Inspection of the stonework revealed that it was of recent construction probably associated with a later phase of boiler house (Photo 14). The wall had an internal face and had been built into the ground slope, hence the rough appearance of the stone work on its northern face. This stone wall filled a cut or void seen in the north facing section of the evaluation trench.

**Photograph 14:** Looking roughly west at the internal face of the substantial stone work seen protruding from under the northern boiler house wall. 1m scale

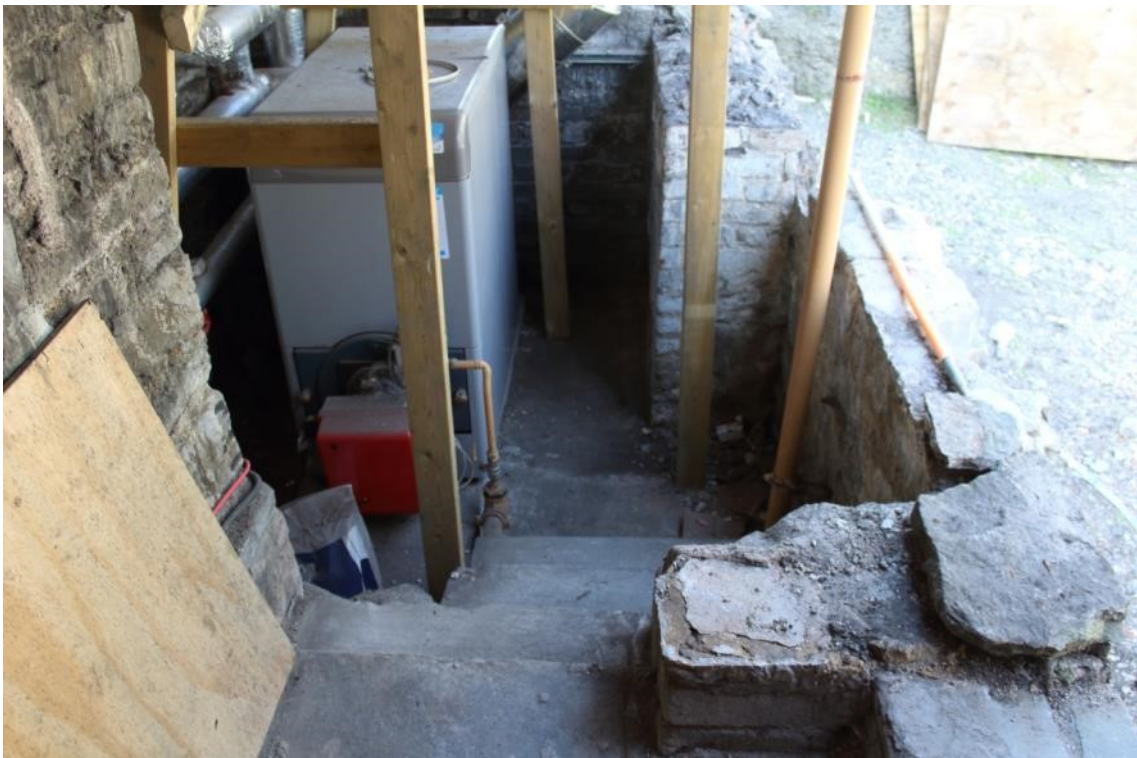
- 4.2.4 It appeared that there had been many alterations to the boiler house and the infilled stonework formed one alteration (Photo 15). However, the nature and size of the stones suggested they could have been re-used from an earlier demolished building, and it is conceivable that that building might be the former medieval church.

**Photograph 15:** Looking roughly west showing the internal area of the boiler house. 1m scale

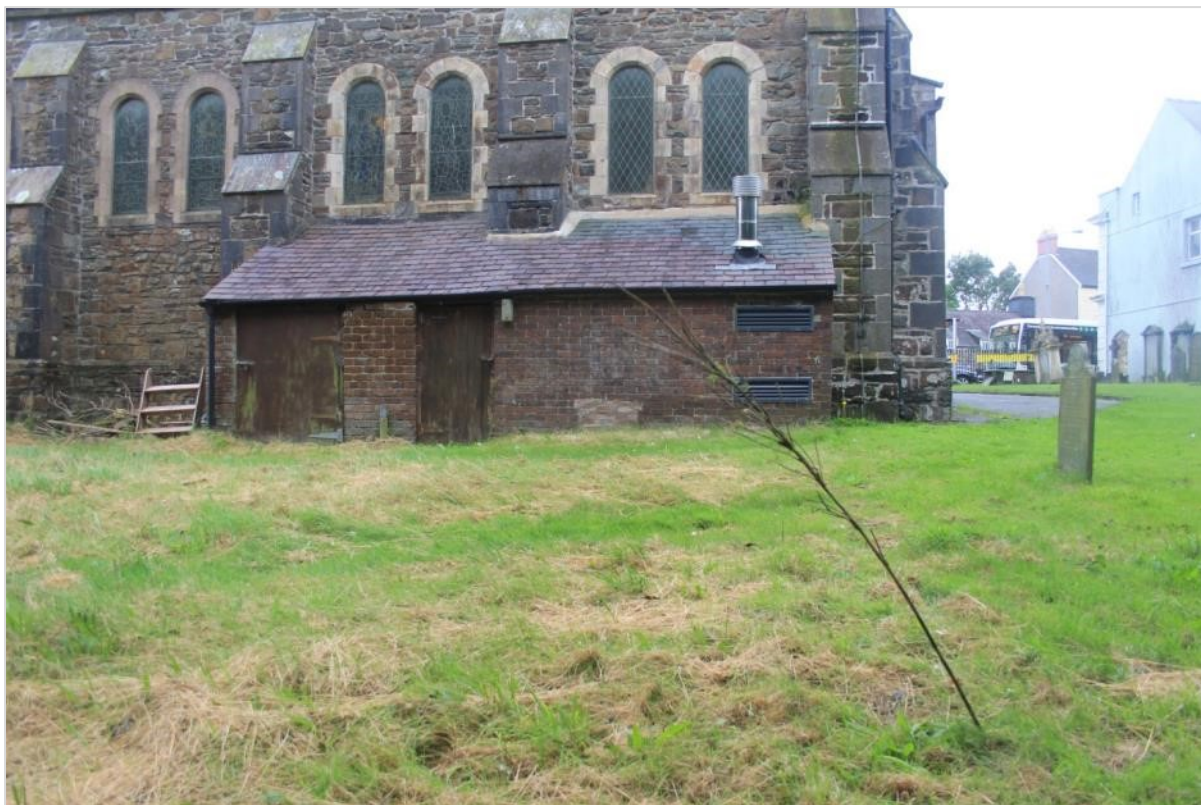
**Photo 2:** Looking south at the area for the proposed extension – note the gravestone to the right of the picture.

- 1.7 The footprint of the proposed extension measures approximately 7.0m by 13.0m (Figure 3) and lies on the north side of the church in an area where there are no marked graves. One 19<sup>th</sup> century gravestone lies a short distance away to the west of the proposed extension (Photos 2 – 3).. The development area lies at a lower ground level than the church floor, and so the floor of the extension, which will run through from the church, will be raised and will be supported on block walls. The walls will sit on a concrete pad within a deep foundation cut (Figure 4). It is the machine excavation of the foundation trenches plus any associated services or ground reduction works that could damage or remove any archaeological remains which may be present in this area. An area encompassing the groundworks required to create a soakaway will also require evaluating.
