GLAN Y MOR HOLIDAY PARK, CLARACH BAY, CEREDIGION:

HISTORIC ENVIRONMENT DESK-BASED ASSESSMENT

RHIF YR ADRODDIAD / REPORT NO. 2019/28 RHIF YR DIGWYDDIAD / PROJECT NO. 118022

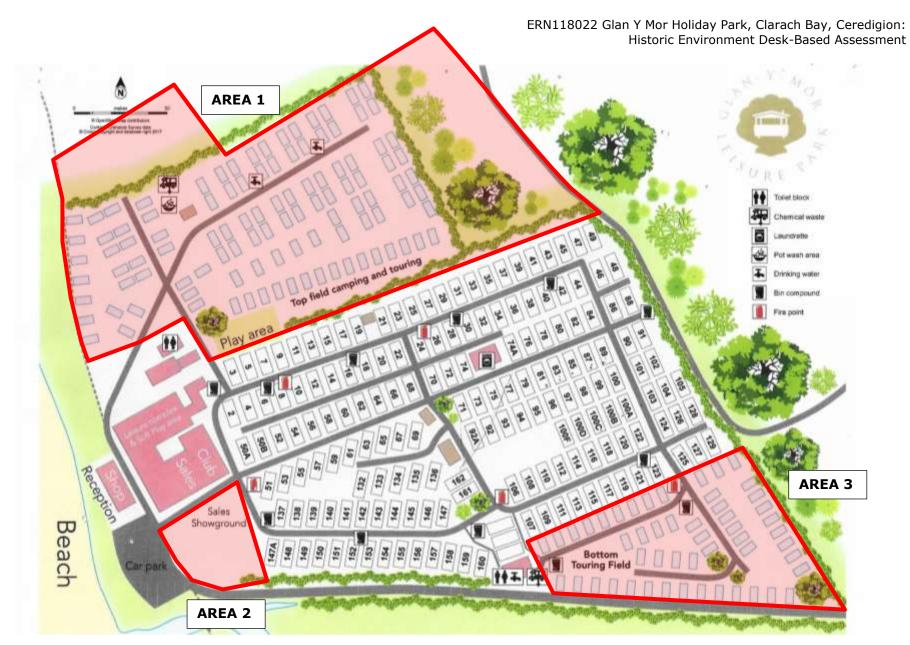
Figure 3: Present layout of Glan Y Mor Holiday Park, with approximate development proposal areas highlighted in red

- 1.1.2 The proposals are for the replacement of existing camping, caravan and motor home pitches to static caravan and lodge style accommodation. Three parts of the Holiday Park are proposed for change, Area 1 lying in the northern field; Area 2 in the southwestern corner and Area 3 in the southeastern corner of the Holiday Park.

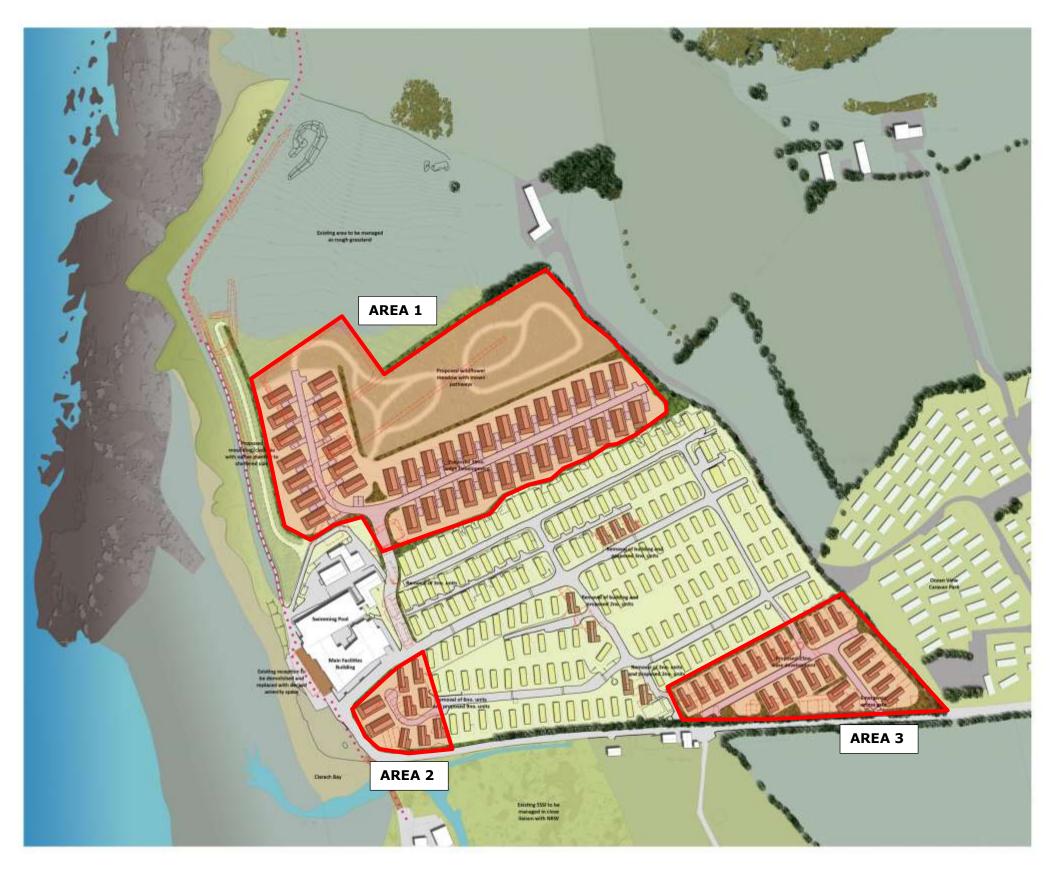
Figure 4: Glan Y Mor Holiday Park Proposals, with specific areas highlighted in red

- 4.2.2 The proposals for Area 1 include two rows of lodges being built on the hillslope above the main Holiday Park. The proposals will require the excavation of shallow concrete raft foundations for the lodges. This could expose, damage or destroy underlying archaeological remains. The area to the northwest will also have two rows of lodges and the associated disturbance associated with the excavation of concrete raft foundations. The northern part of the area will be turned into a wildflower meadow which can be done causing no below ground disturbance. Overall the proposals will reduce the area utilised by caravans/lodges from that which presently exists and around half the area will be turned into a wildflower

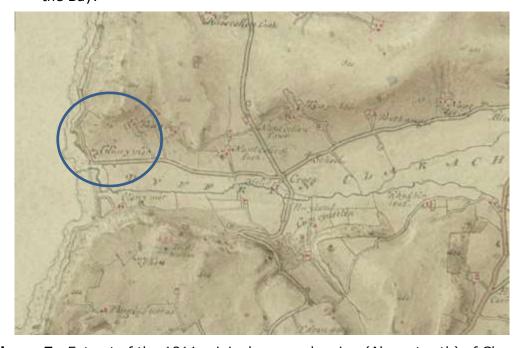
Figure 7: Extract of the 1811 original survey drawing (Aberystwyth) of Clarach Bay, with the proposed development site circled in blue

3.9.1 The original Ordnance Survey (OS) drawing of 1811 of the Clarach Bay area is the earliest available map to show any great detail of the area and its surroundings (Figure 7). Glan Y Mor farm is shown, as are adjacent properties and the road leading west from Clarch village to the Bay. The map suggests the road continues to the north along the western edge of the Holiday Park area. The Afon Clarach does not appear to have been canalised at this time and meanders on its way to the Bay.

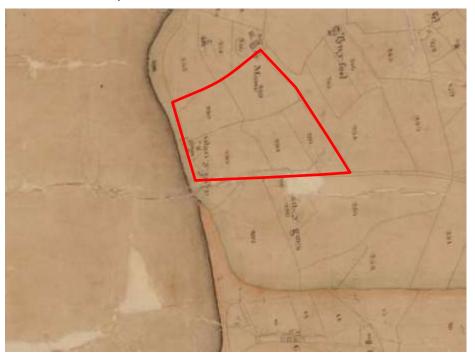
Figure 8: Extract of the 1845 Llanbadarn Fawr Tithe Map, with the approximate position of the proposed development site outlined in red

3.9.2 The Llanbadarn Fawr Tithe Map of 1845 (Figure 8) shows field divisions around Glan Y Mor farm and an indication of the buildings within it. The area was subdivided into 5 fields at this time and the farm. The three southern fields were named 'Cae Dan Ty', 'Cae Dan Ty Hen' and Cae Llainfawr from west to east. The two northern fields were both named 'Cae Bank Y Ty'. All were under arable, except 'Cae Dan Ty' which was under pasture. The farm and fields were all occupied by John Evans and owned by Pryse Pryse Esq. A further small areas just encroach into the Glan Y Mor Holiday Park area, a field to then northwest called 'Wain' under pasture and under the same owner / occupier as the rest. The course of the Afon Clarach to the south looks more regular and it is possible it ahd been canalised by this time.

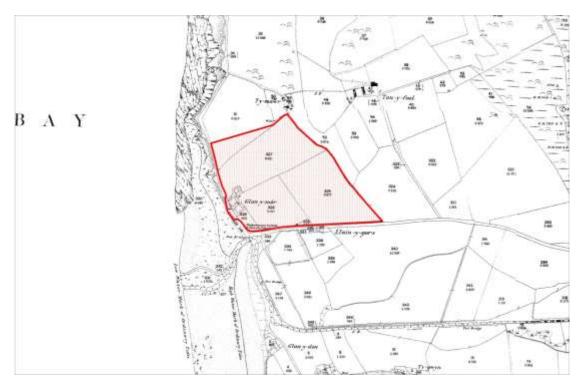
Figure 9: Extract of the 1888 Ordnance Survey 6 inch to 1 mile map, with the proposed development site outlined in red.

3.9.3 Detailed maps of the site were surveyed by the OS in 1888 (Figure 9) which shows little change to that of the Tithe Map, although the two northern fields have been combined to a single field, as have those to the southeast. A small area on the southern central part of the site contains a very small triangular field. This may have been shown on the Tithe Map but the detail was unclear in this part. The Afon Clarach has a very straight course before turning to the north and then into the bay, indicating it had definitely been canalised by that time.

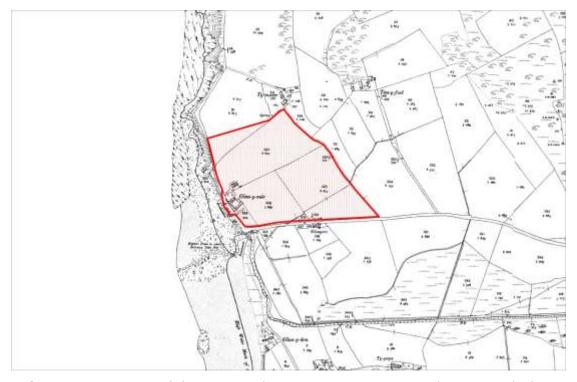
Figure 10: Extract of the 1905 Ordnance Survey 1:2500 scale map, with the proposed development site outlined in red.

3.9.4 The 1907 1: 2500 scale map of the site area (Figure 10) is almost identical to that of the 1889 map.

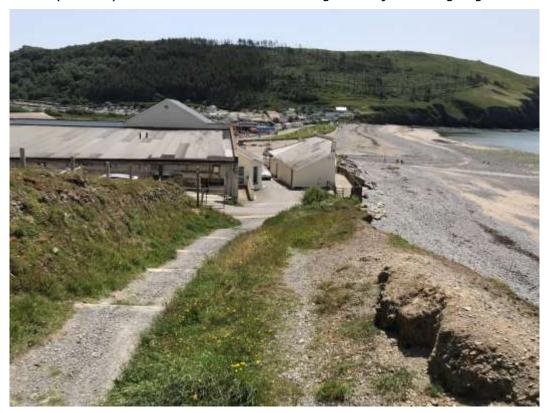
- 3.10.1 A site visit was undertaken on 3rd July 2019. The visit comprised a walkover of the Glan Y Mor Holiday Park, with specific attention to the three areas of proposed redevelopment, and the surrounding area. Photographs were taken and field observations recorded in note form.
- 3.10.2 Clarach Bay lies to the west of the Holiday Park, the southwestern part of the holiday park lying only a few metres above sea level with direct access to the beach. The land then rises quite steeply to the north such that there is an eroding cliff edge west of Area 1, separated from the Holiday Park by the raised bank mentioned above and the coastal path (Photo 1). It is evident that this cliff edge is subject to ongoing erosion.

Photo 1: View south along footpath to west of Glan Y Mor Holiday Park showing the drop down to Clarach Bay beach and some of the permanent buildings

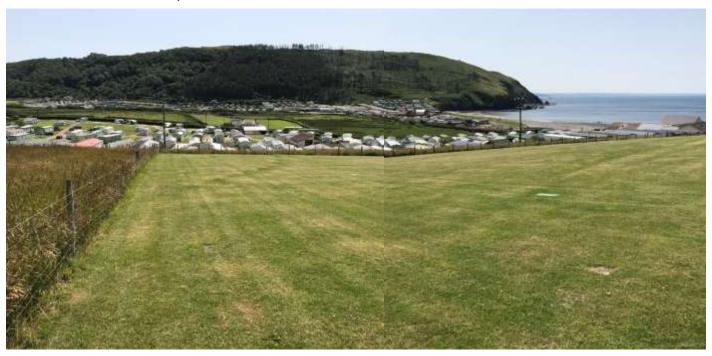
Photo 4: Merged photo showing panoramic view across Gan Y Mor Holiday Park from Area 1, with main facility buildings to left (west)

- 3.10.5 Area 1 lies on the higher ground to the north and is presently laid to mown grass with tents and caravan pitches marked out with white line paint (Photos 4, 6 & 7). The majority of the pitches are serviced with electricity. Water stand pipes and drains are also present across the area. A set of mobile buildings on its northern edge represent the laundry, washing and toilet facilities for this part of the campsite (Photo 8). The northeastern part of Area 1 is presently overgrown and fenced off from the neatly kept camping area (Photo 9). A number of electricity points could be seen within this long grass, indicating it has been subject to service installation in the past. It is assumed water and drains may also be present here. The topography of Area 1 is relatively level in its upper part with a slight fall off to the east and west. There is a sharper drop to the south which runs down to a further step in ground level for the main Holiday Park area (Photo 4).

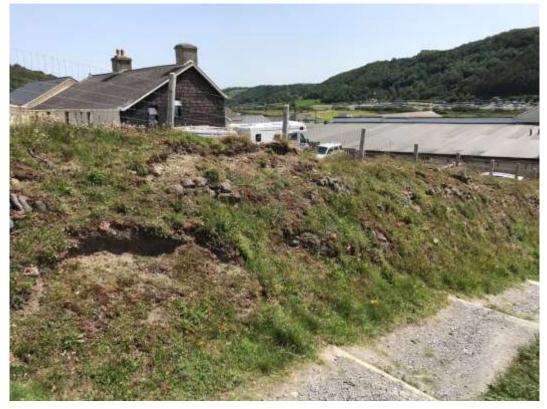
Photo 5: Upper parts of original Glan Y Mor farm buildings visible over western boundary bank (PRN 100620)

3.10.8 The boundary wall to the west of the site area (PRN 100620) is still visible and seems to survive in a relatively good state of preservation although more eroded than as recorded a few years ago (Photos 5 & 14).

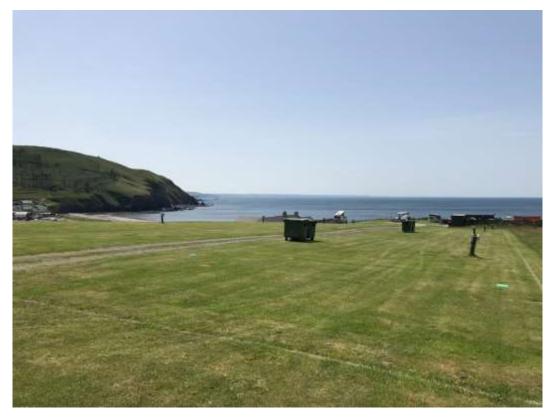
Photo 6: View southwest across Area 1 on the upper part of Glan Y Mor Holiday Park, with roof line of Glan Y Mor farm visible in centre of photo

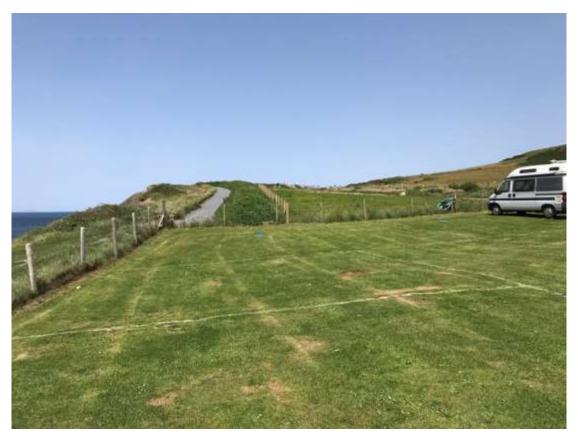
Photo 7: View north on western side of Glan Y Mor Holiday Park, showing resurfaced coastal path heading up slope

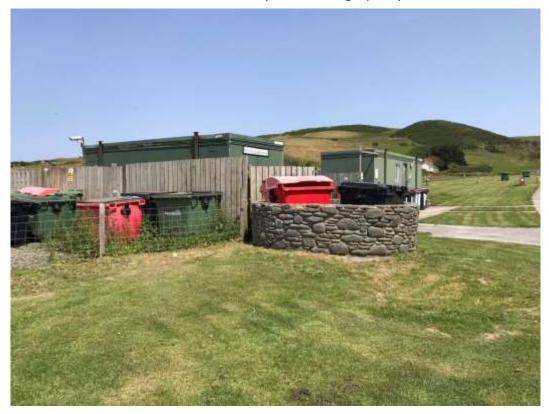
Photo 8: Northern edge of Glan Y Mor Holiday Park Area 1, showing toilet block, wash facilities and bin storage areas

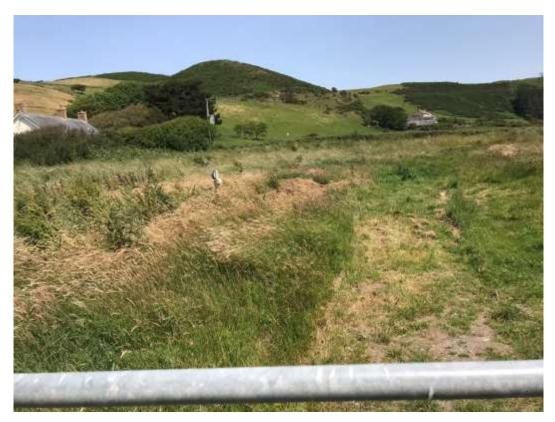
Photo 9: View east across the fenced off and overgrown northeastern part of Area 1, with electricity service connector pole visible

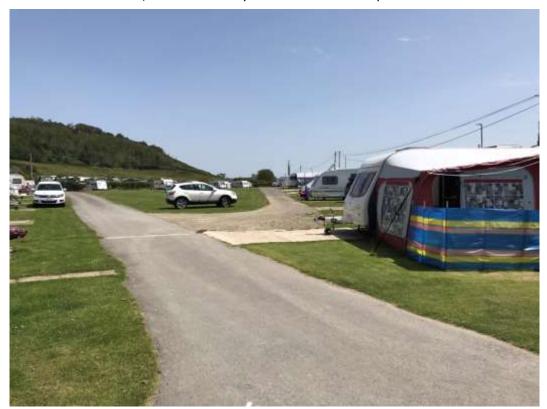
Photo 10: View east across Area 3, showing access roads and caravan pitches

3.10.7 Area 3 lies in the southeastern part of the Holiday Park. There is a road running around the area with a number of concrete bases for caravan pitches around its perimeter (Photos 10 & 11). There are services and

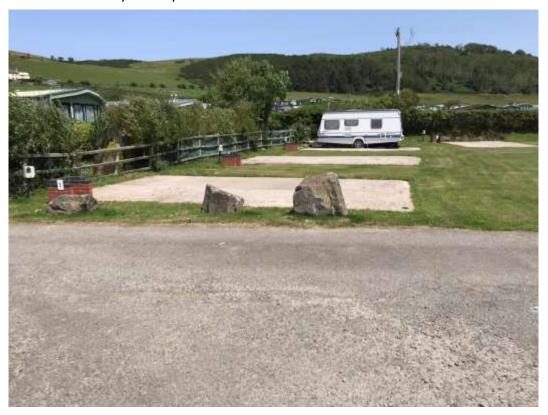
Photo 11: View east across concrete bases for mobile caravans in Area 3

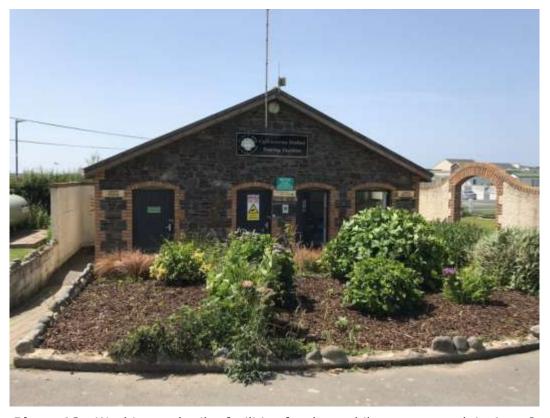
Photo 12: Washing and toilet facilities for the mobile caravan park in Area 3

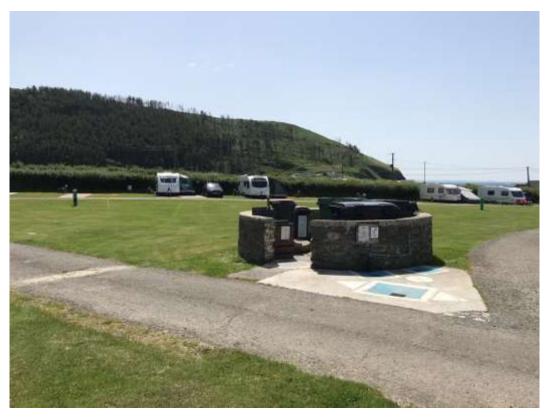
Photo 13: Bins and services locations within Area 3

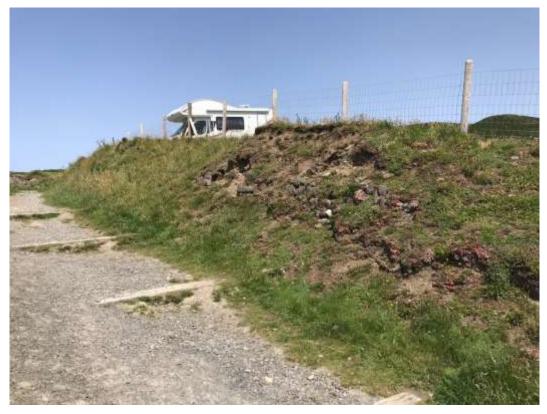
Photo 14: Boundary wall PRN 100620 on western side of Area 1

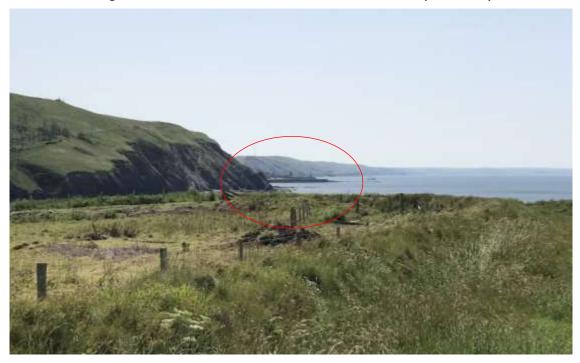
- 3.10.9 There were no indications of the crop marks to the north or south (PRN 63997; PRN 63985/NPRN 404549; NPRN 404550). There were no visible signs of any flint scatters on the footpath to the north of the Holiday Park. Clarach footbridge is still present to the south.
- 3.10.10 The original buildings of Glan Y Mor farm are still present on the western side of the Holiday Park (Photos 5 & 6).
- 3.10.11 As noted in the section above regarding listed buildings and the conservation area, part of Aberystwyth is visible from the site area, although the southern side of Constitution Hill is not (Photo 15).

Photo 15: View south from above northern edge of Glan Y Mor Holiday Park showing part of Aberystwyth pier and castle ruins in distance (highlighted)
