REPORT ON WORK UNDERTAKEN ON SCHEDULED ANCIENT MONUMENTS WITHIN THE PEMBROKESHIRE COAST NATIONAL PARK 2014-15

Prepared by Dyfed Archaeological Trust
For Cadw

Report No. 2015/10

March 2015

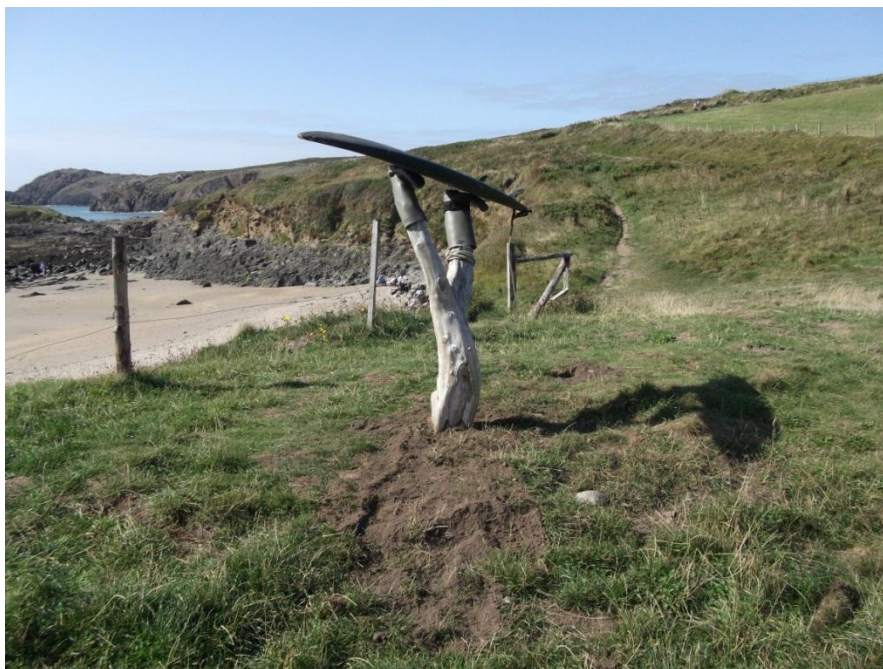
On 1/9/2015 (while on holiday) one of our former Arfodir volunteers from St Davids reported an unpleasant experience when encountering an individual who was putting up an art installation on the site of St Patricks Chapel and when asked not to do so (allegedly) became very abusive and threatening (Appendix 1). Immediately a site visit was made by PC. It would appear that the installation (see photo below) did not penetrate deep in to the soil. According to the Arfodir volunteer he hit stone. It was located approximately on the line of the north wall of the chapel and was outside the May excavation trenches. During the initial conversation with the installer, PC having outlined the facts that he was not entitled to erect this without permissions from Cadw, PCNPA (as land owners) and most likely also National Resources Wales, and his actions may encourage other such intrusions on the site. His attitude was quite aggressive and he appeared to be looking for a confrontation. However, with a lot of pacification it was agreed that he would take it down having photographed it. Evidently the intention was to put this on Facebook. PC declined to be photographed with it in case this was seen as approval. Returning at the end of the day the installation had been removed. Formal note of this aggressive meeting was forwarded to PCNPA. It is considered that no further action should be taken regarding the activity, as it is more likely to cause escalation.

Site of St Patrick's Chapel: Art installation. View N. 1/9/2015

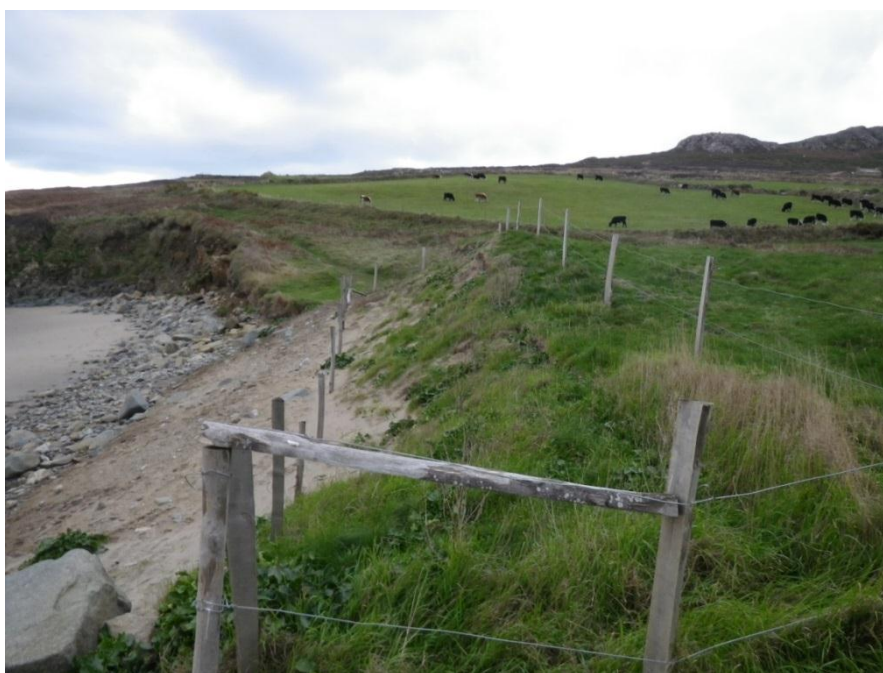
*St Patrick's Chapel: consolidation of sea frontage, condition on 26/11/2014.
View NNE*

A few further visits were made during the winter months, especially after high seas, to check on erosion: the backfilled frontage appears to be holding up well and the turf is retaking.

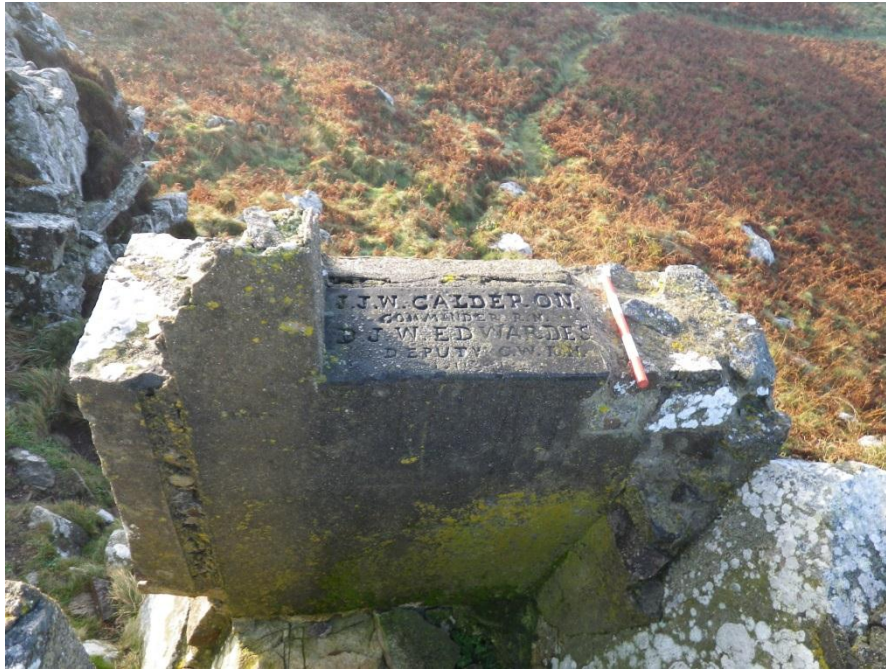
This site was visited on 20/11/2014 to look at the graffiti reported by Roger Thomas. No trace of this was found.

*Garn Fawr: WWI lookouts post some graffiti showing below inscription. View S.
Scale 0.5m. 20/11/2014*

- pursue further if grazing can be re-introduced
- see if volunteers would make a detailed record of the lookout post and compare to earlier records to establish where damage has occurred recently

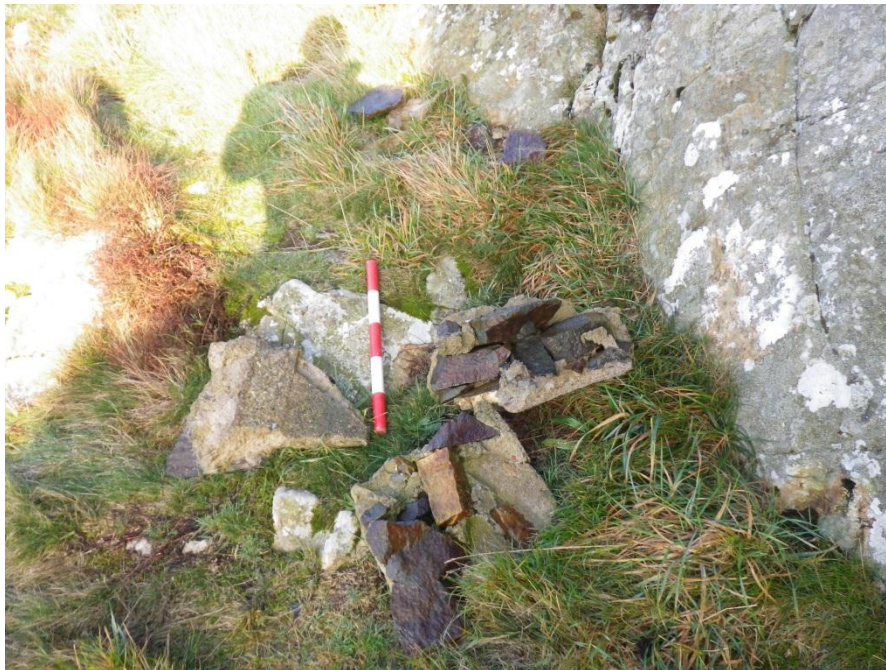
*Garn Fawr: Fallen masonry below WWI lookout post. View W. Scale 0.5m.
20/11/2014*

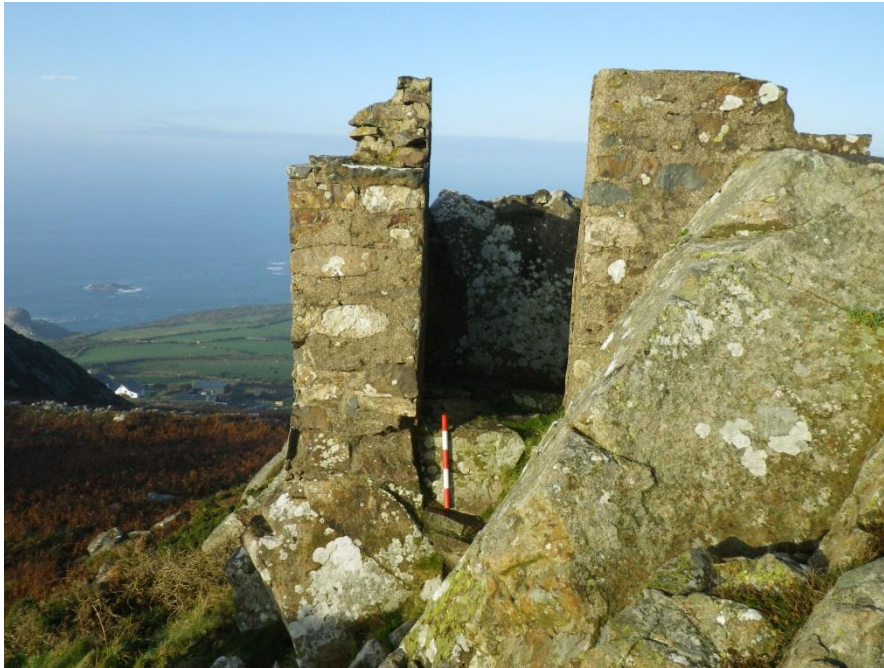
Garn Fawr: WWI lookout post. View W. Scale 0.5m. 20/11/2014

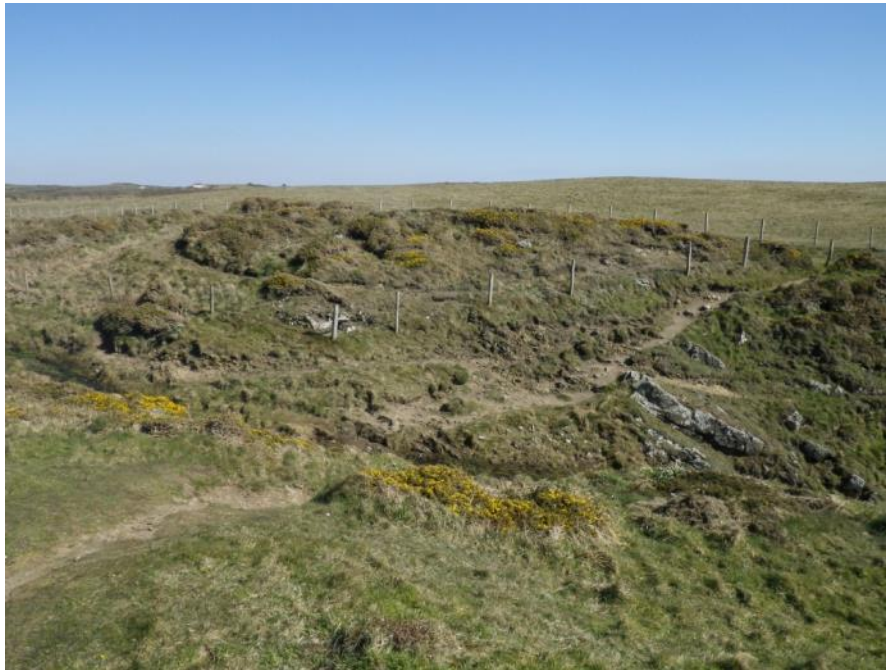
A site visit was made in November 2014 to look at an erosion pinch point to the Coast Path on the north side of the monument. Path erosion, just to the south side of the stream appears, if anything, to have improved with some secondary routes re-grassing (see photos below). Having obtained SMC the pinch point on the coast path was eased by cutting the path slightly back in December 2015; nothing of archaeological significance was encountered. The results of this work have been sent to Cadw and are copied again at the end of this report (appendix 2).

*Watery Bay Rath: footpath erosion to the south of the inner entrance. View S.
03/04/2013*

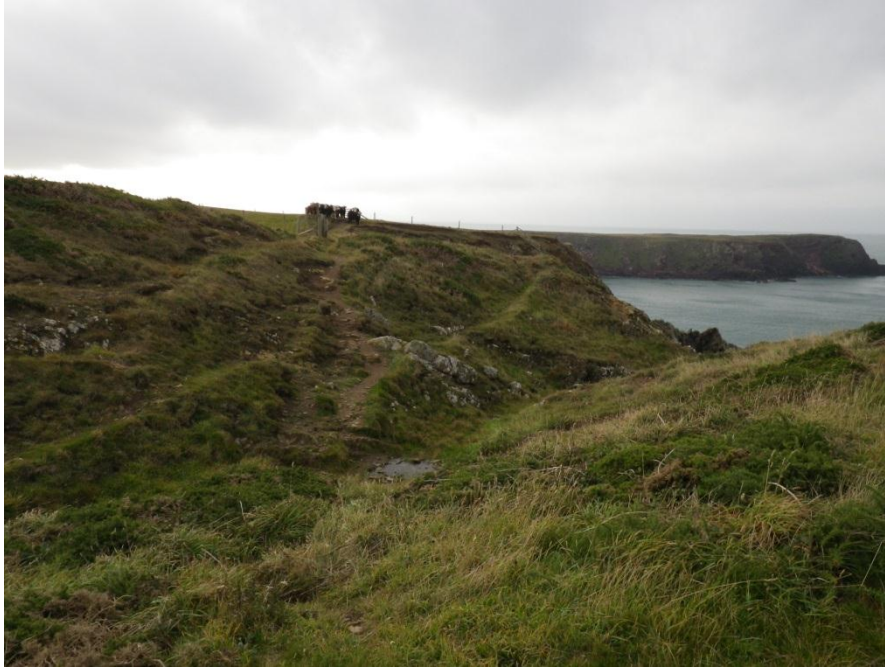
*Watery Bay Rath: footpath erosion to the south of the inner entrance. View S.
15/12/2014*

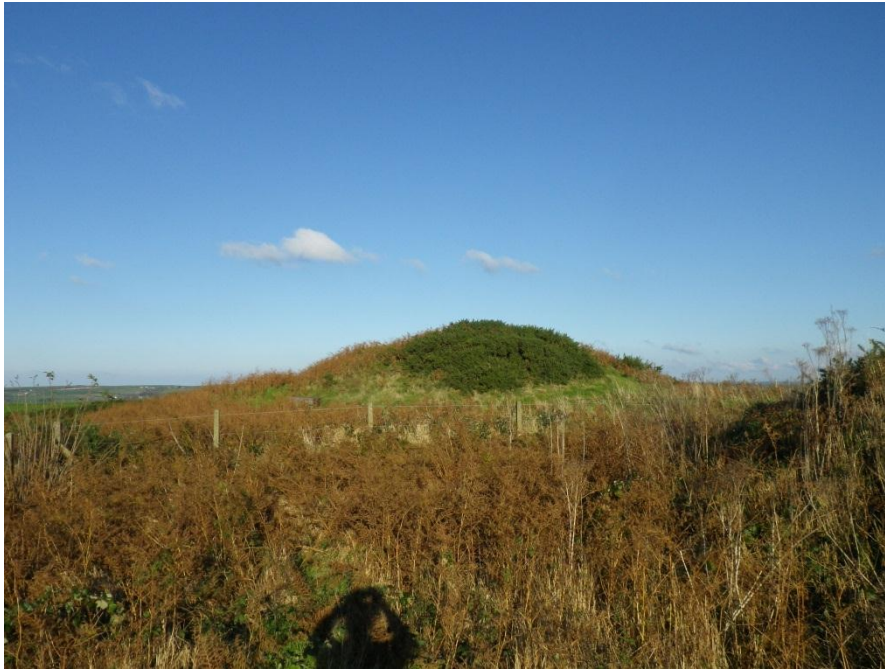
The barrows are becoming increasingly overgrown as no grazing has taken place for some time, but there does not appear to be any recent badger activity around the southern barrows.

Crugiau Cemmaes: Vegetation on the northern of the southern two barrows taken from the reservoir area. View N. 18/11/2015

- PC to continue with efforts to replace and move the fencing around the southern two barrows

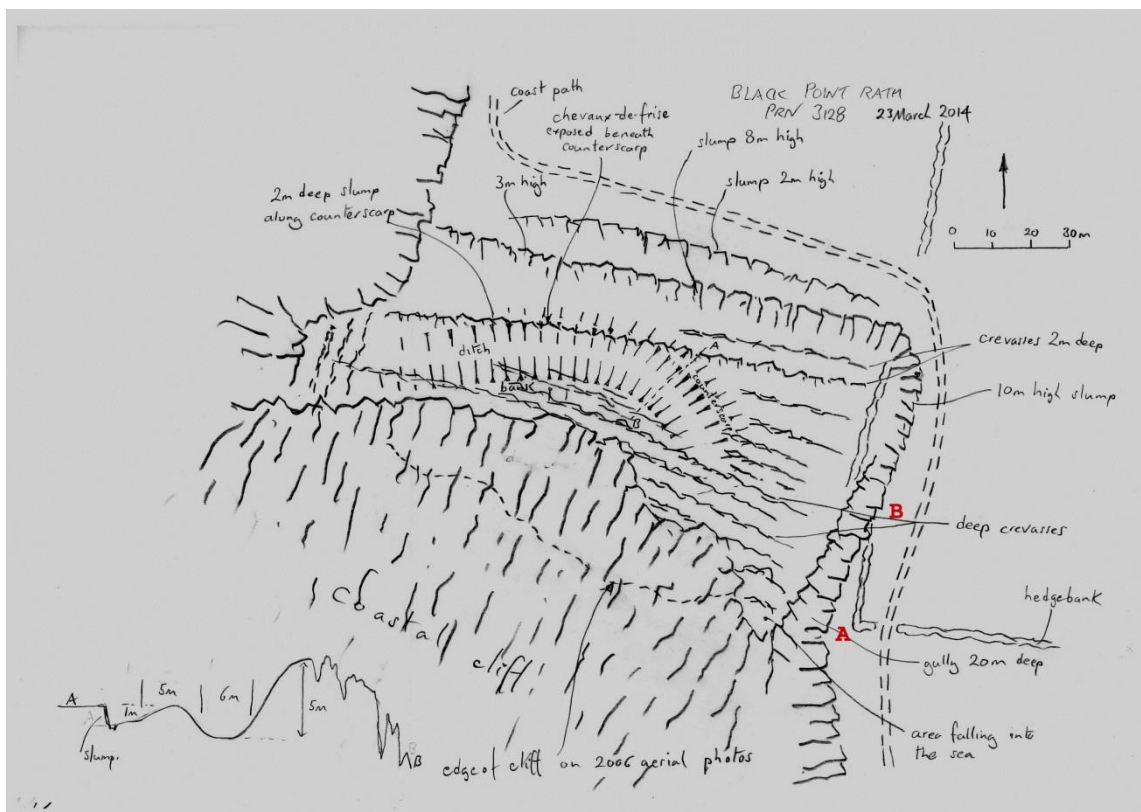
In addition it is recommended that annual photographic recording of the site is undertaken from two fixed positions. These are marked A and B on the plan. This work has been done for 2015.

Plan of Black Point showing recommended positions for photographic recording of the site.

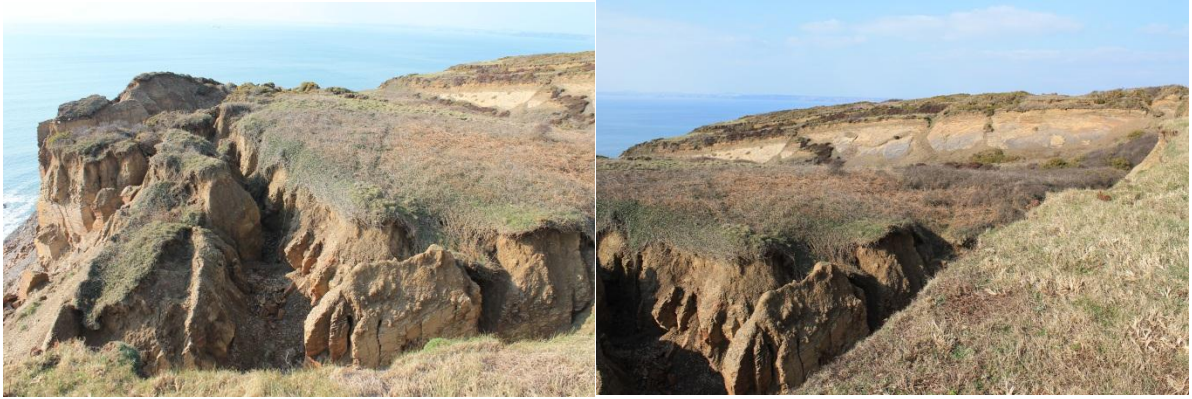
Black Point Rath – photographs taken from position A.

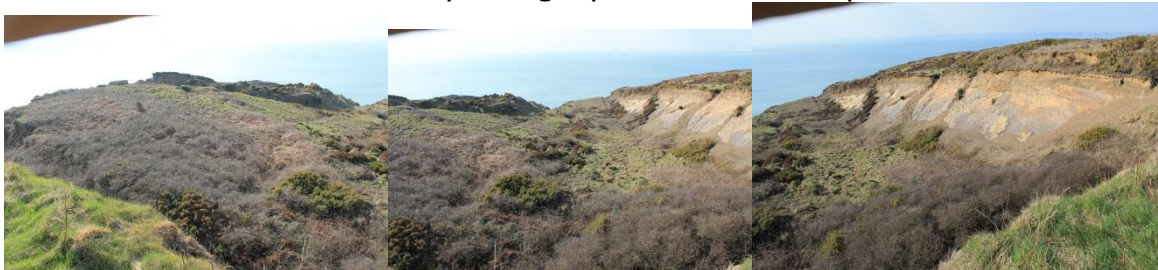
Black Point Rath – photographs taken from position B.

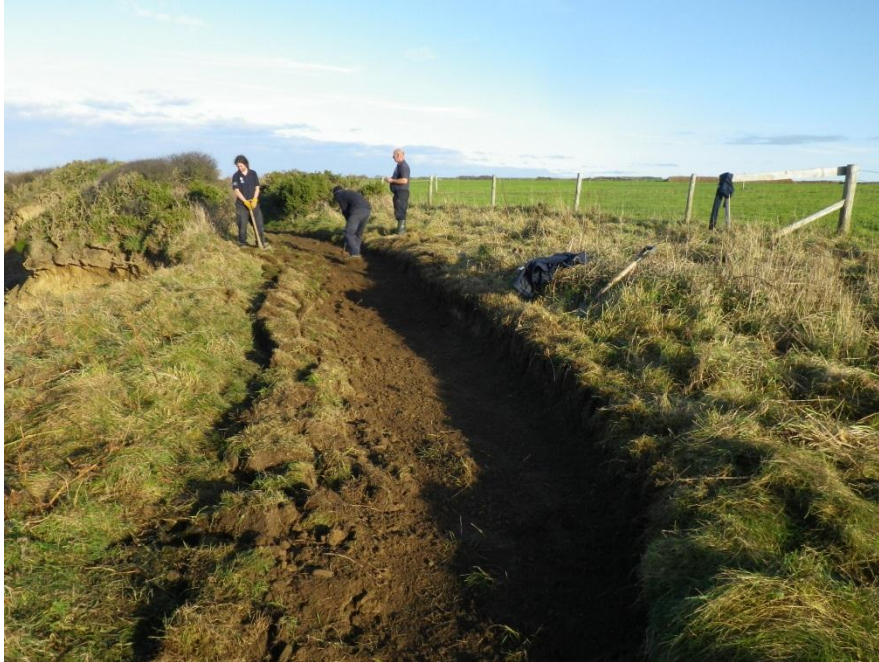
A small watching brief was undertaken adjacent to Black Point Rath for PCNPA on 3/12/2014 when a short section of the Coastal Footpath, approximately 17m to 20m long and maximum depth of cut 0.35m, was moved slightly inland (see below) after winter erosion of the landslip edge. All hand dug, soil disturbed was either turf or old plough soil with very few intrusions. One coal fragment was seen: possibly resulting from liming the land. Nothing archaeological was encountered.

Black Point Rath: adjacent footpath re-routing 3/12/2014. View N

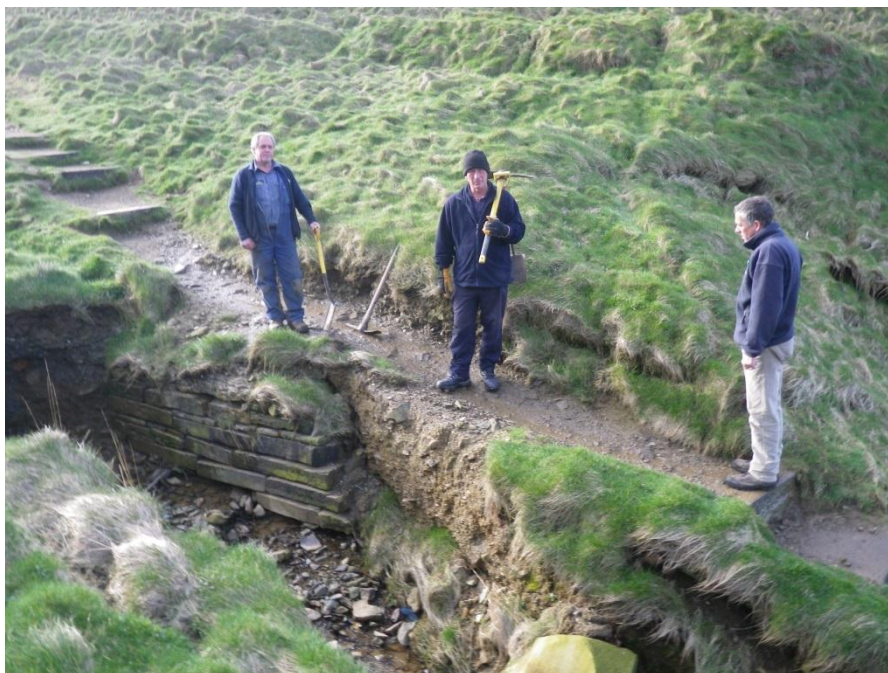
The footpath repairs, mention in the last report, were undertaken on 9/04-10/04/2014, and a new bridge made from old railway sleepers was placed over the stream (see photos below). The footpath cut back, at the pinch point by the stream revetment, was into a natural bank, topsoil and turf: no archaeological deposits were disturbed. However, the programmed footpath resurfacing still has not been done (hence the delay in reporting). It is still intended for this to be done when the works team have time and it is dry enough to bring materials over the adjacent fields.

Porth y Rhaw: before cutting back footpath into bank. View W. 9/04/2014

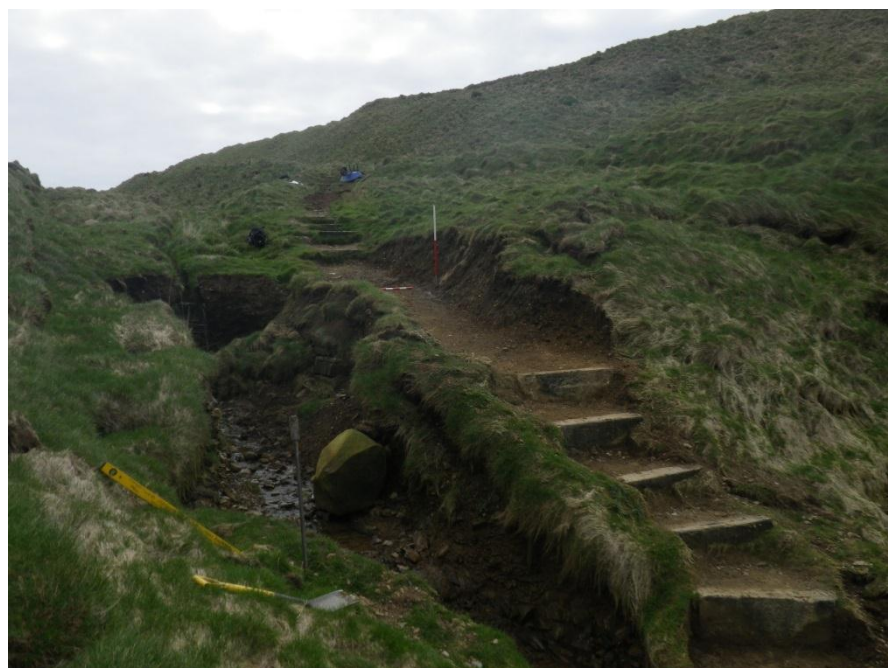
Porth y Rhaw: footpath as cut back. Scales 0.5m and 1m. View SE. 10/4/2014

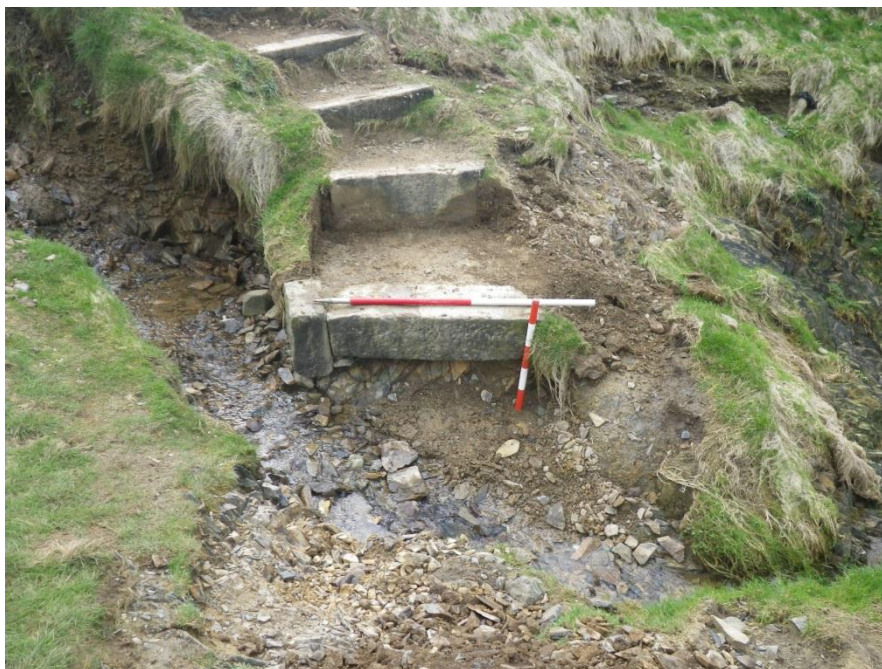
Porth y Rhaw: rebuilt step/base for Sleeper Bridge. Scales 0.5m and 1m.
View SE. 10/4/2014

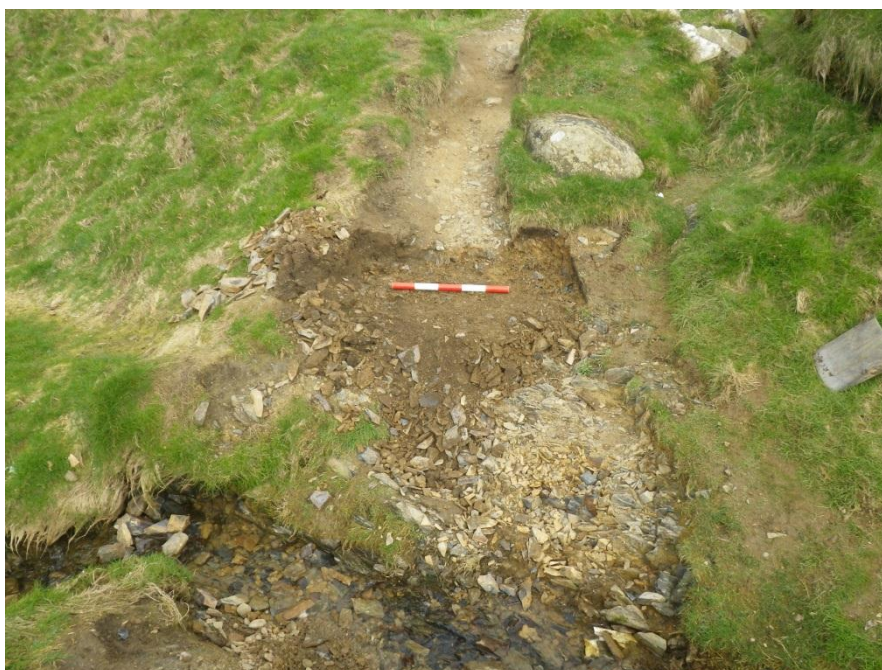
Porth y Rhaw: cut into bedrock for base of Sleeper Bridge. Scale 0.5m.
View W. 10/4/2014

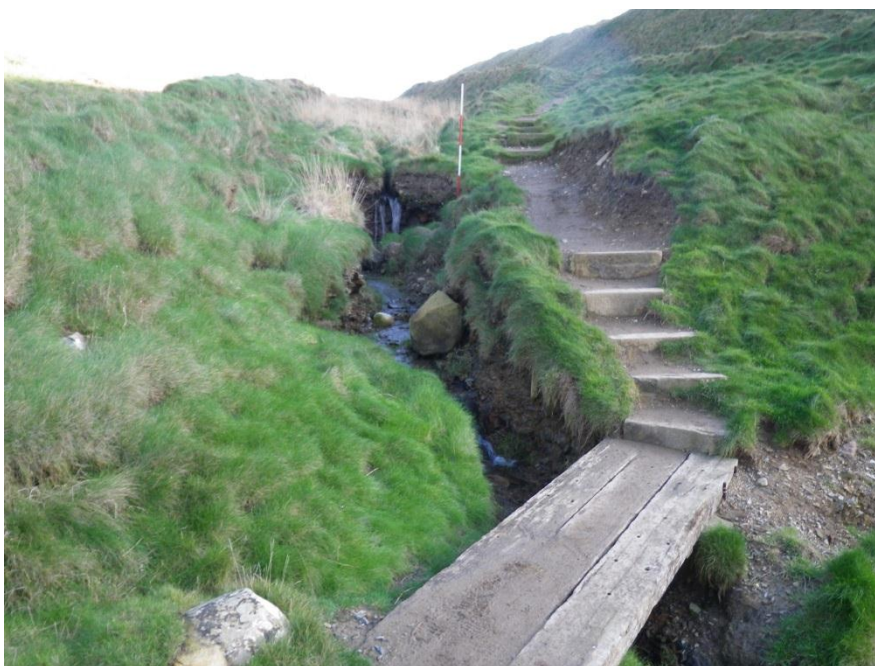
Porth y Rhaw: Sleeper Bridge. Scale 2m. View SE. 3/12/2014

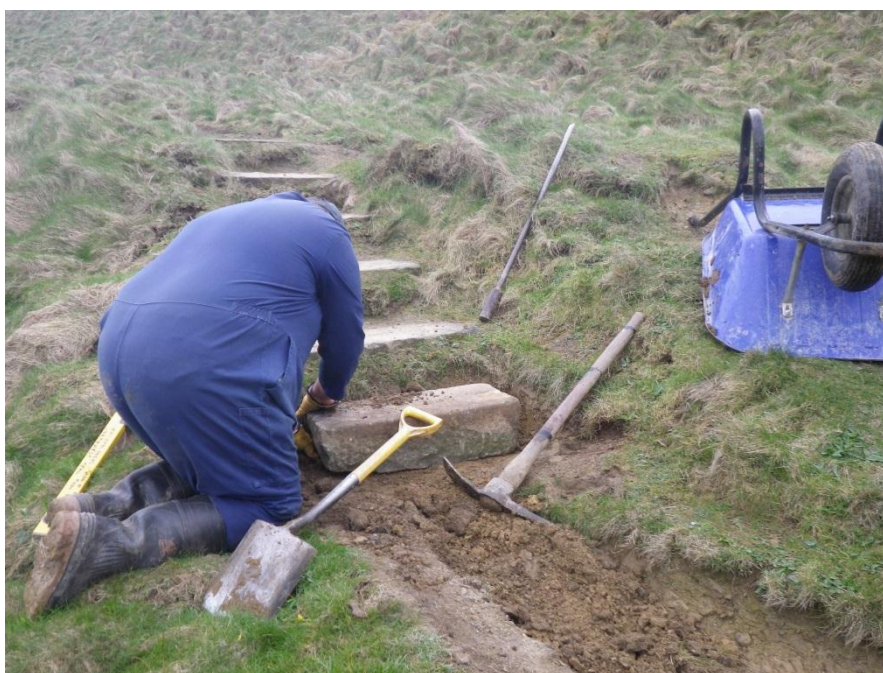
Porth y Rhaw: additional step added. View SE. 10/4/2014

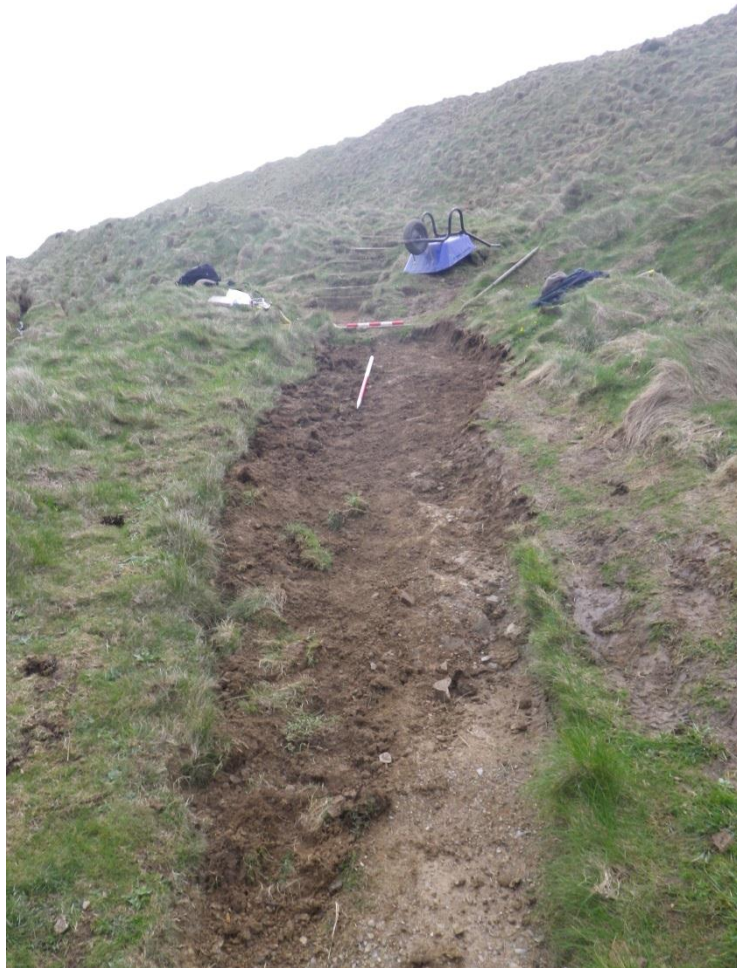
Porth y Rhaw: cut and fill of water erosion gully in path below new step.
Scales 0.5m and 1m. View SE. 10/4/2014

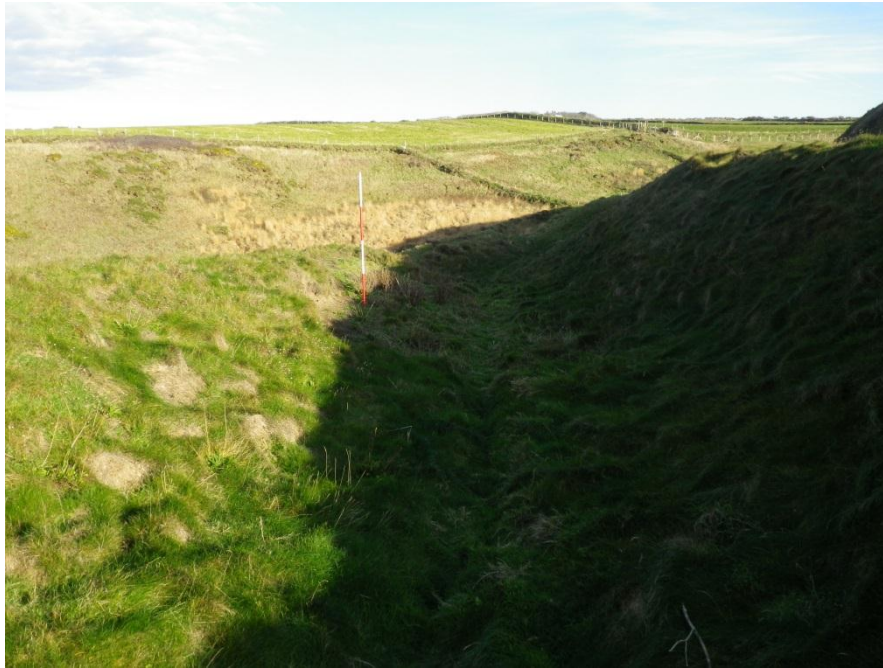
The area of the burn from 2-3 years ago is recovering well (see photo below), but cliff edge erosion continues and a larger fall effecting the inner bank is considered likely in the near future. The eastern edge of the fort's interior and the end of the promontory are also noticeably eroding, but its western side appears stable, for the moment.

Porth y Rhaw: area of burn, now mostly recovered with turf. Scale 2m.
View NE. 3/12/2014

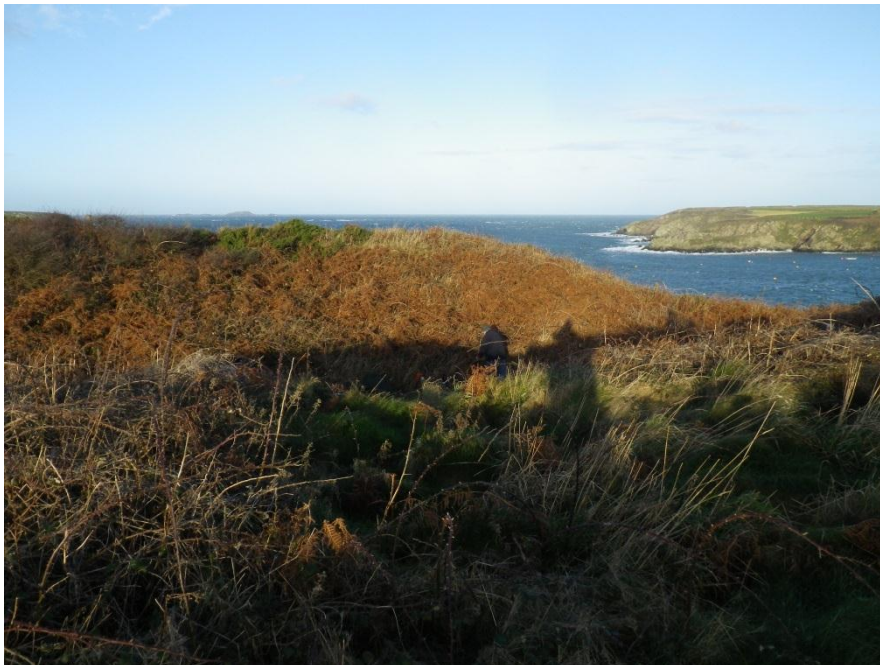
Castell Heinif: Overgrown inner bank. View NW. 9/1/2015

- Monitor any further erosion, especially to visit after any severe weather conditions
- Work again with NT volunteers to encourage clearance of vegetation from the outer side of the ditch

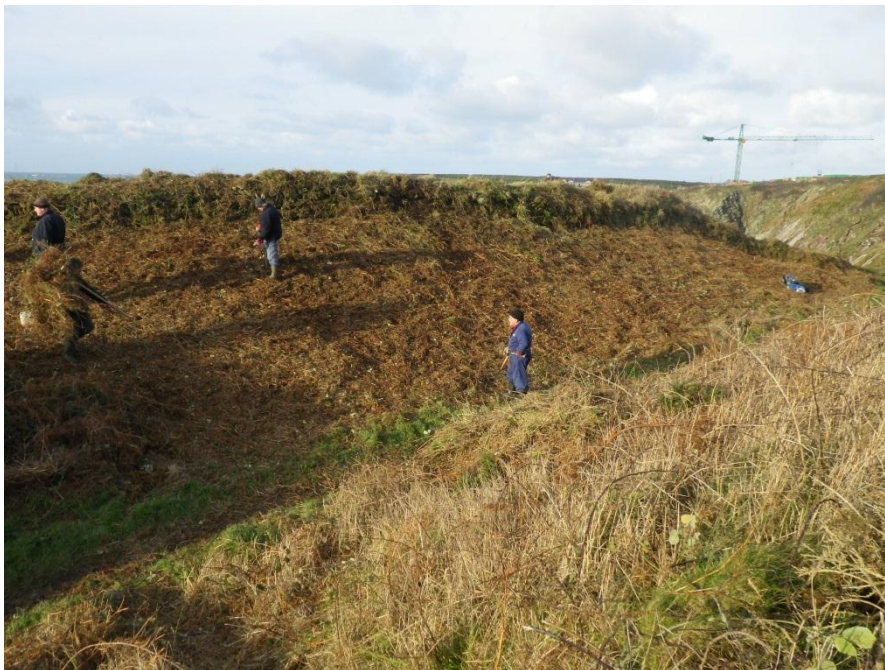
Some time was spent with two National Trust staff and seven volunteers when almost all of the barbed wire fencing was removed from the site. There is one small bit left on the hedge bank to the south of the defences. Almost all of the vegetation was removed from the inner bank revealing the (recent 18th/19th century?) revetment wall on the top of the bank (see photos below). A further work day is planned for late 2015 when the outer slope of the ditch is also to have the vegetation cut.

Castell Heinif: inner bank and revetment wall as cleared. View NW. 9/1/2015

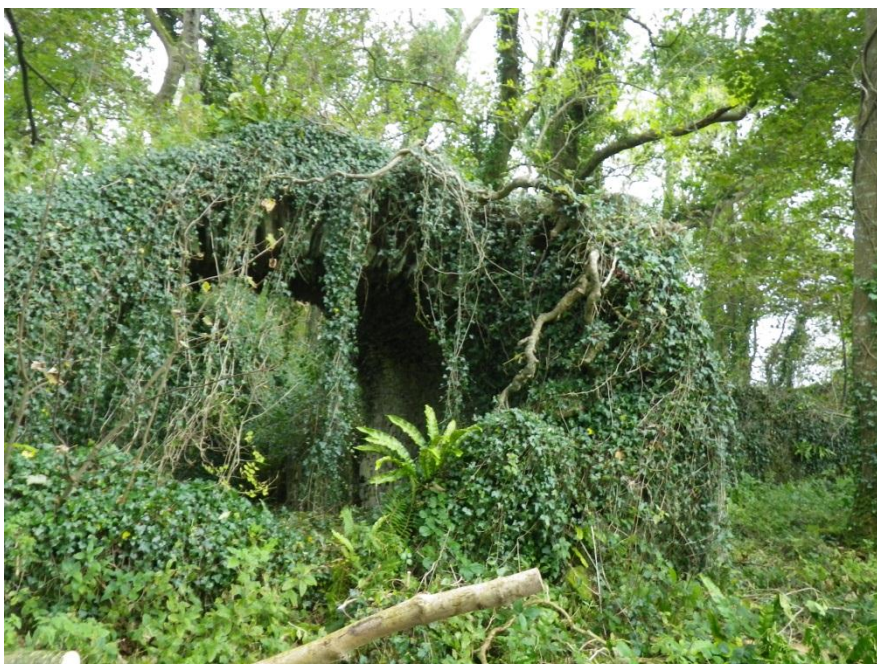
A site visit was made on 22/10/2014 to observe tree felling work that had taken place. A further visit was made on 8/12/2014 with the Cadw Field Monument Warden to examine what work has taken place and intentions in the near future. A final visit was made with the appointed forestry worker and NRW woodland/bat officer Mary Chadwick to discuss and agree next phase of work. Subsequently Mary Chadwick has asked for one tree due to be felled to be left: this information has been passed on. It is planned that the large tree on the vault should come down this year.

Sister's House: trees cut from "chapel" vault. View E. 22/10/2014

- Make certain that any new planting is sympathetic to the monument
- Undertake a watching brief when the large tree is taken from the vault as there could be some damage
- Cadw are recommended to extend the scheduled area to include adjacent features, for example the walled garden and adjacent boundaries

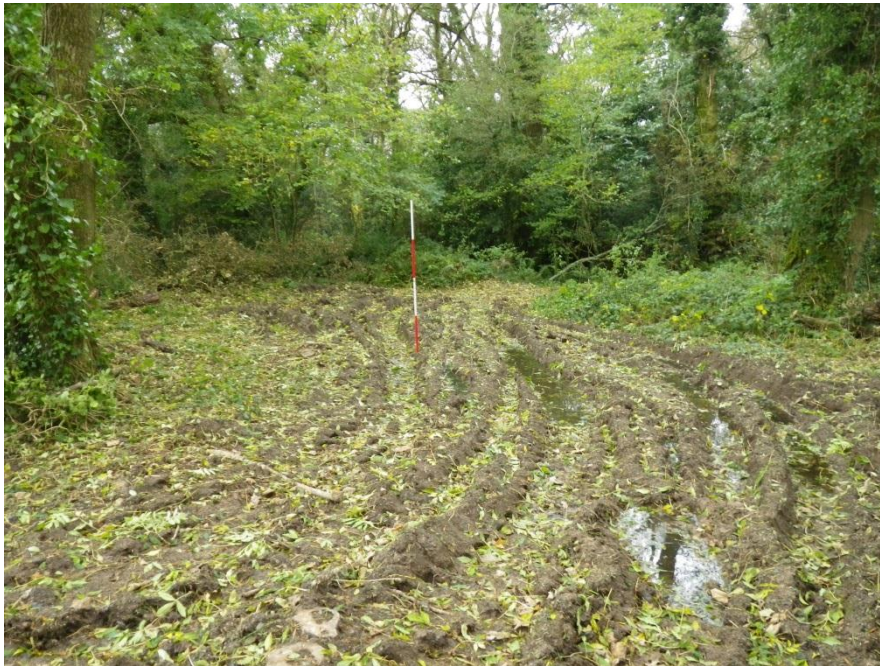
Sister's House: vehicle rutting to west of site. Scale 2m. View W. 22/10/2014

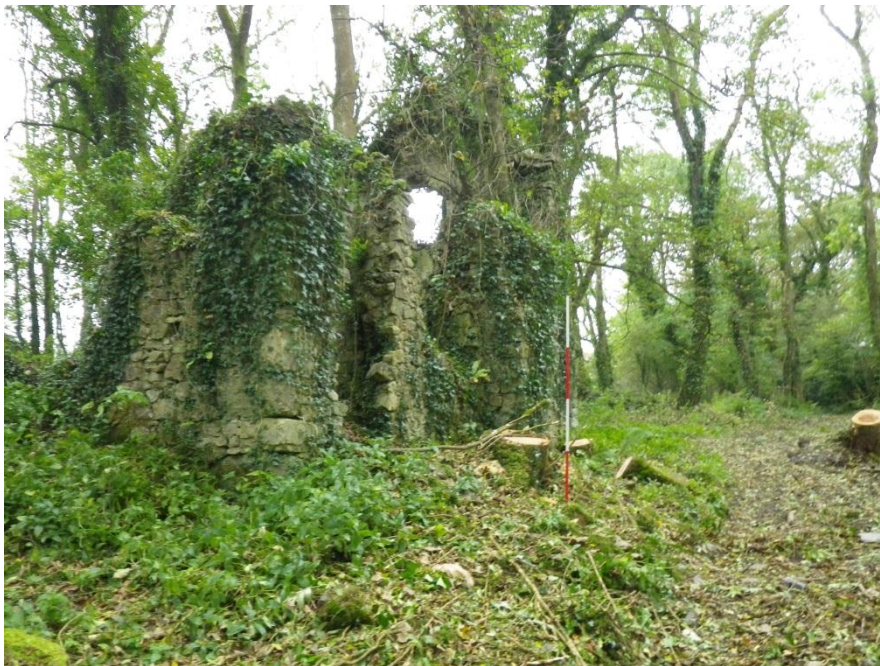
Sister's House: house site to west, adjacent trees cut, minor trees on walls due to come down in 2015. Scale 2m. View W. 22/10/2014

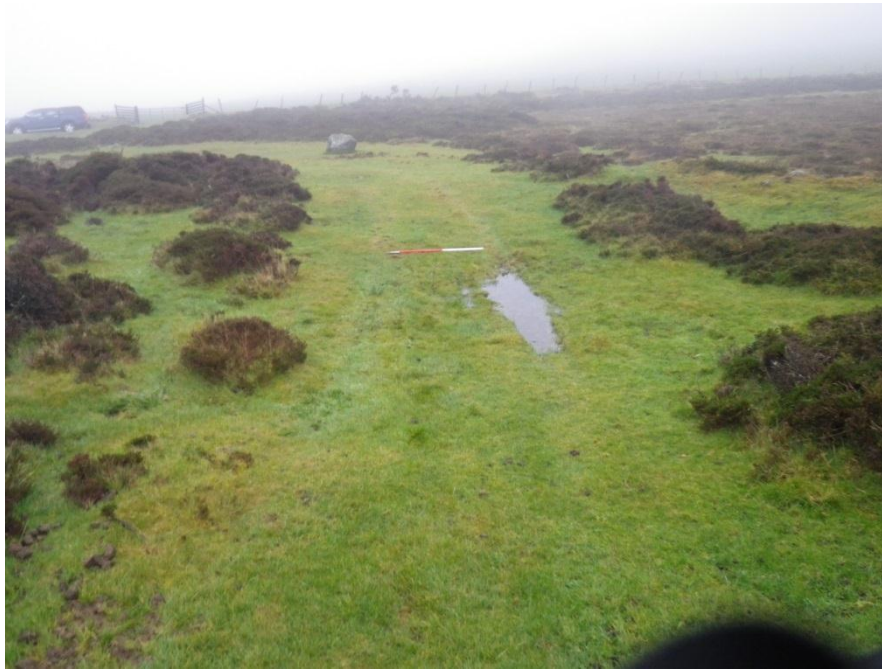
A site visit was made on 18/12/2014 after Judith Wainwright reported vehicle damage to the site. The damage only appears minor and it is likely that this was someone taking food to horses being grazed nearby. JW knows a number of people with horses in the area and will put the word around that this area should not be driven over. No further action was taken.

Glyn Gath: minor vehicle rut (misty wet day). Scale 1m. View W. 18/12/2015

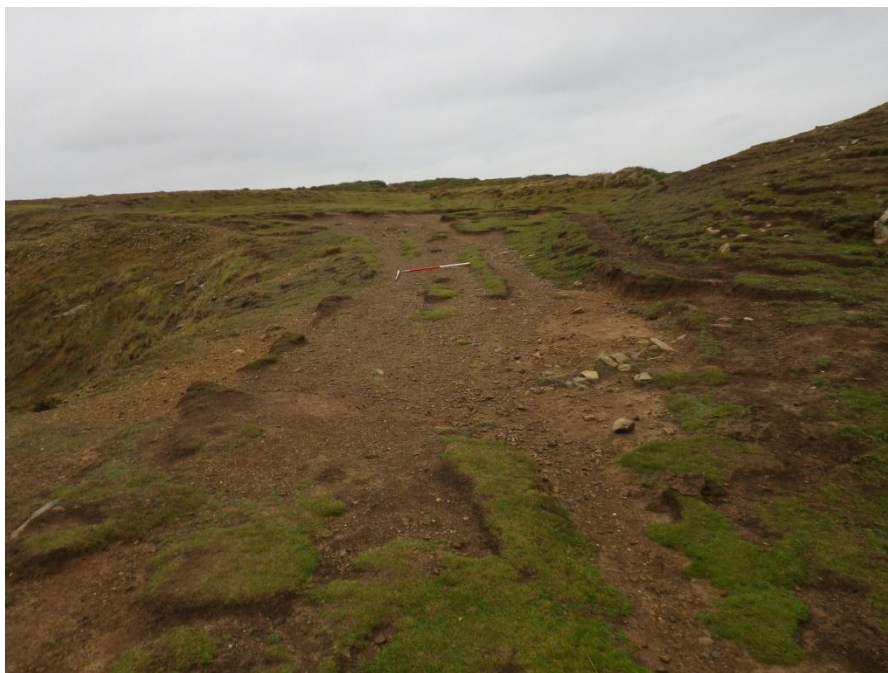
The site was visited on 15/10/2014 while doing work nearby for PCNPA. The southern end of the main fort bank is continuing to erode as is the end of the square enclosure just inside.

*Deer Park: southern end forts bank. Scales 1m and 1m. View W.
15/10/2014*

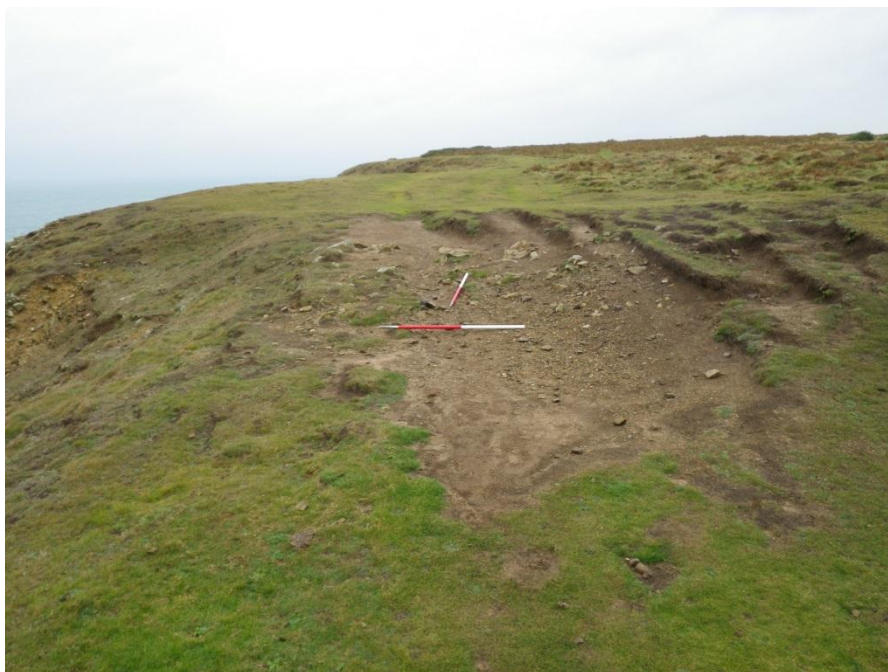
Deer Park: southern end of square enclosure bank. Scales 1m and 1m. View W.
15/10/2014

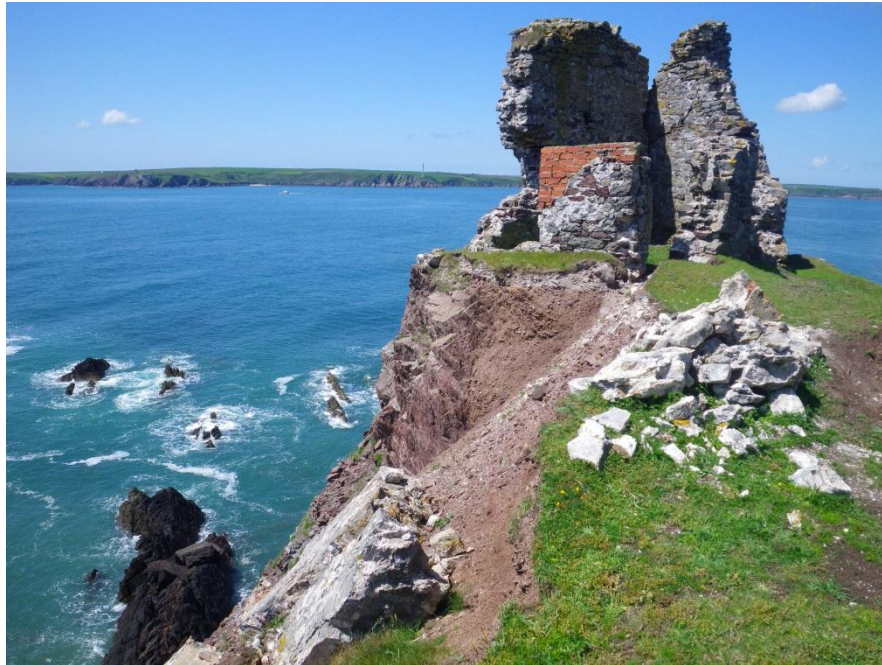
A site visit was made on 15/10/2014 after a report of partial collapse.

East Blockhouse: recent collapse. View N. 15/10/2014

- As previous - It is recommended that this site is monitored at least once a year, preferably in the spring as landslips are more likely over the winter. Of particular importance are the scant remains of the second building, more of which may be revealed as the cliff edge erodes

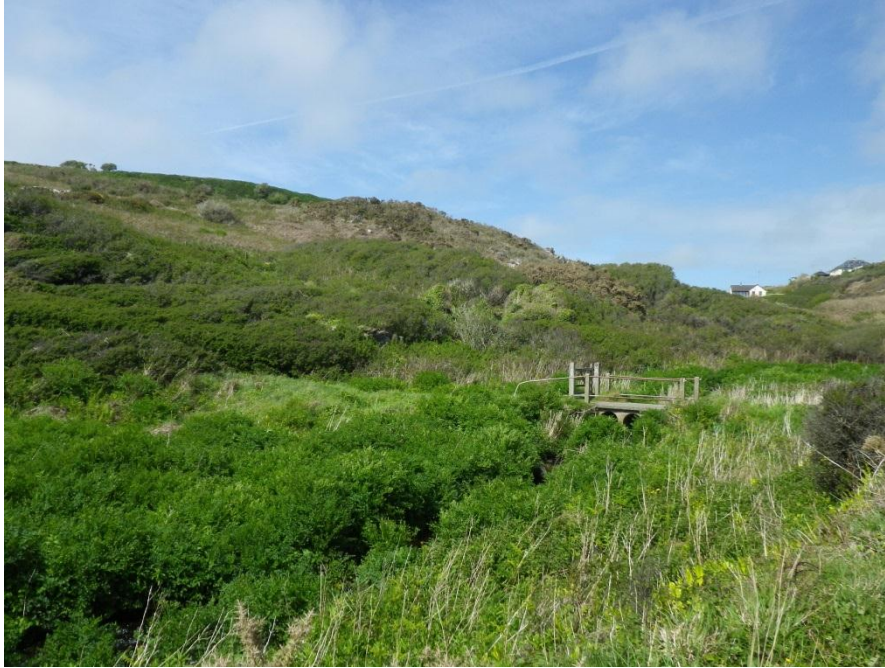
A site visit was made on 7/5/2014 to see if any work had been done on the mill as part of the Tir Gofal condition. No work had been carried out. Natural Resources Wales do not appear to regard following up on this lack of action as their concern.

*Caerbwdy Mill: still over grown (Mill to left and behind bridge). View NW.
7/5/2014*

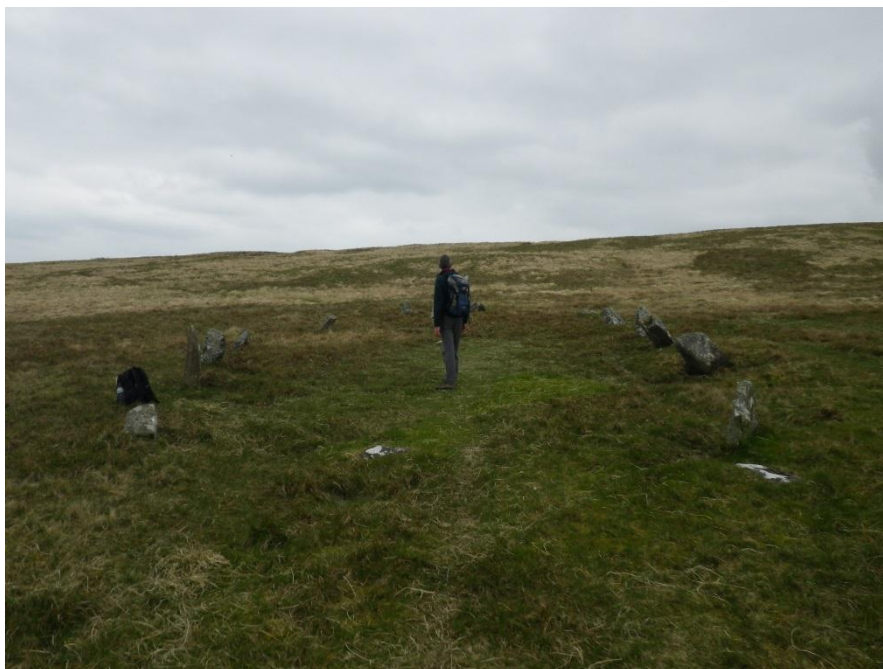
This site was visited while undertaking a reconnaissance for a guided walk on 2/5/2014. The site is being grazed. However, the sheep scrapes filled in a couple of years ago have reappeared and the three stones affected could topple in the near future unless action is taken.

Bedd Arthur: general view. View SW. 2/5/2014

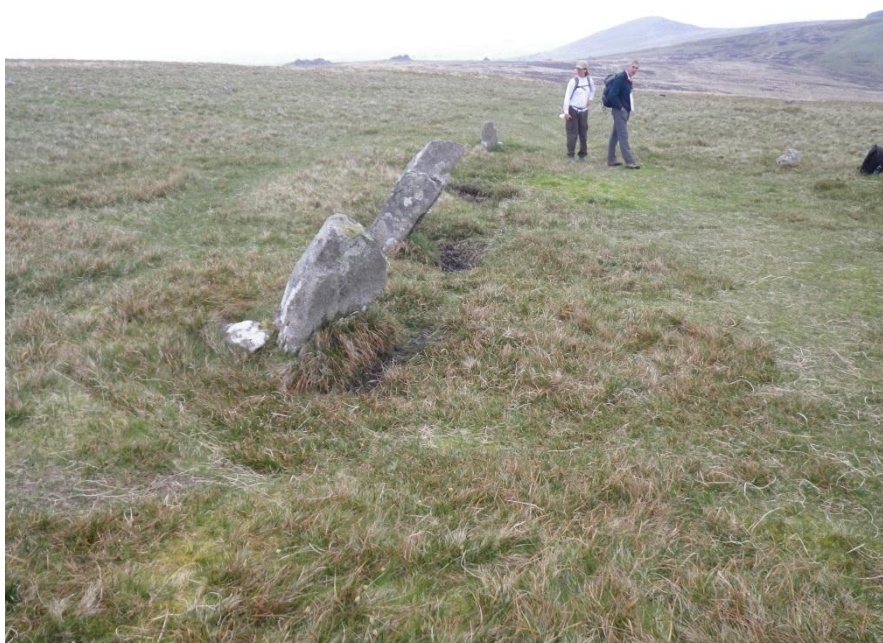
Bedd Arthur: three stones being compromised again by sheep scrapes. View NE. 2/5/2014

- Visit early in spring 2015 and after summer 2015
- Sheep scrapes to be repaired?

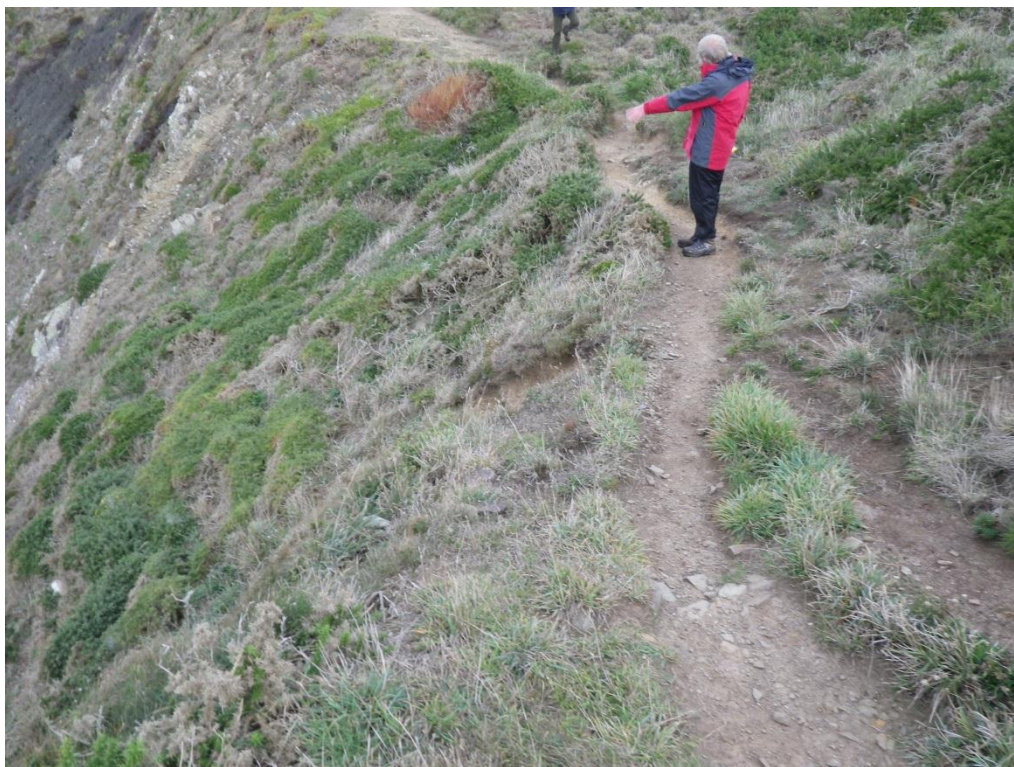
Photo 1: Watery Bay Rath, erosion pinch point adjacent to path. View NNW
