REPORT ON WORK UNDERTAKEN ON SCHEDULED ANCIENT MONUMENTS WITHIN THE PEMBROKESHIRE COAST NATIONAL PARK 2014-15

Prepared by Dyfed Archaeological Trust
For Cadw

Report No. 2015/10

March 2015

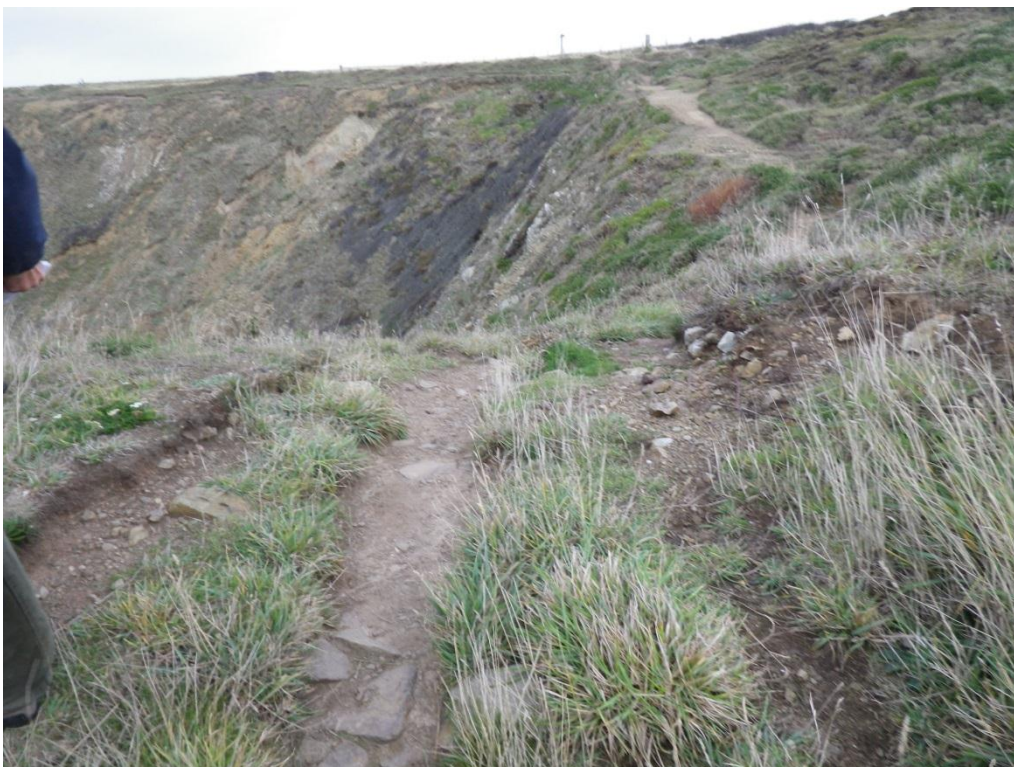
Photo 2: Watery Bay Rath, footpath erosion across bank where Time Team cut their trench. View NNW

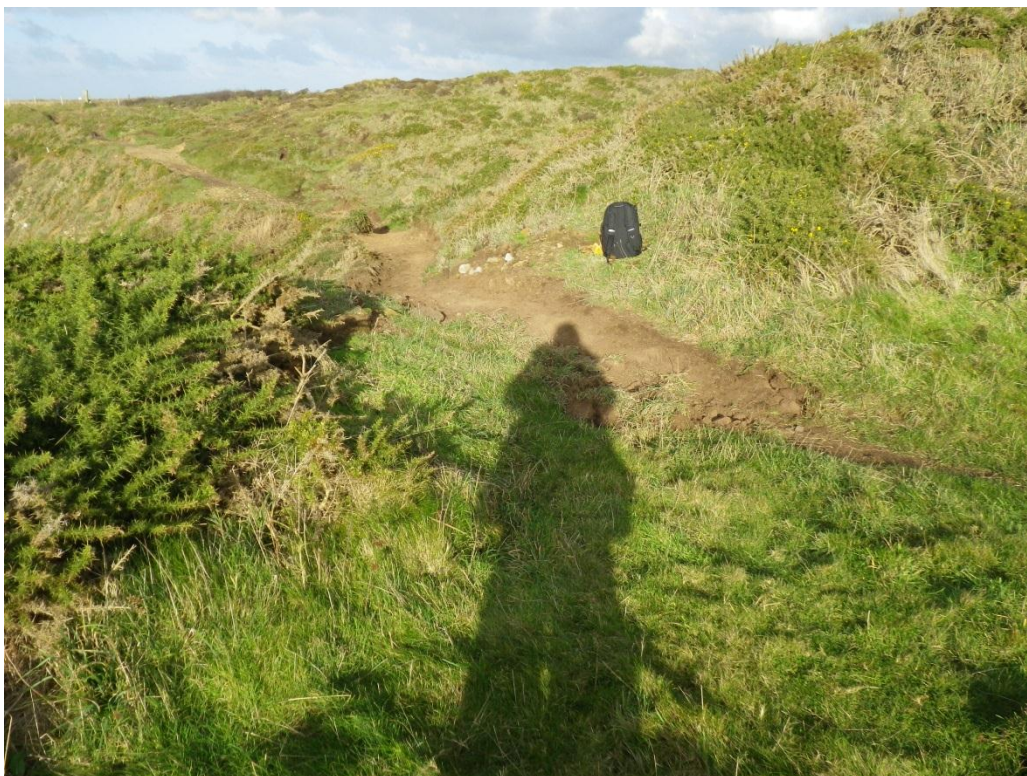
Photo 3: Watery Bay Rath, re-alignment of path across bank 2/12/2014. View N

This small amount of path re-alignment has made this part of the coast path much safer while causing almost no further disturbance to the remains of the Iron Age fort. Furthermore the infilling of the coast path's cut across the small coastal bank should stop any more downwards erosion caused by walkers.

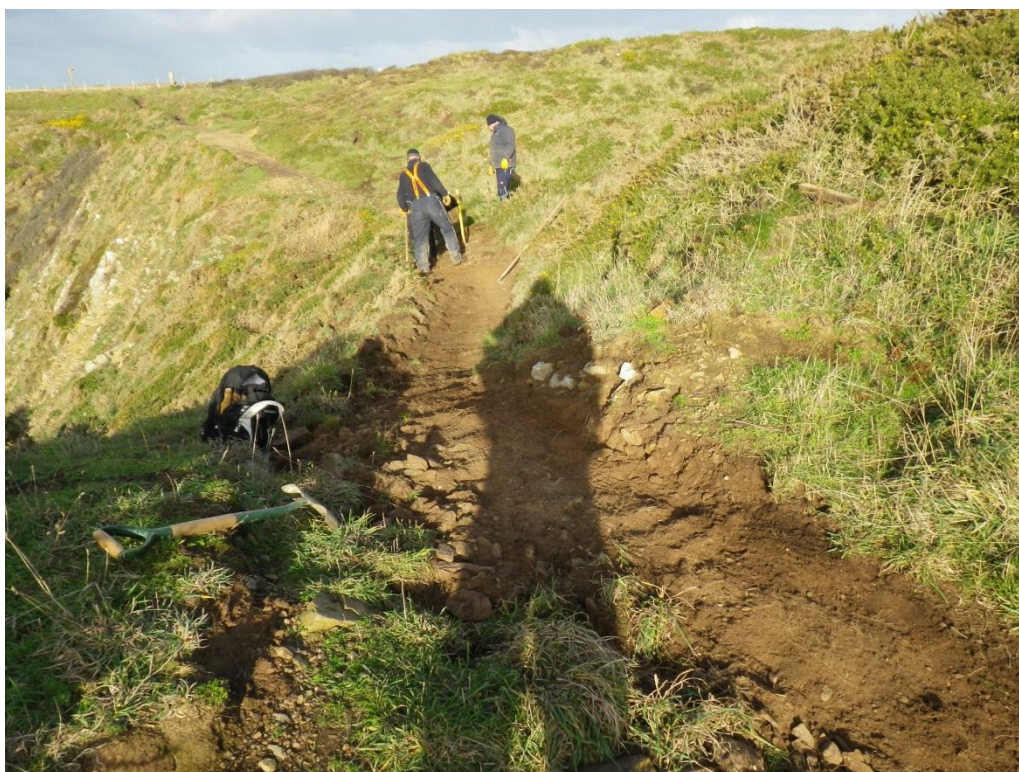
Photo 4: Watery Bay Rath footpath re-alignment as cut 2/12/2014. View N

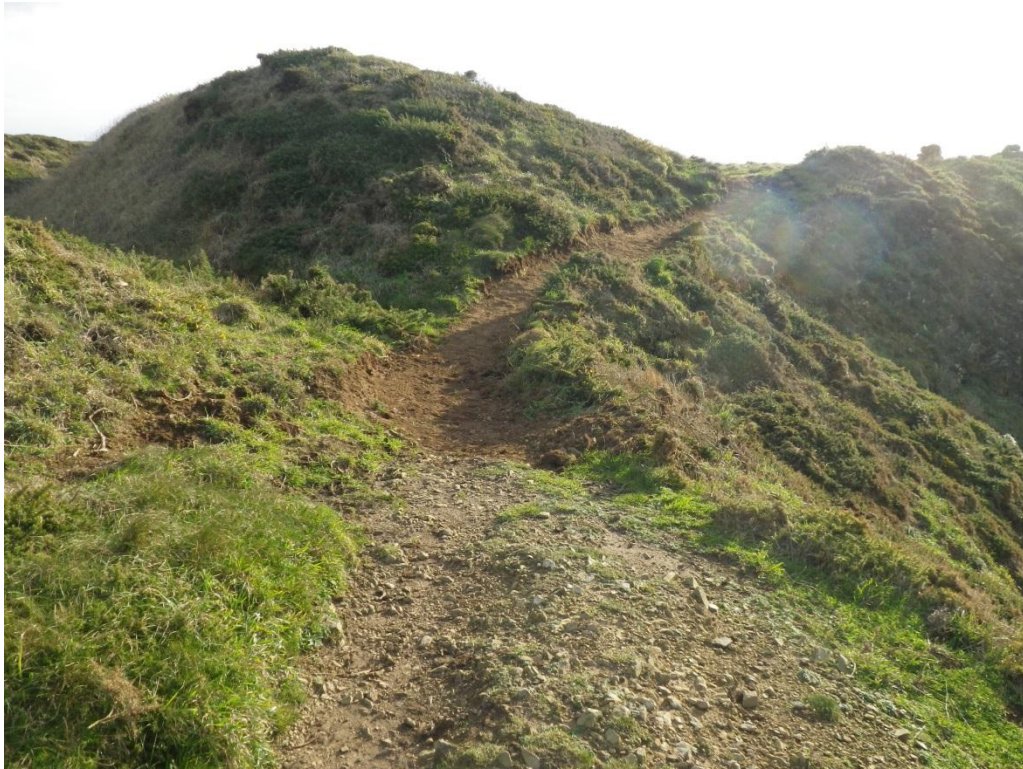
Photo 5: Watery Bay Rath, footpath re-alignment as cut 2/12/2014. View S
