## PEMBROKE REFINERY-VALERO, RHOSCROWTHER, PEMBROKESHIRE: ARCHAEOLOGICAL EVALUATION 2019 (NGR SM 91418 02143)

RHIF Y PROSIECT / PROJECT RECORD NO. 118119 RHIF YR ADRODDIAD / REPORT NO. 2019-41

## PEMBROKE REFINERY-VALERO, RHOSCROWTHER, PEMBROKESHIRE: ARCHAEOLOGICAL EVALUATION 2019

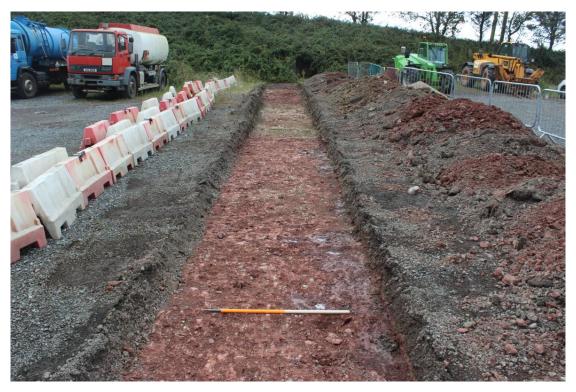
Photo 1: Trench 1, viewing southwest.

- Trench 1 (Photos 1, 2 & 3) was eventually located just southeast of the 4.3 proposed development area and measured around 24.5m long by 1.6m wide and 0.30m deep. The misplacement of the trench outside of the site area was due to other constraints preventing trenches further northwest and the identical ground conditions across most of that part of the car park area. The trench was orientated on a northeast by southwest alignment and was located within an area of car park hard standing. The natural geology was revealed at roughly 0.30m below existing ground level and was formed of a light reddish sandstone bedrock [102] which showed signs of being previously landscaped flat particularly within the central area of the trench were the remains of possible bulldozer tracks or machine wheel ruts were visible (Photo 2). Overlying the bedrock was a thin layer of geotextile membrane [101] which in turn was overlain by a mixed crushed stone hardcore [100] measuring roughly 0.30m in depth and containing inclusions of occasional small pieces of crushed brick and some modern plastic debris.

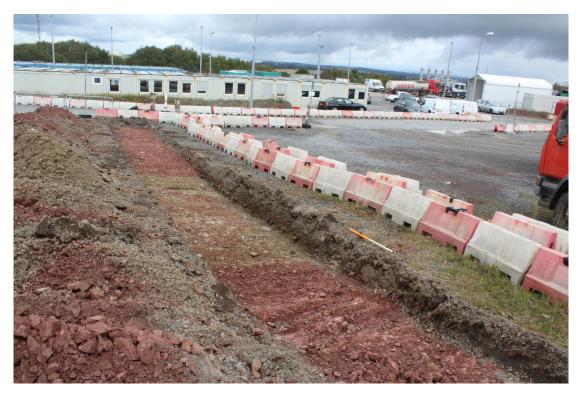
**Photo 2:** Trench 1 viewing east, oblique view of section and wheel/track ruts within central area of trench.

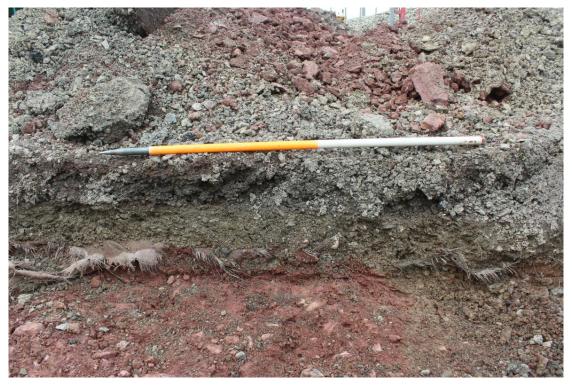
**Photo 3:** Trench 1, view of southeast facing section through crushed stone surface.

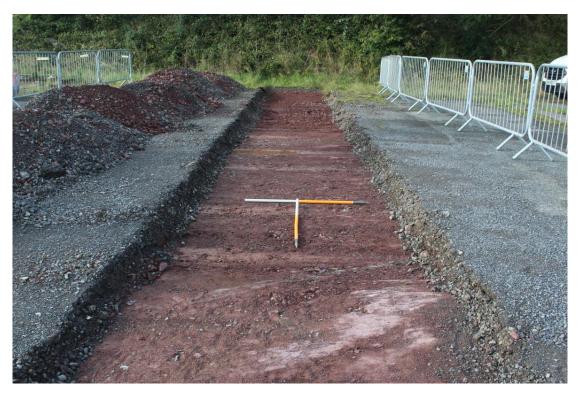
Photo 4: View of Trench 2, viewing southwest.

- 4.4 Trench 2 (Photo 4) was located within the southeastern part of the development footprint measuring 27m long by 1.6m wide and 0.30m maximum in depth. The trench was orientated northeast to southwest and was positioned within an area of car park hard standing. The natural geology was revealed at between 0.30m and 0.20m below the existing ground level formed of light red sandstone [202] which showed signs of previous mechanical landscaping (Photo 4). A layer of geotextile membrane [201] was found overlying the bedrock which in turn was overlain by a layer of crushed stone hard core [202] which contained rare small pieces of plastic with some occasional fragments of crushed brick. This deposit varied between 0.30m and 0.20m deep.

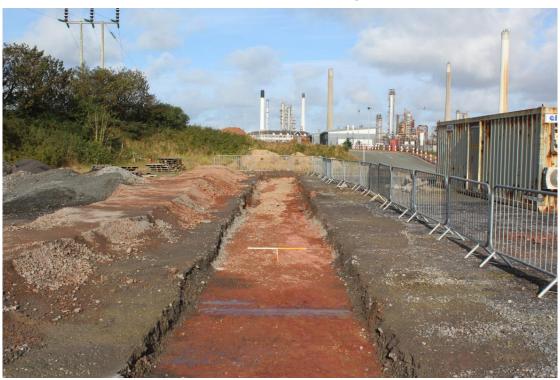
- 4.5 Trench 3 (Photos 5, 6 & 7) was placed within the east of centre part of the development area on a northwest to southeast orientation measuring 31.7m long by 1.6m wide and 0.30m deep. The light red sandstone bedrock [304] was exposed which displayed signs of being heavily truncated by mechanical landscaping. The remains of a redundant service run [302] was identified cut into the natural bedrock and running centrally parallel along the length of the trench for around 25m and on a northwest to southeast orientation (Photo 6). The uppermost fill viewed within the service run comprised of a mixed brick/rubble backfill [303] which was firmly compacted and contained small fragments of modern concrete. The service run was not excavated. Overlying the bedrock and service trench was a layer of geotextile membrane [301] which in turn was overlain by a layer of crushed stone hardcore [300] which measured on average between 0.22m and 0.30m deep.

**Photo 5:** View of Trench 3, viewing northwest.

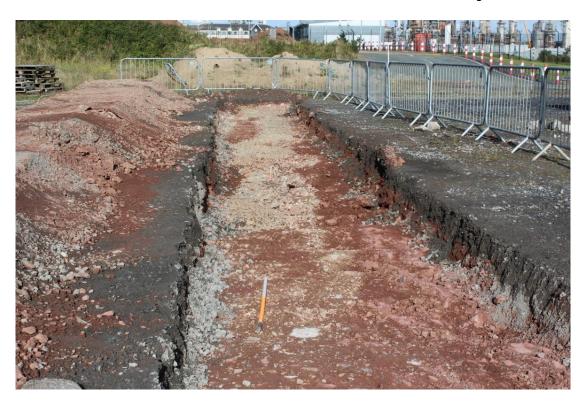
**Photo 6:** Detailed view of service run cut in Trench 3

- 5.4 The service run recorded within Trench 3 is considered to be the remains of either a foul water drain or an electrical service very likely to have been associated with the 1960s accommodation blocks or workers compound.

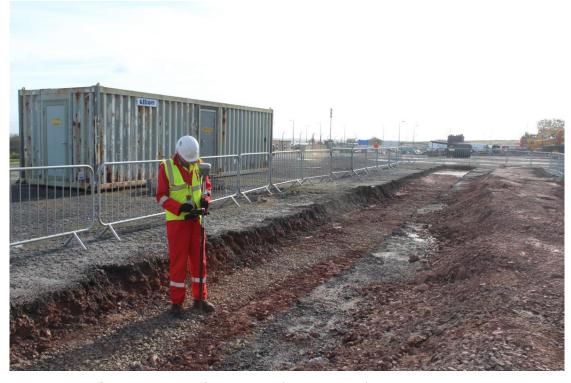
**Photo 7:** View of GPS recording in Trench 3, viewing east.

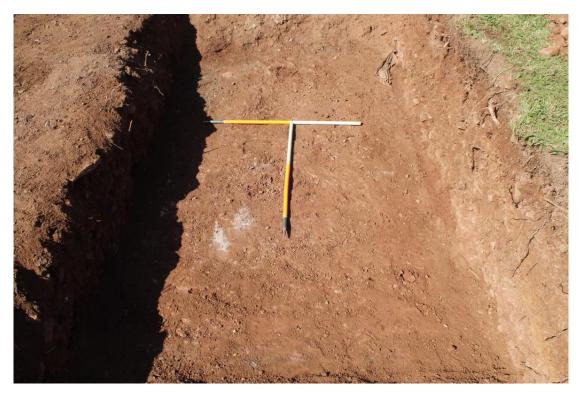
Photo 8: View of Trench 4, viewing northwest.

4.6 Trench 4 (Photo 8 & 9) was located upon a grass covered ridge that protruded northeast into the car park. During the initial excavation of Trench 4 an iron service pipe was encountered, and it was decided that the trench should be moved slightly to the northeast to avoid it. The final dimensions for Trench 4 were 5.68m in length by 3.6m wide and 0.90m deep. Sequentially the earliest deposit revealed within the base of the trench comprised of light reddish brown silty clay [402] which contained frequent fragments of small sub angular stones and some small fragments of brick, plastic and concrete. This deposit was first viewed at 0.90m below existing ground level and is considered to be the remains of modern landscaping. Overlying deposit [402] was a mixed deposit of moderately compacted light to mid brown silty clay [401] which contained frequent inclusions of small sub angular stones and a piece of denim fabric (Photo 9). This deposit measured 0.70m in depth and is considered to be the remains of modern landscaping. A dark brown silty clay topsoil [400] overlay the trench which measured 0.20m in depth and contained occasional finds of plastic and frequent small sub angular stones.

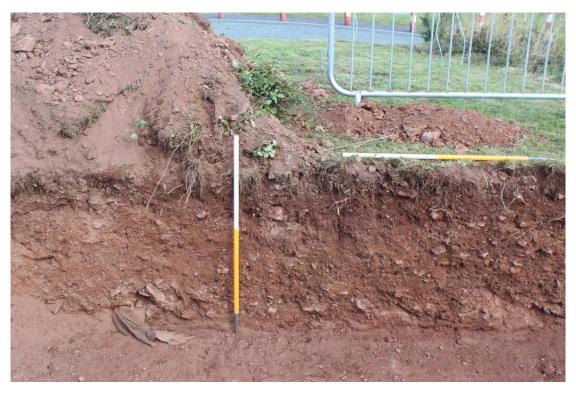
**Photo 9:** South west facing section in trench 4 with denim fabric visible in bottom left corner of picture.

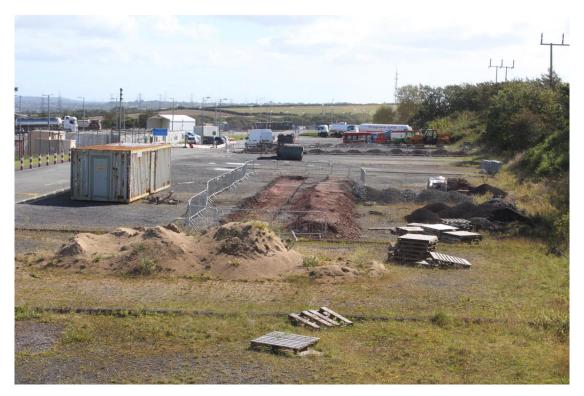
**Photo 10:** View east of Trench 3 from Trench 4, with Trenches 1 and 2 in background.
