# **SWN Y MORLO COTTAGE, GOODWICK, PEMBROKESHIRE: ARCHAEOLOGICAL WATCHING BRIEF**

**NP/18/0561/FUL & NP/19/0569/NM**

REPORT NO. 2020-12  
EVENT RECORD NO. 121690

**November 2019**

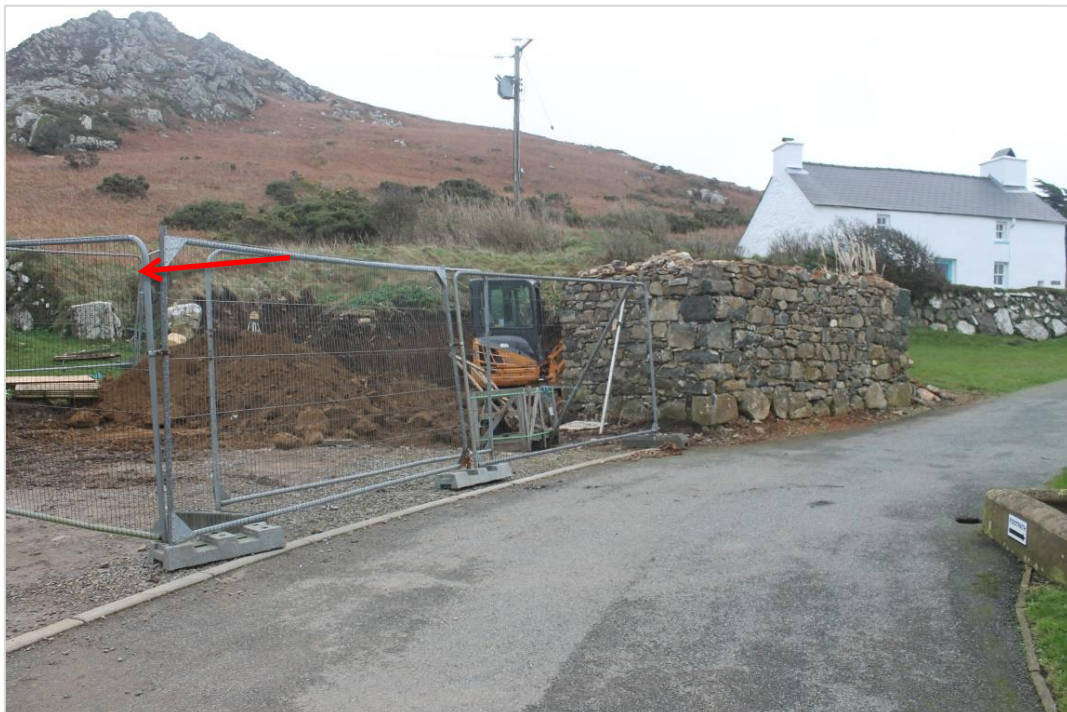
**Photograph 01:** Former barn and development in foreground, Tal Y Gaer Farmhouse (LB1269) back right, Garn Fawr Camp (PE 065) back left. Arrow mark location of Tal y Gaer corbelled hut (210). Looking east.

- 2.3.2 These assets include two Scheduled Ancient Monuments and one Listed Building. These are displayed in Table 2 and Figure 3. The heritage assets include the Iron Age Hillfort of Garn Fawr camp (PE 065) and a corbelled hut (PE 210), which is thought to be Medieval (Photograph 01 and 02). The listed building is Tal y Gaer Farmhouse (LB 12969), a Grade II Listed farmhouse of typical 19<sup>th</sup> Century design (Photograph 01).

- 4.1.5 Upon arrival the site had already been cleared of vegetation, debris and some of the overburden (Photograph 01). This was undertaken by the owner as part of the work to make the former barn safe.

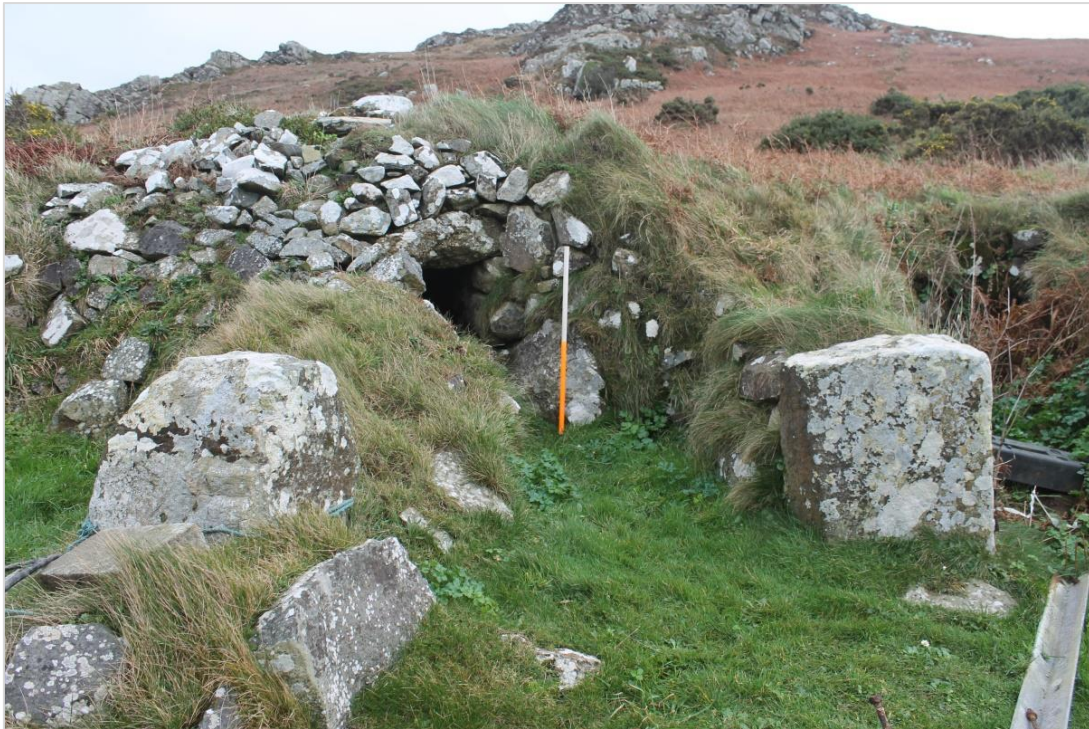
**Photograph 02:** Tal Y Gaer Corbelled hut (PE210). Looking east, 1m scale.

- 2.2.3 There have also been a large number of visits to the Tal y Gaer corbelled hut immediately adjacent to the site to assess its archaeological character. Initially, it was identified as a possible Long Barrow chamber in 1949 by Professor Bruce Perry. More recent visits by Cadw in 2004 thought it more likely to be a Medieval Corbelled hut.

- 2.2.5 The corbelled hut (PE210) immediately adjacent to the site provides good evidence of Medieval activity in the area. The Grade II Listed farmhouse (LB 12969) is definite evidence of post-medieval activity nearby.

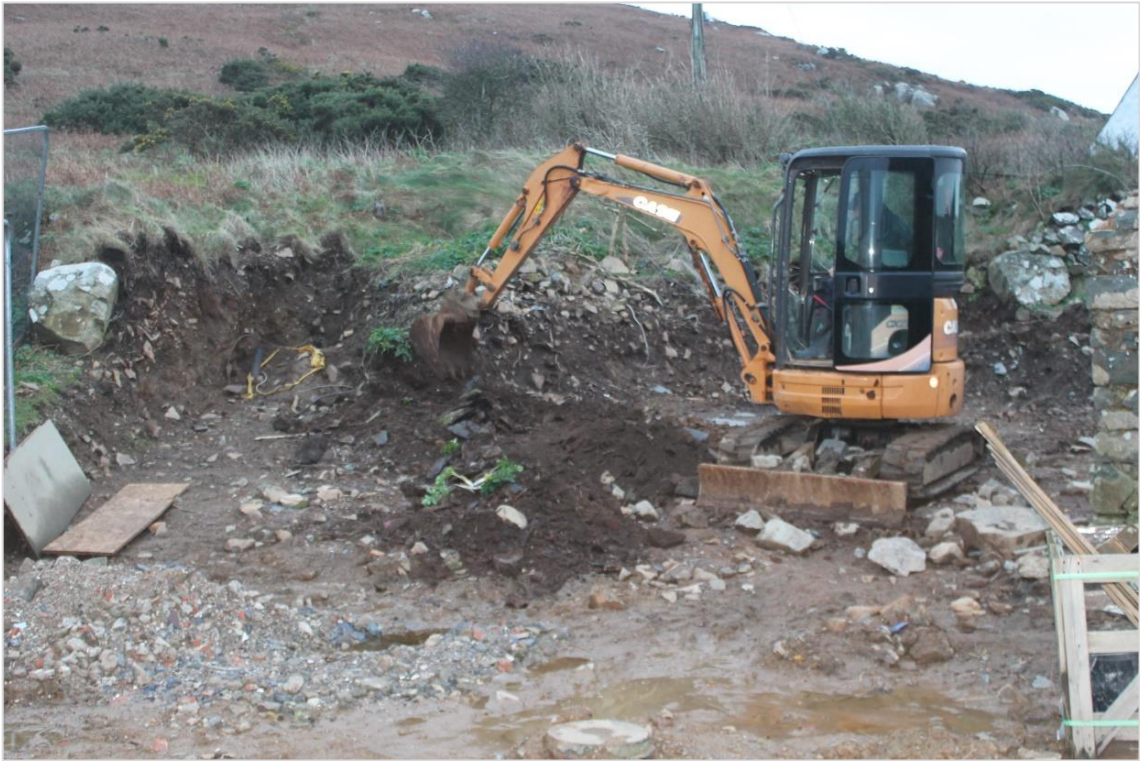
**Photograph 03:** Development Zone upon arrival. Looking east.

- 4.1.7 Initial work involved the clearing of the area immediately to the north of the former barn to allow access to the development area (Photograph 03). Most of the overburden had already been removed in this area.

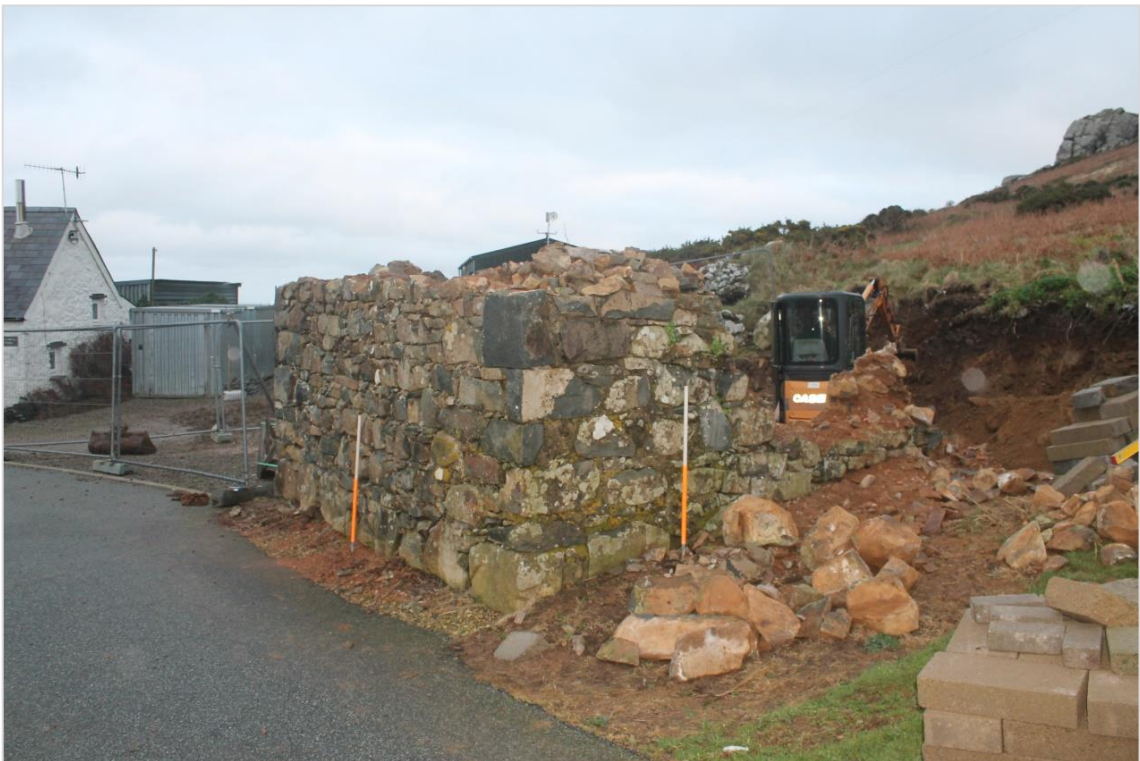
**Photograph 04:** Showing remaining standing walls of outbuilding. Looking northeast, 2x1m scales.

- 4.1.2 The development area measured approximately 7m x 10m and included the western end of a former barn (Photograph 04 and 07). The development zone was mostly restricted to the interior plan of this building but also expanded to the north to allow access to the site. The eastern section of the former barn had been declared unsafe so had been demolished previous to arrival (Figure 3).

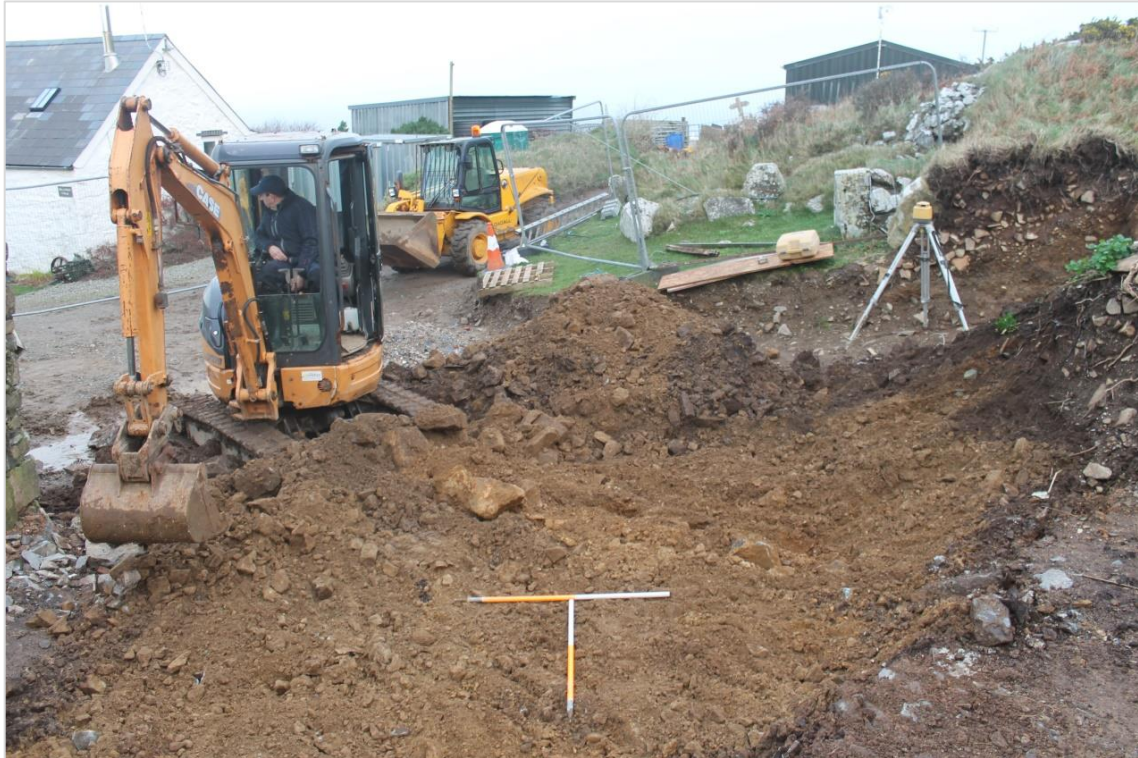
**Photograph 05:** Stripped area to the north of the development zone. 2x1m scales

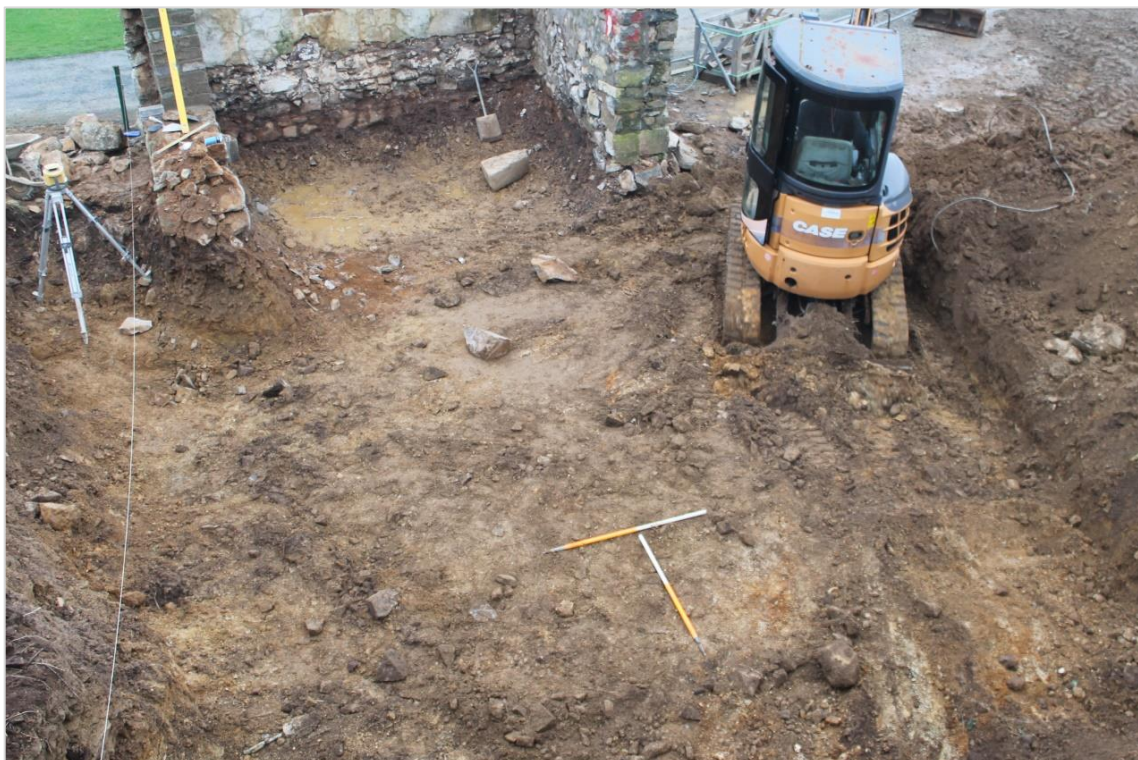
**Photograph 06:** Eastern end of the site after stripping. Looking west, 2x1m scales.

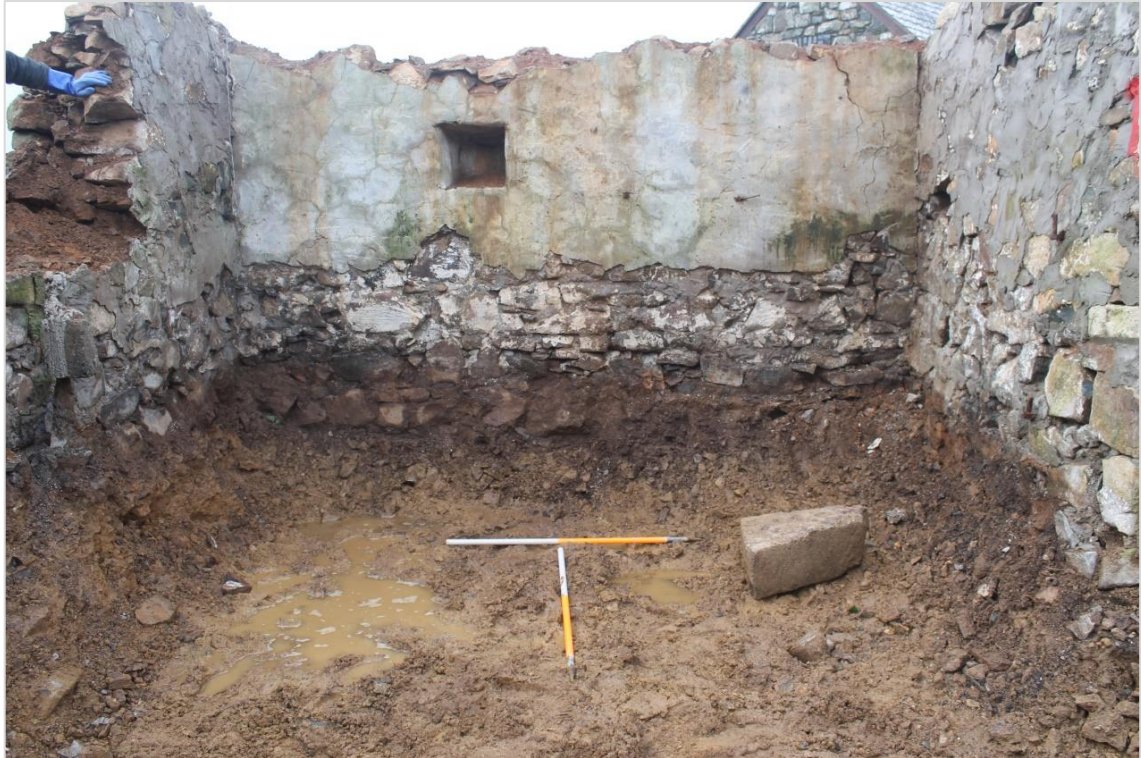
**Photograph 07:** Showing area within walls of outbuilding after stripping. 2x1m scales.

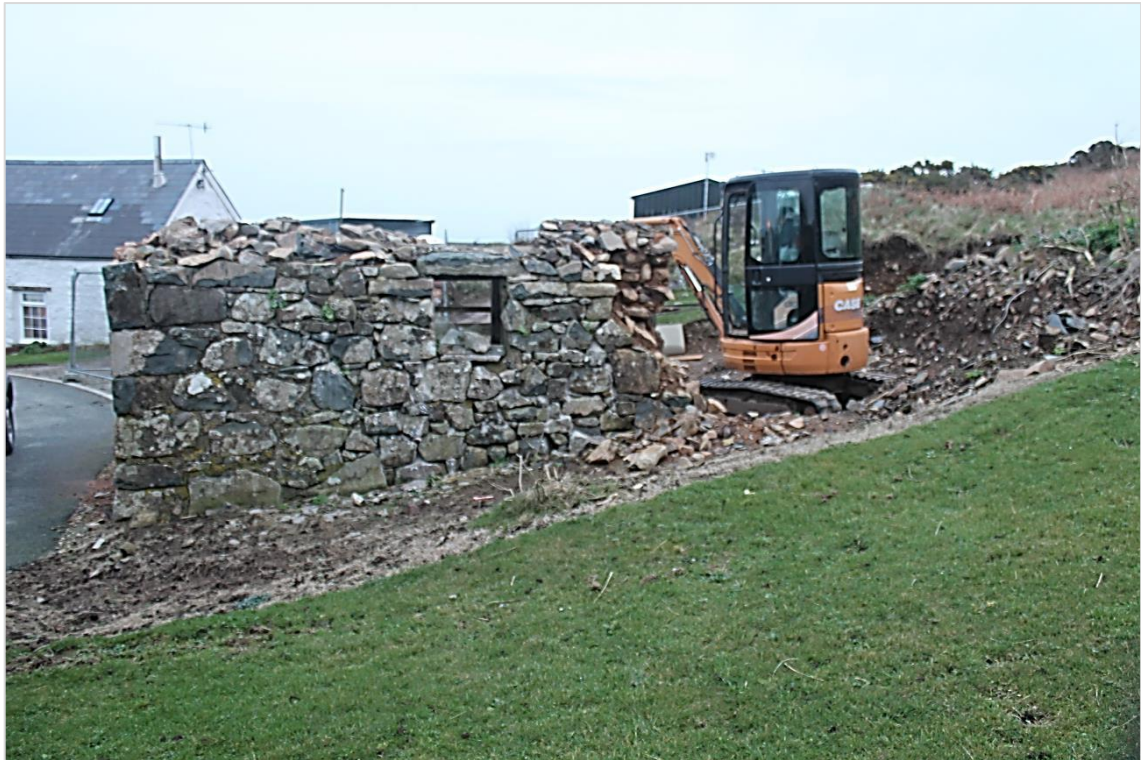
- 4.2.3 As it stands the southern wall is 4m long and approximately 0.3m thick (Figure 3 and Photograph 08). This wall was probably originally *circa* 10m long but had been considerably reduced due to safety concerns. There was a small window *circa* 2m from the western end which was later taken out as it was unsafe. Beyond the window, the wall reduced in height towards its eastern extent.

**Photograph 08** Showing southern wall of former barn. Note small window.  
Looking north.

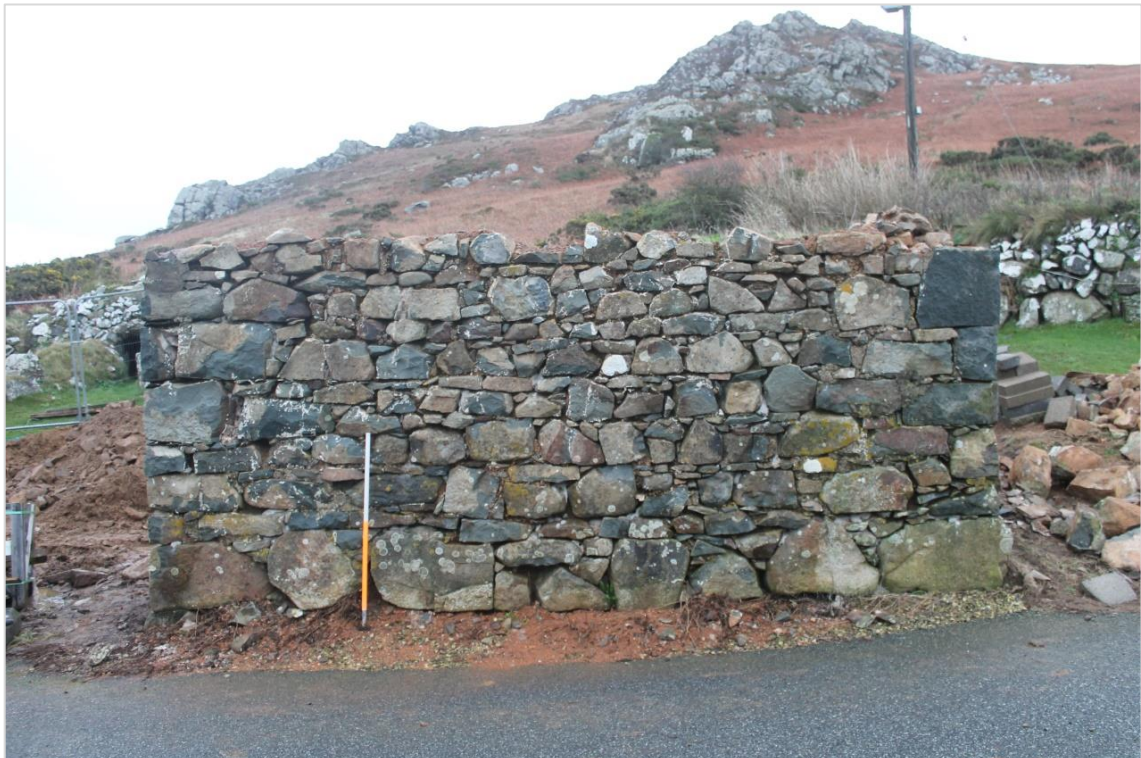
- 4.2.4 The western wall represented the most intact section of the building measuring 2.1m in height along its length and approximately 5.0m wide (Figure 03 and Photograph 09). This end of the building is well constructed with large key stones in the corners. This is likely because it is the most visible part of the building and because this wall was originally gabled. The interior of this wall has a small niche for an unclear purpose (Photograph 10).

**Photograph 09:** Western wall of former barn (exterior). Looking east, 1m scale.

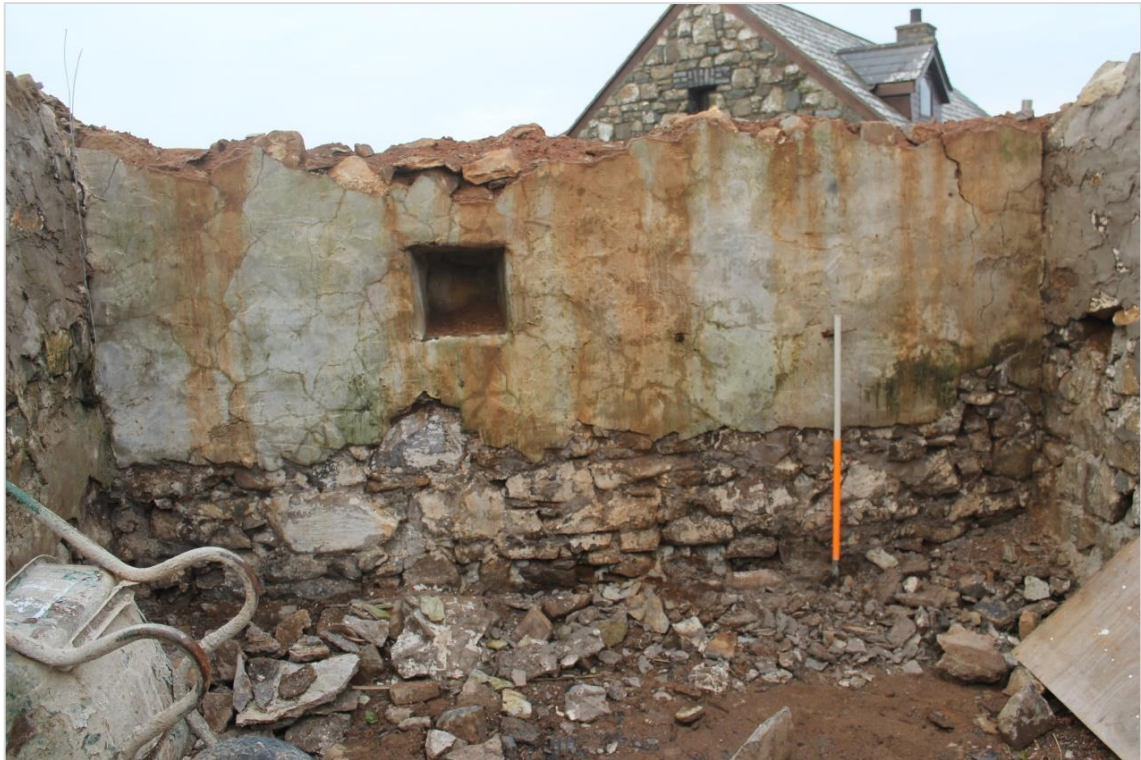
**Photograph 10:** Western wall of former barn (interior). Note small niche. Looking west, 1m scale.

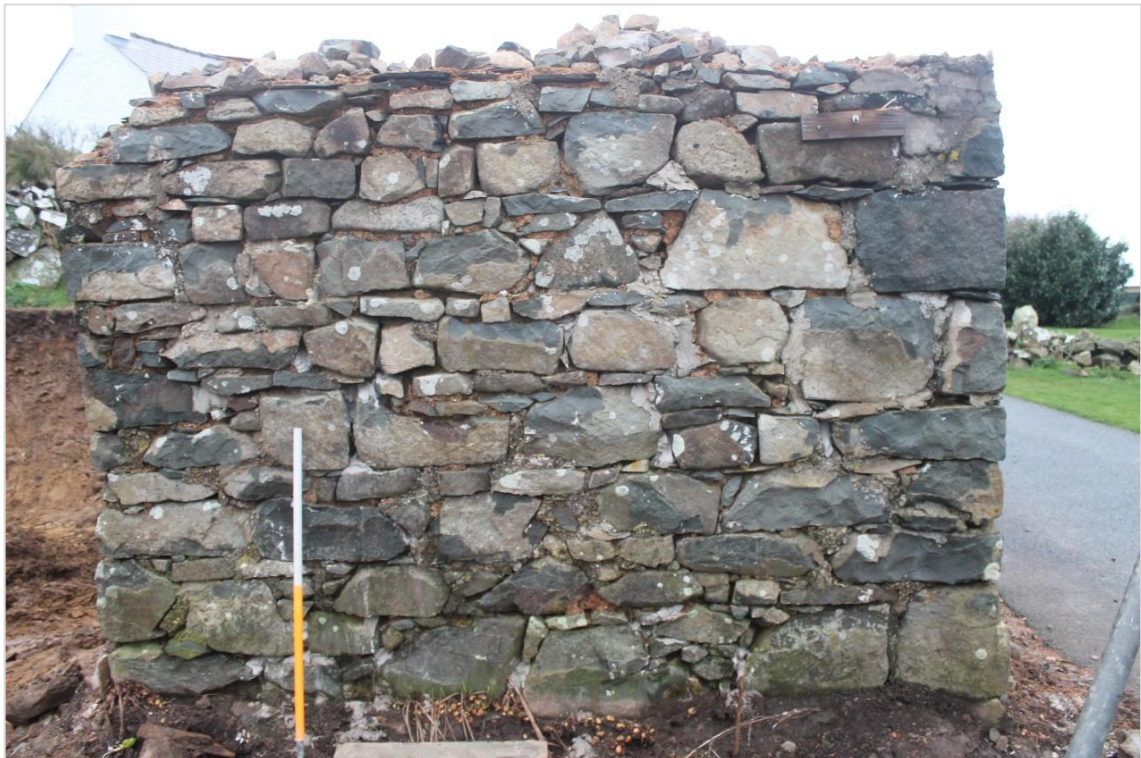
- 4.2.5 The northern wall was approximately 3m long by 2.5m wide (Figure 03 and Photograph 11) and seems to be relatively intact in height. The eastern end appears to represent the area where a door may have stood.

**Photograph 11** Showing northern wall of former barn (exterior). Note the keyed in wall on left of photograph indicating that this may have once been a doorway. Looking south, 1m scale.
