LAND AT STATION ROAD, LETTERSTON, PEMBROKESHIRE: HISTORIC ENVIRONMENT DESK-BASED ASSESSMENT

REPORT NO. 2020-14
PROJECT NO. 121693

March 2020

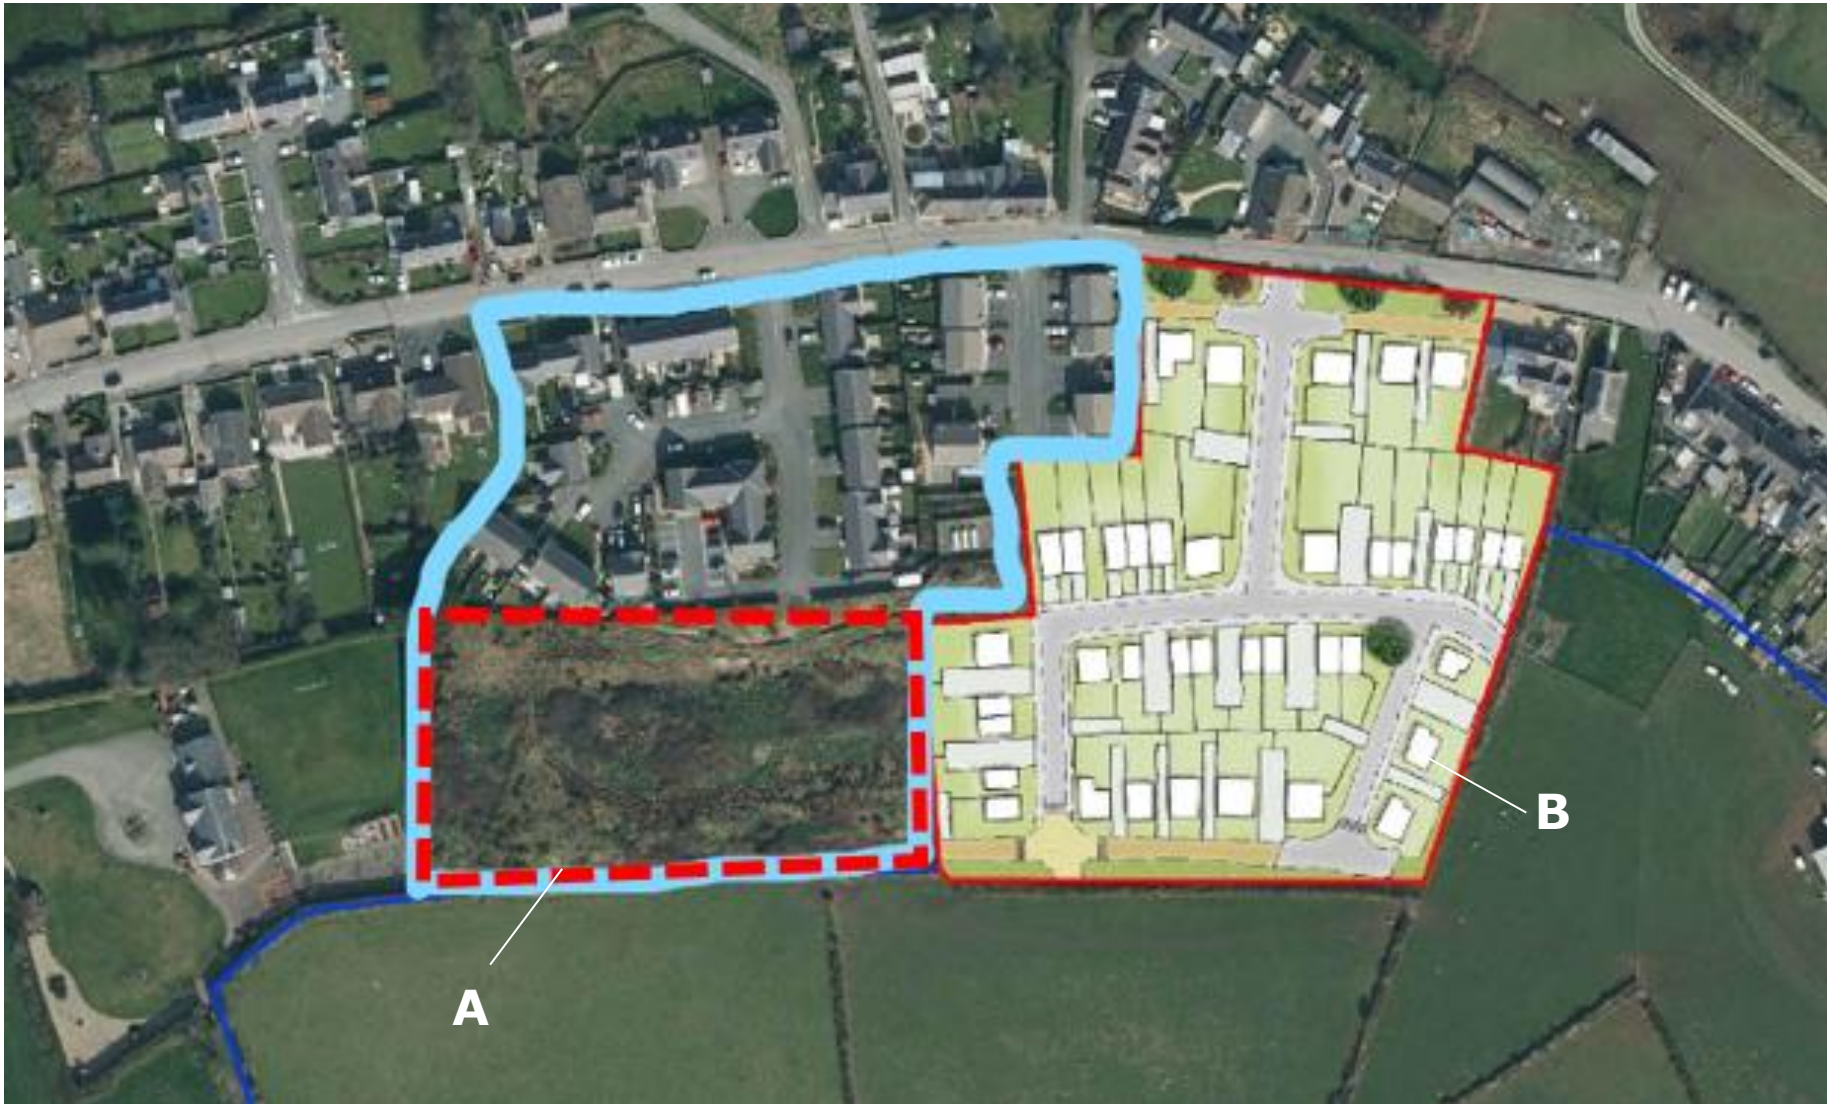
Figure 3: Aerial photograph showing boundaries of the western part (A) of the development area (outlined with a red dashed line) and the eastern part (B) outlined with a continuous red line (supplied by client).

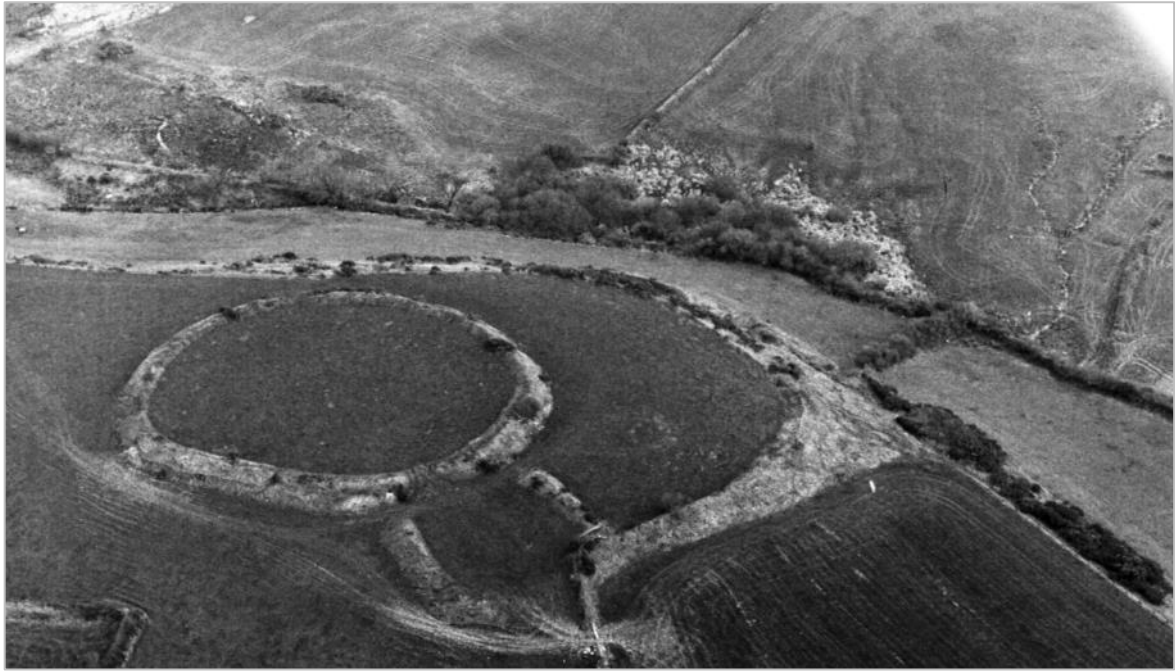
Photo 1: Bucket Camp (PE 062). Looking south (DAT Images/AP93-13.51.jpg).

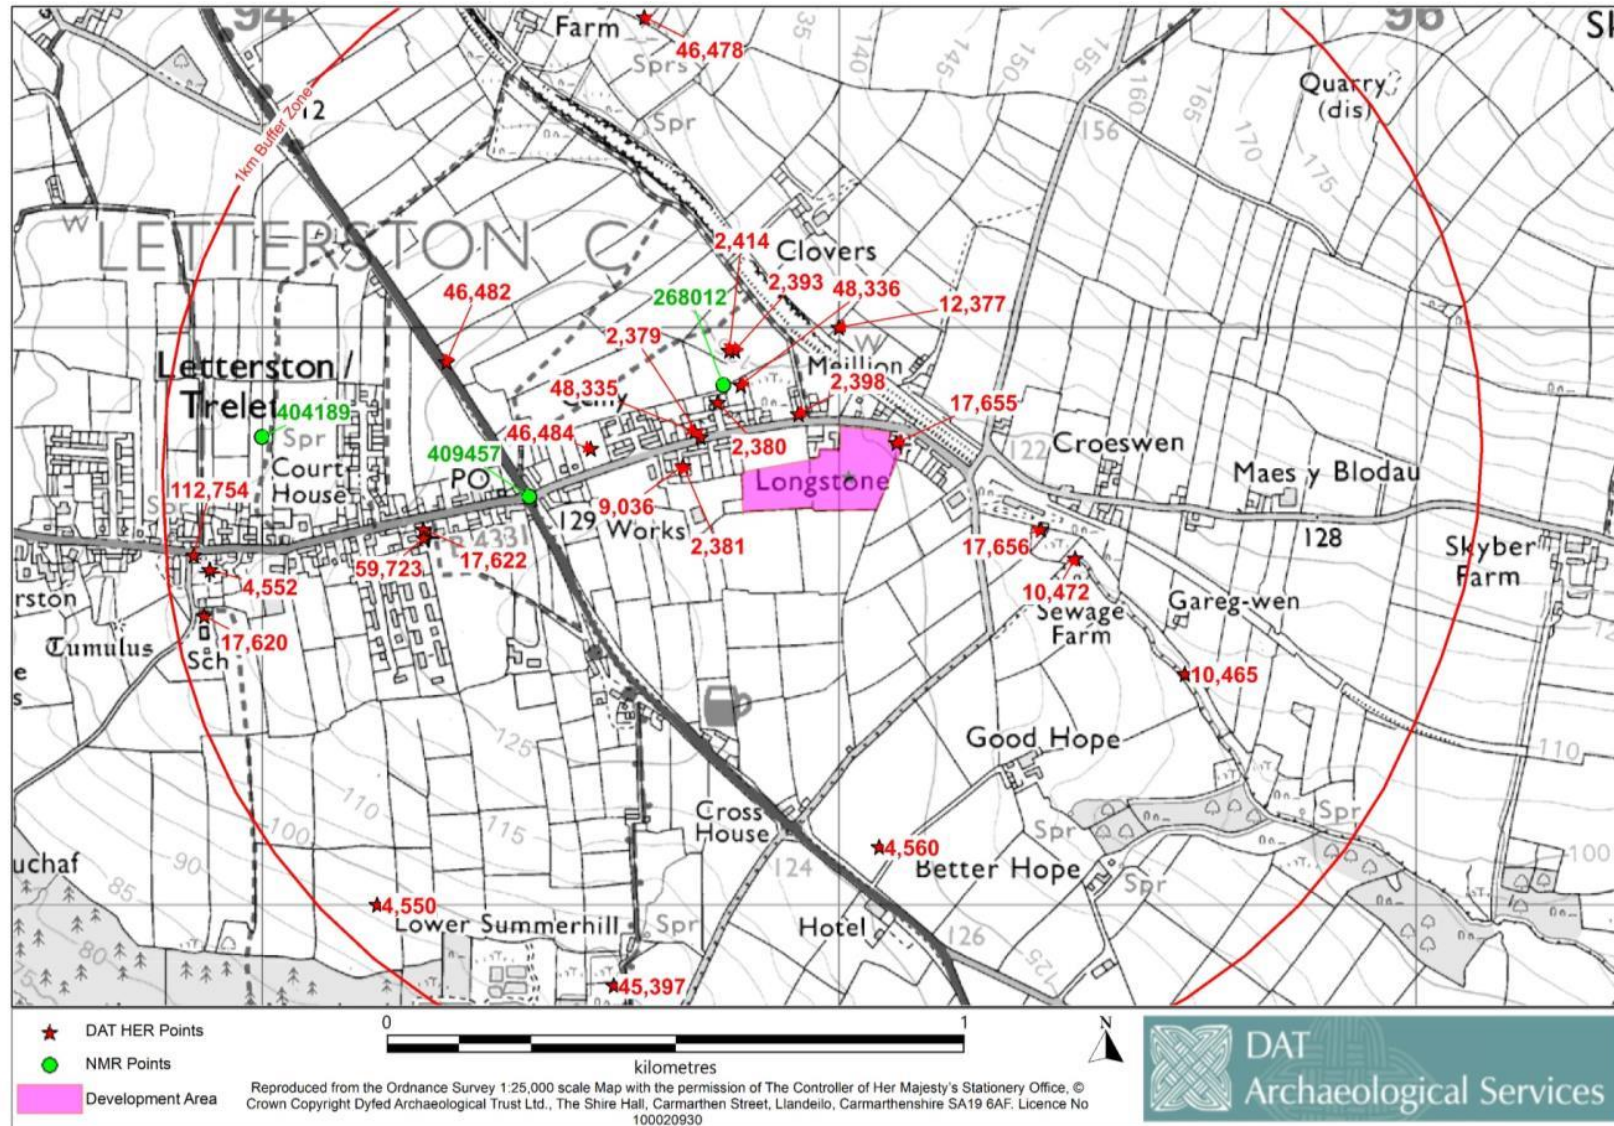
Figure 5: HER and NMR entries within 1km of the development area.

6 NON-DESIGNATED HERITAGE ASSETS (Table 3 and Figure 5)

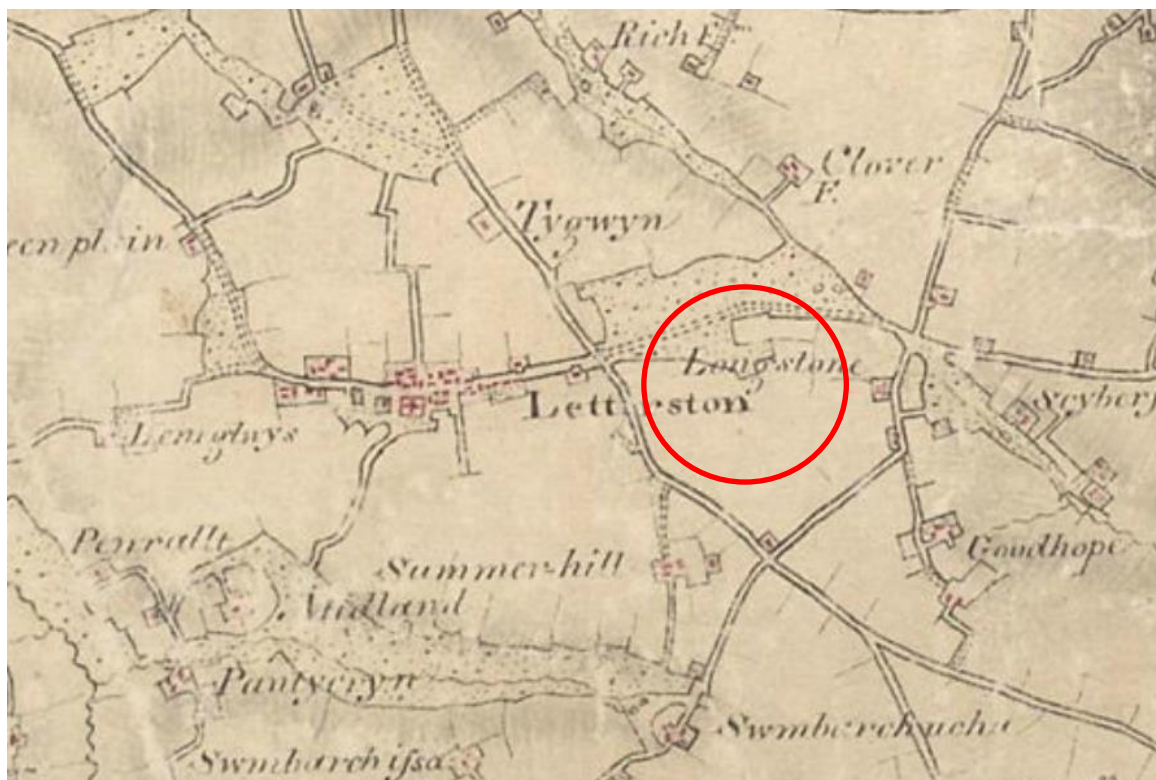
Figure 7: Extract of the 1811 original survey drawing (Fishguard) of Letterston, with the approximate position of development area circled in red.

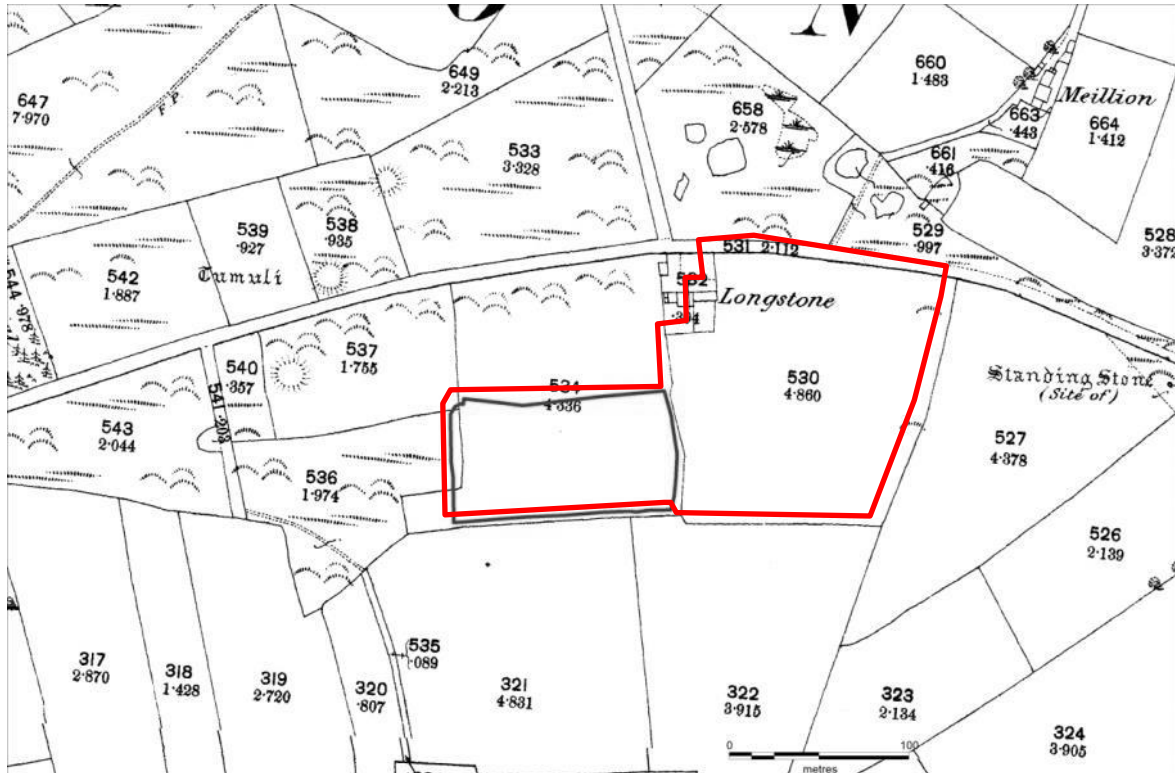
Figure 9: Extract of the 1889 Ordnance Survey 6 inch to 1 mile map, with the proposed development site outlined in red.

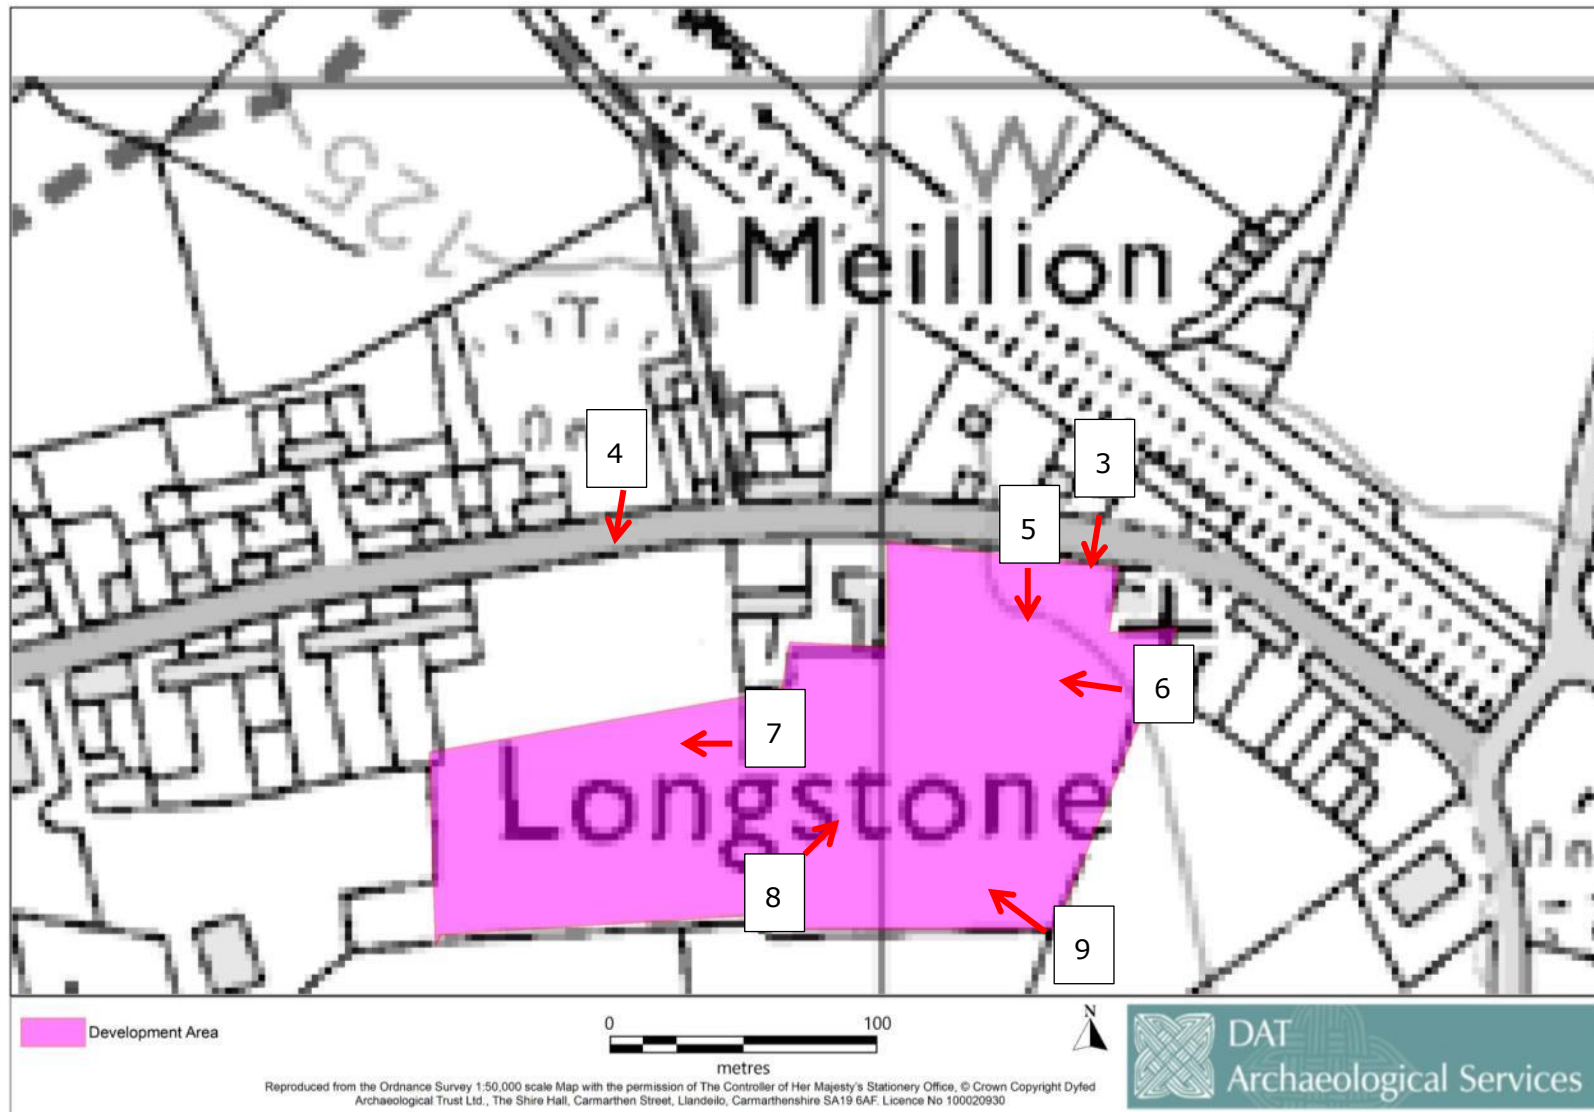
Figure 11: Locations of Photographs 3-8 taken during site walkover.

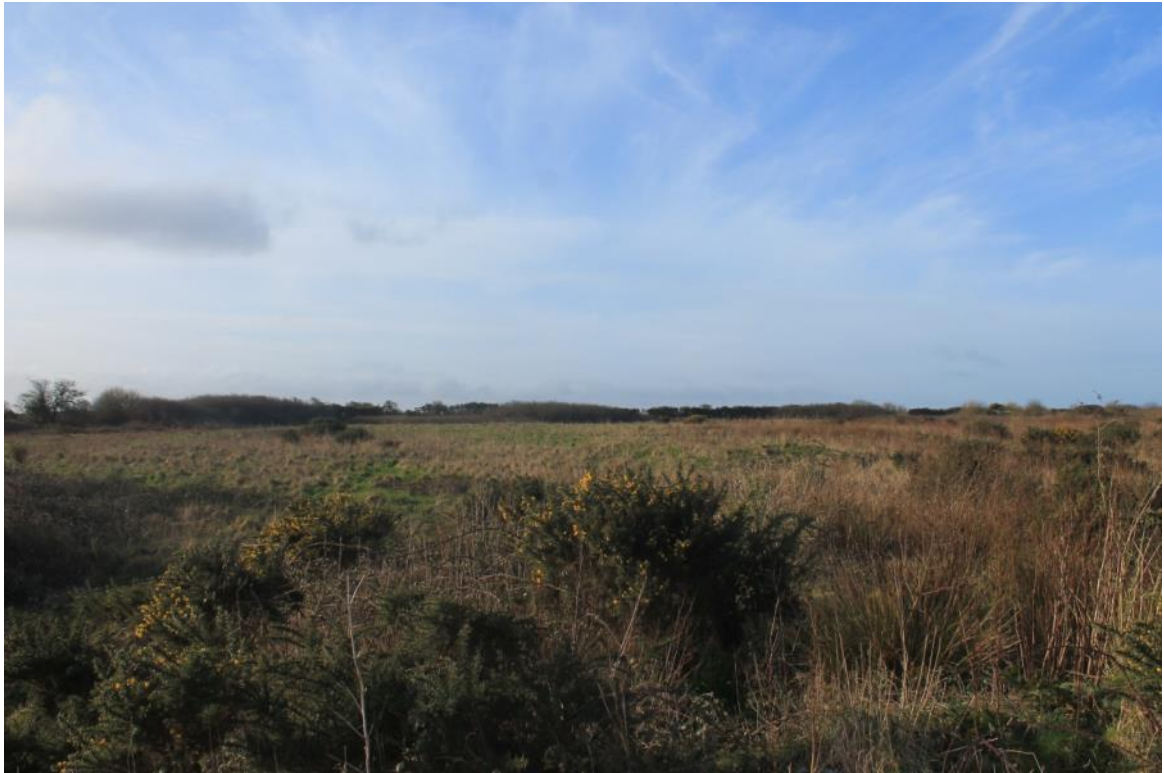
Photo 5: Eastern end of the development area showing ground gently sloping to south. Looking south
